## The Case for Demolition of Back/Sloped Roof Addition

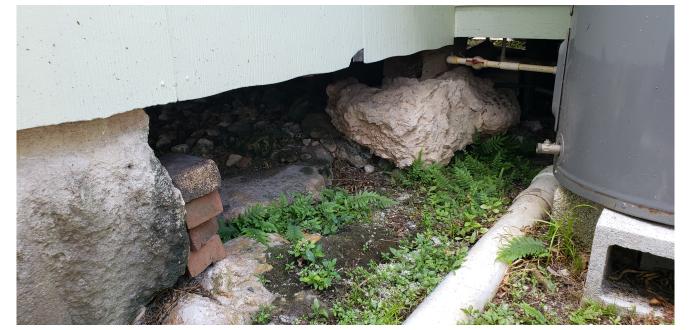
Support beams rotting on unstable piers, large boulder holding corner up.
