Tree Removal Report

PROPERTY: 308 Front St. ROW

APPLICATION NUMBER: T2026-0109

REQUEST: The applicant is requesting removal of (1) Cuban Mahogany.

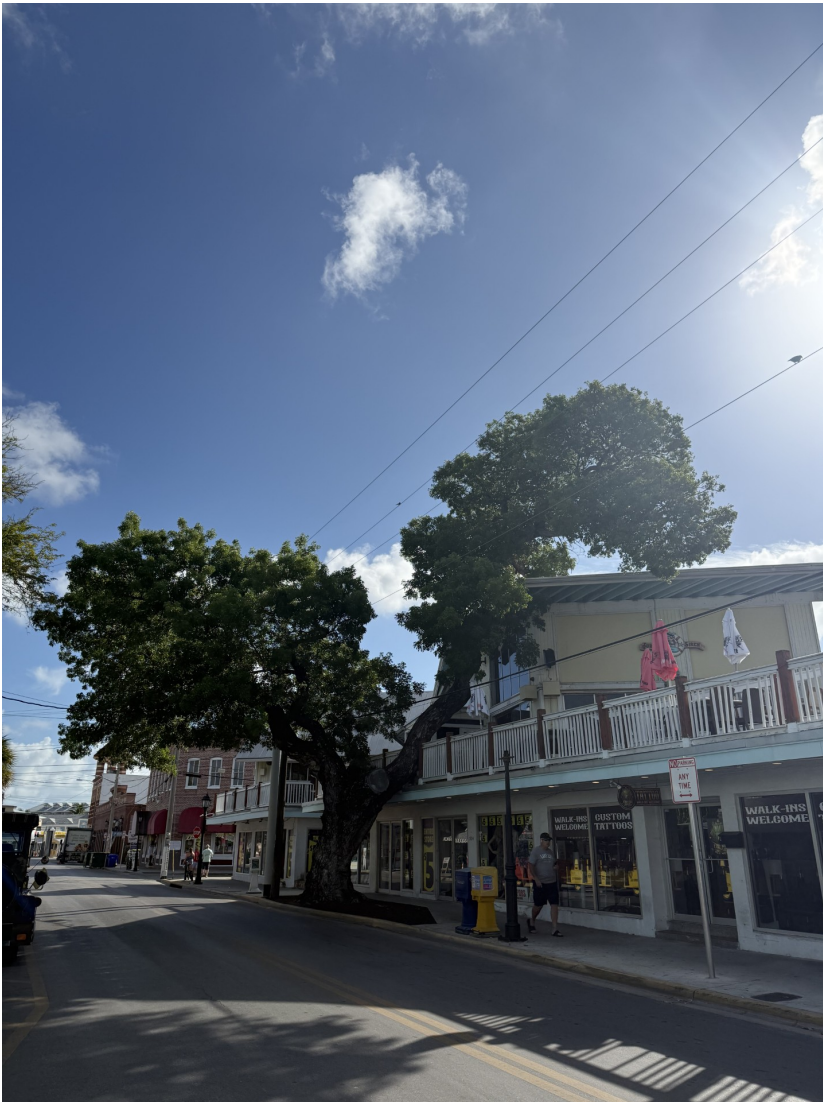
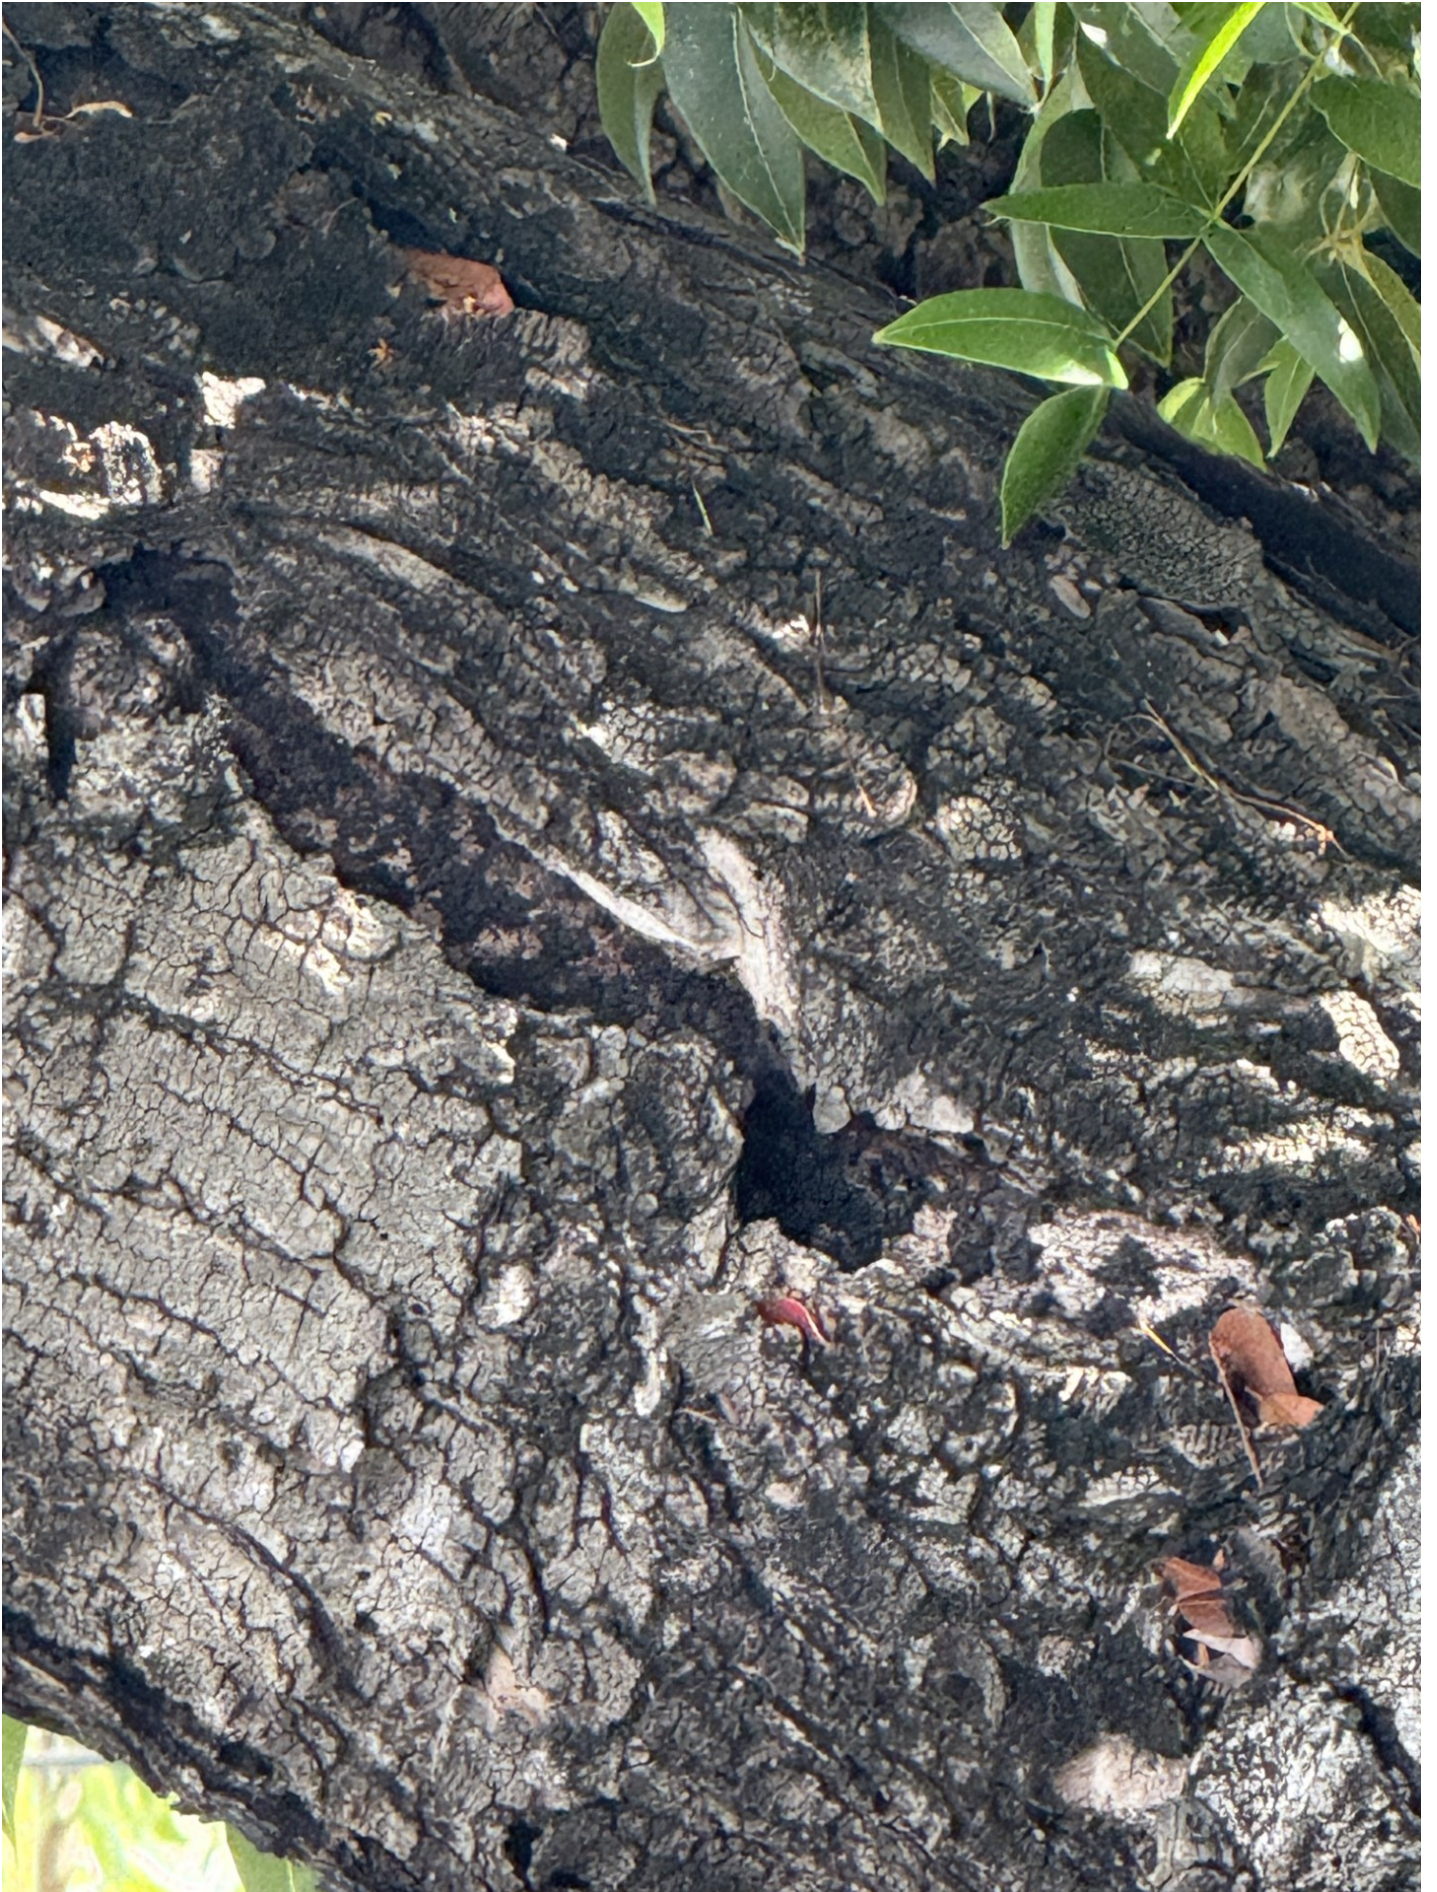
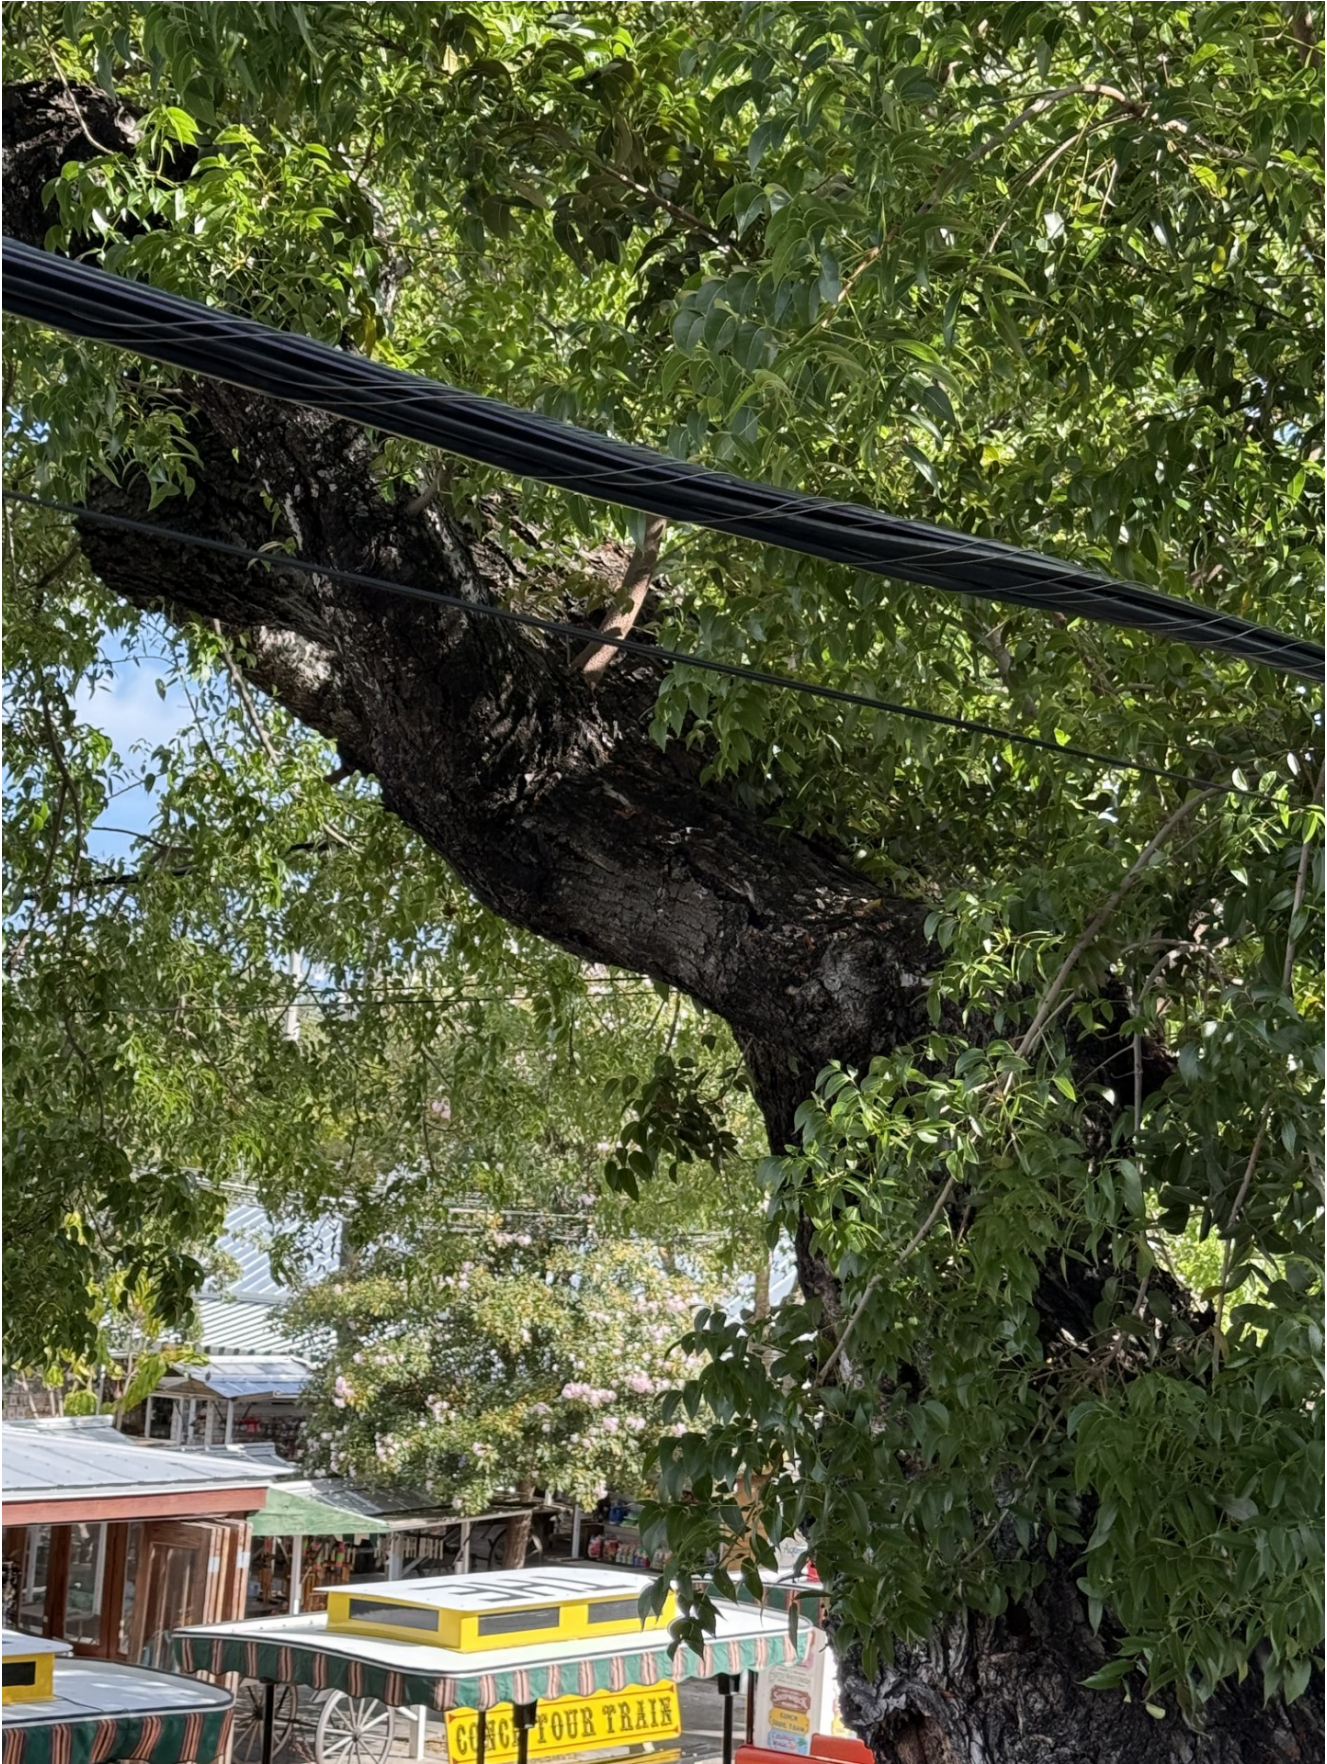
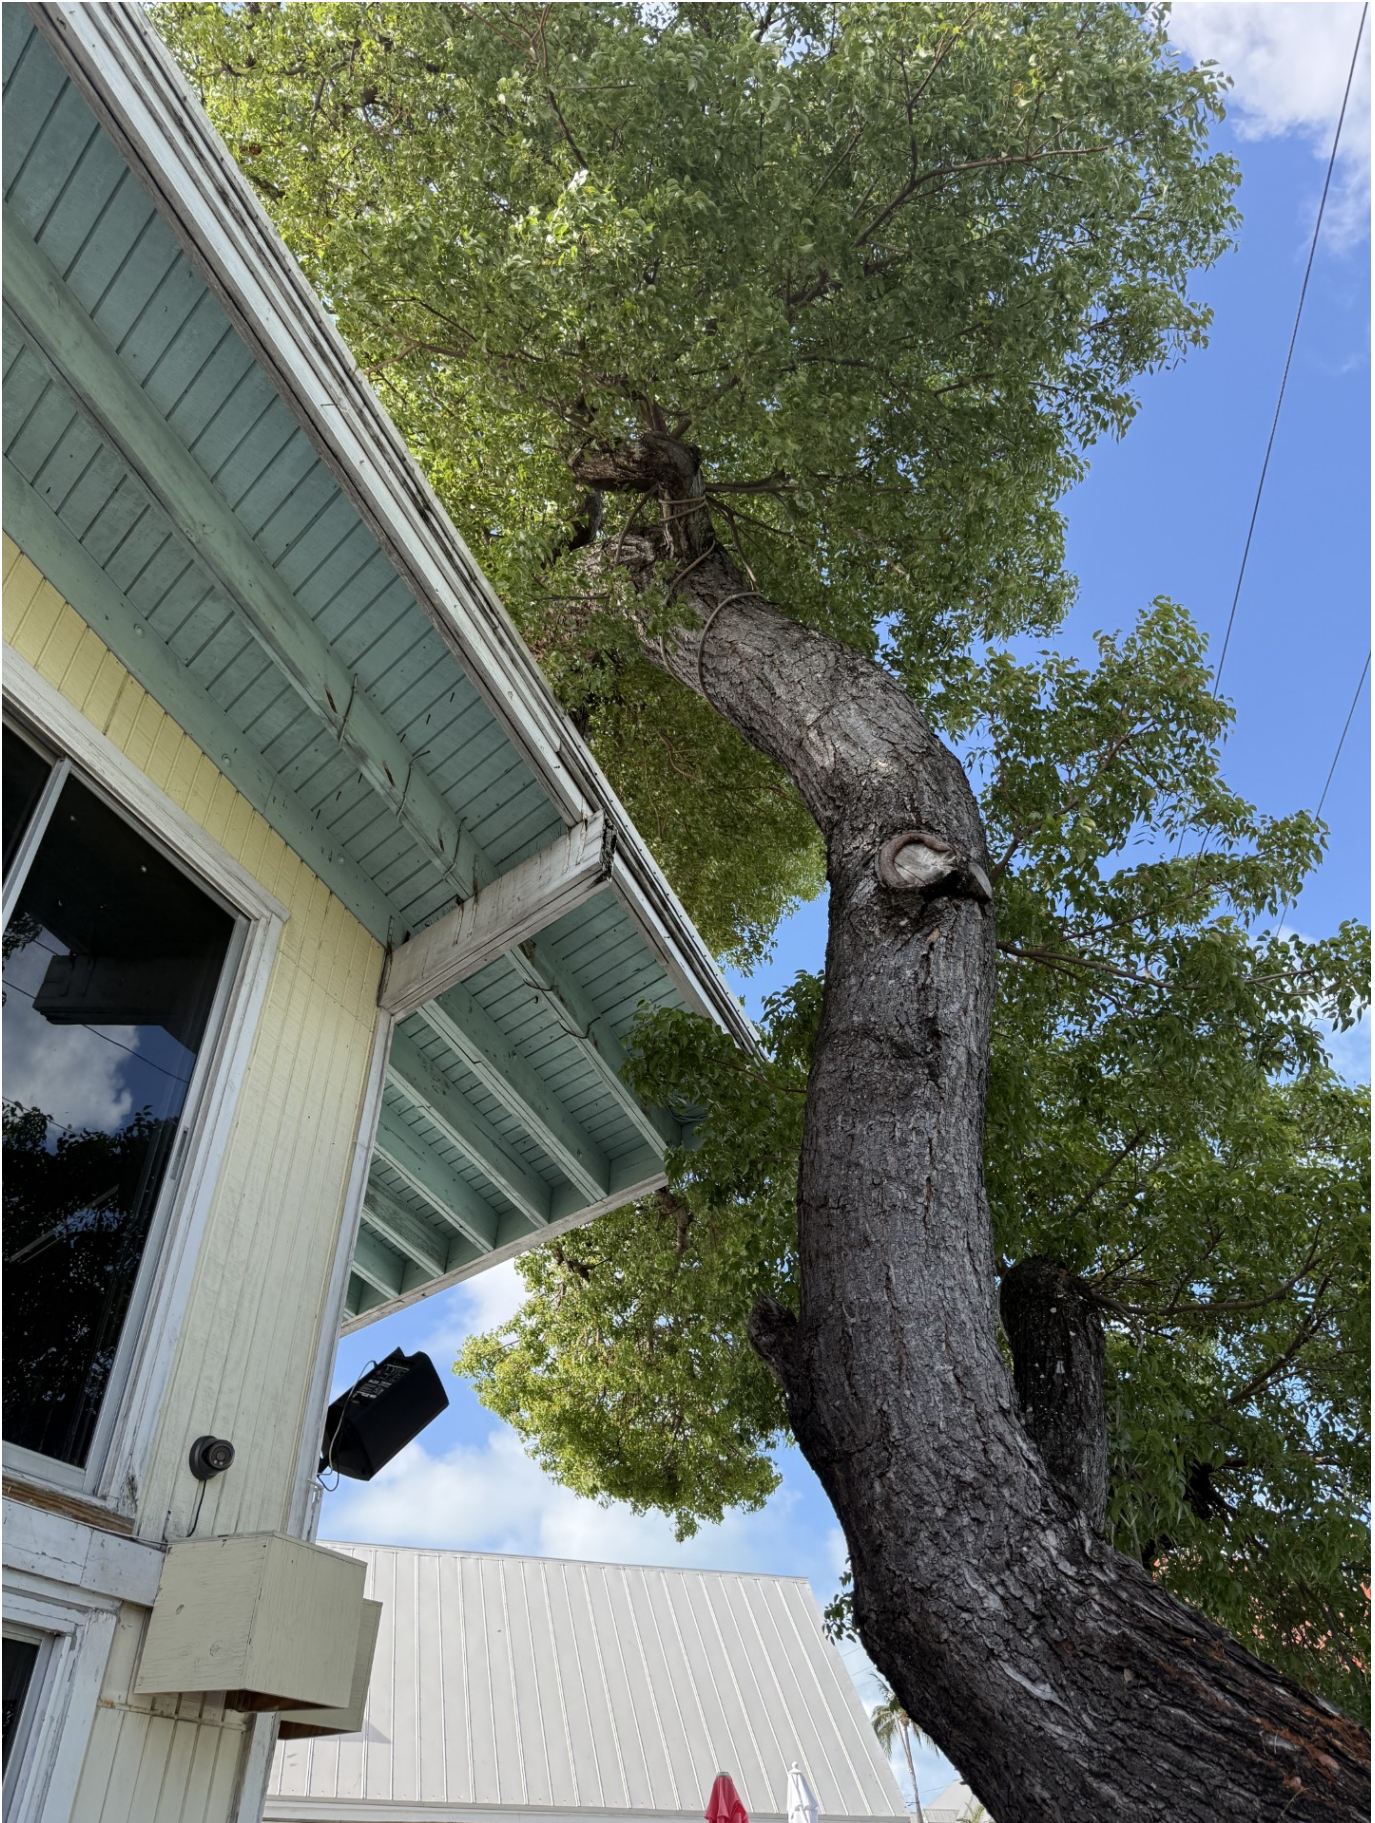
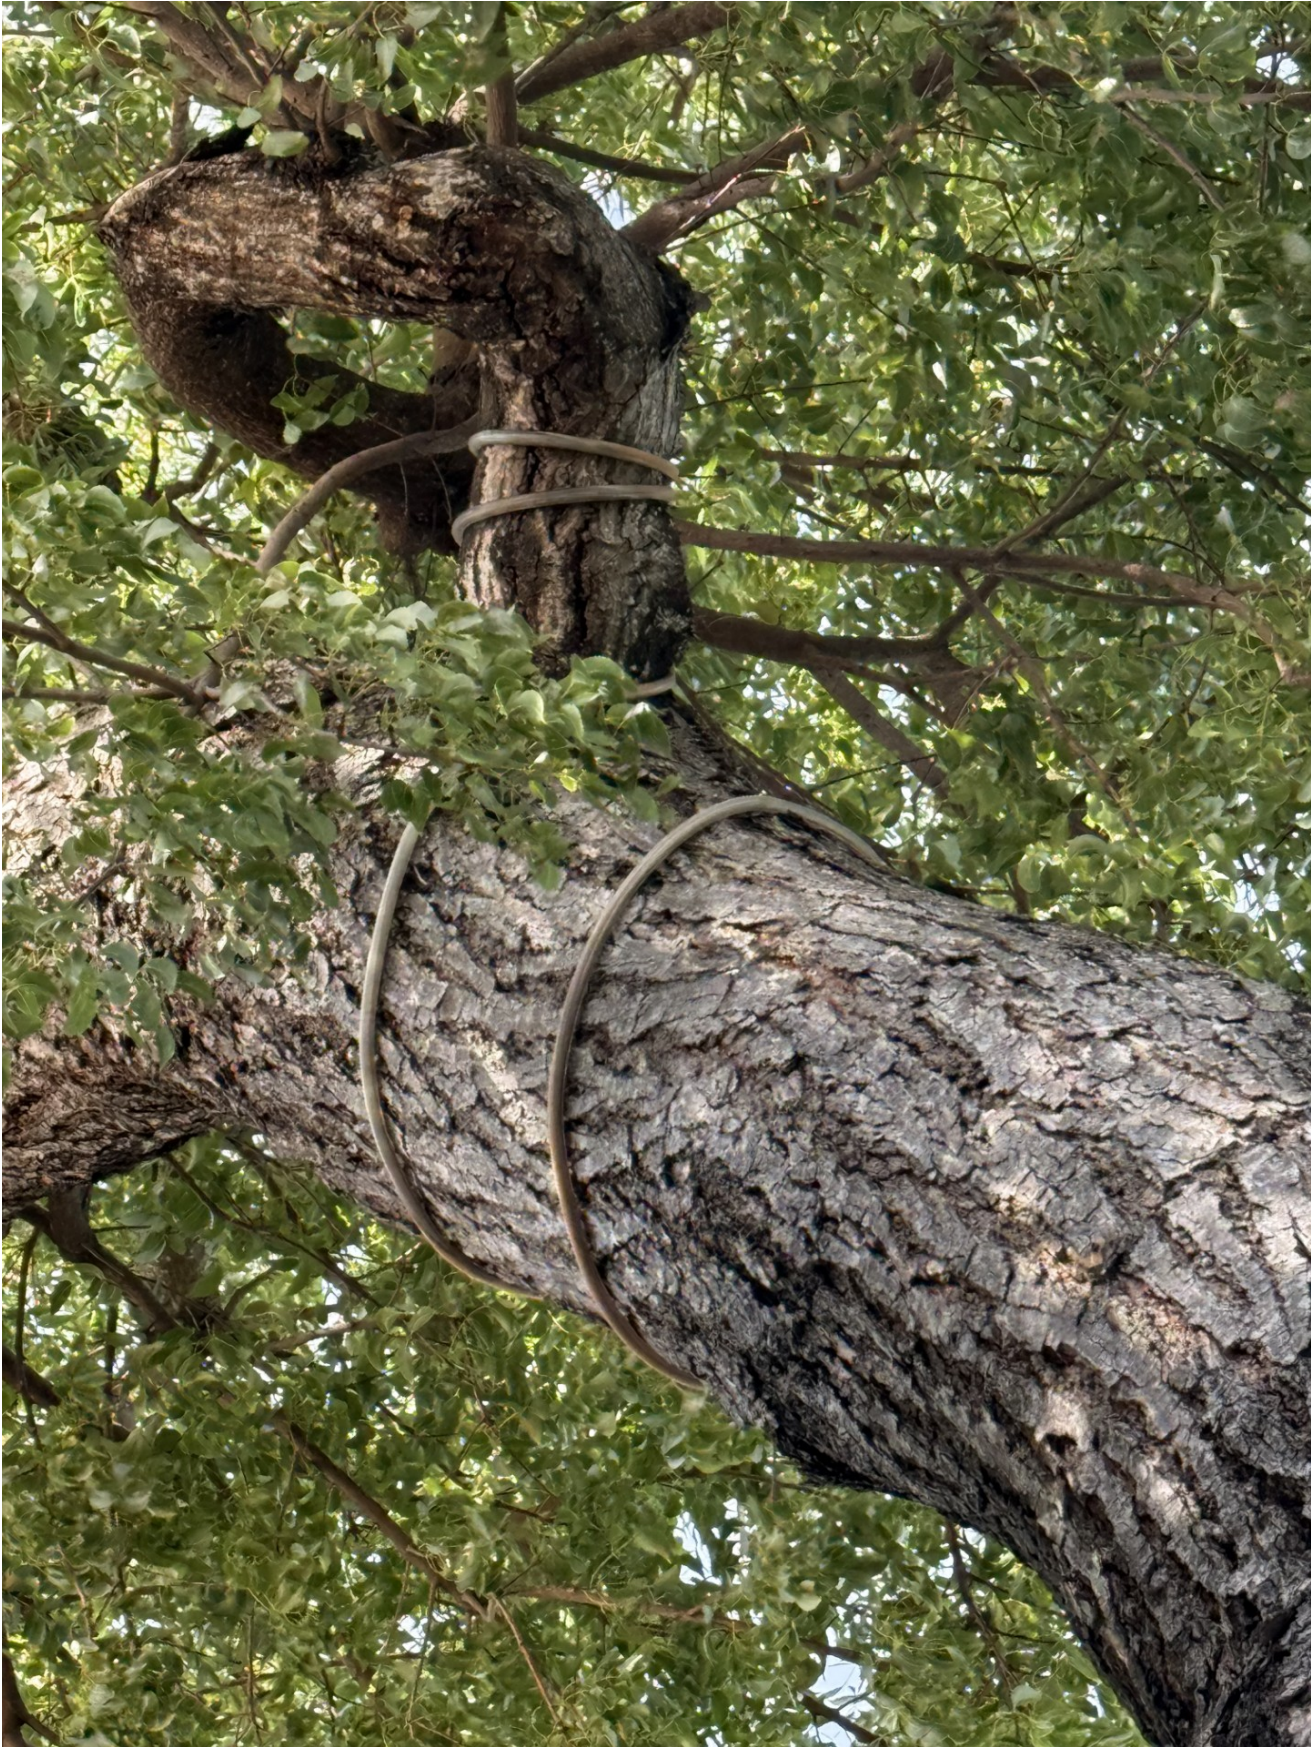
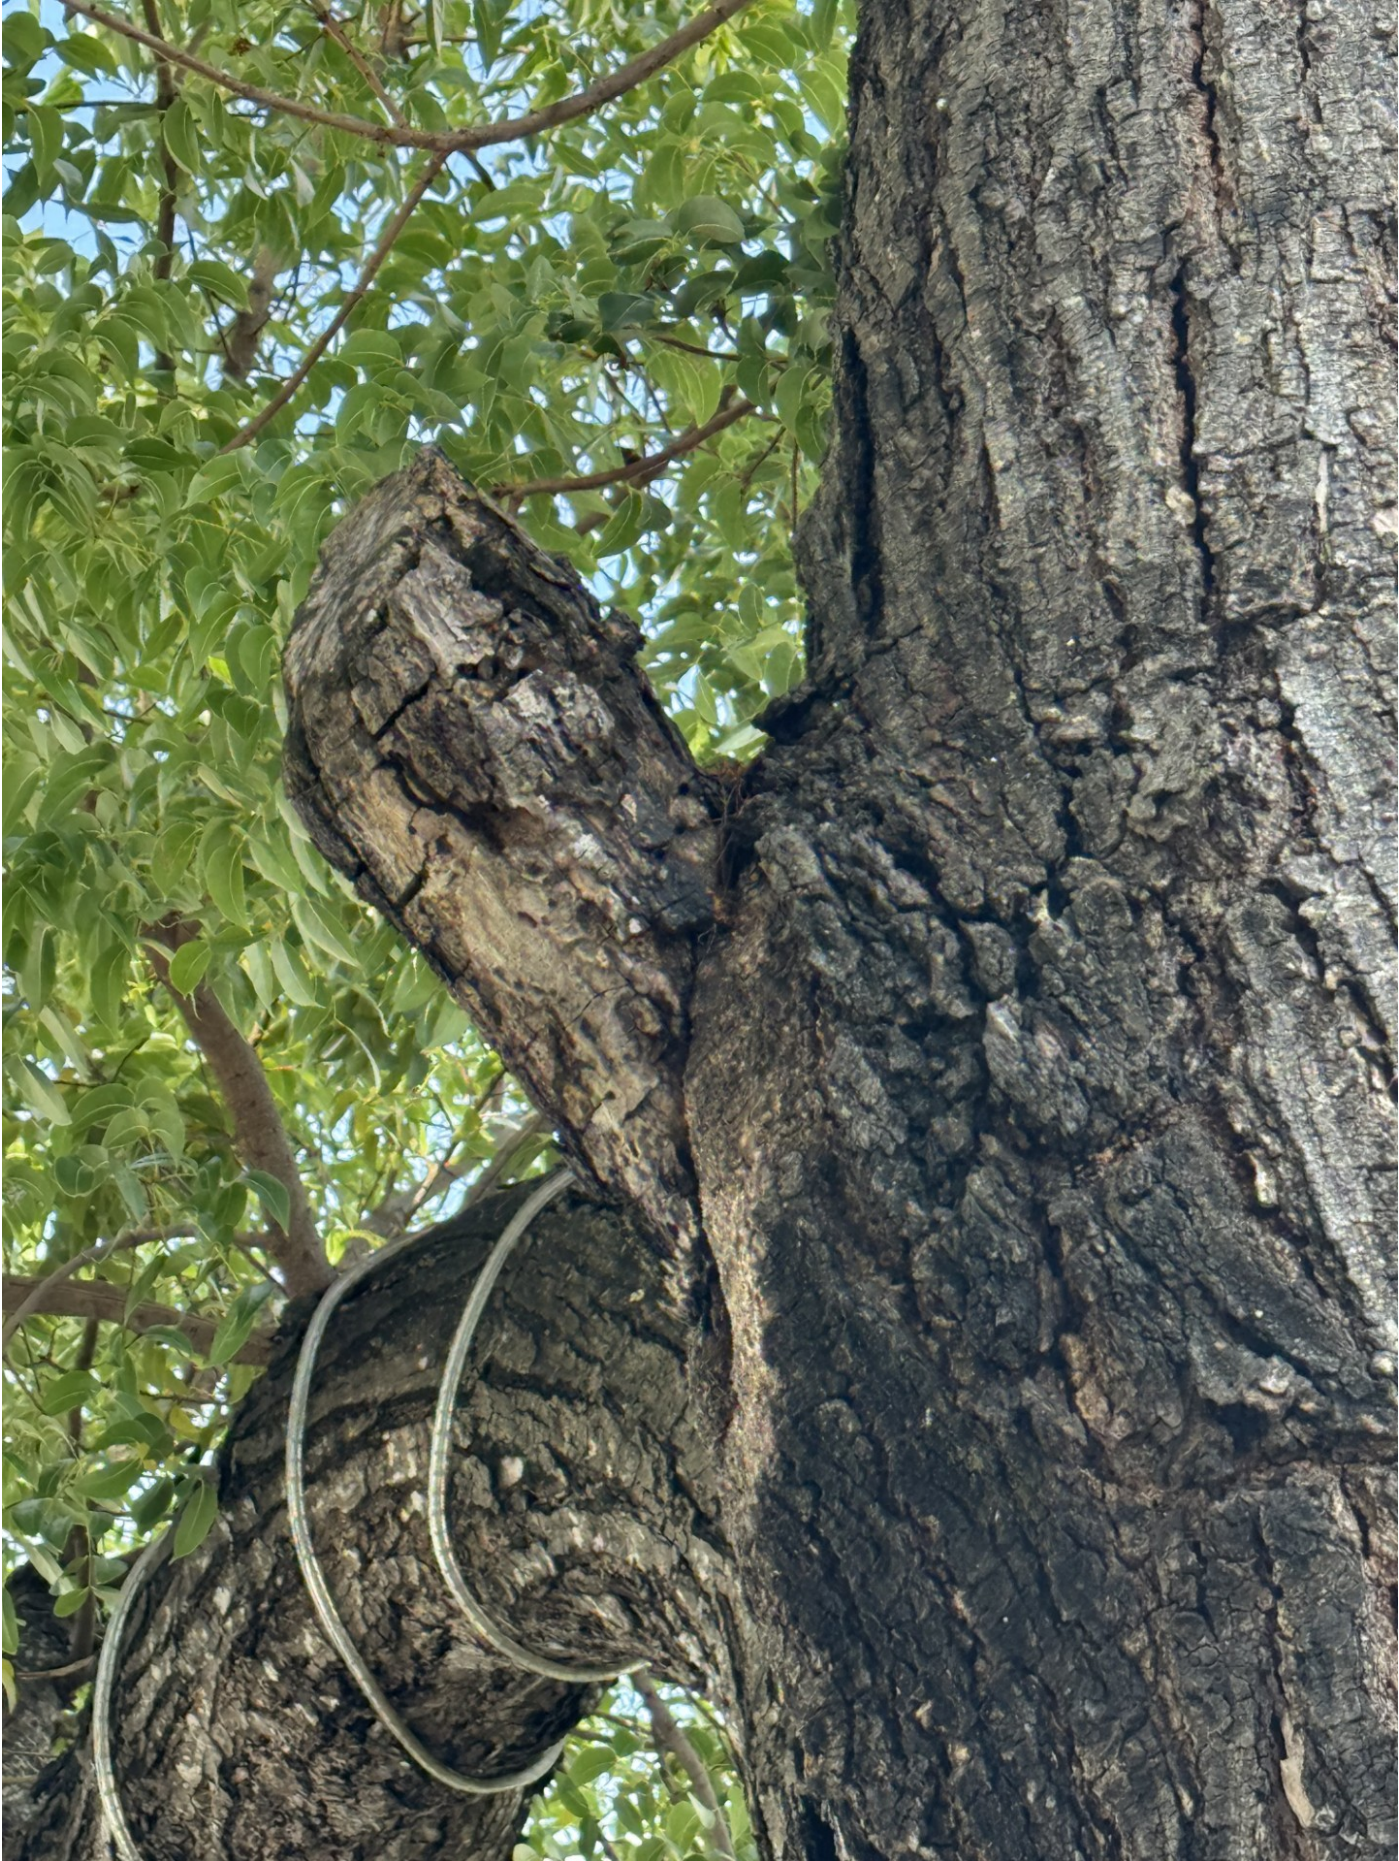
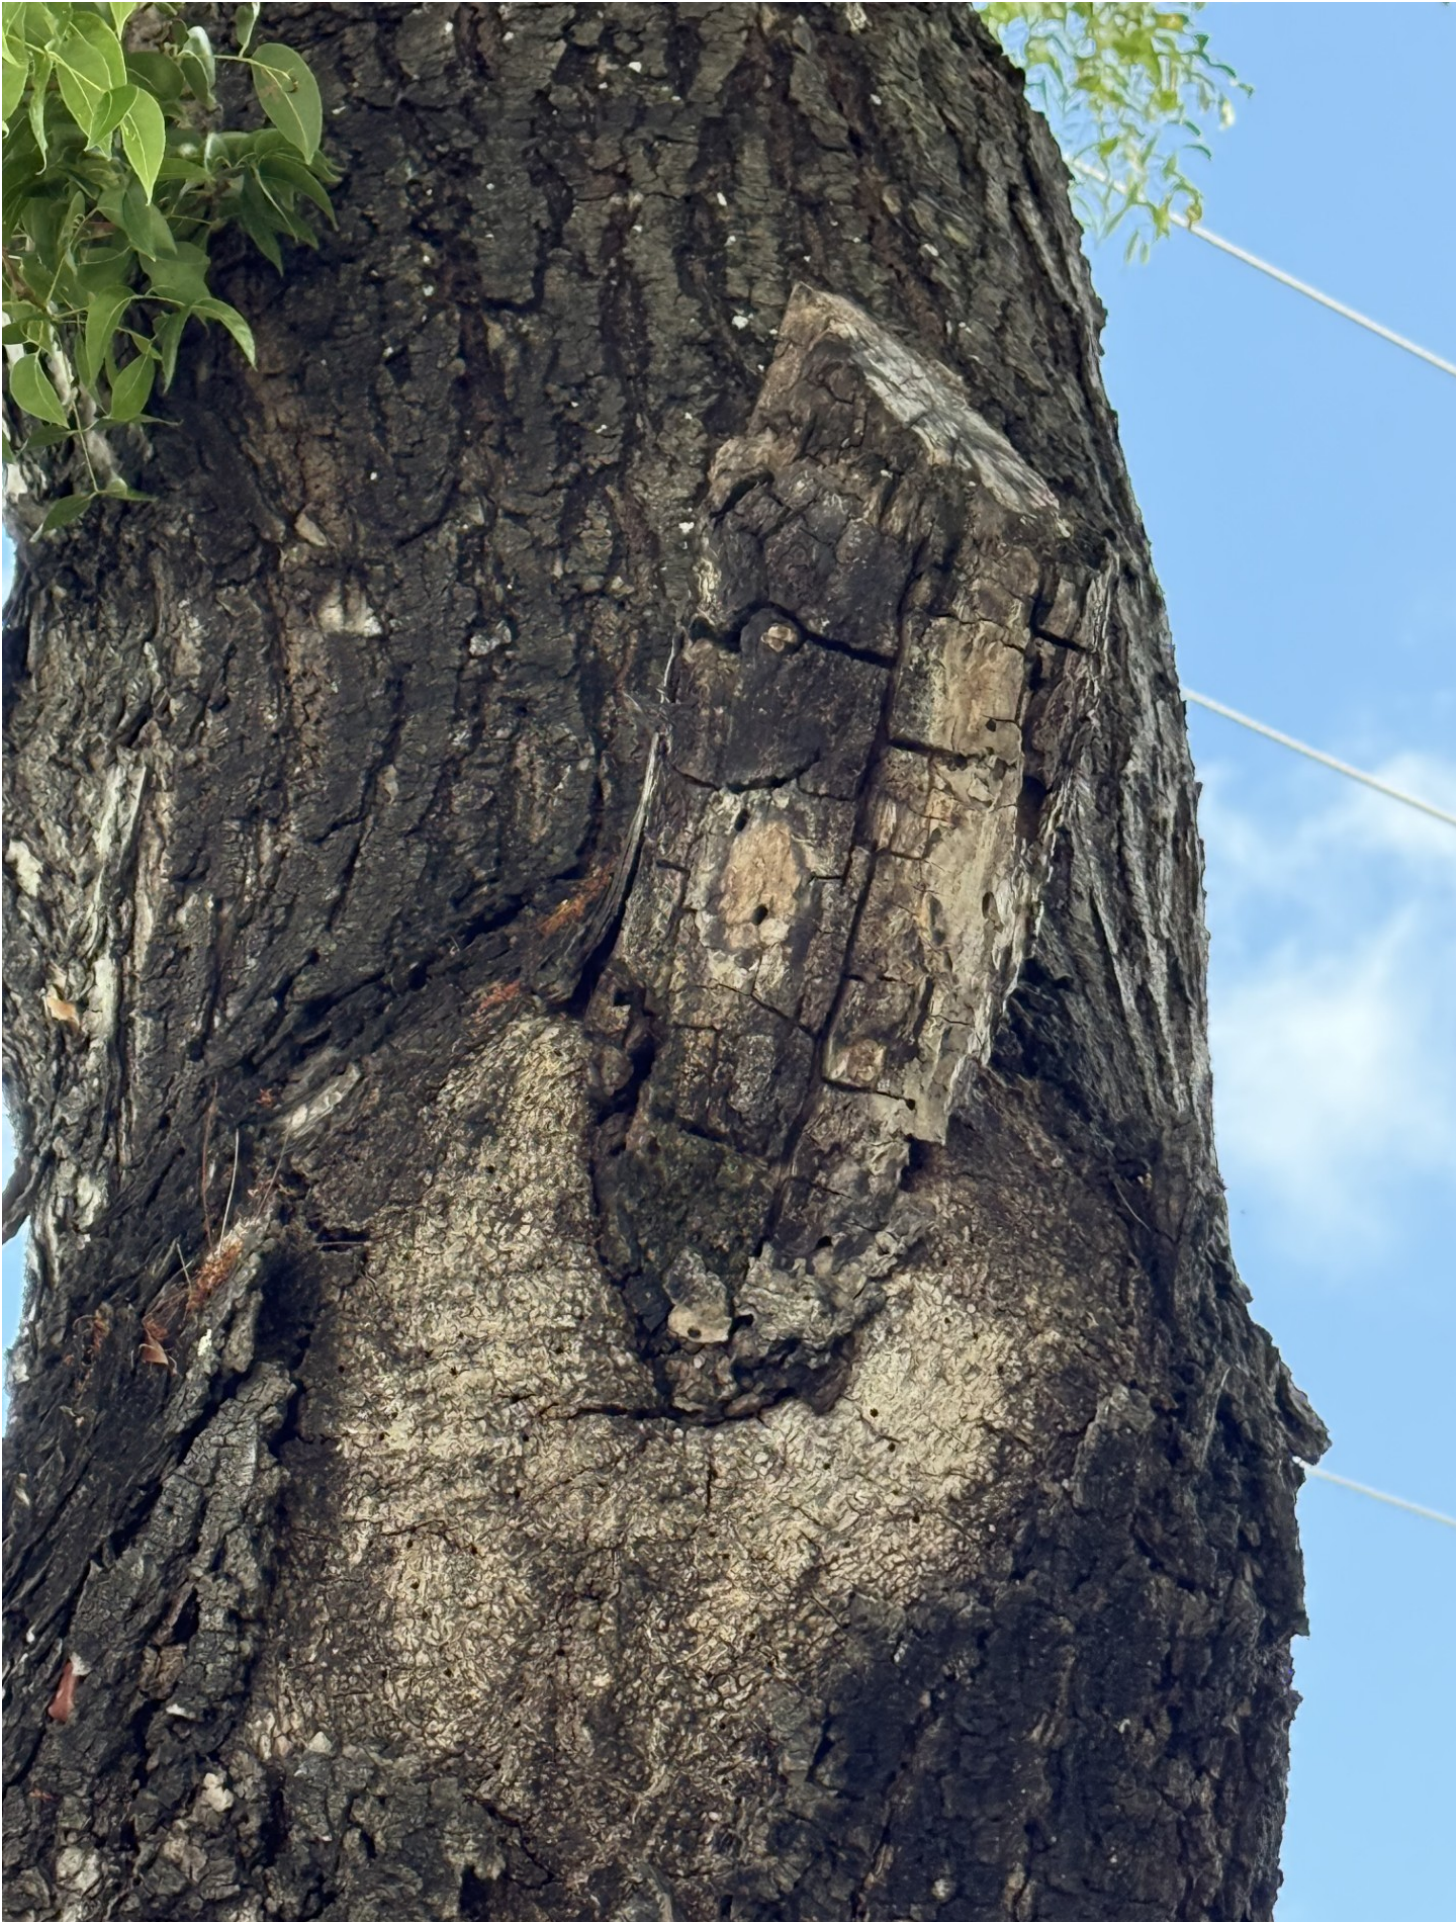
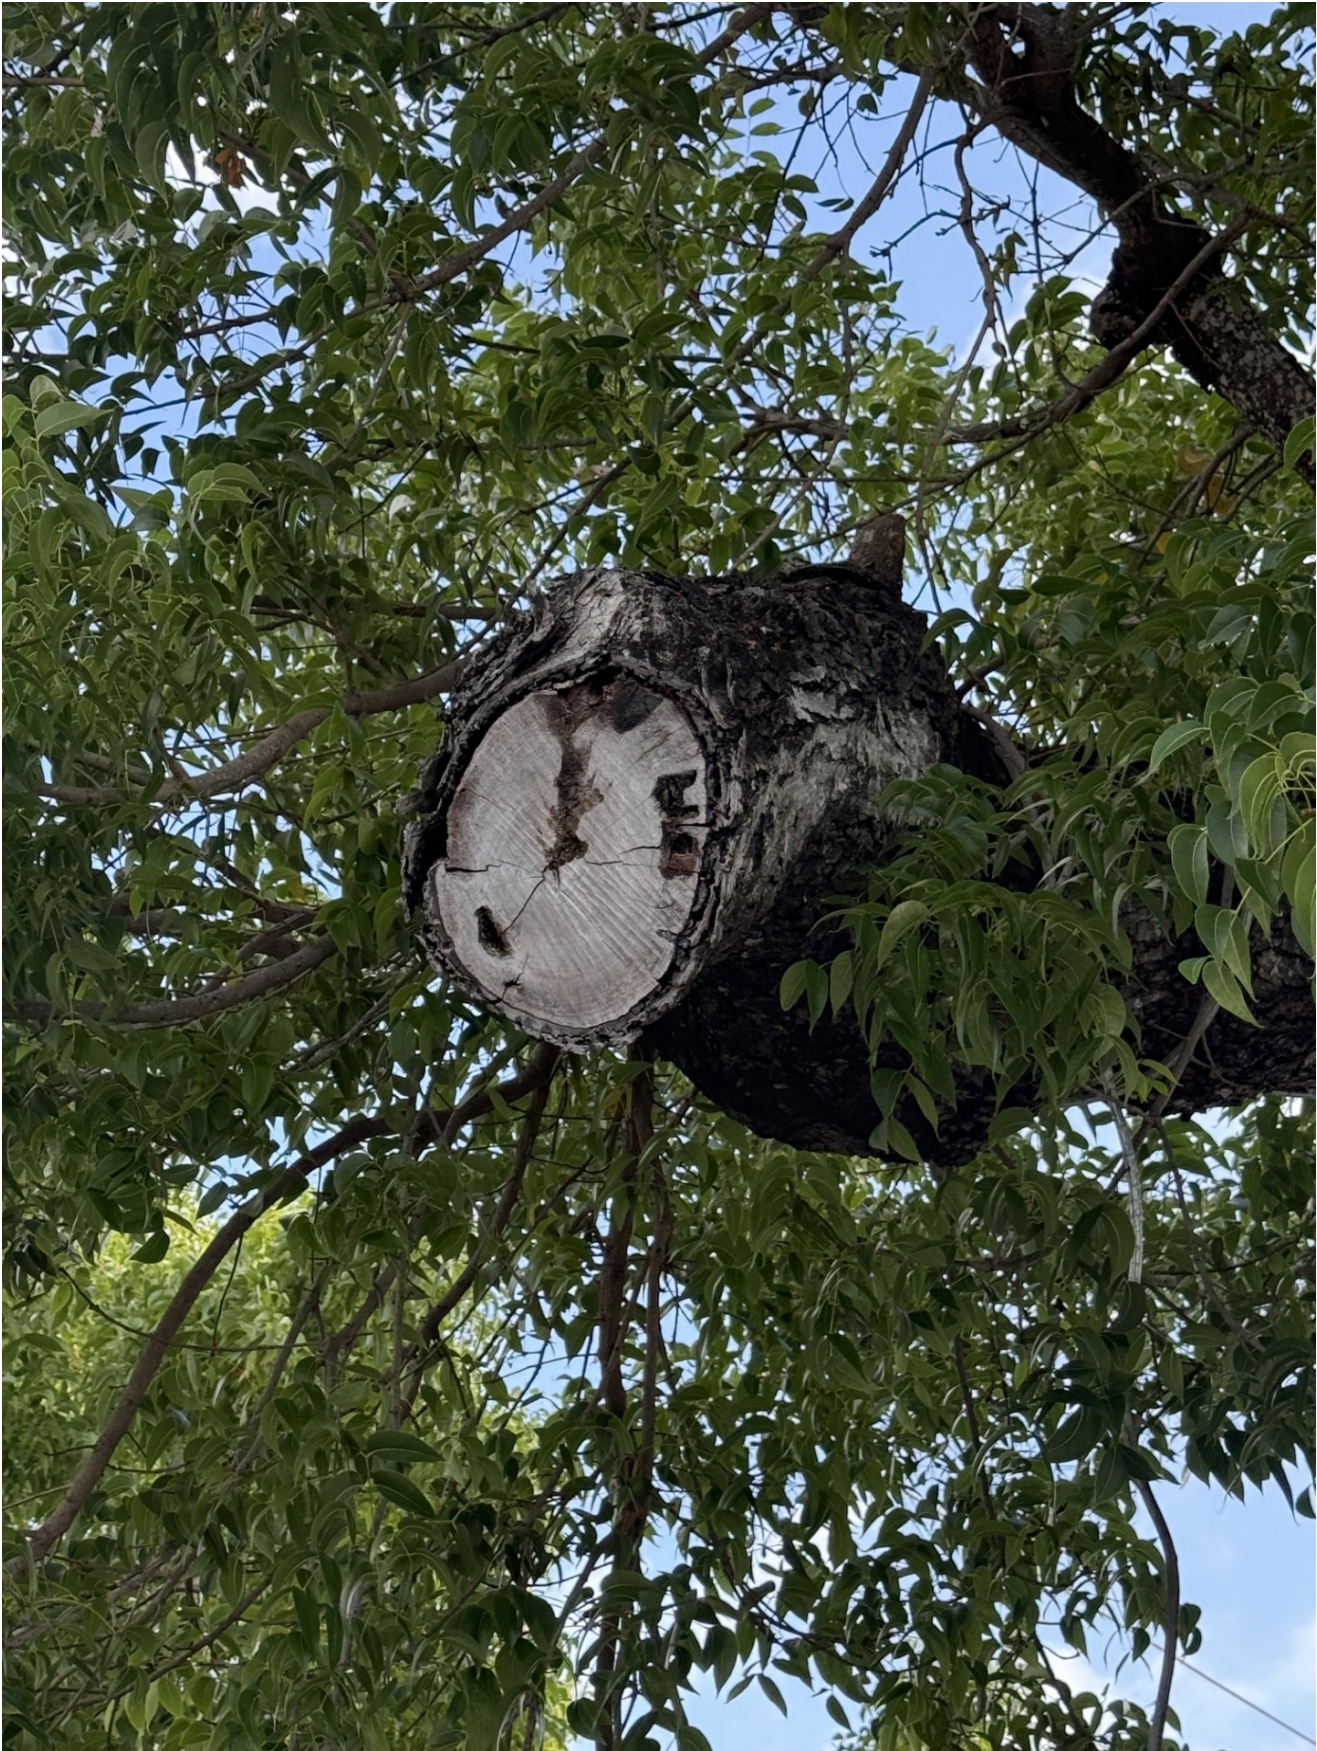
The subject tree is a mature Cuban Mahogany (*Swietenia mahagoni*) measuring approximately 50 inches DBH and is estimated to be several decades old. The tree is located within a constrained right-of-way planter surrounded by asphalt and concrete, conditions that have likely subjected the root system to prolonged soil compaction and restricted rooting volume. Despite these site limitations, the tree has developed a substantial trunk and canopy. The trunk is divided into two primary codominant leaders approximately eight feet above grade. One leader extends over an adjacent restaurant balcony and continues above the restaurant roof. While the balcony appears to have been constructed to accommodate the tree, direct contact currently exists between the leader and portions of the roof structure below the balcony railing.

The second leader extends over the adjacent street and exhibits a large area of exposed wood associated with a significant trunk wound estimated at approximately eight square feet in size. The location and characteristics of the wound are consistent with repeated mechanical impacts, likely from commercial delivery vehicles operating beneath the canopy. Additional defects were observed throughout the tree, including a pronounced longitudinal crack within the leader extending over the restaurant, visible from the balcony at eye level. Several large historic pruning wounds are present, including one substantial branch removal site exhibiting evidence consistent with wood decay and insect activity. Additional areas of missing bark, exposed wood, and suspected decay pockets were observed throughout the trunk and scaffold structure.

Although the canopy remains relatively balanced due to the similar size of the two primary leaders, the tree exhibits numerous structural and biological defects that warrant concern. The combination of codominant stem architecture, extensive wounding, visible cracking, suspected decay, repeated mechanical damage, and the advanced age and size of the tree increases the likelihood of partial or whole-tree failure. Equally significant is the presence of high-value targets beneath and adjacent to the tree, including a heavily utilized public street, pedestrian traffic, restaurant patrons, and nearby structures. Based on the observed defects and target occupancy, this tree should be considered a significant risk concern and warrants further evaluation, risk mitigation measures, or removal consideration by the Tree Commission.
