# Engineer Report

**Cable Storage Structure  
Mallory Square  
Key West, Florida 33040**

August 3, 2010

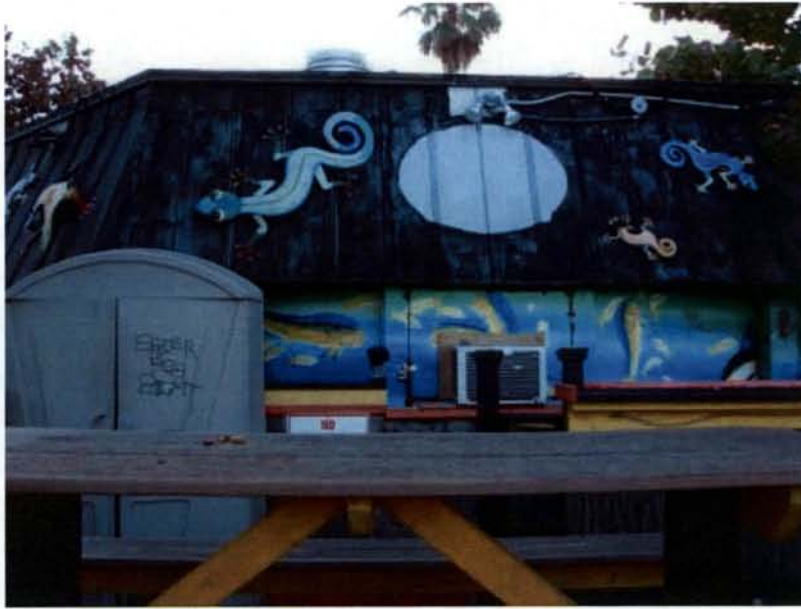
Picture #1

**BUILDING EXTERIOR**

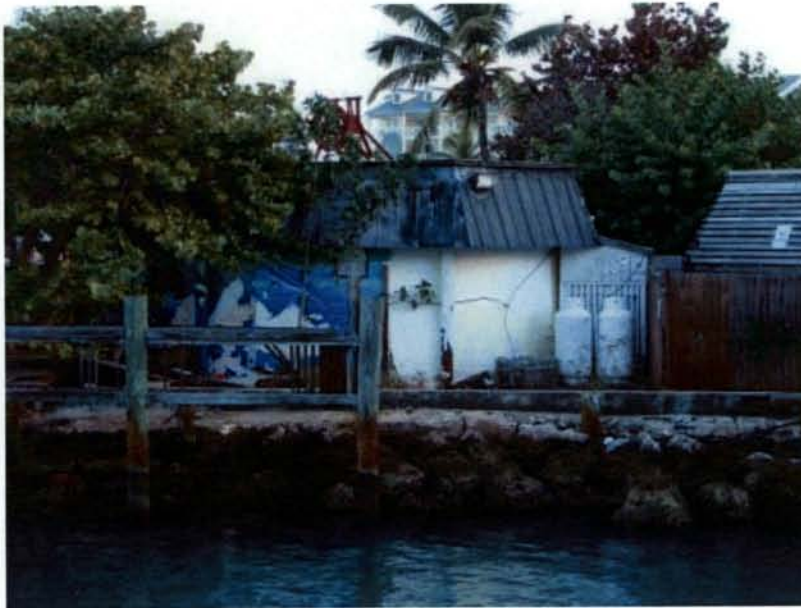
Picture #3

BUILDING EXTERIOR

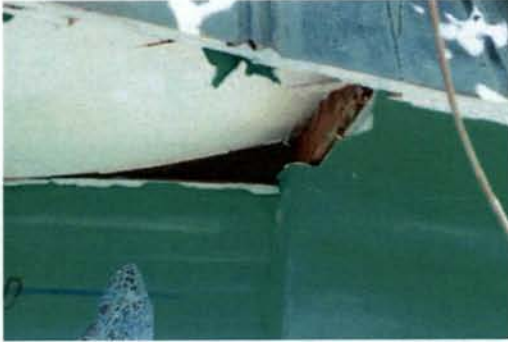
Picture #5

ROTTED WOOD FRAMING
