## Tree Removal Report

**PROPERTY:** 1004 Thomas St.

**APPLICATION NUMBER:** T2026-0130

**REQUEST:** The applicant is requesting removal of (1) Spanish Lime Tree.

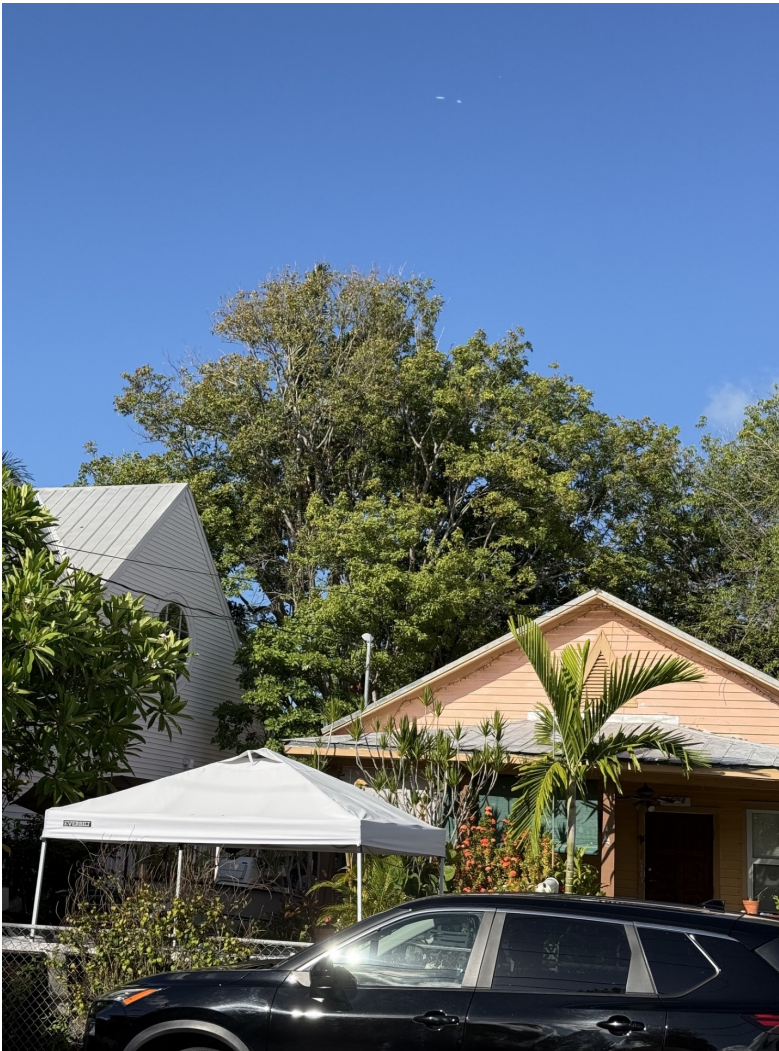
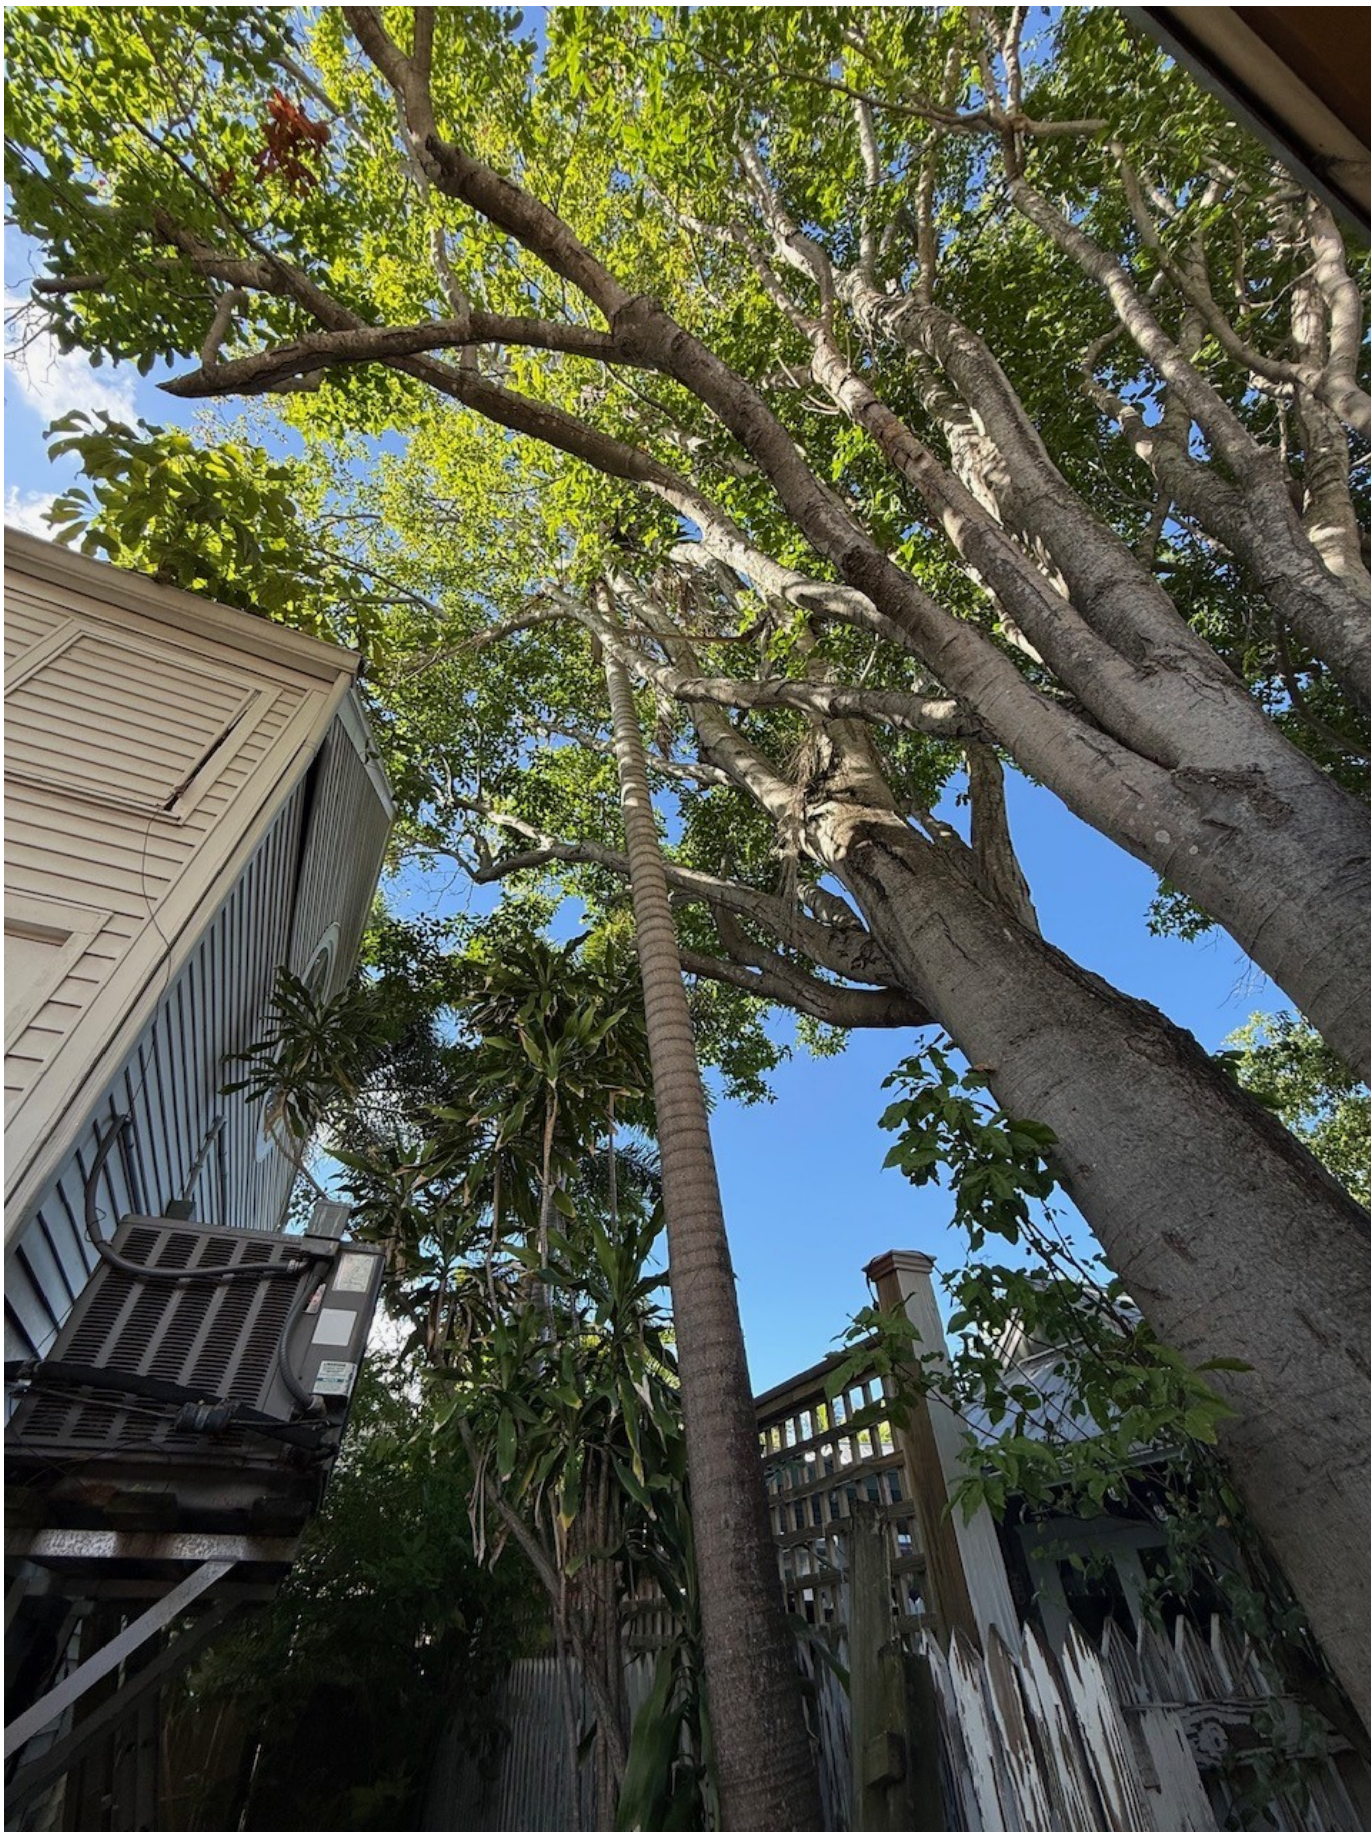
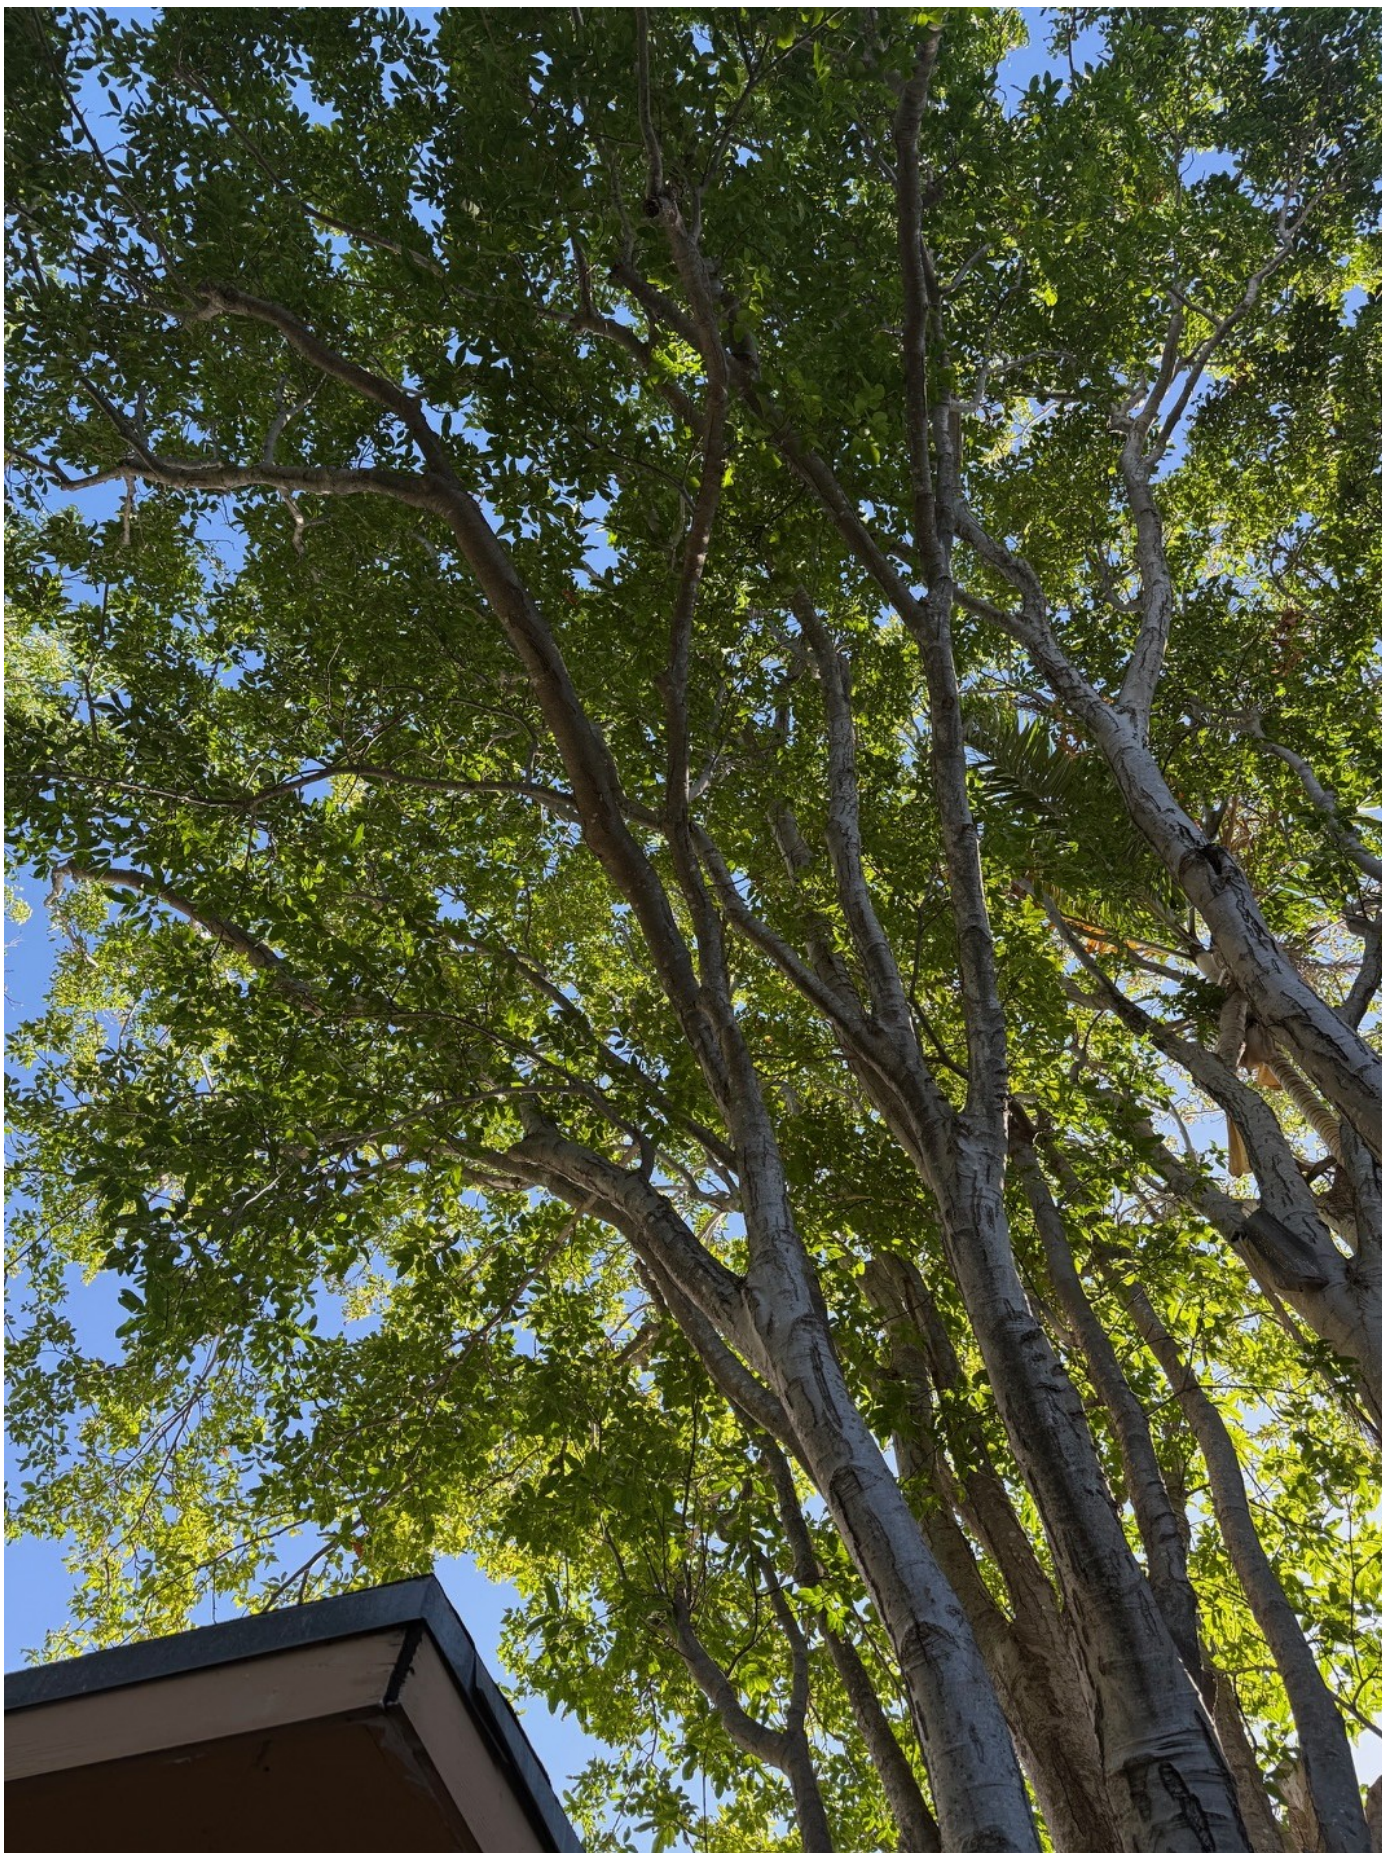
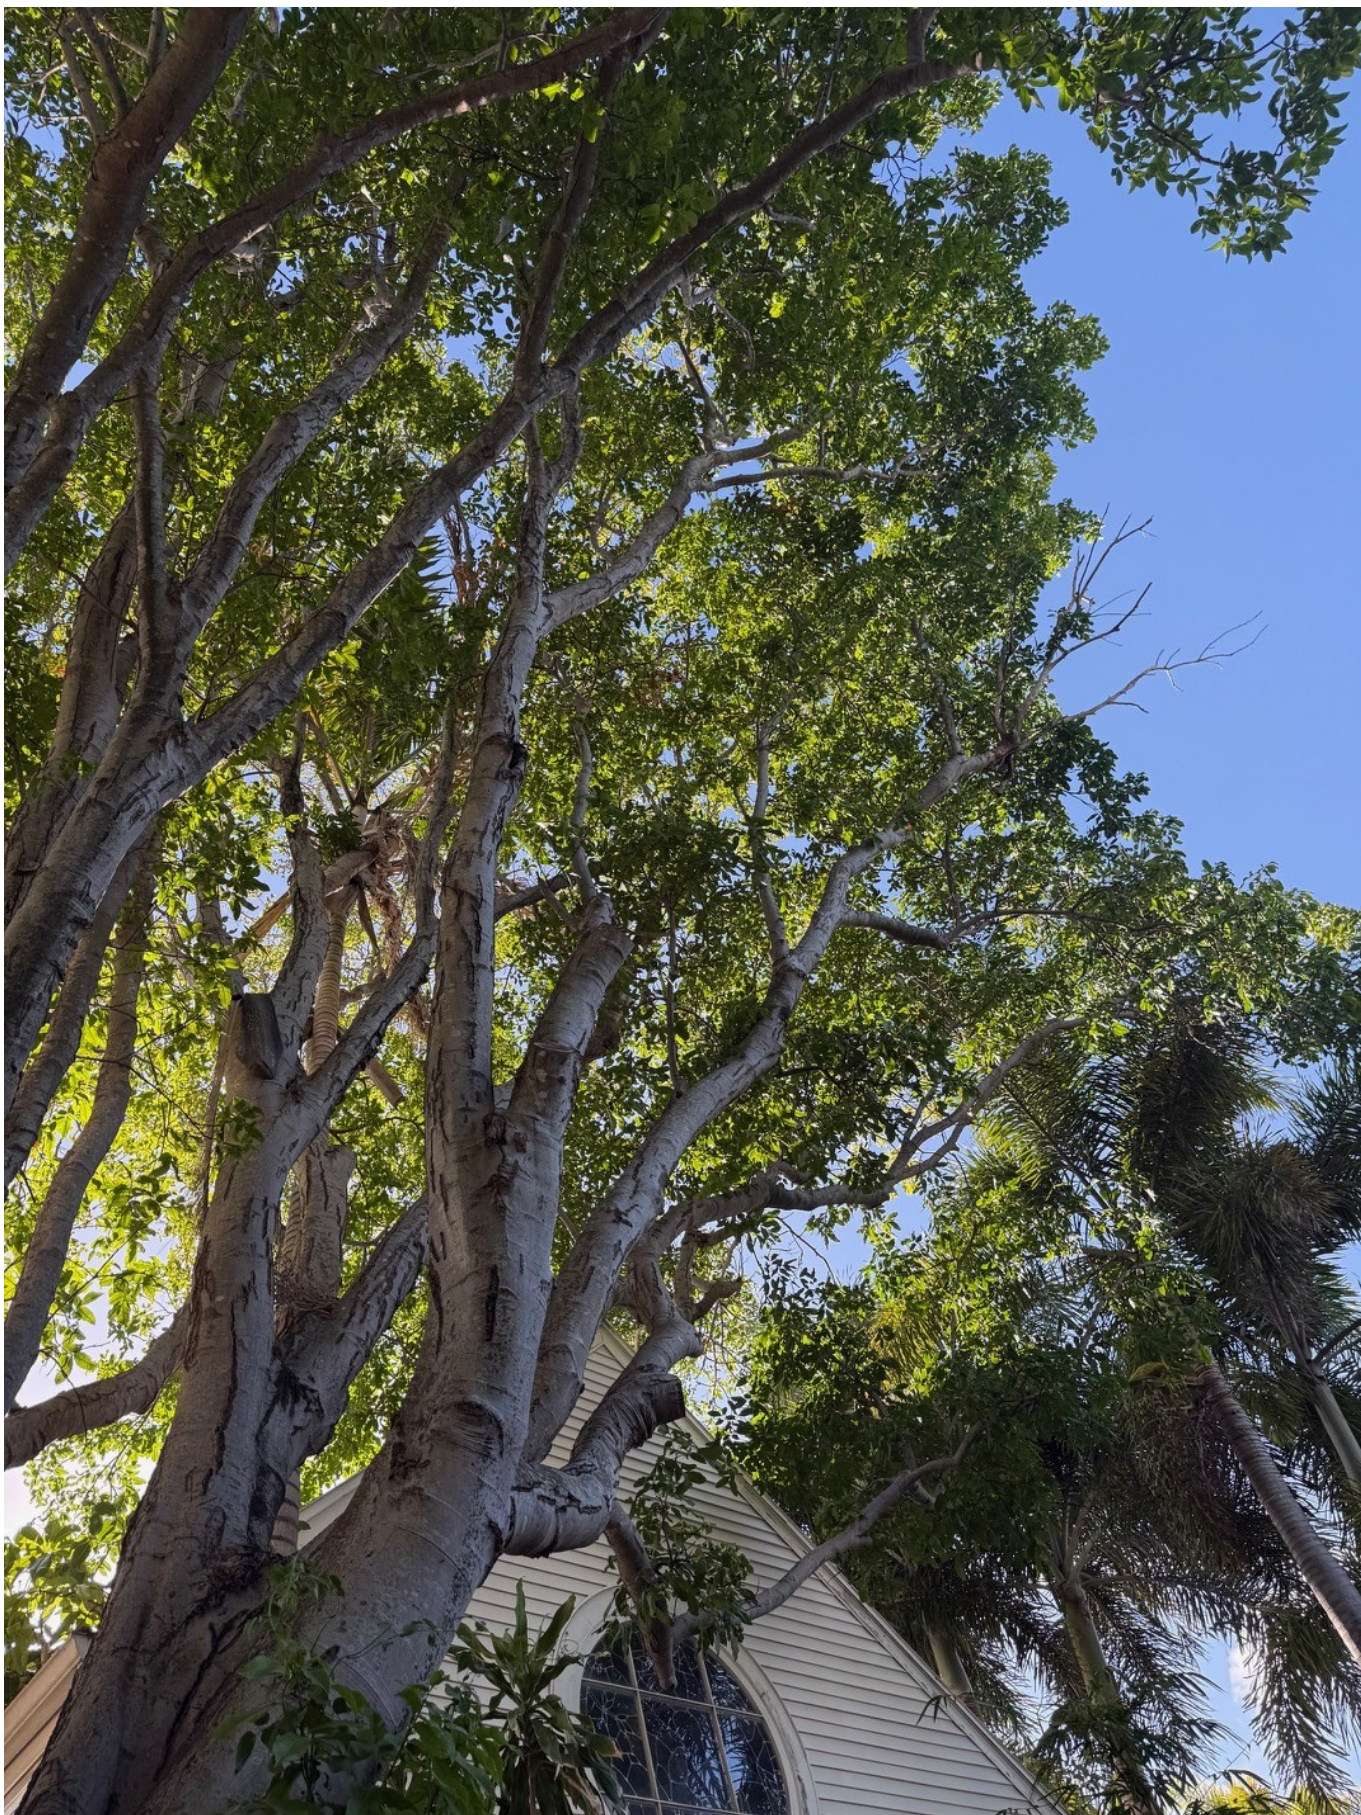
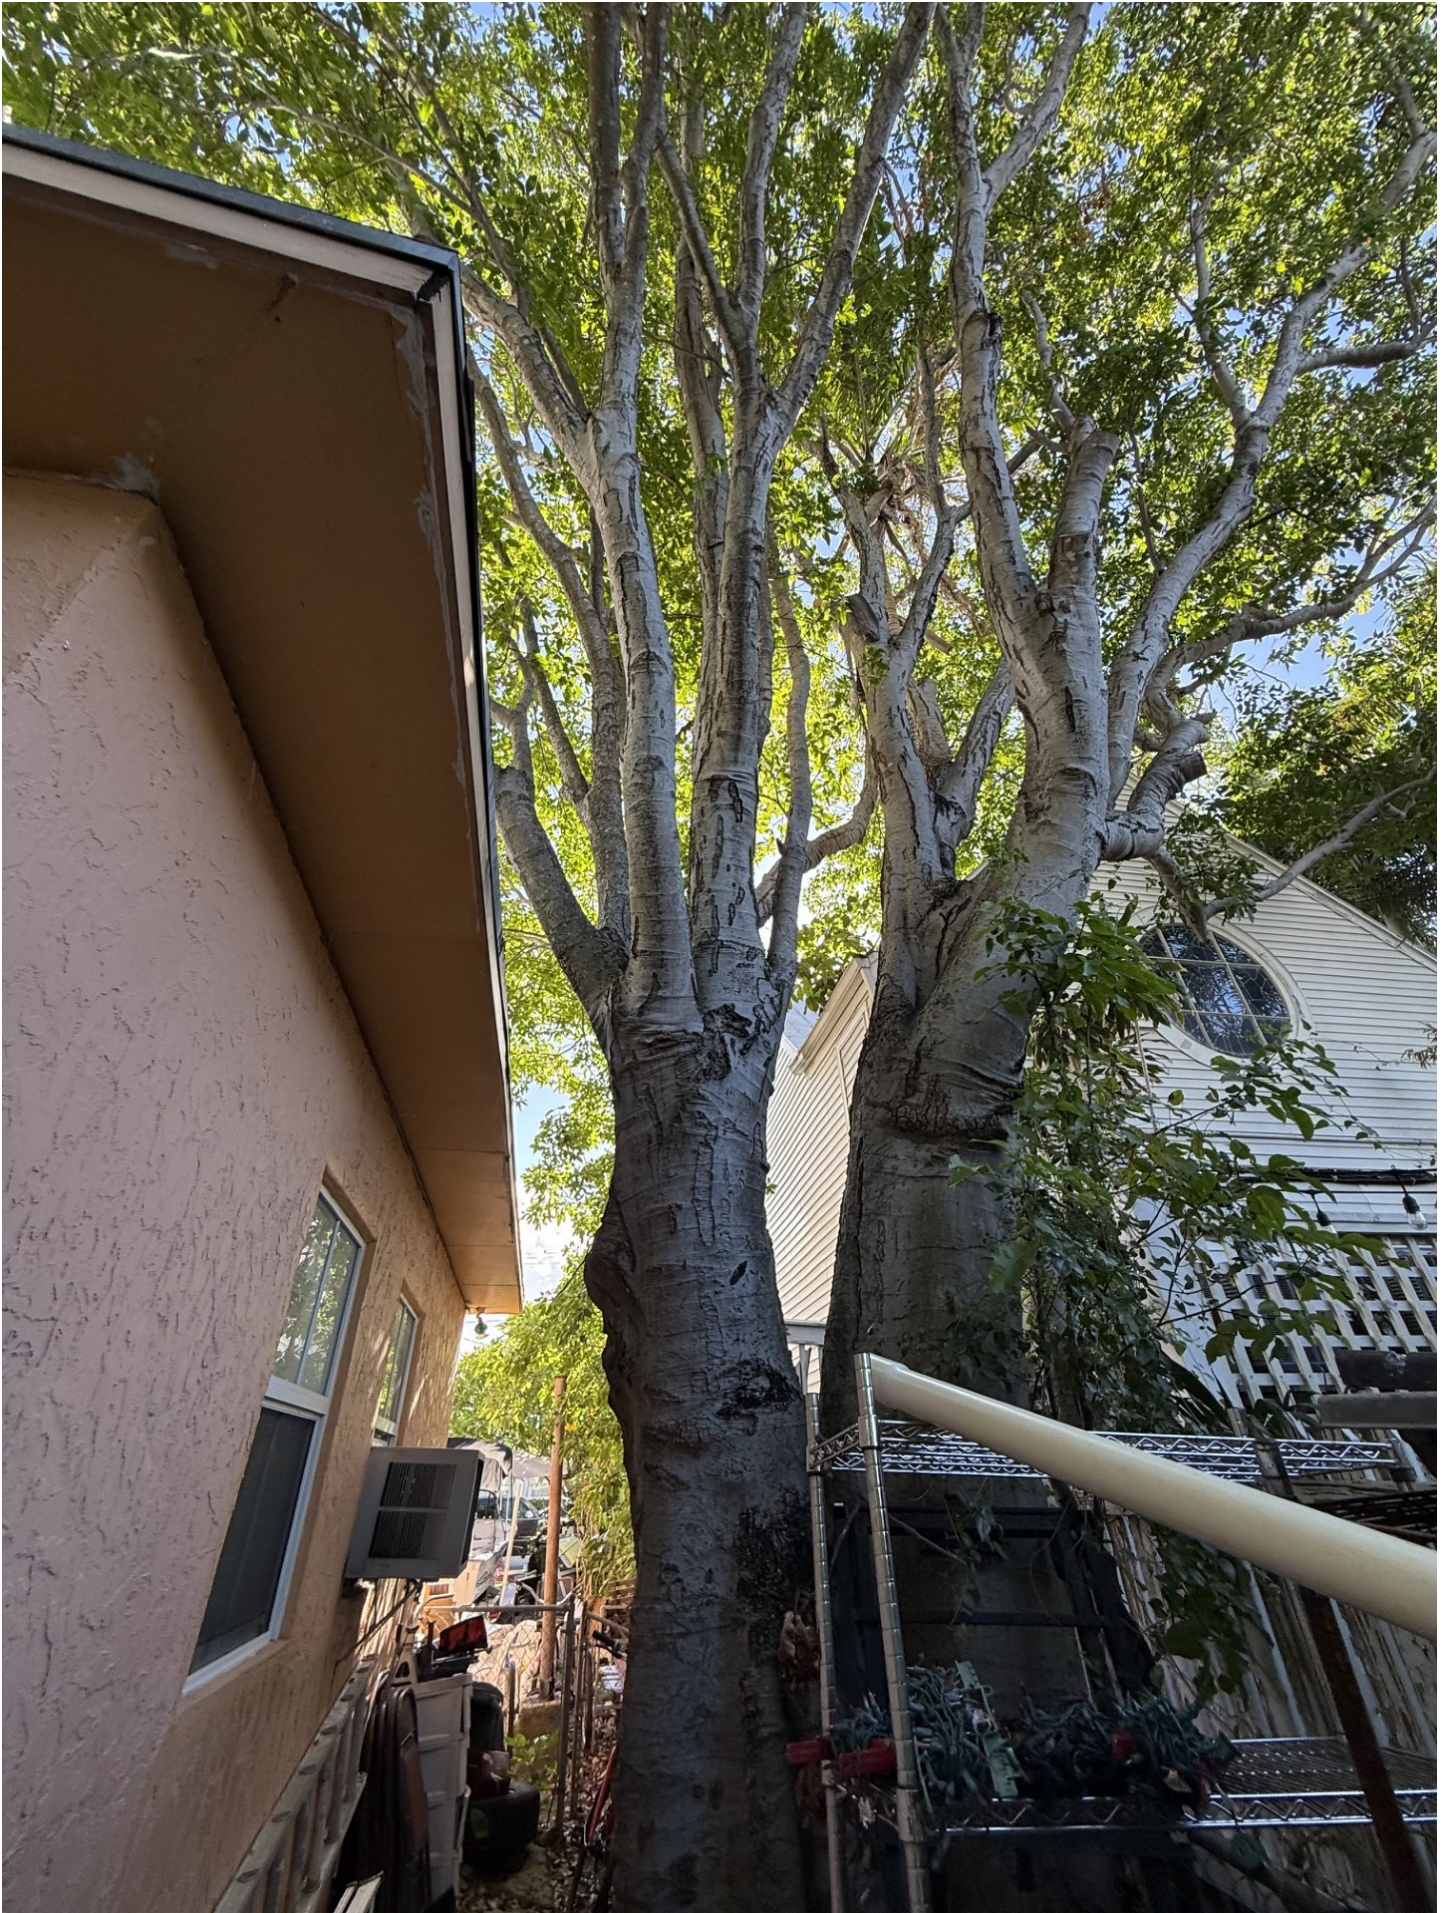
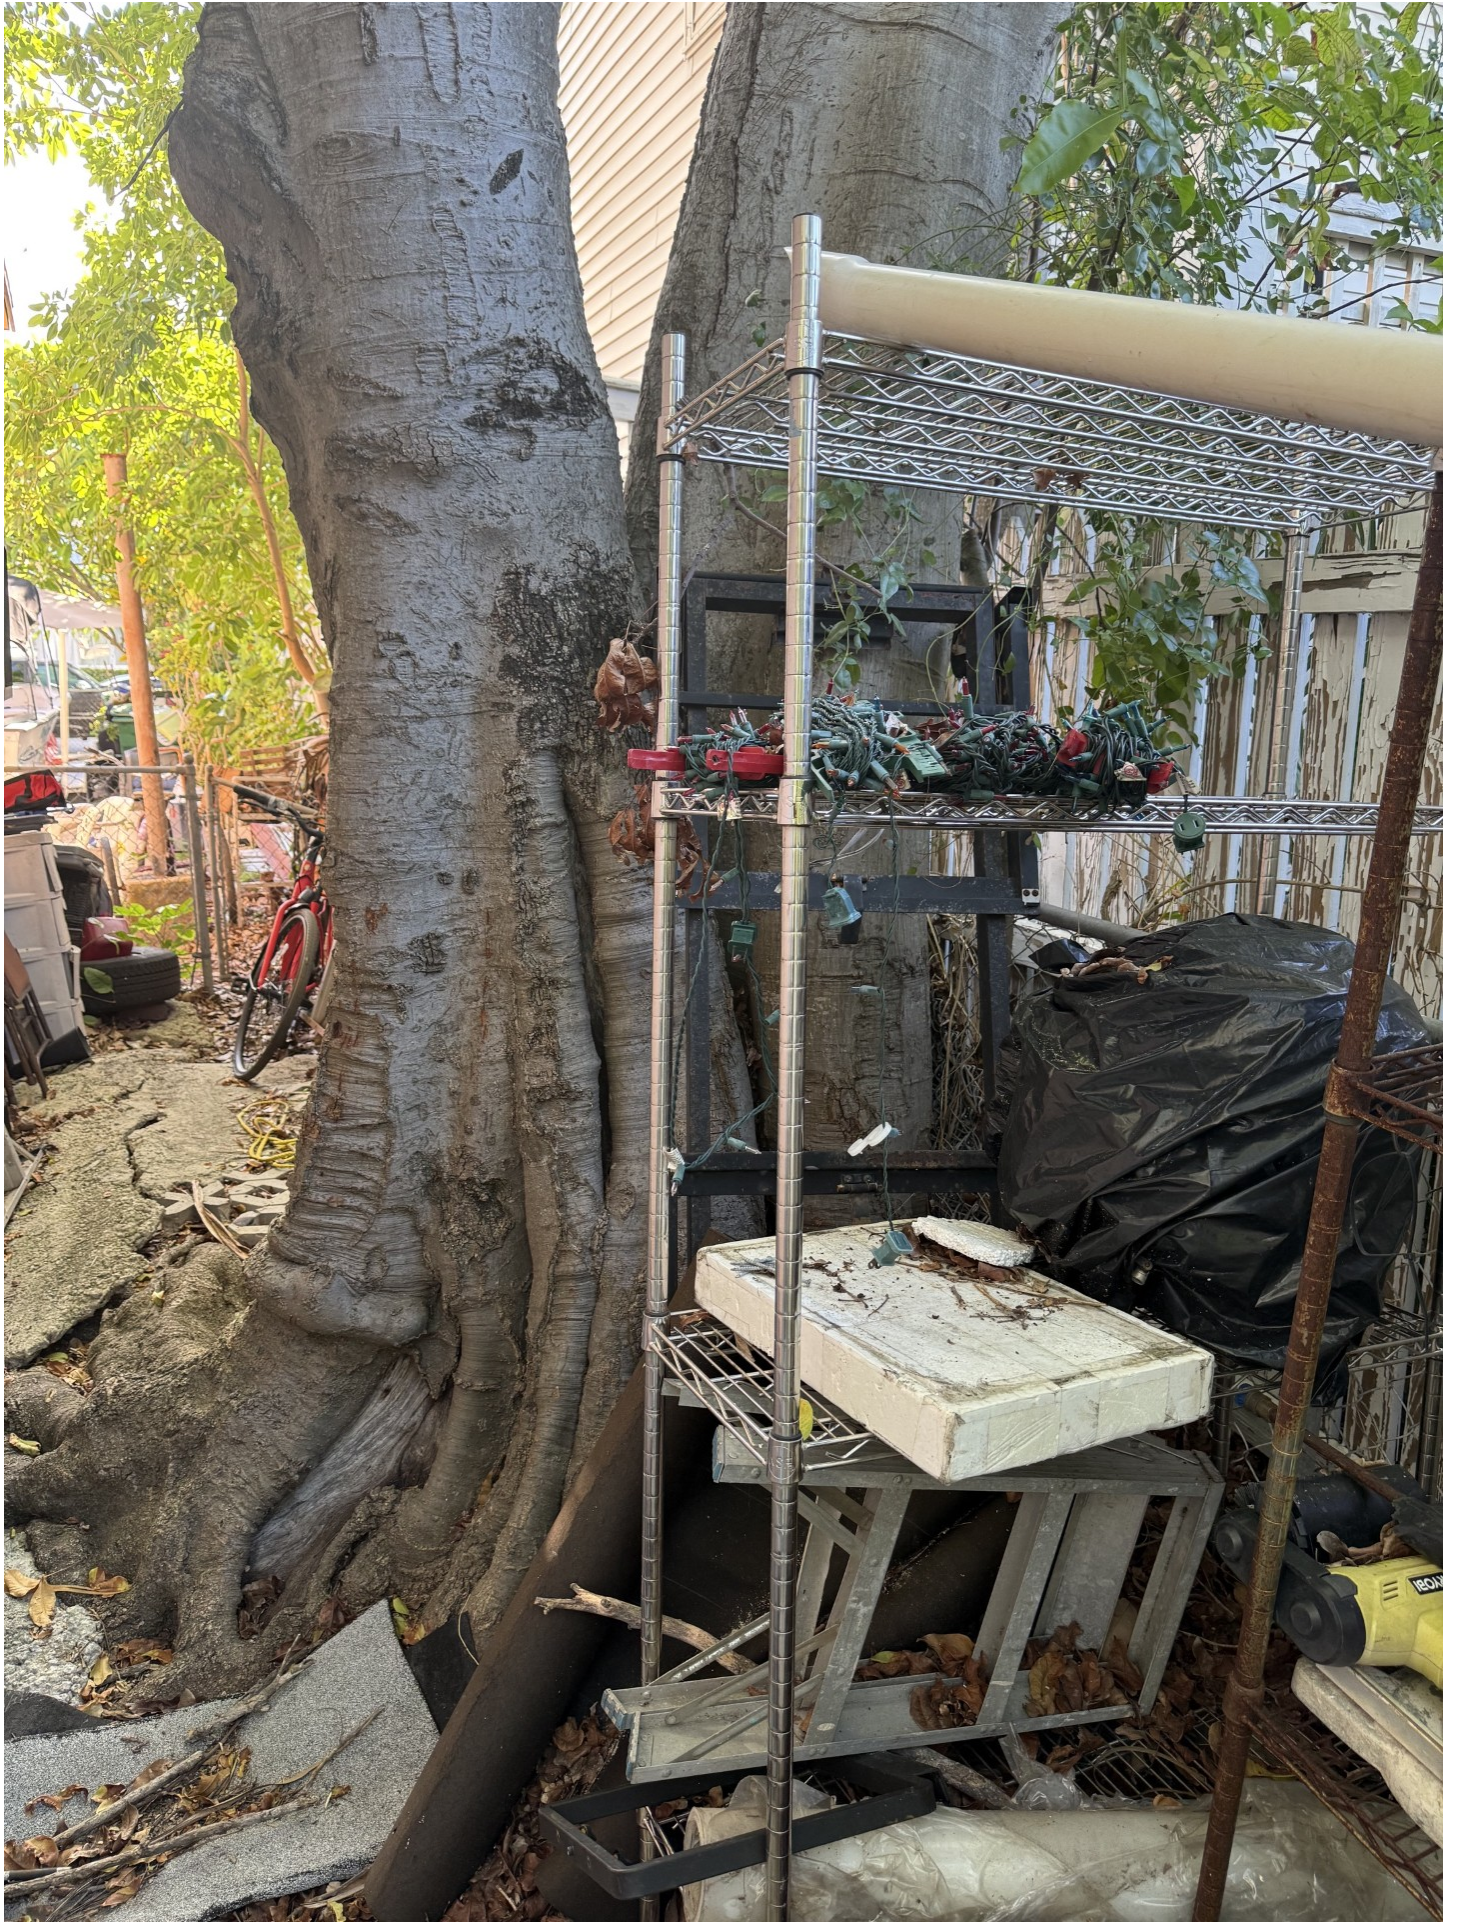
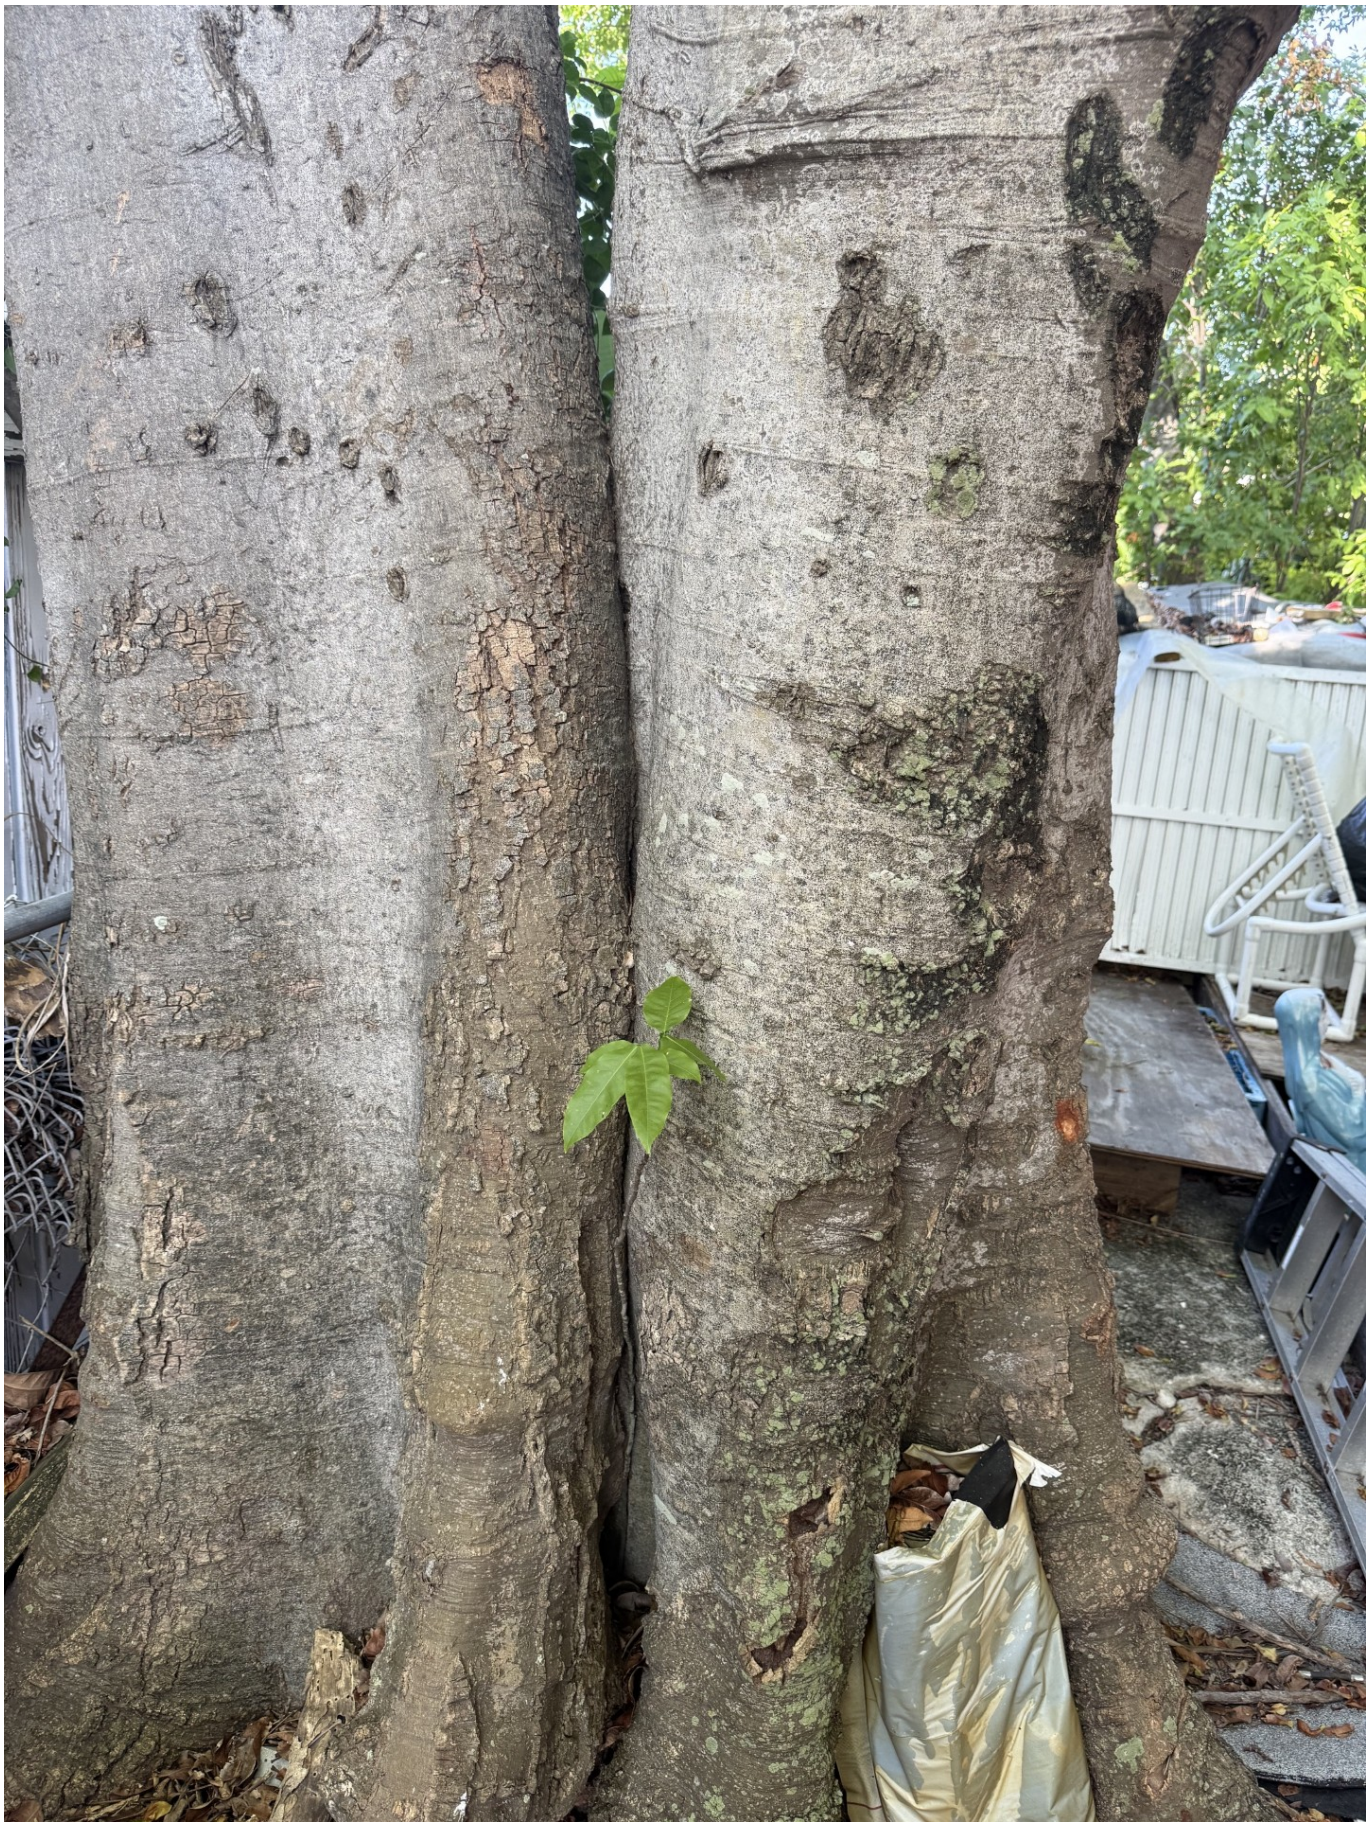
The subject tree is a mature Spanish Lime (*Melicoccus bijugatus*) growing less than 2 feet from a single-family residence. The tree possesses large buttressing roots. At the time of this Level 2 visual assessment, there is no evidence that the root system has caused structural damage to the residence; however, the size and proximity of the tree to the structure warrant continued consideration, as the available growing space is not compatible with a tree of this size.

The most significant structural concern is the presence of a large codominant stem originating immediately above the root flare. The tree effectively consists of two major stems arising from a common root system, with approximately 3 to 4 linear feet of included bark extending vertically through the codominant union. This configuration represents a notable structural defect, as included bark reduces the strength of the attachment between the stems and increases the potential for separation under loading.

The canopy extends substantially over the roof of the subject residence. Additionally, a neighboring two-story single-family home is located less than 10 feet from the base of the tree, and portions of the canopy also overhang that structure, increasing the number of potential targets should a significant branch or stem failure occur.

A moderate amount of dieback is present throughout the upper canopy, and the overall canopy condition is best described as fair. While no other significant structural defects were observed during this visual assessment, the combination of the tree's mature size, its extremely close proximity to two residential structures, and the extensive codominant stem with included bark at the base of the trunk represents the primary concern.

Based on this Level 2 assessment, the subject tree exhibits a significant structural defect at its primary union, and its location provides little separation from nearby structures. These factors should be carefully considered when evaluating the tree's long-term management and associated risk.

**Recommended Mitigation: 22.4 Caliper Inches**
