## Tree Removal Report

**PROPERTY:** 629 Dey St.

**APPLICATION NUMBER:** T2026-0125

**REQUEST:** The applicant is requesting removal of (2) Cuban Mahogany Trees (1) Gumbo Limbo Tree.

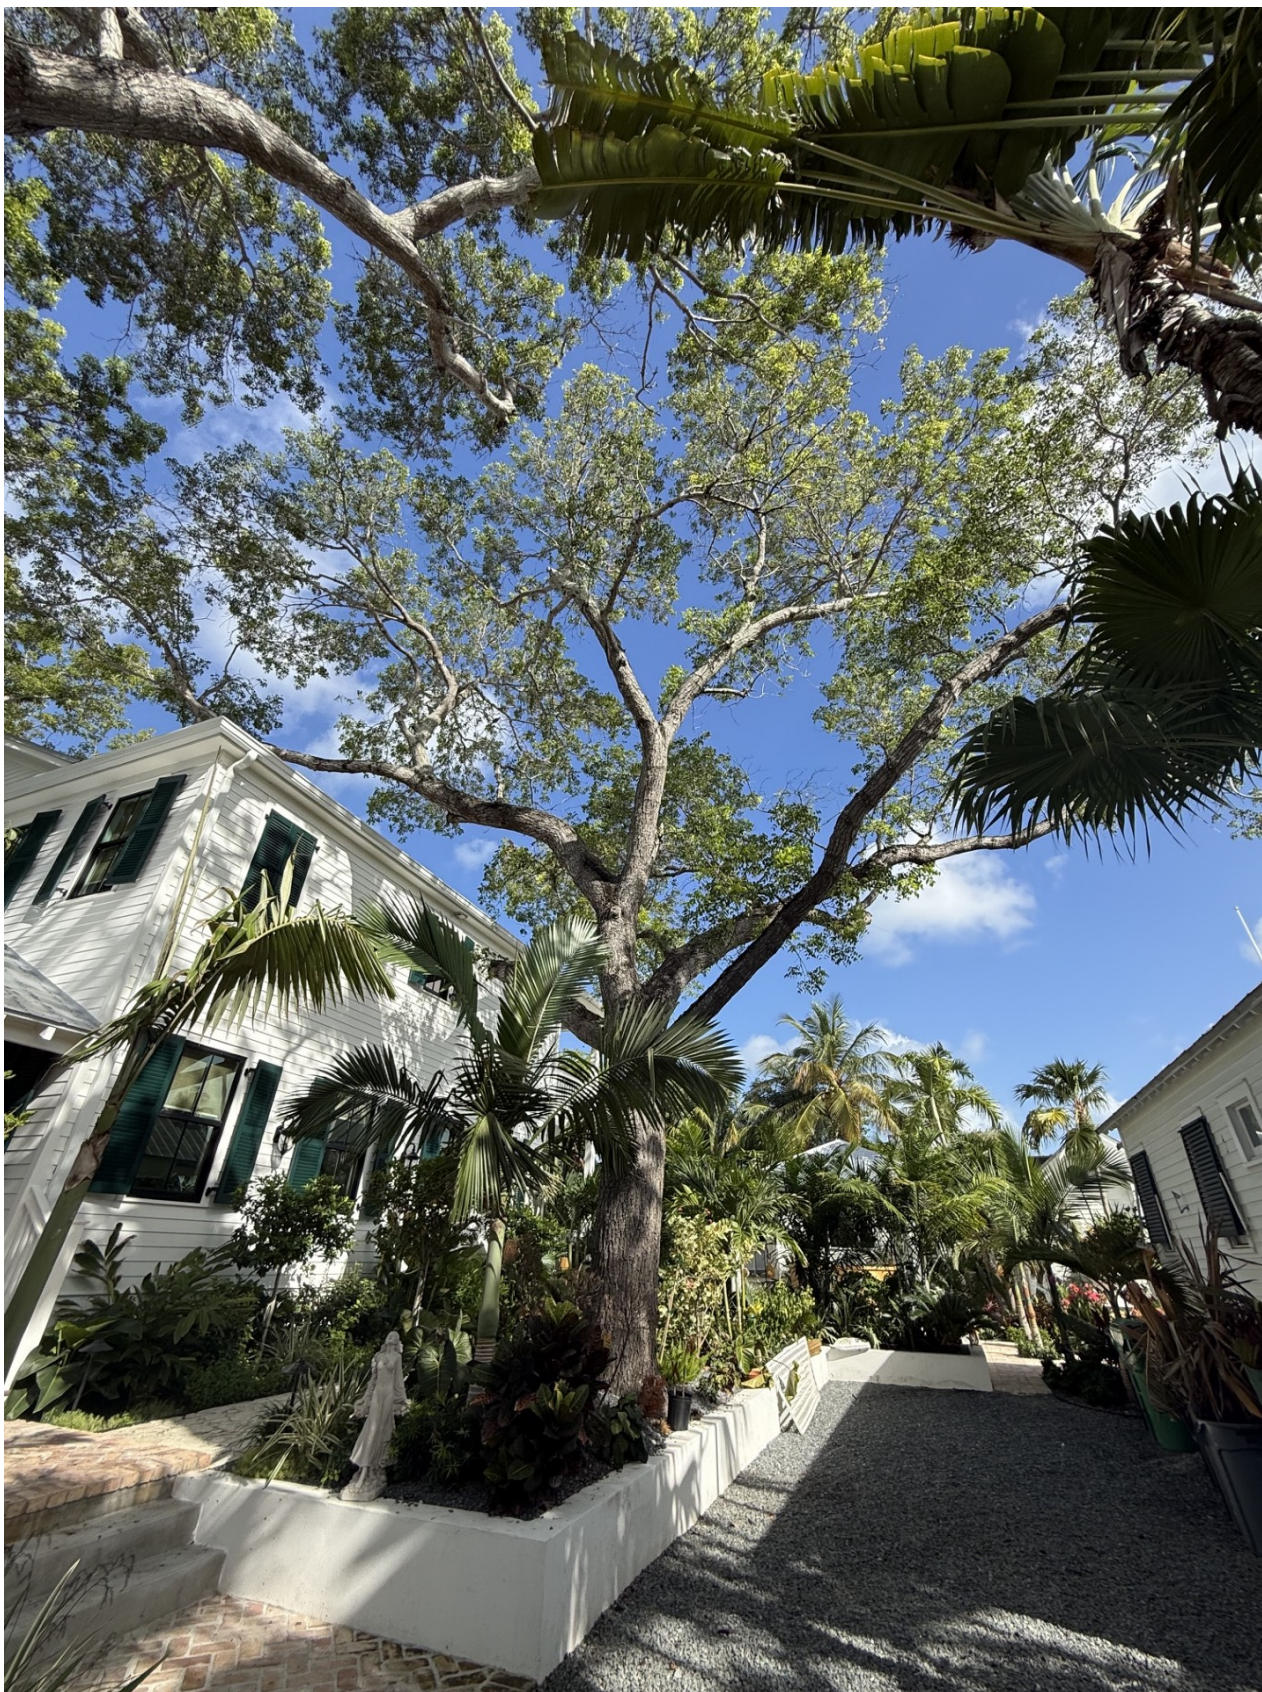
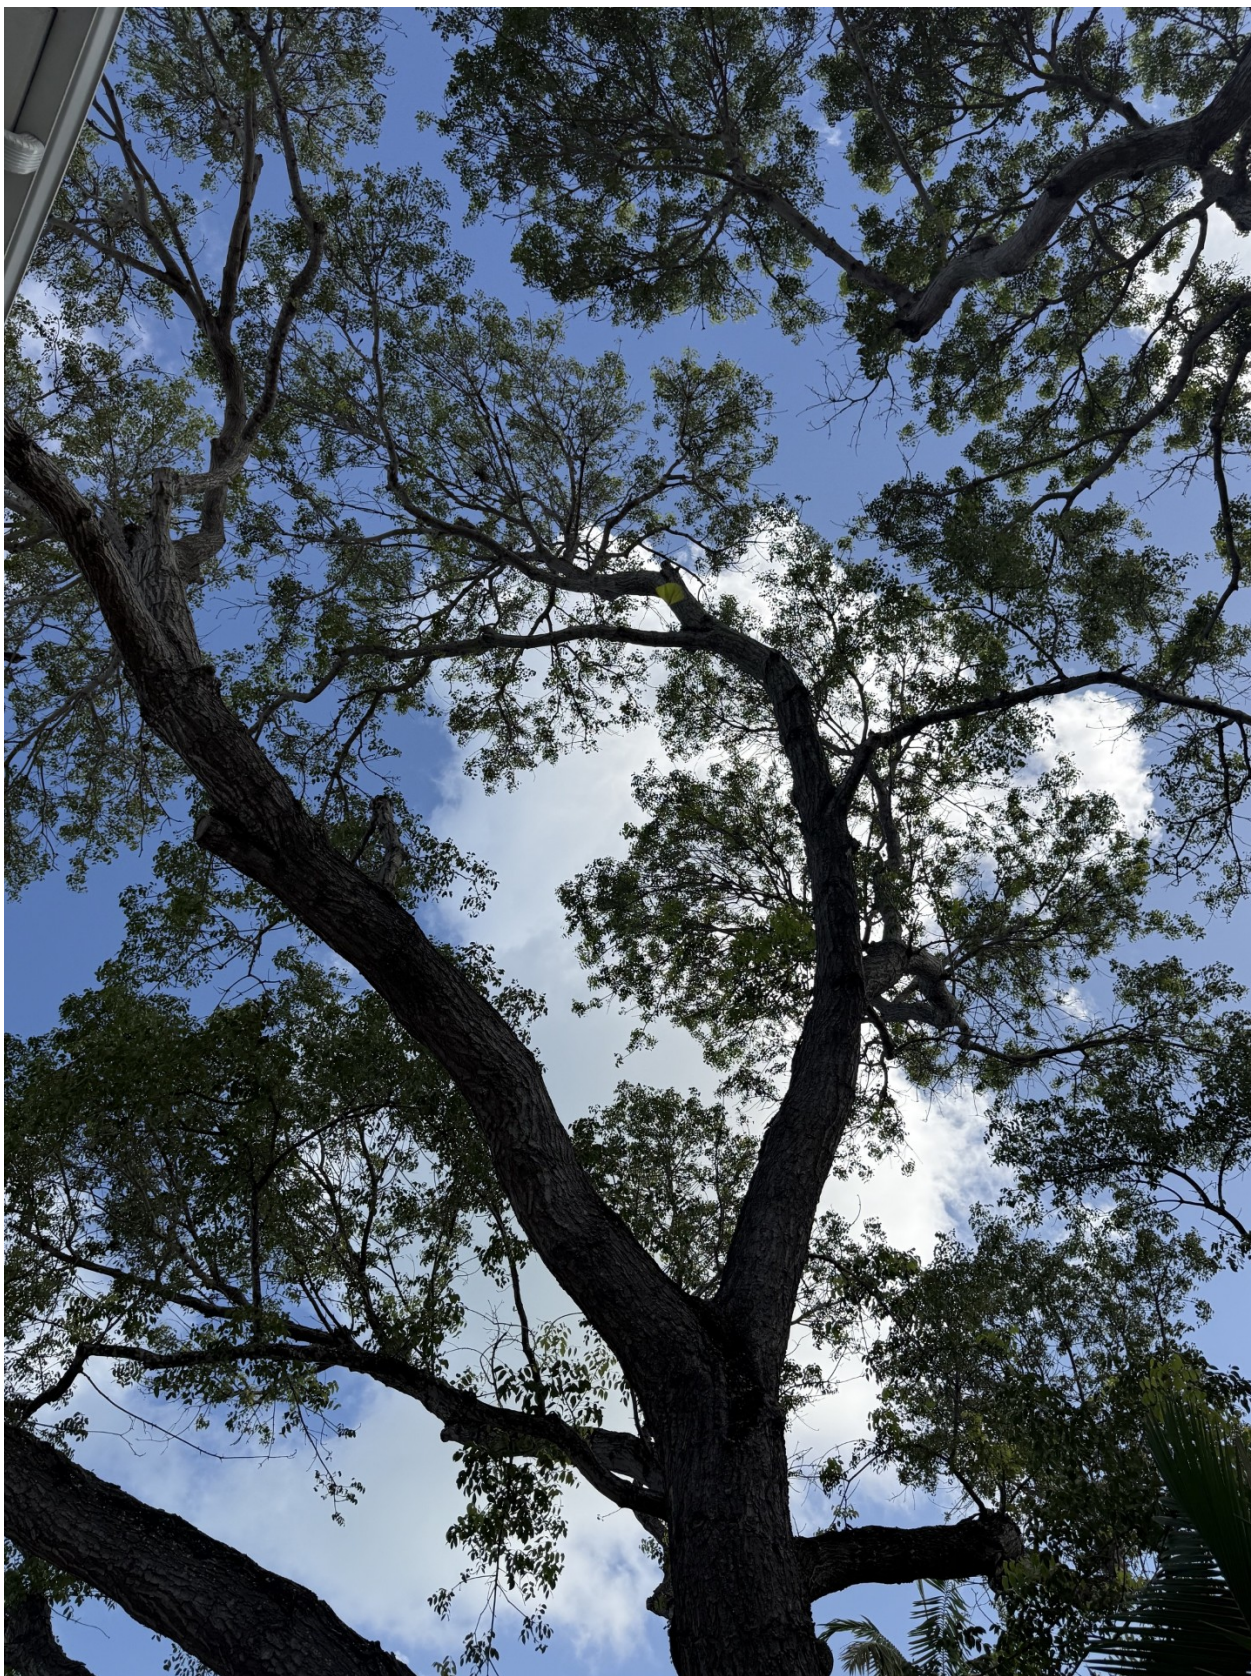
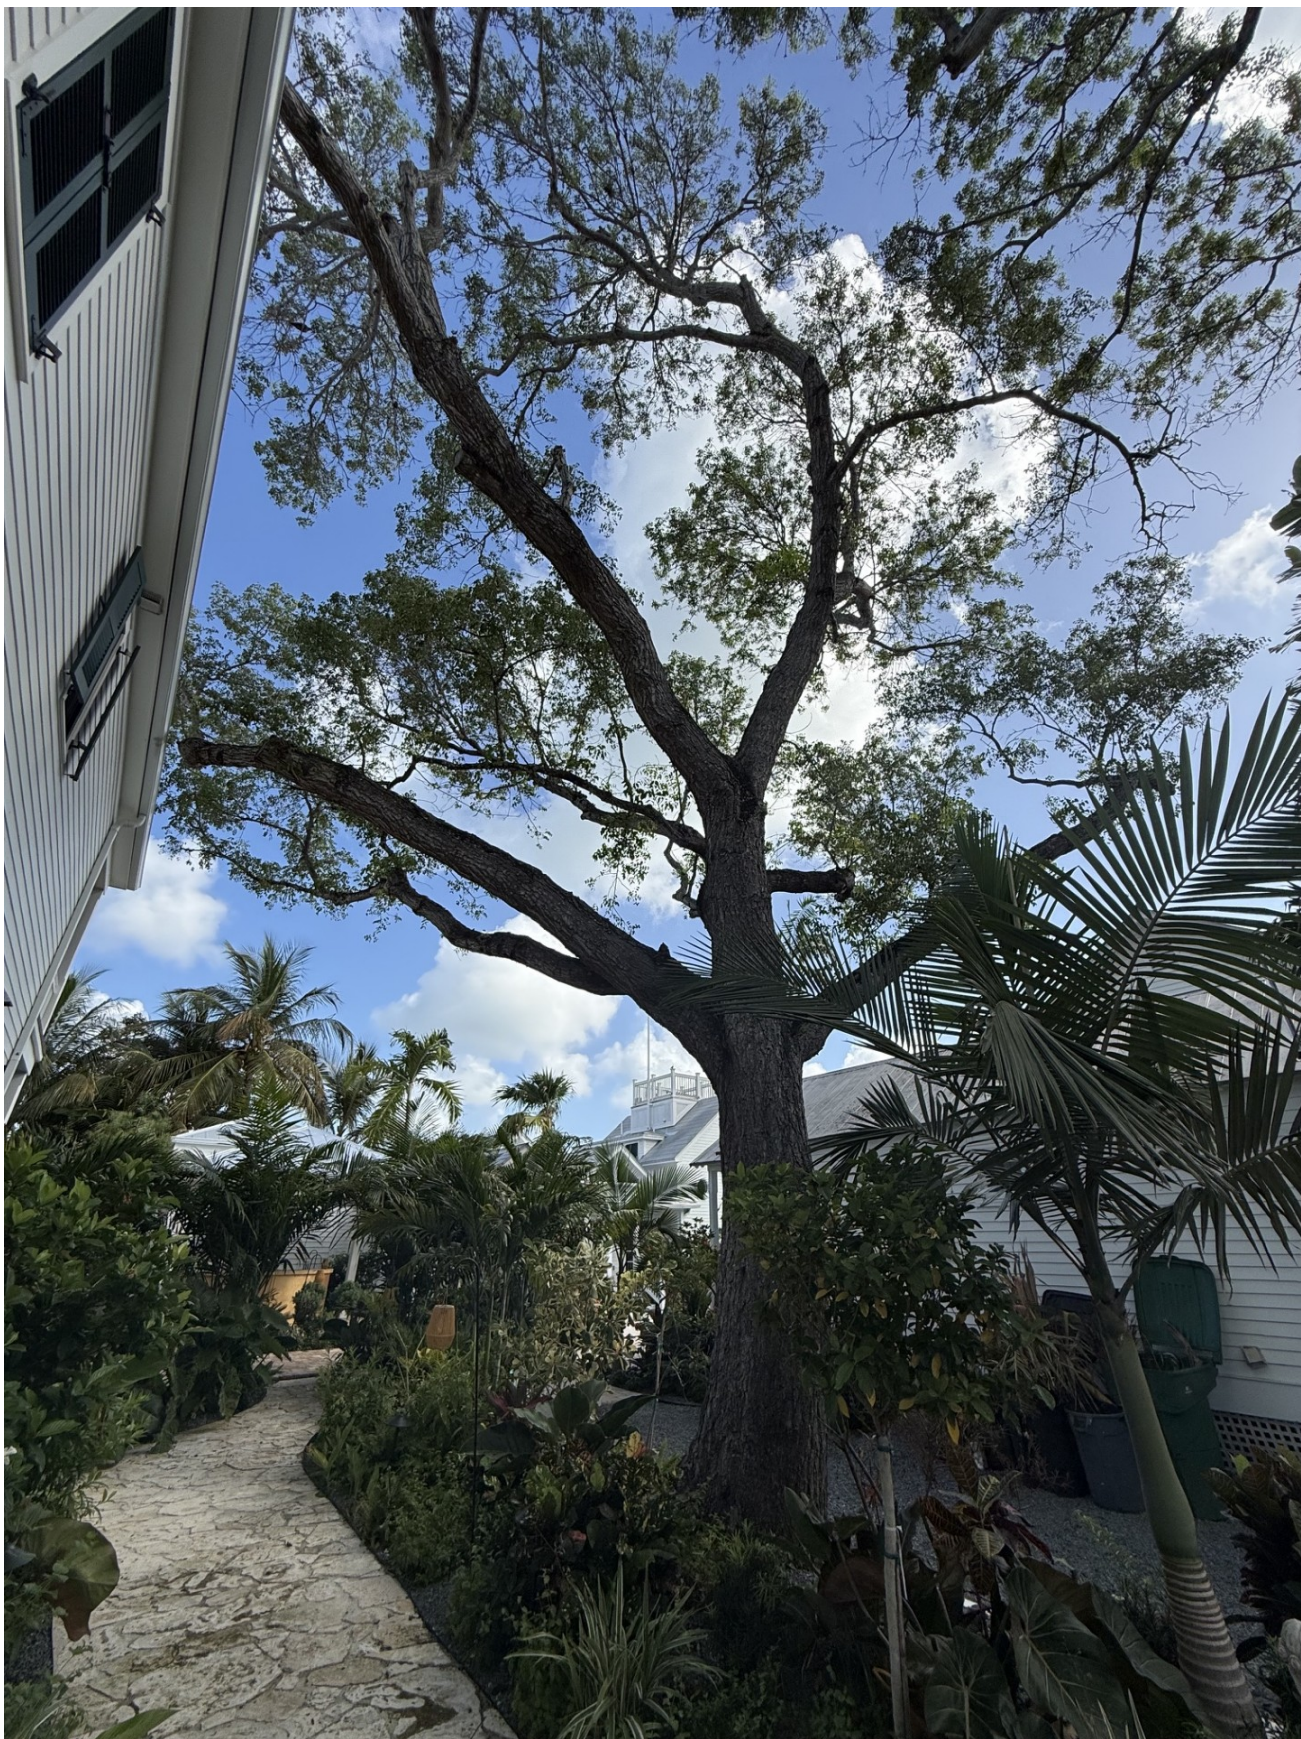
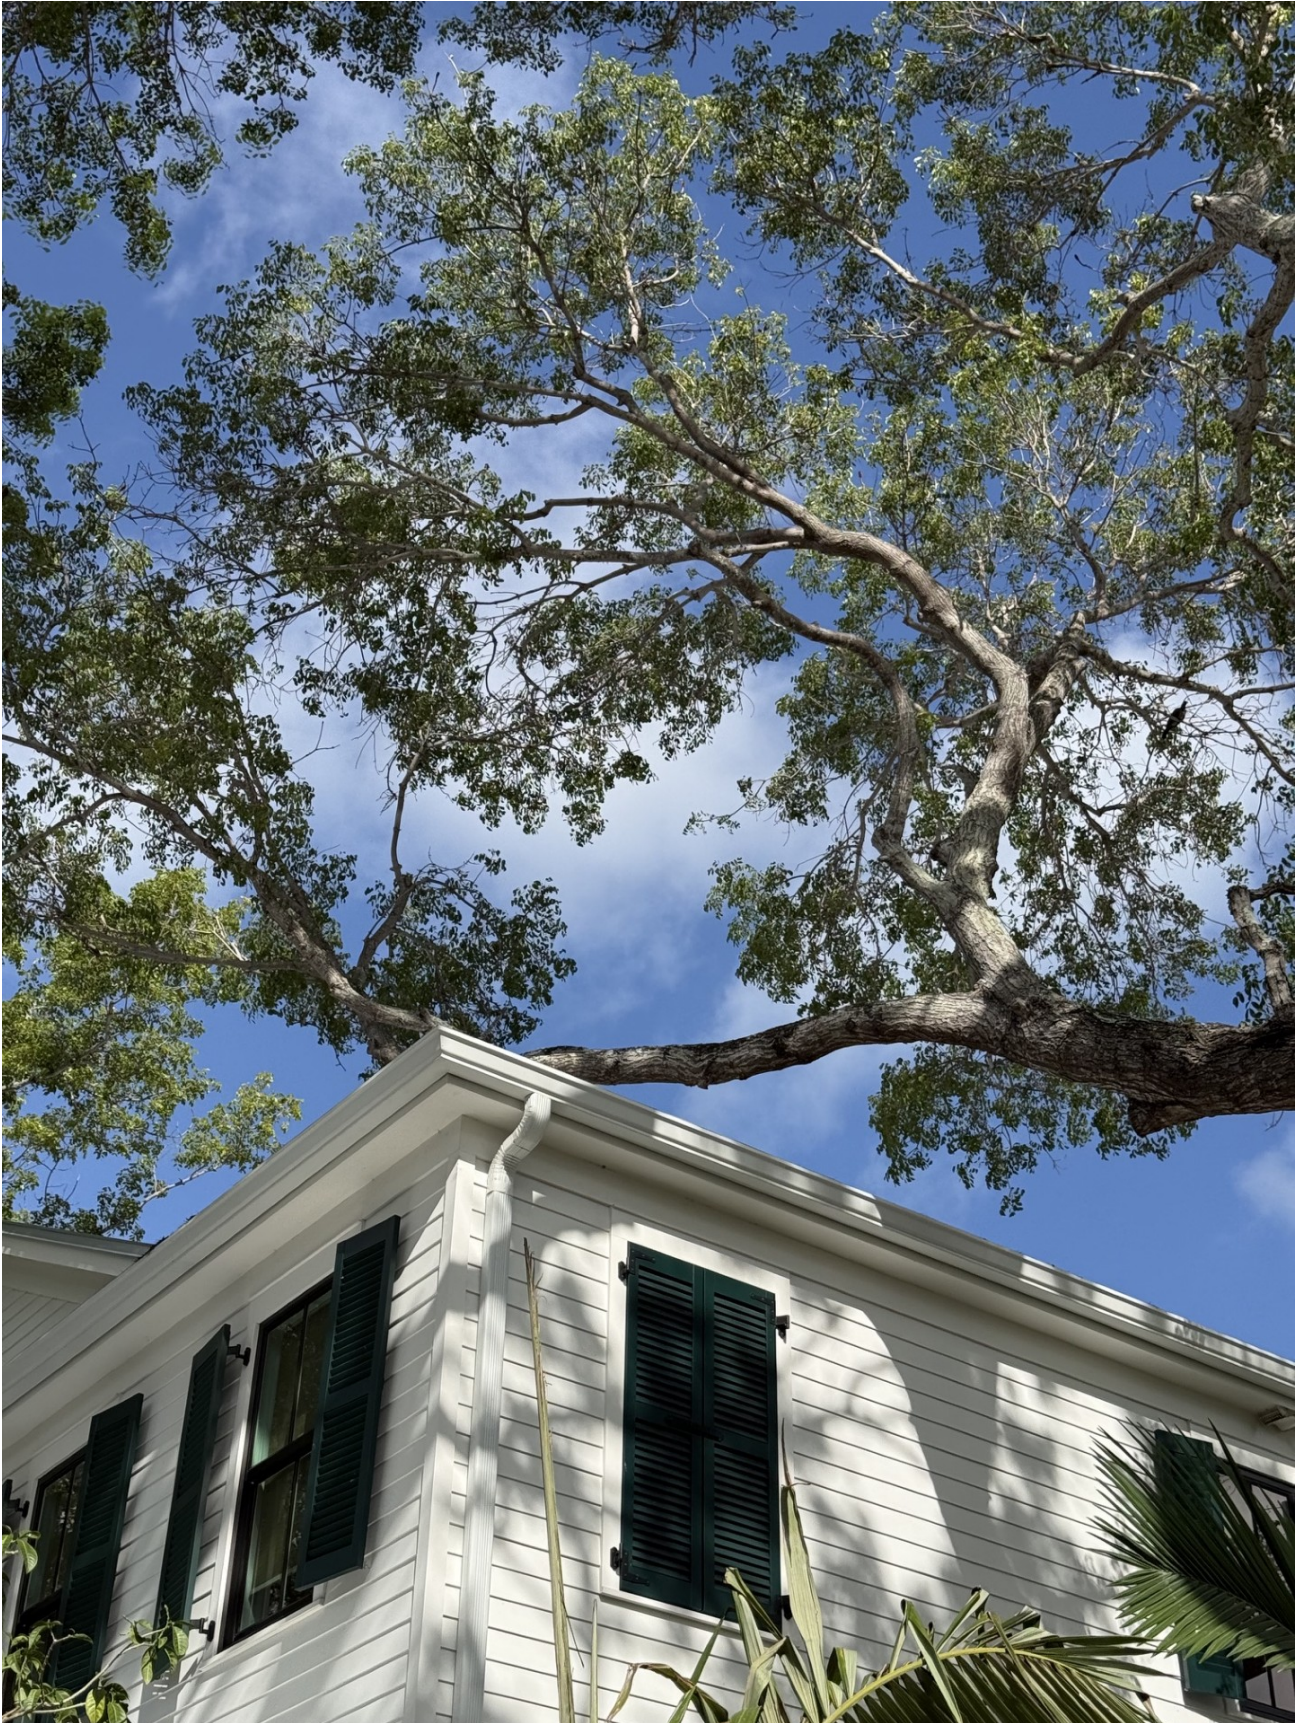
**Mahogany #2**

The subject tree is a mature Cuban mahogany exhibiting an atypical canopy architecture resulting from previous heavy pruning. The canopy is composed of several elongated scaffold branches extending from the main trunk, with most primary leaders measuring approximately 8 to 10 inches in diameter at their points of origin. Although the canopy is relatively open and lacks significant density, overall vigor appears fair, with no evidence of widespread canopy decline.

The root flare is visible and appears healthy, with no obvious indications of basal decay, root damage, or structural instability observed during the inspection.

One scaffold branch extends toward and partially over the roof of the adjacent two-story residence. While branch overhang of a structure is generally not considered ideal, this particular limb tapers substantially before reaching the home. The branch originates at approximately 10 inches in diameter and is located roughly 12 feet from the residence. By the point where it extends over the roof gutter, the branch has tapered to approximately 3 to 4 inches in diameter. Based on the branch taper and the reduced loading at its distal end, this condition is not considered an immediate structural concern.

A second scaffold leader located below the overhanging branch was previously removed approximately 7 to 8 feet from its point of origin, leaving a large pruning stub. The location and nature of the cut suggest it was likely performed to accommodate construction of the adjacent residence, which appears to be relatively new. Although the pruning cut is not consistent with current ANSI A300 best management practices, the modification appears to have been made to facilitate building clearance rather than as an arboricultural pruning operation.

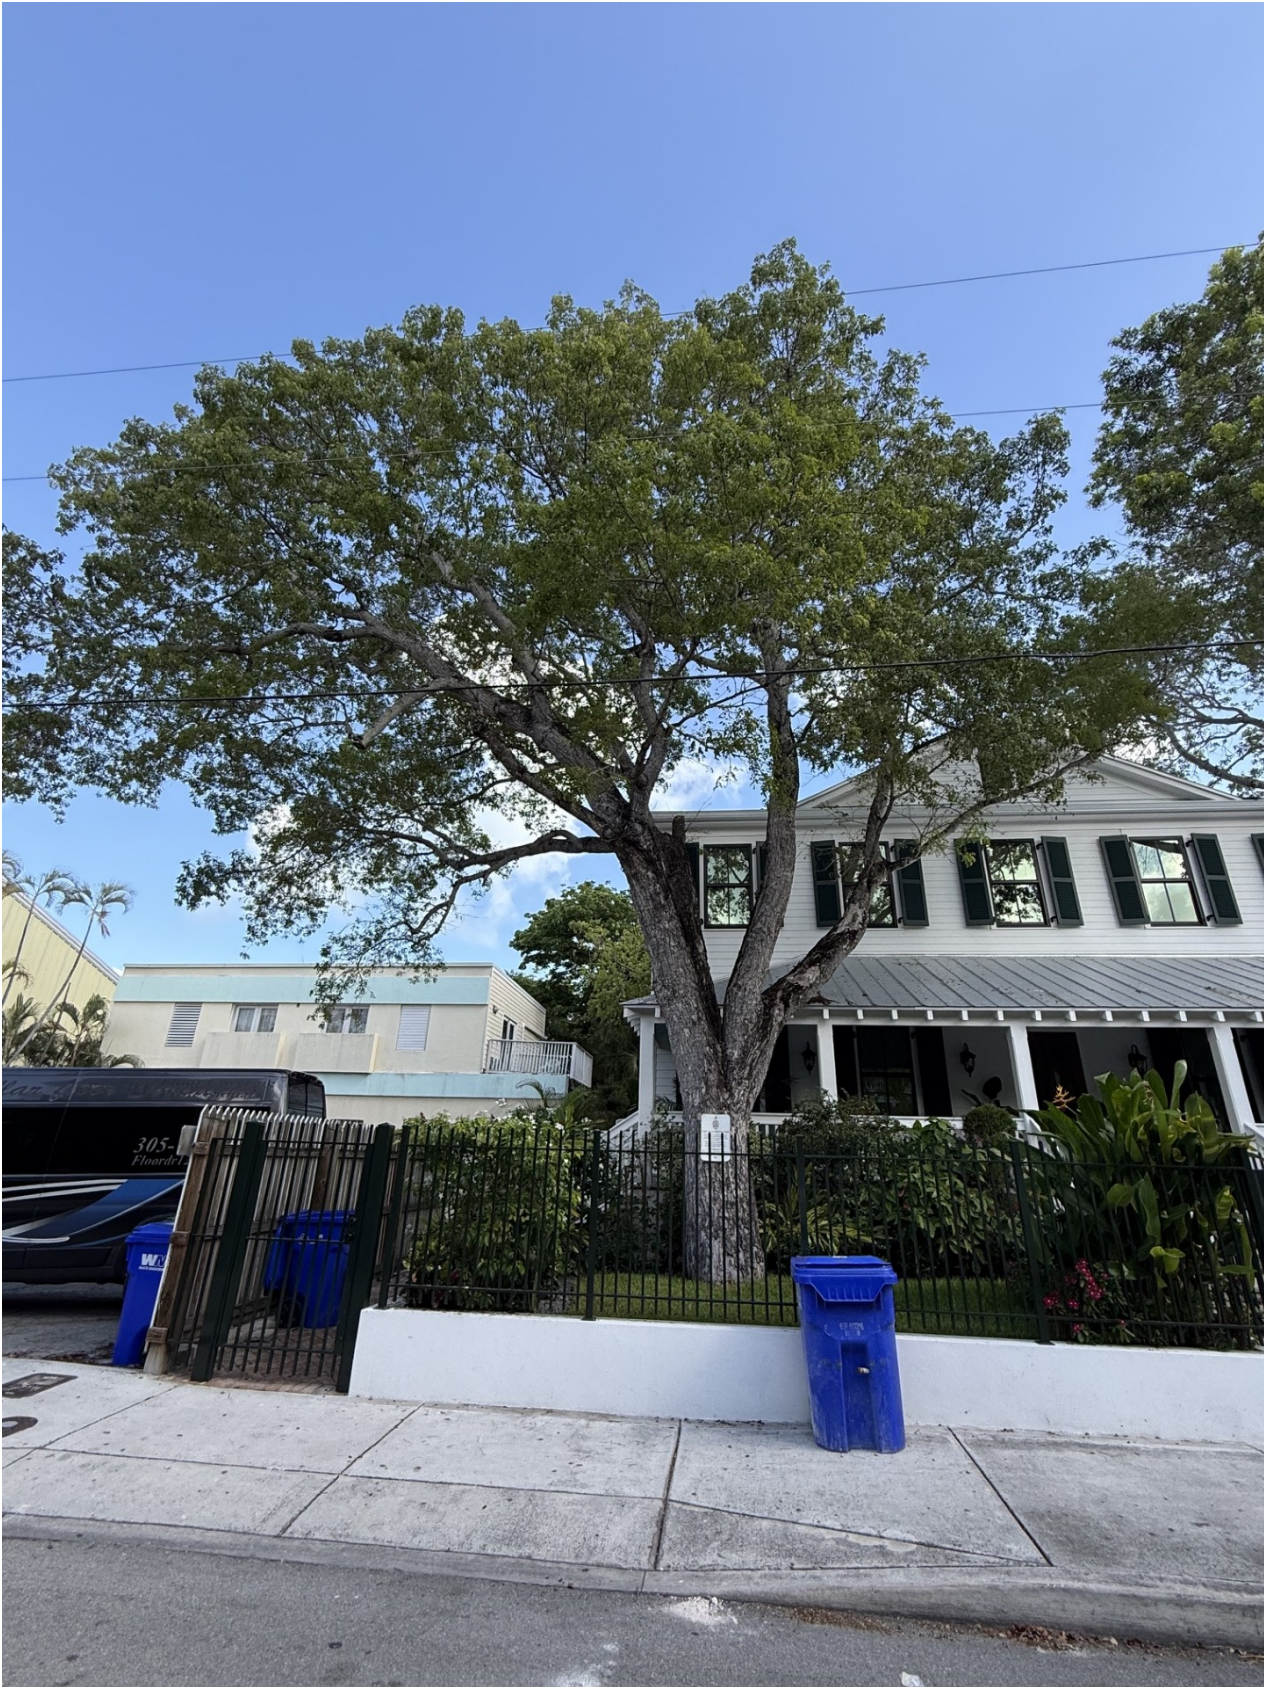
**Mahogany #1**

The subject tree is a mature Cuban mahogany measuring approximately 28 inches DBH and is located in the front yard of a single-family residence. Overall, the tree exhibits fair canopy condition with acceptable foliar density and no significant canopy-wide decline observed during the inspection.

The primary observation of concern involves one of the main scaffold leaders extending over the home's front porch. This leader exhibits extensive bacterial wetwood, which has progressed to the point of causing substantial bark sloughing. Large sections of bark have detached, exposing underlying wood that appears dry, dull, and lacking the typical appearance of healthy cambial tissue. While bacterial wetwood is a relatively common condition in Cuban mahogany, it is less common for the condition to result in bark loss of this magnitude. The extent of exposed wood warrants continued observation as it may indicate localized structural degradation or advancing decline within this leader.

A second large scaffold leader is in direct conflict with the residence. The home's front porch soffit has been constructed with a large cutout to accommodate the stem, indicating the structure was built around the existing tree. At the time of inspection, no obvious signs of active structural failure, cracking, or significant defects were observed within this leader.
