THE CITY OF KEY WEST – Tree Commission

Reference: 711 Frances Street Tree Trim (PO 093800)

Tree Commission
MEMORANDUM

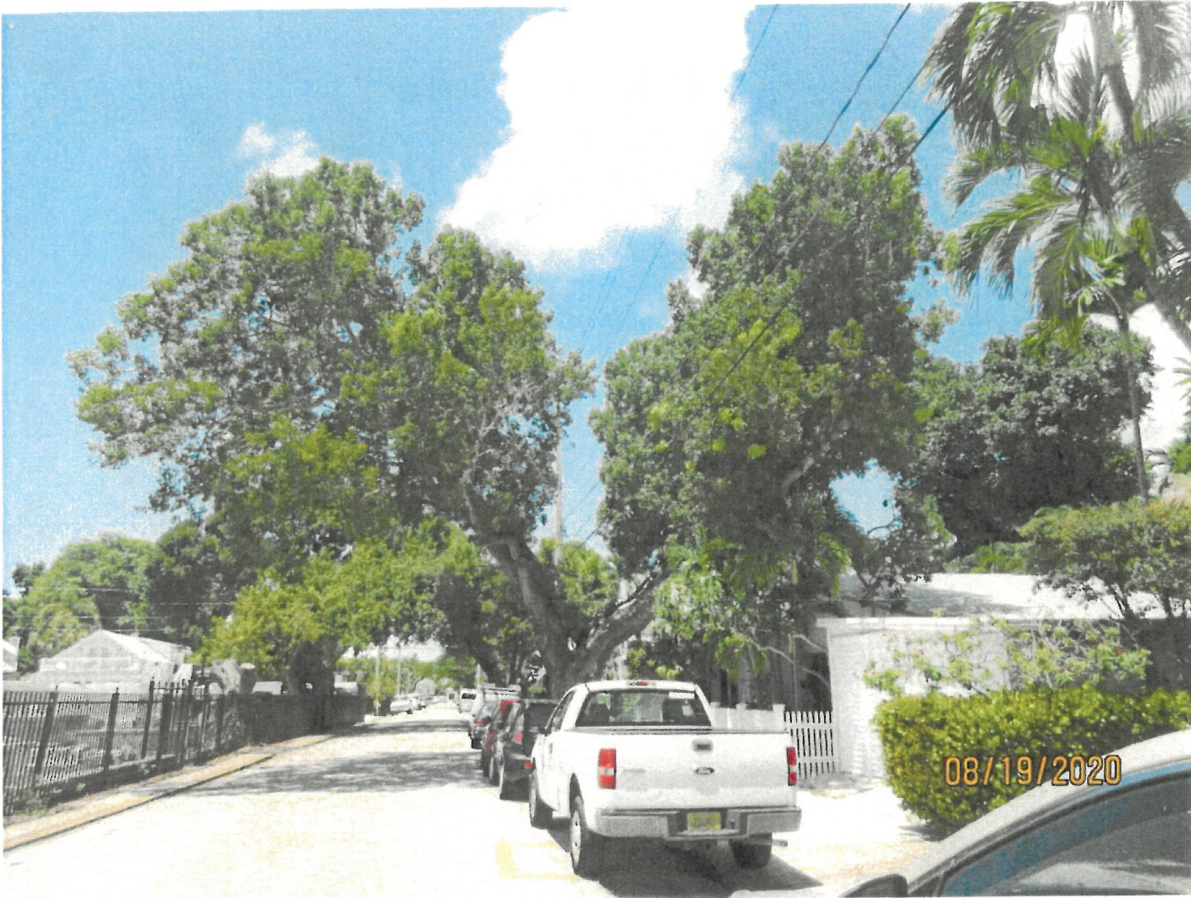
Photo #1-
photo of whole
tree 9 months
prior to
trimming.

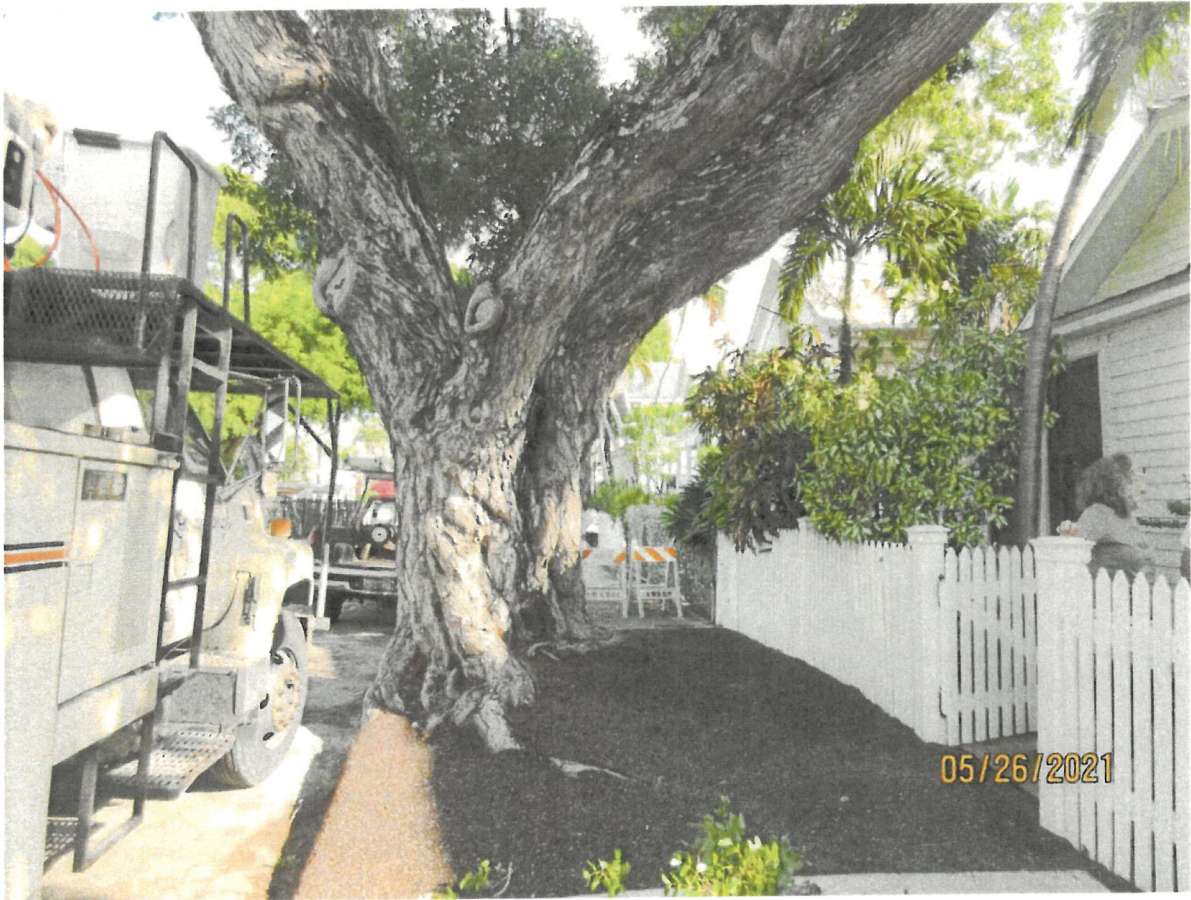
Photo #2-
photo of base
of tree on day
of trimming.
Large
branches on
right side of
photo of main
concern to
property
owners.

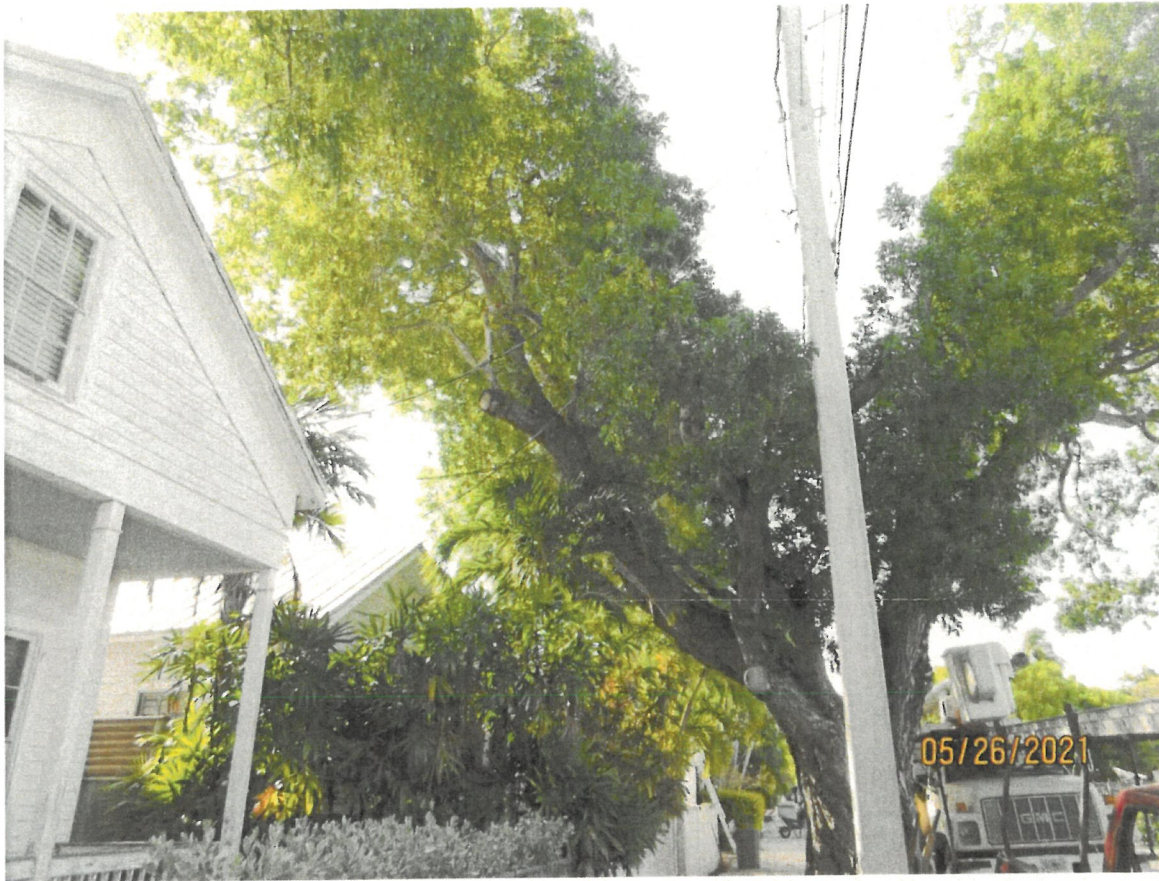
Photo #11 – shows canopy of tree over house prior to trimming

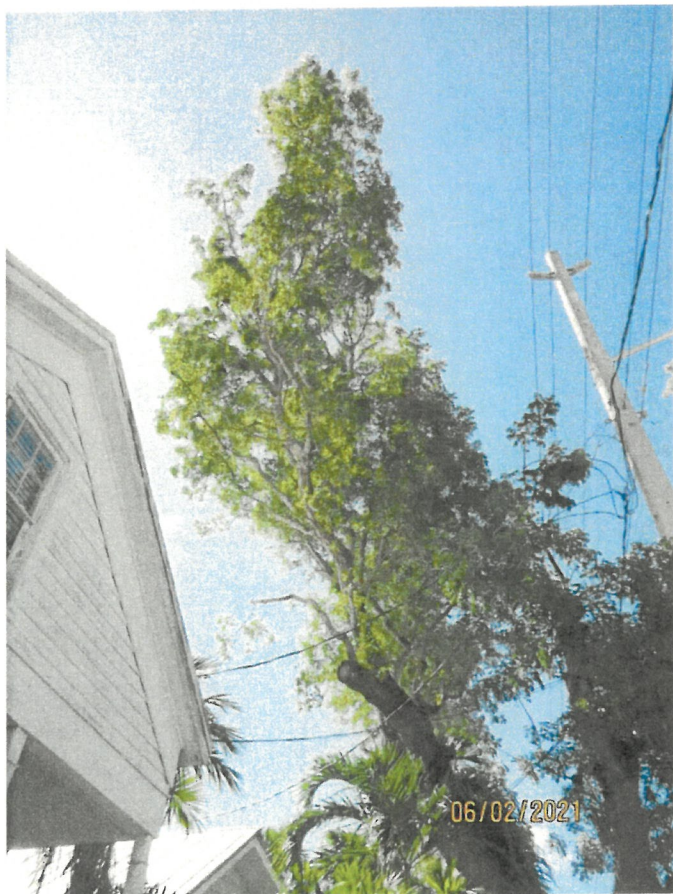
Photo #12 – shows canopy of tree over house after trimming

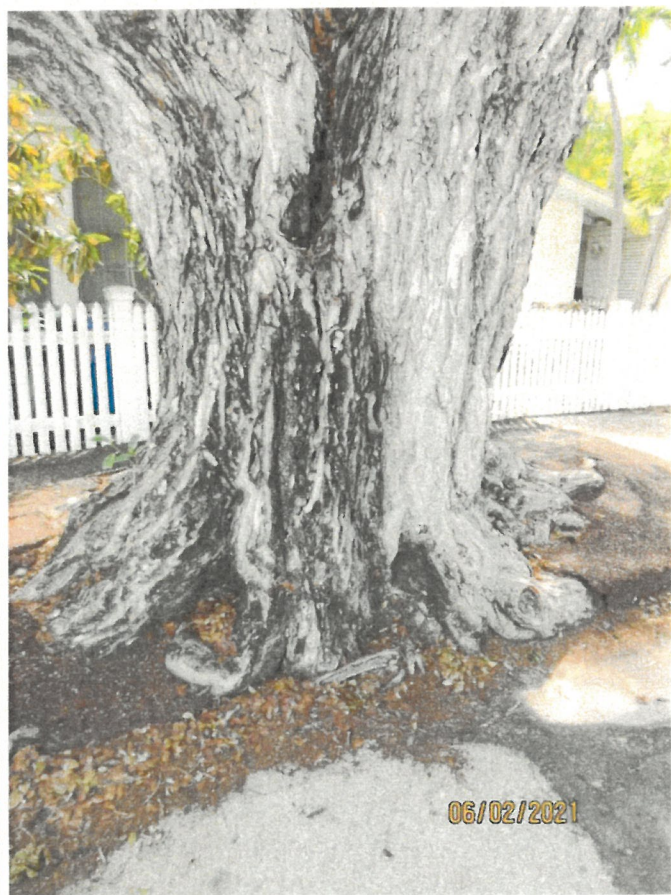
After the trimming work was completed, Mr. King called and we discussed the overall condition of the tree. He noted during his final visual evaluation of the whole tree that there was an area on the street side where a crack had developed from the base of the tree up to the main crotch (photos #13 to #16). This area appears to have some included bark and might be separating. It was recommended that the tree be observed this next year and that this tree might be a good candidate for a new type of cabling system that is being advertised in the Arborist News magazine. Cabling would stabilize the large trunk/branch system.

Photos #13 – shows the base of the tree street side view.

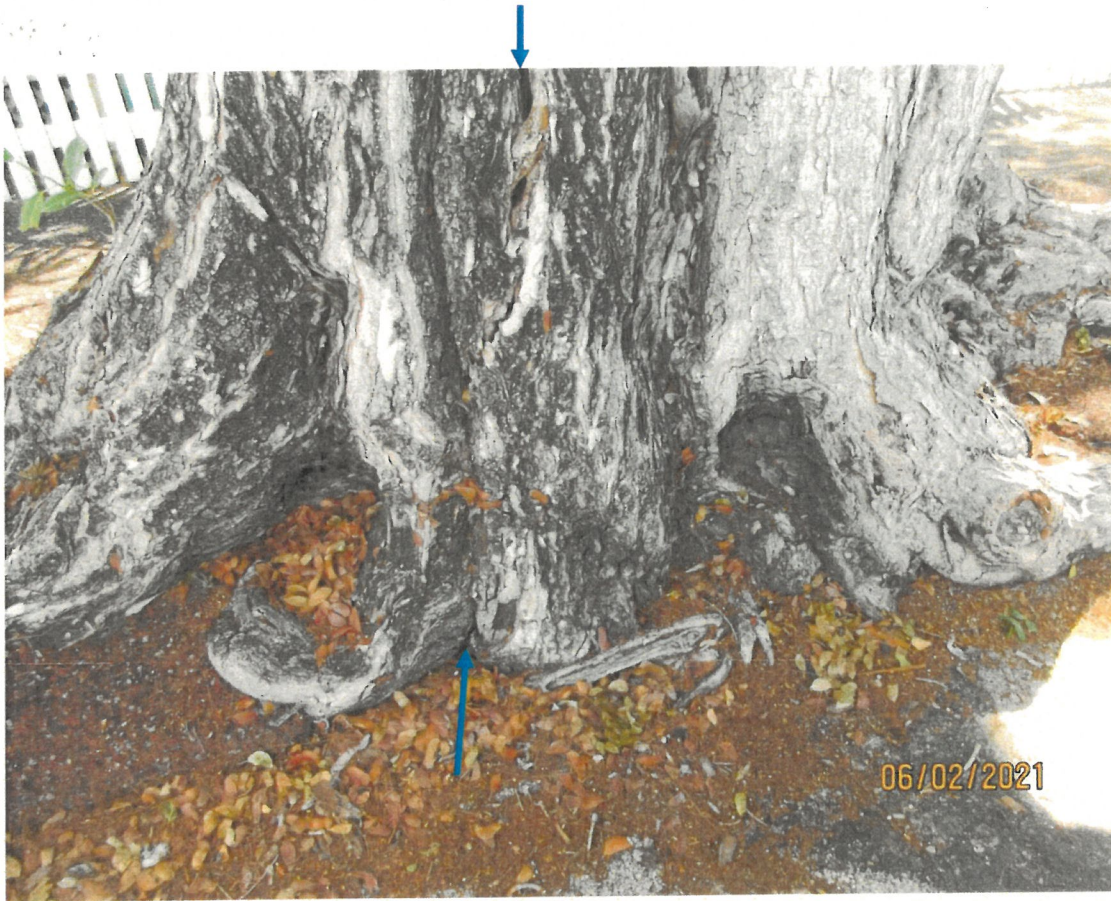
Photo #14 – shows base of tree street view and notations as to the bark crack

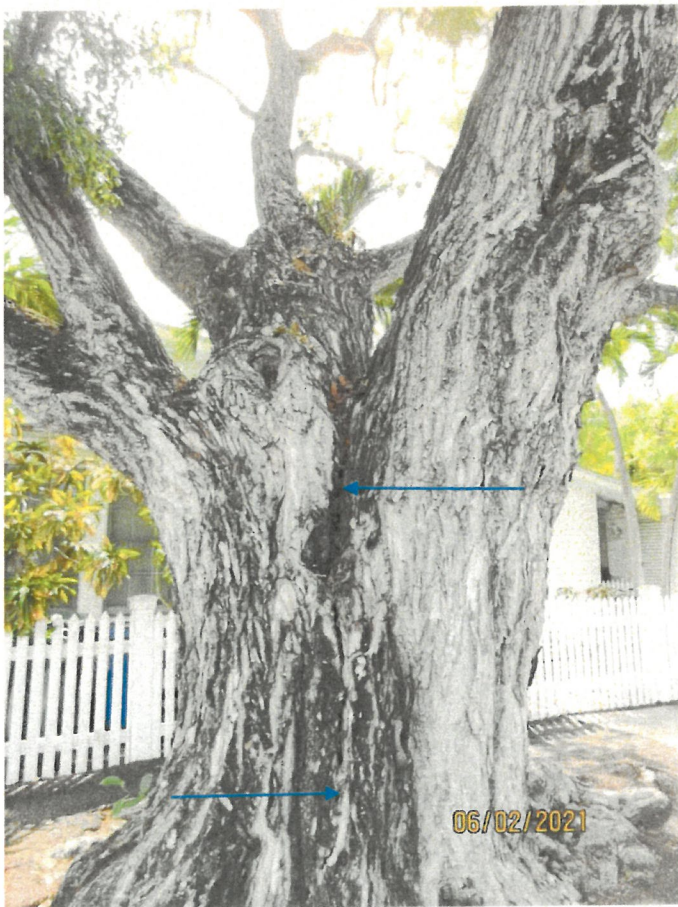
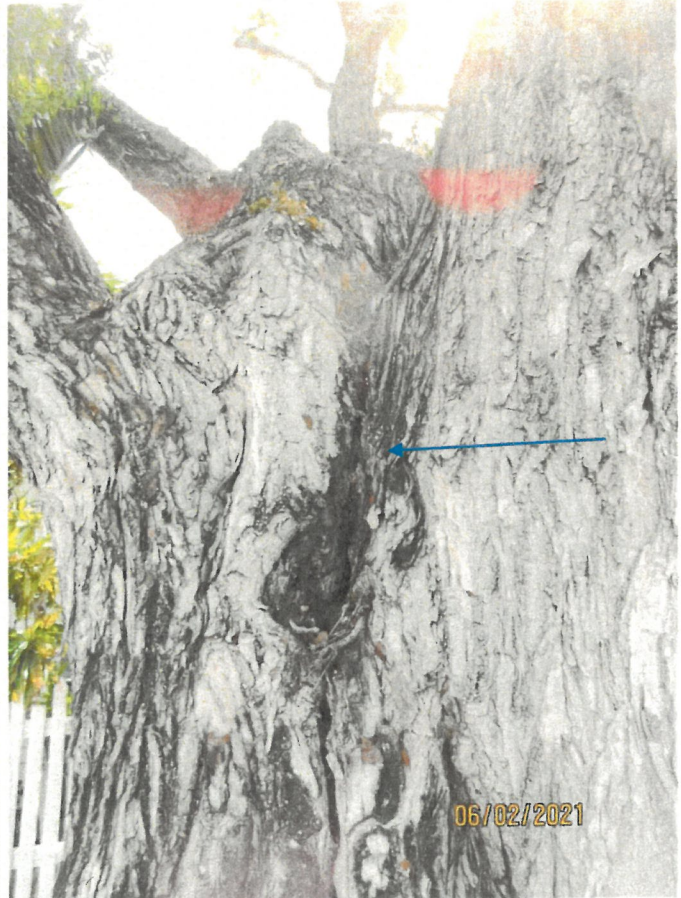
Photos #15 & #16 - photos show bark crack area

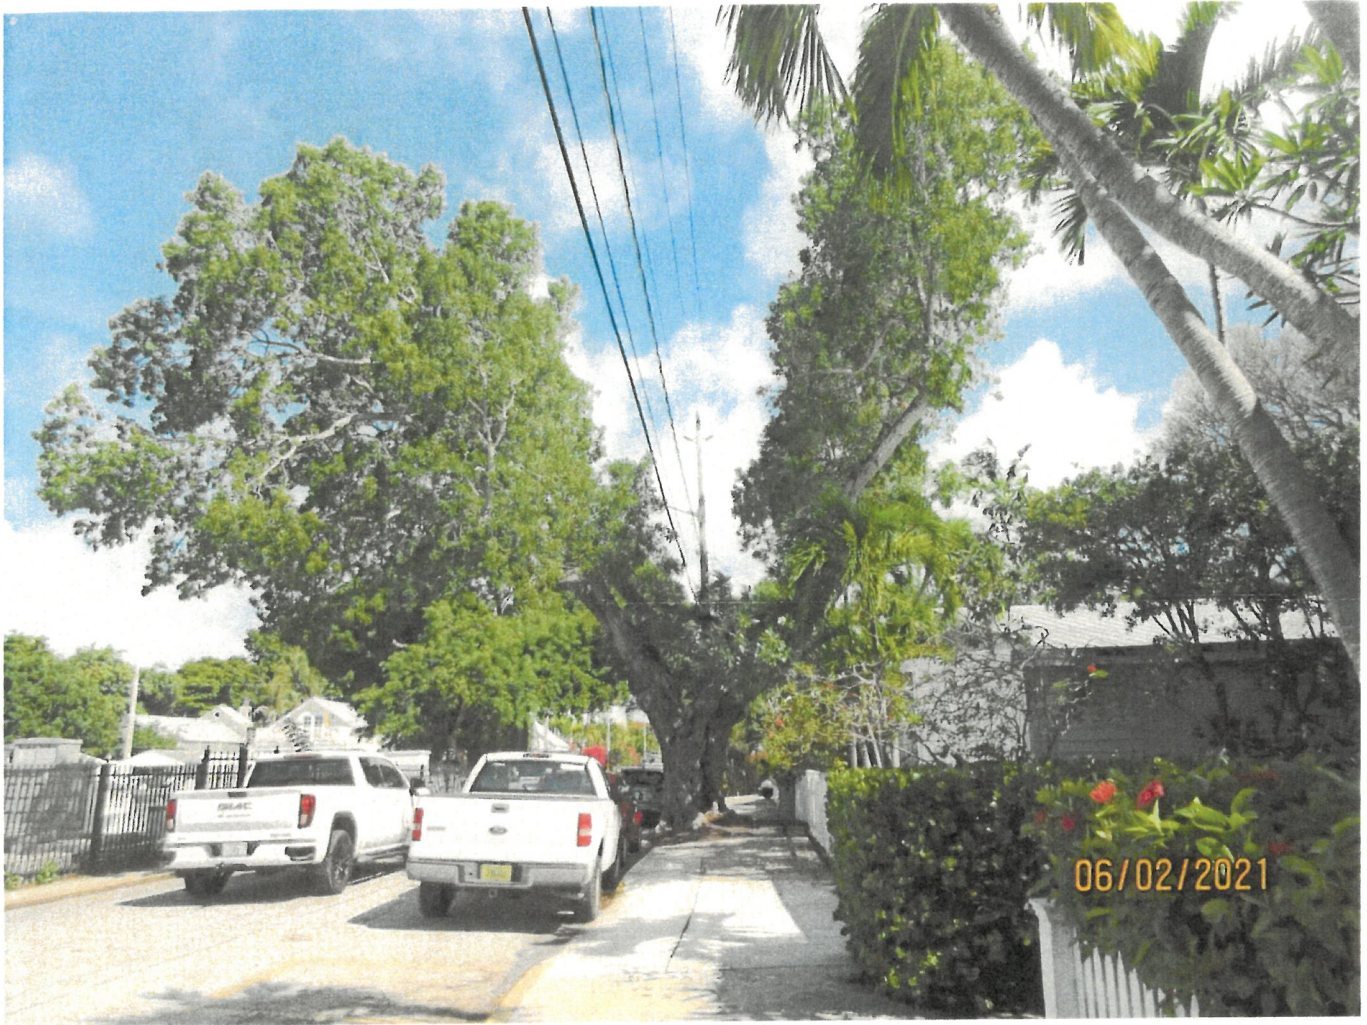
Photos #17 – View of whole tree canopy after trimming. Community Services will need to trim/lift branches on street side.
