**Building Inspection Report and Schedule of Repairs**

## Inspection Report

**Property Address:**  
231 Margaret St.  
Key West Fl. 33040

**Conch Republic Home Repair Inc.**

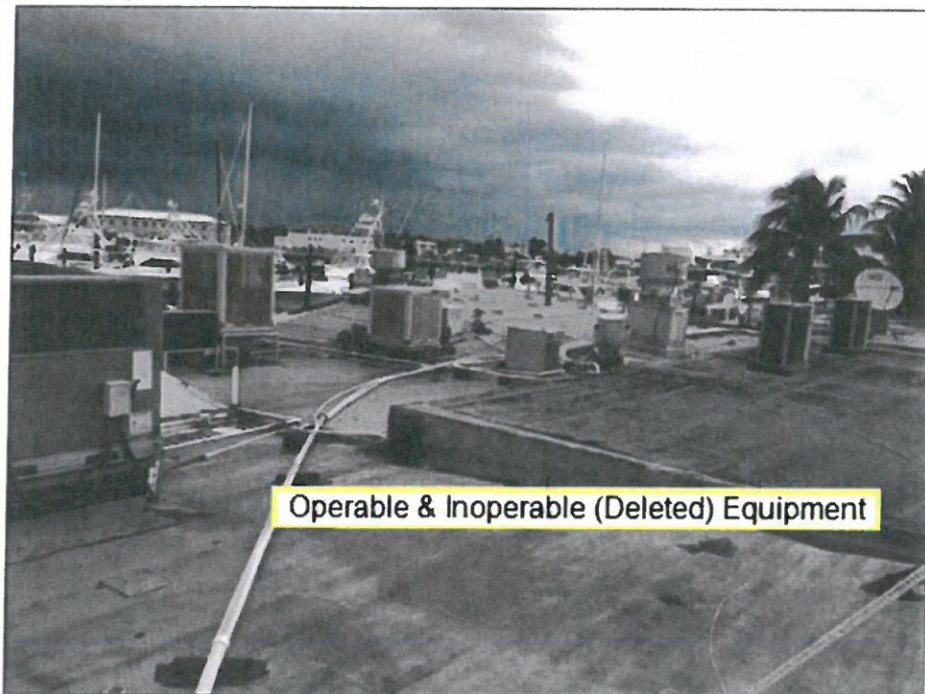
1.0 Picture 1 Roof

1.0 The roof covering on the building was an extremely poor condition. A lot of abandoned/deleted equipment was left on the roof at some point in the past.

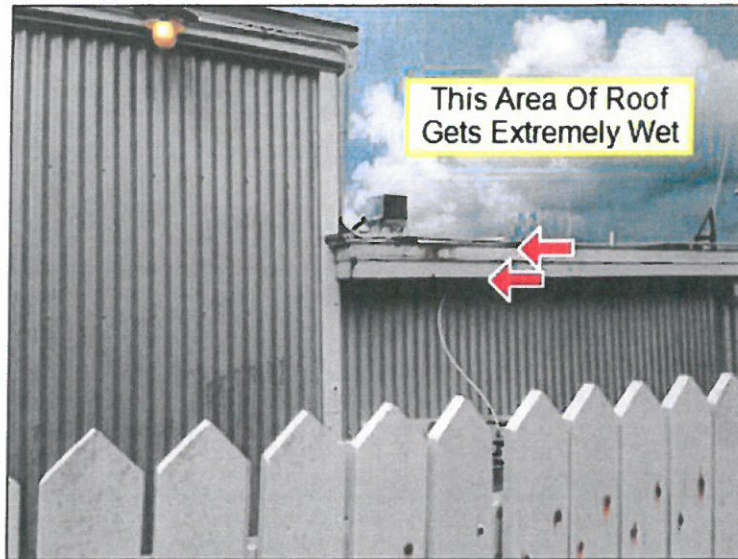
1.1 Picture 1 NE Side Of Building

1.1 The roof flashings on the building was also extremely poor condition. Two areas of the most concern are shown in this report as being extremely wet areas and should be dealt with as soon as possible.

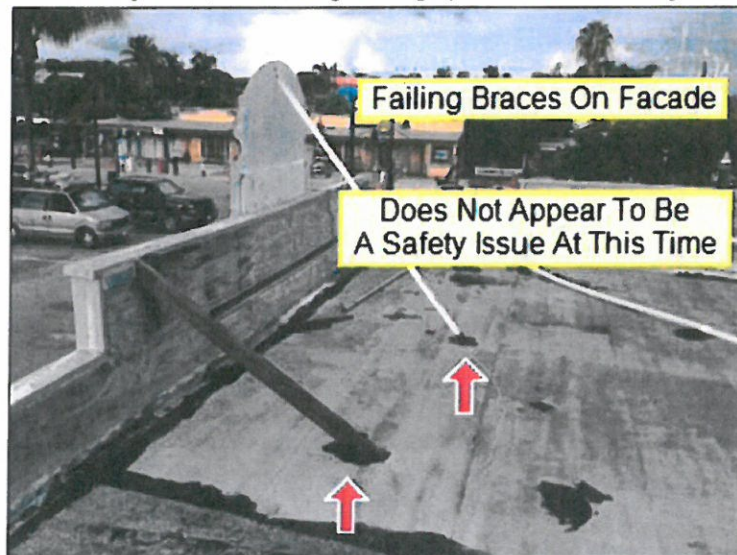
1.3 Picture 1 Facade

1.3 Although I don't believe it's a safety issue, the bracing holding up the facade is failing

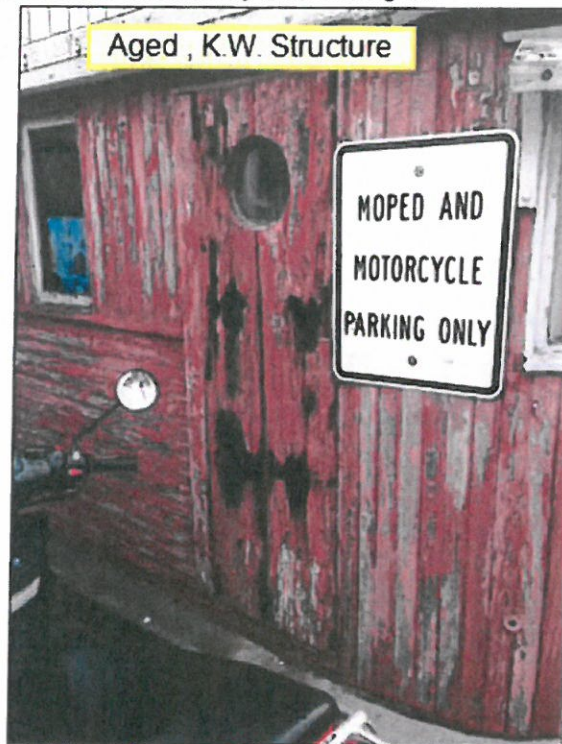
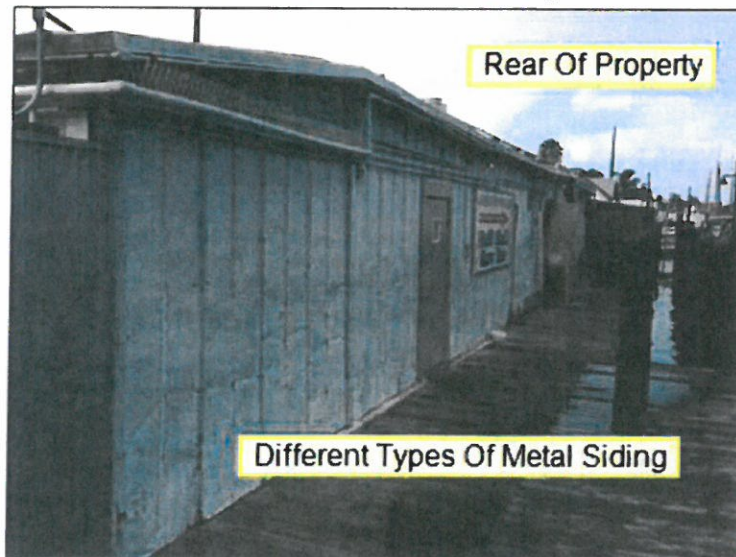
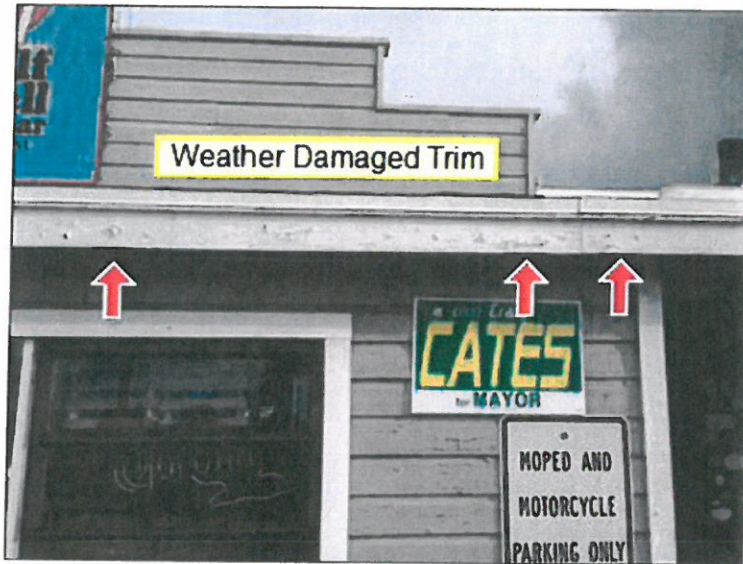
2.0 This is a somewhat typical waterfront historic restaurant in Key West Florida. The exterior of the building is indeed in poor condition but was probably meant to be left that way to some degree.

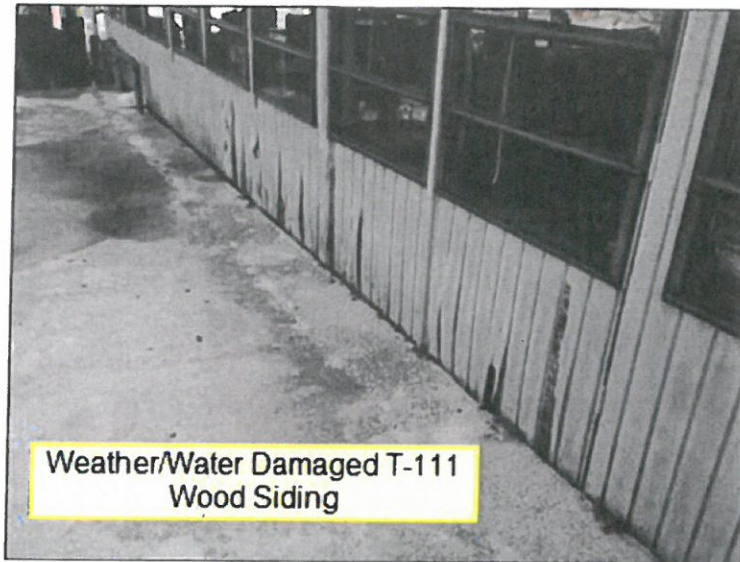
2.0 Picture 5 Wall Cladding

Weather/Water Damaged T-111  
Wood Siding

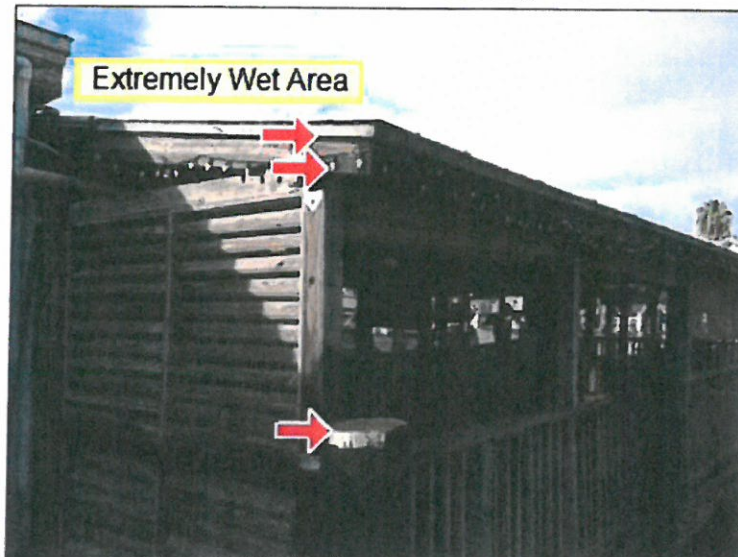
2.0 Picture 6 NW Side Of Building

Extremely Wet Area

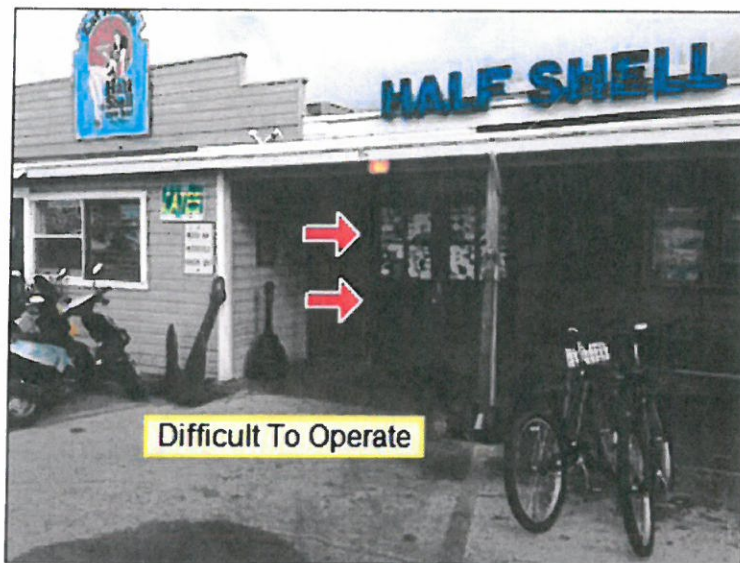
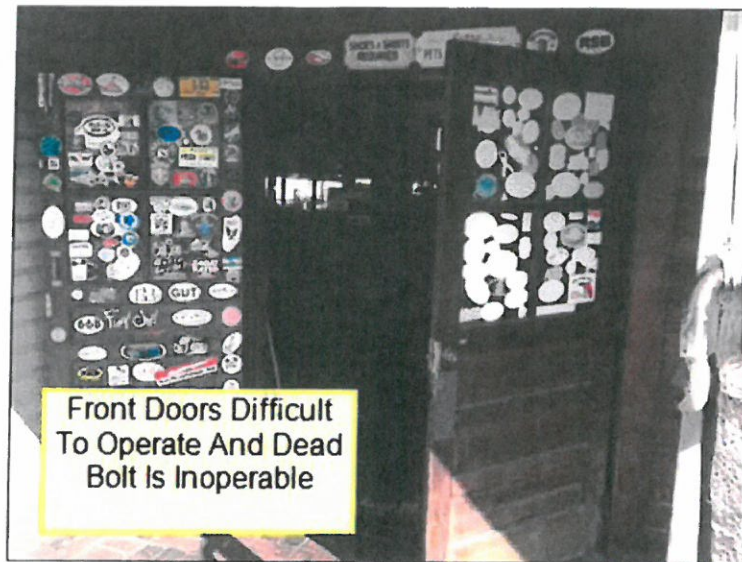
2.1 The double front doors are extremely difficult to operate.

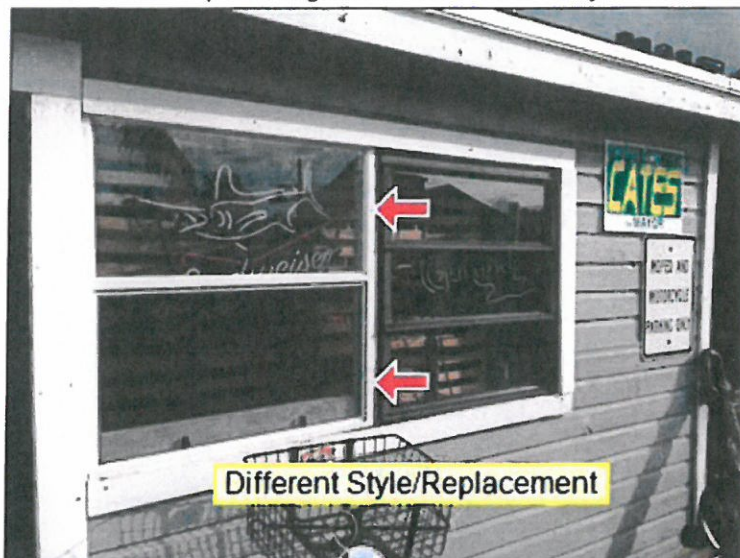
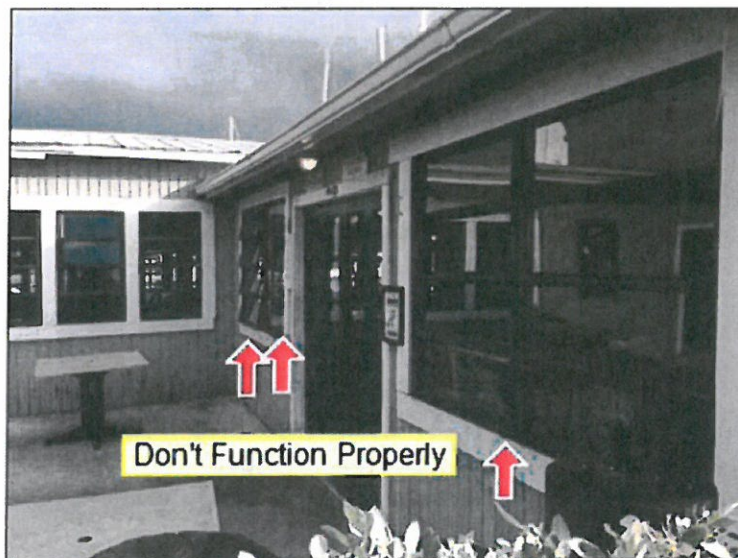
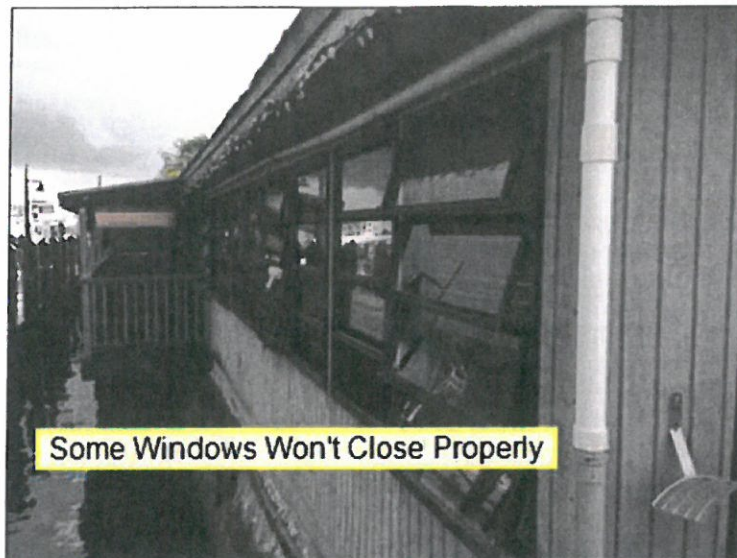
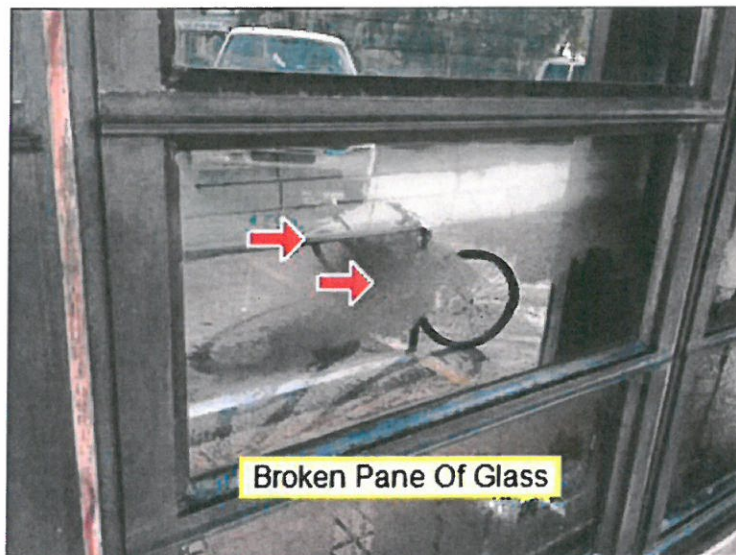
**2.2** The windows throughout the restaurant are in poor condition. Most of the hardware is missing or inoperable. A lot of the windows could not be closed. One of the panes of glass out front was actually broken as shown in picture number four.

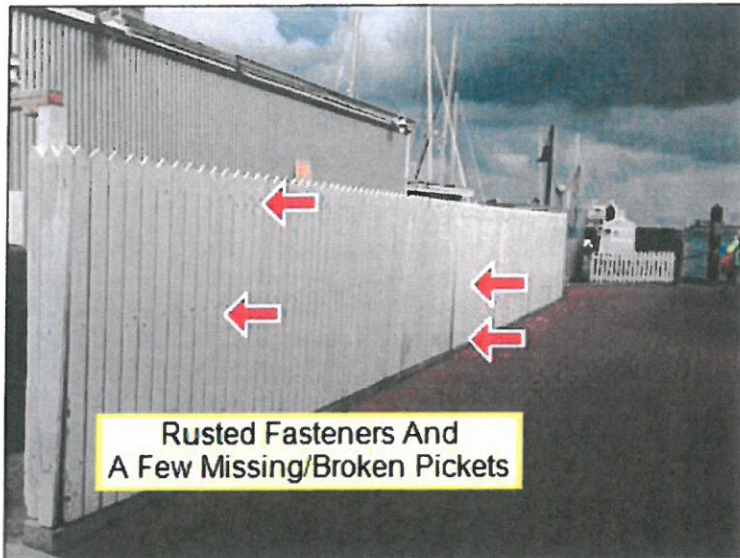
2.3 Picture 2 Fence

The fence along the northeast side of the property was found in fairly good condition although the fasteners are rusted and a few pickets are loose or missing.

**Rusted Fasteners And  
A Few Missing/Broken Pickets**

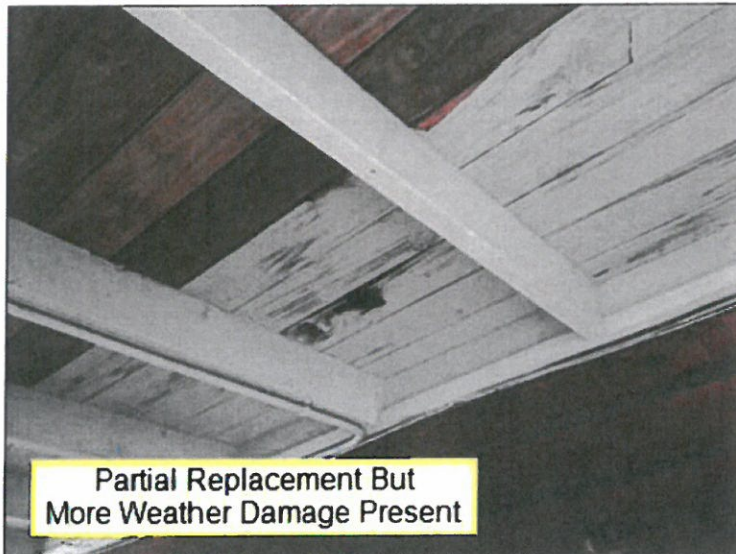
2.3 Picture 3 Front Porch Ceiling

**2.3** Although the front porch cover seems to have been repaired recently a lot of rot still remains.

**Partial Replacement But  
More Weather Damage Present**

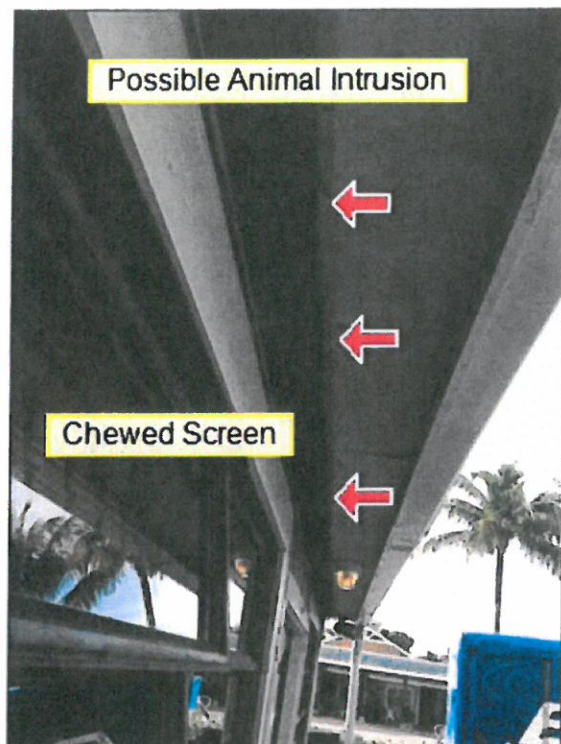
**2.5 Picture 1 Soffits**

**2.5** The soffit around most of the building was found to be in poor condition. Most of the screen has been ripped or chewed which could invite animal activity.

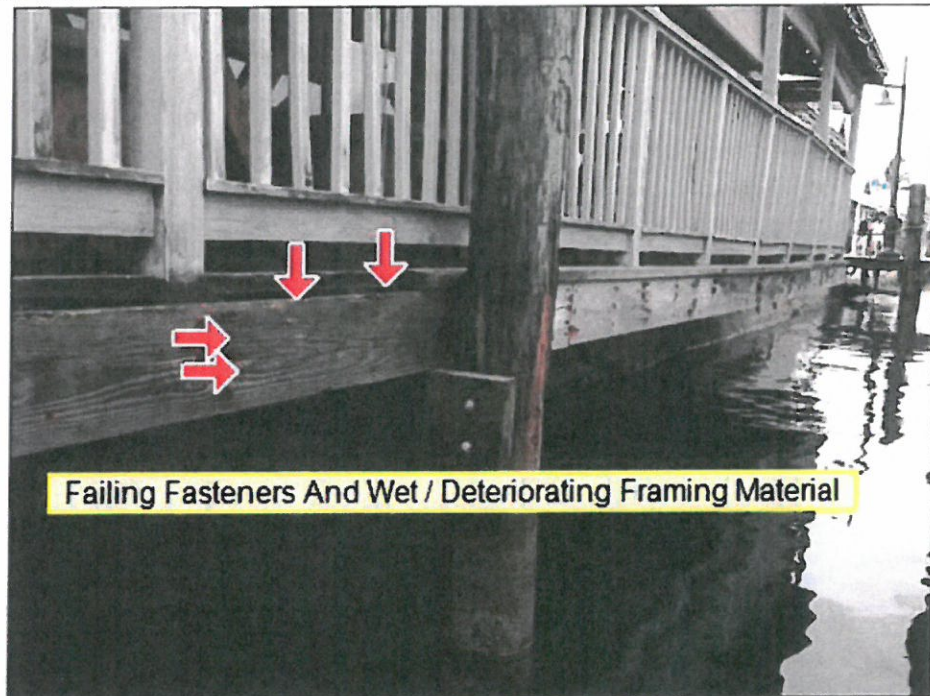
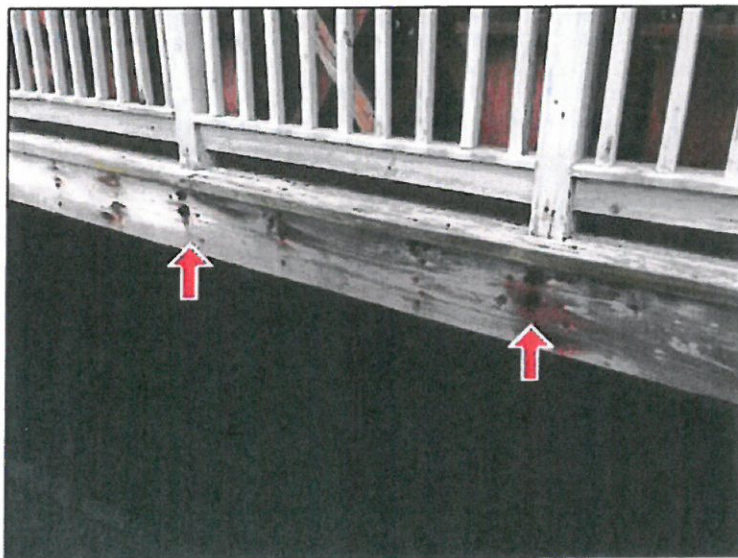
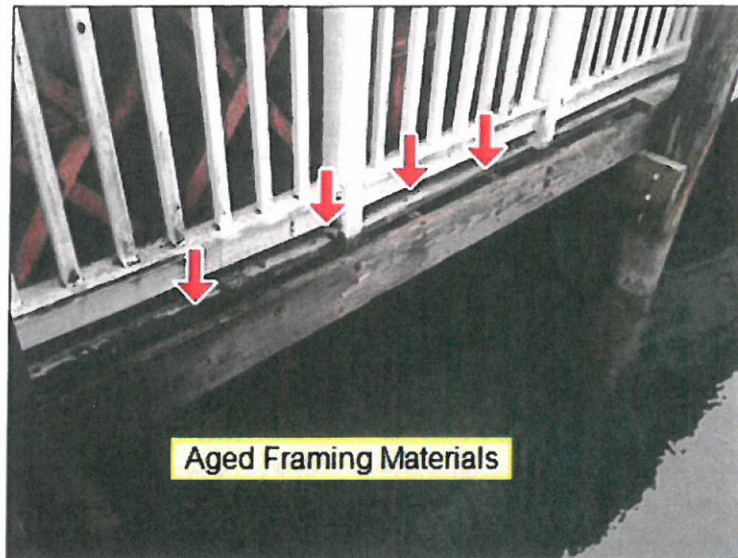
3.2 The cantilever structure of the restaurant appears to be structurally sound at this time. A number of fasteners are rusted and the framing material does show signs of water damage and it is my recommendation a structural engineer be contacted for further evaluation and recommendation.

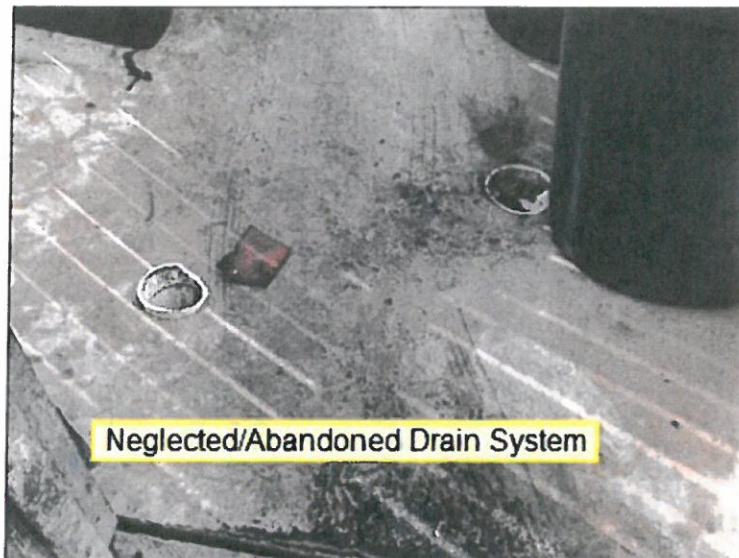
4.0 Picture 1 Drain

**4.0** Picture number one shows two PVC drains that appear to have been discarded and left open.

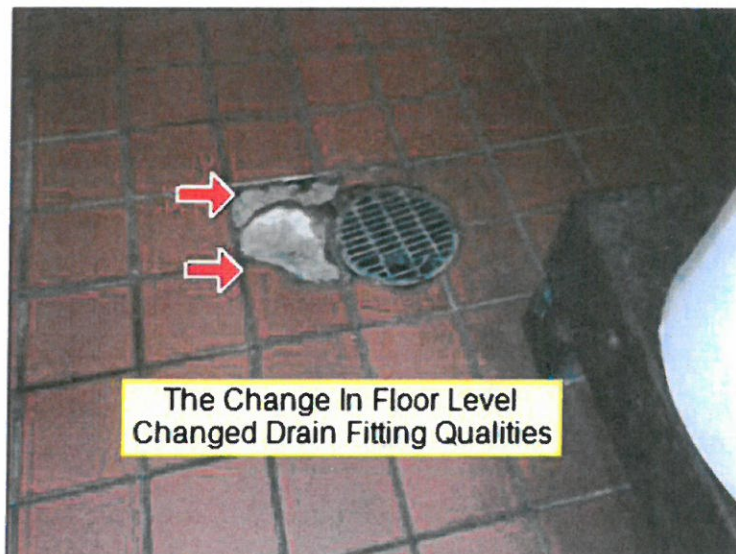
4.0 Picture 2 Kitchen Drain System

The changing of floor heights throughout the kitchen area has made the drain system faulty.

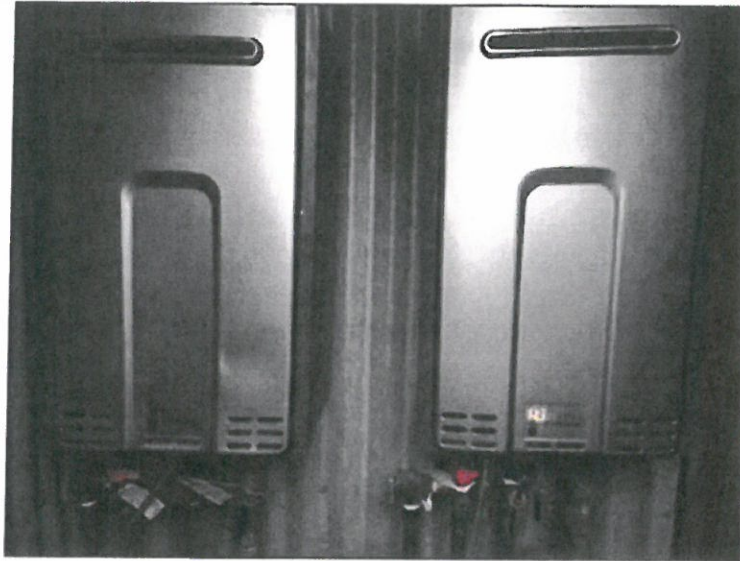
**4.2 Picture 1 2 Tankless Units**

**4.2** The two tankless water heaters shown in picture number one were difficult to access for further inspection due to clutter in the area.

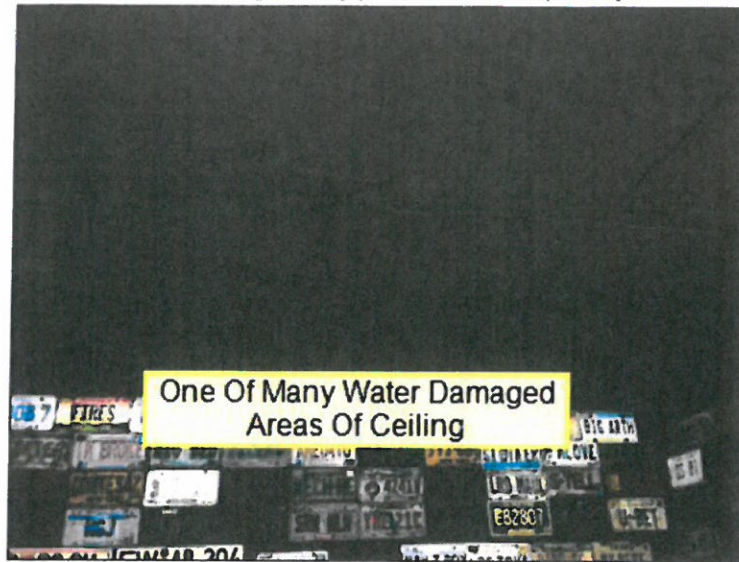
5.0 Picture 1 Ceiling

5.0 The ceilings throughout the restaurant are in generally poor condition especially in the kitchen area..

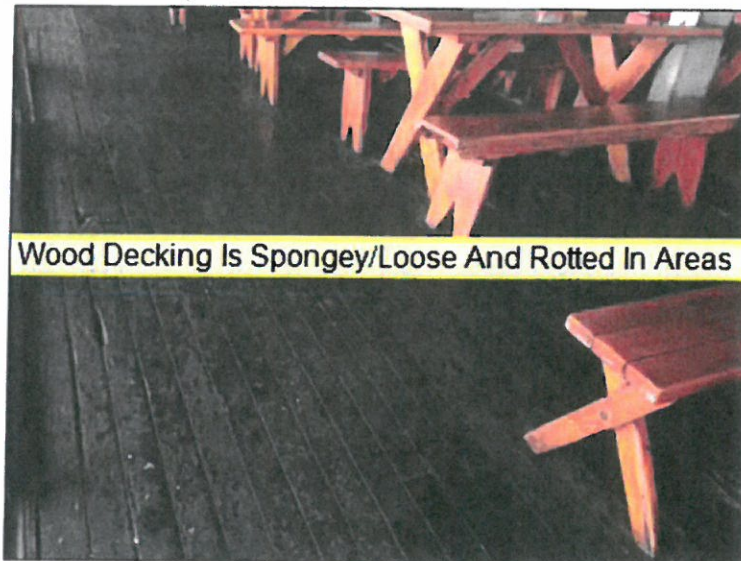
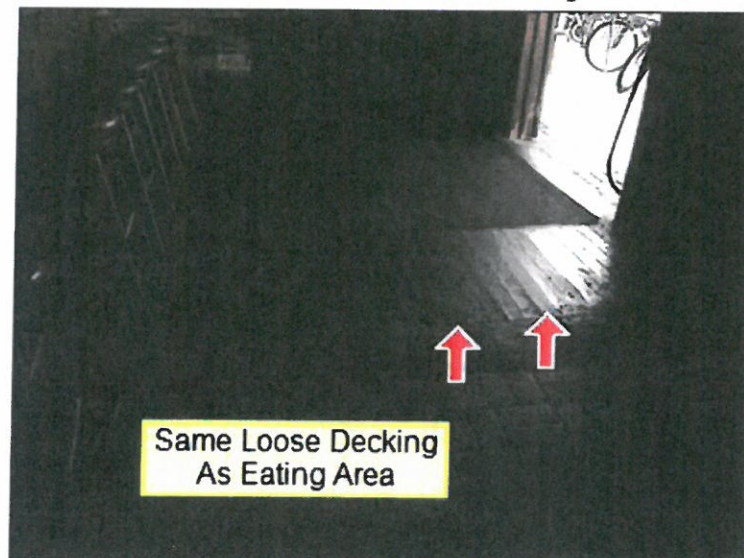
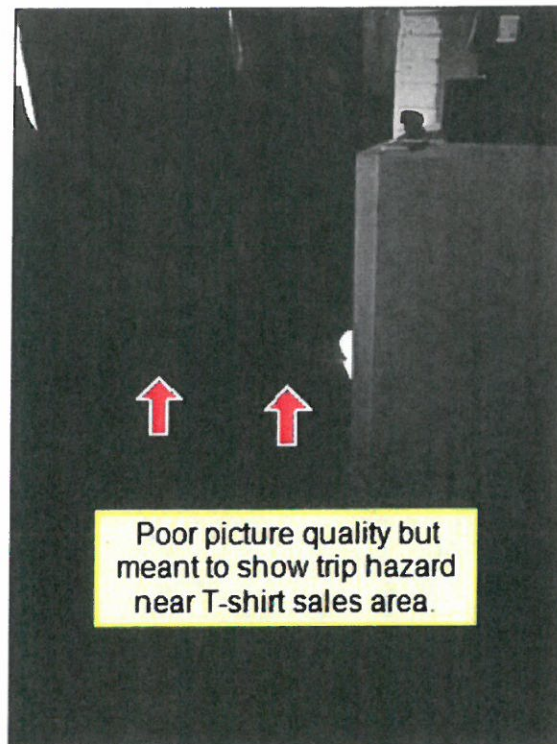
5.2 The floors throughout the restaurant are obviously aged and stand in different degrees of condition. The areas of wood decking painted black are loose and in the process of failure.

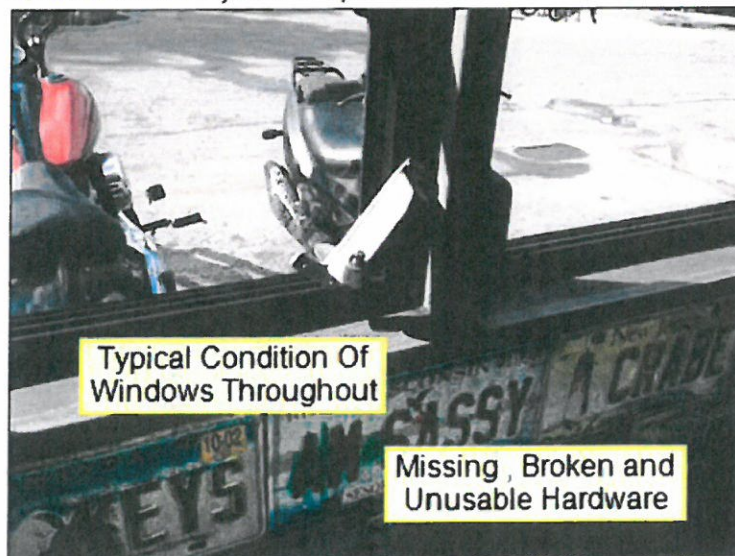
5.4 Picture 1 Windows

5.4 The windows throughout the restaurant are in extremely poor condition. a large percentage are either missing hardware, have hardware that doesn't work or just don't operate at all.

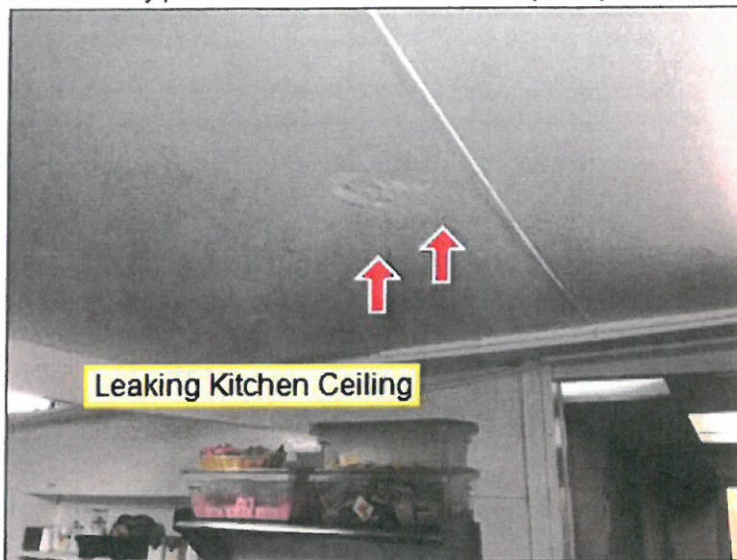
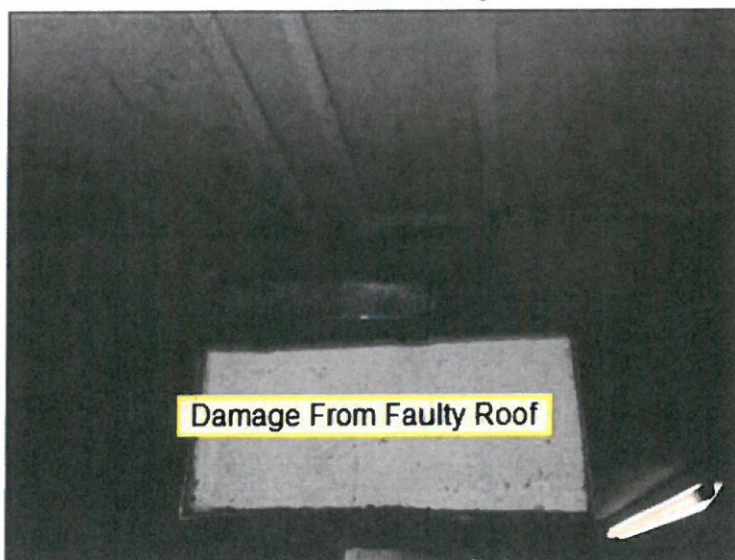
6.0 The kitchen ceilings are in extremely poor condition. There are obviously many areas that leak due to the faulty roof.

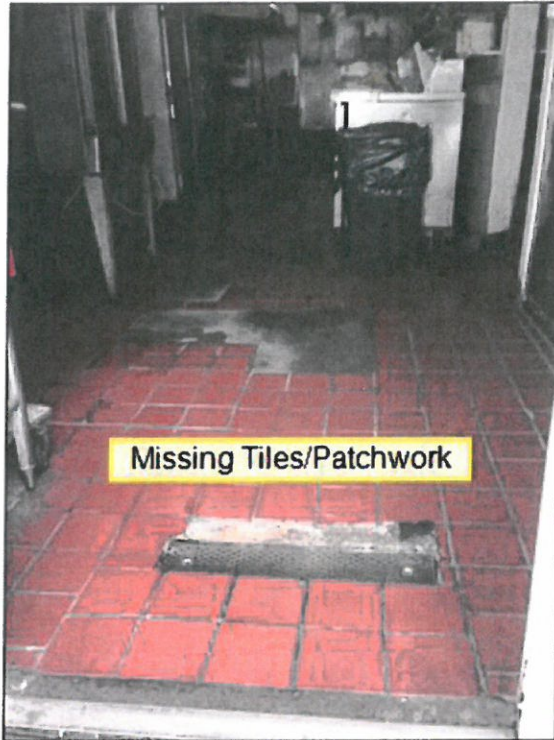
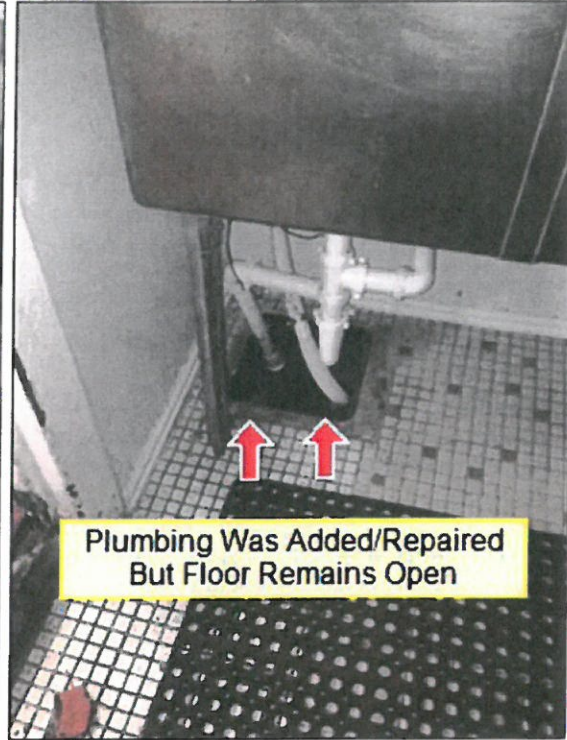
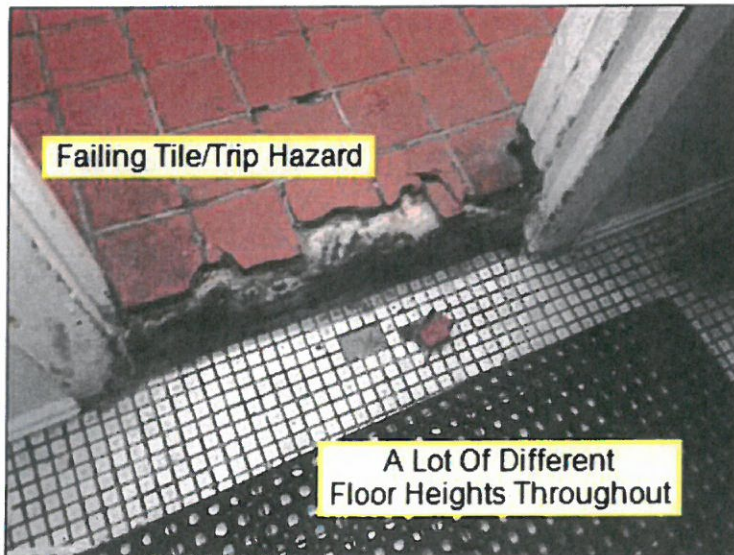
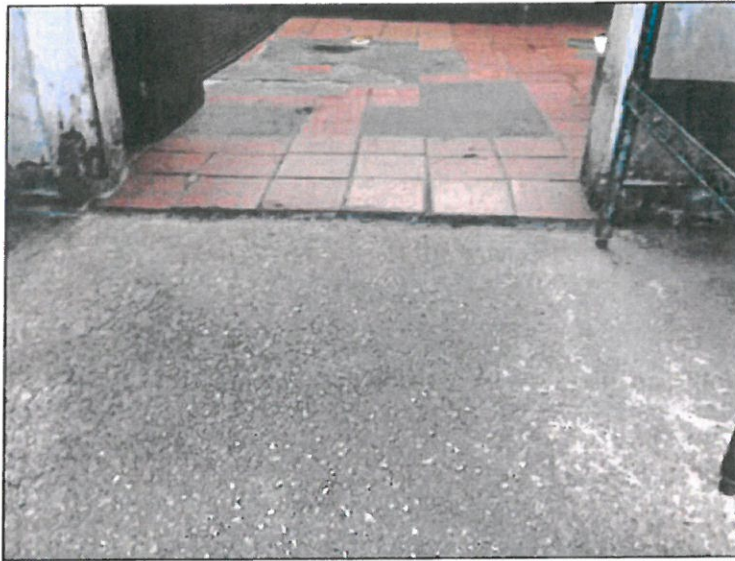
6.2 The kitchen floor in this aged building has obviously undergone quite a few changes over the years.

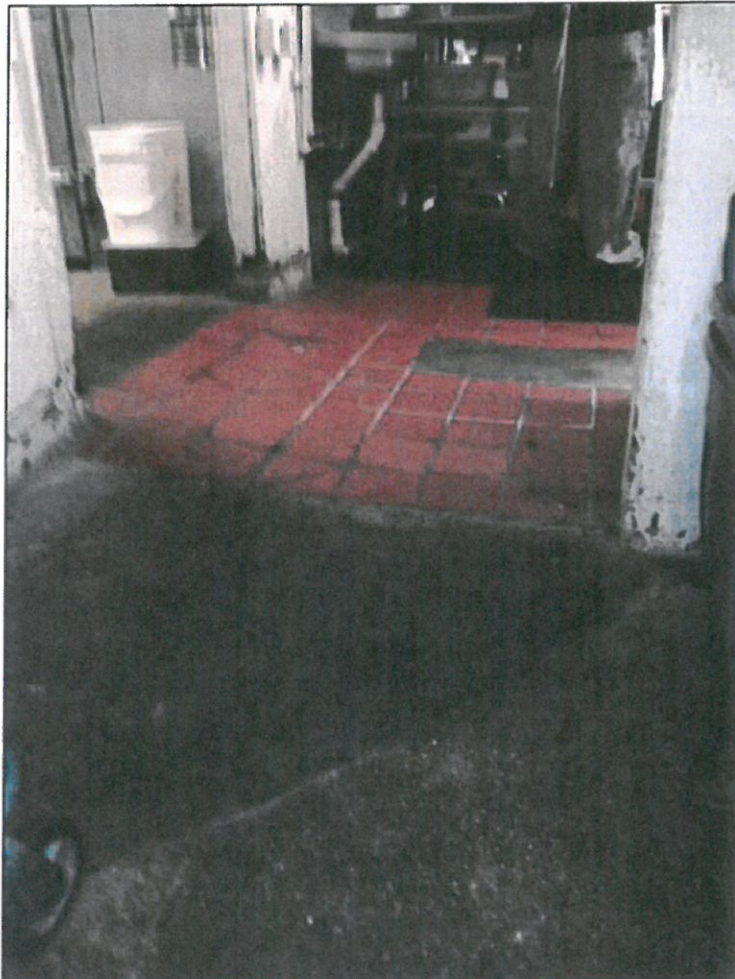
6.2 Picture 5 Typical Flooring Situation

Flooring in this area Does Have Problems  
But Some Repairs Have  
Been Made

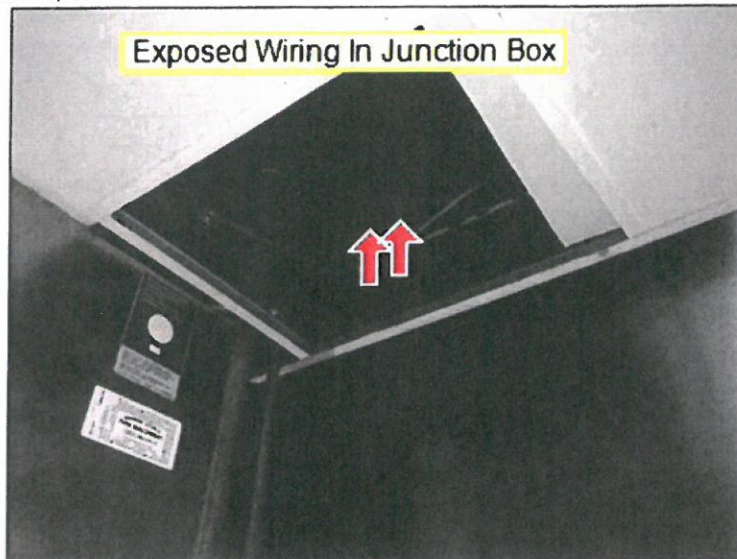
6.8 Picture 1 Kitchen Ceiling

6.8 The outlets and switches throughout the restaurant were in an aged condition and you will notice the exposed wiring in the kitchen ceiling as shown in picture number one.

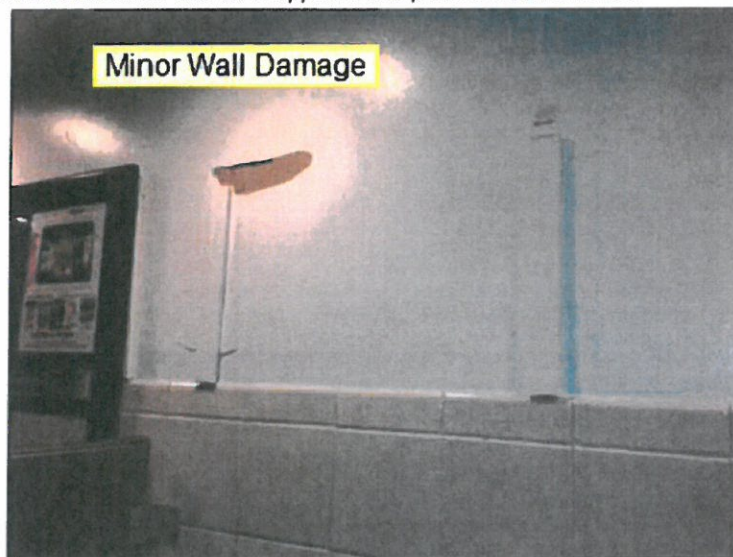
7.1 Picture 1 Mens Bathroom

7.1 Minor damage to the men's bathroom wall as it appears the picture was removed.

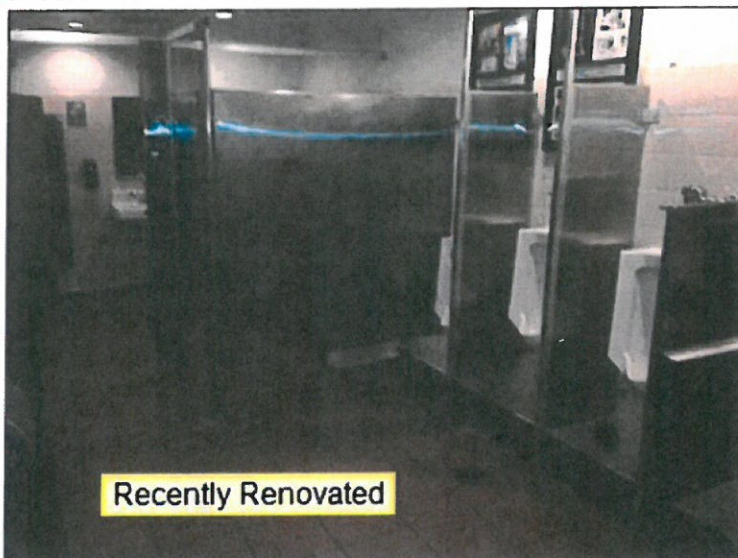
7.5 Picture 1 Mens Bathroom

7.5 The men's bathroom appears to have been recently renovated and was found in good working order with the exception of an open ground at the wall outlet.

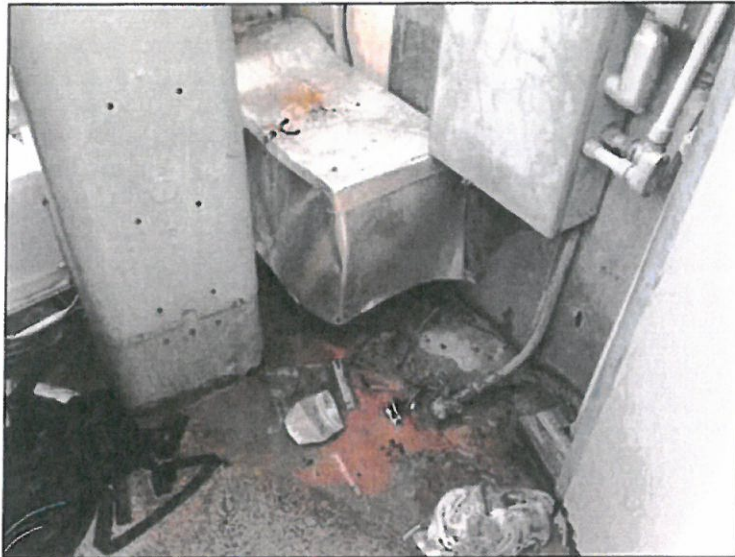
**8.0 Picture 1 Service Entrance**

**8.0** Again, the service entrance is in a poor cluttered , overloaded condition. Consulting a licensed electrical contractor for further evaluation and recommendation is suggested.

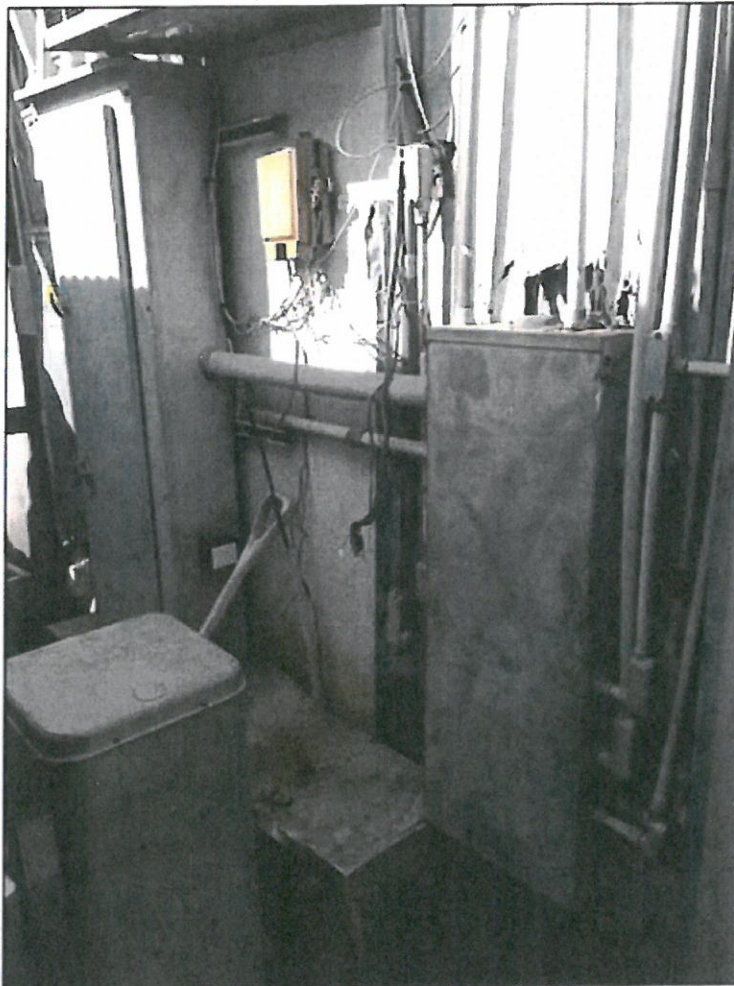
8.1 Picture 1 Underground Service Entrance

8.1 The service entrance as a whole was in poor condition. Loose panels, loose panel covers, overloaded circuits and an extreme amount of moisture in that area makes a poor overall situation.

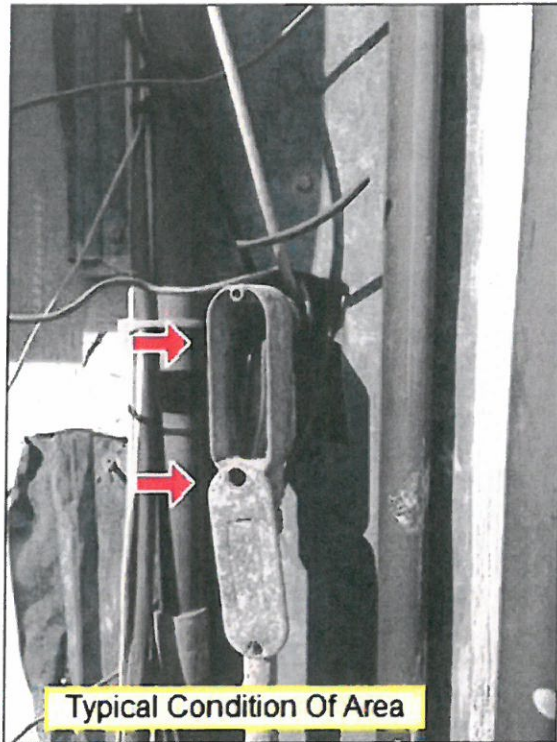
8.1 Picture 2 Exposed Wiring

Typical Condition Of Area

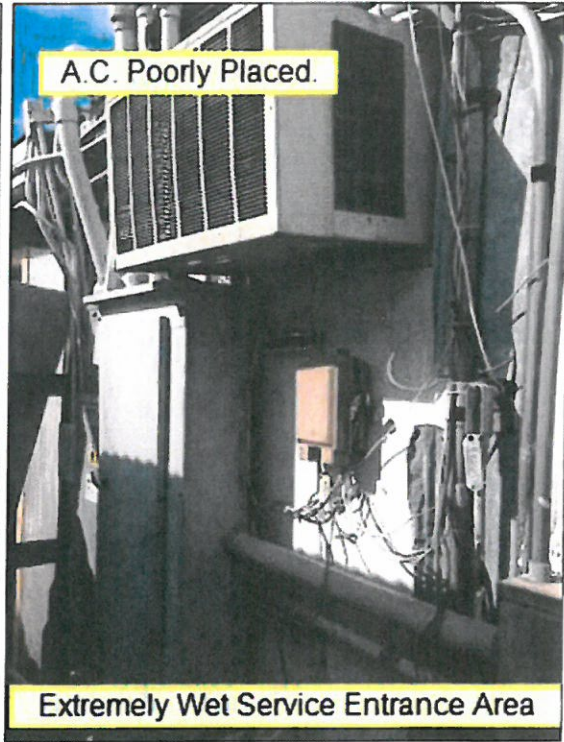
8.1 Picture 3 Main Distribution Panel

A.C. Poorly Placed.

Extremely Wet Service Entrance Area

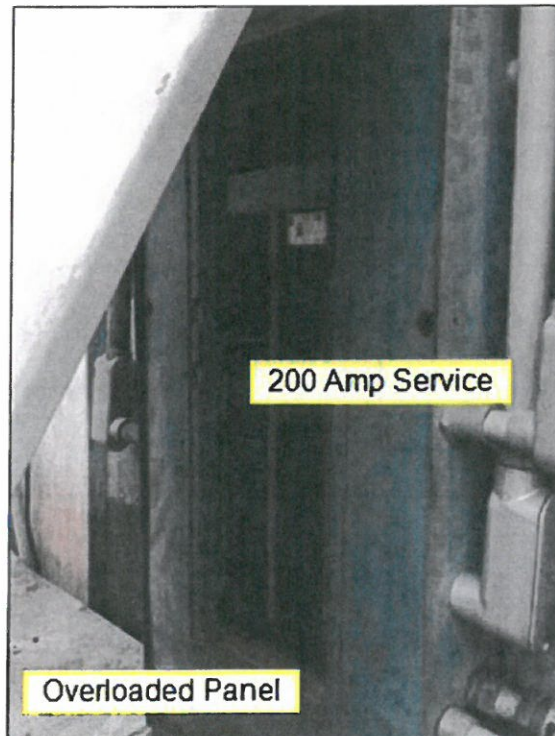
8.1 Picture 4 Distribution Panel

200 Amp Service

Overloaded Panel

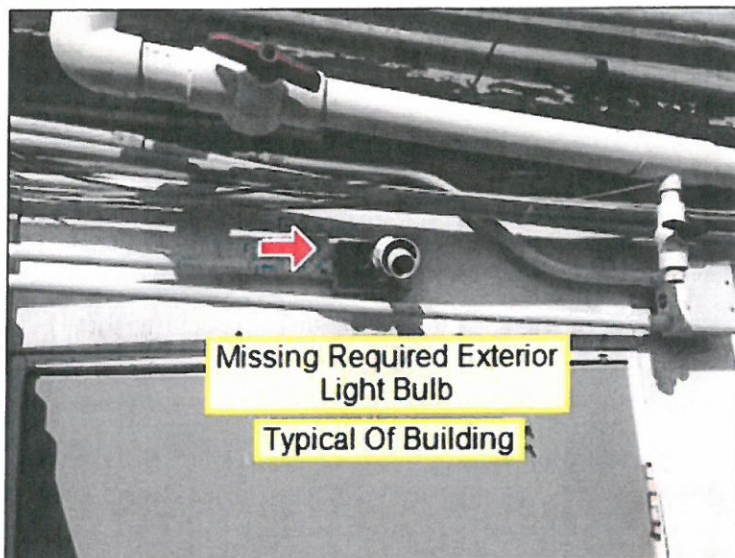
8.3 Picture 1 Maintenance Issues

**8.3** This is an old building which made determining functional equipment as opposed to operational equipment very difficult. A lot of the existing conduit/PVC and wiring are obviously obsolete but just left behind. Picture number one shows a typical minor issue at the restaurant.

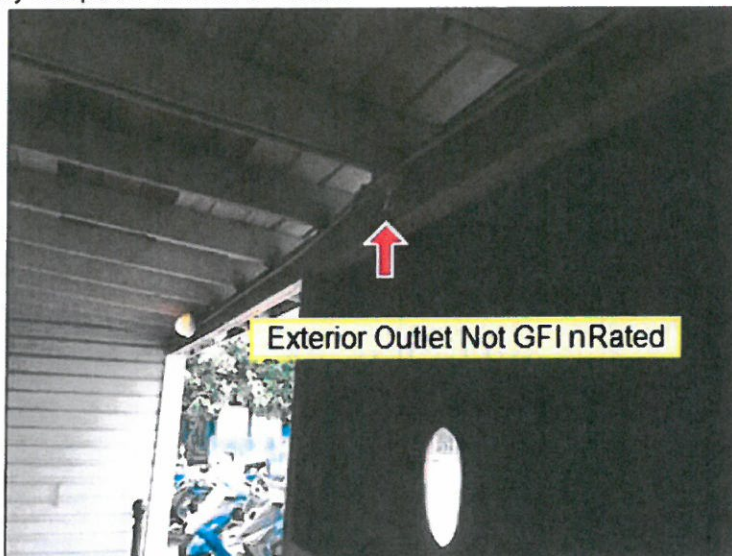
8.4 Picture 1 Front Entry

**8.4** The overhead front entry receptacle was not GFI rated.
