**Building Inspection Report and Schedule of Repairs**

## Inspection Report

**Property Address:**  
231 Margaret St.  
Key West Fl. 33040

**Conch Republic Home Repair Inc.**

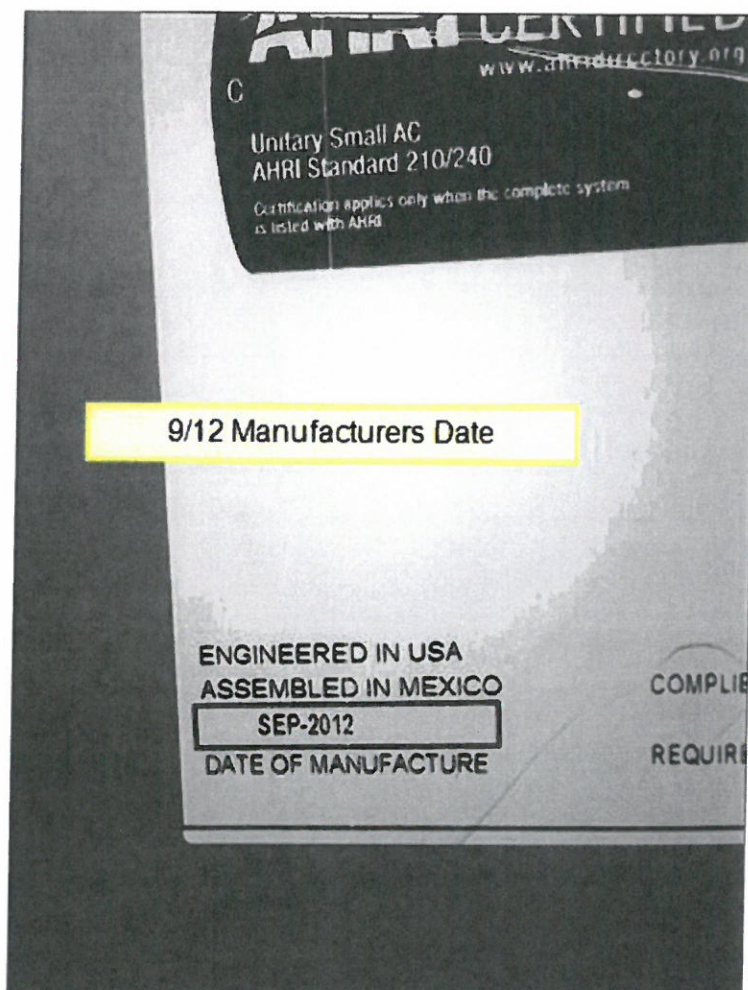
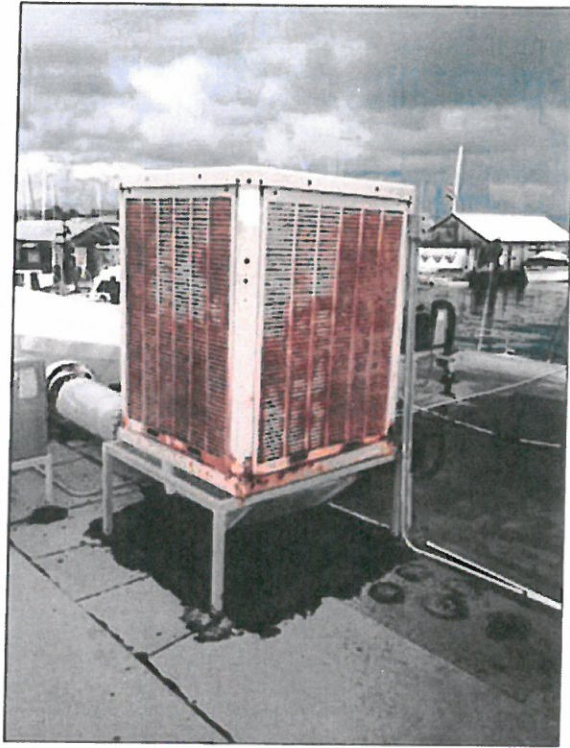
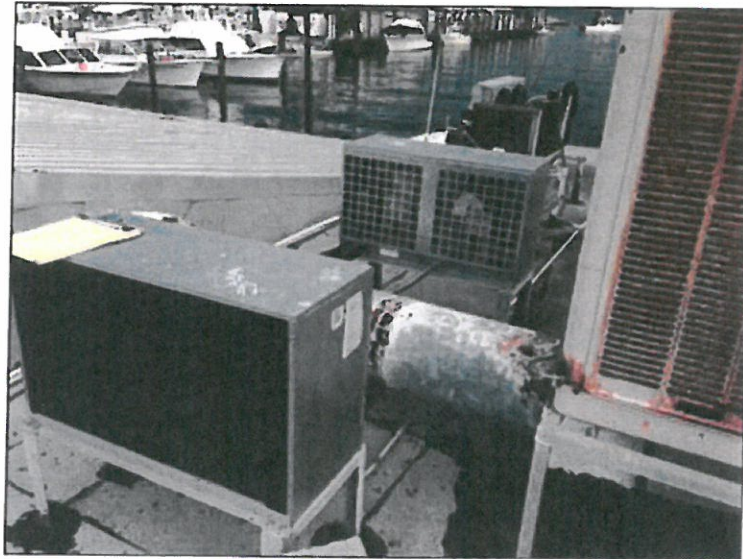
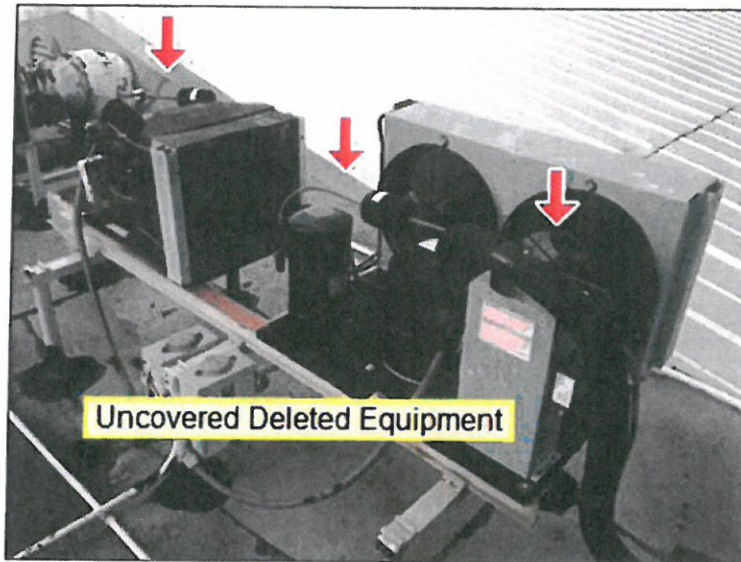
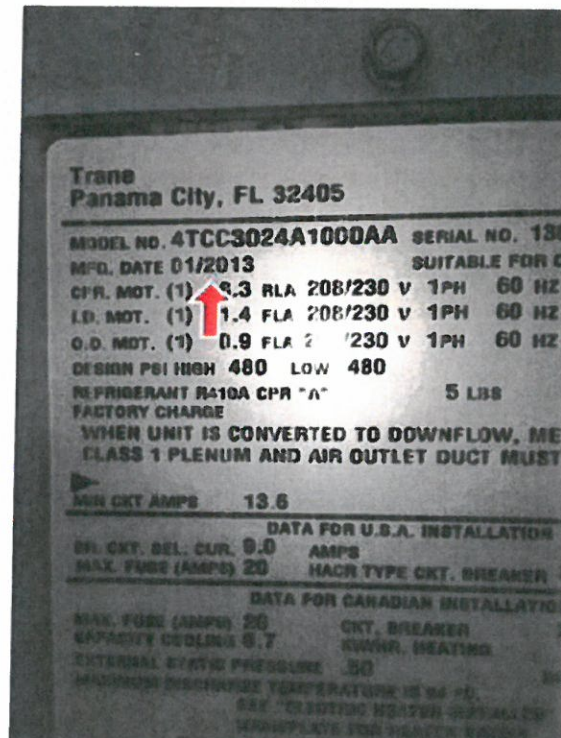
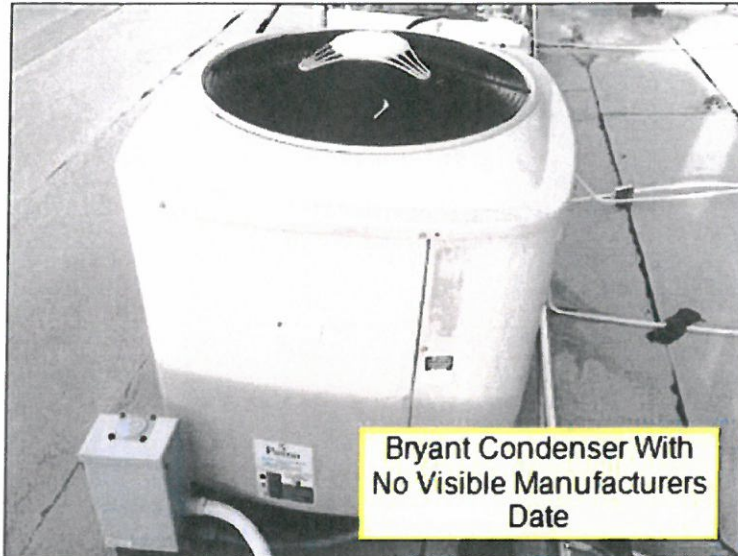
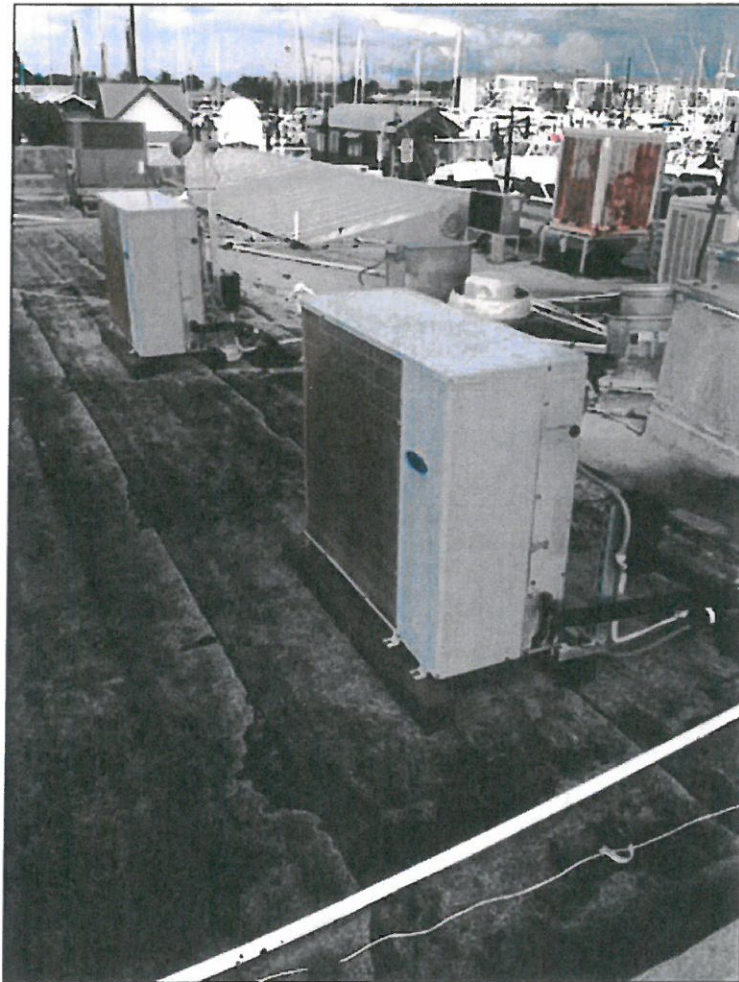
**9.0** A lot of the cooling equipment on the property is obsolete. A lot of cooling equipment is in good working order with manufacturer's information present, and a lot of cooling equipment on the property is functional yet no records of manufacturers information could be found.
