MEMORANDUM

RE: 2023 Flagler Avenue

FROM: Karen DeMaria, Urban Forestry Manager, City of Key West

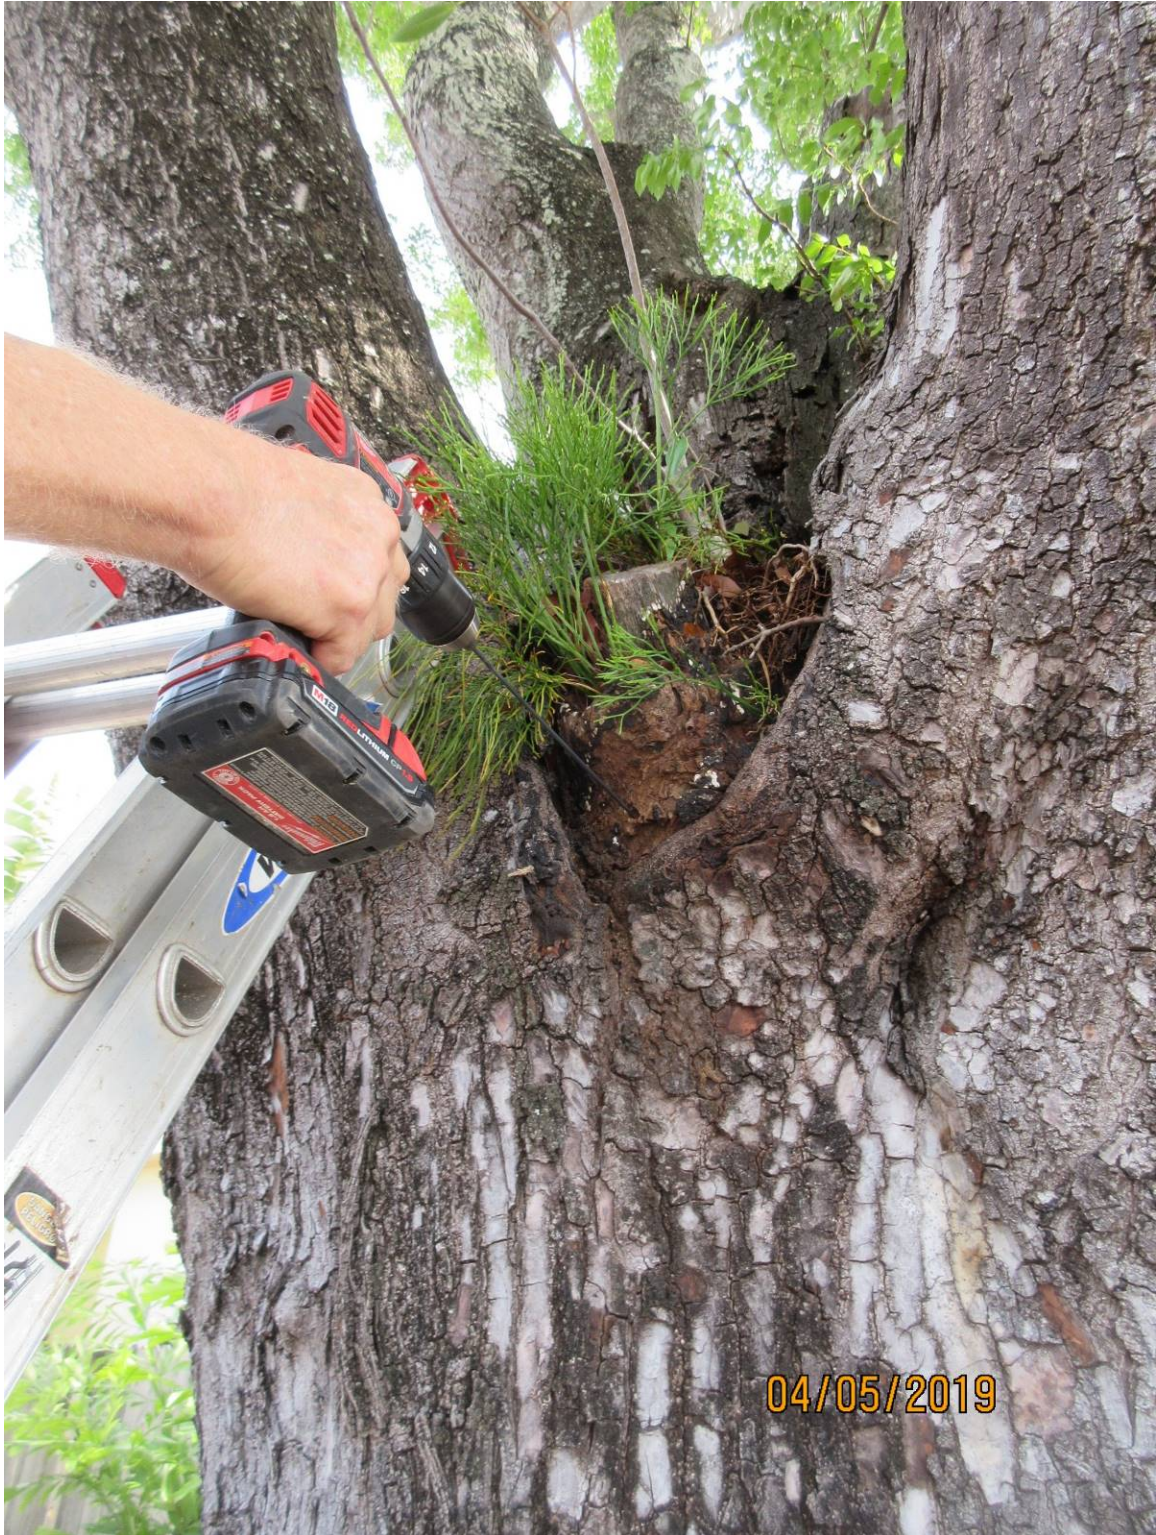
Drill location above- 2" soft then hard wood.

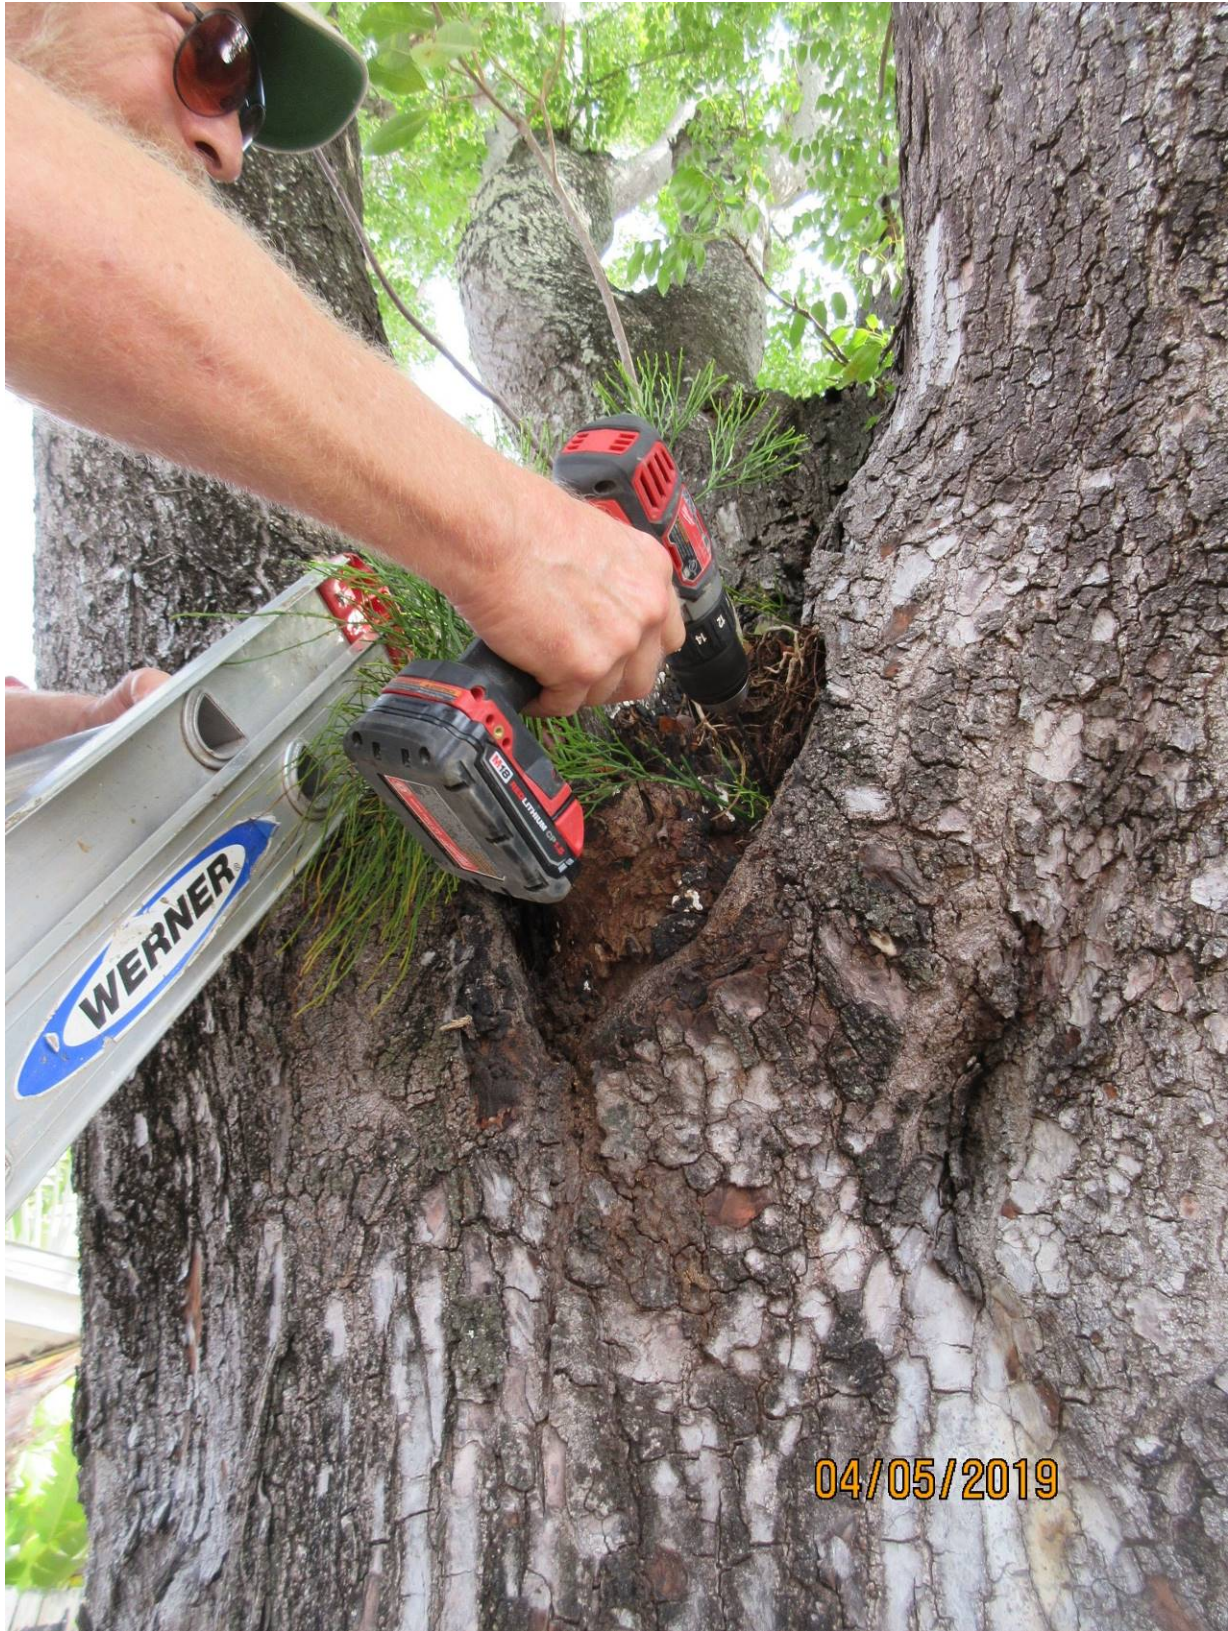
Drill location above-drill bit easily into trunk-10" soft wood.

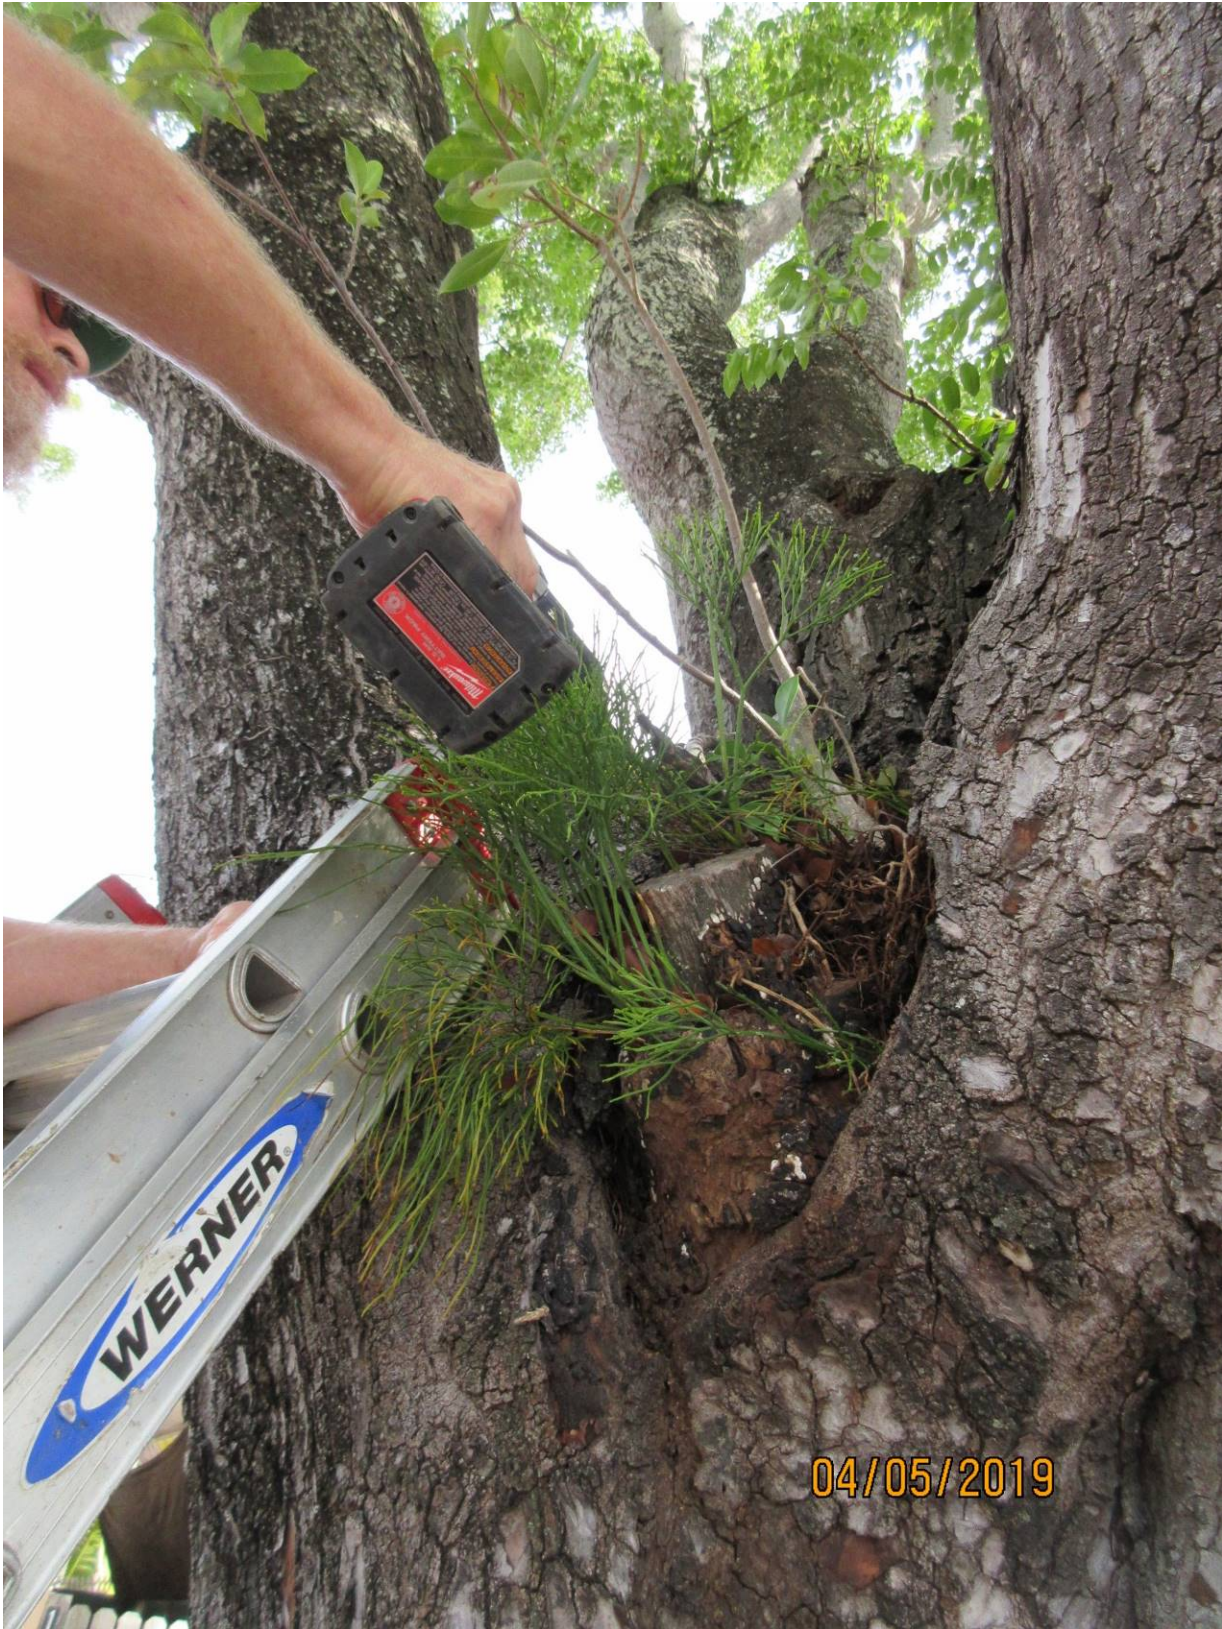
Drill location above: drill bit easily into the wood-10" soft wood

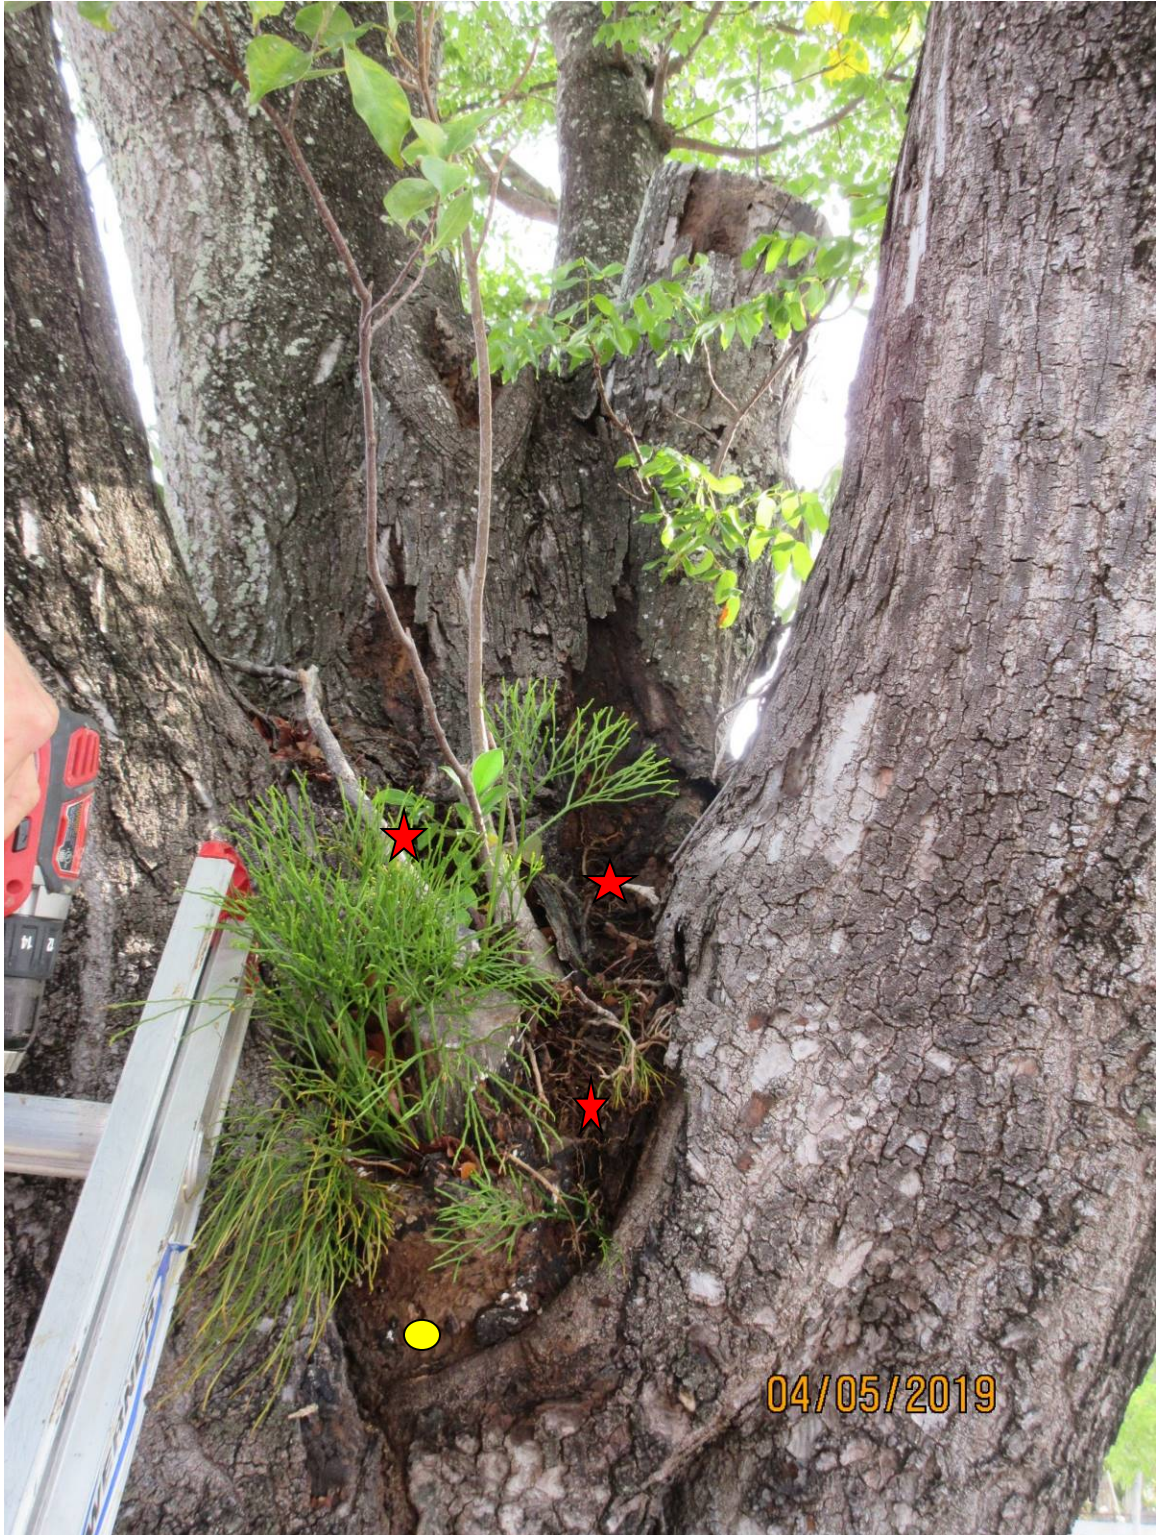
★: Location of soft/decay wood as per drill bit inspection

●: Location of hard wood as per drill inspection

Close up of crotch area

Ant/decay area

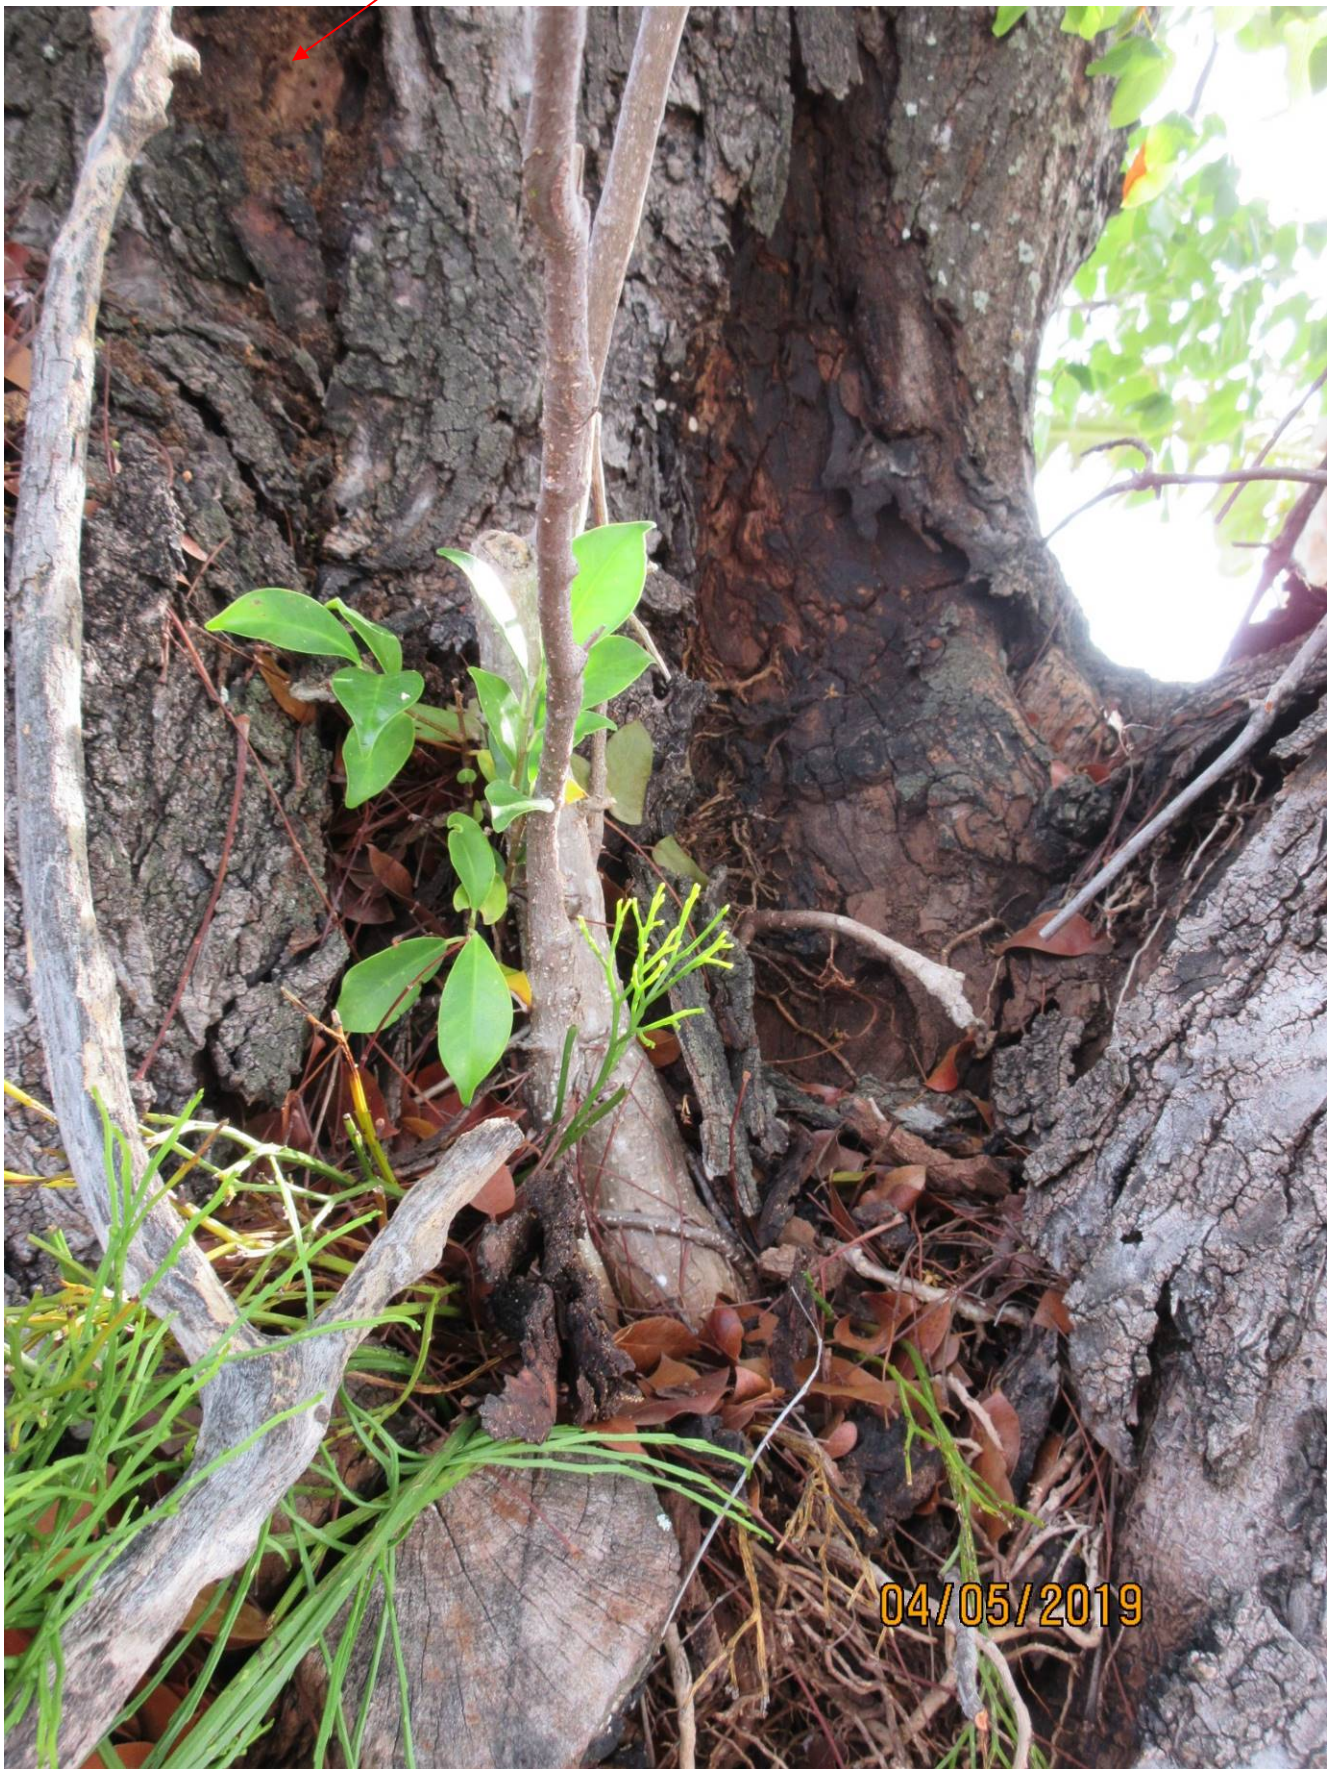
Close up of ant/decay area
