## Structural Assessment Report for the existing Edward B. Knight Pier

Property Address:  
**Edward B. Knight Pier**  
**1900 White Street, Key West, FL 33040**

AUGUST 2025

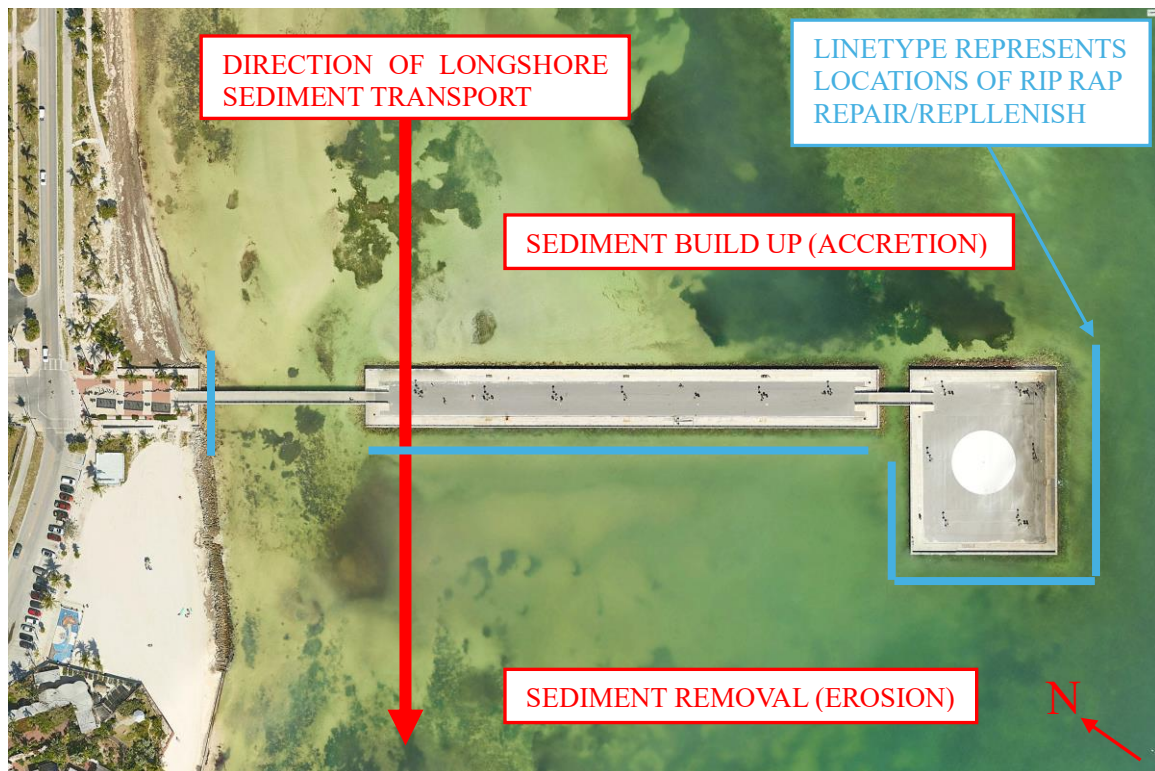
**Figure 5:** Site Map: Sediment and Rip Rap (Google Earth Imagery Date: 2/2/2018)

Rip rap is present at the perimeter of the pier. Rip rap re-directs wave energy, mitigating sediment erosion and wave impact on the structure. The existing rip rap is in fair condition, however there are some areas that would benefit from rip rap repair/replenishment.

The pier is experiencing sediment build up (accretion) on the east side and sediment removal (erosion) on the west side. This is evident when observing the water depths around the pier. Accretion and erosion occur with all "hard structures" that extend into the ocean. Key West experiences a predominant east-southeast wind, causing east-to-west longshore sediment transport. Therefore, the west side of the pier experiences erosion and is much more susceptible to loss of backfill.

It is recommended that rip rap be repaired/replenished, with a focus on the areas shown in figure 5.

It is recommended that backfill mitigation efforts be focused on the west side of the walkway, as well as the south face of the terminus (due to wave exposure).

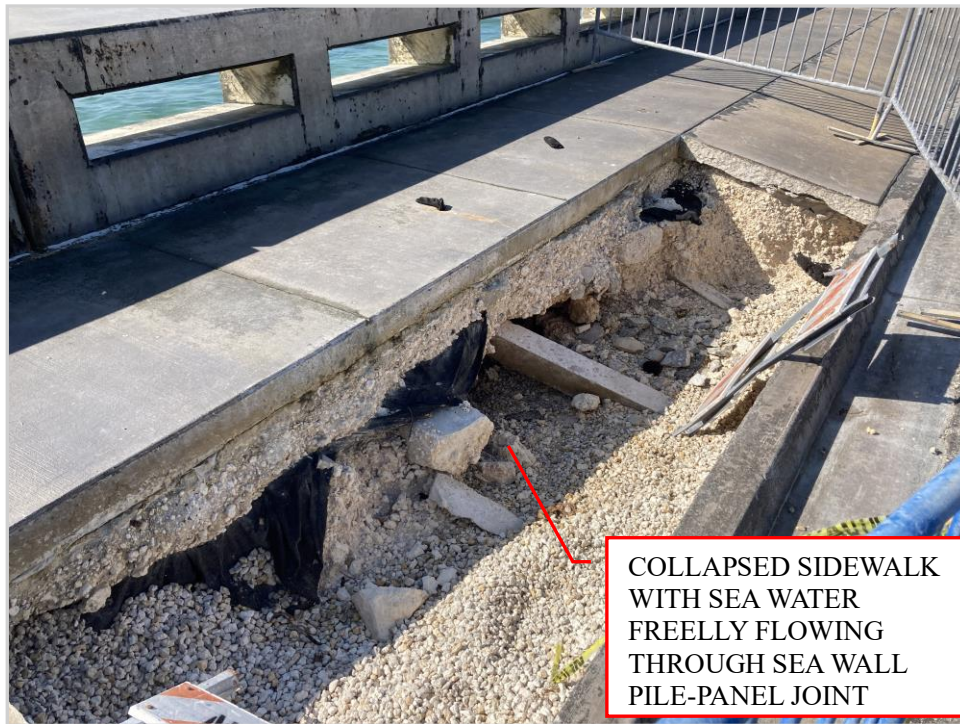
As shown by the typical section above, the Plaza, Walkway, and Terminus are constructed of earth fill with surrounding sea walls. Loss of backfill is causing settlement and partial collapse of the adjacent concrete sidewalk (as pictured below). If loss of backfill is not mitigated, it reduces the structure's capacity to resist wave loads and could lead to collapse of portions of the seawall. It is expected that backfill is being lost through pile-panel joints and undermining of the sea wall panels (where erosion has exposed, or nearly exposed the bottom of the panels). Both of these conditions allow for the flow of water through the sea wall causing loss of backfill.

It is recommended that loss of backfill be repaired and mitigated by excavating limited areas of concern, patching pile-panel joints (from the inside face), replacing backfill with flowable fill, and reconstructing the sidewalks. Additionally, geotextile fabric may be a useful inclusion to mitigate backfill loss.

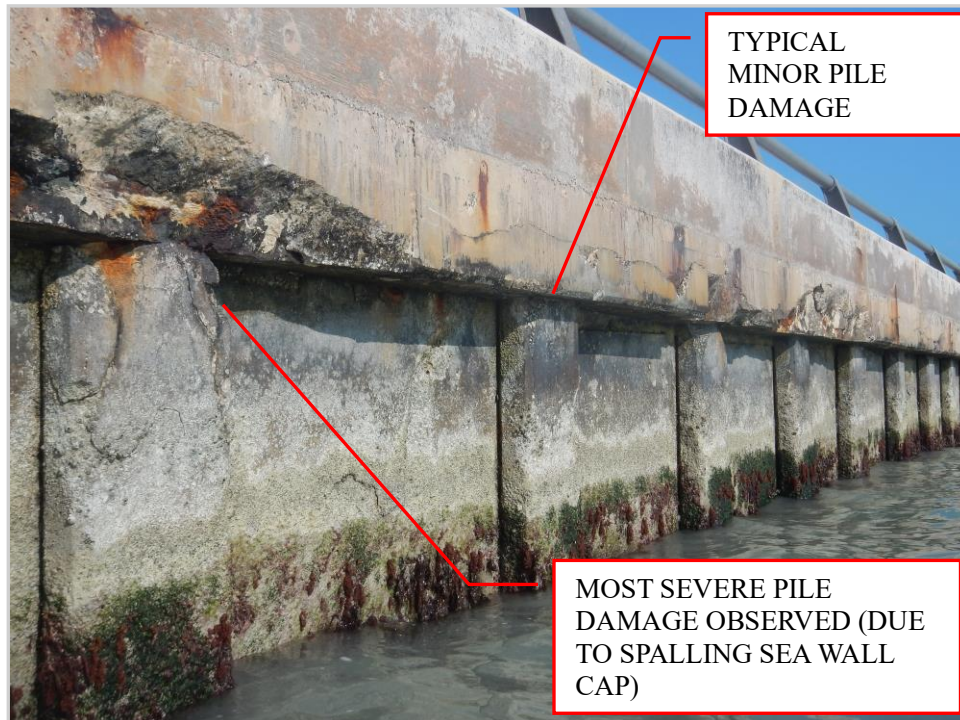
The sea wall is constructed of driven concrete piles (typically "H" piles) with precast wall panels spanning between piles. The pile and wall panel configuration retains the backfill and is tied together with the cast-in-place concrete cap. The piles evidenced minimal damage. However, deterioration at the pile-panel joints, as discussed below, is the cause of significant damage, due to loss of backfill. Other minor damage to piles was observed sporadically throughout; however, this damage was minimal and generally located above the waterline.

It is recommended that existing sea wall piles remain as is, until entire pier replacement. However, where pile damage coincides with sea wall cap repairs, the piles shall be repaired.

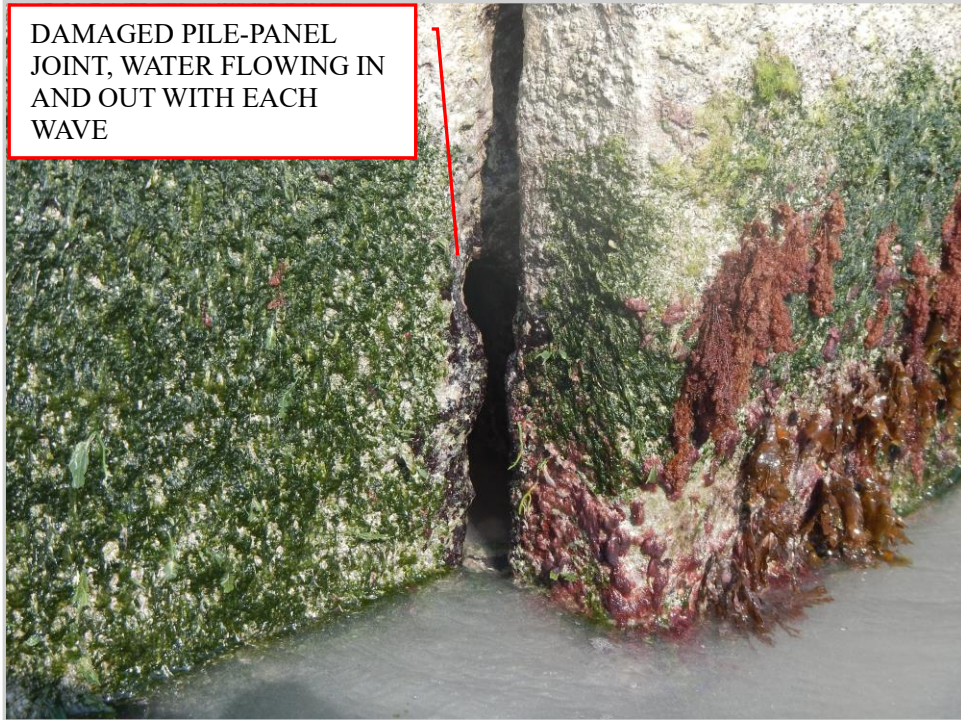
Generally, these panels did not evidence extensive damage. However, erosion at the pile-panel joint is the cause of significant damage, due to loss of backfill. This damage is consistent across the south face of the terminus and is likely caused by continuous wave exposure. Additionally, some minor damage was observed at the panel-cap interface. However, this damage does not pose a significant hazard to the structure.

DAMAGED PILE-PANEL  
JOINT, WATER FLOWING IN  
AND OUT WITH EACH  
WAVE

It is recommended that pile-panel joints be repaired, by packing the interior face of joints with repair mortar (or other material) to mitigate the flow of water. These repairs should be completed where they coincide with areas of backfill mitigation. Repair of the panel-cap joint should be made wherever they coincide with sea wall cap repairs.

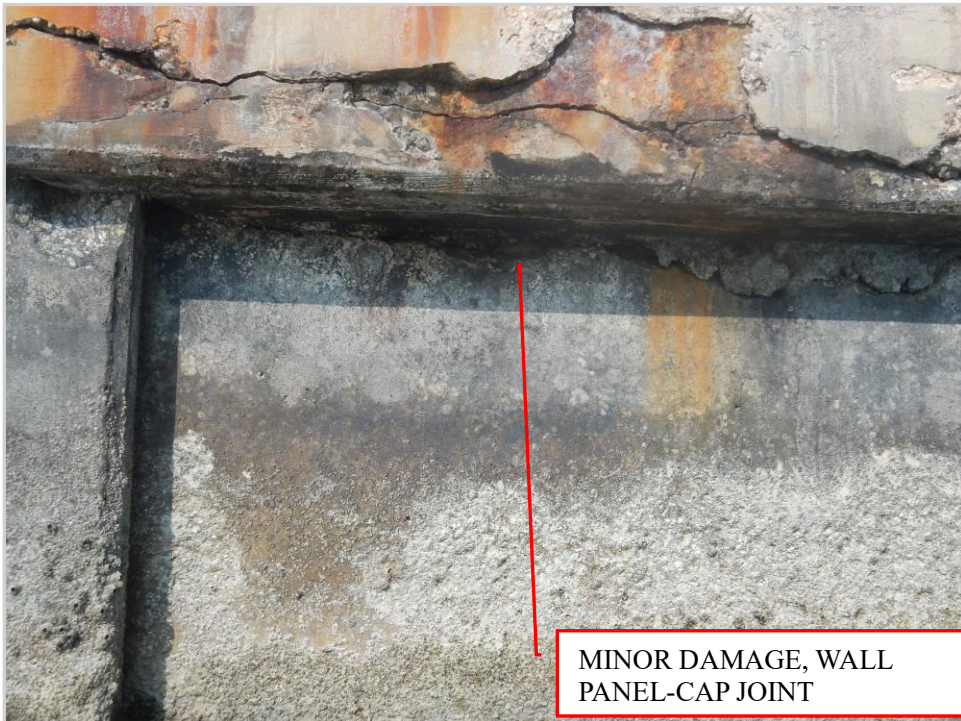
MINOR DAMAGE, WALL  
PANEL-CAP JOINT

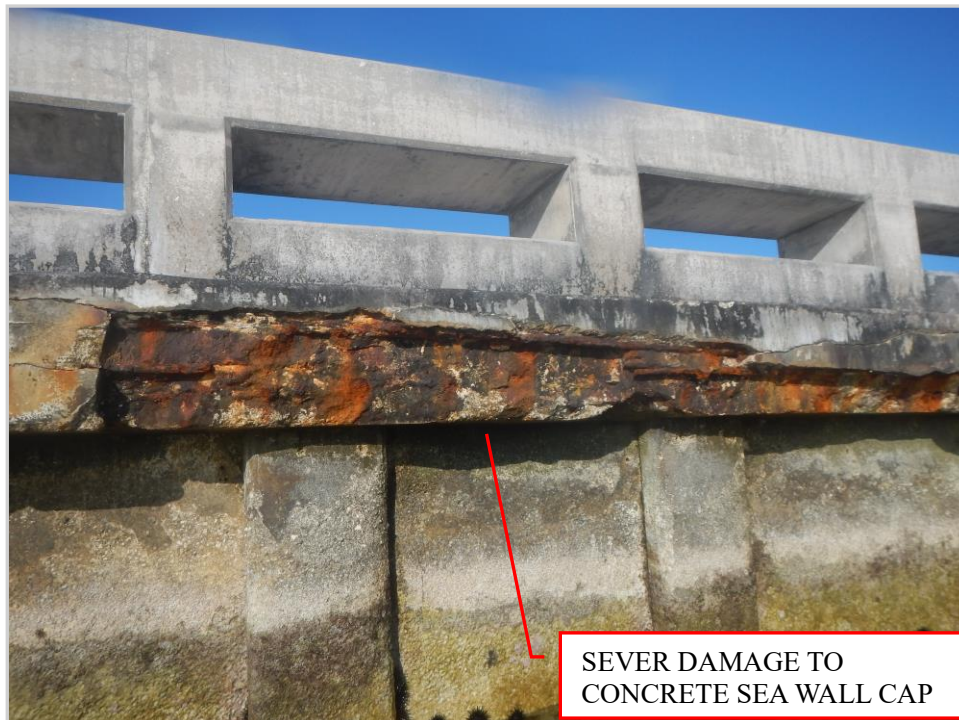
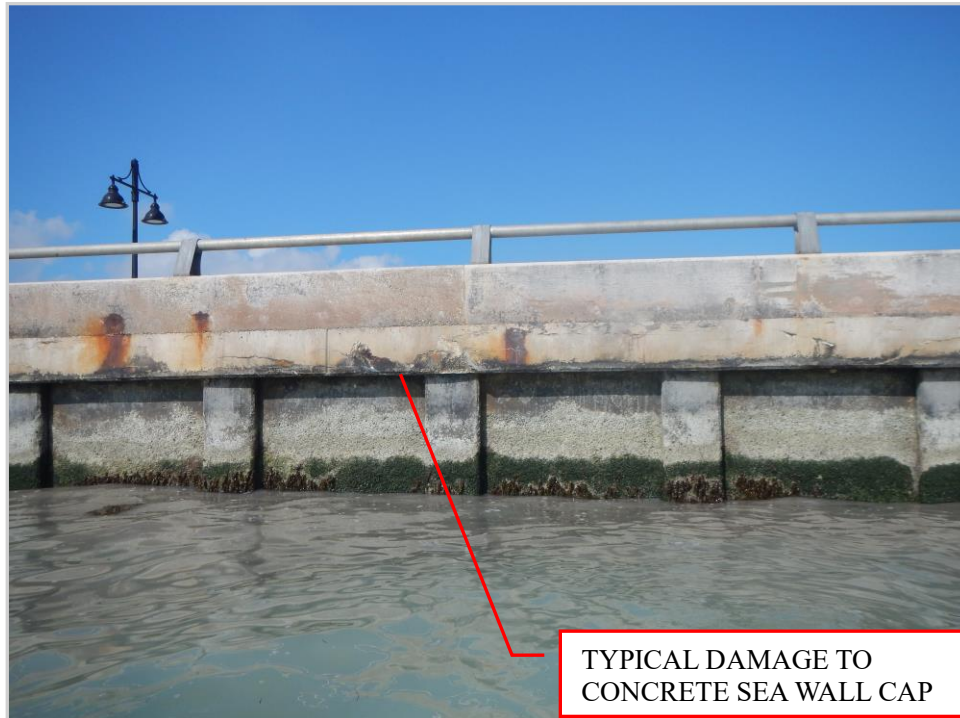
The sea wall cap evidenced minor to severe damage throughout the structure. The majority of the cap evidenced moderate to severe damage, with few areas undamaged. This is due to spalling from corroding rebar. It is expected that rebar corrosion has initiated even in visually undamaged areas. The cap is critical to the structural integrity of the sea wall; however, it does not pose an immediate risk of structural failure. The remaining capacity of the cap as well as the incidental support provided by the concrete railing and the adjacent concrete pavement provides a stable structure.

It is recommended that limited sections of the cap be reconstructed, as required to maintain use of the structure, until entire pier replacement. Patch repairs are not recommended, as they are difficult, costly, and have a short expected service life. This is due to the damage type and the severe exposure. This recommendation is made to reduce repair cost as the City plans for replacement of the pier.

Reconstruction of sections should utilize glass fiber reinforced polymer (GFRP) rebar as well as anodic and/or cathodic corrosion protection on any remaining steel embedded in the concrete.

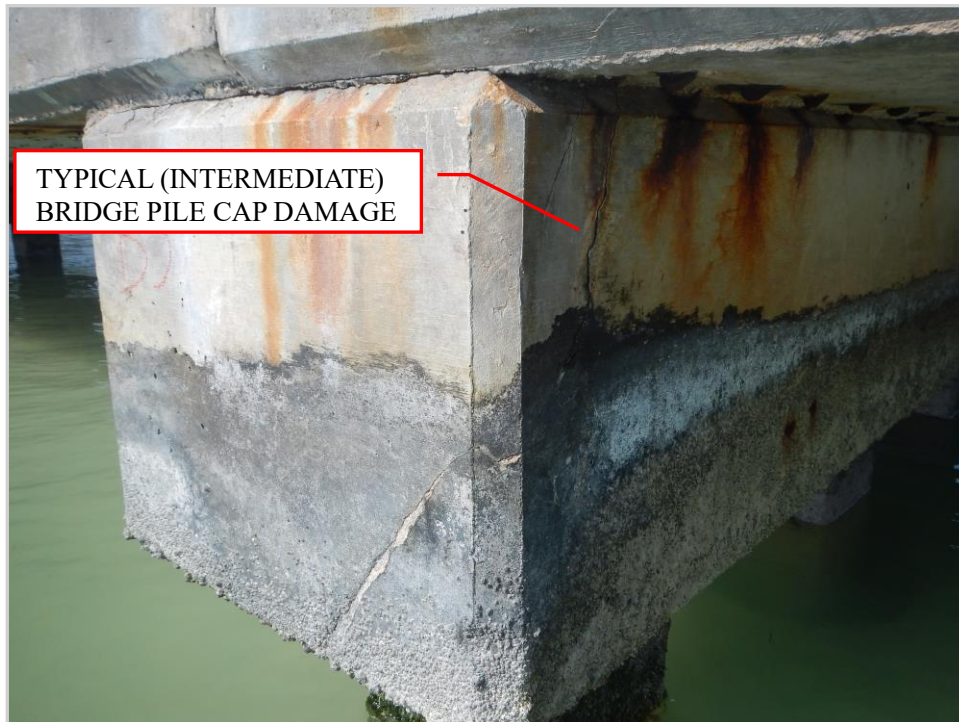
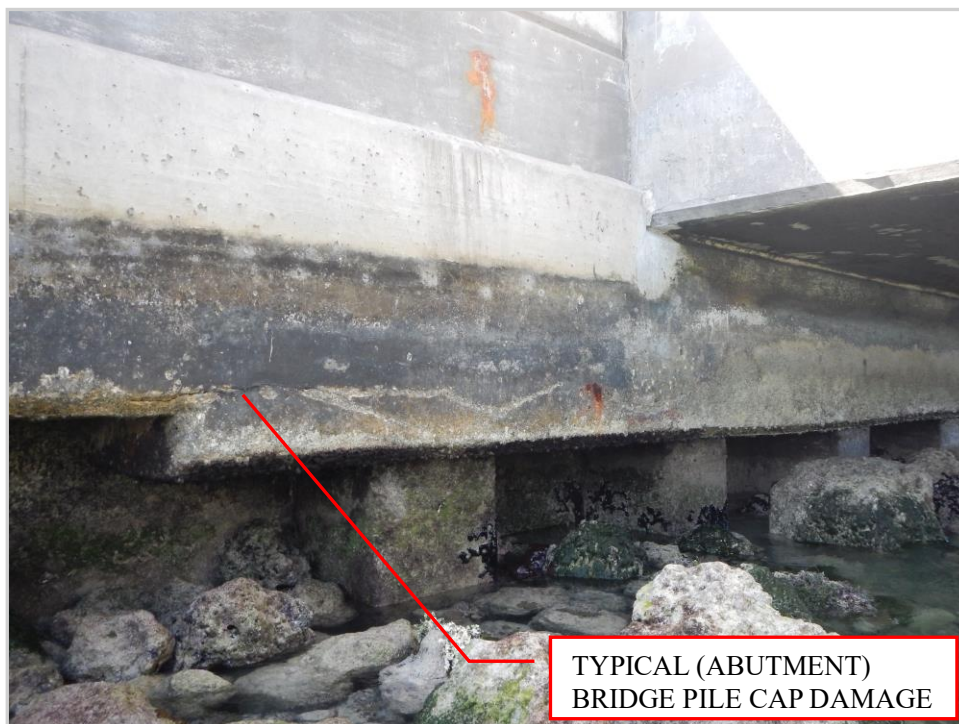
Minor pile cap damage was observed throughout intermediate piers and abutments. This is consistent for the approach bridges and the terminus bridge.

It is recommended that these members remain as is, until entire pier replacement. It is estimated that this damage will not increase to a significant level, within the proposed timeline for pier replacement. However, they should be monitored throughout the remaining life of the structure.

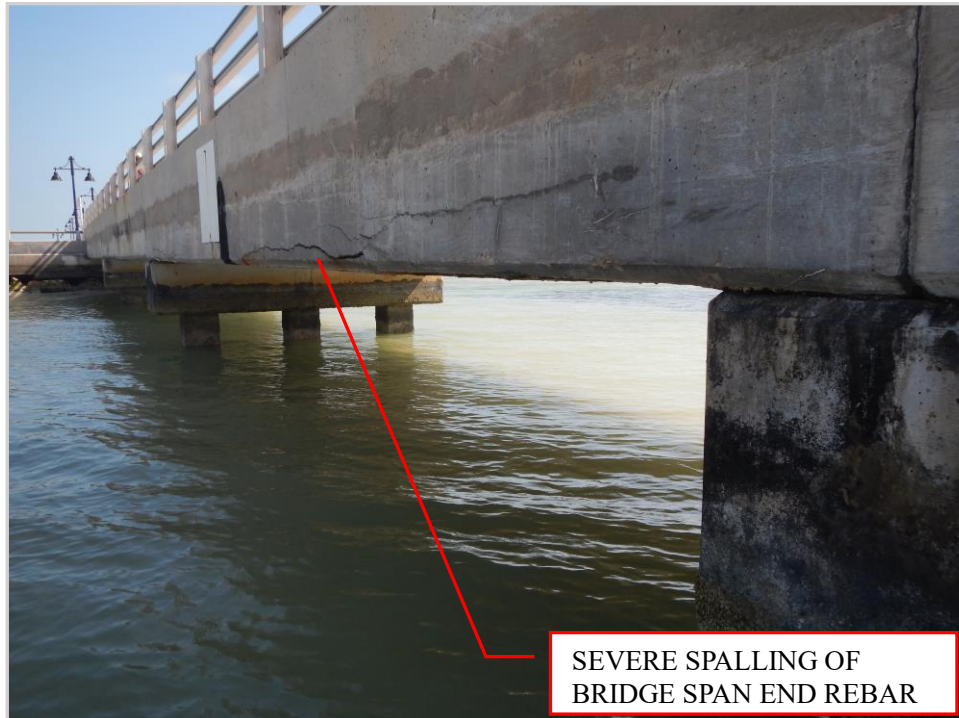
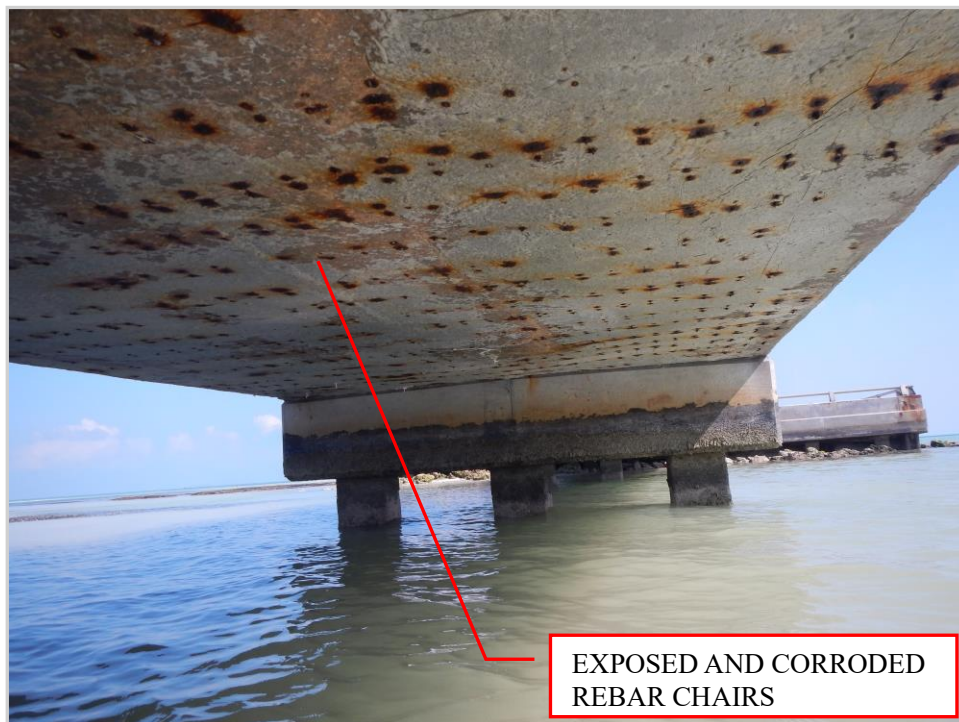
These spans were a modification to the pier and added circa 1994. Moderate to severe damage was observed throughout the approach bridge spans and the terminus bridge (with the exception that no damage was observed on the north span of the approach bridge, replaced in 2018). The most significant damage type is concrete spalling of the end rebar along the sides of the bridges. It is expected that these spans were constructed of cast in place concrete with standard grade 60 rebar, utilizing metal rebar chairs. These construction materials have proven to be insufficient, considering that significant damage has occurred within 31 years of service. While these bridge spans were constructed using design and material standards typical at the time, the fact that they are located in the saltwater splash zone has significantly reduced their service life.

Although more dramatic spalling is present on the sea wall cap, the bridge span rebar is more critical and provides a greater concern for structural integrity. This damage does not pose an immediate risk of structural failure; however, it is expected to worsen with time. Further corrosion of the rebar will reduce the capacity and eventually lead to failure.

Additionally, it was observed that steel rebar chairs were used during construction. The chair legs are exposed and corroding on the underside of the bridge spans. This does not pose an immediate structural deficiency; however, this condition will accelerate the deterioration of the spans by allowing a pathway for chlorides to penetrate the member and reach the rebar. The corroded rebar chairs may remain, as it is impractical to repair this condition.

It is recommended that this damage be monitored, with the expectation that major repairs and/or span replacement will be required, prior to entire pier replacement. Repairs and replacement should utilize type 316 stainless, ChromX, and GFRP rebar, in lieu of plain steel. Concrete mix should be designed to meet or exceed the Florida Department of Transportation specifications for concrete located in the saltwater splash zone. An epoxy coating should be utilized to protect the concrete from salt spray.

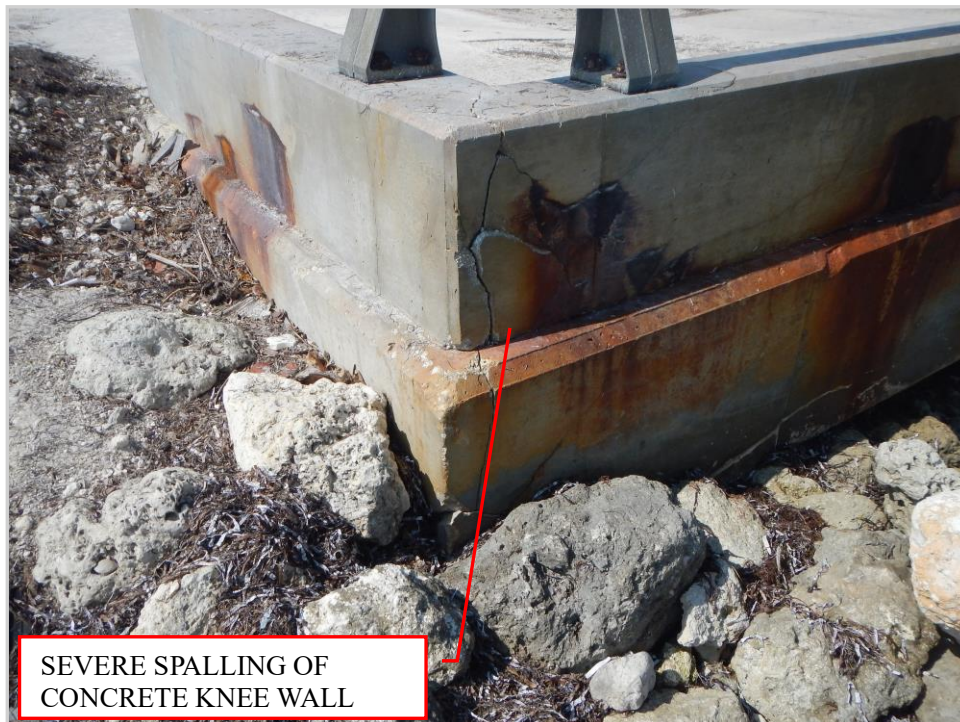
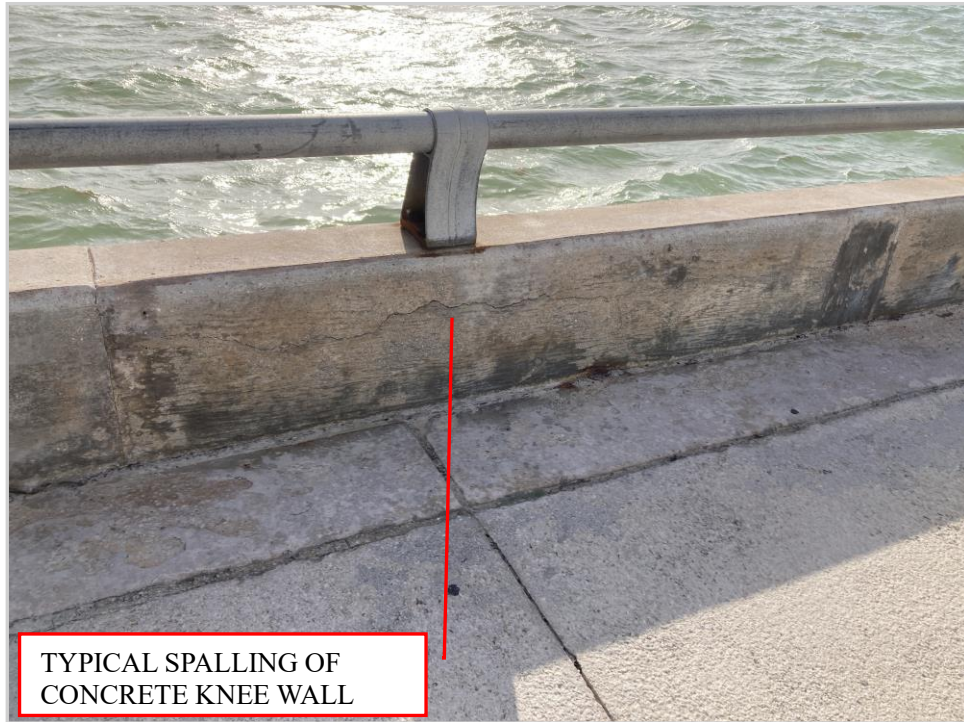
The concrete knee walls evidenced moderate damage throughout, with some areas of severe damage. However, this damage does not currently pose a concern for structural integrity or occupancy safety. The rate of this damage is expected to increase over time, as the existing cracks allow water and chlorides to readily penetrate the concrete member.

It is recommended that this damage be monitored, with the expectation that limited section replacement will be required, prior to entire pier replacement. Repairs and replacement should utilize GFRP rebar, in lieu of plain steel. Concrete mix should be designed to meet or exceed the Florida Department of Transportation specifications for concrete located in the saltwater splash zone.

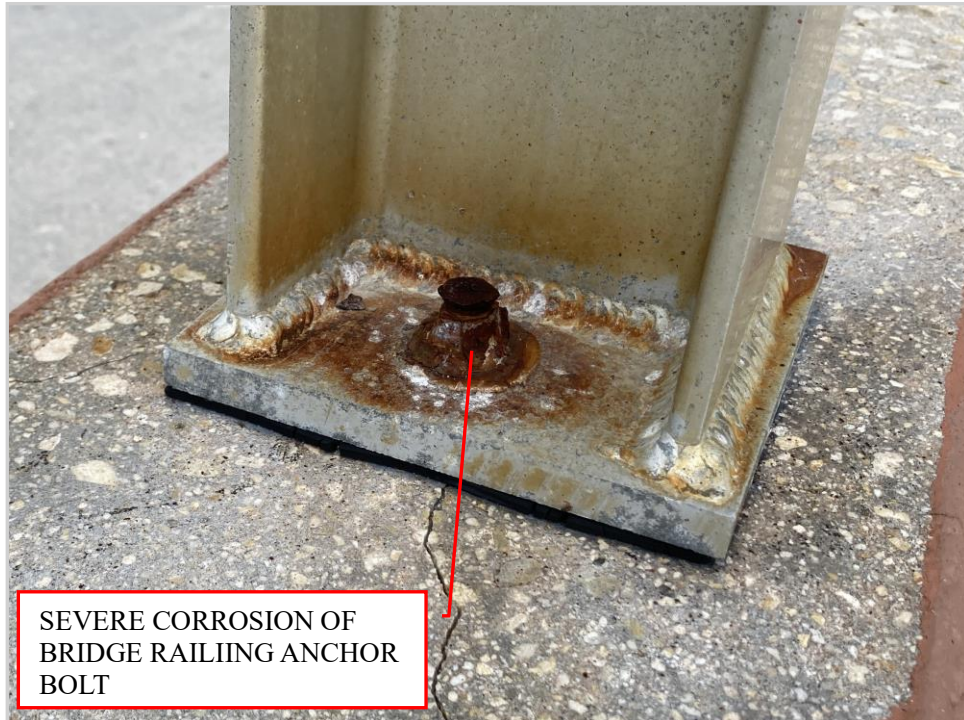
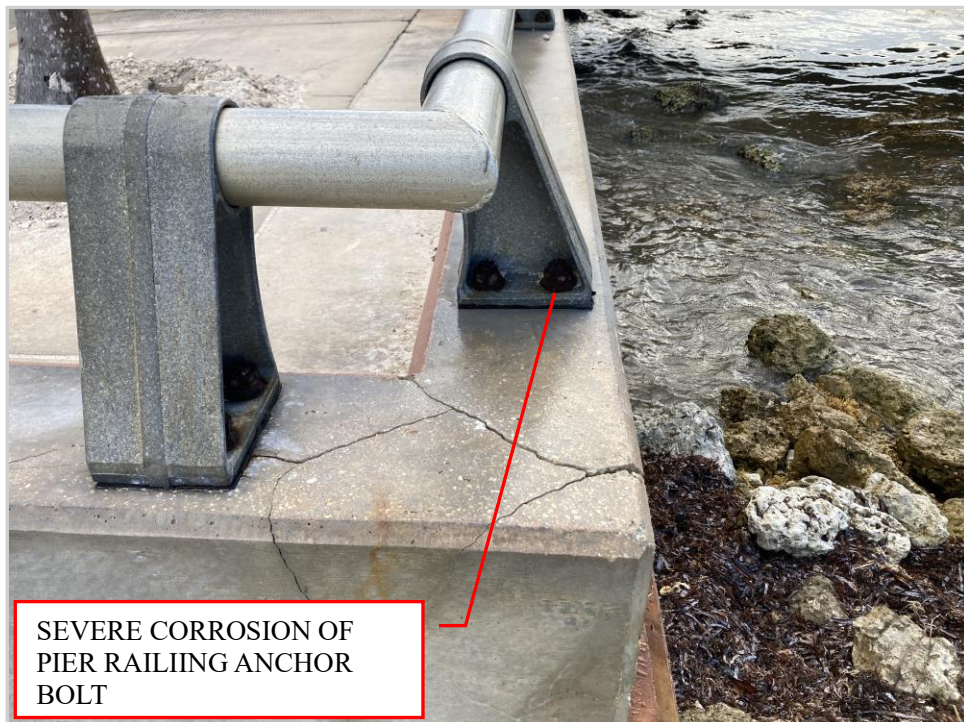
The aluminum railing (atop the concrete knee wall) was observed to be in acceptable condition. However, the railing anchor bolts are badly corroded. It is assumed that galvanized anchor bolts were used.

It is recommended that these anchor bolts be replaced throughout. New anchor bolts should be type 316 stainless steel and utilize a separation barrier (Teflon washers and bituminous paint) where in contact with aluminum. It is recommended that the existing railing be shifted, allowing new anchors to be installed in sound concrete. Some sections of railing will require modification, due to shifting. Existing anchors may be cut flush with the concrete surface, then covered with an epoxy coating. This approach will require isolated concrete repair as abandoned bolts corrode over time. This is recommended in lieu of complete anchor bolt removal and concrete patching, to reduce repair costs as the City plans for replacement of the pier.

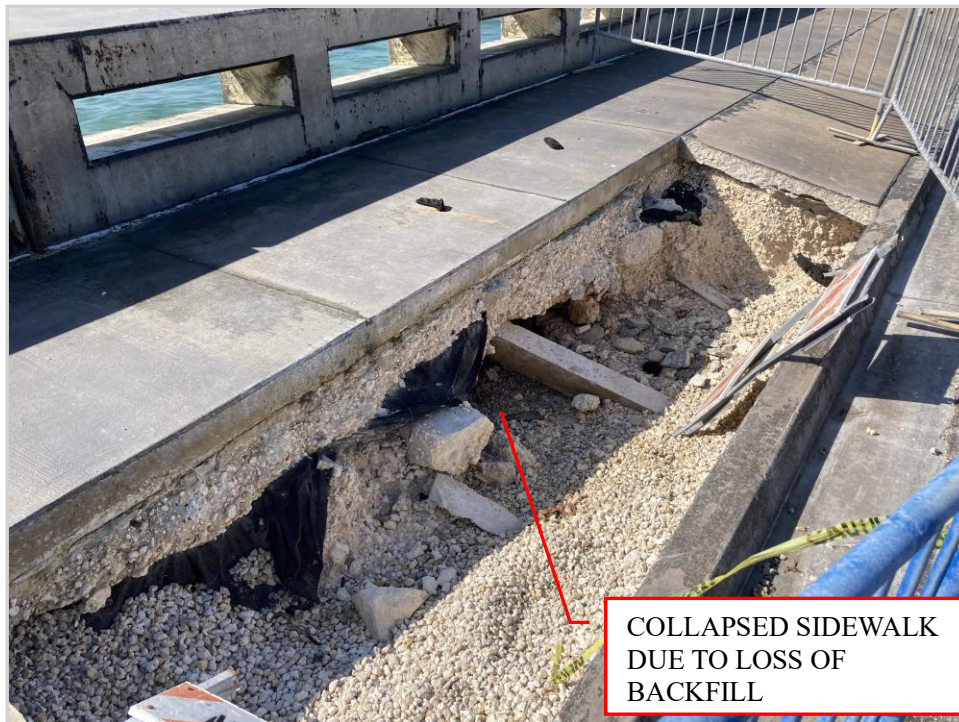
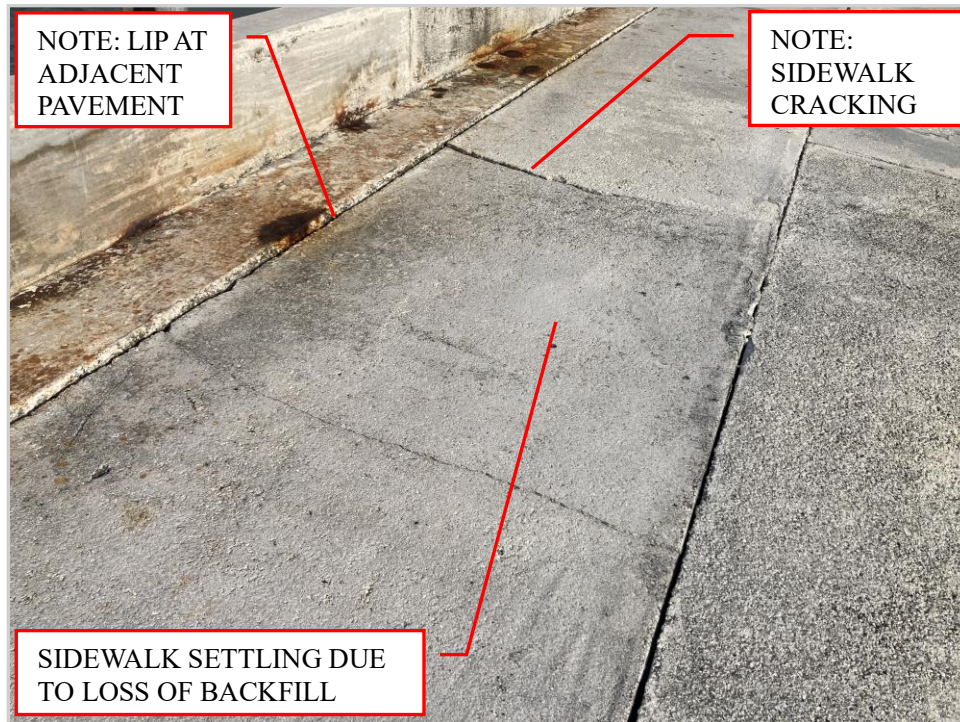
One area of collapsed sidewalk was observed (at terminus) and multiple areas of concern were identified (west side of walkway & south side of terminus). This sidewalk damage is the result of loss of backfill, as discussed above. Otherwise, the existing sidewalk was observed to be in acceptable condition with minor surface erosion.

It is recommended that backfill stabilization (see "Loss of Backfill") be completed in the damaged areas. Additionally, the City should continuously monitor the sidewalk for signs of settlement and unsafe conditions (e.g. tripping hazards). Backfill stabilization and sidewalk reconstruction should be completed as required, until entire pier replacement.

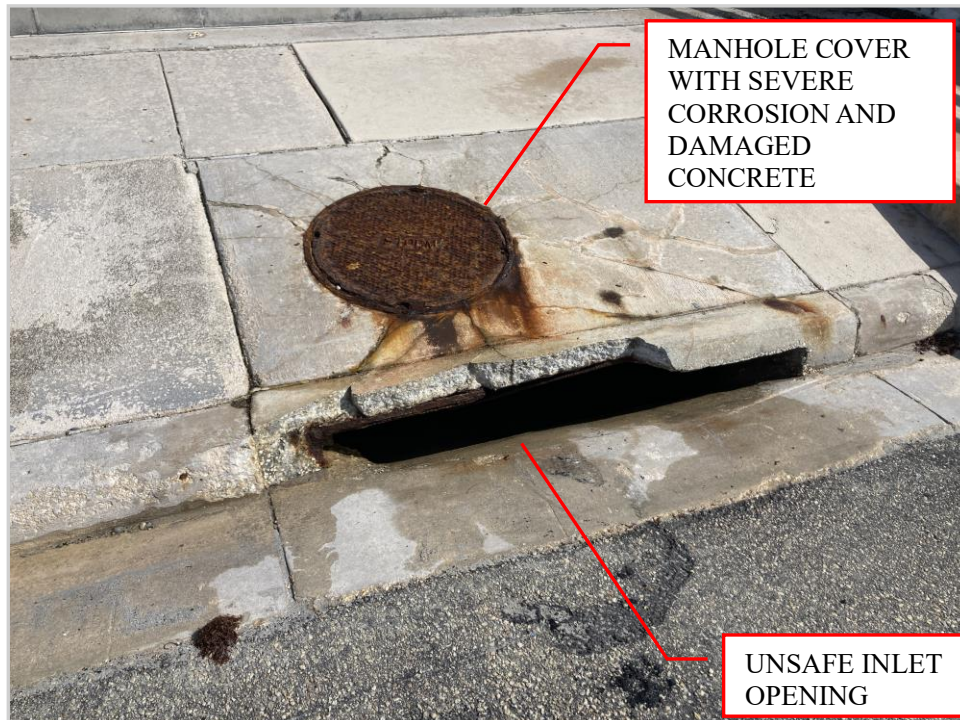
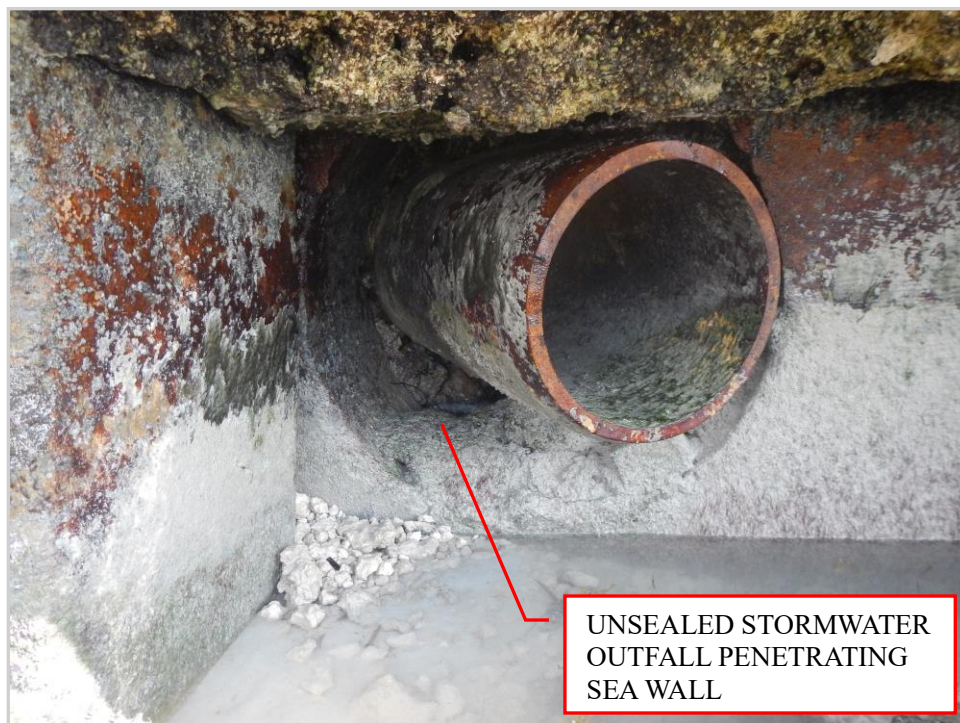
The stormwater inlets (identified in appendix A) present an unsafe condition due to severe spalling and corroding manholes. These manholes and slabs are heavily deteriorated and at risk of collapse. Furthermore, the spalling concrete has enlarged the inlet opening. This opening could cause a foot trap or allow access by small children and dogs.

Additionally, the stormwater outfalls evidenced moderate damage. Some drainage outfalls were not properly sealed (grouted) and may contribute to loss of backfill.

It is recommended that access to these areas be restricted until repairs are made. Repairs should include complete reconstruction of the concrete slabs covering the stormwater inlet. Reconstruction should utilize type 316 stainless, ChromX, or GFRP rebar, in lieu of plain steel. Replacement slabs should not include manholes, or include non-metallic manholes (if required). The remaining inlets should be monitored by the City and reconstructed as required, until entire pier replacement.

It is recommended that unsealed outfalls be grouted to stop water intrusion and the loss of backfill.

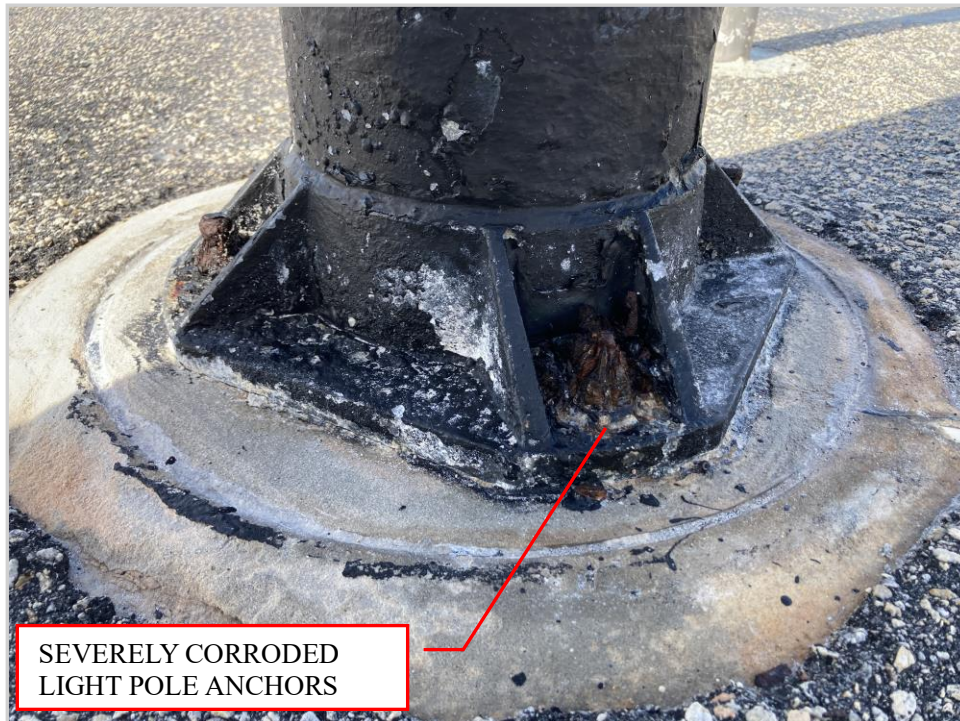
The observed light pole anchor bolts are severely corroded and present an unsafe condition. It is assumed that galvanized anchor bolts were used. Two light pole bases were observed; the remainder had covers concealing the anchor bolts. However, it is expected that all anchor bolts are severely corroded. These anchor bolts are considered structurally failed due to corrosion.

It is recommended that the light poles be removed while the anchor bolts be reconstructed. This will likely require new foundations, however, retrofitting the existing foundations may be a feasible solution, after further analysis.

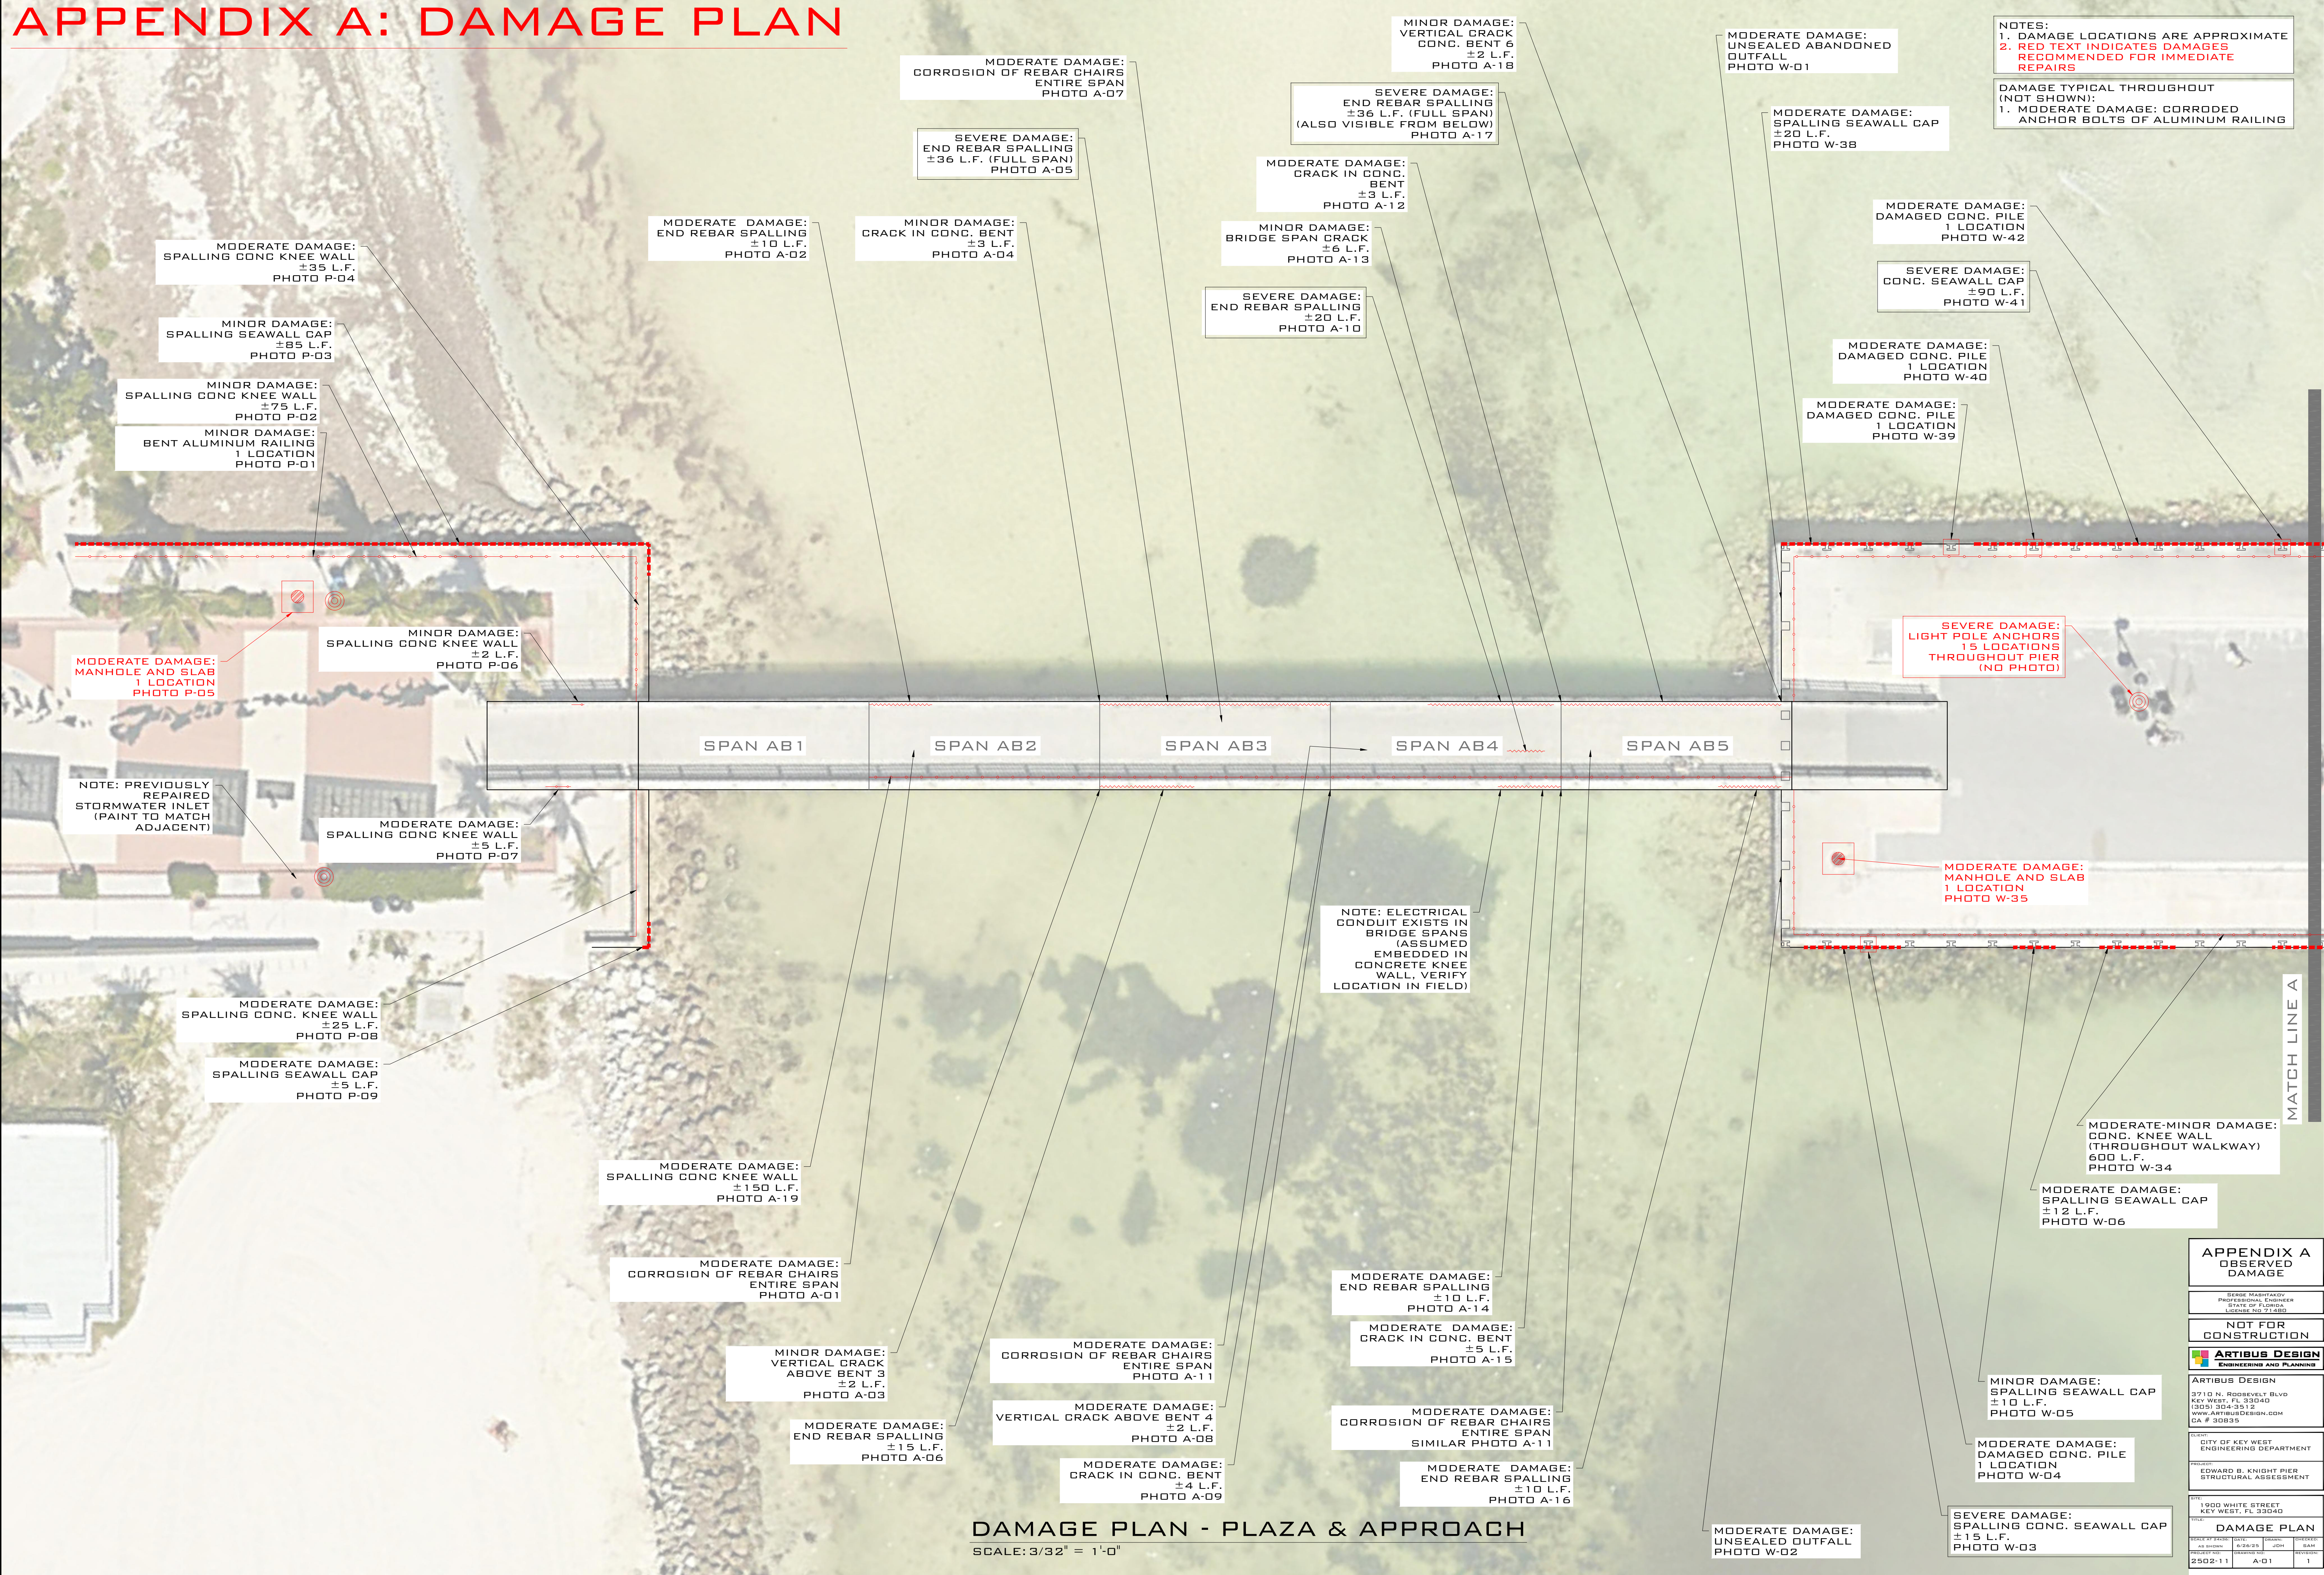
DAMAGE PLAN - PLAZA & APPROACH  
SCALE: 3/32" = 1'-0"

DAMAGE TYPICAL THROUGHOUT (NOT SHOWN):  
1. MODERATE DAMAGE: CORRODED ANCHOR BOLTS OF ALUMINUM RAILING
