**Re: Frederick Douglas Gym
Structural Repairs
111 Olivia Street
Key West, FL
McCarthy Project No. M13178**

At your request, I visited the site on April 26 and 27, 2017 to investigate and document various types of damage to the existing concrete tie beams, columns, window header beams and window sills. The damage can be classified into three categories:

Repair Details SK 1 – 10

Field Notes from Site Visits

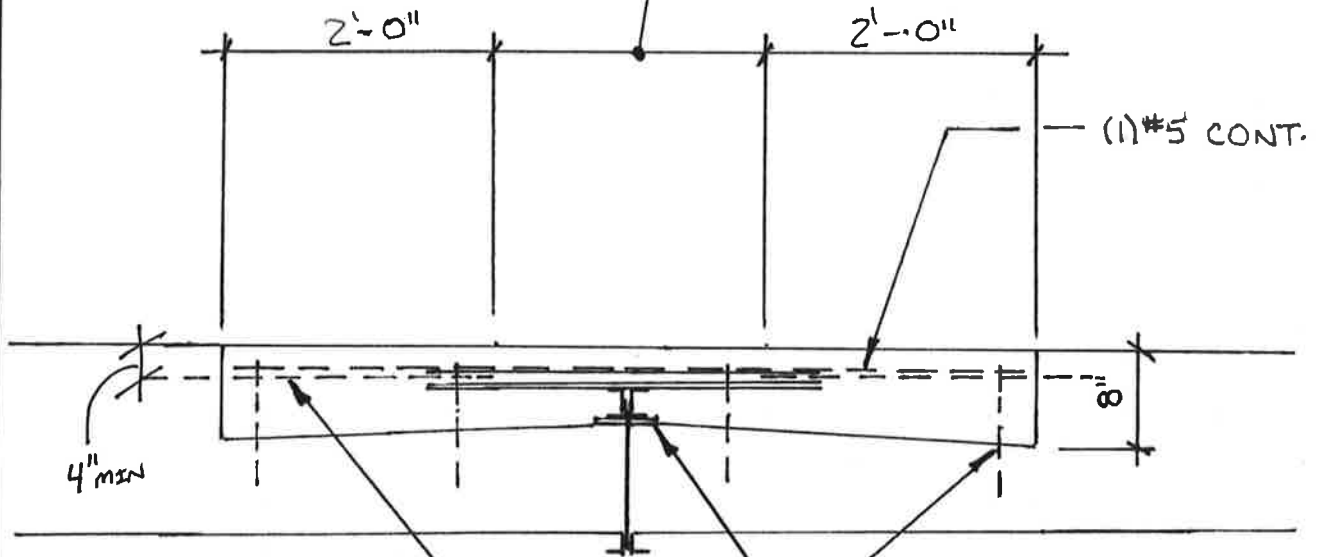
SK-1

TOP/WALL REPAIR DTL.
(EAST & WEST WALLS)

NOTE:
TREAT TOP OF EXIST'G.
TIE B.M. WITH A CHEMICAL
BONDING AGENT PRIOR TO
RE-POURING WALL CAP.

NOTE:
1. BONDING AGENT TO BE BASF P124 CORROSION
INHIBITOR AND BONDING AGENT OR APPROVED EQUAL

TREAT ALL EXPOSED AREAS W/A CHEMICAL BONDING AGENT.

AREAS OF CRACKED OR SPALLED CONC. CUT & REMOVE AN ADDN'L. 2'-0" EA. SIDE.

— REPLACE DAMAGED ARE W/ 3000 PSI MINIMUM CONCRETE

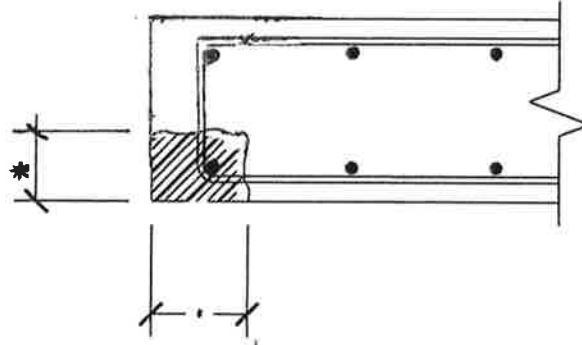
SK-3

WINDOW SILL REPAIR DTL.

1. REMOVE DAMAGED, LOOSE OR DELETERIOUS CONCRETE TO SOLID CONCRETE.
2. IF DAMAGED AREA EXTENDS GREATER THEN 75% SILL LENGTH REMOVE AND REPLACE ENTIRE SILL.
3. CLEAN AND PREPARE AREA FOR REPLACEMENT SIM SK-4

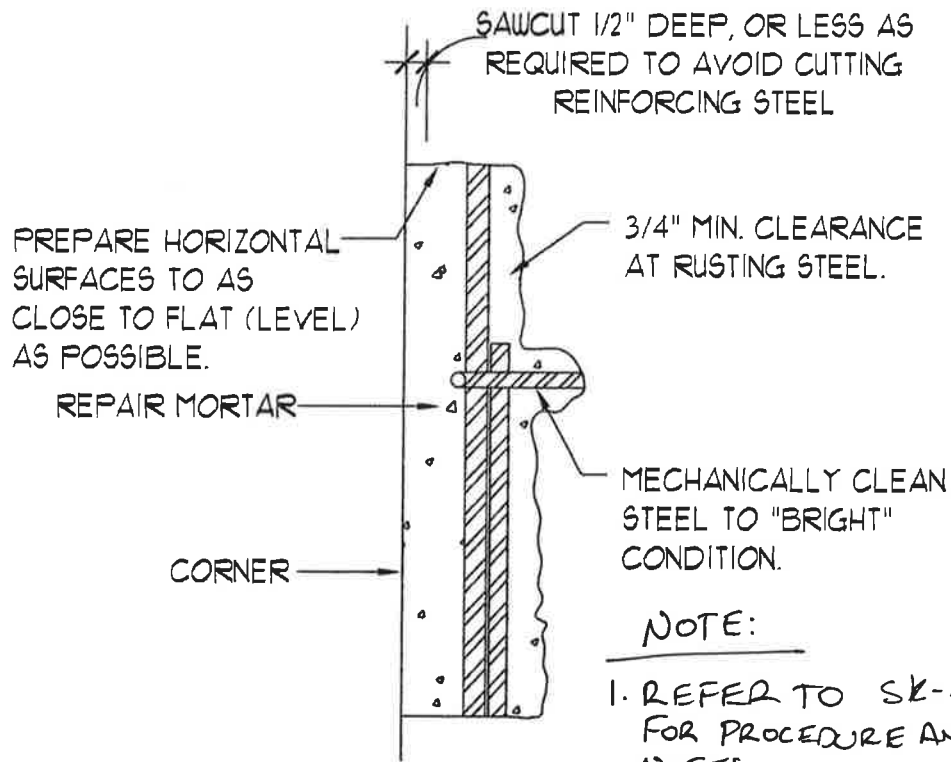
SK-4

COLUMN OR BEAM REPAIR

* UNLESS TEMPORARILY SHORED,
REPAIR AREA SHALL NOT
EXCEED 20% OF THE CROSS
SECTIONAL AREA OF THE COLUMN.

NOTE:
1. REFER TO SK-5 & SK-6
FOR PROCEDURE AND ADDITIONAL
NOTES

1. CONTRACTOR TO READ, UNDERSTAND AND FOLLOW ALL OF THE MANUFACTURERS RECOMMENDATIONS FOR THE INSTALLATION OF REPAIR MATERIALS LISTED HEREIN.
2. INSTALL ANY REQUIRED SHORING PRIOR TO THE START OF ANY DEMOLITION. SHORING SHALL BE DESIGNED BY A REGISTERED PROFESSIONAL ENGINEER.
3. CONTRACTOR TO INSPECT/ SOUND THE SUSPECTED DAMAGED CONCRETE AND REVIEW THE POTENTIAL REPAIRS LOCATIONS PRIOR TO DEMO.
4. PREPARE REPAIR AREA PER ICRI GUIDELINES # 310R. SAWCUT THE PERIMETER OF THE PROPOSED REPAIR AREA TO A MINIMUM DEPTH OF 3/4" WITHOUT DAMAGING THE REINFORCEMENT. THE SAWCUT AREA SHOULD BE GEOMETRICALLY EQUAL, IE. SQUARE.
5. REMOVE ALL LOOSE AND DELETERIOUS CONCRETE MATERIAL THAT ENCOMPASSES THE DAMAGED AREA WITHIN THE CONCRETE BEAM/COLUMN.
6. THE CONCRETE WITHIN THE REPAIR AREA SHALL BE PREPARED TO A MINIMUM OF C SP-6 SURFACE ROUGHNESS OR GREATER THAN THE REPAIR MORTAR SPECIFICATIONS.

1. IF NECESSARY, THE CONTRACTOR SHALL CHIP UNDER THE EXISTING REINFORCEMENT AND POSITIVELY HOLD DOWN THROUGH MECHANICAL MEANS TO ACHIEVE MINIMUM 1-1/2" COVER.

2. PRESSURE WASH REPAIR AREA (1500PSI MINIMUM) TO REMOVE ALL DUST OR LOOSE MATERIAL AND ALLOW TO DRY. OIL FREE COMPRESSED AIR MAY BE USED TO ACCELERATE THE DRYING PROCESS.

3. REPAIR SURFACE SHALL BE PREPARED TO BE SATURATED SURFACE DRY (SSD) WITH NO STANDING WATER.
4. AT MINOR LOCATIONS INSTALL BASF N425 (GEL PATCH) OR APPROVED EQUAL AT REPAIR AREA PER MANUFACTURER SPECIFICATIONS. REPAIR MATERIAL SHALL BE INSTALLED IN MAXIMUM LIFTS OF 2 INCHES.

5. AT FULL DEPTH REPAIR LOCATIONS COAT REPAIR AREA AND ALL EXPOSED STEEL REINFORCEMENT WITH BASF P-124 CORROSION INHIBITOR AND BONDING AGENT. FORM AND POUR REPAIR AREA WITH BASF S 440 MC POURABLE AND PUMPABLE PRE-EXTENDED SELF-CONSOLIDATING REPAIR MORTAR OR APPROVED EQUAL.

6. ALL REPAIR WORK SHALL BE FINISHED TO MATCH THE SURFACE LEVEL OF EXISTING CONDITIONS.

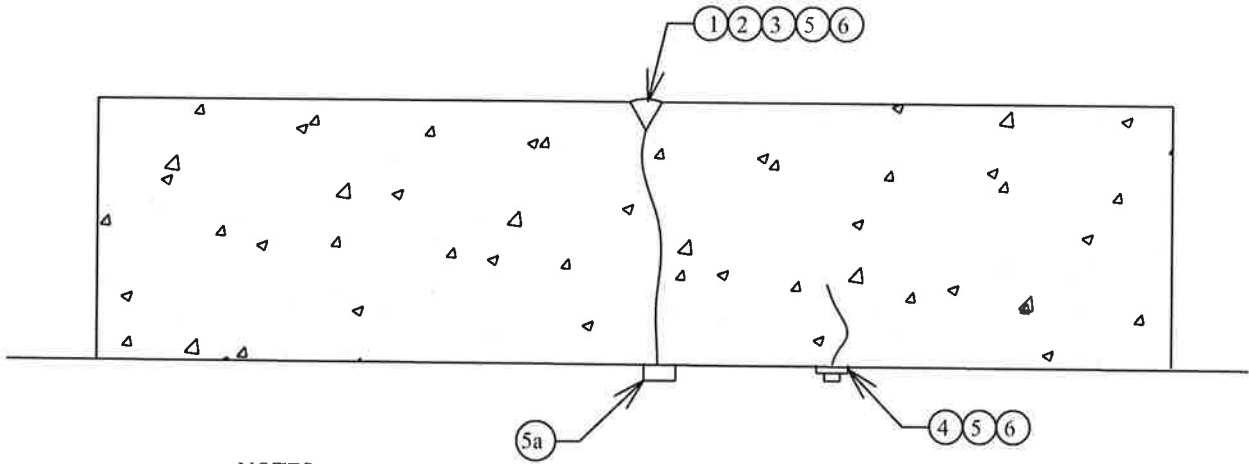
SK-7

STRUCTURAL CONCRETE CRACK REPAIR 1/32nd OR GREATER
 NOT TO SCALE

- 1: FOR HORIZONTAL CRACKS, ROUT CRACK TO MINIMUM OF 1/4" X 1/4".
- 2: REMOVE ANY DELETERIOUS MATERIAL.
- 3: CLEAN CRACK SURFACES W/ OIL FREE COMPRESSED AIR.
- 4: FILL CRACKS W/ BASF MASTERINJECT 1500 EPOXY SYSTEM OR APPROVED EQUAL, PER MANUFACTURE SPECIFICATIONS.
- 5: FOR OVERHEAD / VERTICAL CRACKS INSTALL INJECTION PORT CAP SEAL ALONG CRACK LENGTH. EPOXY SYSTEM AND BASF MASTERINJECT 1500.
- 5a: CHEMCO SYSTEMS CC GROUT; STRAP SEAL MAY BE USED AS AN ALTERNATIVE PRODUCT TO CAP SEAL.
- 6: EPOXY INJECT MECHANICALLY, FINISH TO MATCH EXISTING SURFACE PROFILE AND REMOVE EXCESS EPOXY.

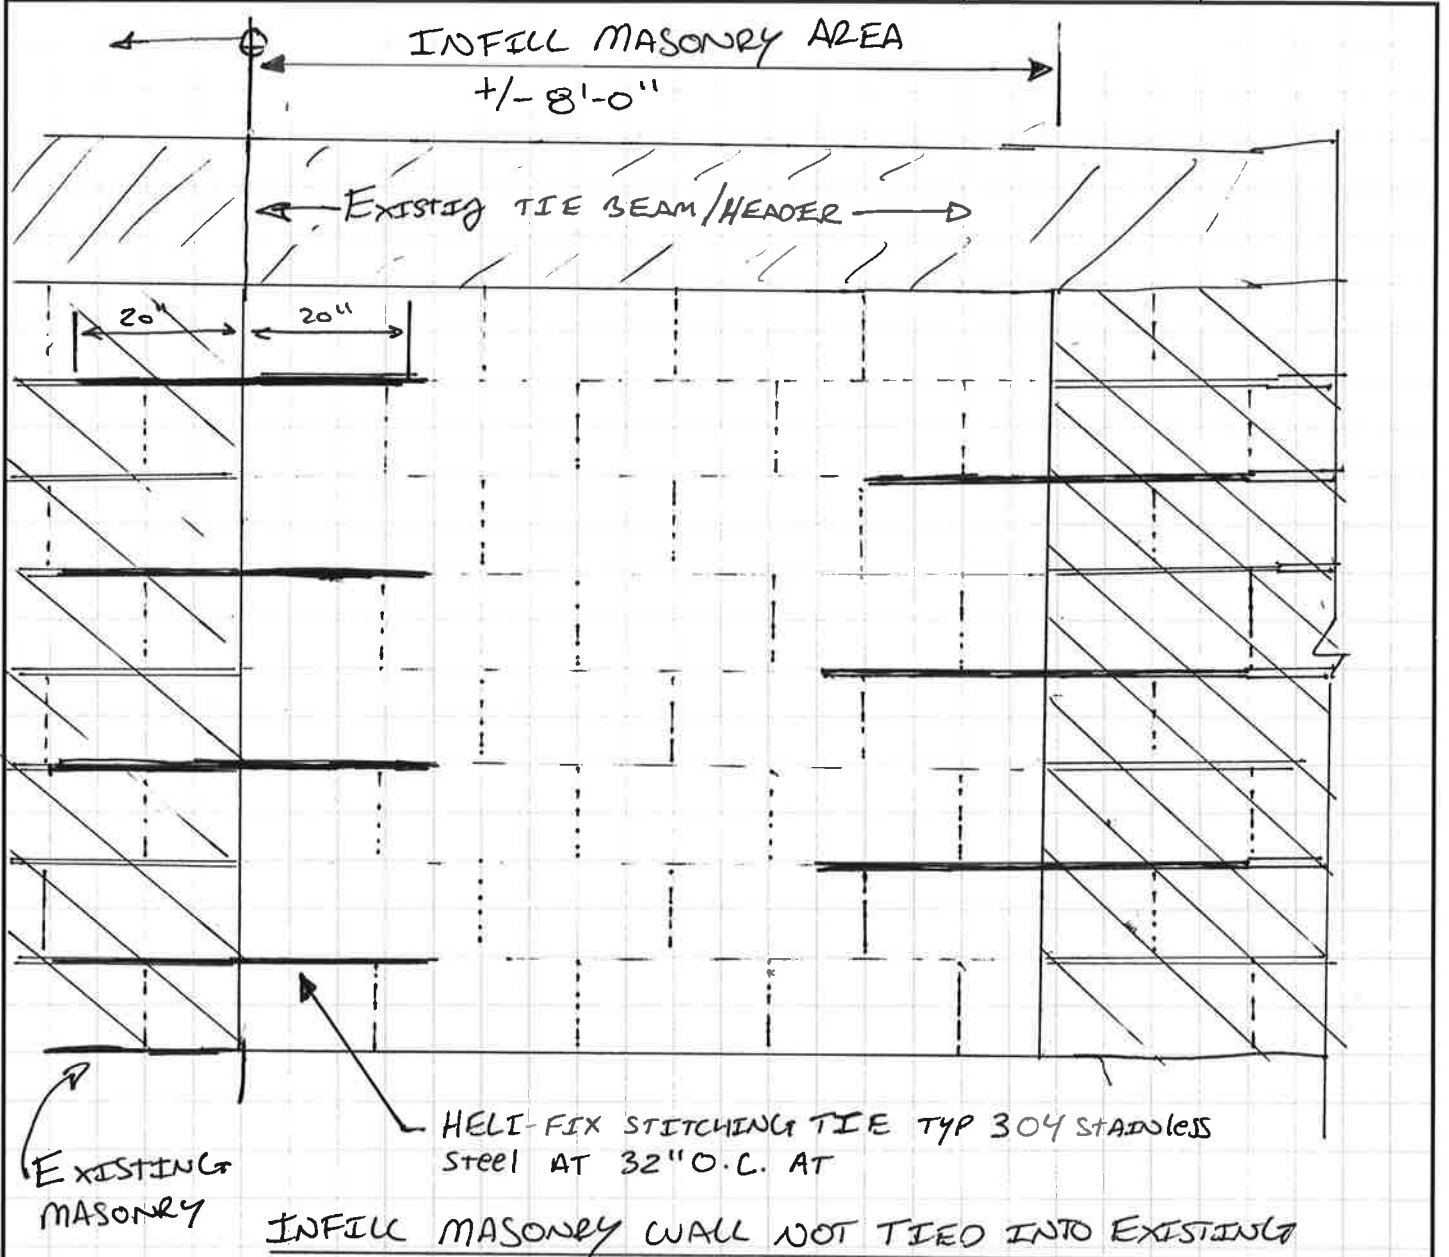
SK-8

THIS WALL IS LOCATED BETWEEN COLUMNS 8B & 8C,
SEE PLAN S-101 DATED 6/29/16 FOR REFERENCE

FILL WALL SOLID W/ 3000 PSI CONCRETE.

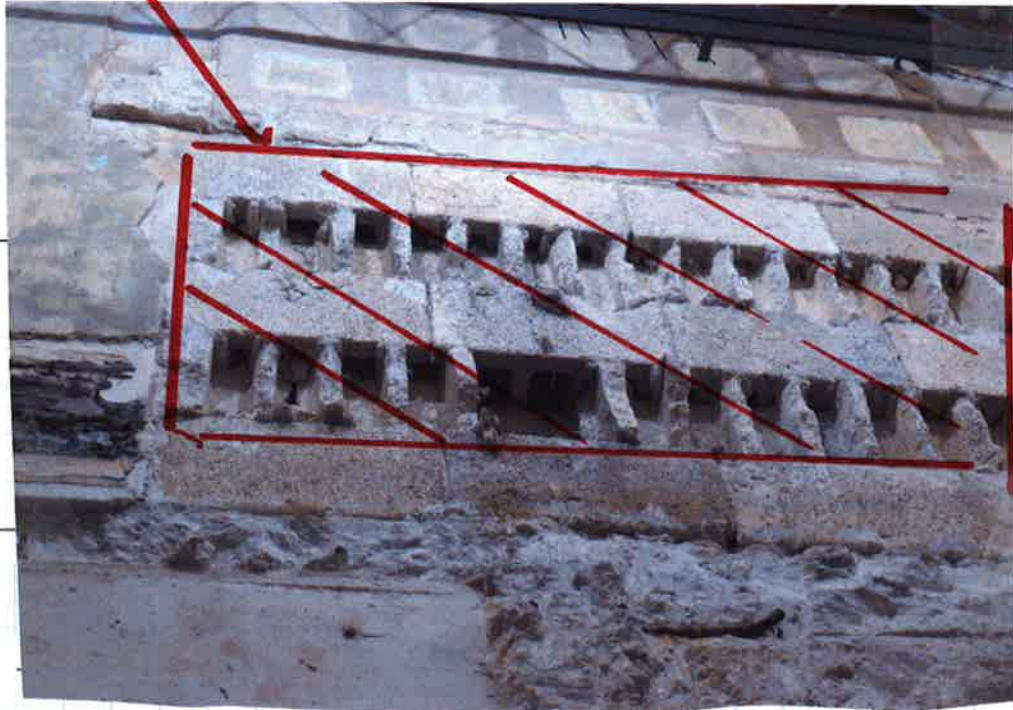
SK-9

* MASONRY WALL BETWEEN COLUMNS 4A & 5A
SEE ORIG STRUCTURAL PLANS FOR COLUMN LAYOUT.

INFILL OF CUT MASONRY BLOCKS

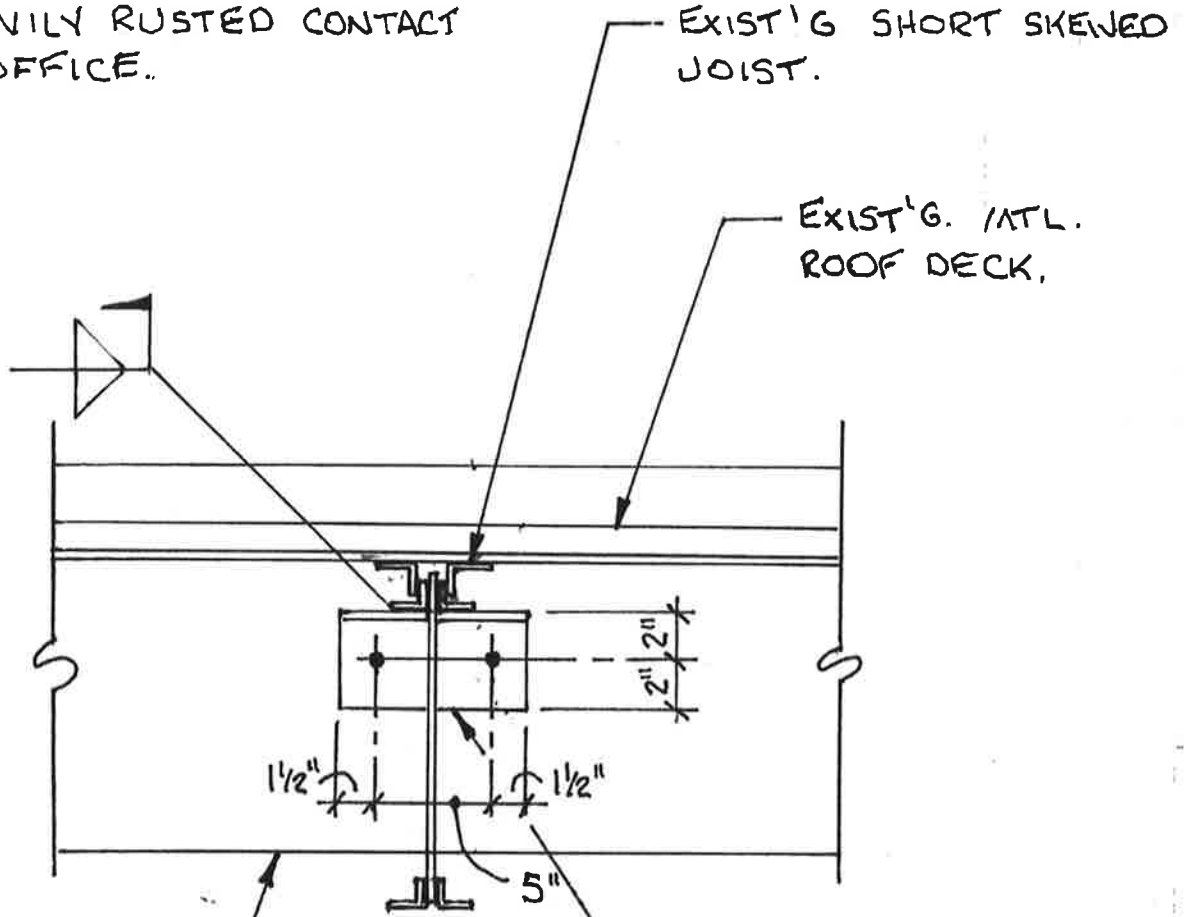
SK-10

JOIST SEAT REPAIR

GC NOTE:
 FIELD VERIFY CONDITION
 OF EXIST'G. JOIST SEAT.
 IF HEAVILY RUSTED CONTACT
 THIS OFFICE..

INSTALL L4x4x3/8x0'-8"
 W/ (2) 3/4" Ø EPOXY BOLTS.
 (5 1/2" EMBED)

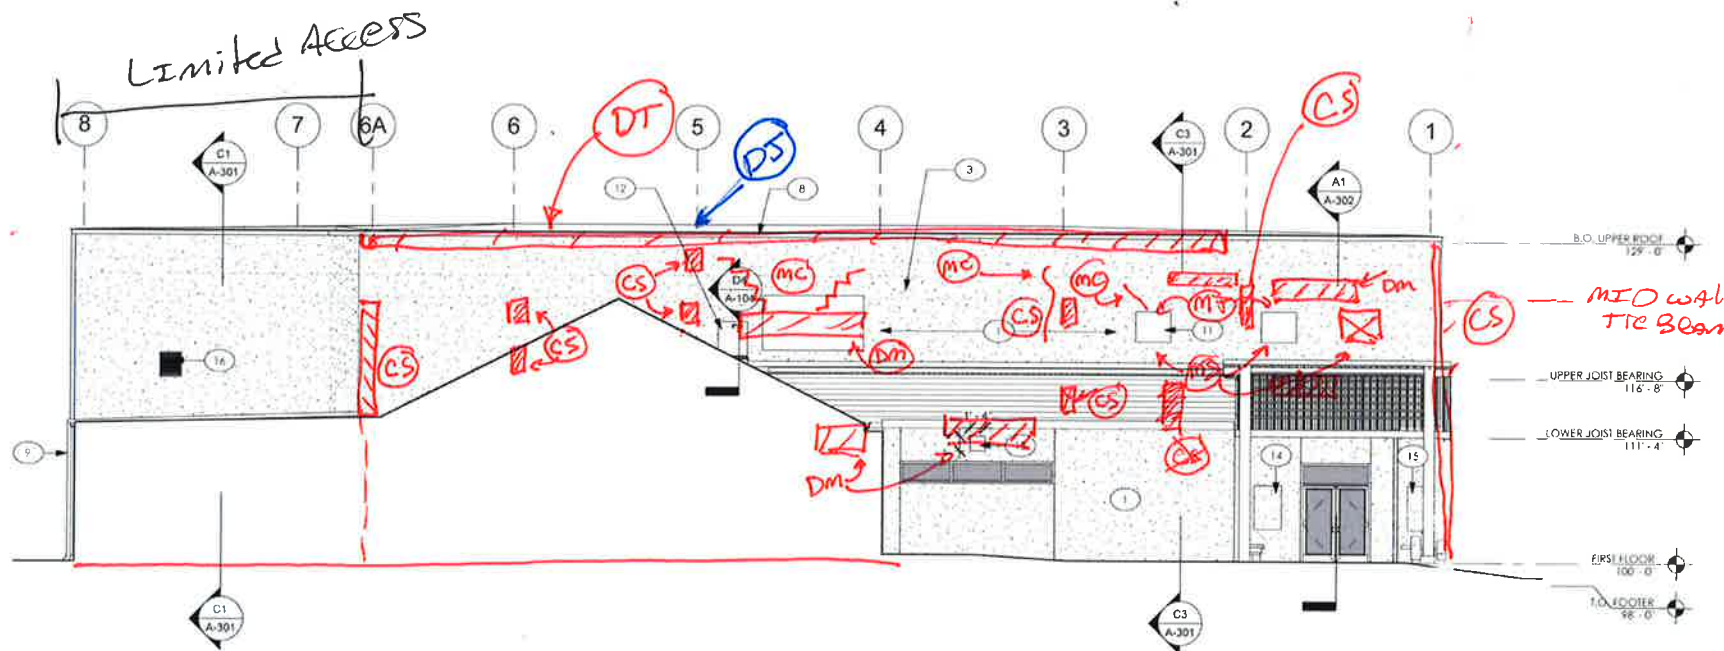
C1 WEST ELEVATION
1/8" = 1'-0"

LIMITED ACCESS TO TOP OF WALL
AT ROOF DUE TO ROOFING ATTACHMENT

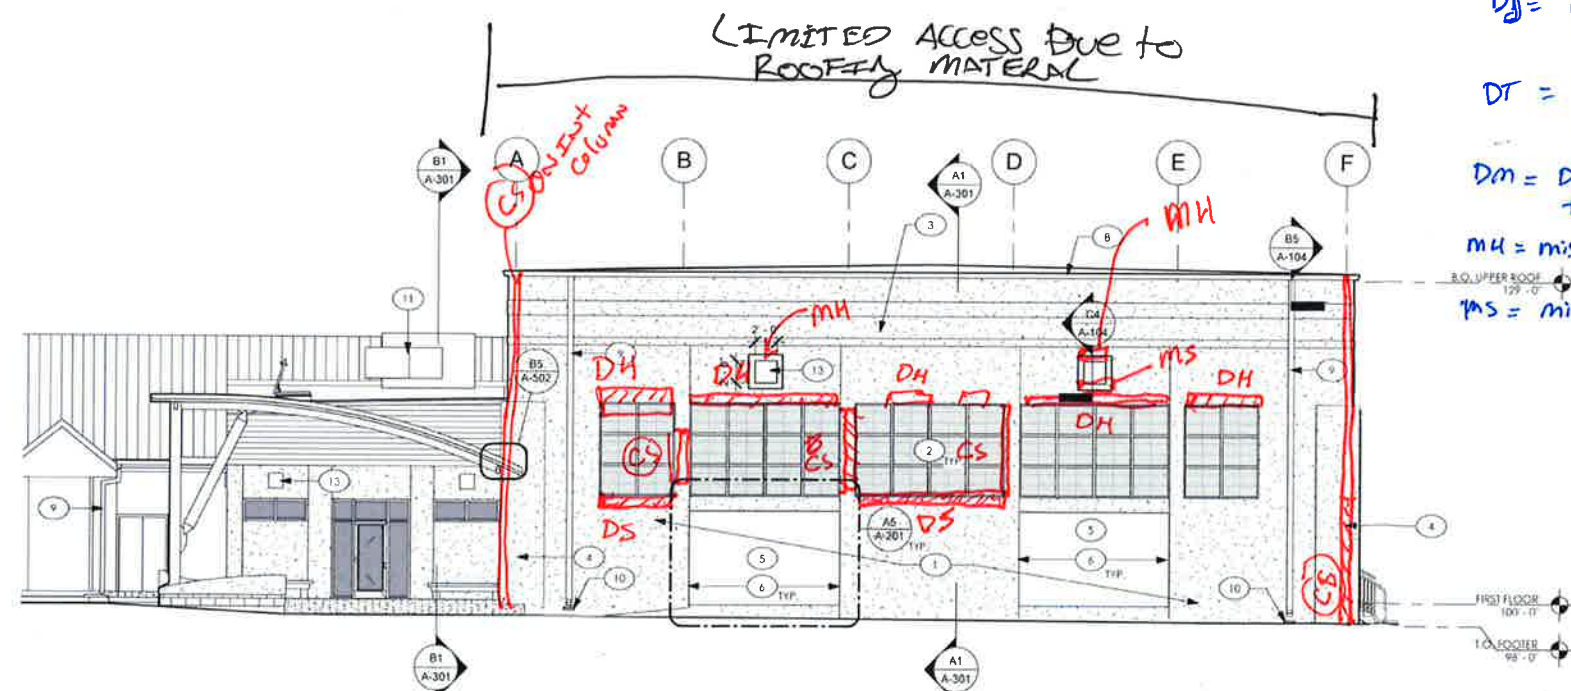
A1 SOUTH ELEVATION
1/8" = 1'-0"

LIMITED ACCESS OF TOP
OF WALL DUE TO ROOFING SYSTEM

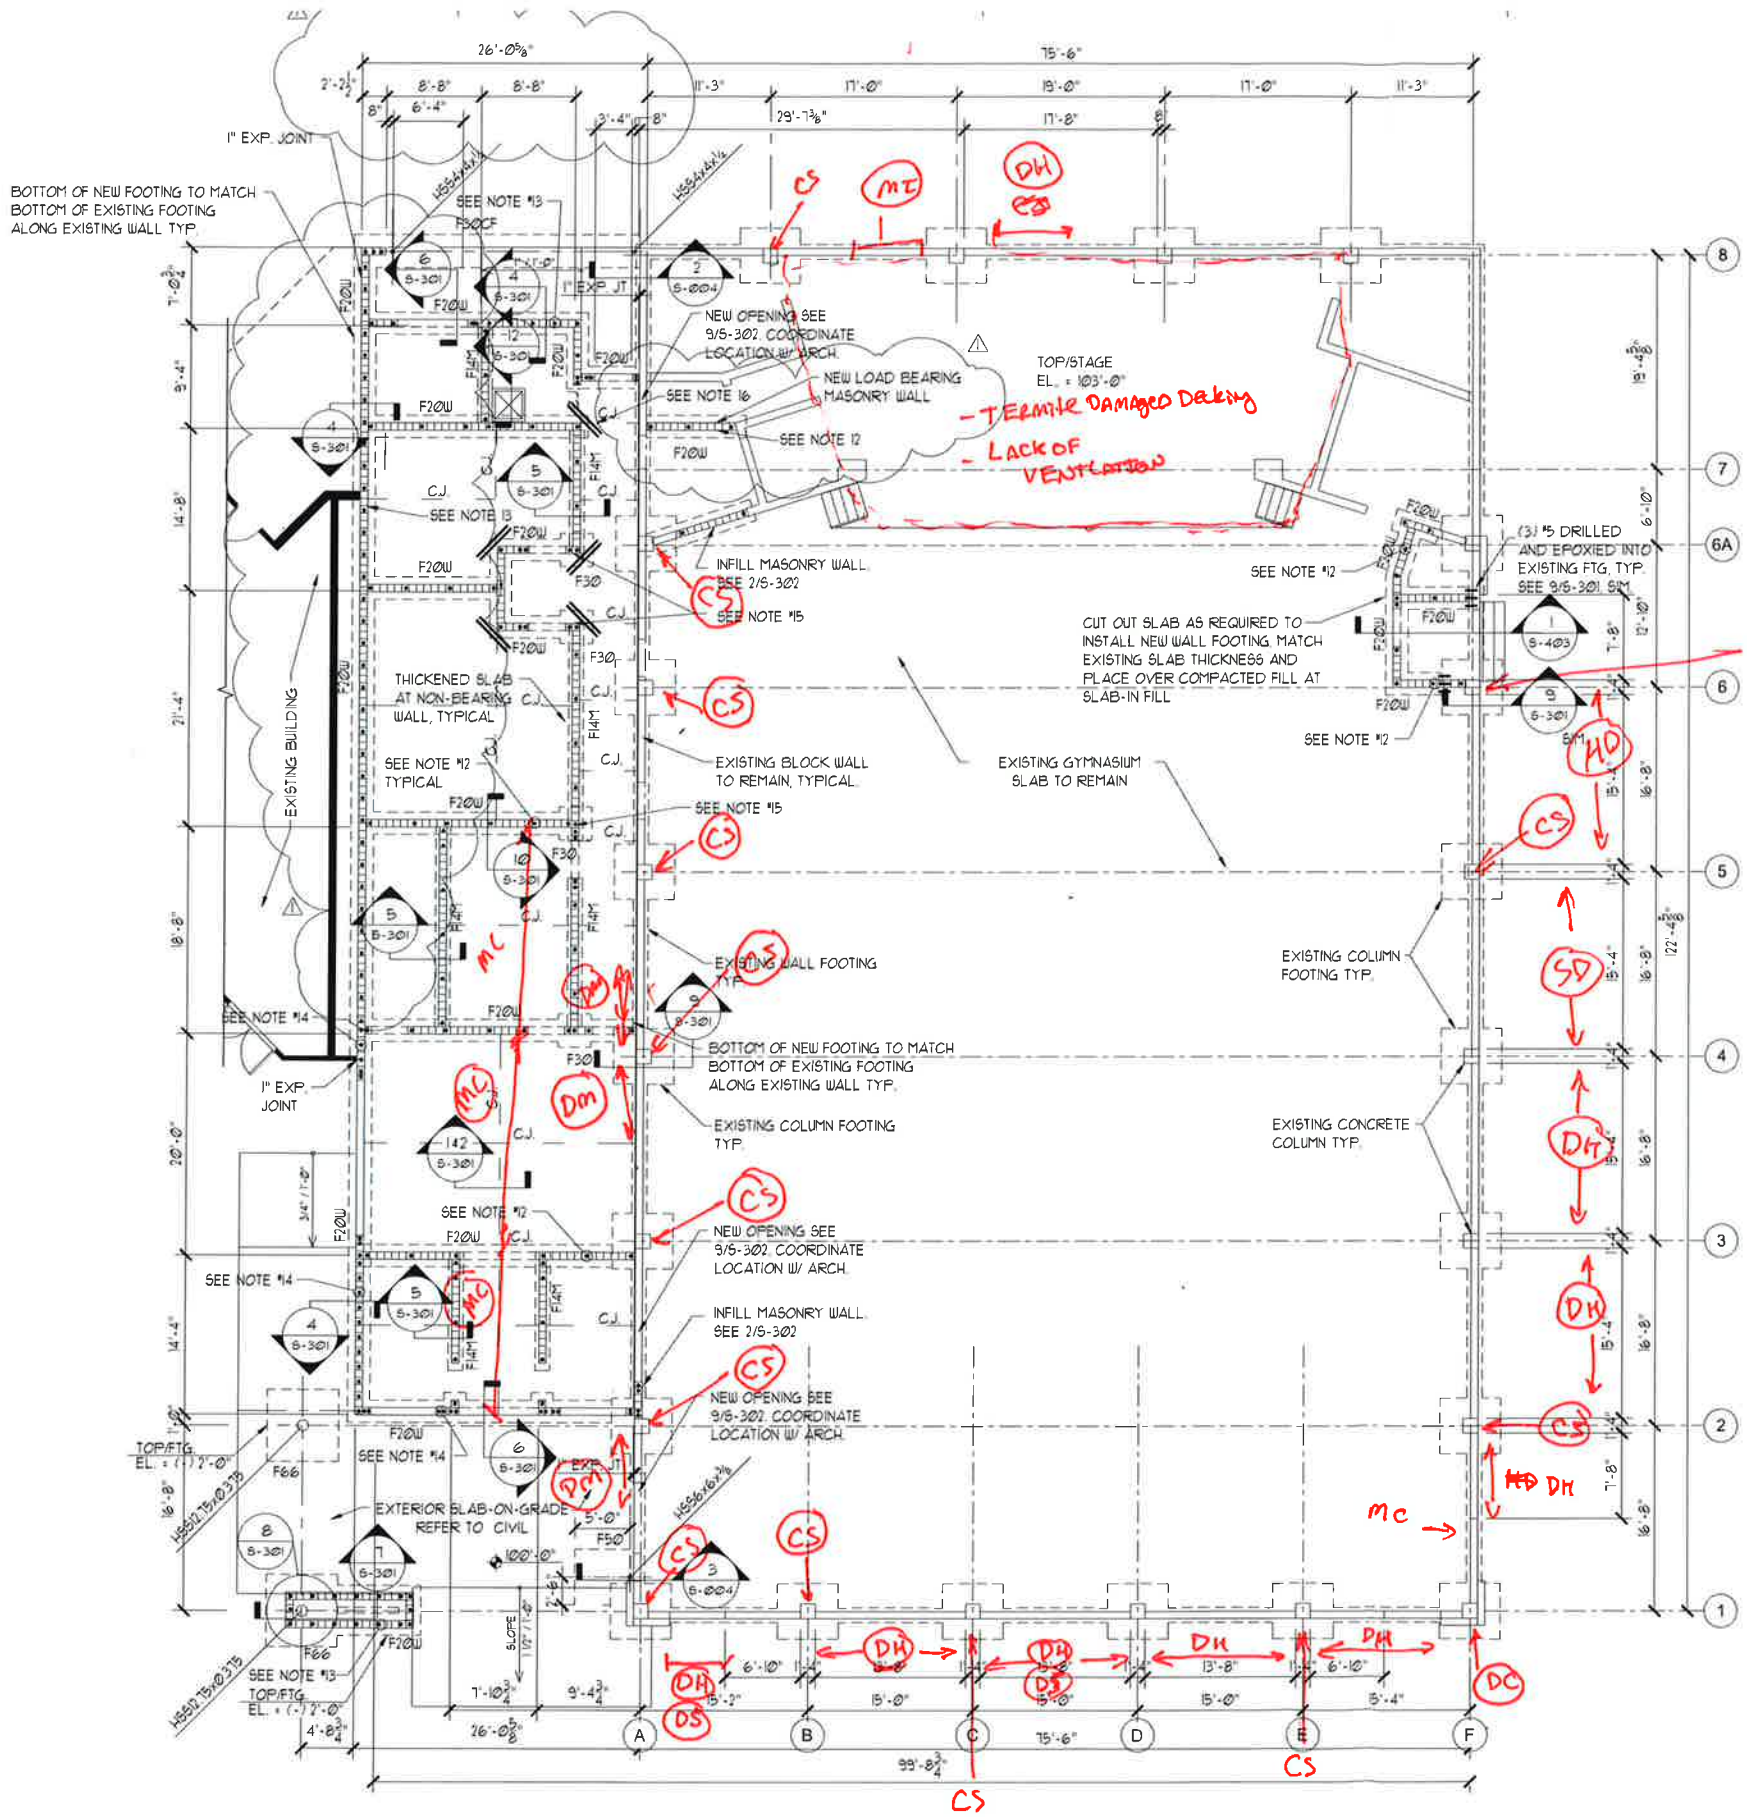
FOUNDATION PLAN

Cosmetic Damages
 * MD = MISCELLANEOUS DAMAGE TO INFILL MASONRY & STUCCO DAMAGE IS NOT SHOWN FOR CLARITY
 * MC = FOUND TO BE AN ISOLATED LOCATION AND APPEARS TO BE REFLECTED THROUGH STUCCO CRACKS. THIS DAMAGE IS COSMETIC

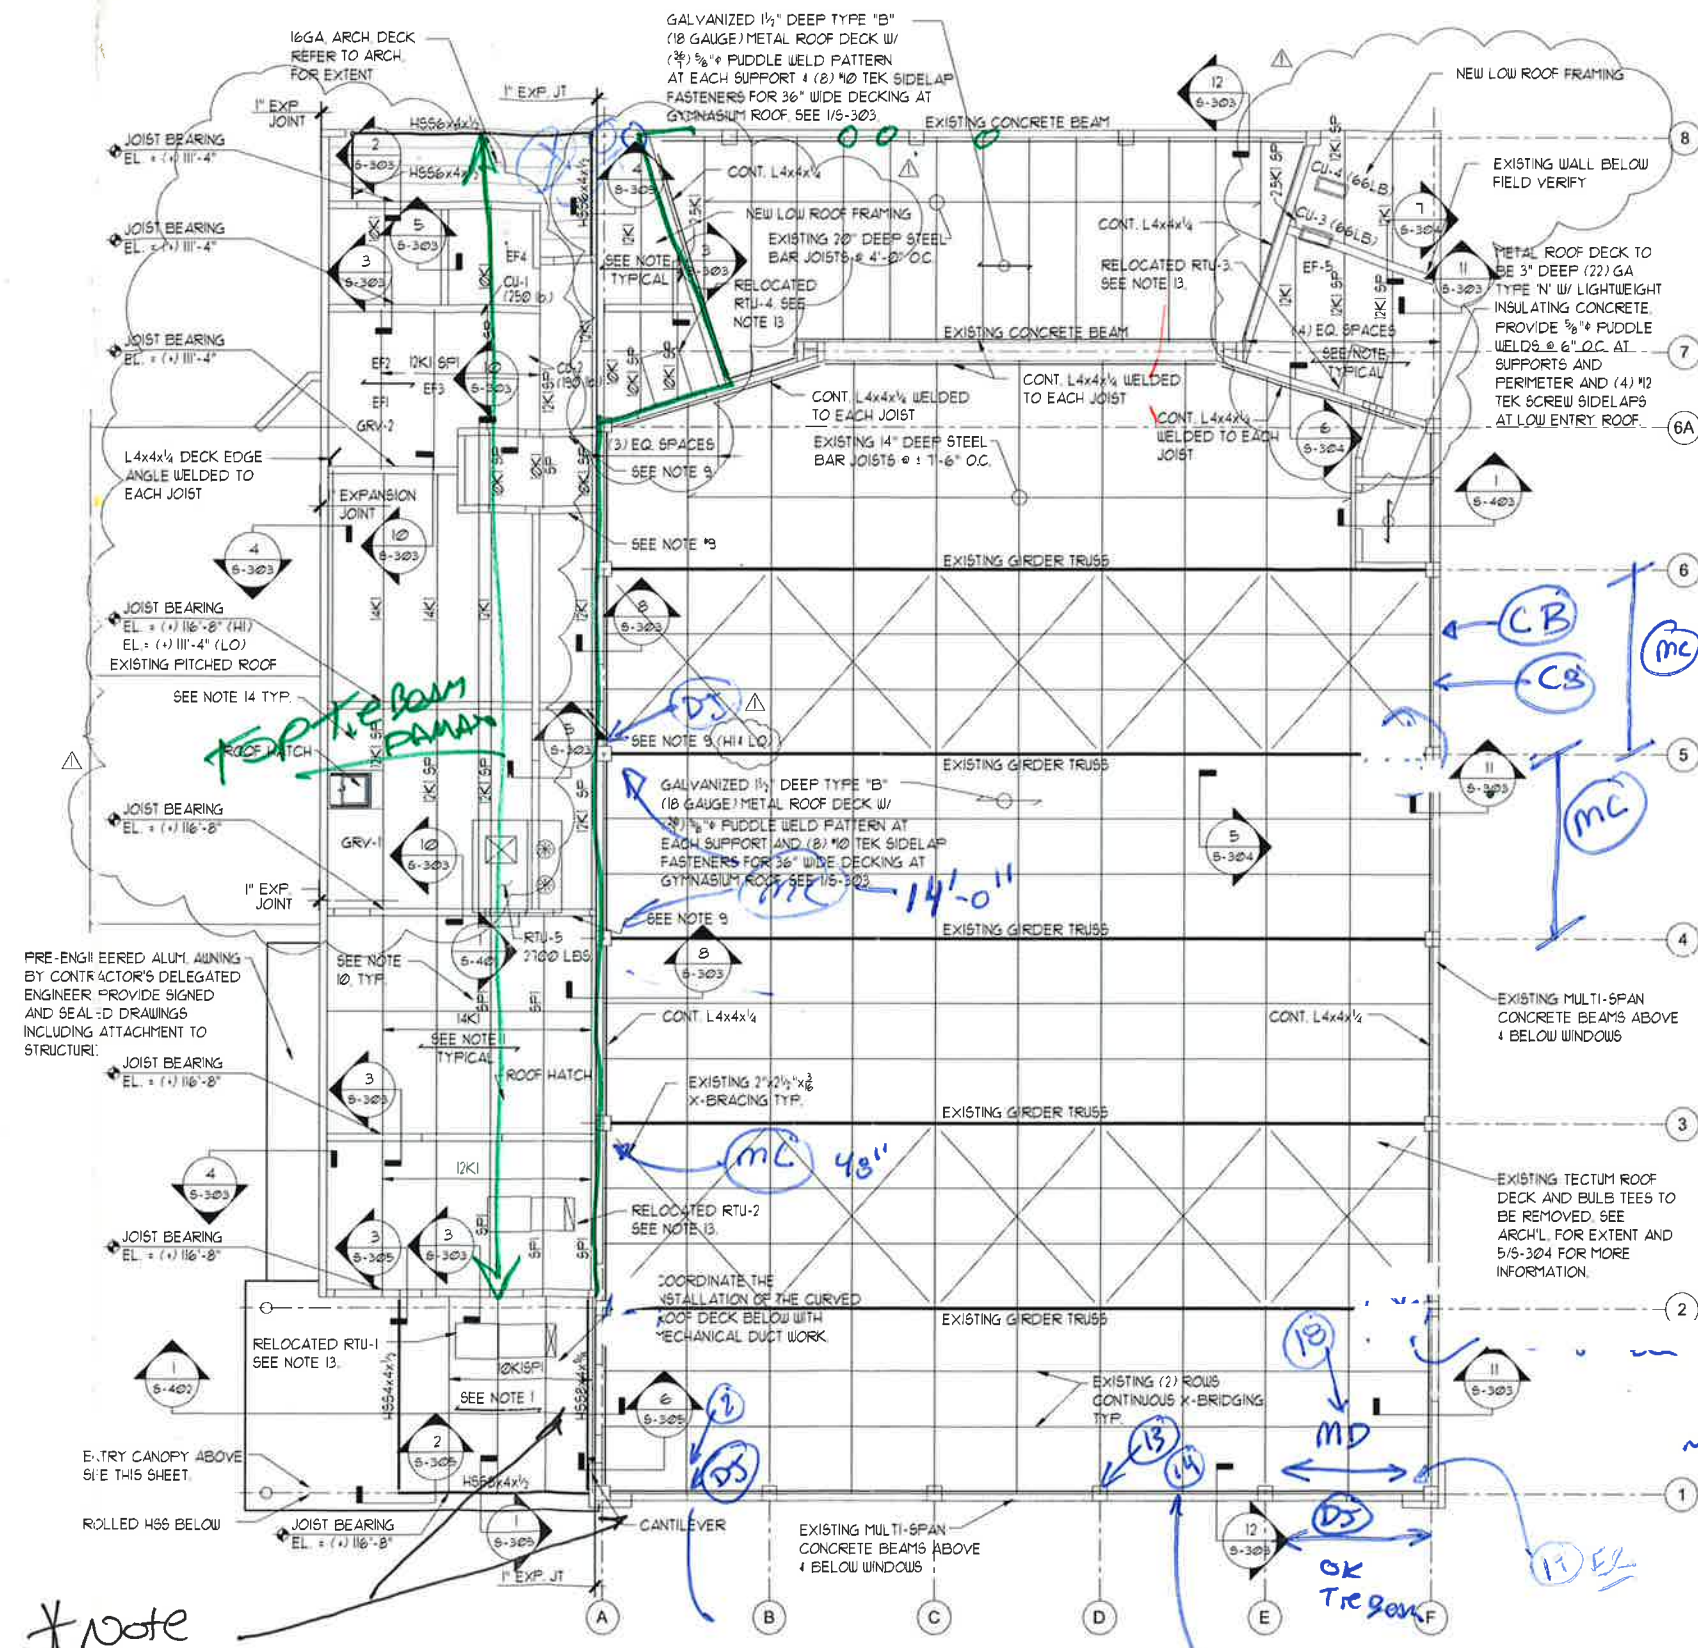
ROOF FRAMING PLAN
SCALE 1/4" = 1'-0"

***note**
Due to the installation of the new roof system, there was LIMITED VISUAL ACCESS to the top perimeter wall AT the North, South & East Elevations

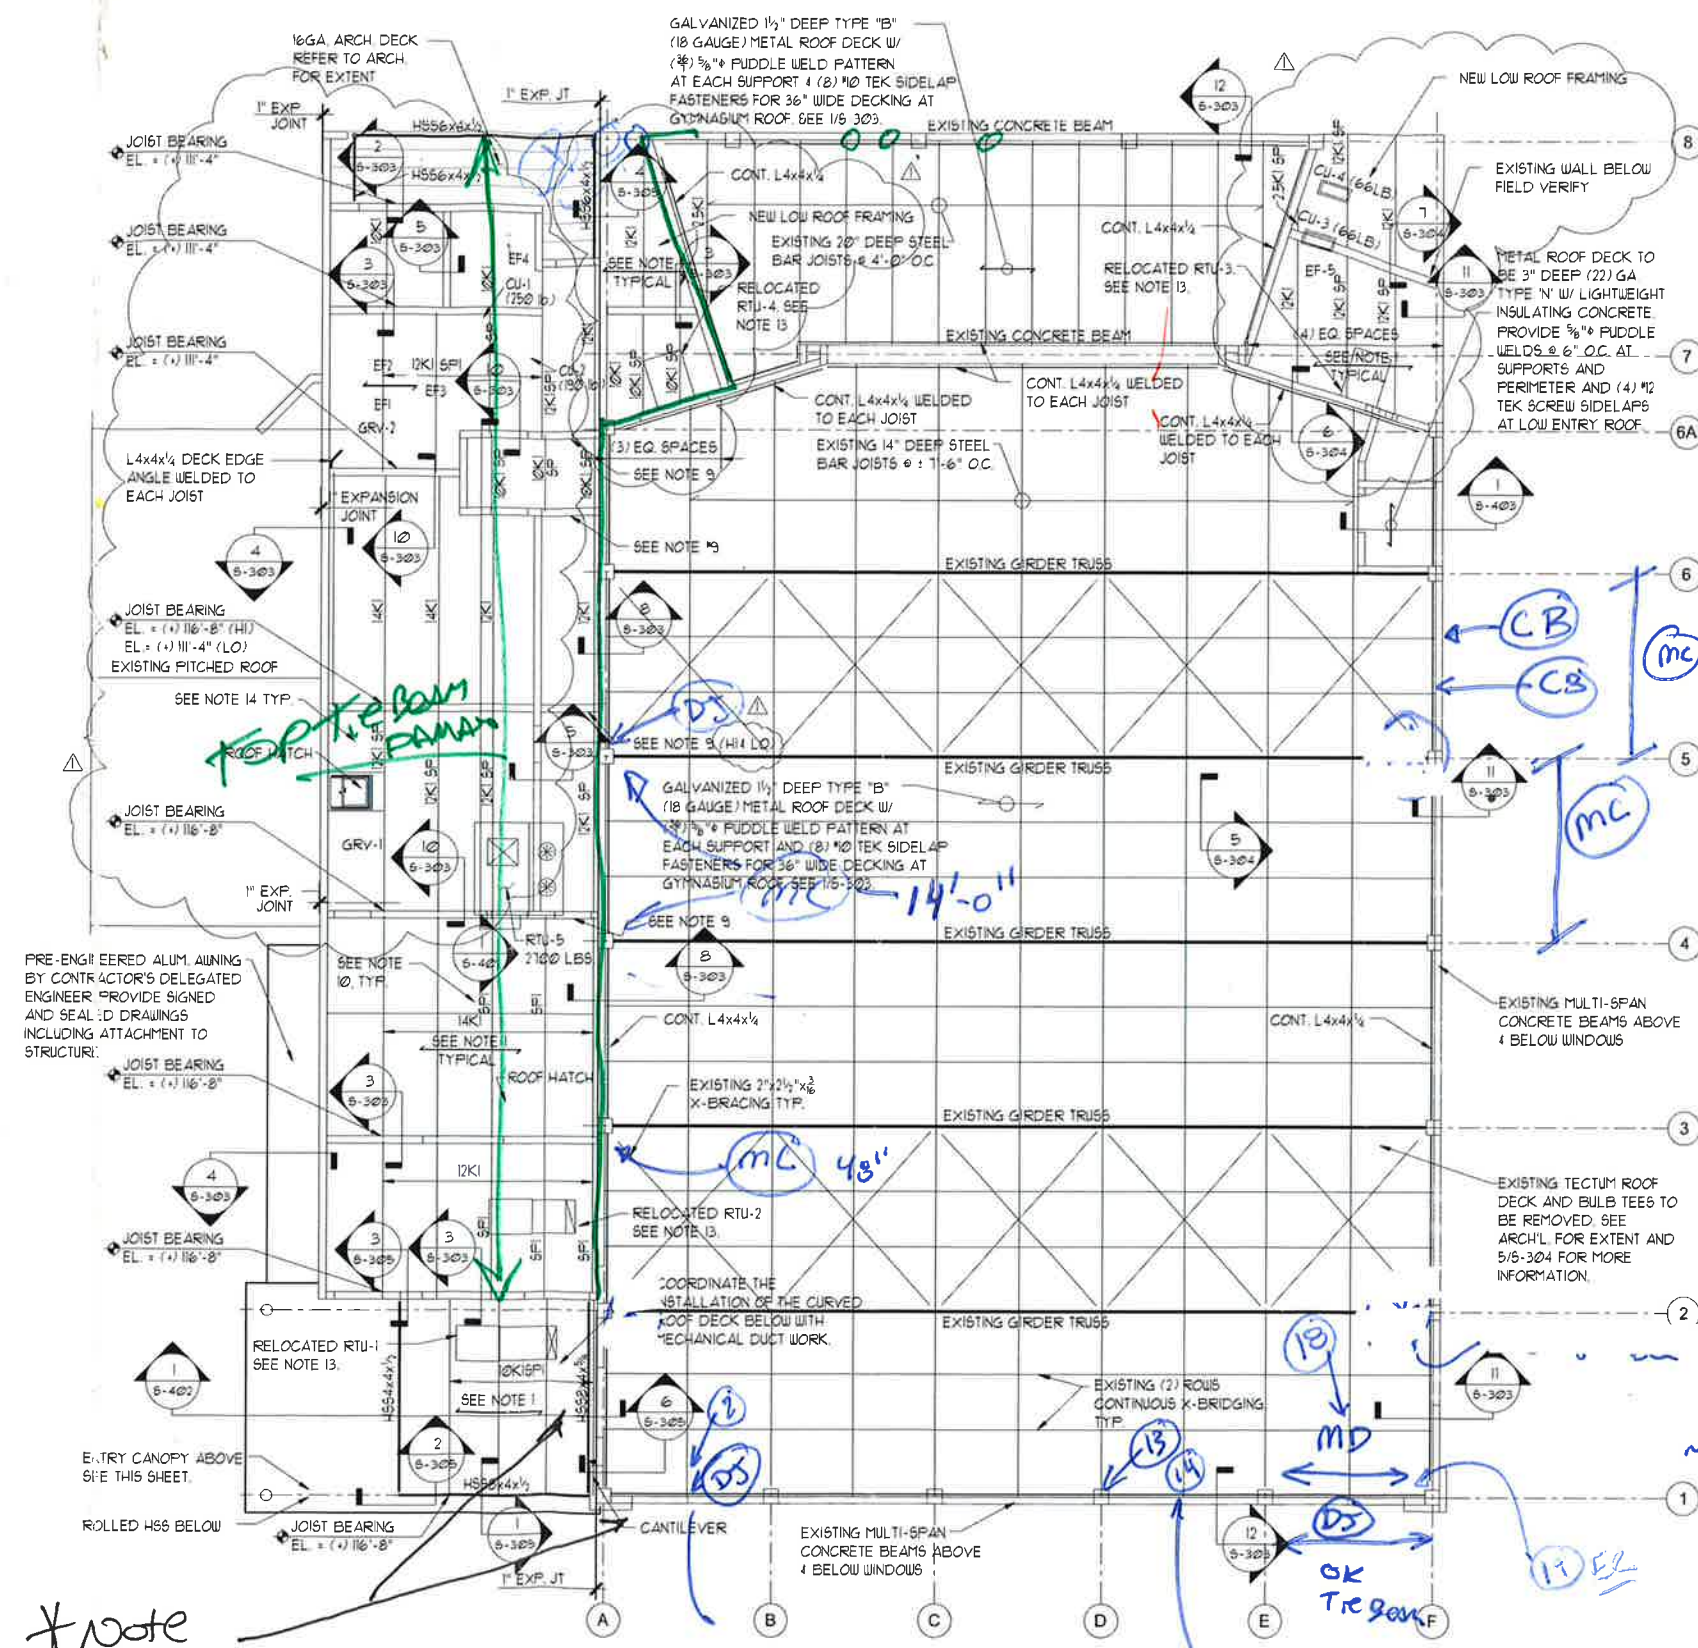
ROOF FRAMING PLAN
SCALE 1/4" = 1'-0"

*note
Due to the installation of the new roof system, there was LIMITED VISUAL ACCESS to the top perimeter wall AT the North, South & East Elevations
