Structural Engineering Services
Due Diligence Period Building Assessment
KW Citizen Building

Property Address:
3420 Northside Dr,
Key West, FL 33040

AD Job#: 1812-04
City of Key West P.O.: 088365

Artibus Design
December 2018

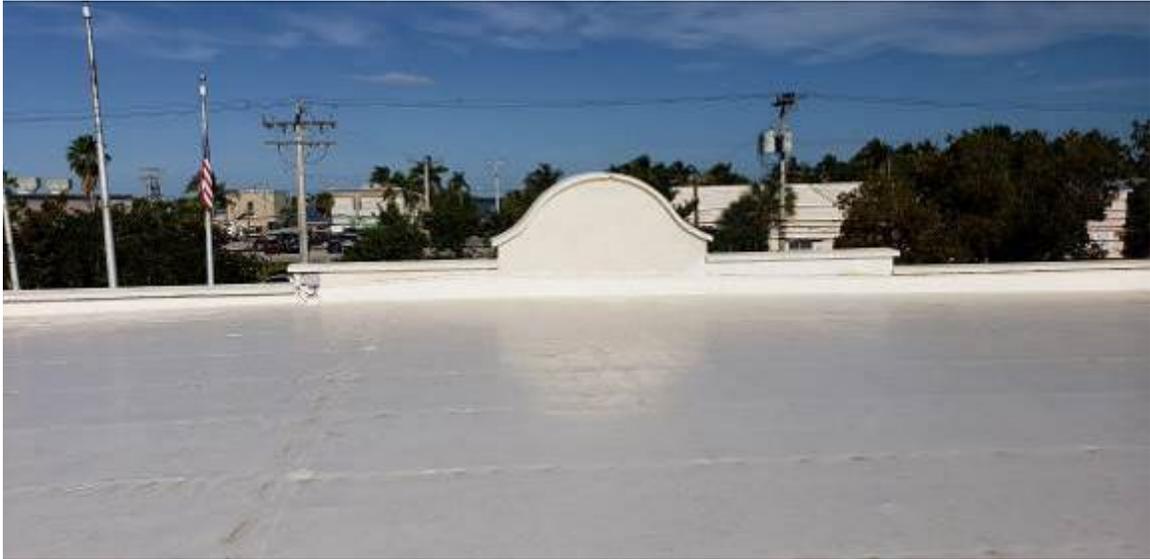
Figure 3. View over new roofing membrane vinyl (TPO) over tapered insulation. Roofing surface looks good, small imperfections reflect uneven nature of the underlying insulation capping sheet. The roofing is likely to be under current construction warranty and manufacturer material warranty. Owner should be contacted directly to transfer all warranties as part of the closing procedures if the City decides to proceed with the purchase.

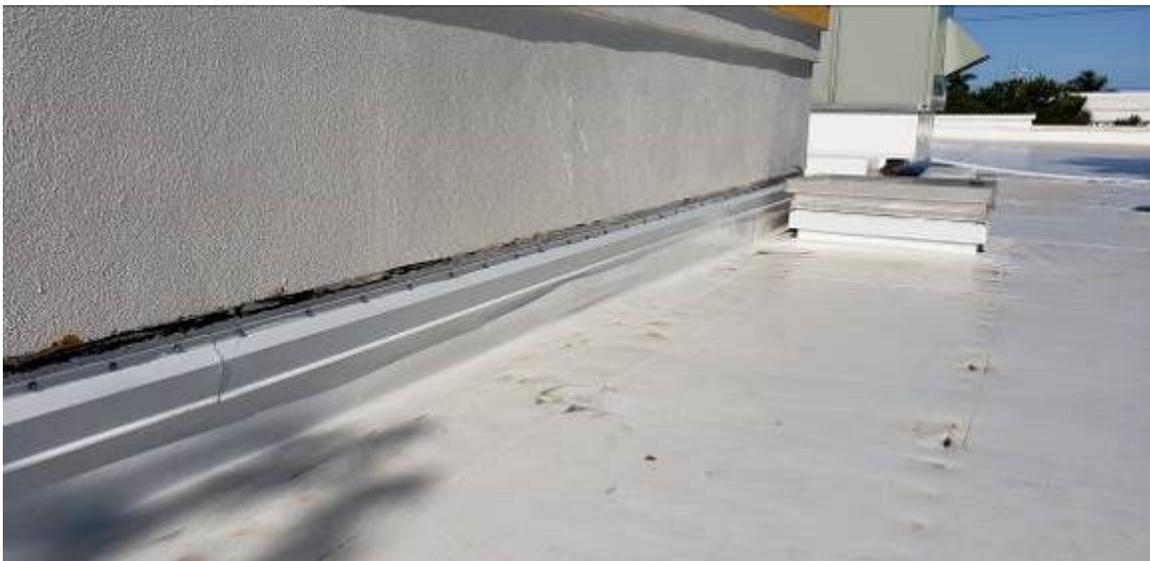
Figure 4. Same new roofing with new aluminum flashing and roof access hatch connected to the interior. Hatch is heavy duty aluminum (by "Bilco") with hydraulic assist and waterproofing gasket similar to current hurricane rated designs in good functional condition.

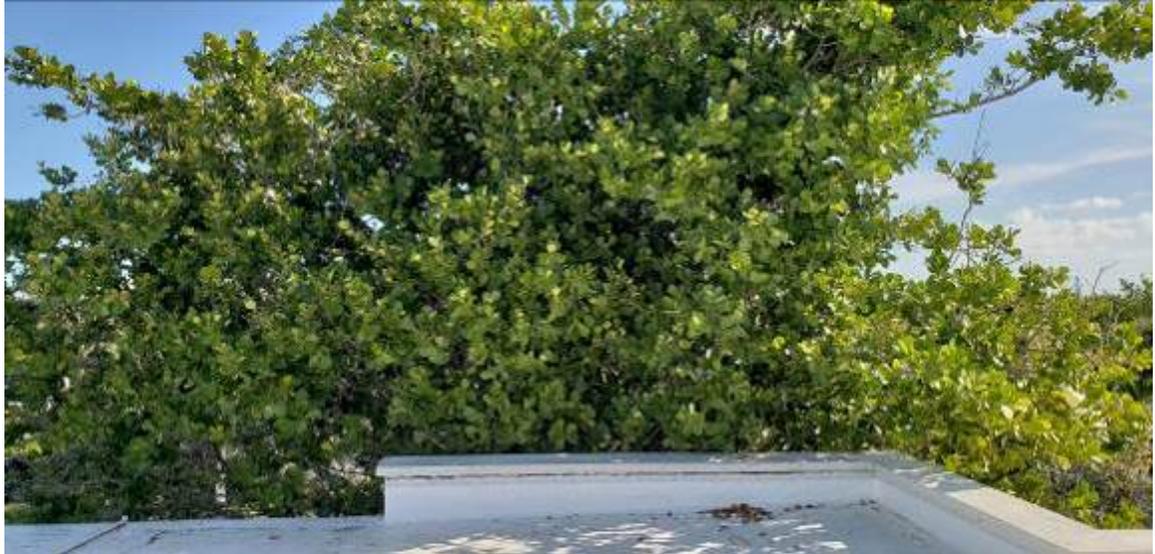
Figure 5. Same new roofing with tree branches overhanging and tree debris collecting along the short parapet walls. All trees around the building should be professionally pruned to prevent damage to the roofing and structure cladding.

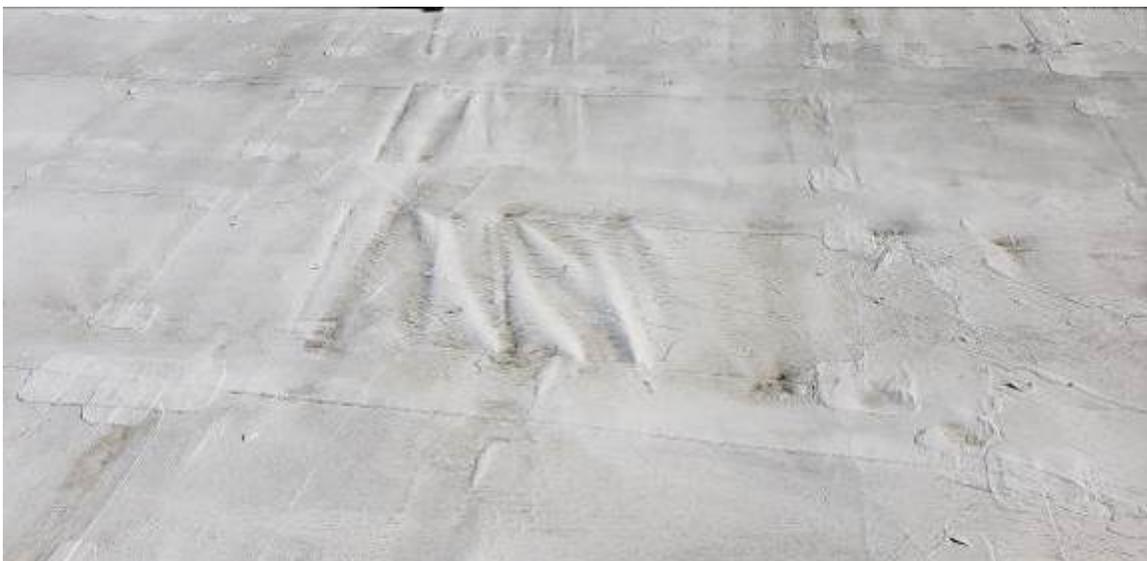
Middle and rear sections of the roof (upper roof and rear low roof) over printing, sorting and storage areas are of TPO style membrane installed over tapered insulation. Roofing appears to have been installed in 2005 or 2006 based on review of permits (see permit status list). Multiple patch repairs are evident across the membrane. A liquid applied coating system was observed applied to the membrane.

Figure 6. Aging membrane surface with adhesion imperfections, small patches and liquid applied coating.

- Two roof surfaces covering rear portion of the building with total area of 5,376 sq.ft are approaching their useful lifespan limit and shall be replaced within next 3 to 5 years. The replacement efforts shall be coordinated with any mechanical work to be done on the roof in case of change of occupancy use for the spaces below (if any) to prevent damage to newly installed roofing membranes. Please see Appendix "B" for engineer's opinion of probable cost.
- Mechanical components shall be serviced as described in the report.
- Glazing in one broken window shall be replaced.
- Corroded water heater shall be replaced.
- Miscellaneous damage to the exterior insulation and finishes shall be repaired.
- Miscellaneous damaged electrical components shall be repaired or removed depending on the intended new use of spaces.

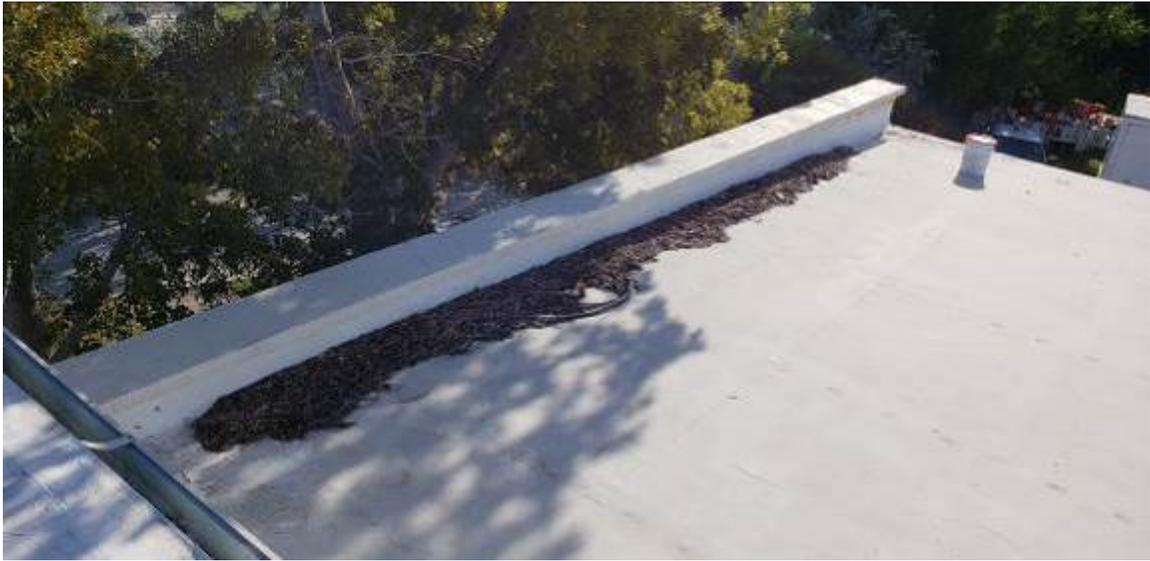
Figure 7. Low rear roof east side. Tree leaves and branches are accumulating along the short parapet wall. (See comments to figure 5).

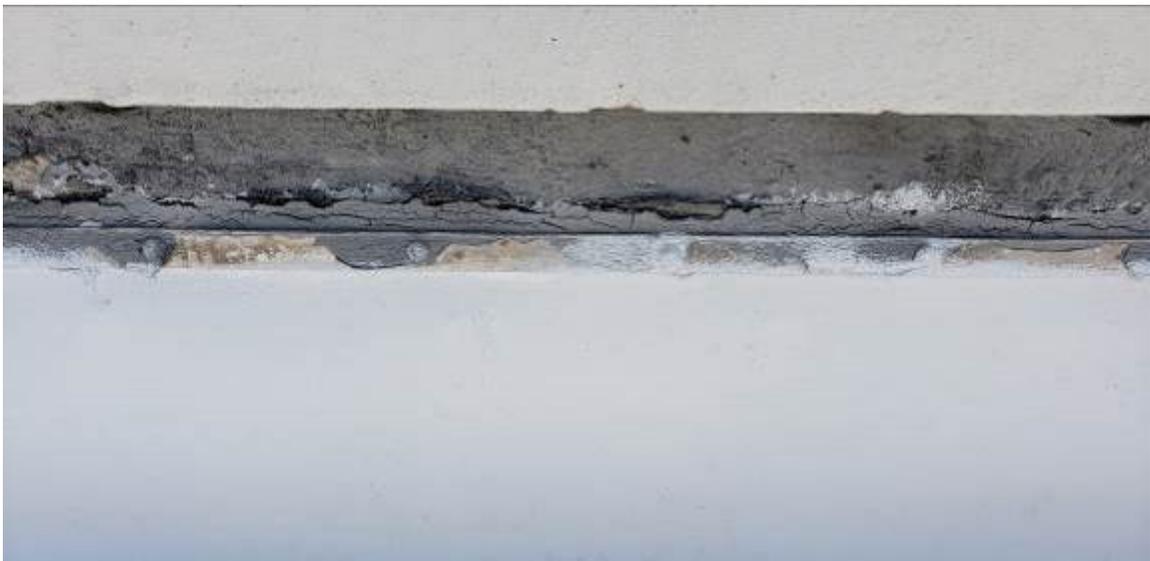
Figure 8. Membrane termination strip attached to the parapet walls and cracking sealant. No protective flashing is installed over the termination strip. Failure of the sealant will likely result in water intrusion into building envelope.

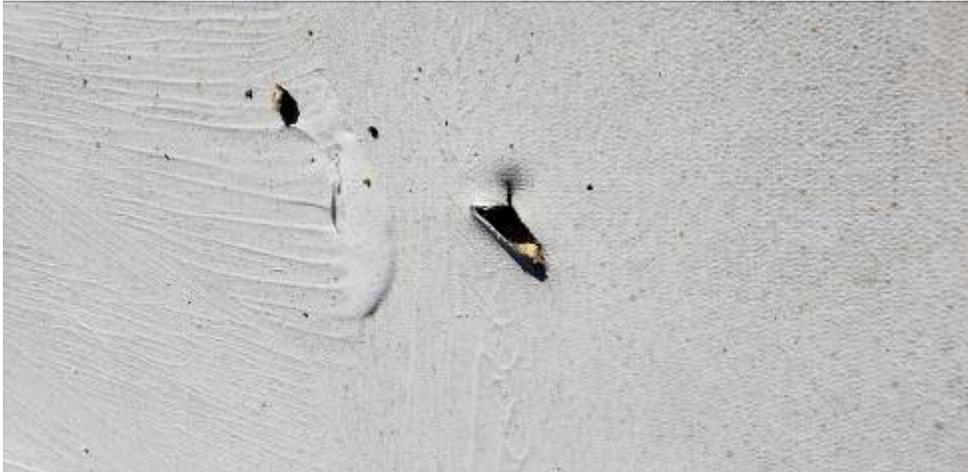
Figure 9. Small tear puncture of the roofing membrane was found in one location. Requires a small local patch.

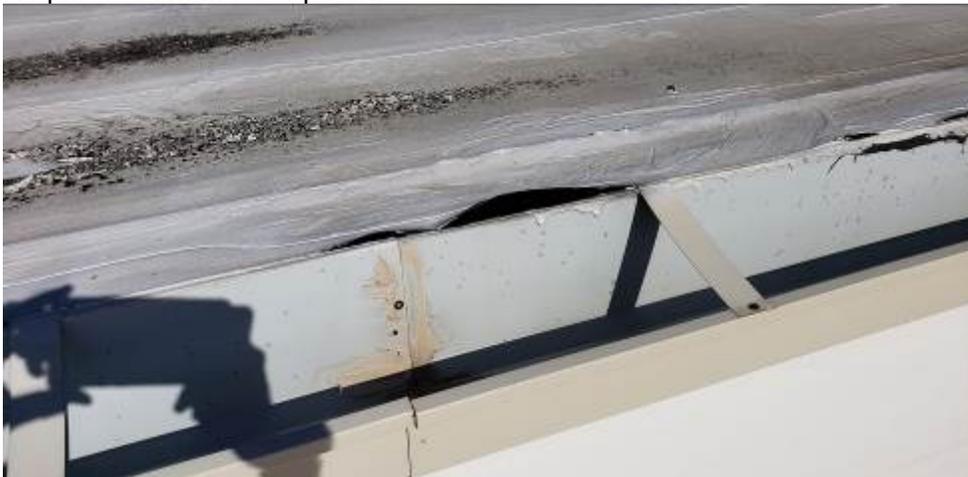
Figure 10. Peeling up edge of the membrane at the gutter between two roof levels. Requires maintenance.

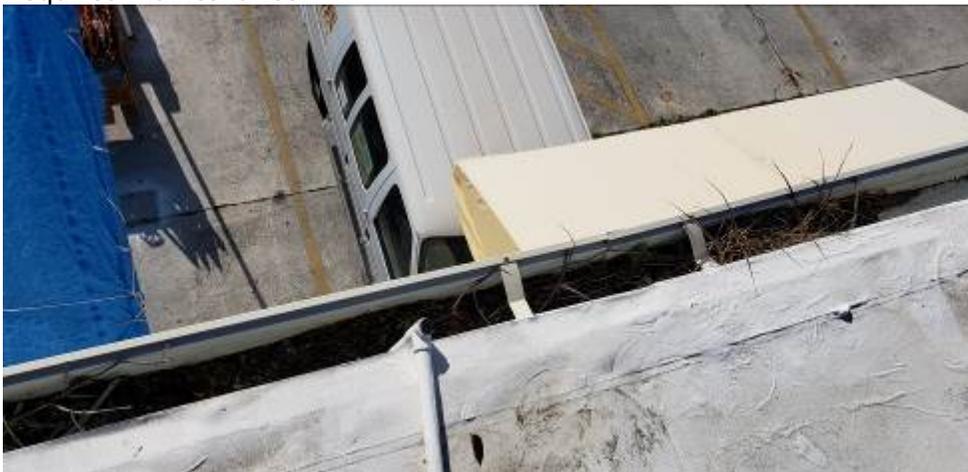
Figure 11. Tree leaves and branches in the rear gutter, requires maintenance, tree pruning and perhaps leaf guard for the gutter system.

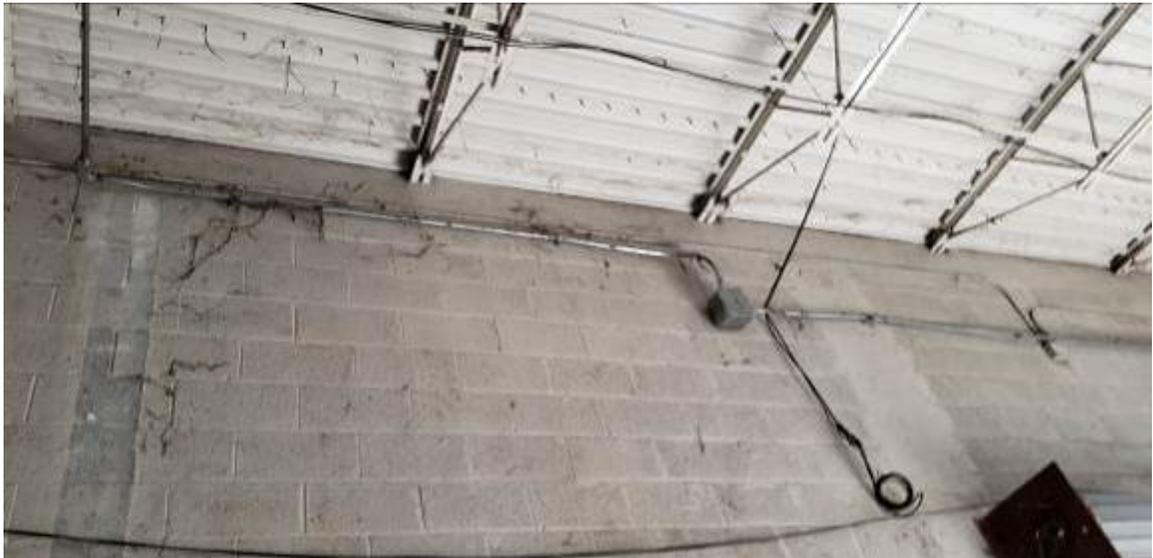
Figure 12. CMU wall – interior of storage and loading area - with visible tie-beam and tie-column.

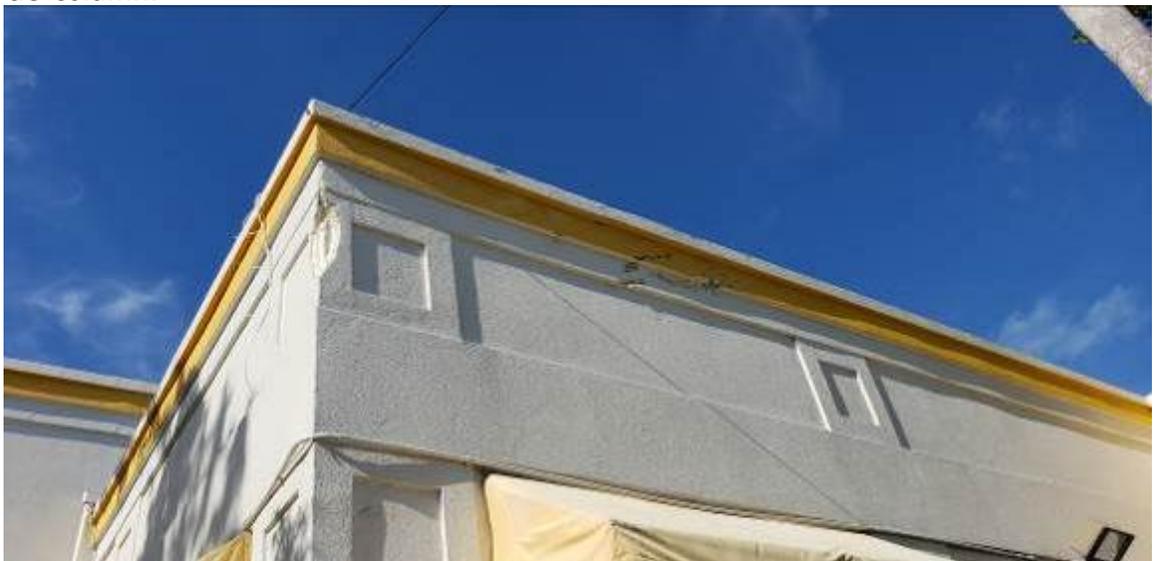
Figure 13. Exterior wall with small damage to the corner and surface (likely hurricane debris damage). Similar small damage in other locations. Cosmetic repairs are needed.

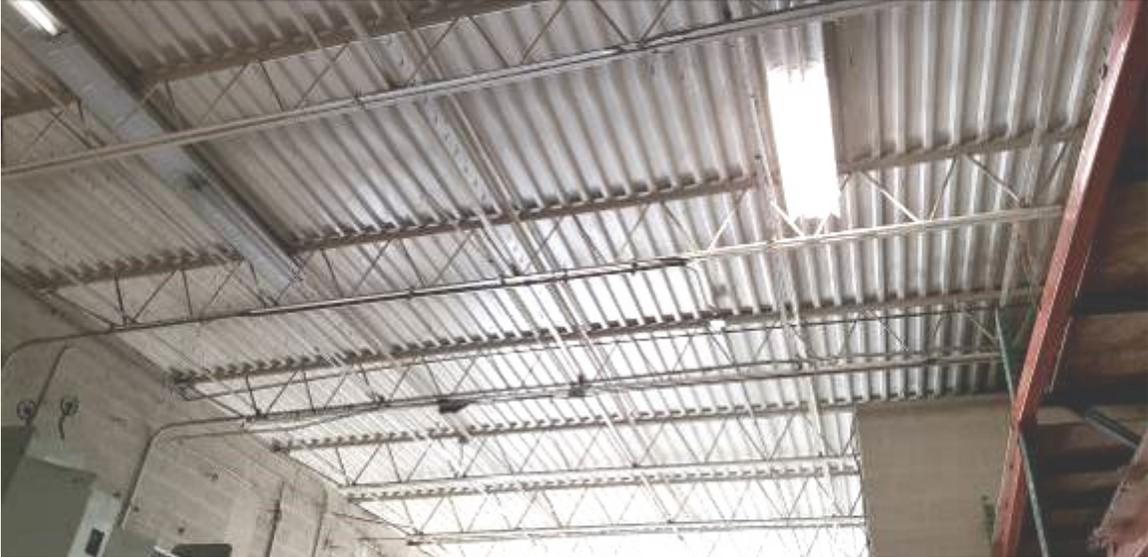
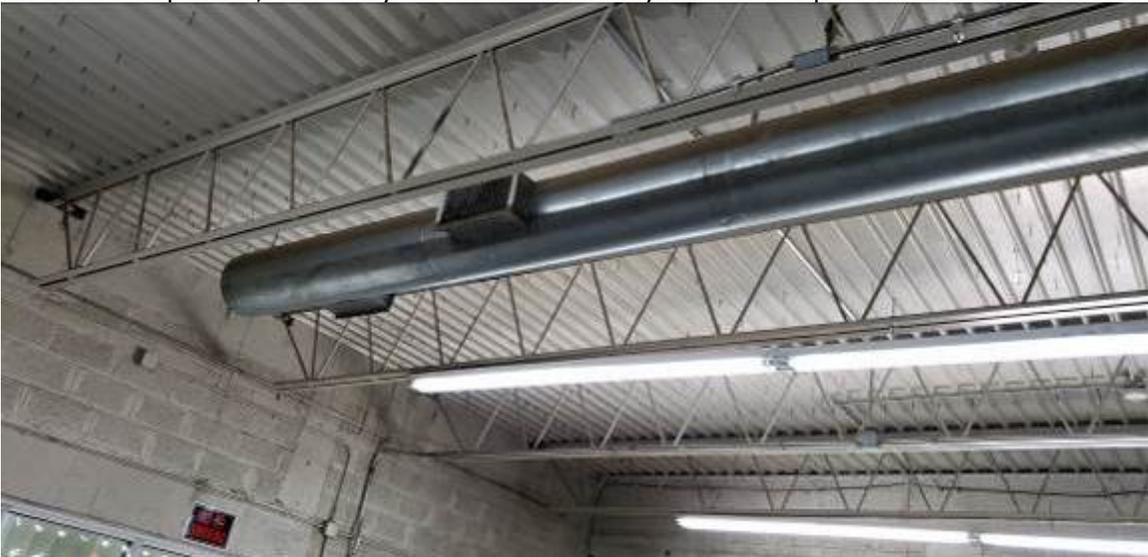
Roof framing is a steel bar joist system with corrugated galvanized steel deck attached to the top chord. No structural defects were discovered in the available for inspection locations. Roof framing and roof deck condition can be considered as good.

Figure 14. Exposed steel bar joists system exposed to the interior in the rear part of the building. In front offices the roof deck and roof joists are concealed by the finishes and were not inspected, but likely to be same or very similar shape.

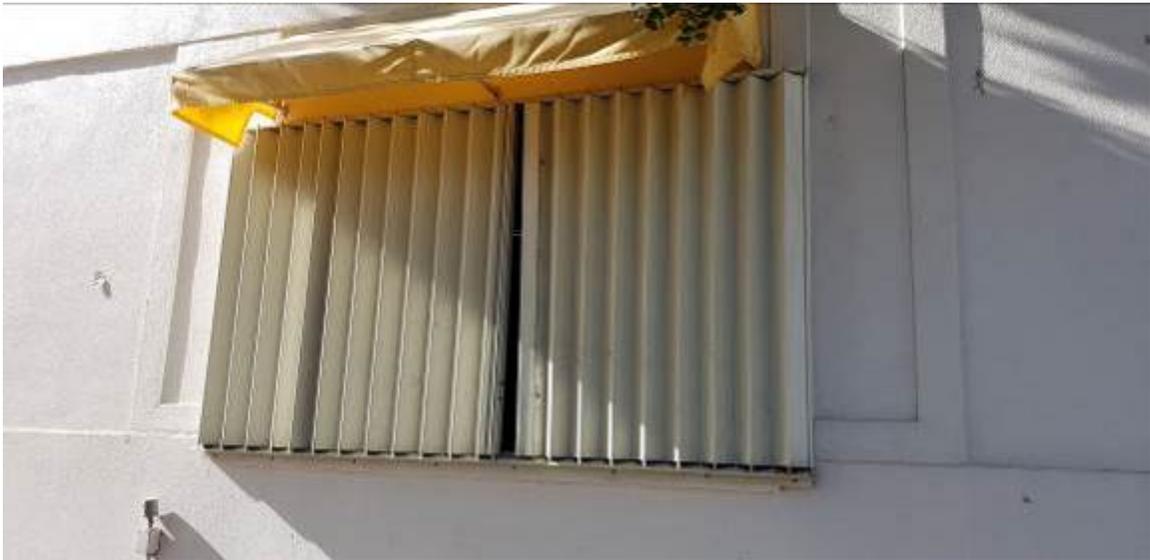
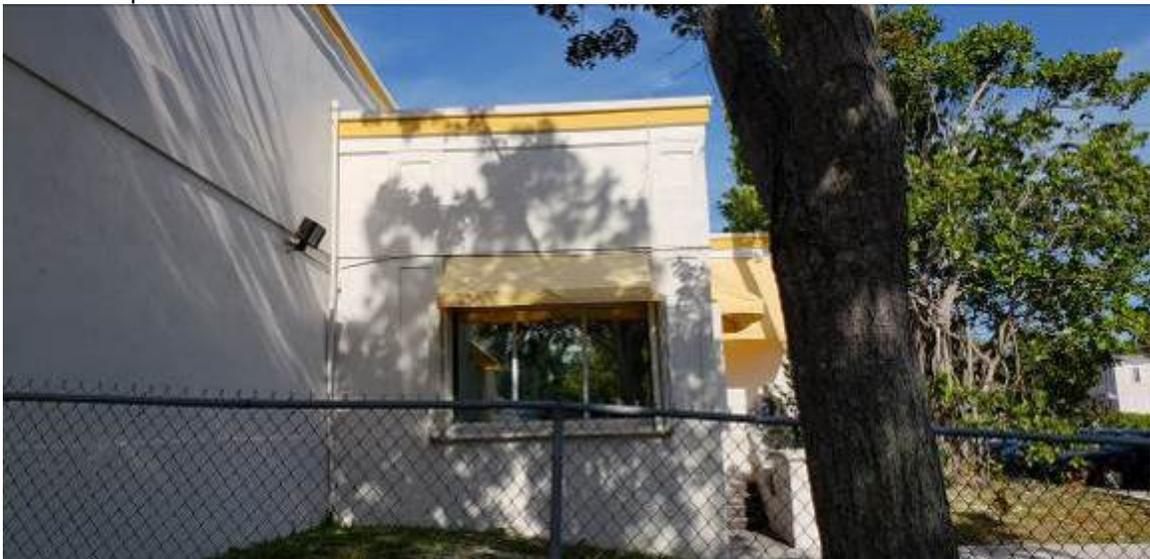
Figure 16. Typical window opening with removable fabric awning and accordion shutters in closed position.

Figure 17. Same with shutters in open position.

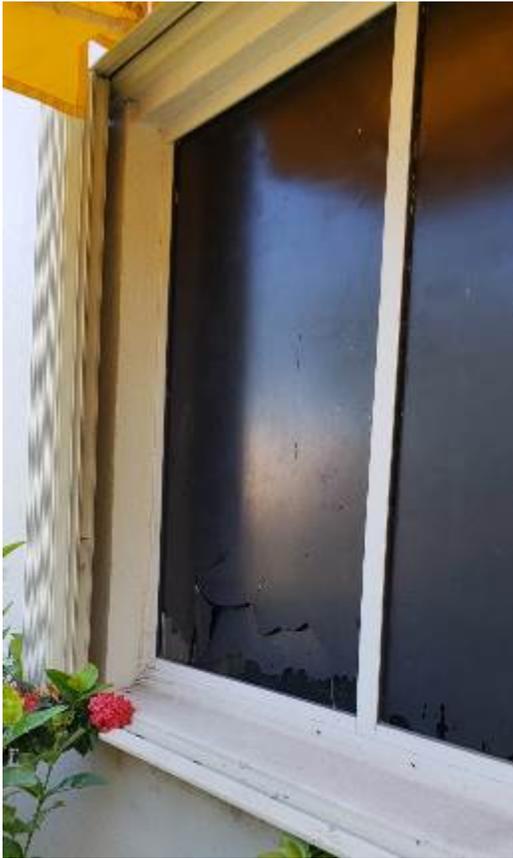
Figure 18. Broken outer pane of a double glass fenestration system in one location. Replacement of the glass is needed. Please note that some windows have black-out coating for privacy.

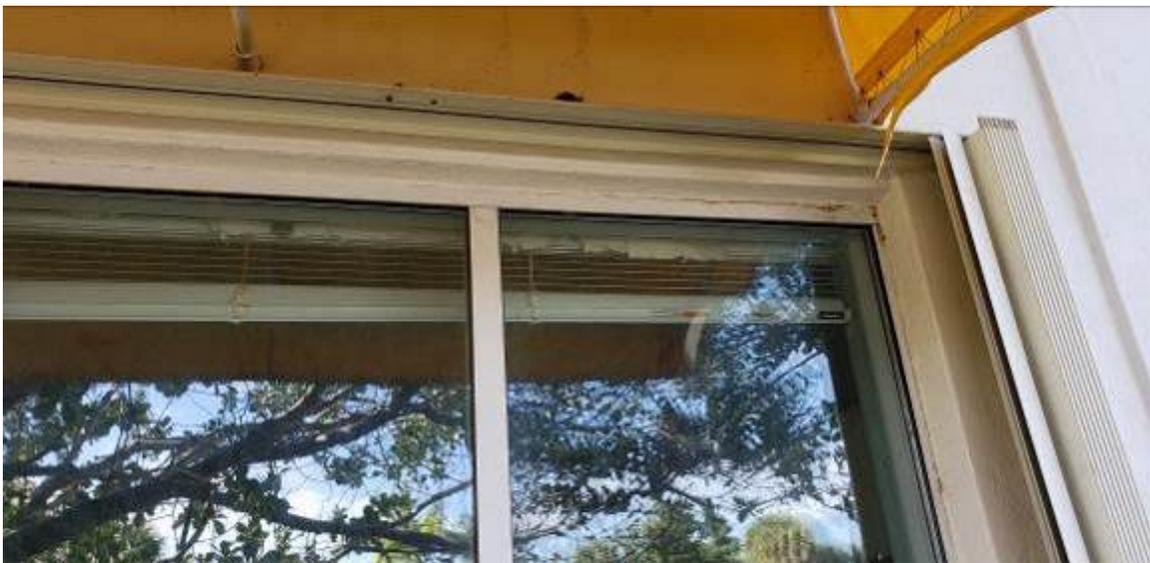
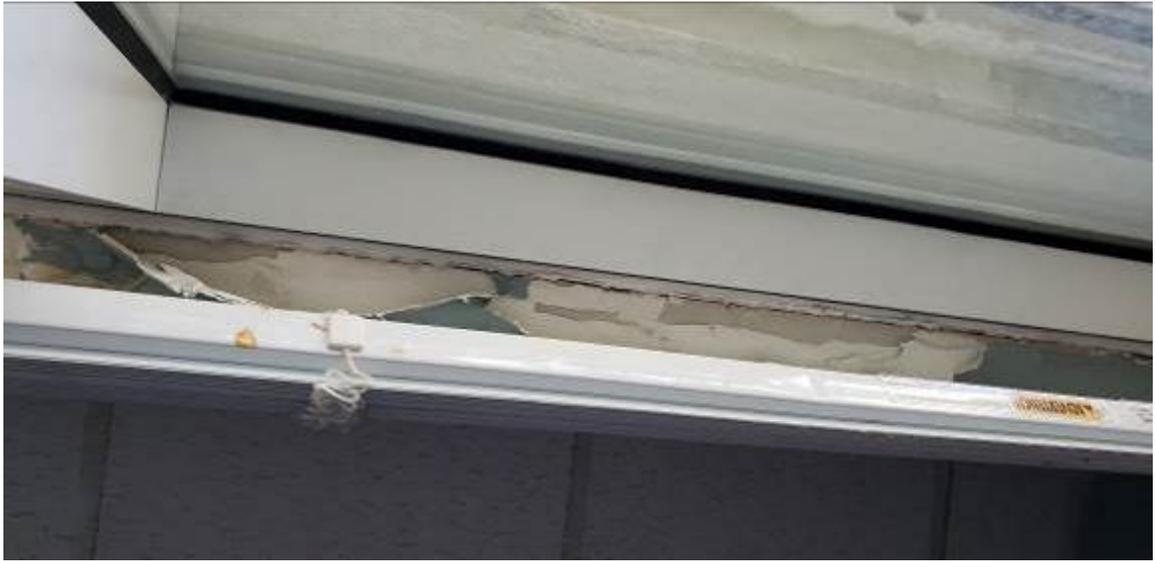
Figure 21. Signs of water intrusion – visible damage to the drywall trim of the window opening on the interior (likely prior new roofing installation).

Figure 22. Same as Figure 21 on the interior.

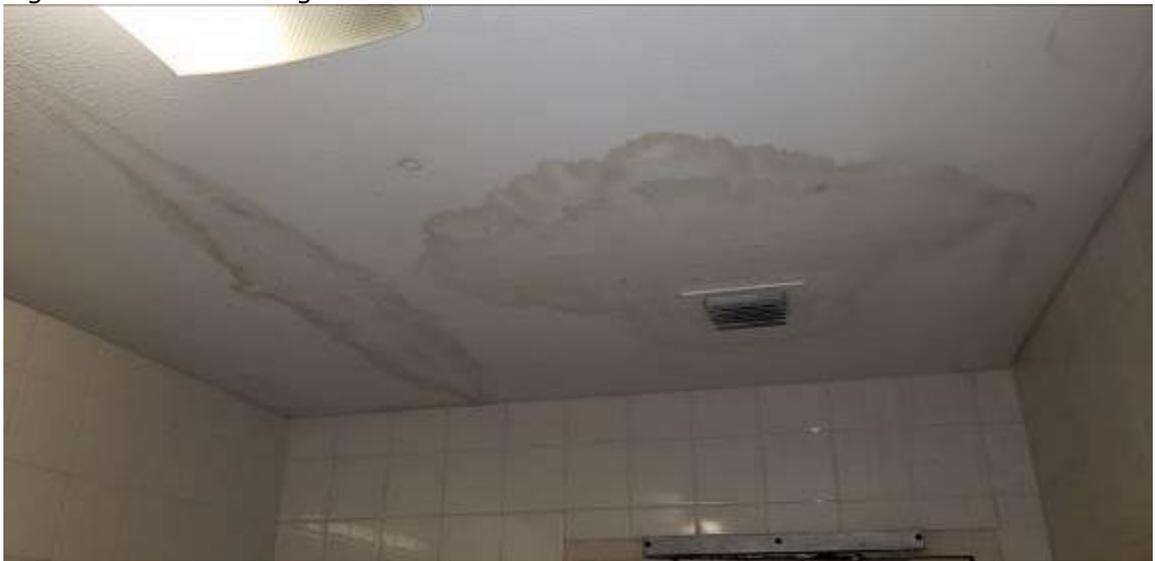
Figure 23. Water damage to the drywall ceiling in the front section of the building in the bathroom. (likely prior new roofing installation). Please note that all locations were dry during the inspections – however no recent significant rain events.

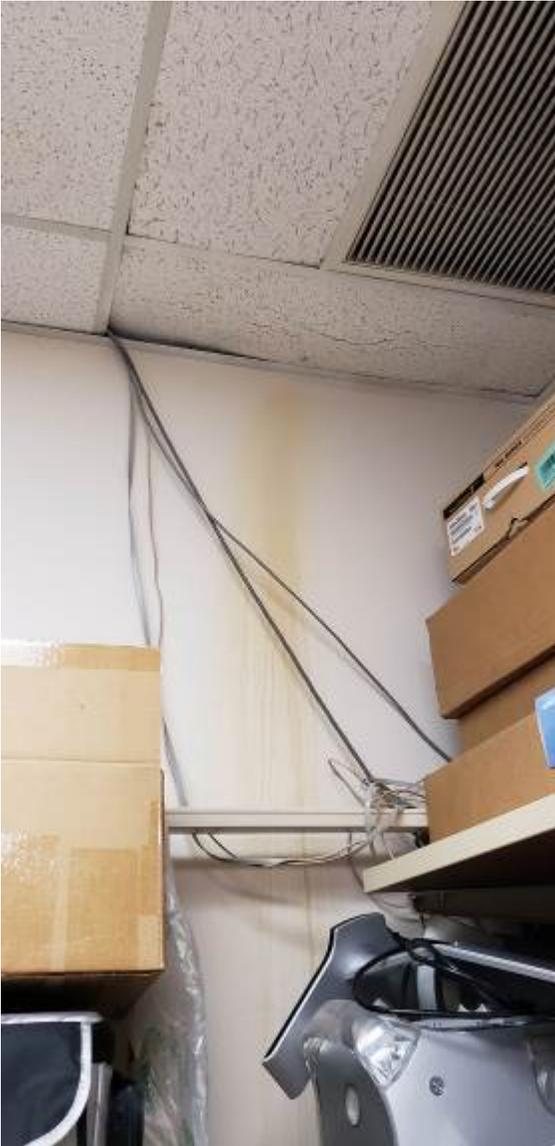
Figure 24. Water damage on the wall surface, similar conditions in various limited locations on walls in the front section of the building (offices). Again, all stains are likely to be prior recent re-roofing project and damages are limited to interior finishes.

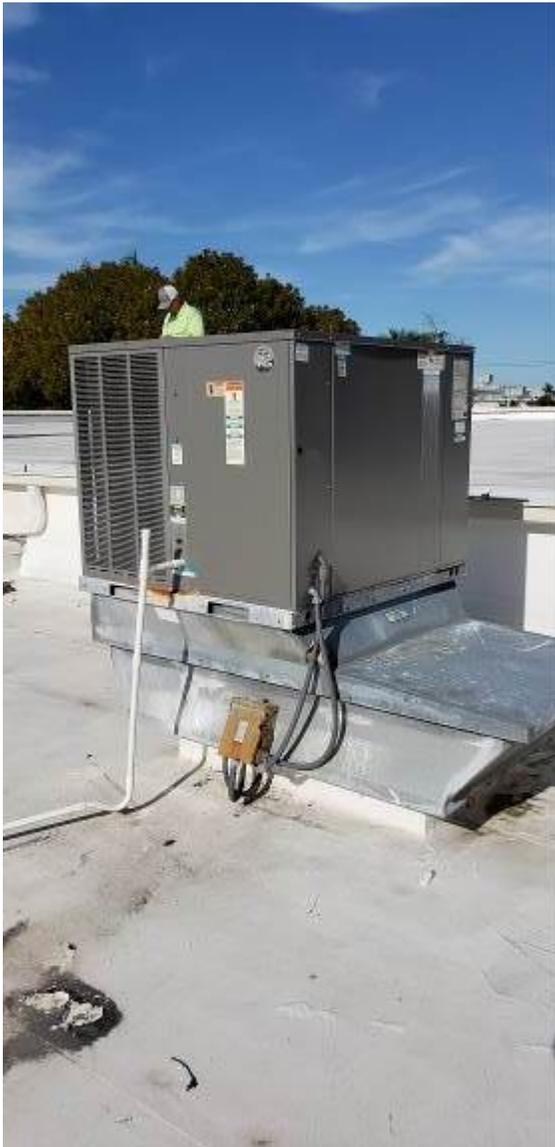
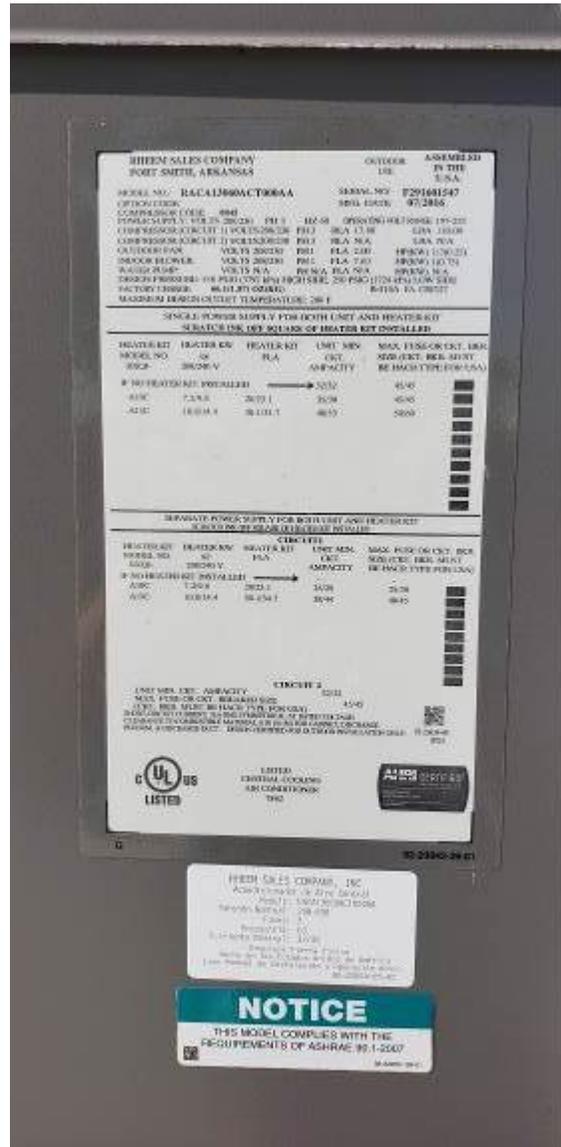
Figures 25&26. Rooftop package unit servicing rear end of the building. Unit manufactured and installed in 2016. Installation is adequate and unit equipment is likely to still be under manufacturer warranty.

RHEEM SALES COMPANY,
Model# RACA13060ACT000AA is a commercial grade 5 Ton, 13 SEER, 3 Phase.

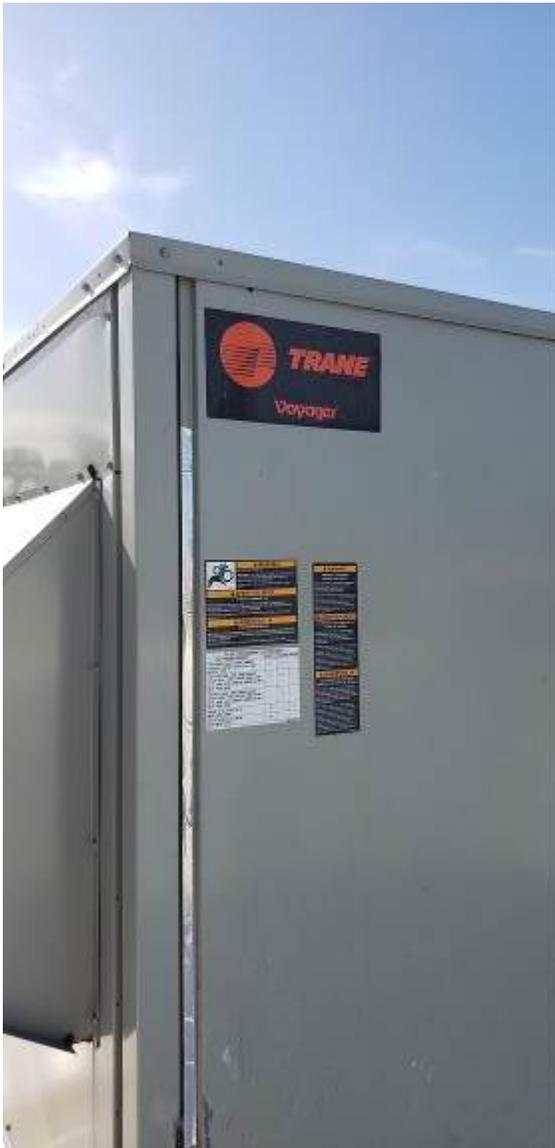
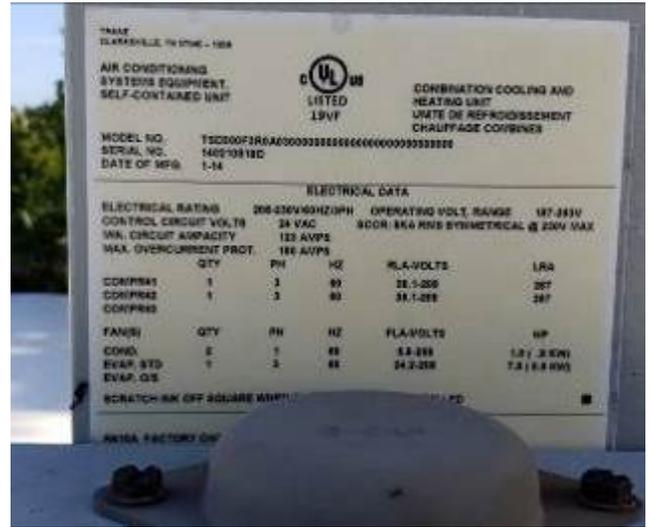
Figures 27&28. Rooftop package unit servicing front of the building.
Trane Voyager Model# TSD300F3R0A030, Date of Manufacturing 1-14.
25 Tons Standard Efficiency, 208-230/60/3 phase.

Inspected unit appears to be in generally adequate condition with exception of few maintenance issues (refer to Figures 29-31).

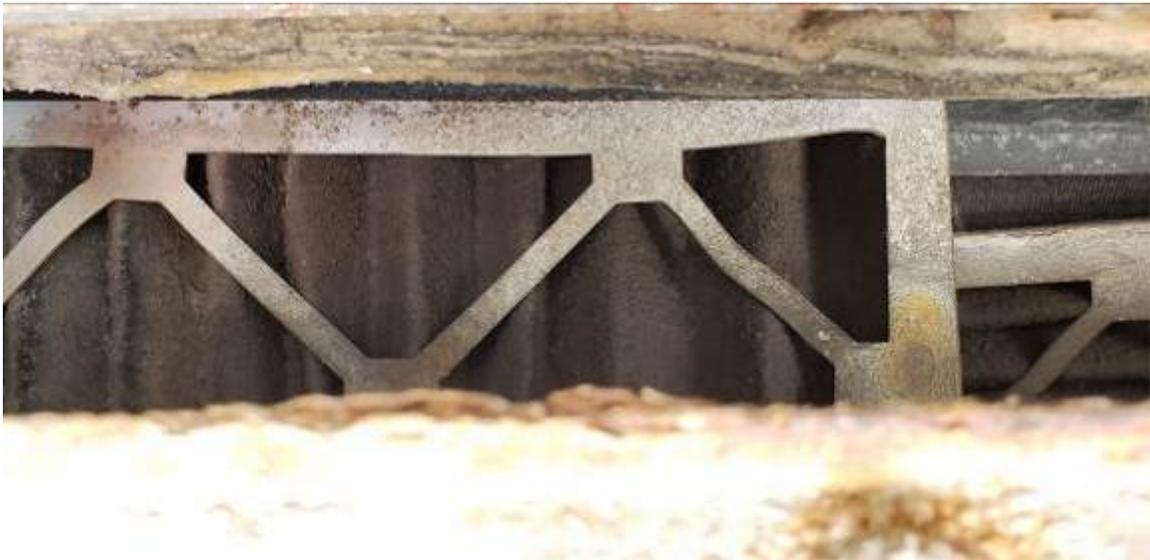
Figure 29. Dirty fresh air intake filters are visible through the otherwise unprotected opening. Requires maintenance and coil cleaning.

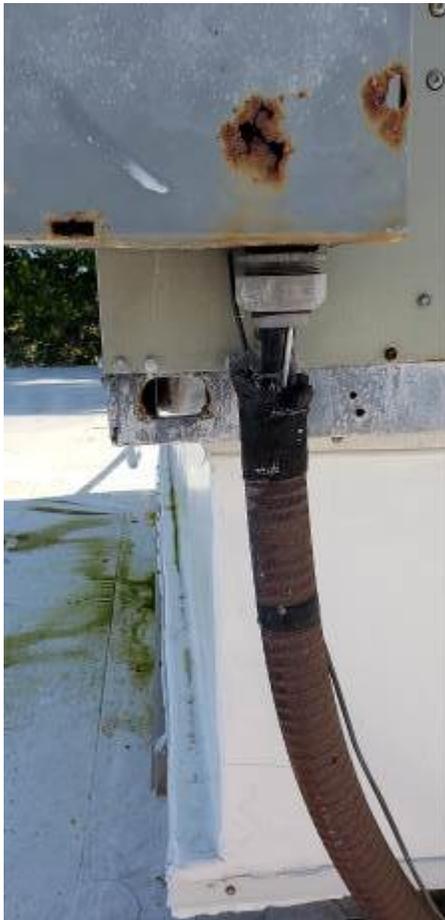
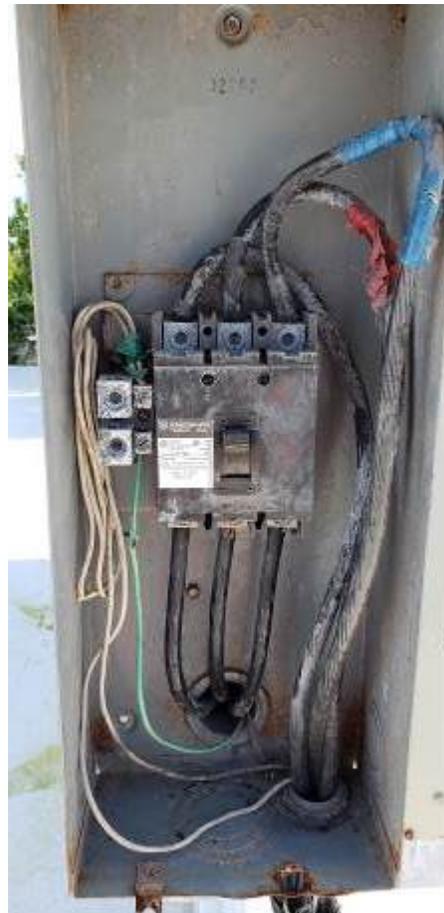
Figures 30&31. Disconnect enclosure box cover is corroded and conduit protecting wiring from the rooftop J-Box are damaged and require replacement.

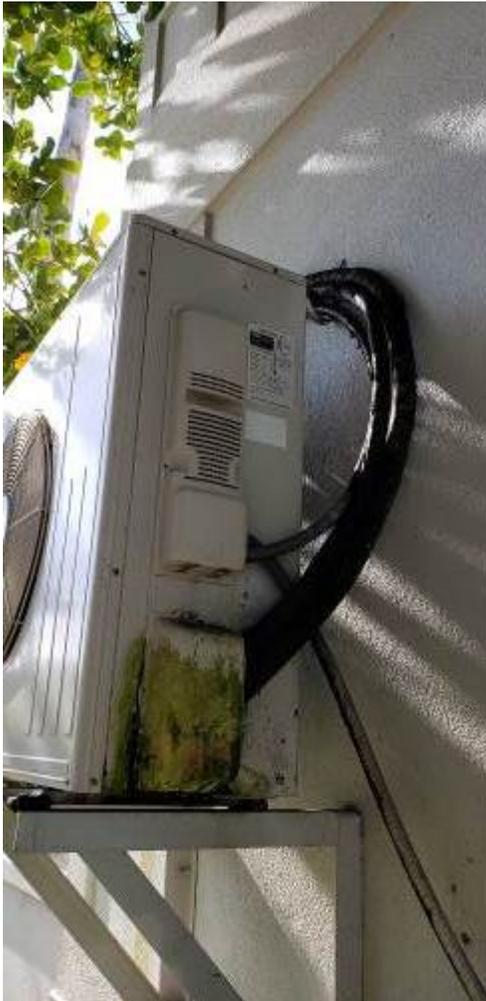
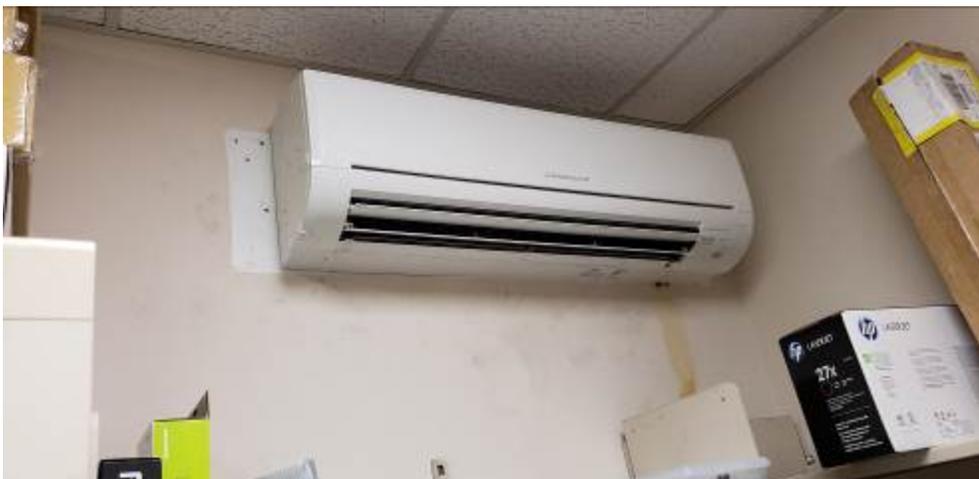
Figures 32&33. Minisplit unit servicing IT Server room (East Side of the building). Line insulation excessive sweating and waterlogging. The unit requires maintenance, all lines insulation needs to be replaced, coils cleaned, and refrigerant levels checked.

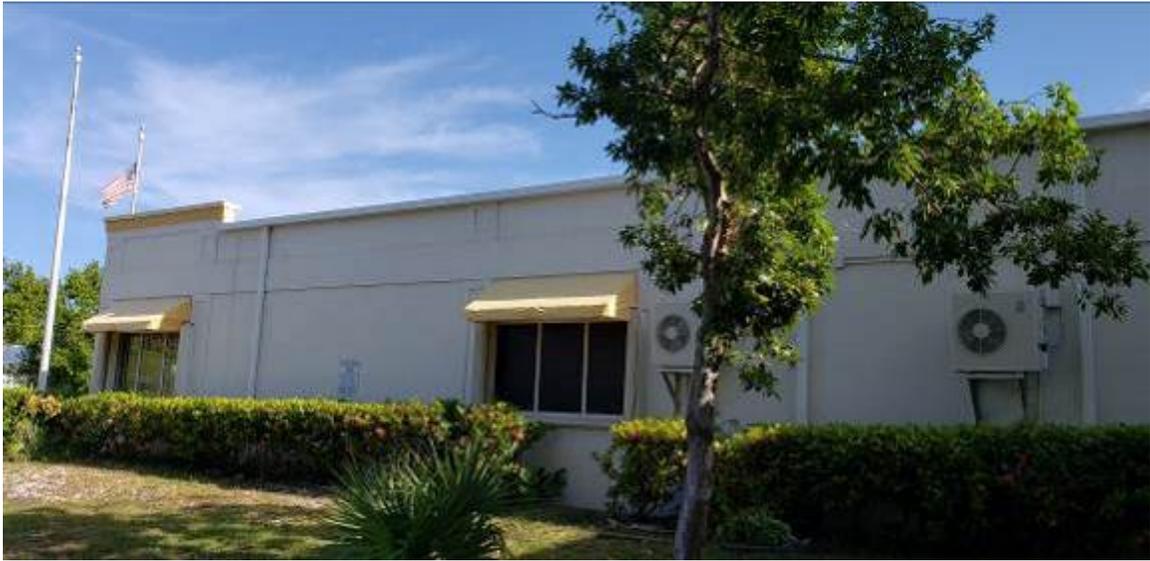
Figure 34. Two more similar mini-split units servicing currently unused space in the front part of the building (likely were used for additional cooling of printing equipment). In good condition.

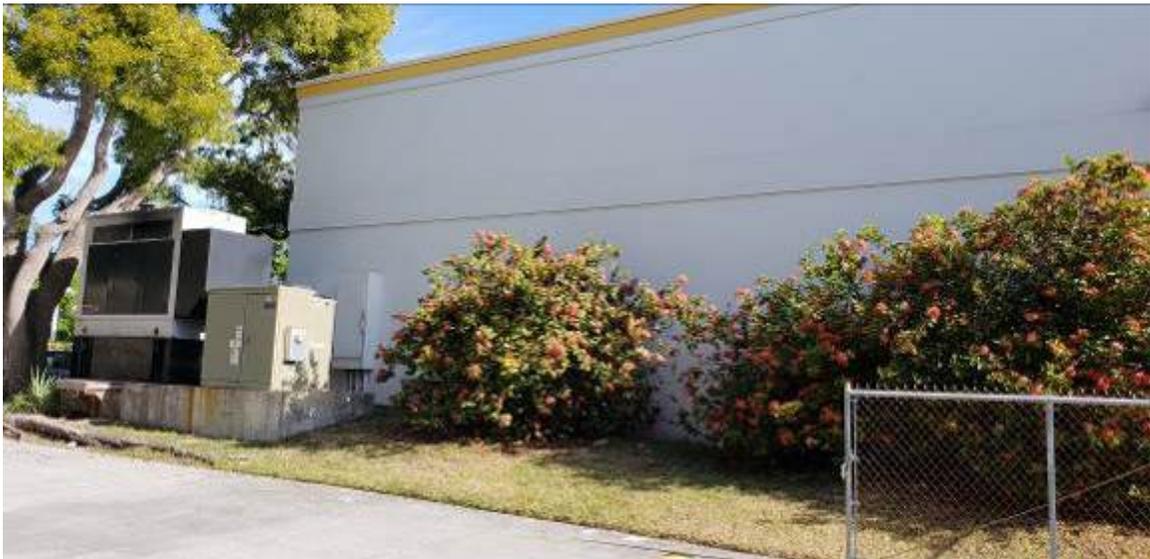
Figure 35. Concrete pad with belly-tank generator and transformer. Transfer switch and disconnect on the building wall behind.

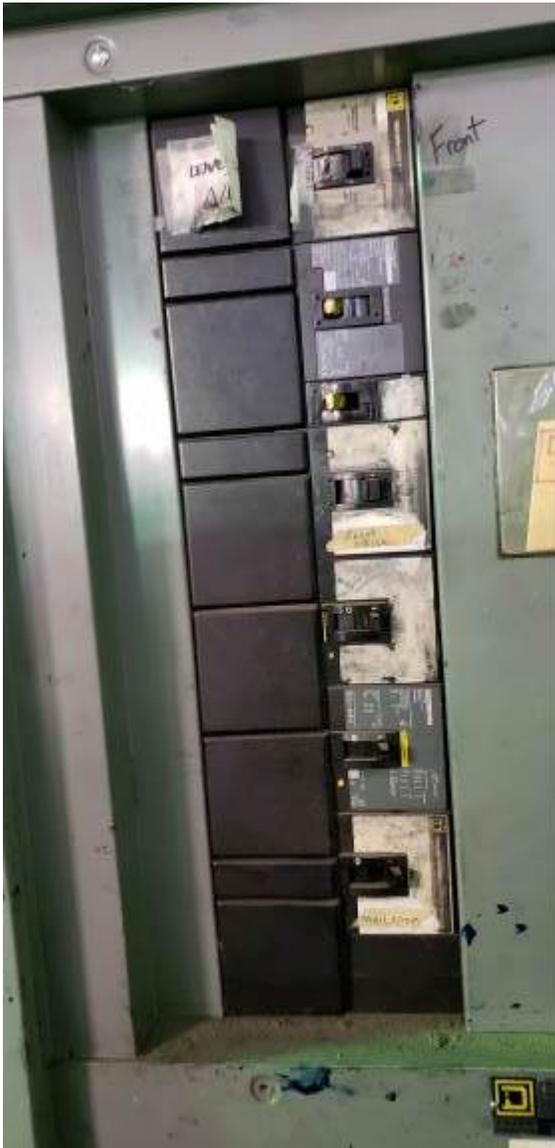
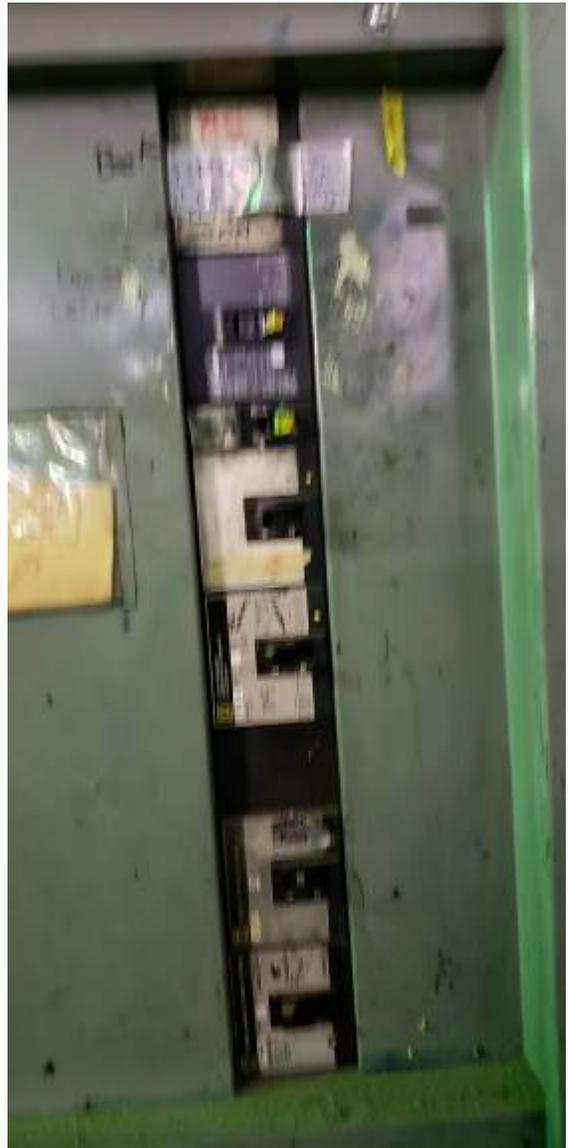
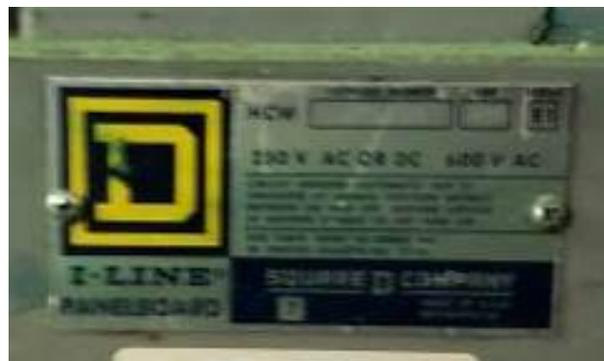
Figure 36. 3-phase 1200 AMP main distribution panel in good condition. Missing protective cover and proper labeling for all disconnects.

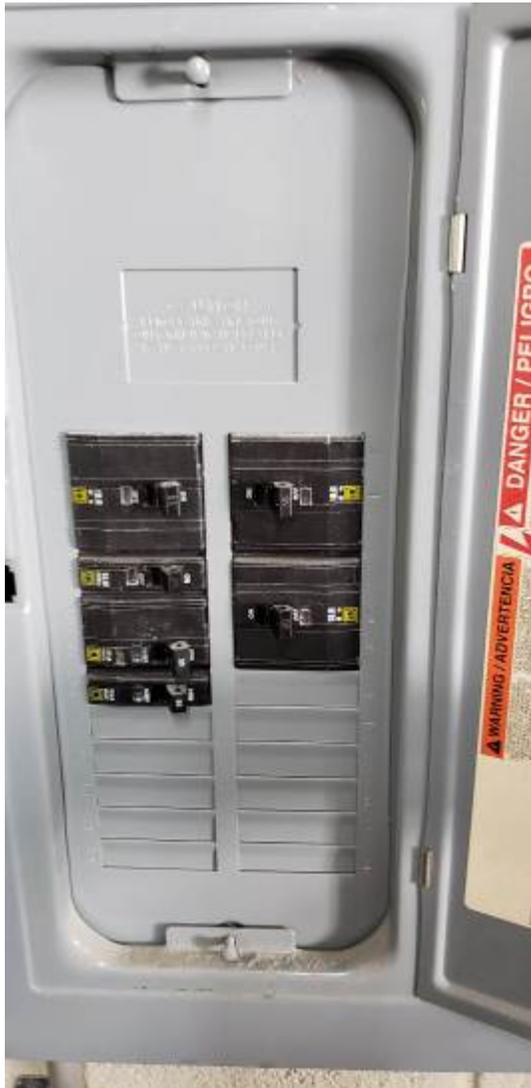
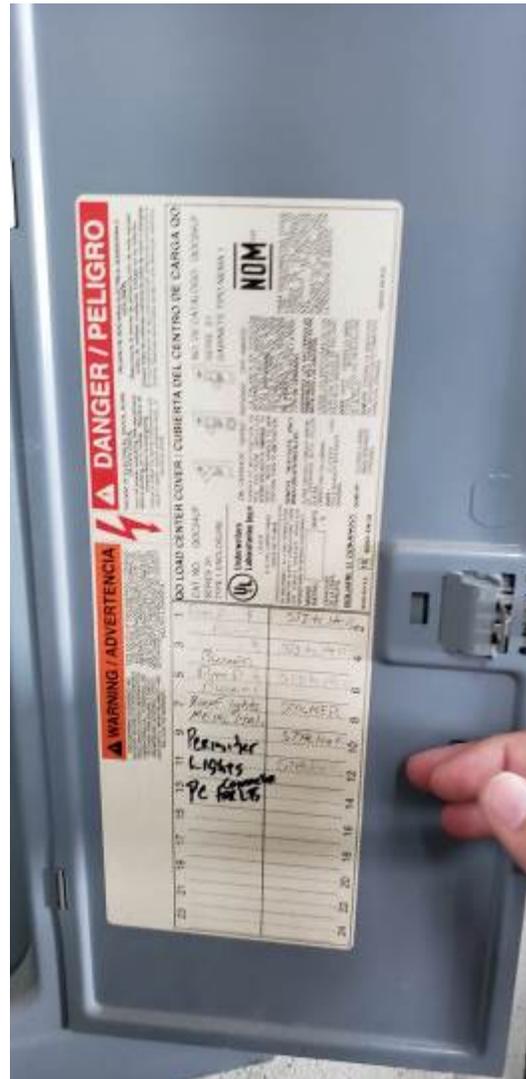
Figures 37&38. Multiple load centers are installed in various locations inside of the building with local breakers for lights, receptacles and various printing equipment. The condition of the electrical systems is good and serviceable. Few items require service or replacement (refer to Figure 39)..
