Structural Engineering Services
Due Diligence Period Building Assessment
KW Citizen Building

Property Address:
3420 Northside Dr,
Key West, FL 33040

AD Job#: 1812-04
City of Key West P.O.: 088365

Artibus Design
December 2018

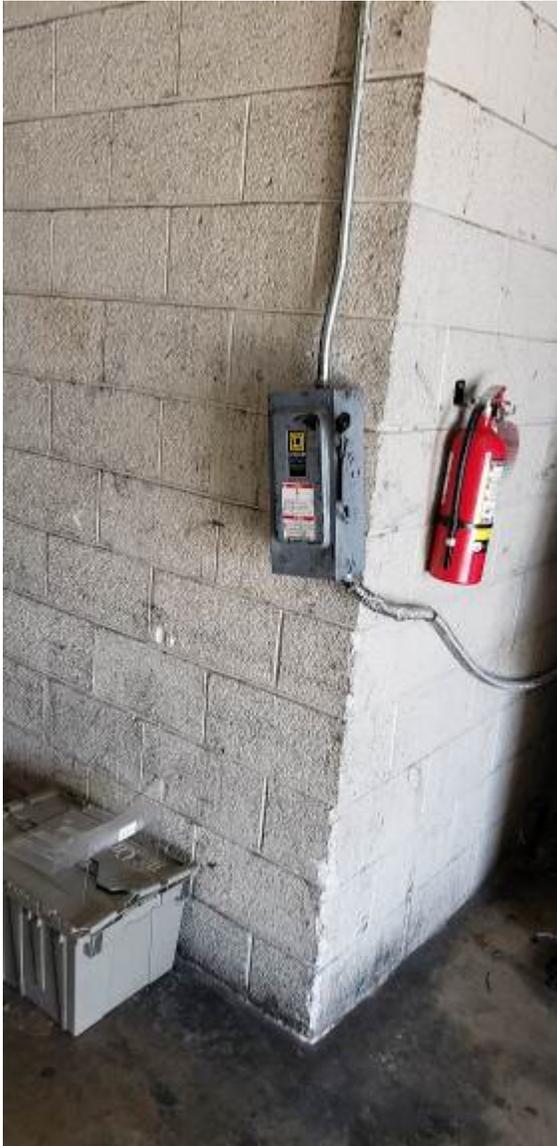
Figure 39. Example of the damaged disconnect enclosure and conduit (in the way of forklift traffic) needs to be moved, replaced or abandoned. The equipment connected may not be in service.

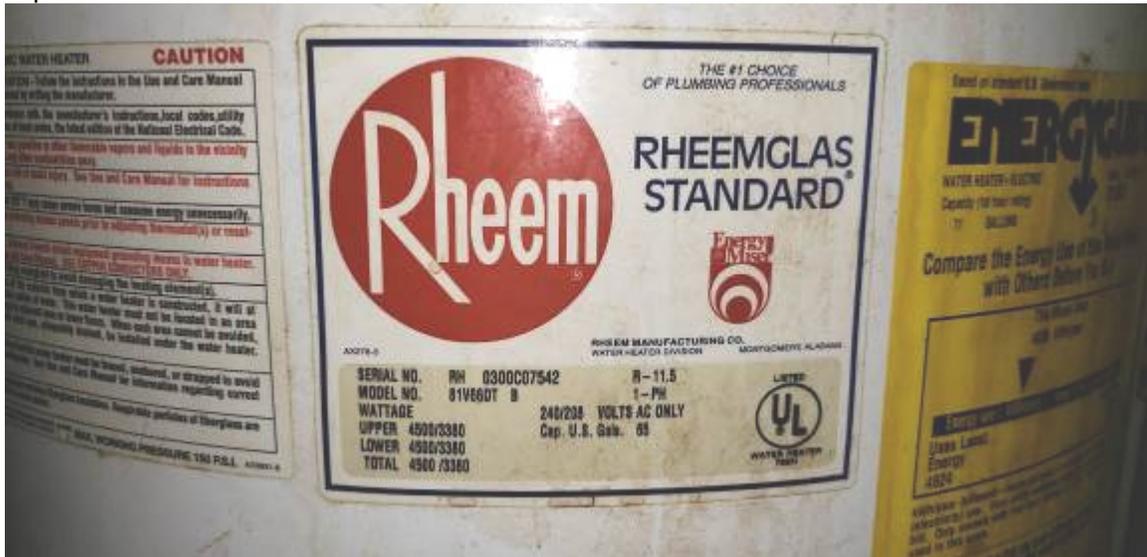
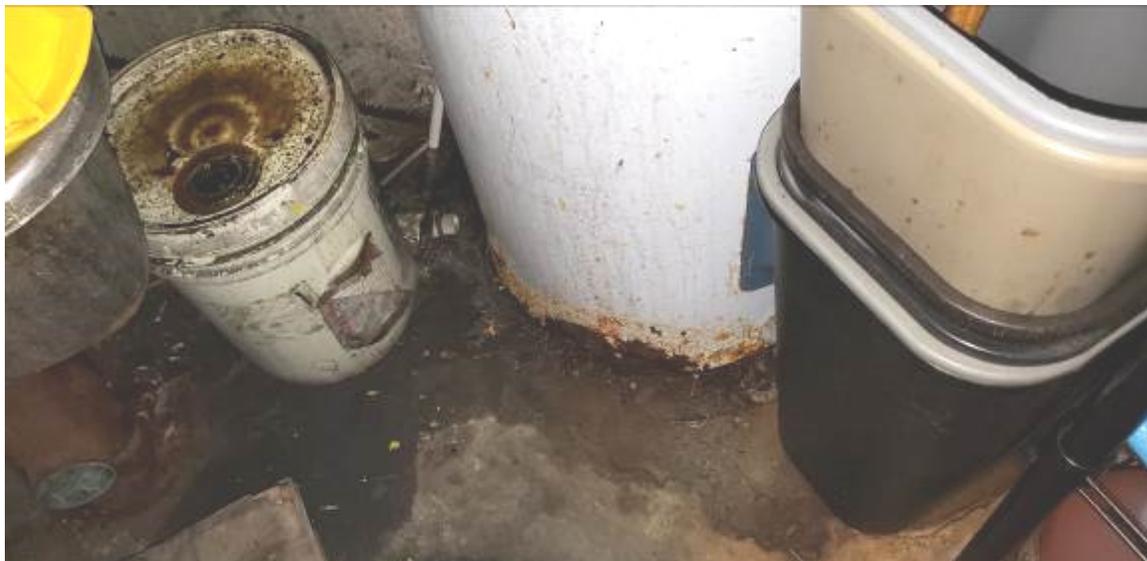
Figure 40&41. Hot water tank. Functional but will require replacement due to corrosion of the outer shell.

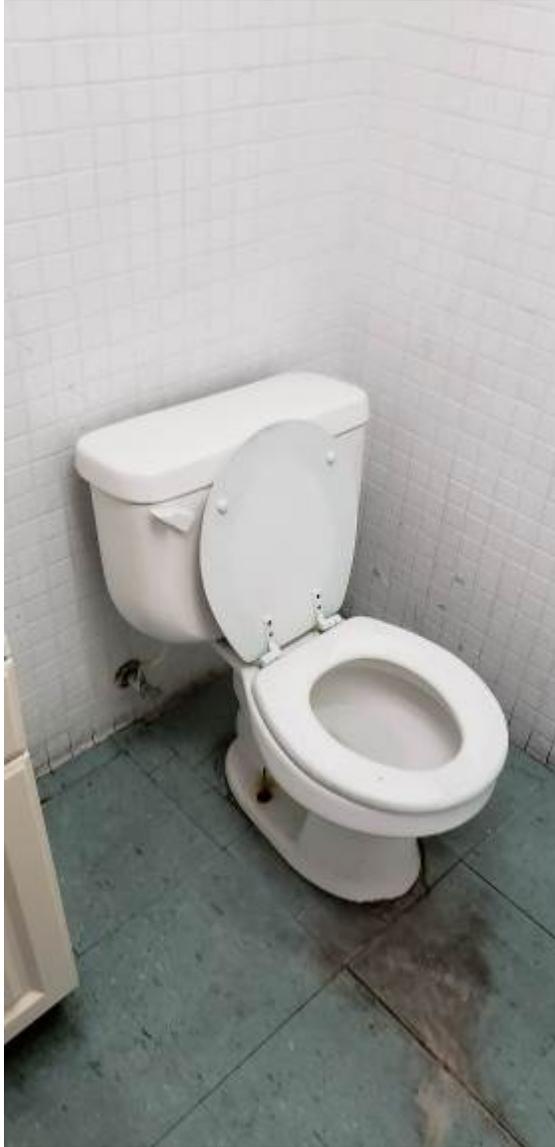
Figure42. Plumbing fixtures and finishes. Adequate but require maintenance and improvements to finishes.
