**TREE COMMISSION TREE REMOVAL REPORT  
CITY of KEY WEST**

**PROPERTY: 729 Truman Ave**

**APPLICATION NUMBER: T2026-0102**

**REQUEST: The applicant is requesting removal of (1) Gumbo Limbo & (1) Poinciana tree.**

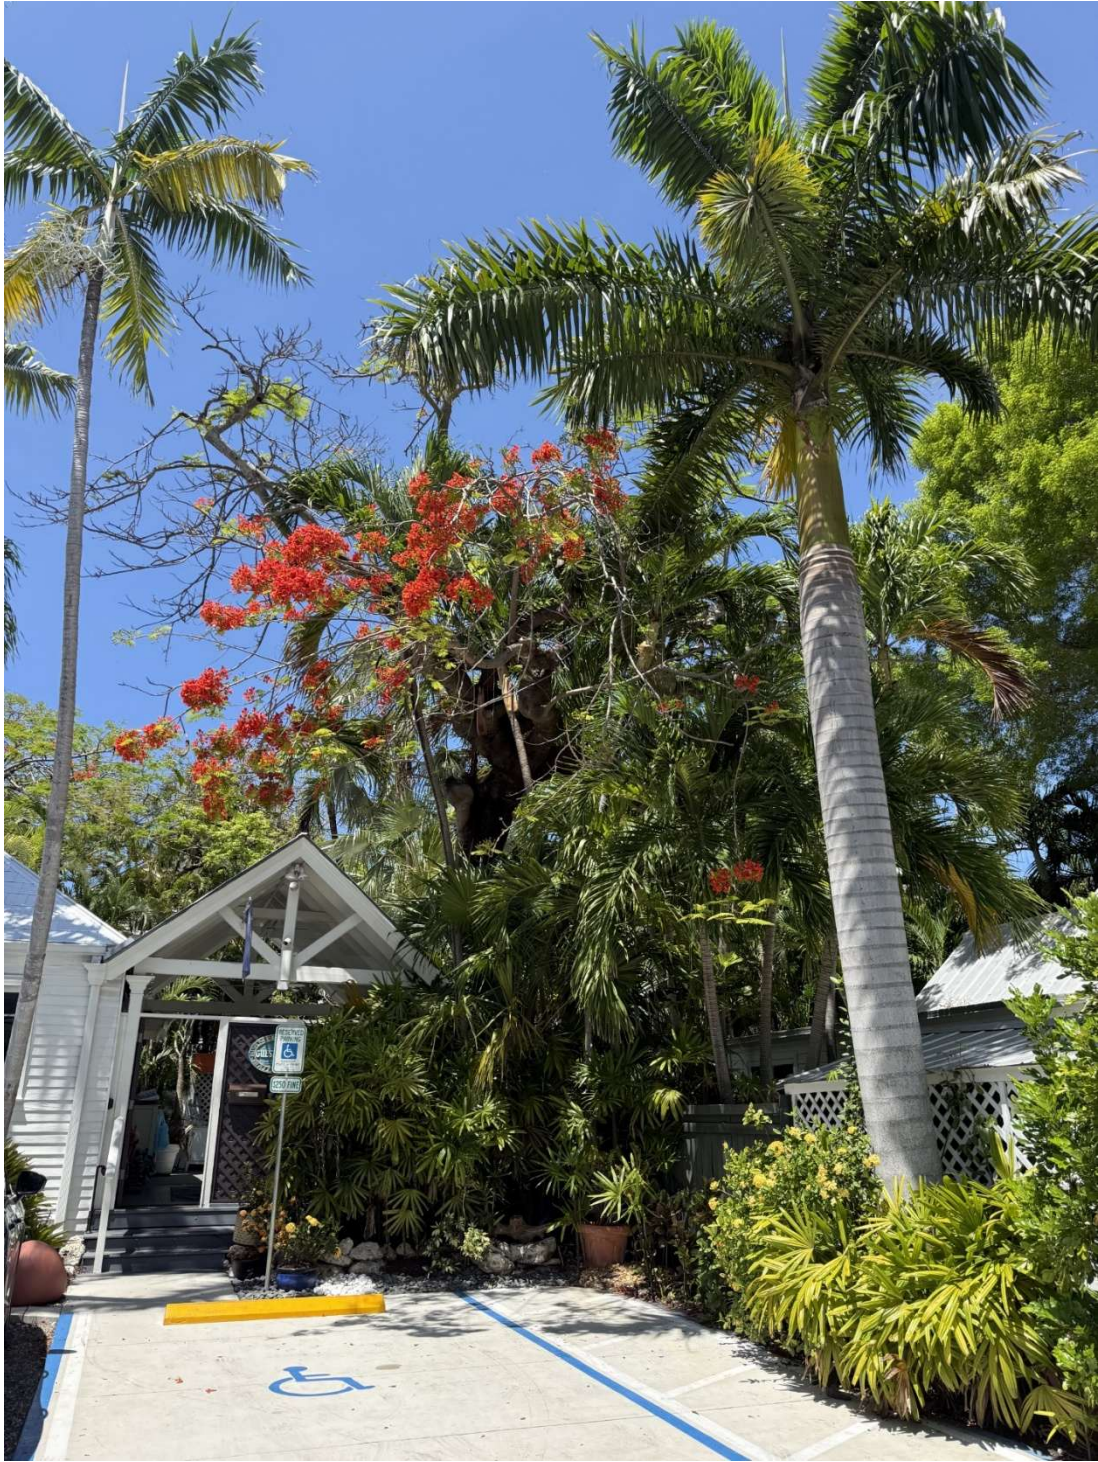
**Poinciana has very little canopy especially for a 28” trunk.**

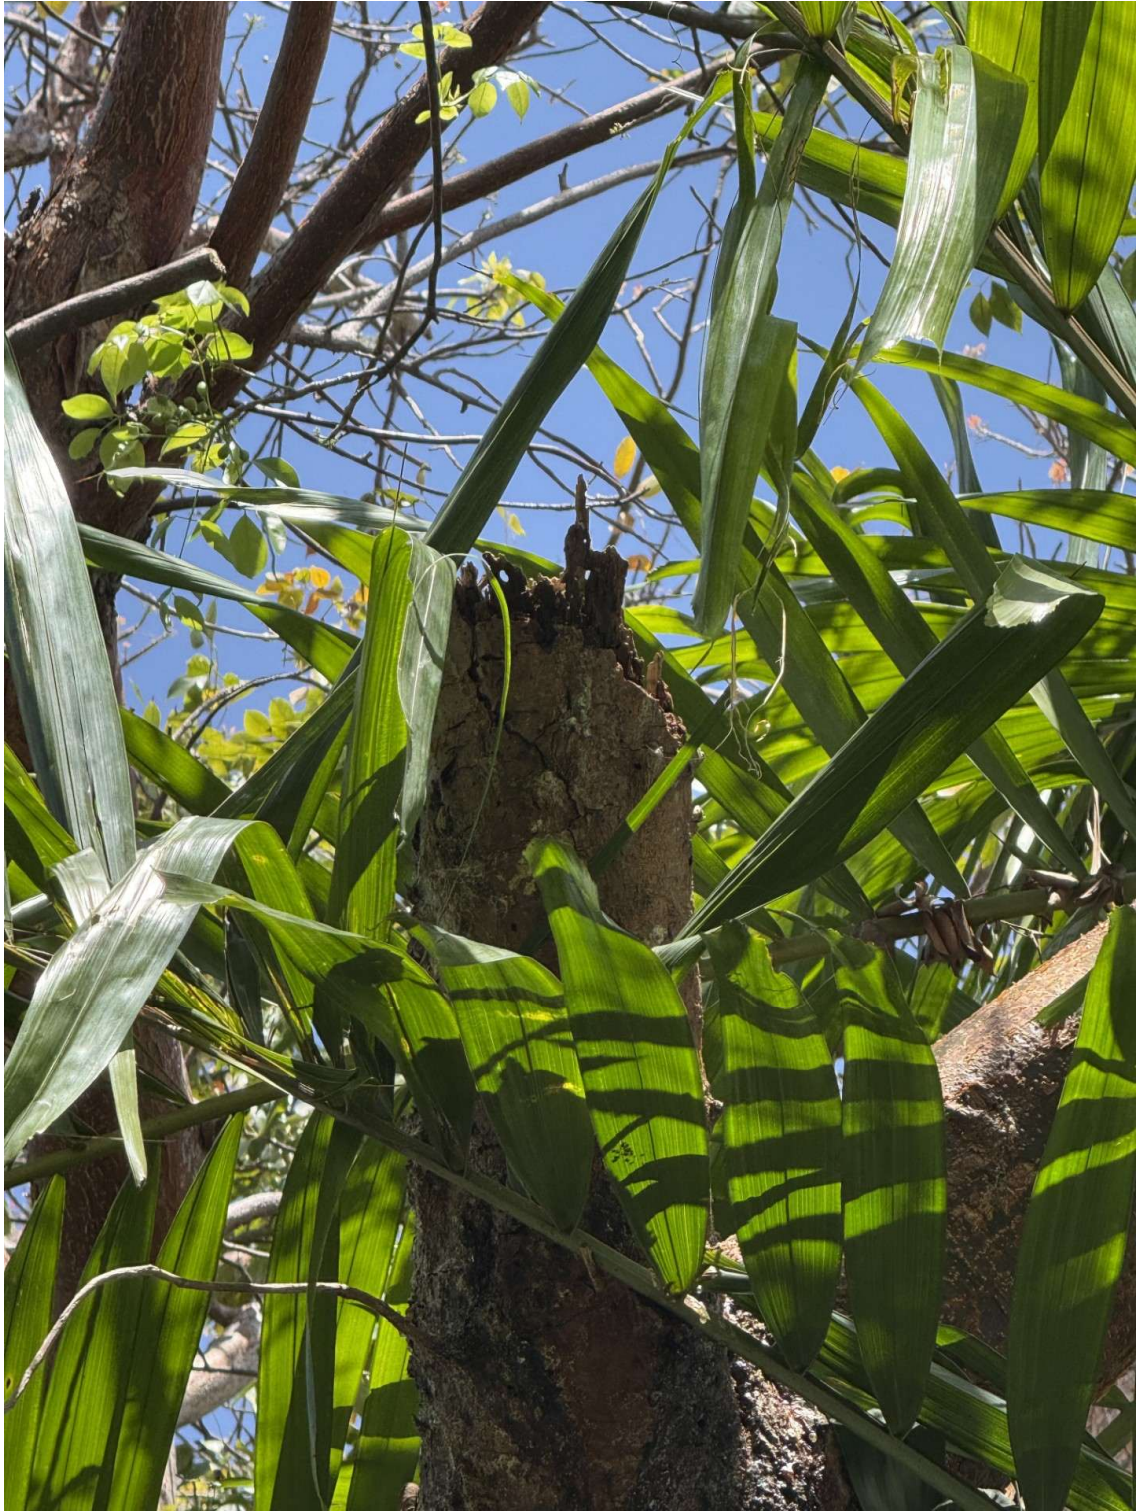
**Gumbo Limbo broken branch**

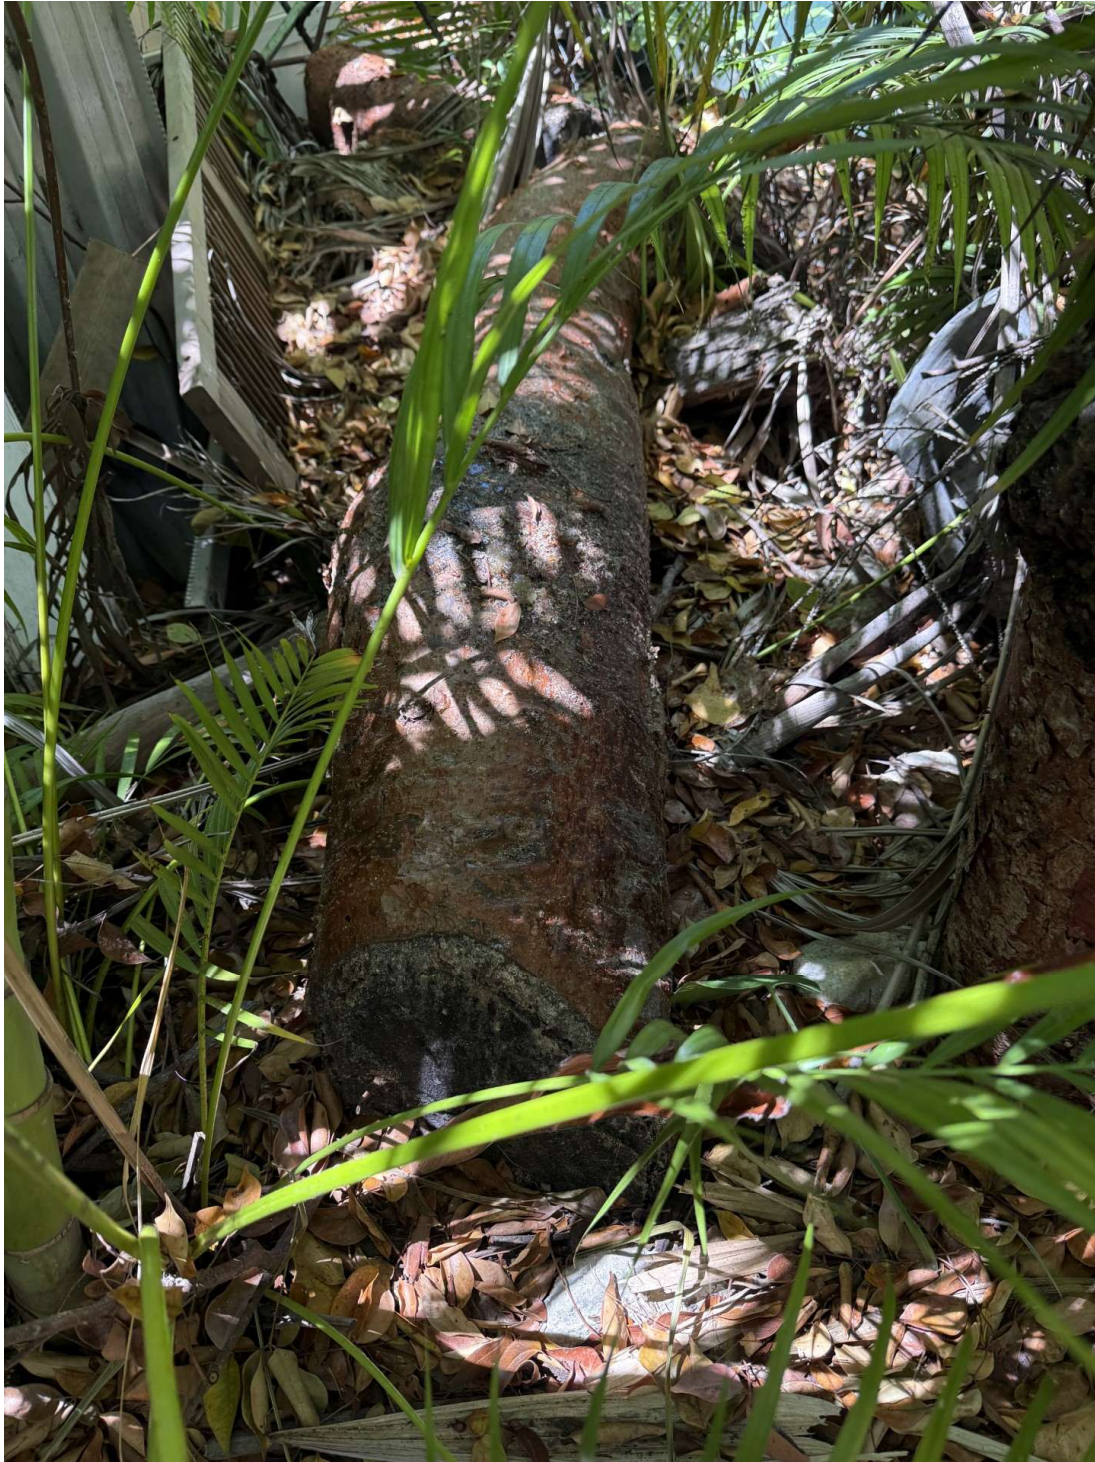
**Broken branch. I am told it fell into neighboring property and was tossed back over the property line.**
