## Cynthia's Blue Palms

City of Key West Tree Commission

July 25, 2018

Purpose: Following are my findings of plant evaluation located at Marty's Place, 1515 Bertha and Dennis Streets, Key West, Florida, concerning the removal of: 1 Black Olive tree, 2 Bridalveil trees, 1 Pigeon Plum tree, 1 Frangipani tree, 1 Spanish Stopper tree, 1 Crabwood tree, 1 Barbados Cherry tree, 1 Jamaica Caper seedling, 1 Orange Geiger tree, 1 Bay Cedar shrub, 1 Green Buttonwood tree, 1 Fiddlewood tree, 3 Bahama Tabebuia trees, 1 Simpson Stopper tree, 2 Paradise trees, 6 Gumbo Limbo trees, 1 Royal Poinciana tree, 2 Yellow Tabebuia trees, 7 Washingtonia palms, 23 Christmas palms, 9 Coconut palms, 13 Areca palms, 1 Alexander palms, and 1 Triangle palm. This tree disposition is to be used in conjunction with the submitted July 16, 2018, tree inventory.

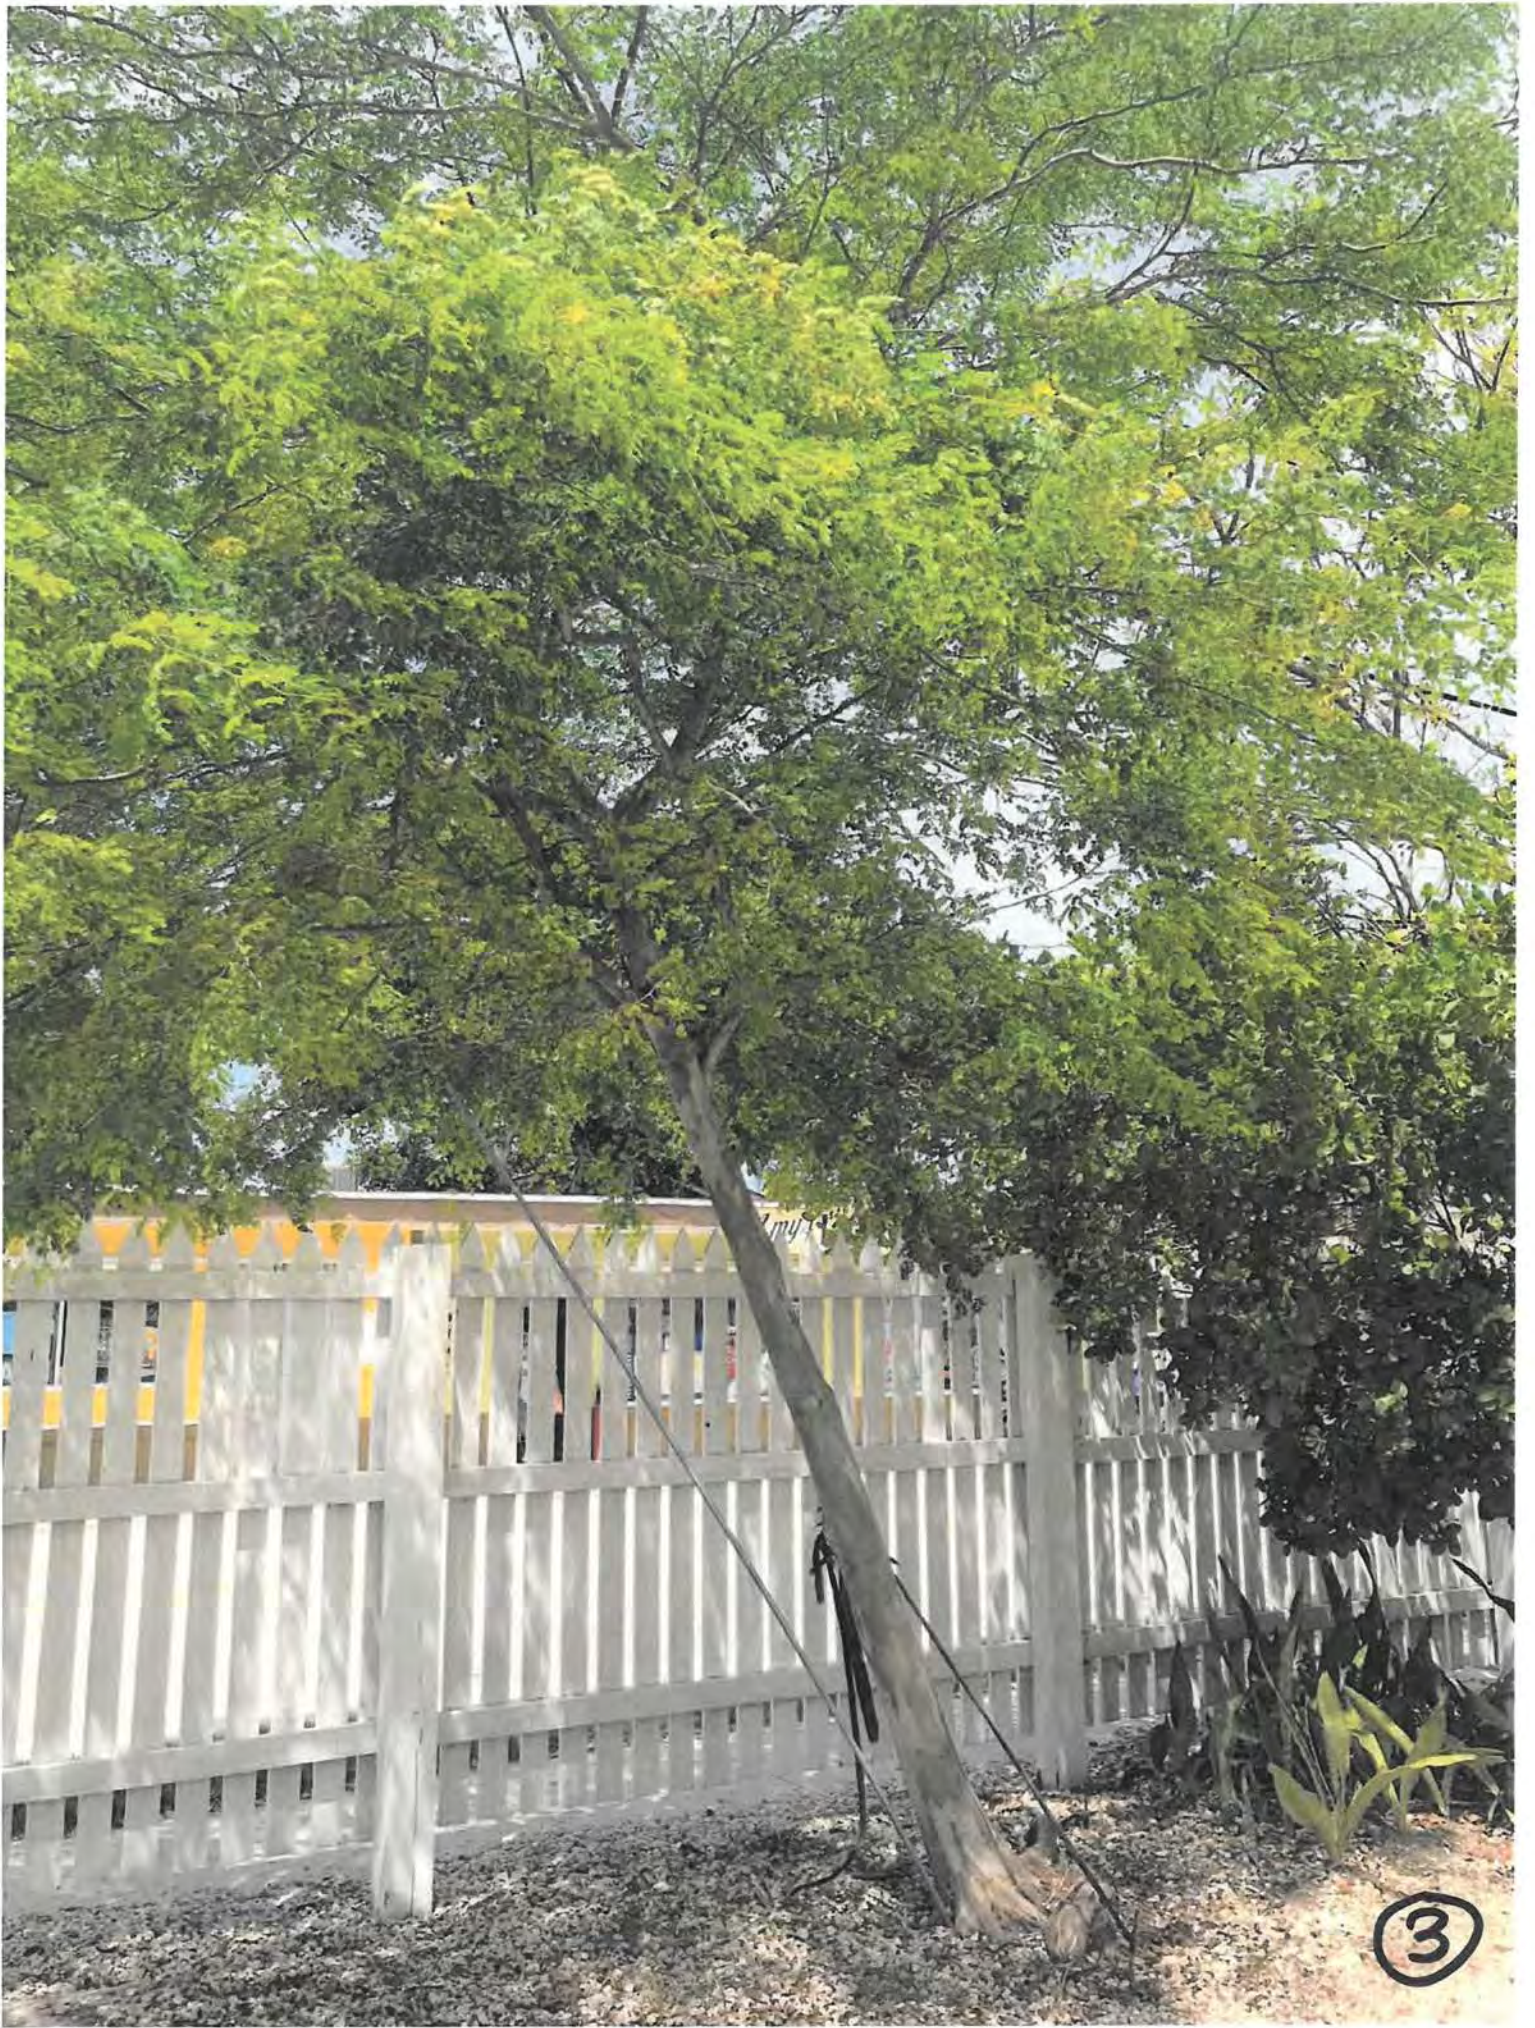
3

6. Fishtail Palm/*Caryota mitis* -Remove
7. Paradise/*Simaruba glauca* -Remove Poor, 6 ½ ", tip and branch dieback, lead and canopy top dead
8. Bridalveil/*Caesalpinia grandillo* -Remove Poor, codominant with included bark

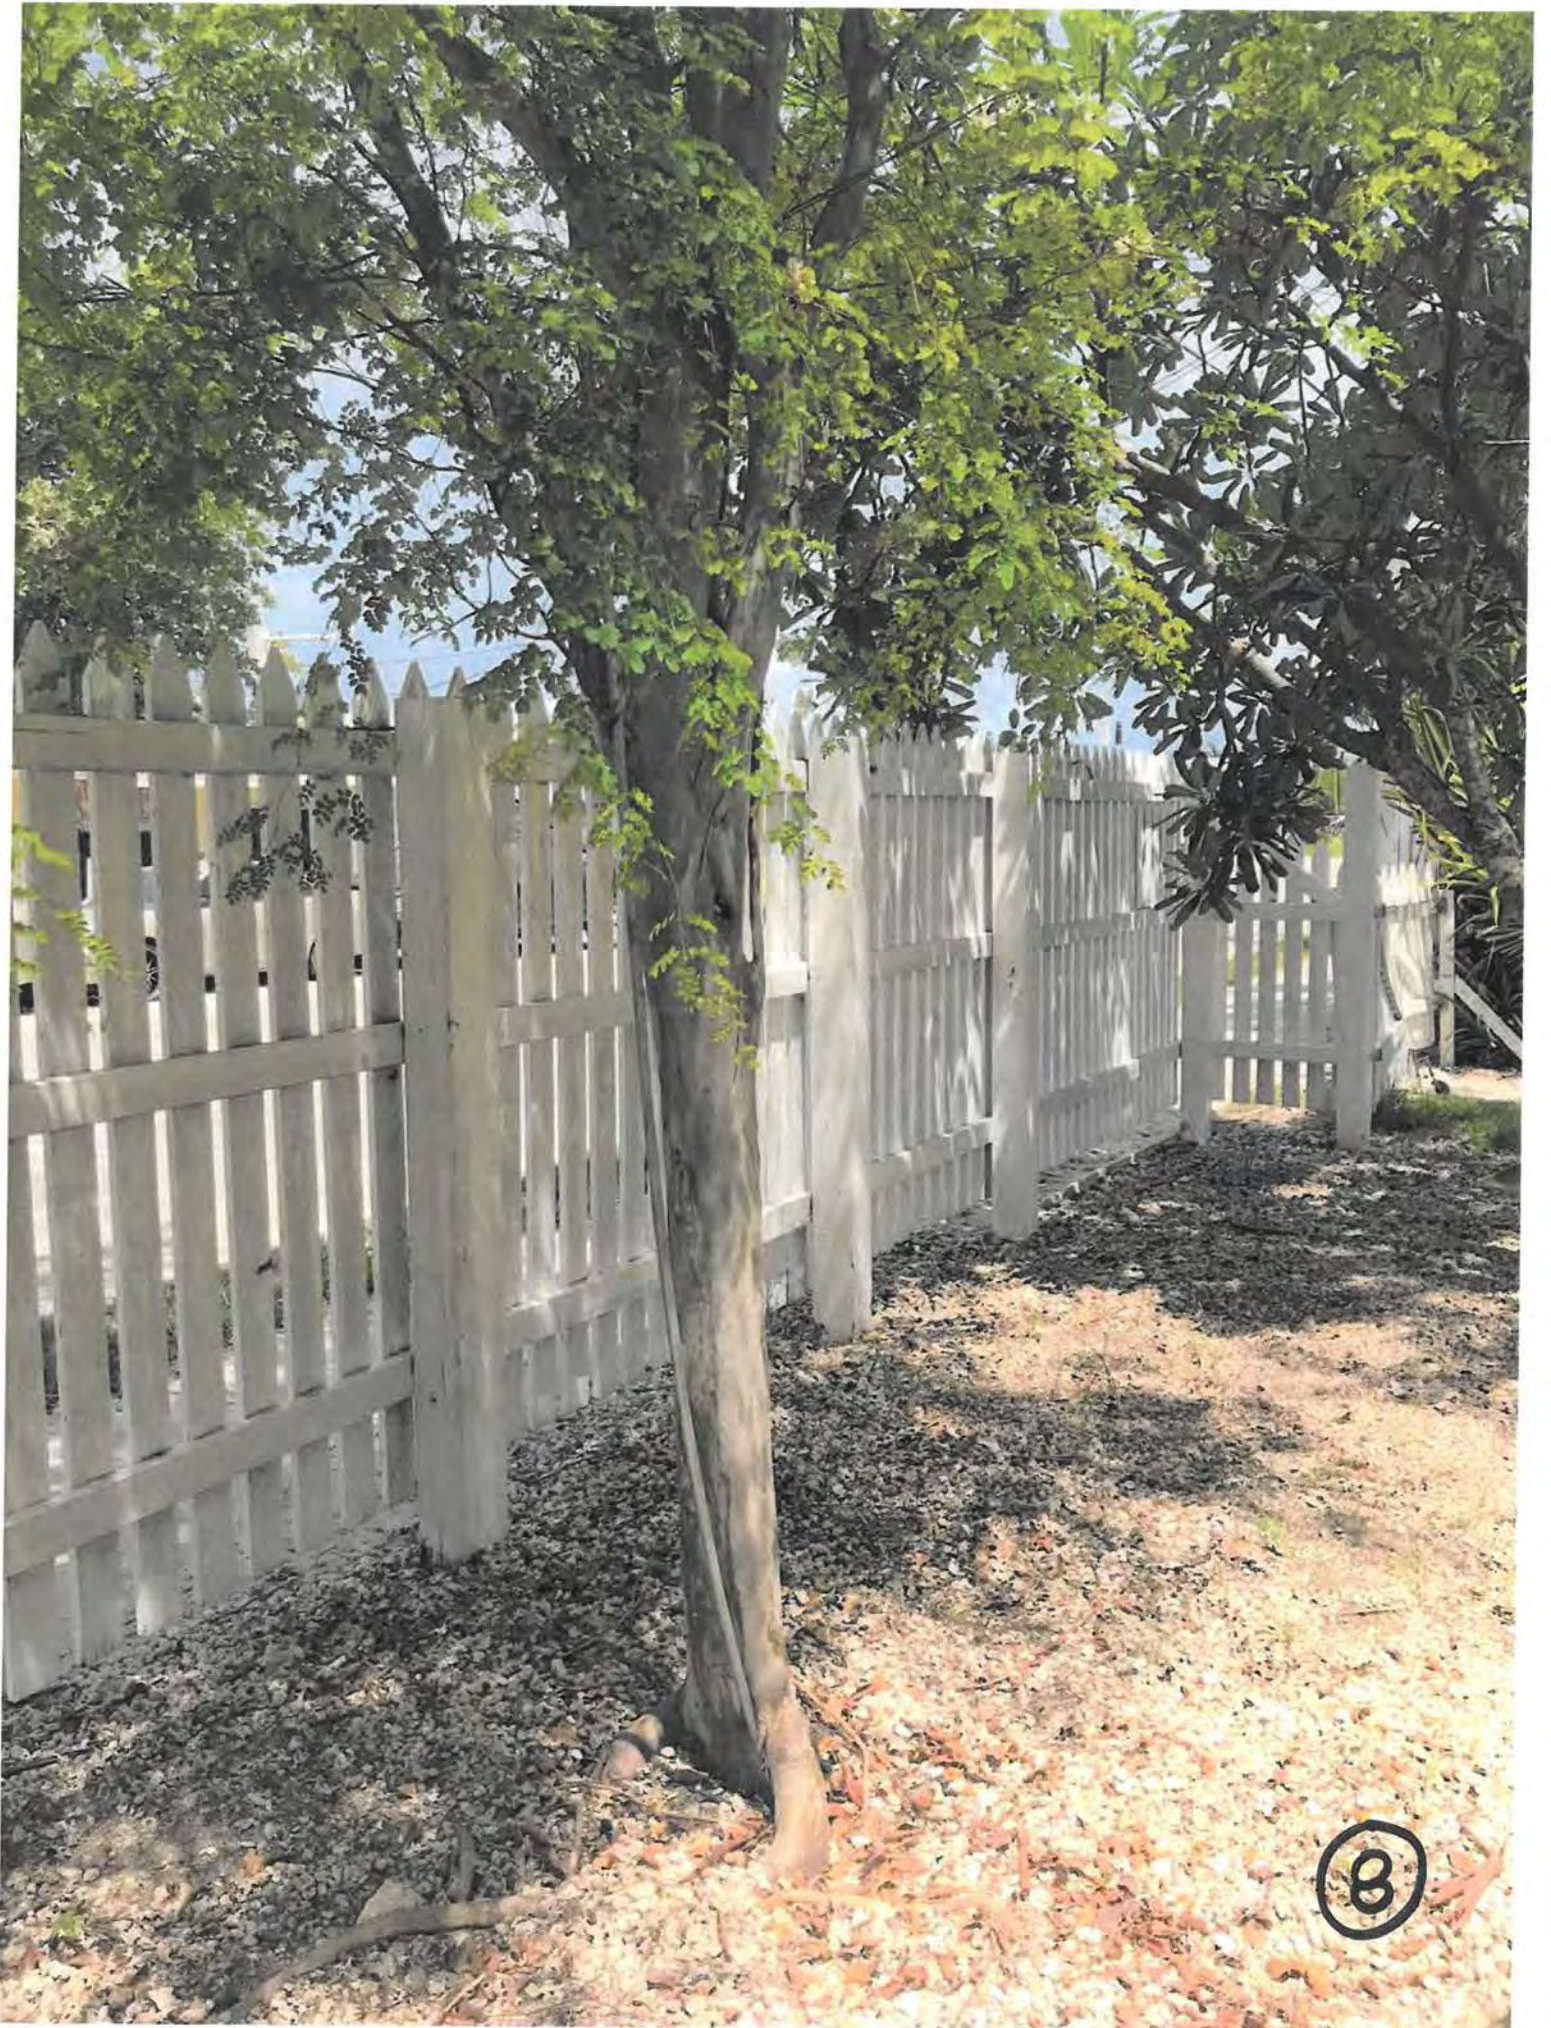
8

**Bridalveil**, tree number 8, remove, poor condition, 6.5" diameter, codominant with included bark.

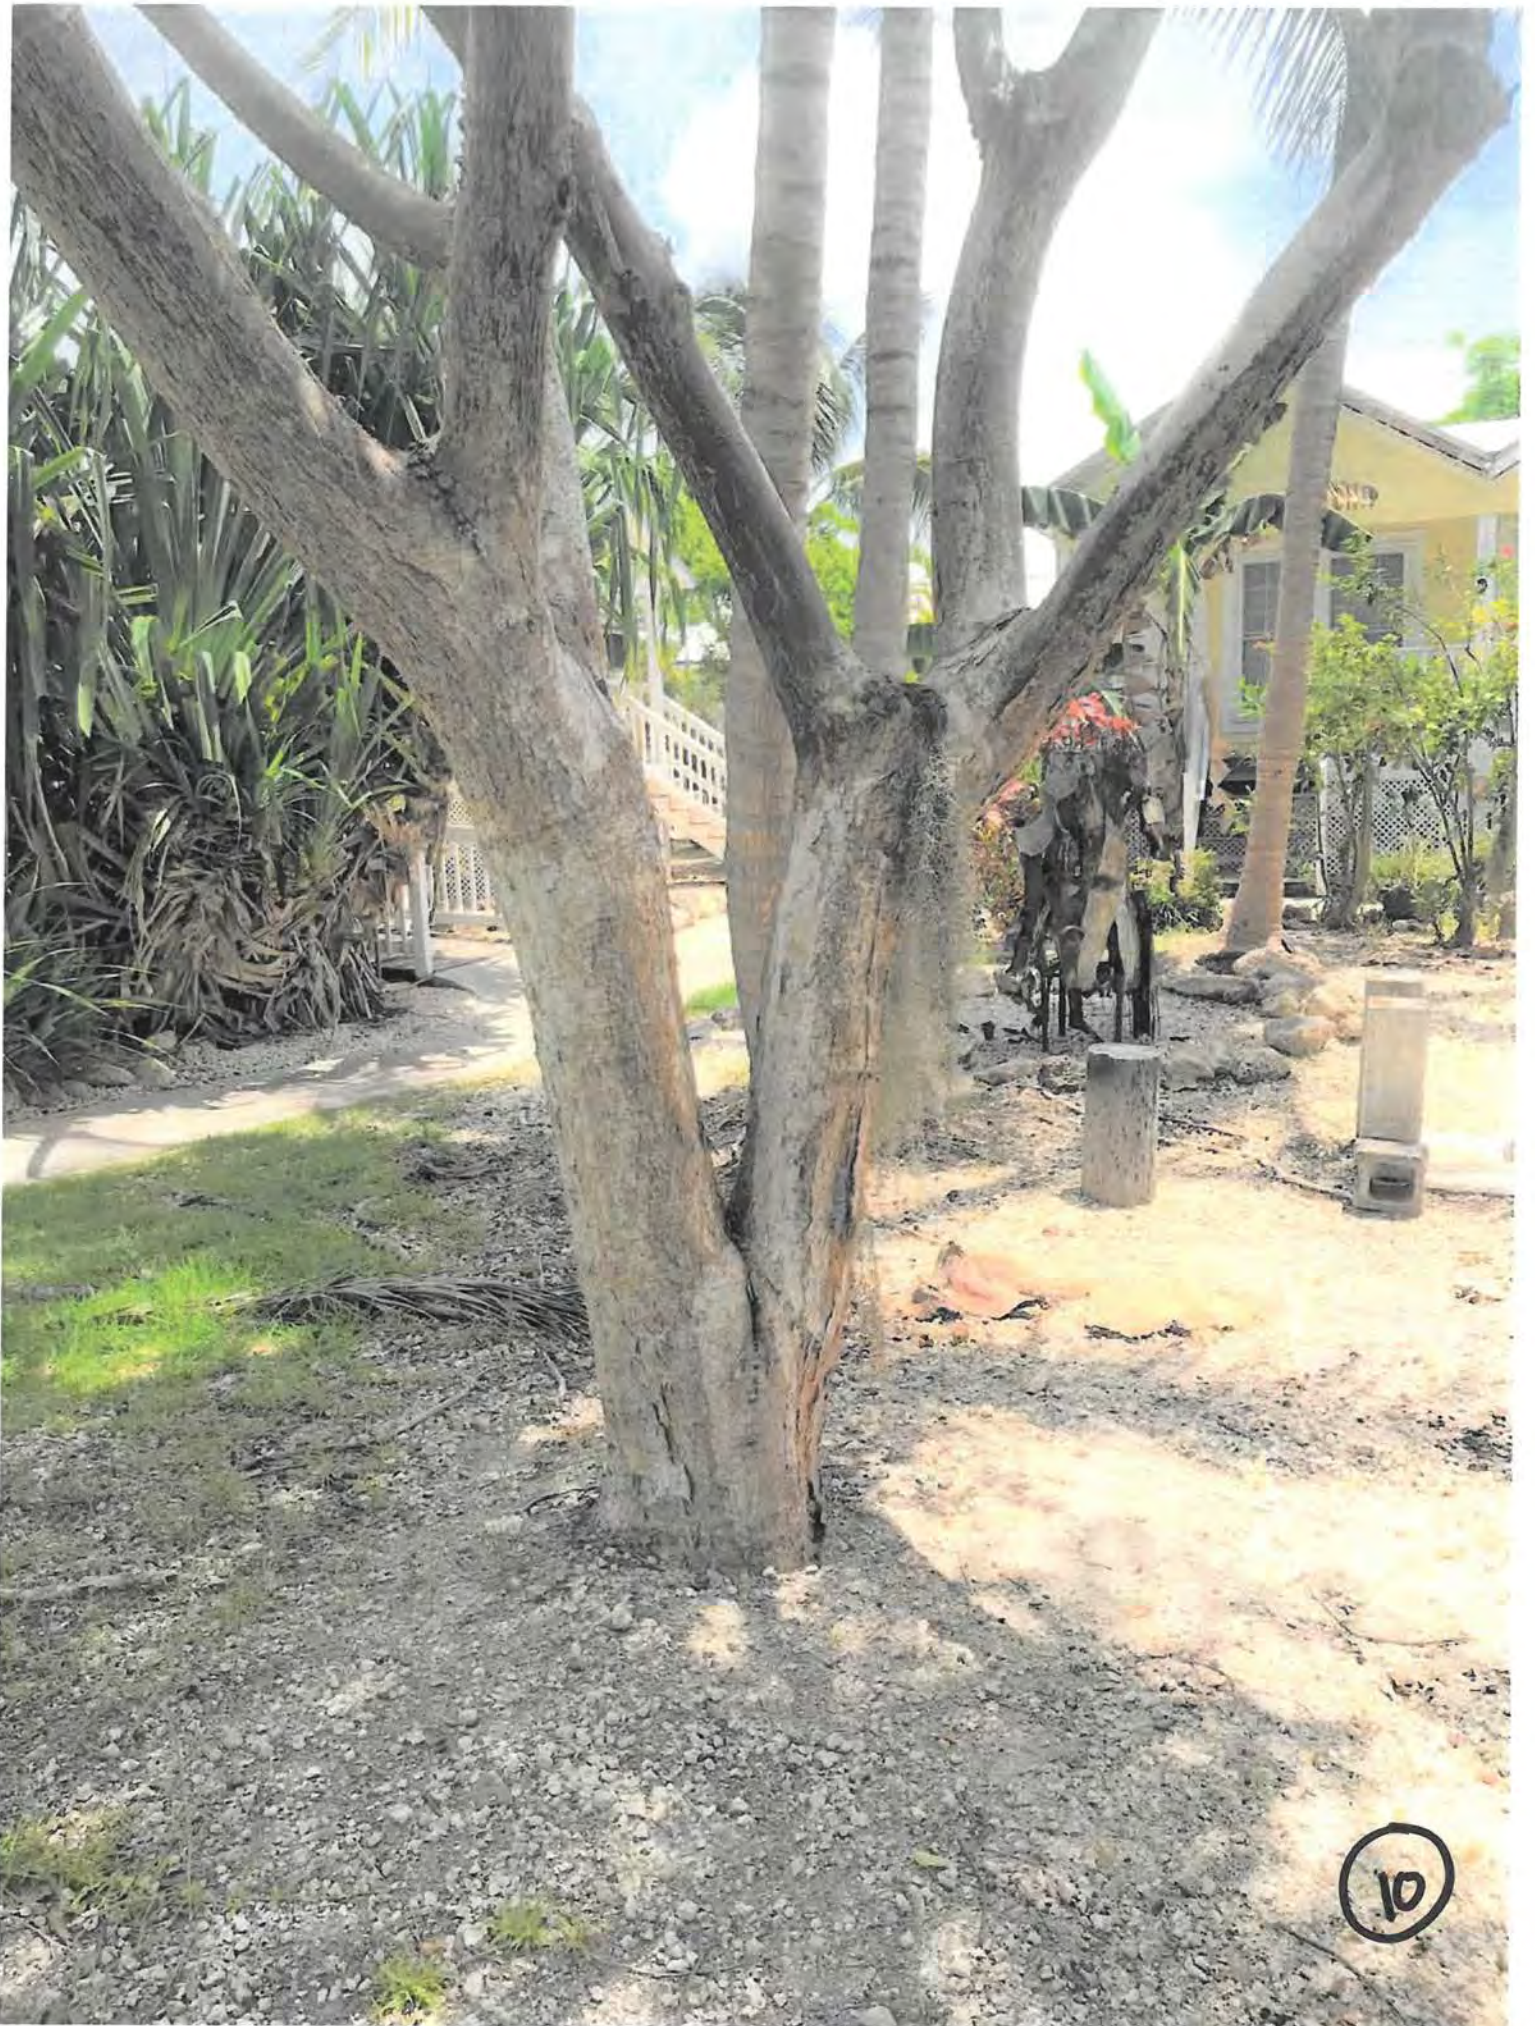
10

9. Frangipani 'Key West'/*Plumeria* -Retain/Protect 4 ½ " Fair-Good
10. Gumbo Limbo/*Bursea simaruba* -Remove Poor, 16 ½ ", low branching codominant with included bark

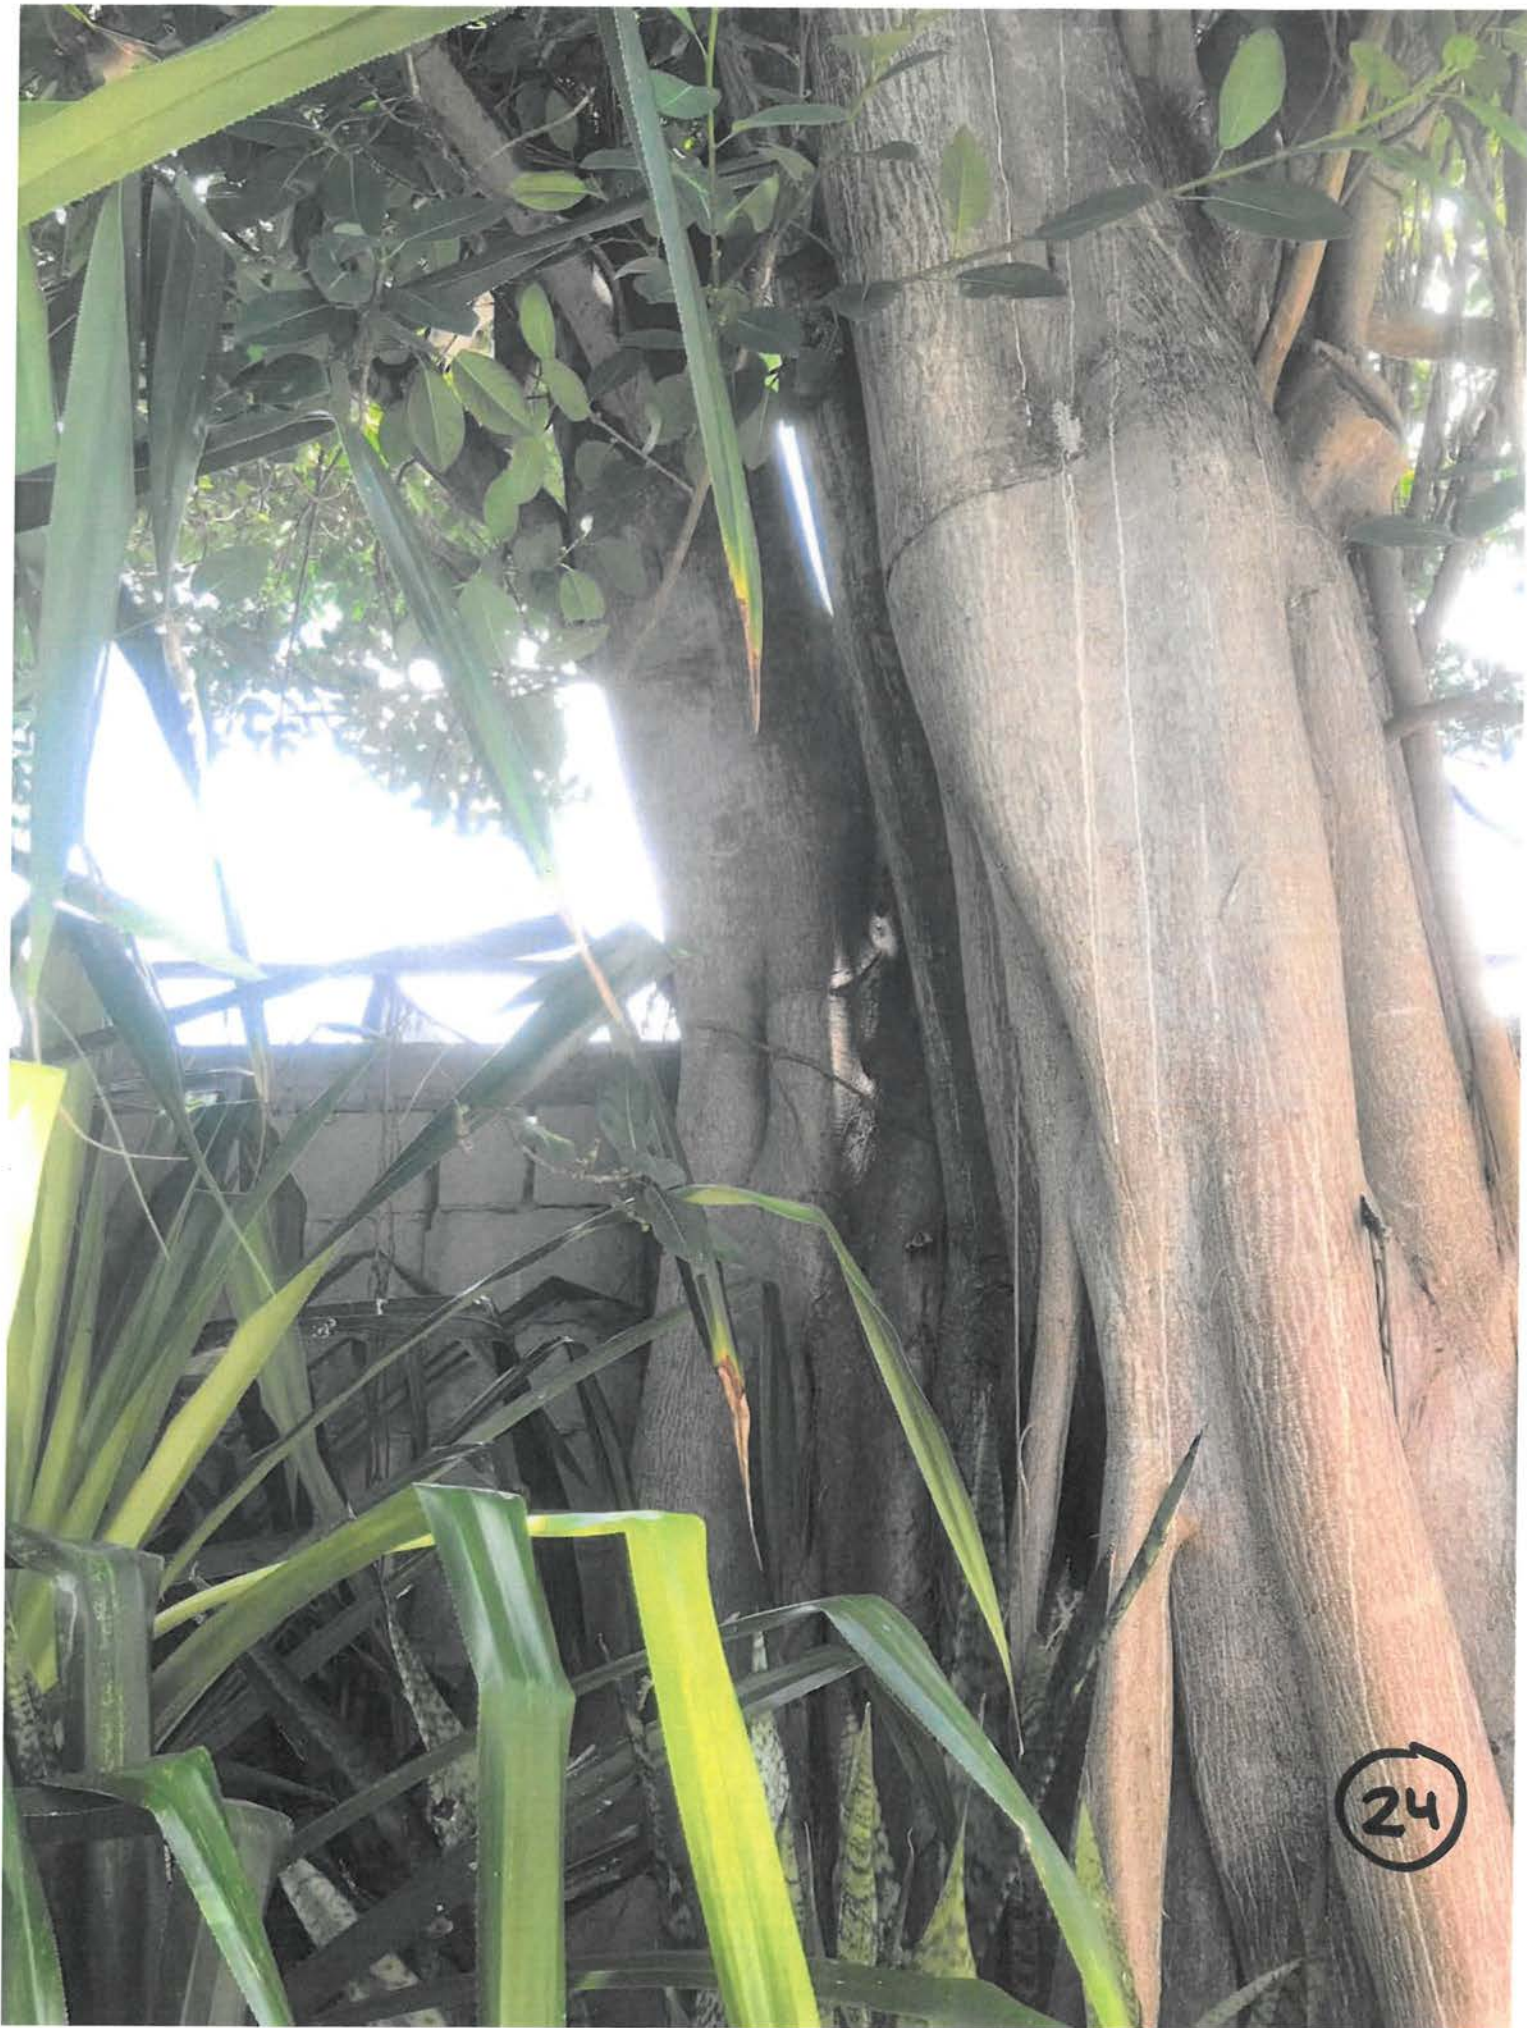
24

23. Christmas Palm/*Adonidia merrillii* -Remove 10'-13' wood
24. Ficus/*Ficus aurea* -Retain/Protect 4 ½ - 5' diameter, fair, storm and utility pruning damage

**Ficus aurea**, tree number 24, retain and protect with fencing.

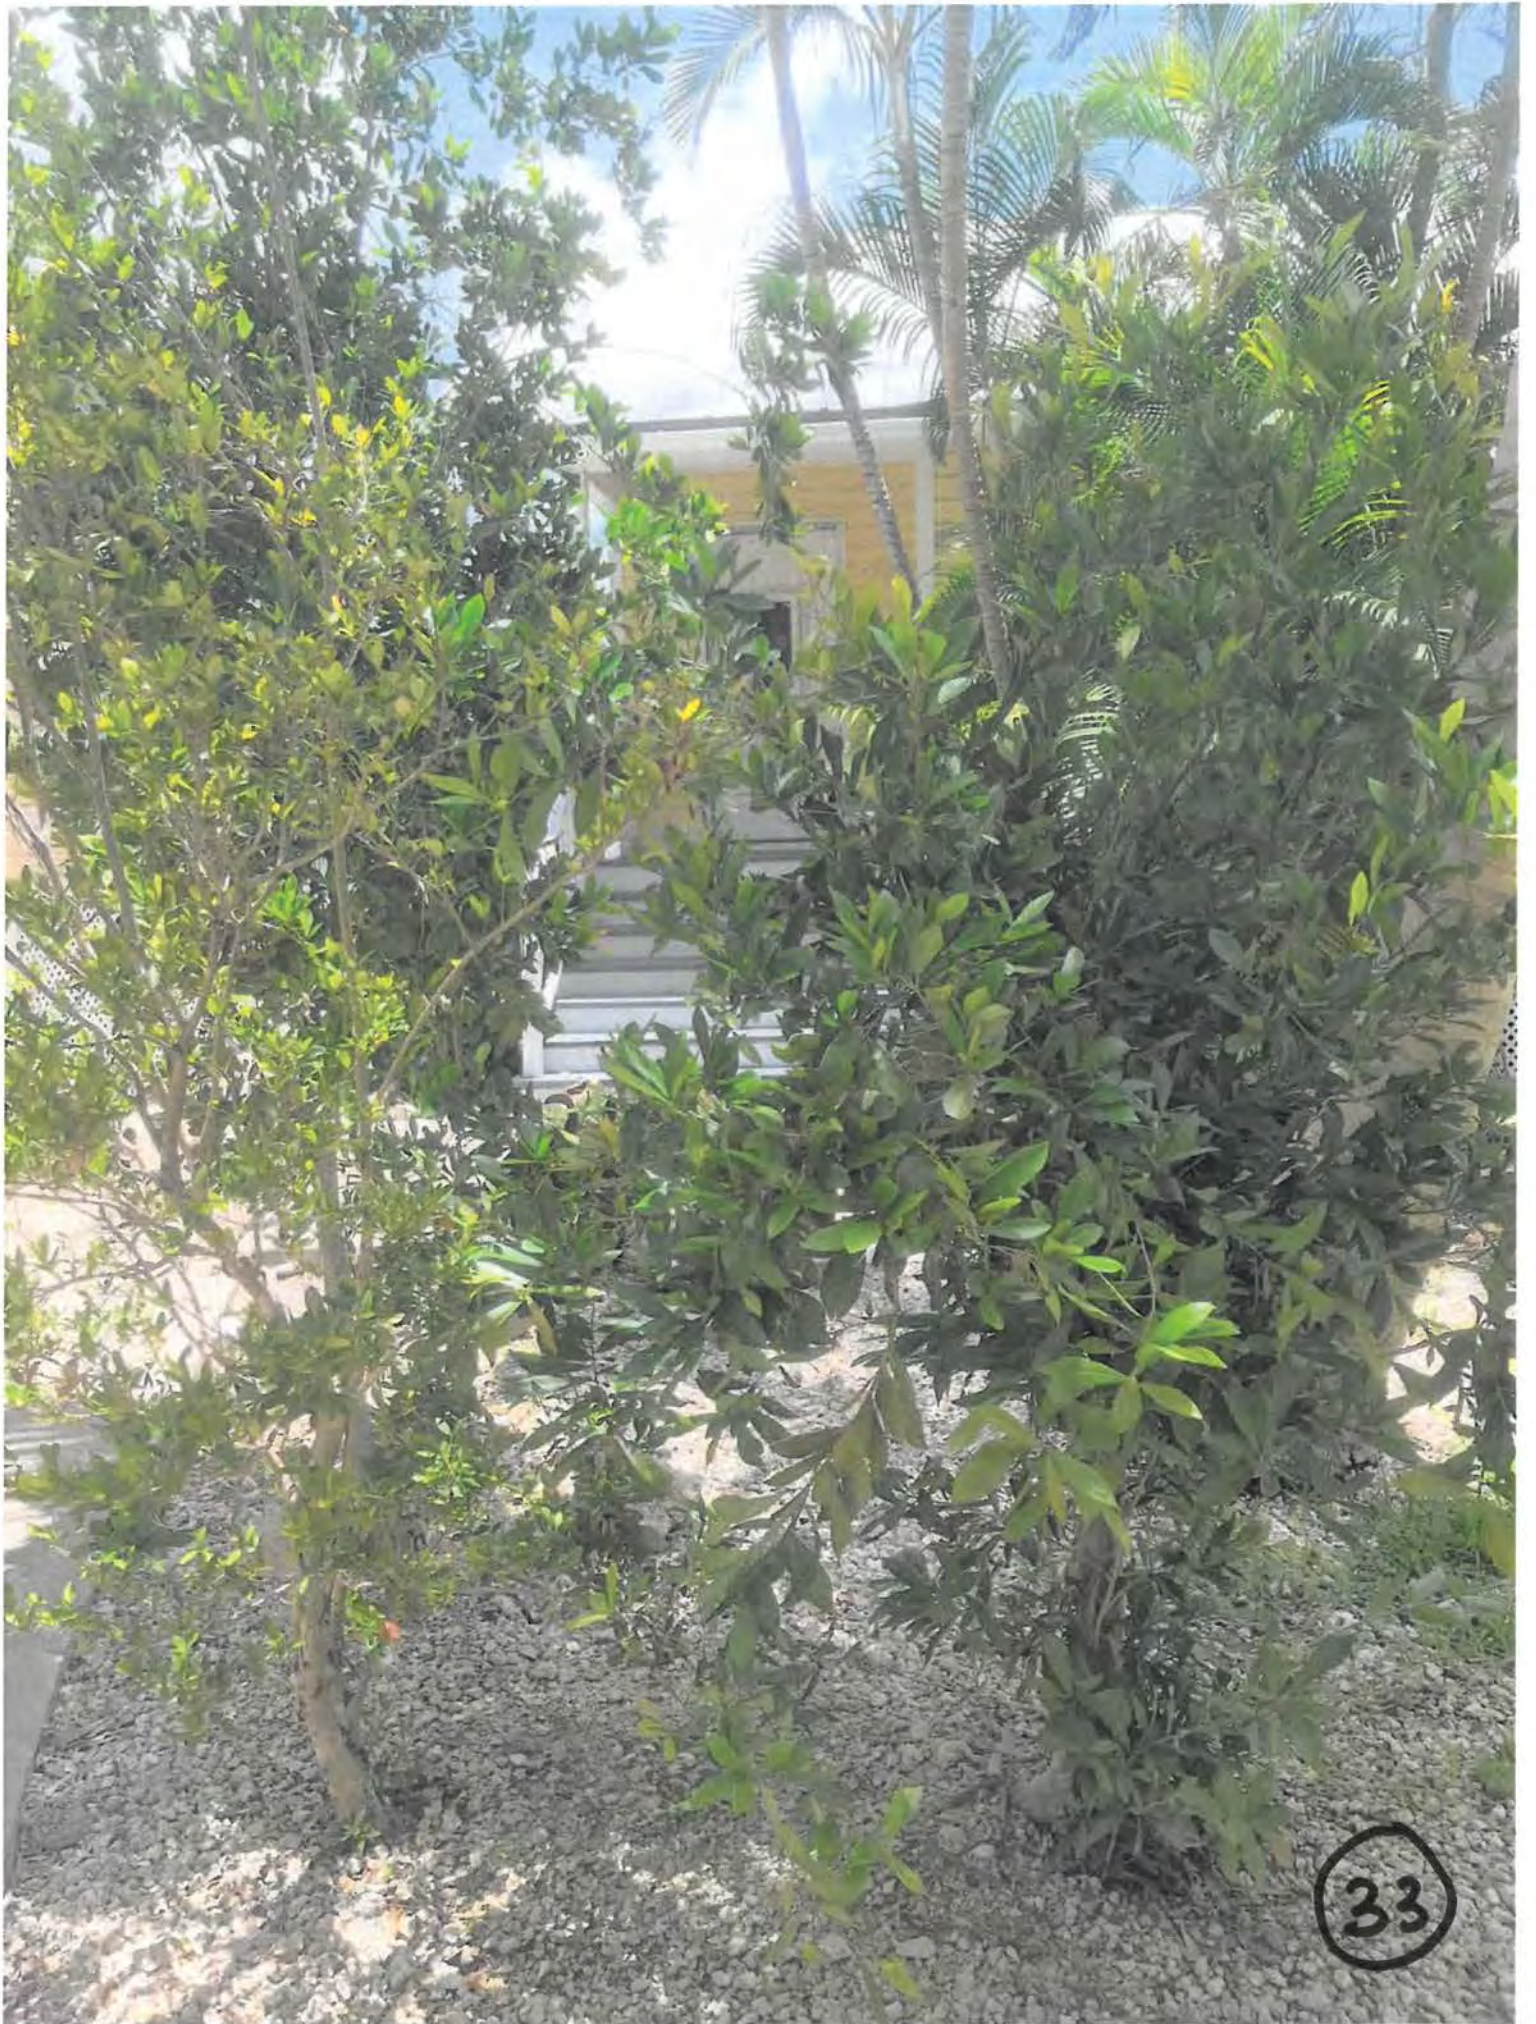
33

31. Christmas Palm (4)/*Adonidia merrillii* -Remove 12'-20' wood
32. Ficus 'Shortleaf'/*Ficus citrifolia* -Transplant Fair, 9 ½ "
33. Crabwood/*Gymnanthes lucida* -Remove Poor, 1 ¾ ", storm damage, shrub

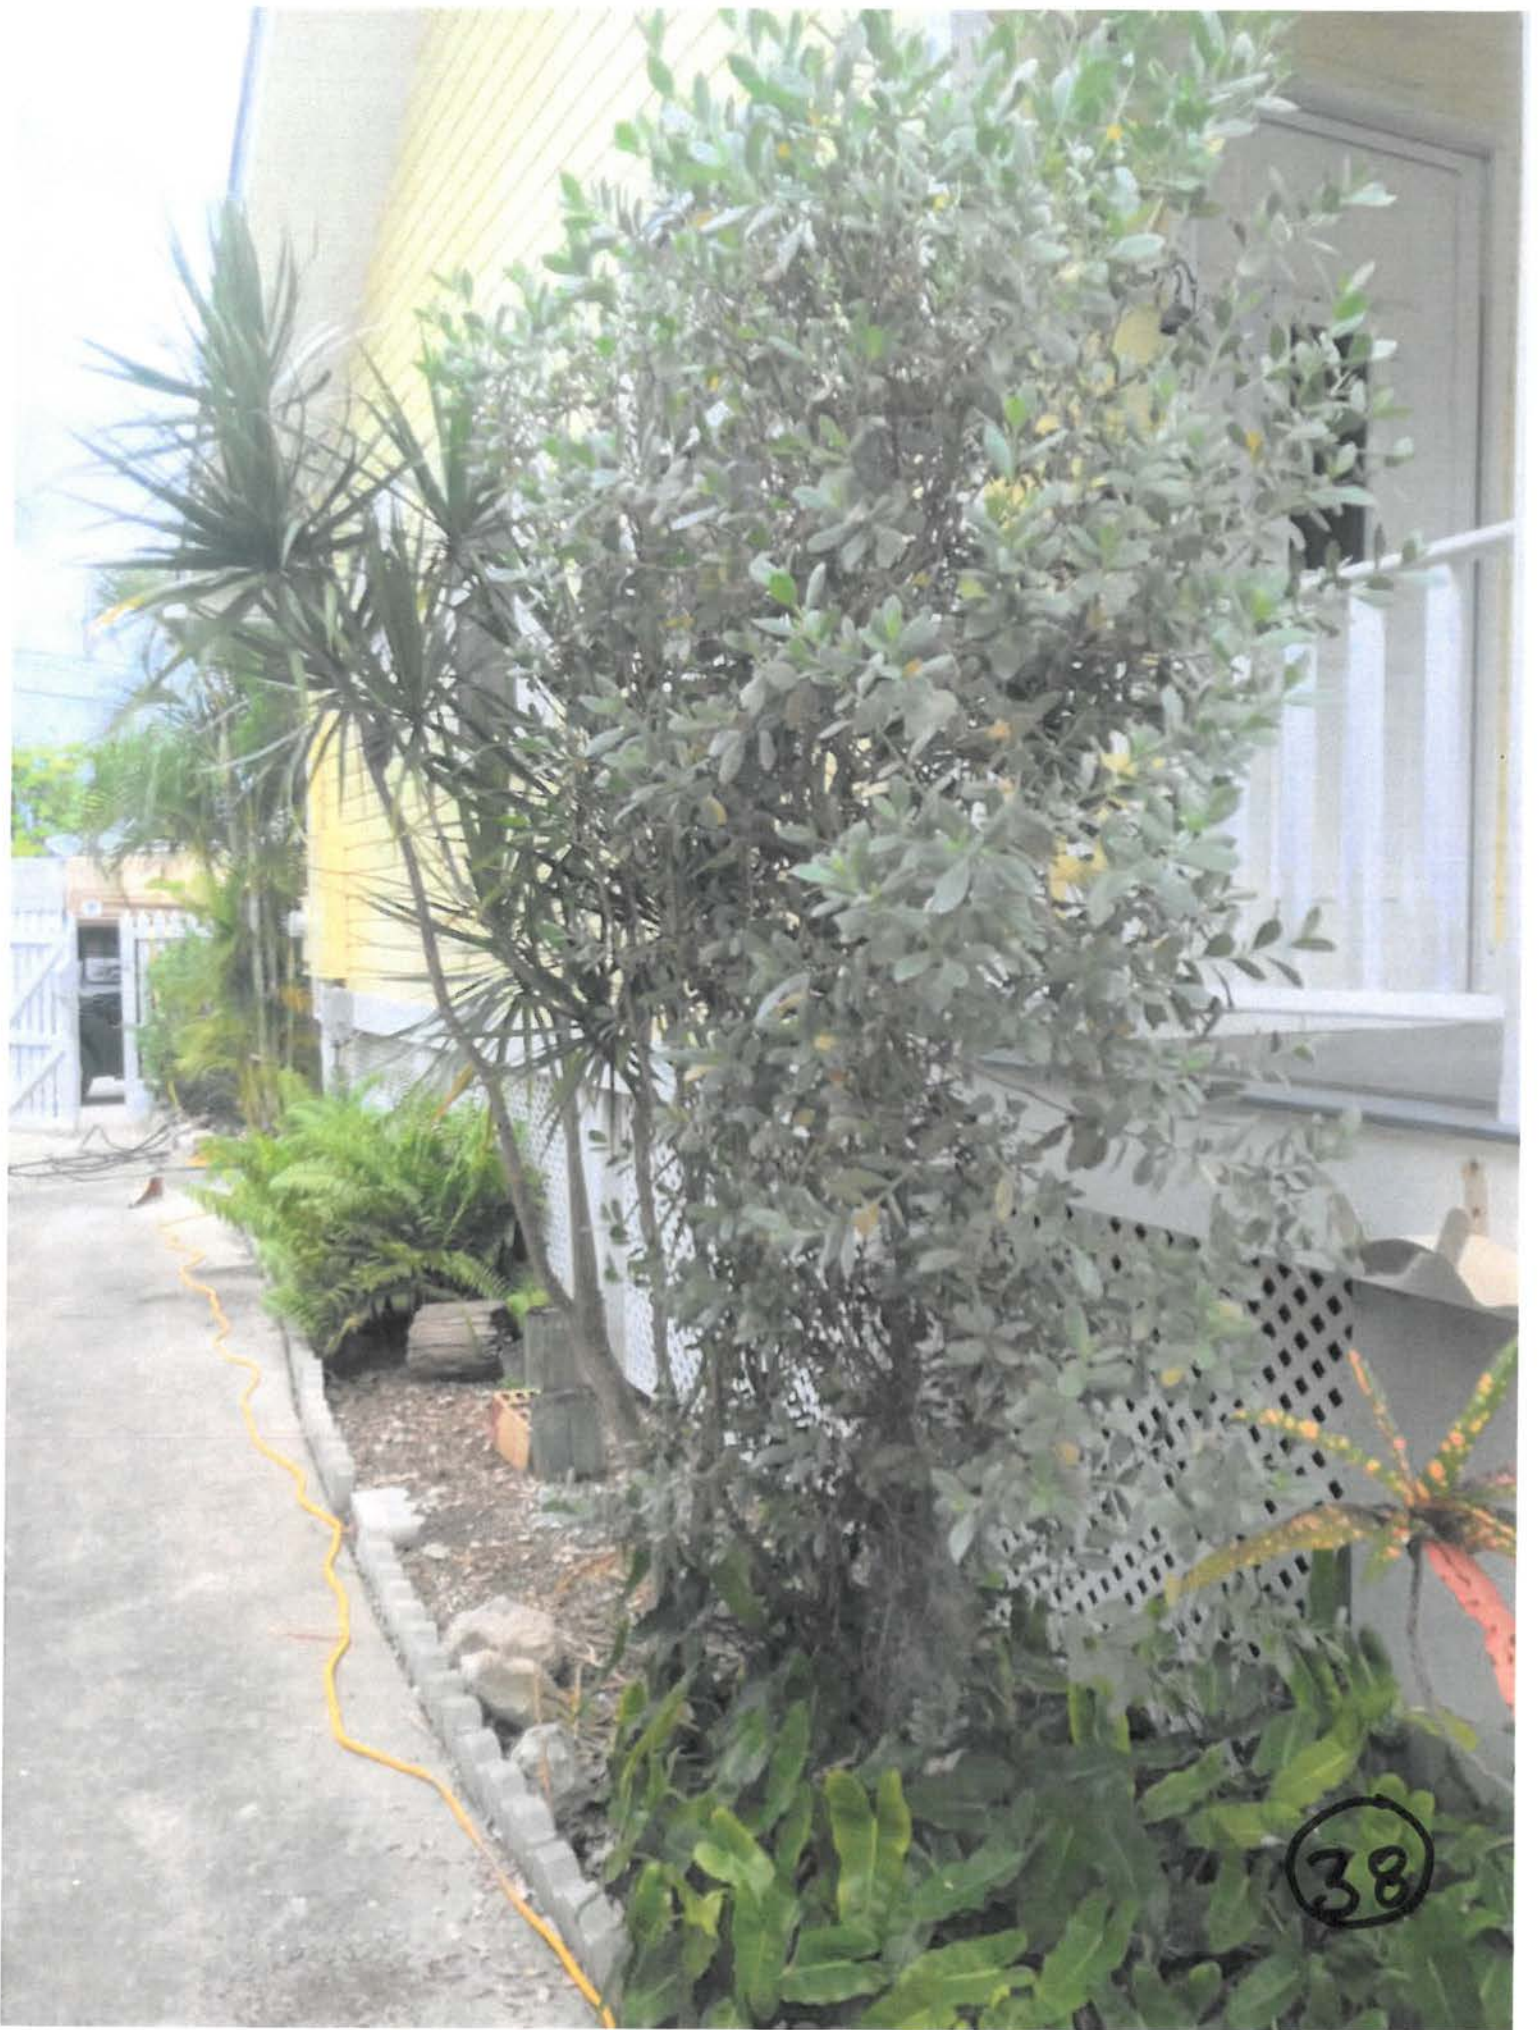
38

37. Areca Palm/*Dyopsis lutescens* -Remove
38. Silver buttonwood/*Conocarpus erectus sericeus* -Remove Poor, 1 ½ ", maintained as hedge
39. Silver buttonwood/*Conocarpus erectus sericeus* -Remove Poor, 8 ¾ ", maintained as hedge
