**TREE COMMISSION TREE REMOVAL REPORT  
CITY of KEY WEST**

**PROPERTY: 3720 Duck Ave.**

**APPLICATION NUMBER: T2026-0091**

**REQUEST: The applicant is requesting removal of (1) Mahogany tree.**

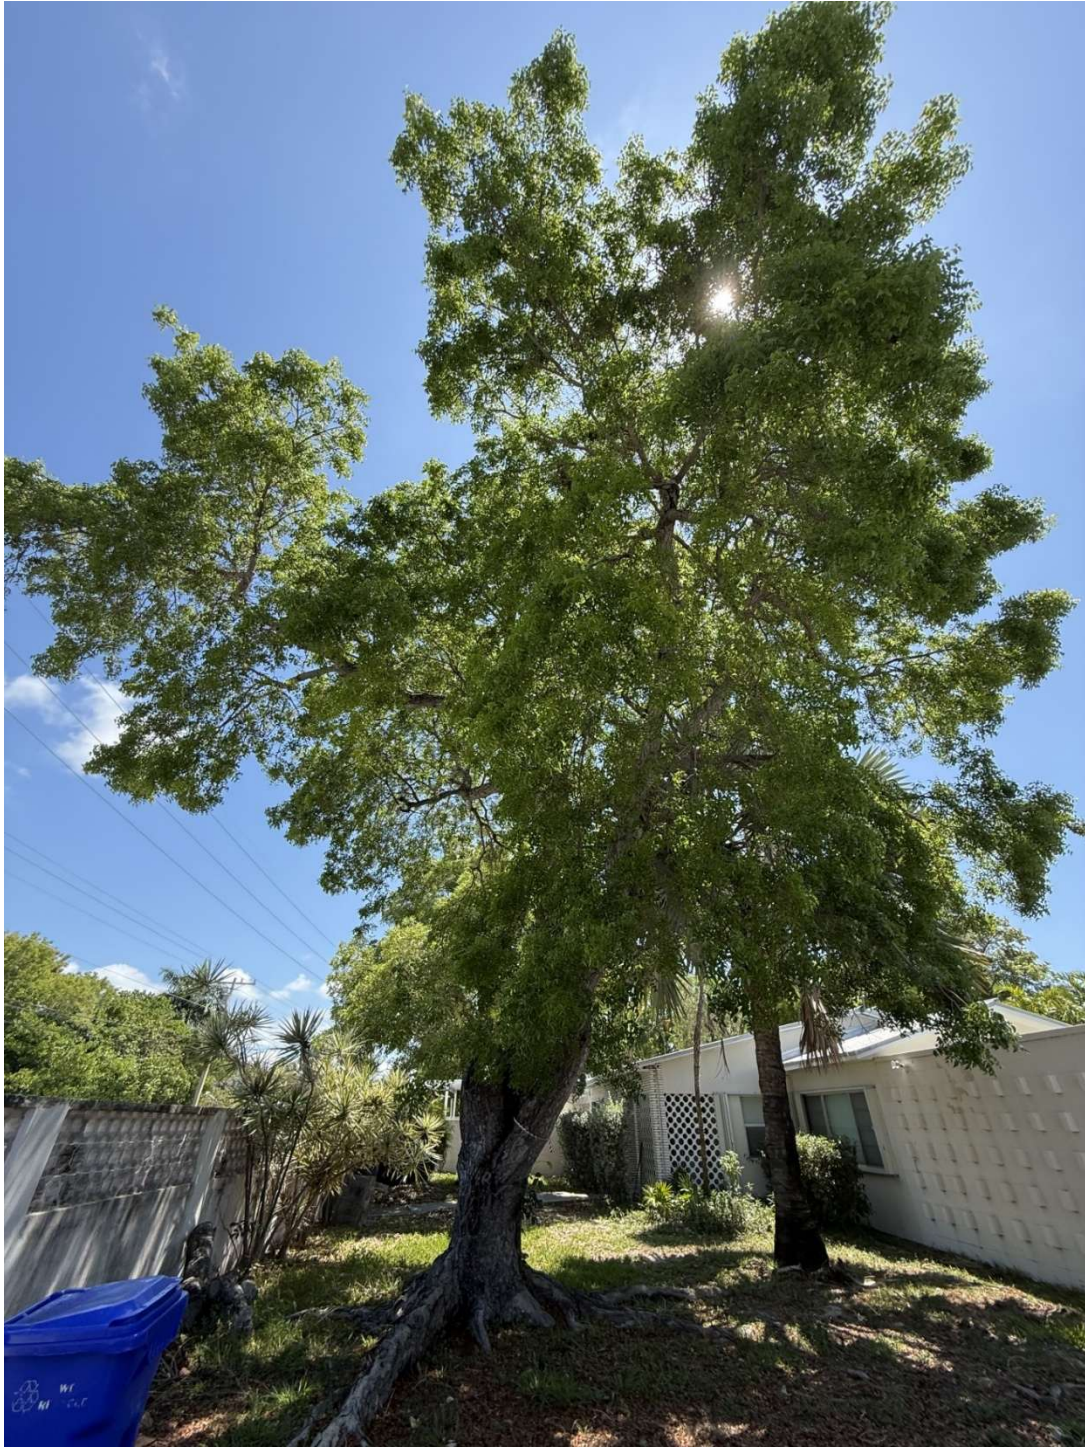
**Tree appears to have a lean. It does not appear to be from phototropic growth which means the tree likely lacks reaction wood associated with phototropic growth.**

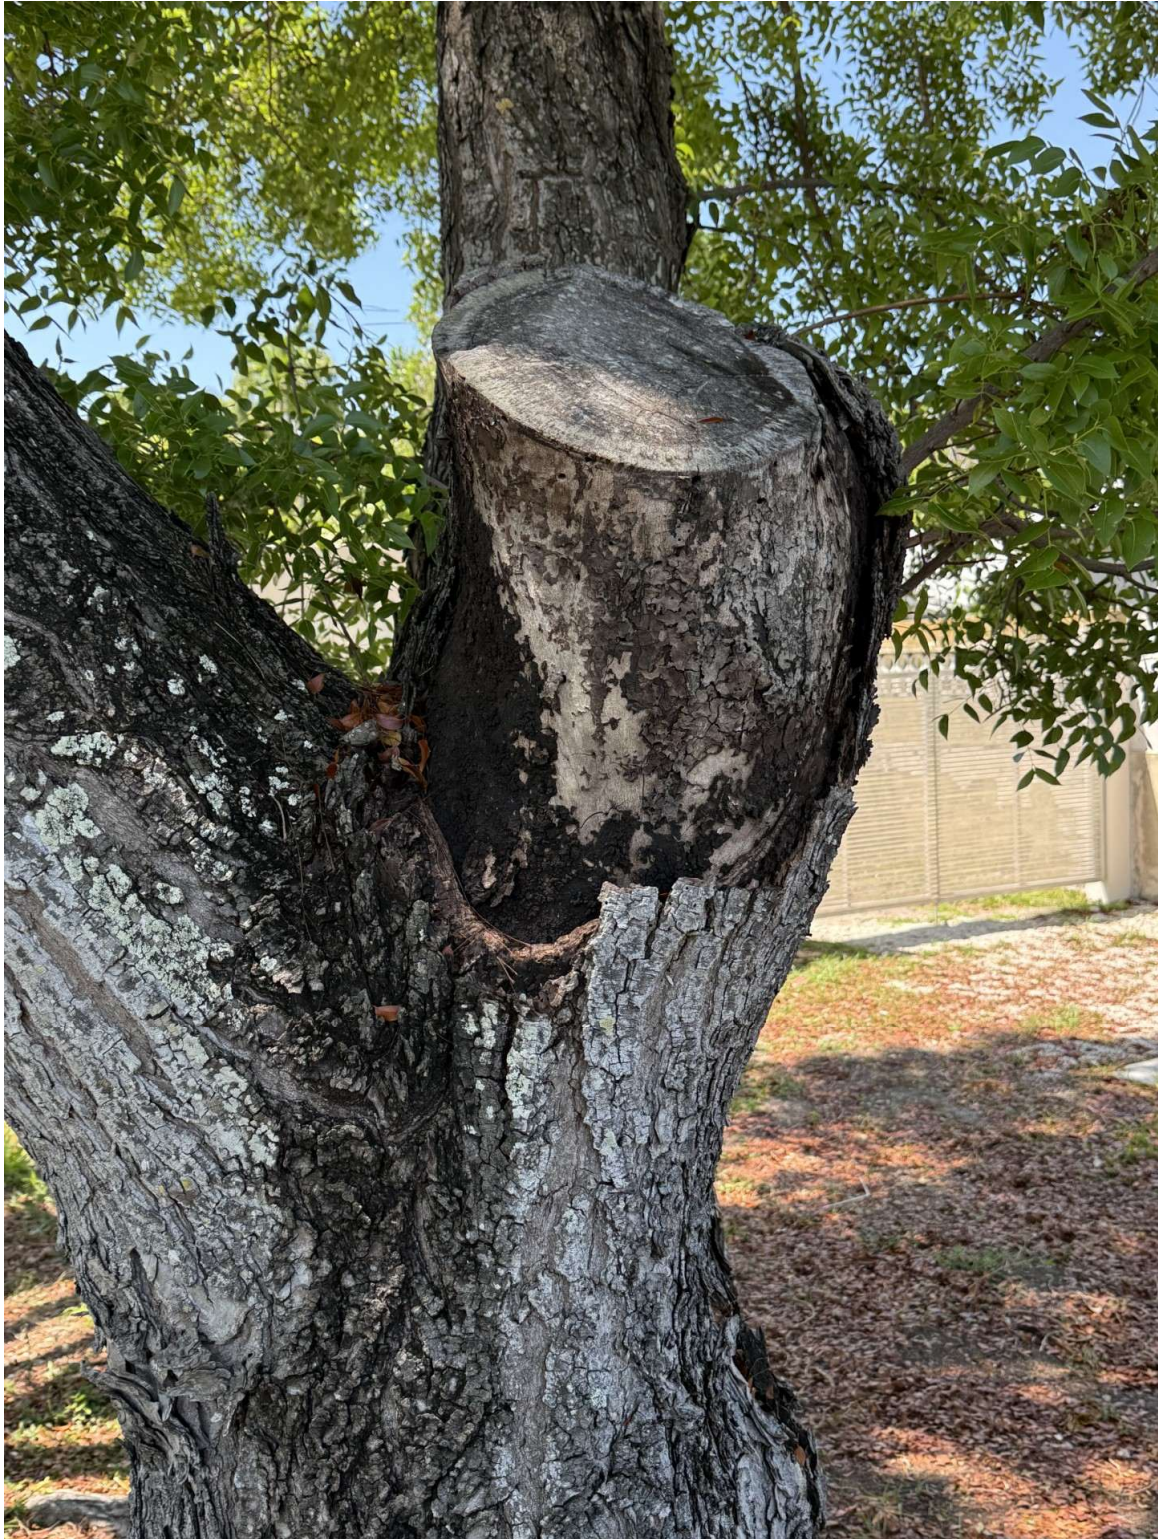
**Poor pruning and resulting exposed heartwood and decay.**
