November 20, 2013

**Subject: Arborist Assessment of Trees  
Former Glynn Archer Elementary School Site  
1302 White Street, Key West, FL 33040  
E Sciences Proposal Number 1-1702-01**

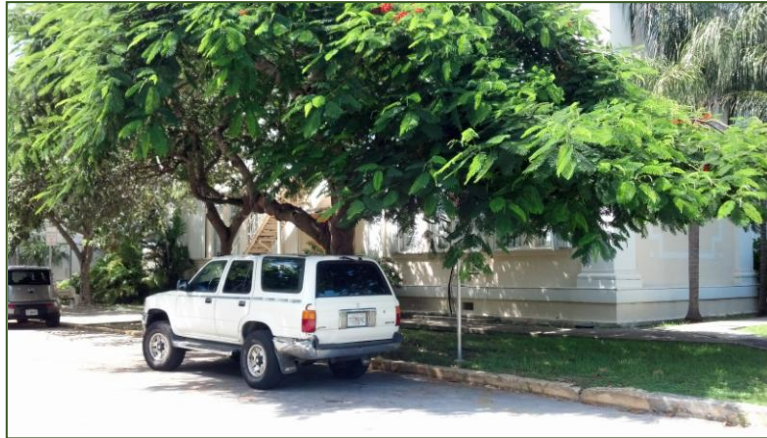
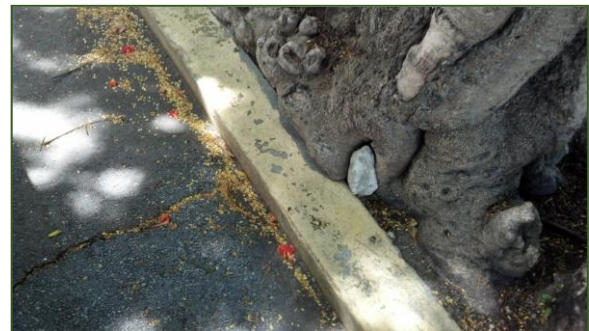
### Tree 1: Royal Poinciana (*Delonix regia*)

**Observations:** This tree is located in a highly trafficked location at the corner of White Street and Seminary Street. The tree crown structure is typical of the species, as are the surface roots present throughout the root zone. E Sciences observed some decay within old pruning cuts at some of the branch connections. These cuts range from four to eight inches long. Roots show signs of mechanical damage, likely

due to mowing. The tree abuts the Seminary Street curb and is impacting the integrity of the curb and street. The curb is likely to be limiting the growth of roots on the south side of the tree. Grass does not grow well under royal poinciana trees and thus erosion has occurred at the base of the tree. This erosion and the lack of root structure to the south create a situation where the tree's stability is compromised. There is concrete in the base of the tree, which likely was used in an attempt to stabilize the area under the tree. The tree is cracking the road and growing over the curb (see photo right).

**Rating:** Fair

**Disposition:** Removal and replacement

**Recommendation:** While this species is visually appealing and iconic to Key West, this particular specimen is located too close to the sidewalk and street. This placement has resulted in potential destabilization of the tree due to lack of root structure to the south and the likelihood of continued damage to the street and curb. E Sciences recommends removing and replacing this tree in association with Sec. 110-327(a) of the City's municipal code.

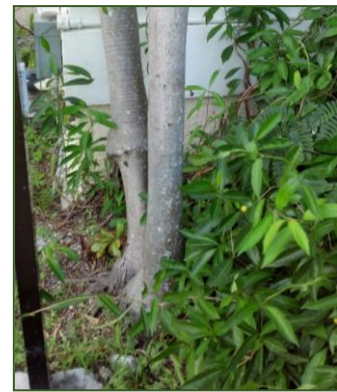
### Tree 7: Alexander Palm

**Observations:** This double palm has slight pencil-necking at the base (see photo right), but is otherwise healthy.

**Rating:** Fair

**Disposition:** Removal and replacement

**Recommendation:** If this tree does not fit within the context of the new landscape design, E Sciences recommends removal and replacement.

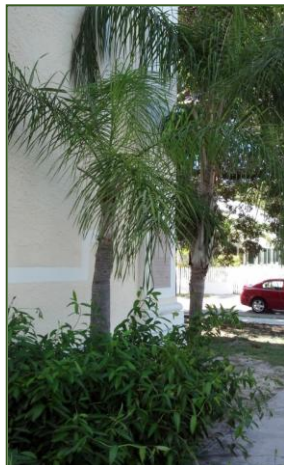
### Tree 9, 9a: Queen Palm

**Observations:** Next to Tree 9 is another queen palm, which will be identified as Tree 9a. Both of these palms are stunted and chlorotic. They are too close to the building and have had too many fronds removed (see photo left).

**Rating:** Poor

**Disposition:** Removal and replacement

**Recommendation:** This palm is listed on the FLEPPC List of Invasive Plant Species. These two palms are too close to the building and in poor condition. E Sciences recommends removal and replacement.

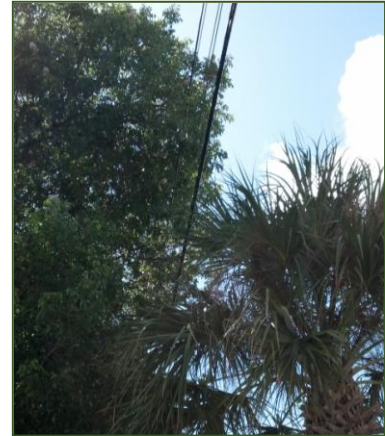
### Trees 12 and 13: Cabbage Palm (*Sabal palmetto*)

**Observations:** Only one tree is located at the corner of White Street and United Street as opposed to the two shown on the tree survey. The remaining tree is a cabbage palm in good condition. Palm fronds are close to the overhead utility line that runs along the south side of United Street but should not interfere with the lines (see photo right).

**Rating:** Good

**Disposition:** Preservation

**Recommendation:** E Sciences recommends preservation.

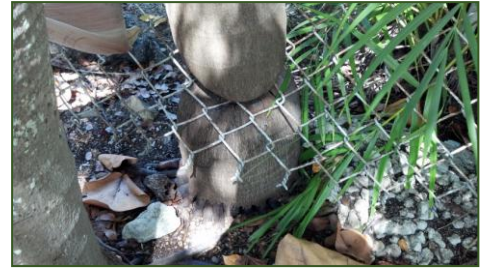
### Tree 15, 16, 16a-d: Alexander Palm

**Observations:** Two of these palms are listed on the tree survey; however, there are six total within this courtyard. E Sciences did not observe any obvious signs of health or structural deficiency with the exception of one double-stemmed palm that is growing through the fence (see photo right). Only palms that are eight feet tall are protected per Sec. 110-321(a)(2).

**Rating:** Good, poor

**Recommendation:** E Sciences recommends removal of palms in good condition only if needed due to conflict with new landscape elements.

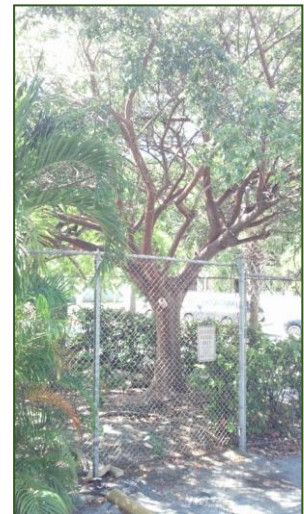
### Tree 17: Gumbo Limbo (*Bursera simaruba*)

**Observations:** This tree appears to be in good health and has good structure for a tree of this species (see photo right). E Sciences observed some dead branches, attached and hanging, and some crossing limbs. There is also a small structure attached to the tree with a rope that will soon be girdling the tree.

**Rating:** Good

**Recommendation:** While this tree is in relatively good condition, E Sciences recommends removing and replacing this tree due to conflict with new landscape elements

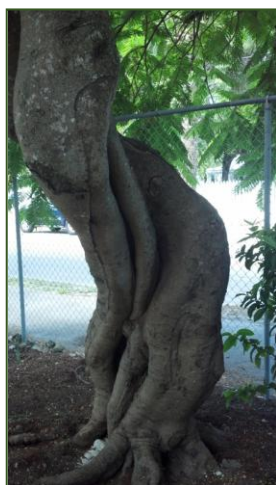
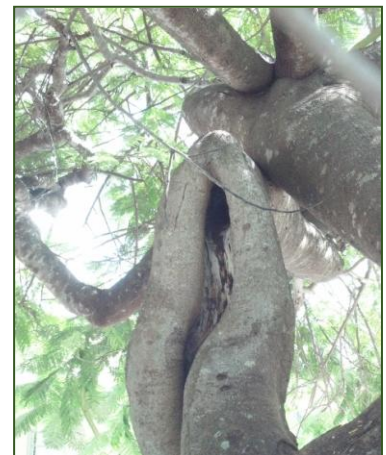
### Tree 18 Royal Poinciana

**Observations:** This tree has major structural flaws, including crossing leaders and bark and major decay throughout the center of the trunk (see photos to the right and left).

**Recommendation:** E Sciences recommends removal of this tree in accordance with Sec. 110-327(a) of the City's municipal code. If the City desires to keep this tree due to the canopy it provides, E Sciences recommends structural pruning for correctable defects and frequent monitoring. E Sciences also recommends consultation with an arborist experienced with bracing and propping.

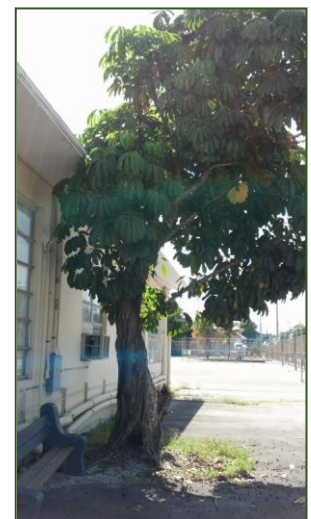
### Tree 27: Queensland Umbrella (*Schefflera actinophylla*)

**Observations:** This tree is in poor condition and is conflicting with the building (see photo right). There have been major cuts or breaks in this tree, resulting in large wounds and reduced canopy.

**Rating:** Poor

**Recommendation:** E Sciences recommends removing this tree, which is not a protected species per Sec. 110-254 of the City's code and is listed on the FLEPPC list of invasive species.

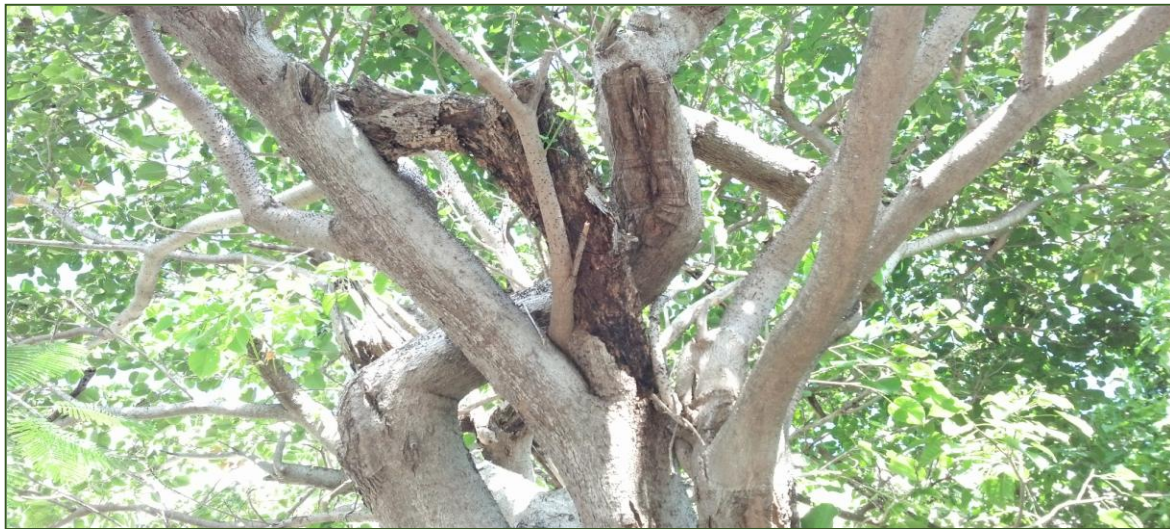
#### Tree 47: Sandbox Tree (*Hura crepitans*)

**Observations:** This tree conflicts with the utility lines along Seminary Street and has structural flaws and signs of diminished health and condition. The tree is being impacted at the base by concrete. E Sciences observed numerous hanging and fallen limbs, with a number of dead or decaying limbs likely to fall in the near future. The tree has a substantial lean and decay within old wounds (see photo below).

**Rating:** Poor

**Recommendation:** E Sciences recommends removal of this tree per Sec. 110-327(a) of the City's municipal code and replacement. If the City desires preservation, E Sciences recommends structural pruning and crown cleaning. E Sciences also recommends monitoring the condition of this tree annually or biannually.

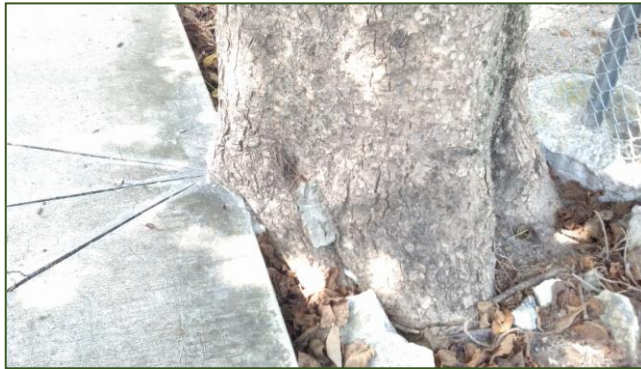
#### Tree 49: Sandbox Tree

**Observations:** This tree conflicts with the utility lines along Seminary Street and has structural flaws and signs of diminished health and condition. The tree has co-dominant leaders, with included bark and excessive growth at the attachment. E Sciences observed stress cracks along some of the larger limbs and die-back towards the tips of some of the leaders hanging over the street. There is an old wound on the trunk, which is cracked to the base of the tree (see photo right).

**Rating:** Poor

**Recommendation:** E Sciences recommends removal

of this tree per Sec. 110-327(a) of the City's municipal code and replacement. If the City desires preservation, E Sciences recommends structural pruning and crown cleaning. E Sciences also recommends monitoring the condition of this tree annually or biannually.

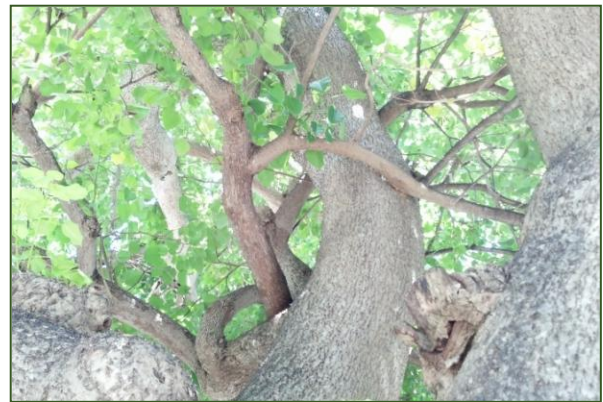
#### Tree 50: Sandbox Tree

**Observations:** This tree is abutting the sidewalk along Seminary Street and is growing over the cement and interfering with the fence behind it (see photo left) which is damaging the sidewalk and the tree. Overall, the crown structure of this tree is poor, with included bark at attachments, crossing and/or pressing leaders (see photo below) and decay visible at the locations of old

pruning cuts or breaks. Fungus was observed, which is an indication of decay.

**Rating:** Poor

**Recommendation:** E Sciences recommends removal of this tree per Sec. 110-327(a) of the City's municipal code and replacement. If the City desires preservation, E Sciences recommends structural pruning and crown cleaning. E Sciences also recommends monitoring the condition of this tree annually or biannually.

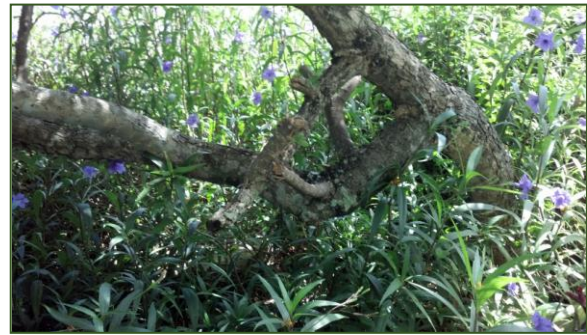
**Tree 58: Tree of Life**

**Observations:** This tree is planted in poor soil and leans heavily. E Sciences observed some decay and sprouts at the site of previous pruning cuts, which include stub cuts. Because the tree is small, defects are unlikely to pose a risk (see photo right).

**Rating:** Fair

**Recommendation:** E Sciences recommends preservation.

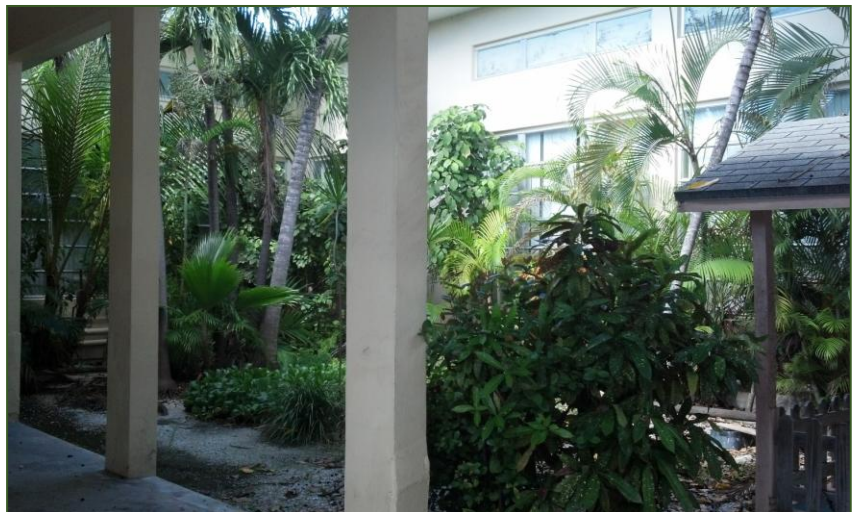
**Courtyard Trees**

There are trees located within a courtyard surrounded on four sides by buildings (see photo right). These trees include fourteen Alexander palms, one coconut palm, and one umbrella tree. Because the courtyard is surrounded by buildings on all four sides (with one small opening), these trees should be exempt from permitting per Sec. 110-322(b).
