**TREE COMMISSION TREE REMOVAL REPORT  
CITY of KEY WEST**

**PROPERTY: 630 Mickens Lane**

**APPLICATION NUMBER: T2025-0229**

**REQUEST: The applicant is requesting removal of (2) Tropical Almond Trees, (1) Spanish Lime Tree, and (1) Sapodilla Tree.**

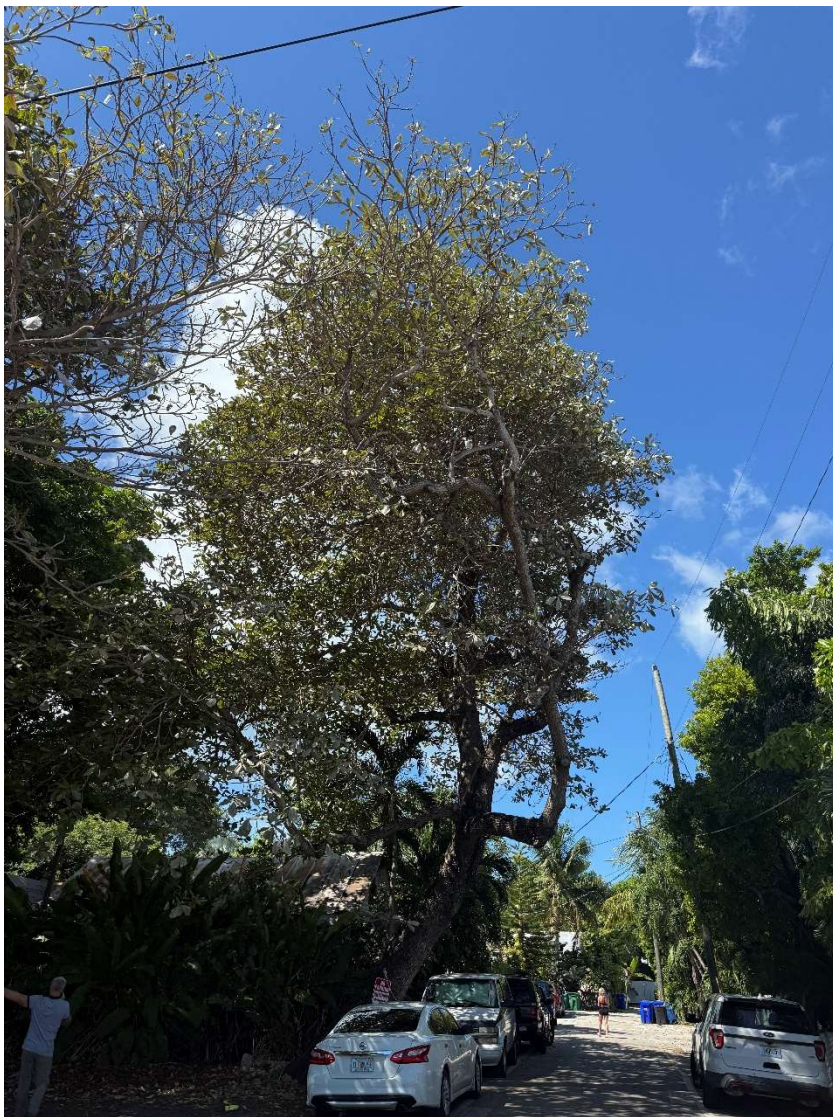
**Tropical Almond #1 is severely stressed. The color of the canopy which can be seen in the close-up picture of the leaves is an early indicator of vascular issues.**

**Condition: 40%**

**Recommended Mitigation: 21 Caliper Inches**

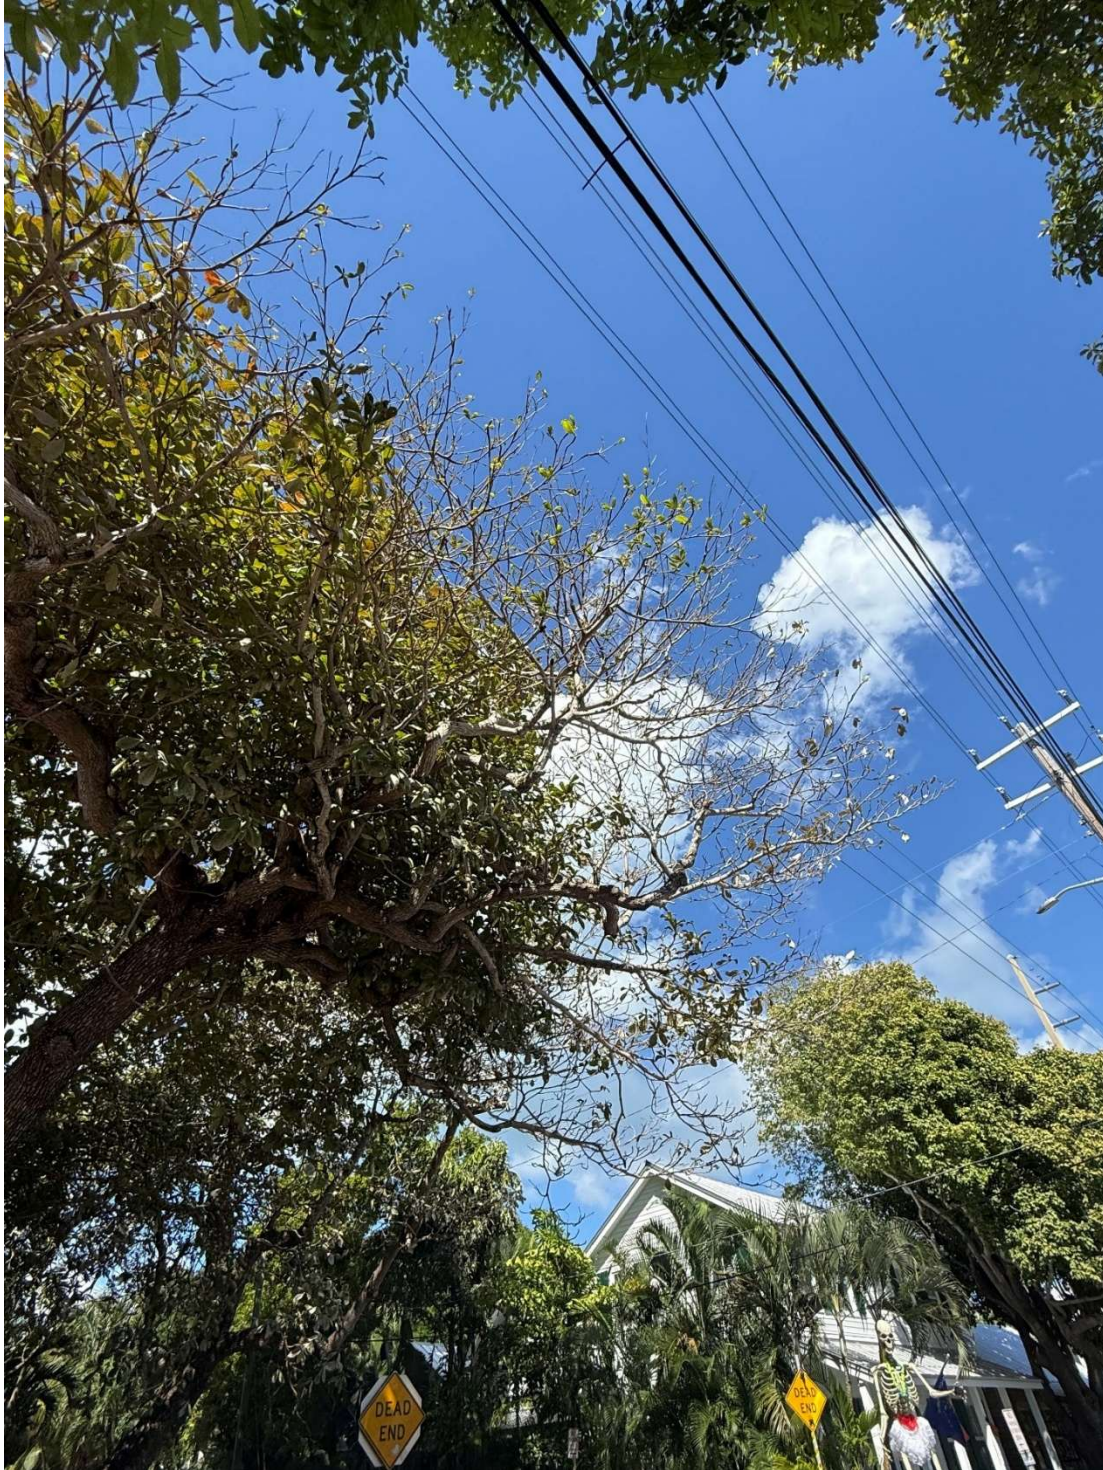
**Tropical Almond Tree #2 also has an unhealthy canopy. It is unbalanced, leaning, and the leaves show the same discoloration/fungus. Although a tropical almond tree can flourish for many years in Key West, they seem to lack the resiliency one would expect from a native tree.**

**Condition: 40%**

**Recommended Mitigation: 17 Caliper Inches**

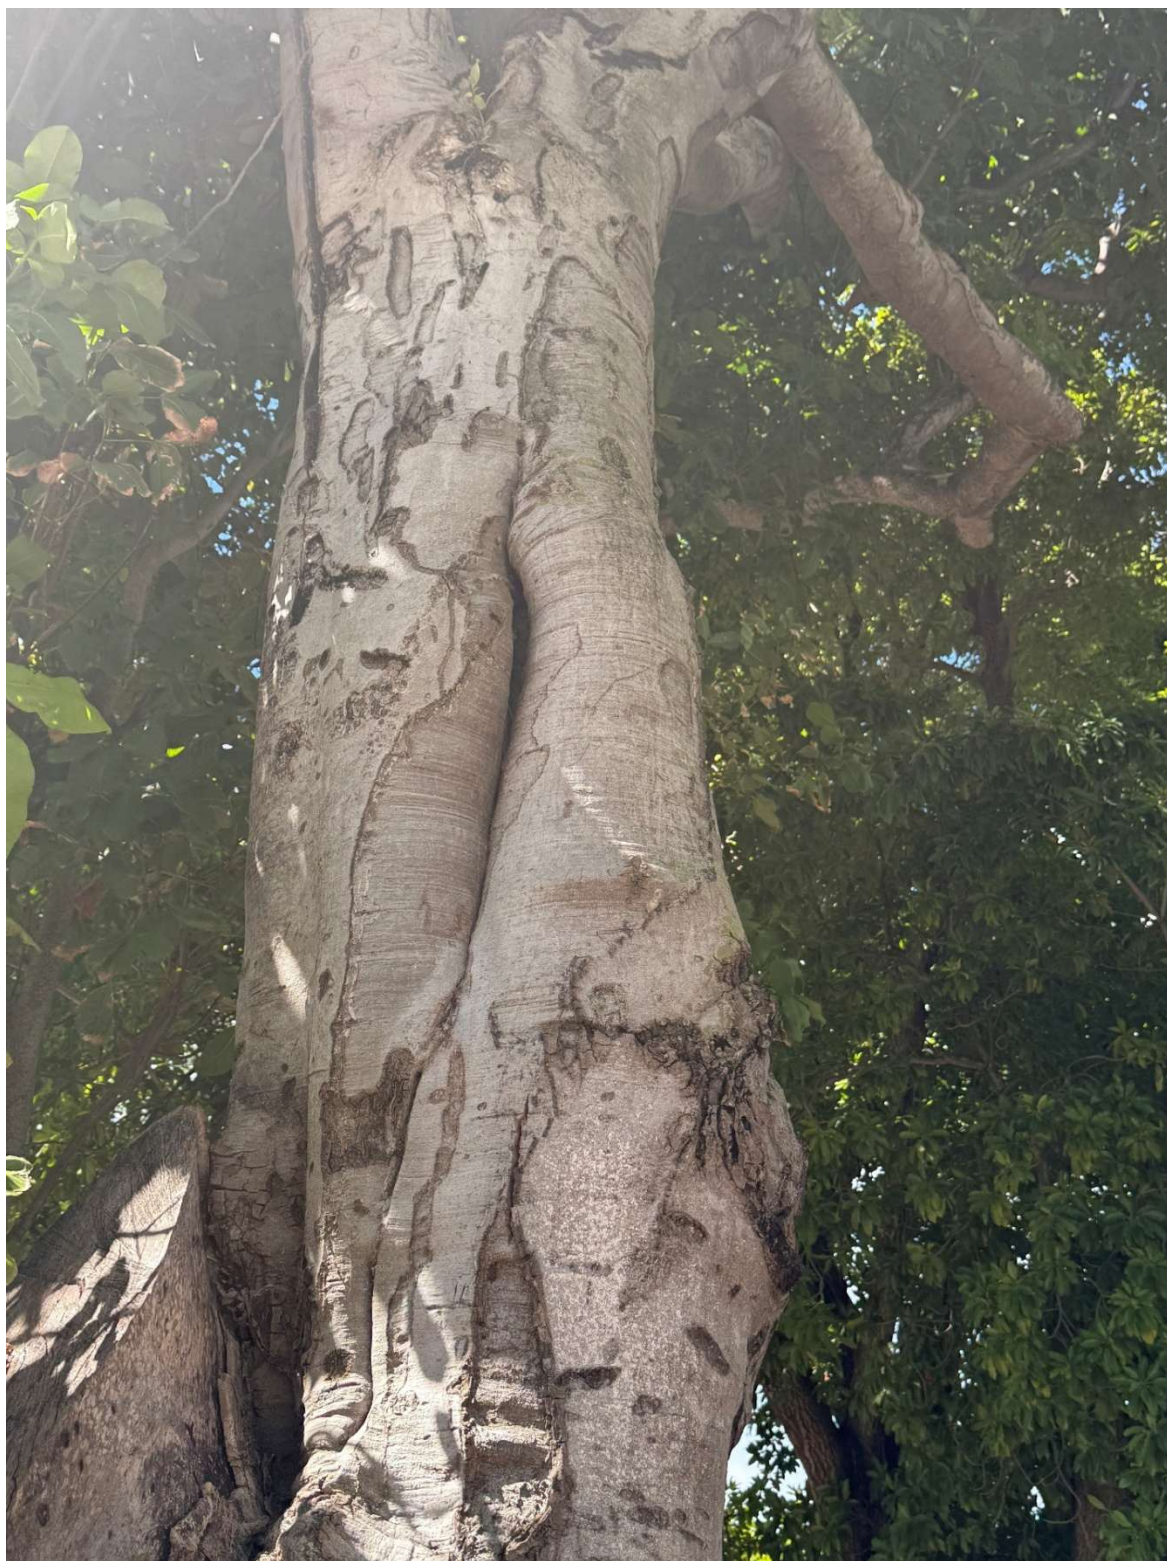
**Almond Tree #2 has excessive die back and is leaning towards wires.**

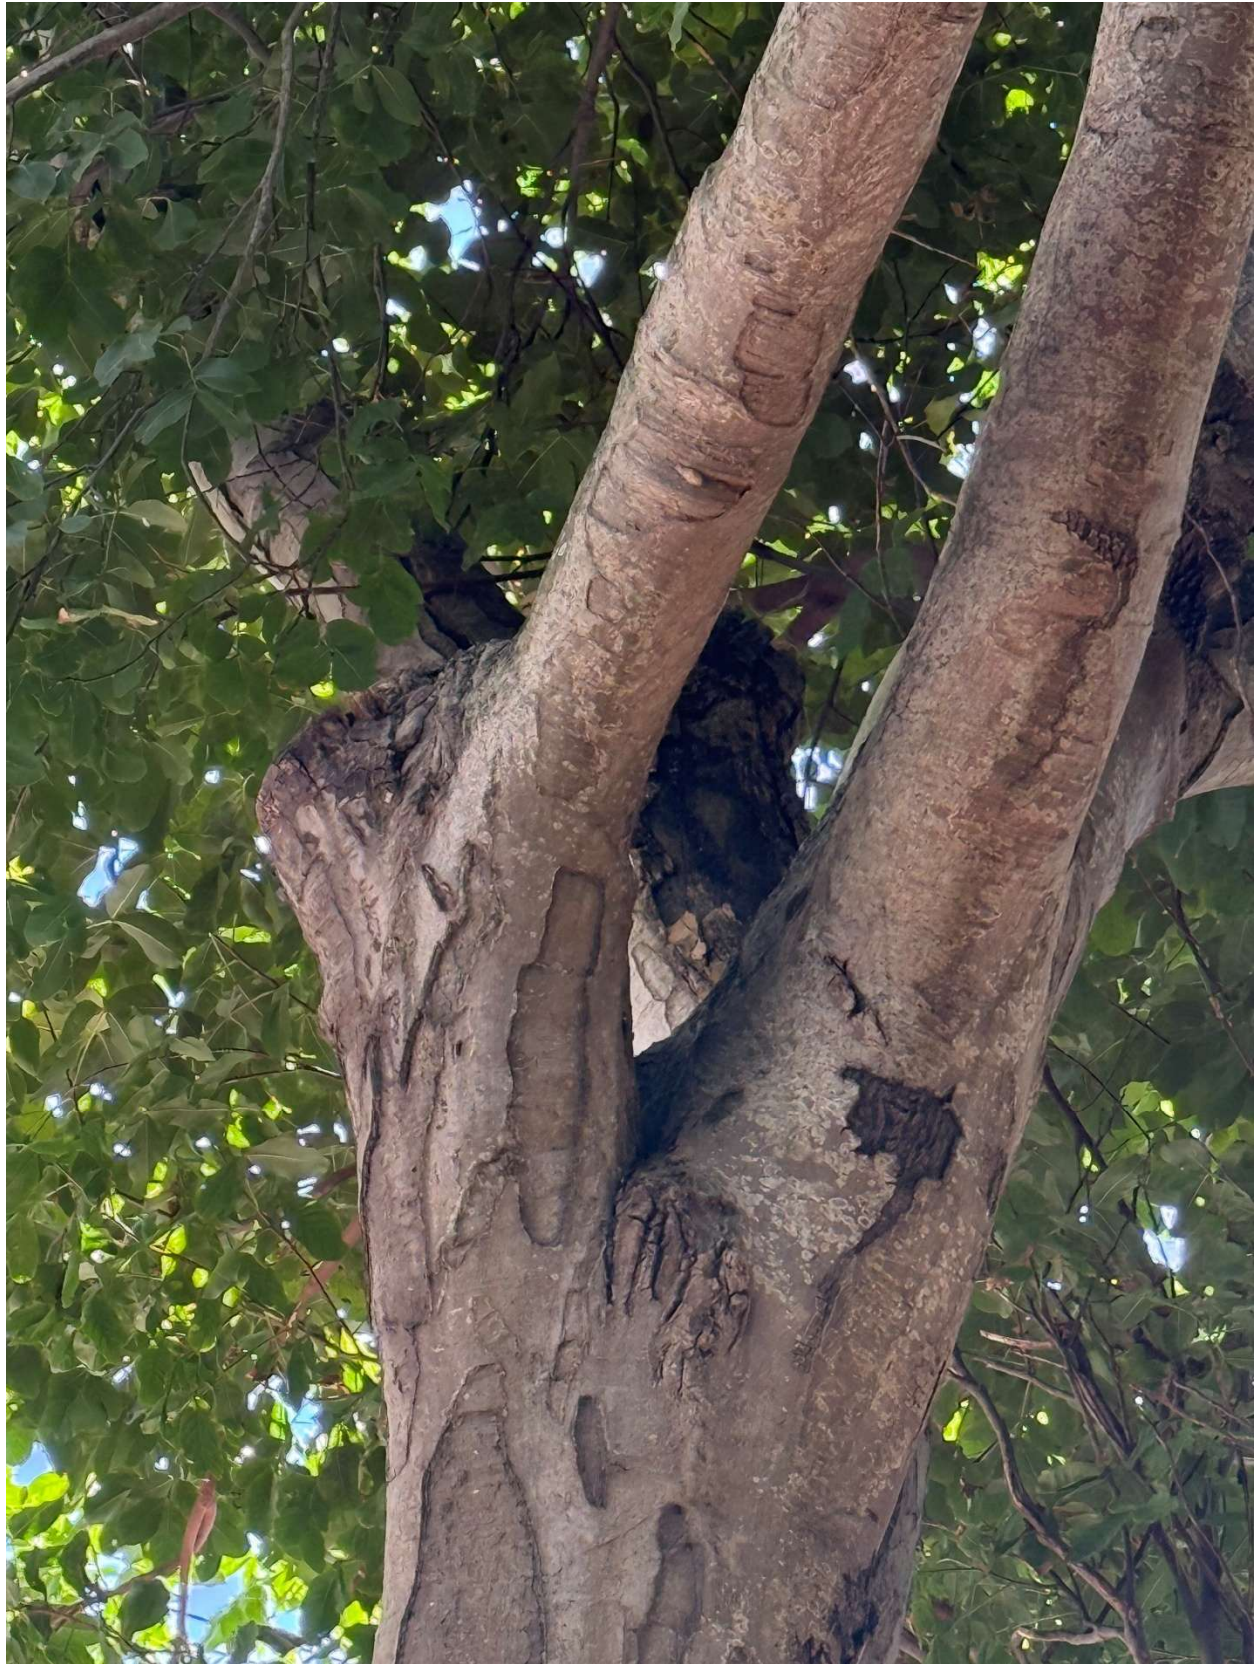
**Spanish Lime Tree**

**Condition: 50%**

**Recommended Mitigation: 18 Caliper Inches**

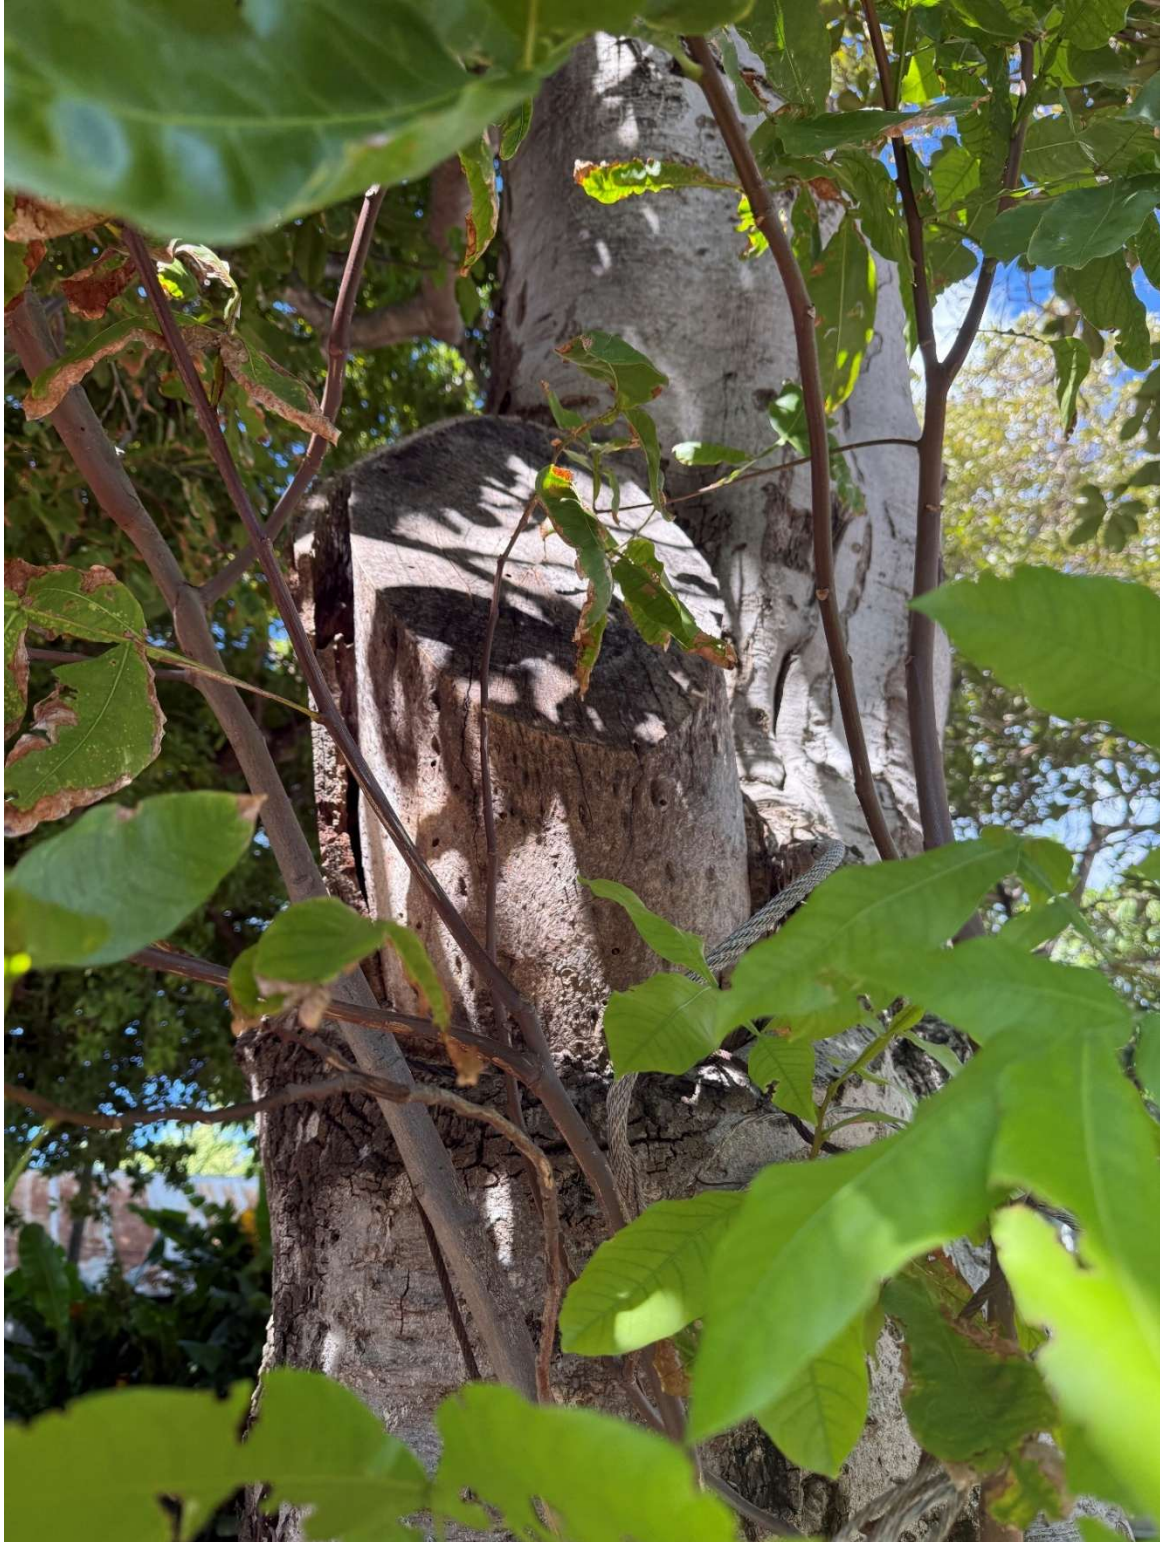
**Tree was not maintained with ANSI 300 pruning standards.**

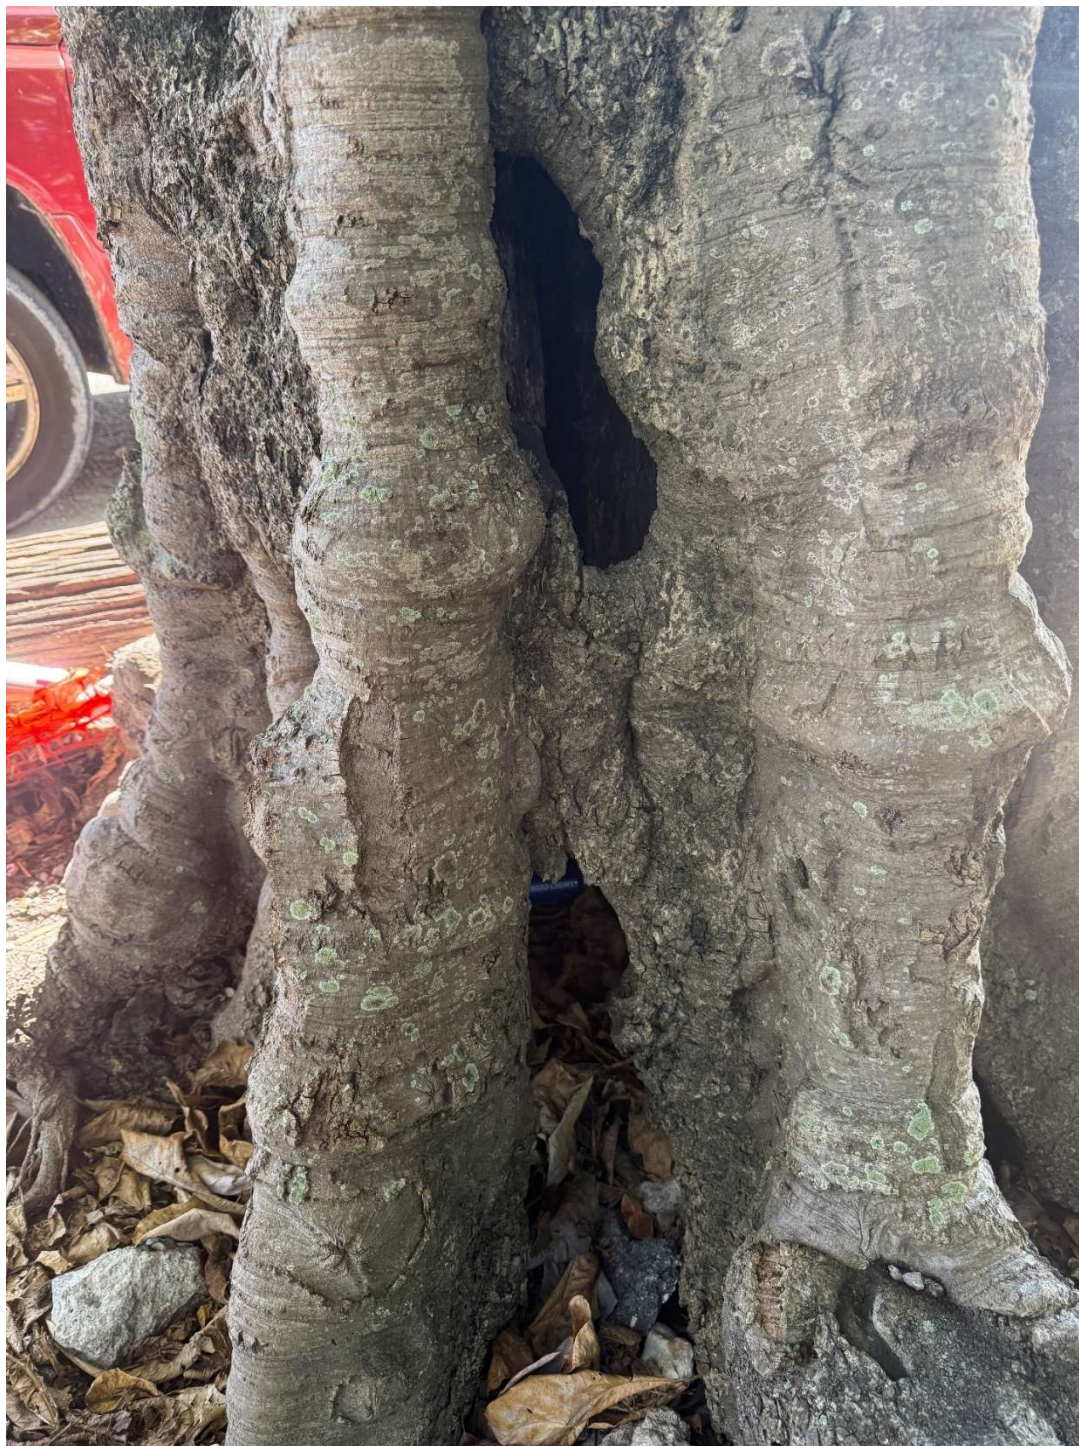
**Base of stem is 50% hollow.**

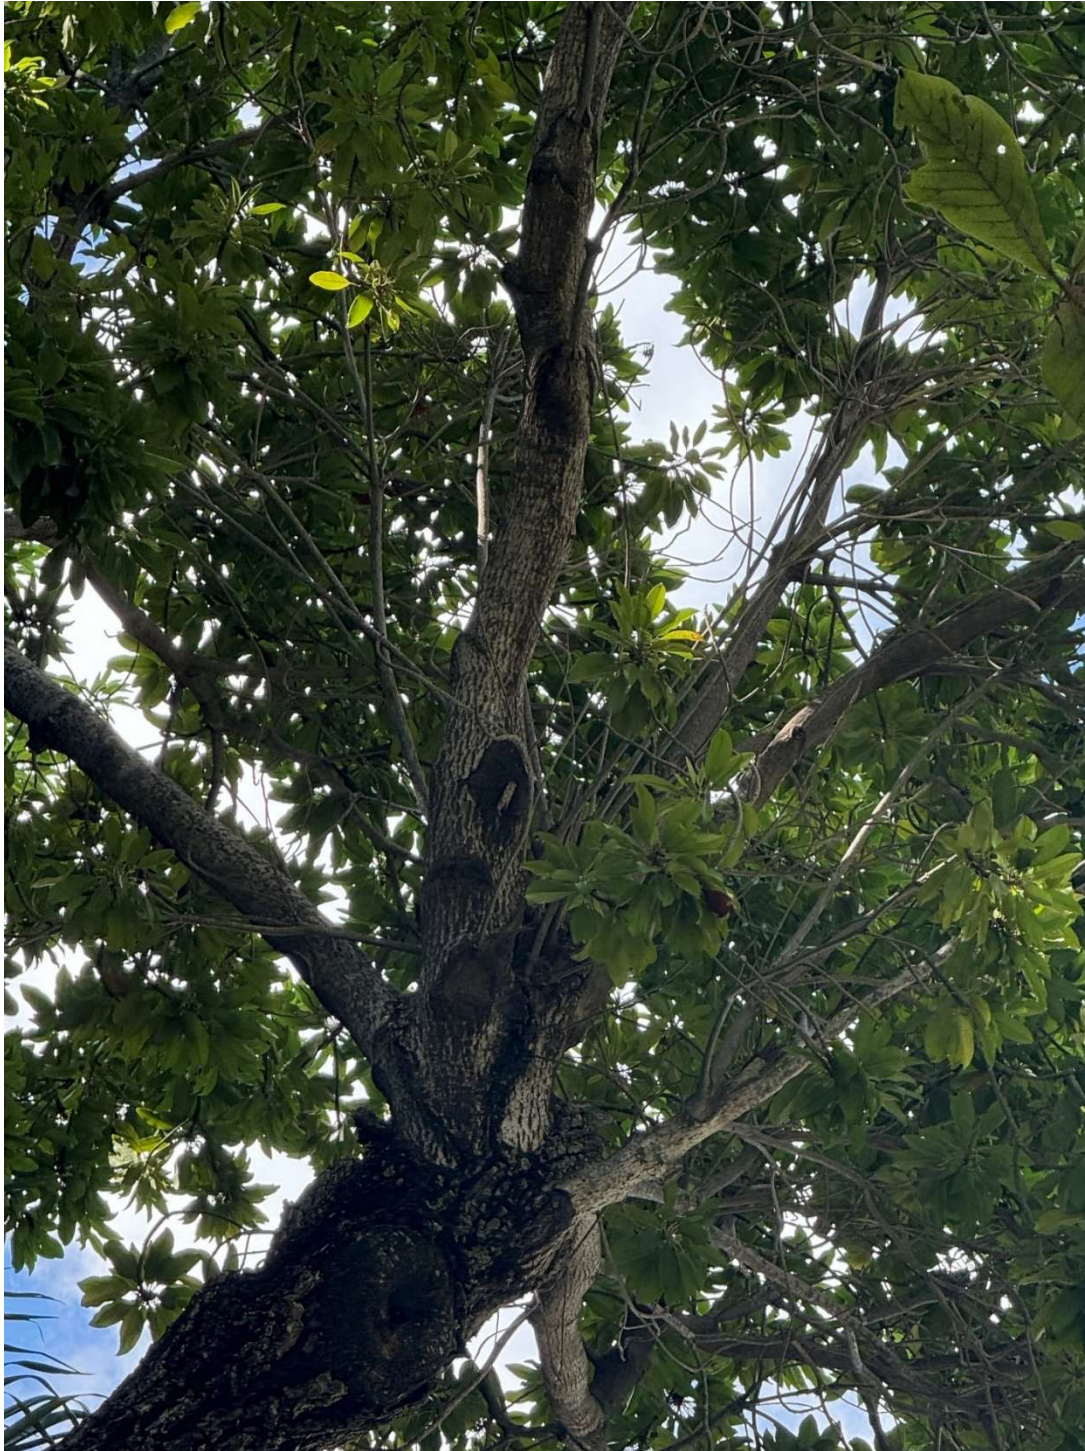
**The Sapodilla Tree was also not pruned in accordance with ANSI 300 standards. The stubs that were left behind create growth patterns and a growth form that is not conducive to a healthy canopy structure.**

**Condition: 60%**

**Recommended Mitigation: 38 Caliper Inches**
