Subject: Key West Angelfish Pier Seawall Structural Assessment

CITY OF KEY WEST
PORT & MARINE SERVICES

KEY WEST GARRISON BIGHT MARINA
ANGELFISH PIER SEAWALL STRUCTURAL ASSESSMENT REPORT

Prepared By:
Tetra Tech, Inc.
759 South Federal Highway, Suite 314
Stuart, FL 34994

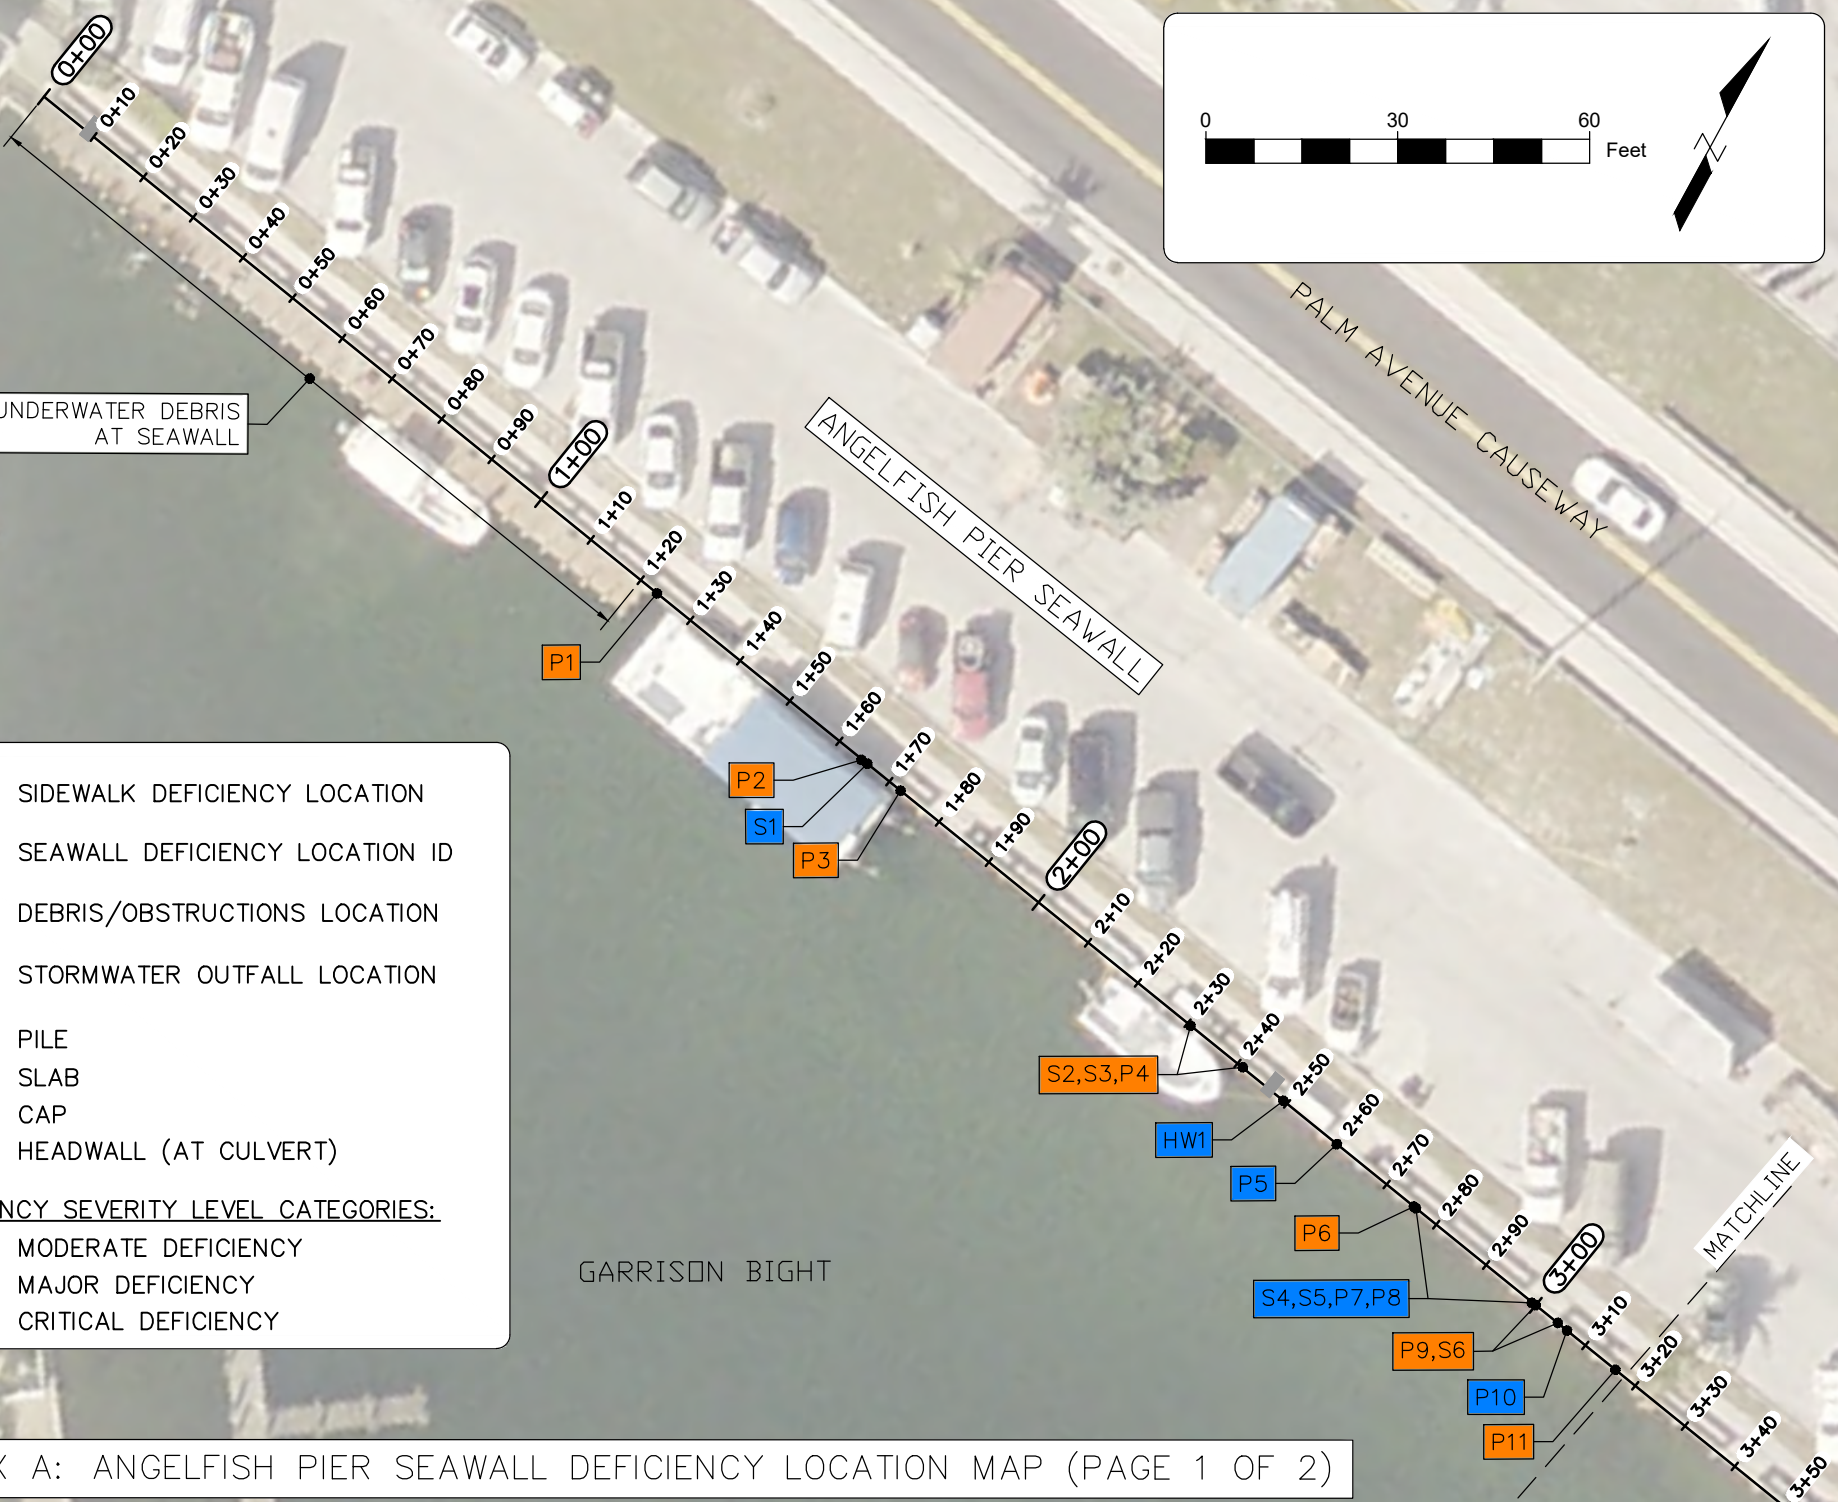
APPENDIX A: ANGELFISH PIER SEAWALL DEFICIENCY LOCATION MAP (PAGE 1 OF 2)

- 1) Appendix A (Angelfish Pier Seawall Deficiency Location Map). Appendix A is a two-page map illustrating the project location, marked deficiencies locations, relevant existing utilities, and built-up dock at the seawall.

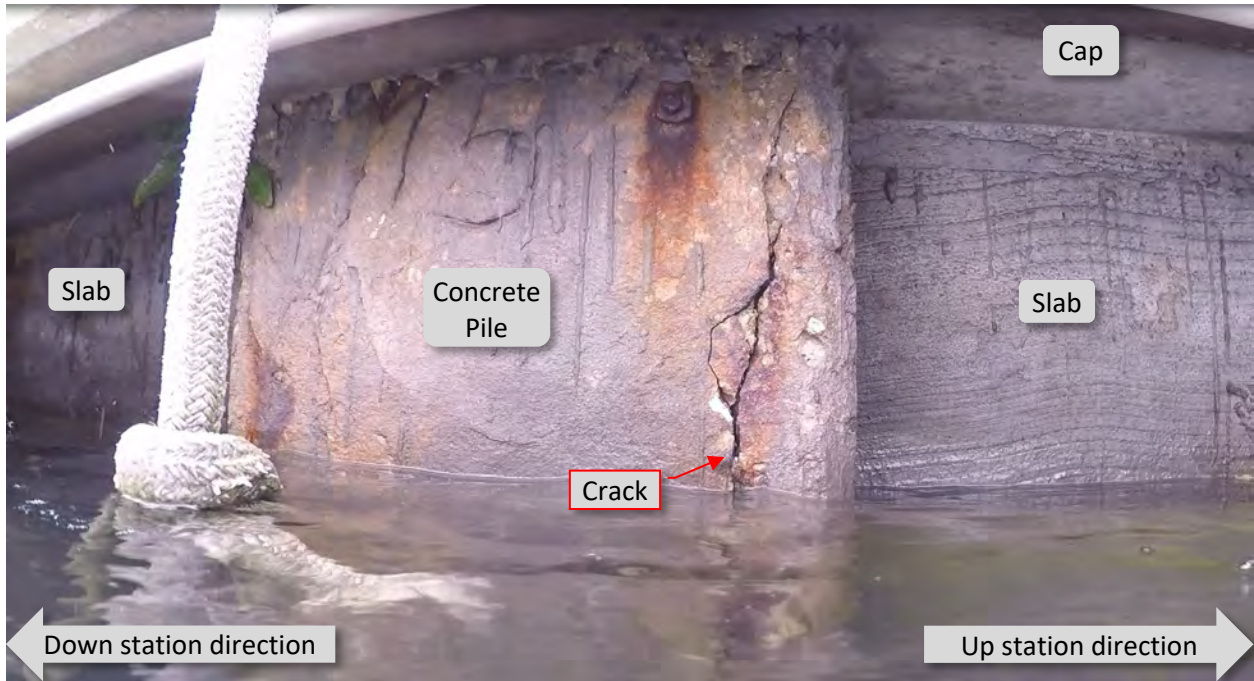
Figure 1: P1. STA 1+23. Crack/spall on pile and corroded anchor bolt. TYPICAL seawall components and direction is shown.

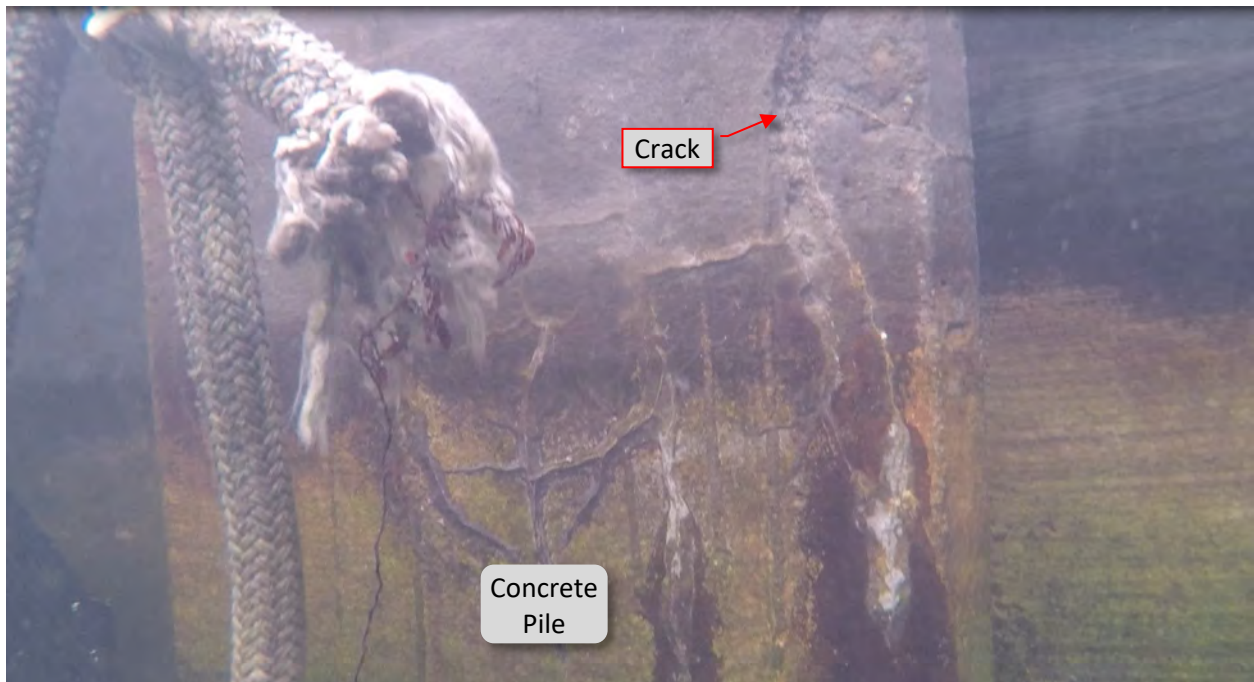
Figure 2: P1. STA 1+23. Crack/spall on pile. Underwater view.

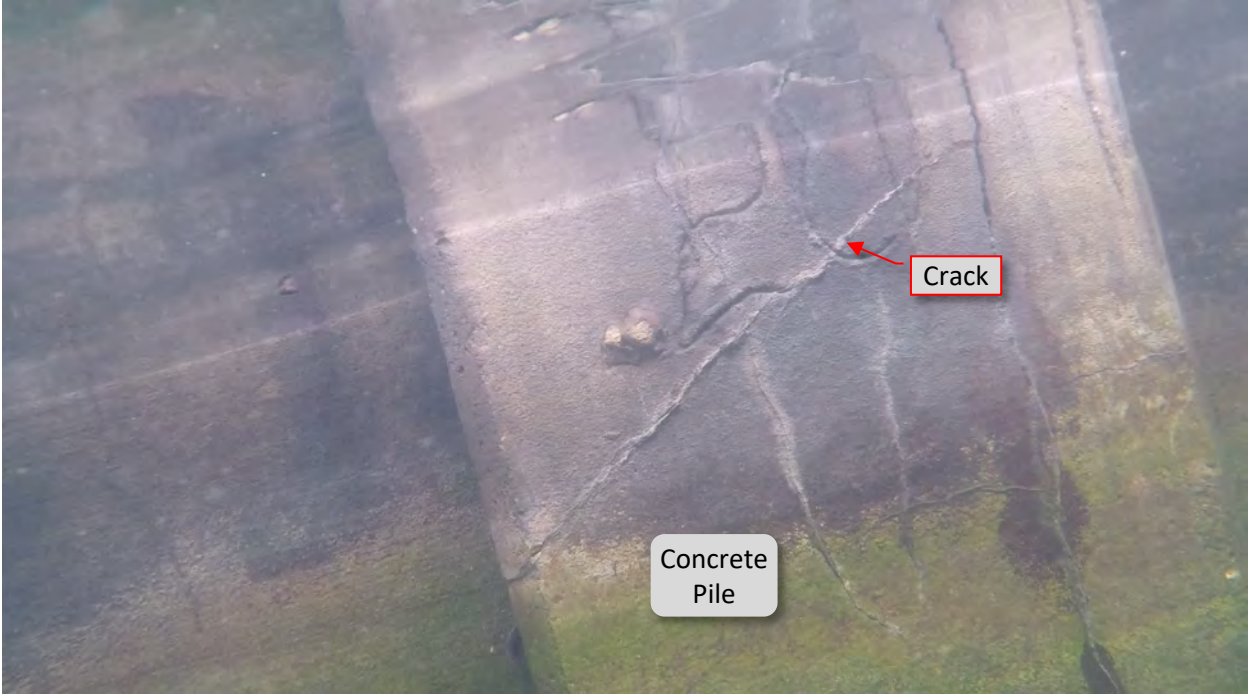
Figure 10: P4. STA 2+35. Multiple cracks and spalls at pile. Underwater view.

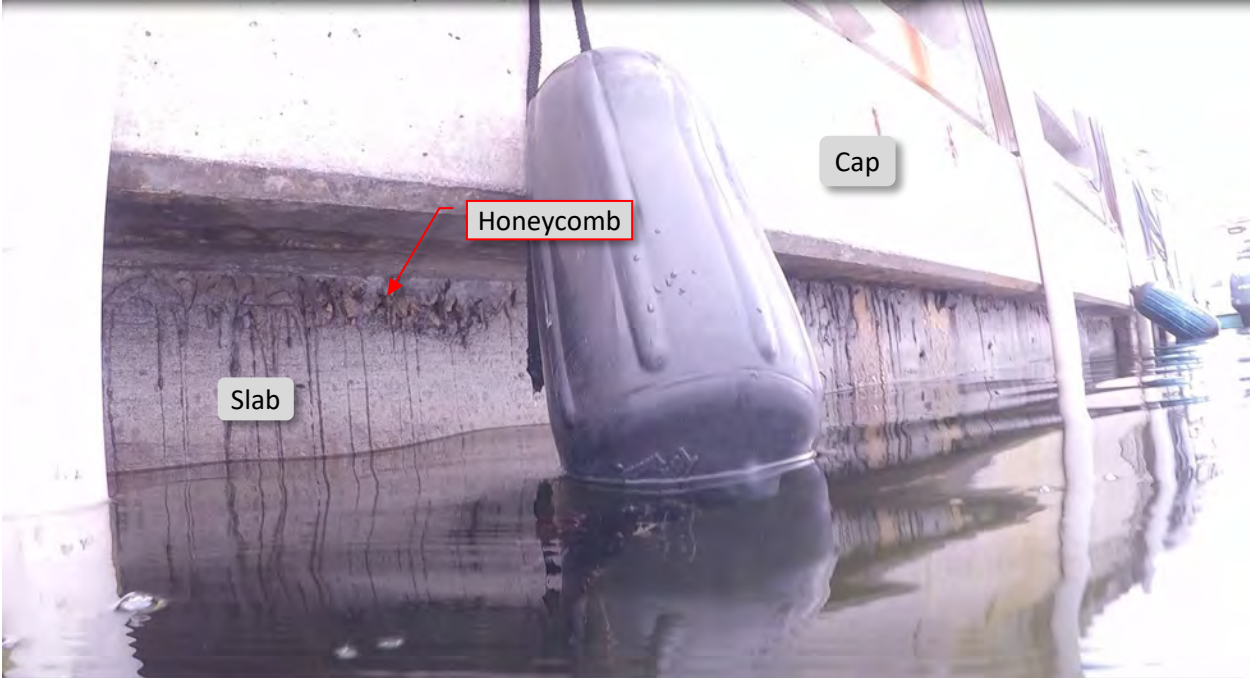
Figure 11: S3. STA 2+38 - 2+41. Concrete erosion at honeycomb area on slab.

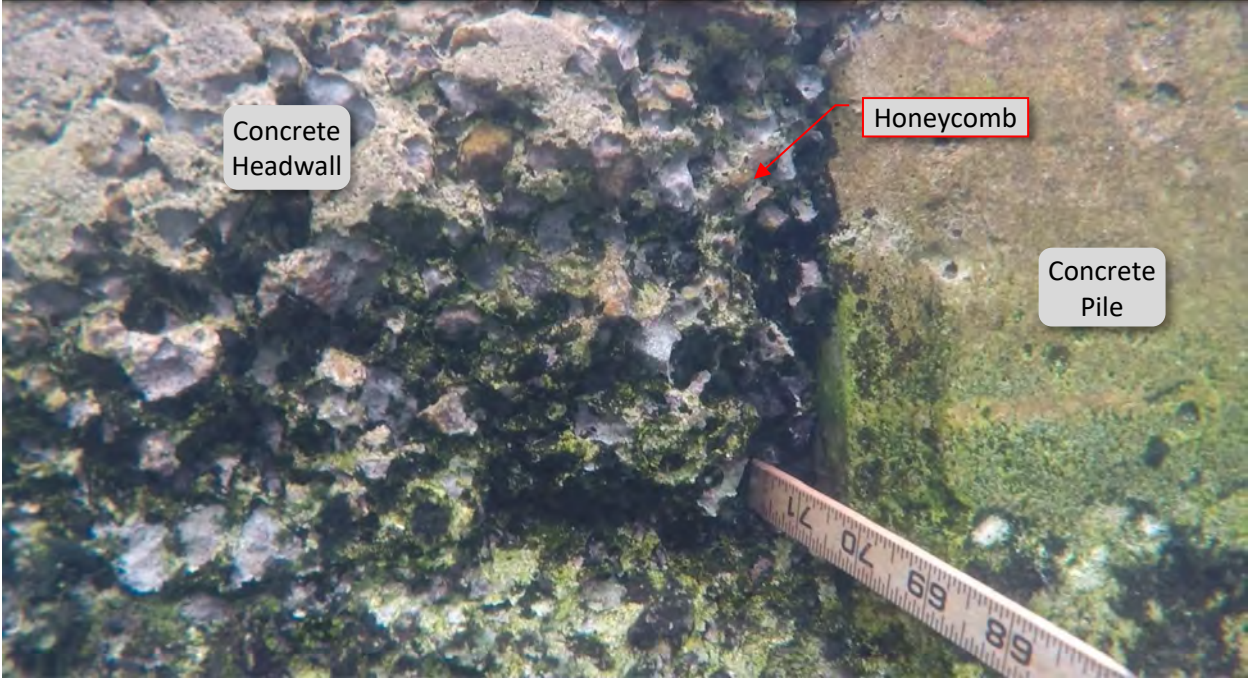
Figure 13: HW1. STA 2+49 - 2+50. Honeycomb depth at culvert headwall.

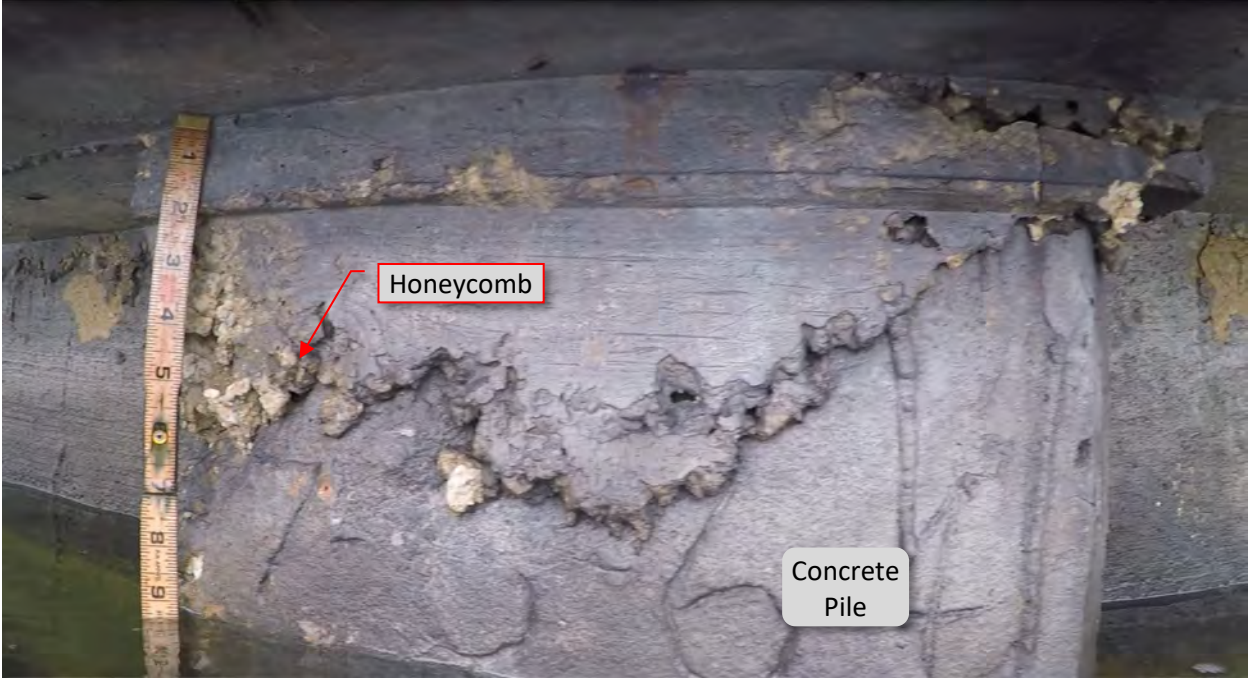
Figure 15: P6. STA 2+76. Honeycomb across the pile top.

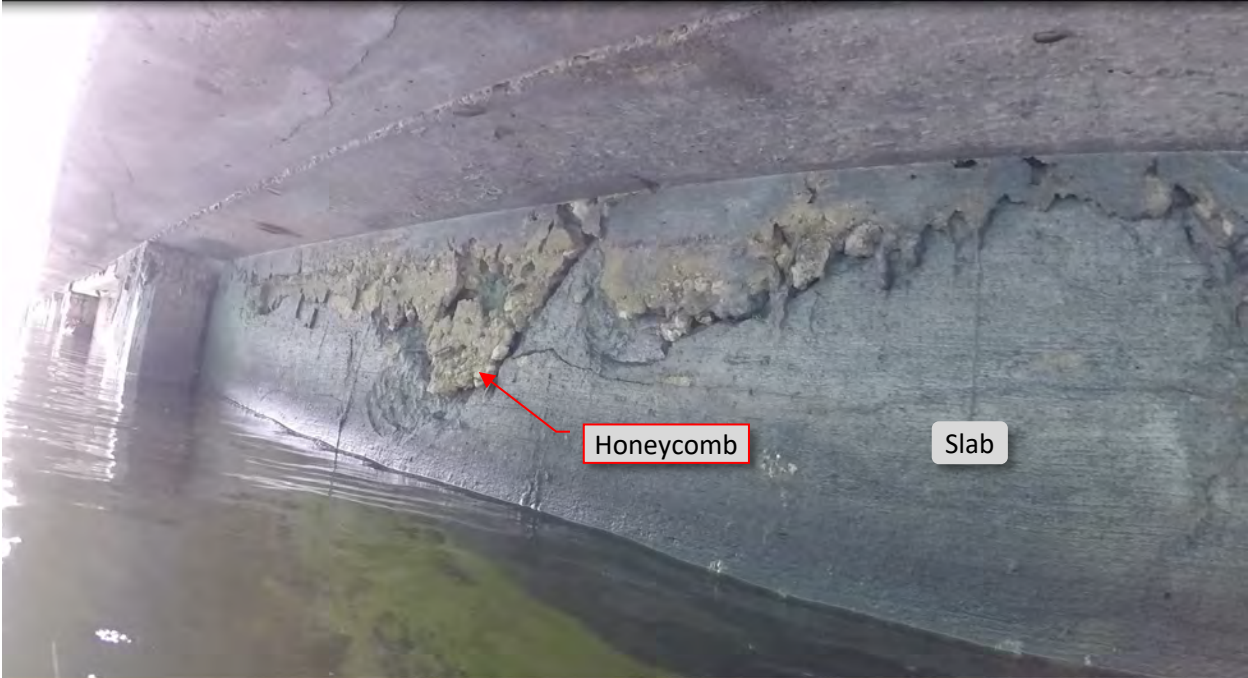
Figure 22: S5. STA 2+93 - 2+99. Honeycomb at top of slab. West direction view.

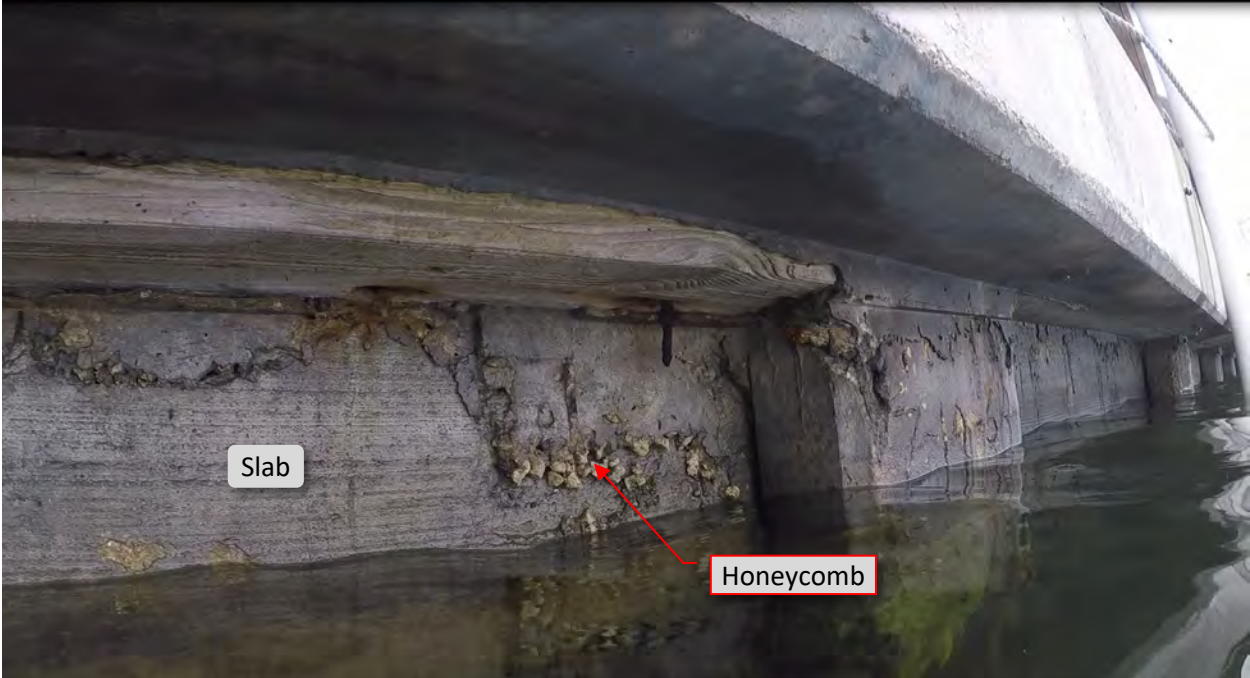
Figure 30: S7. STA 3+21 - 3+23. Honeycomb at slab.

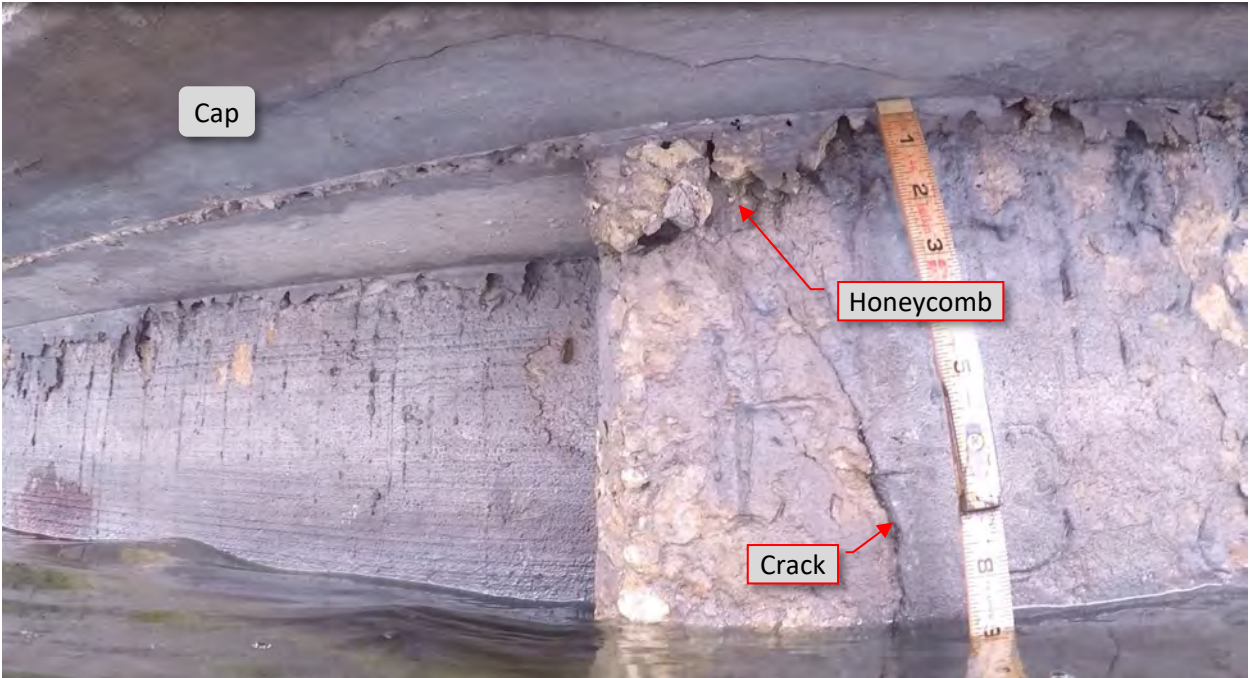
Figure 32: P13. STA 3+31. Crack at west flange at pile. Honeycomb area.

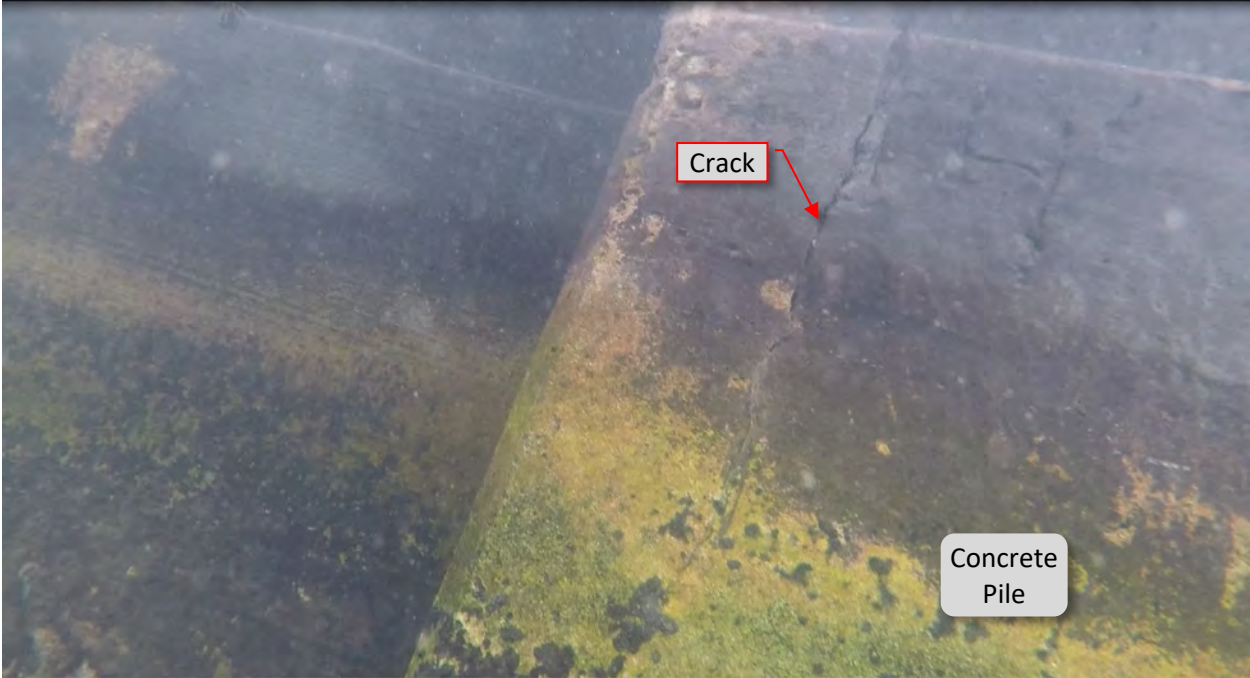
Figure 33: P13. STA 3+31. Crack at west flange at pile. Underwater view.

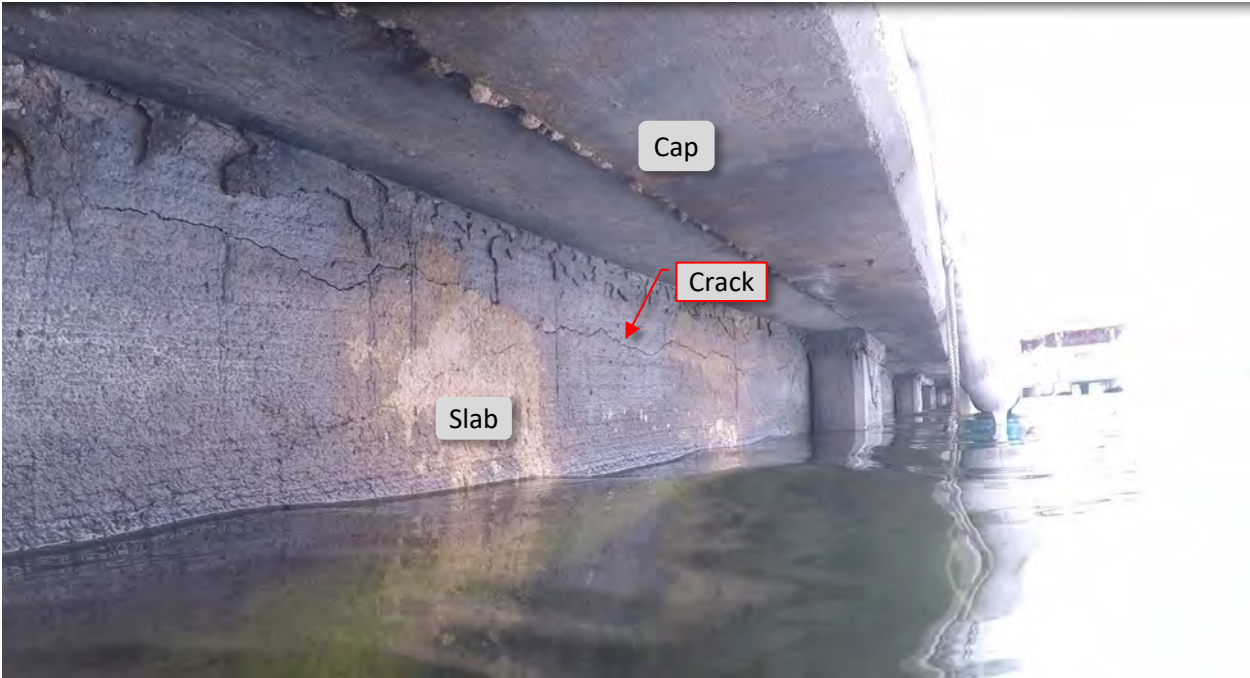
Figure 34: S8. 3+33 - 3+41. Crack/spall at top of slab.

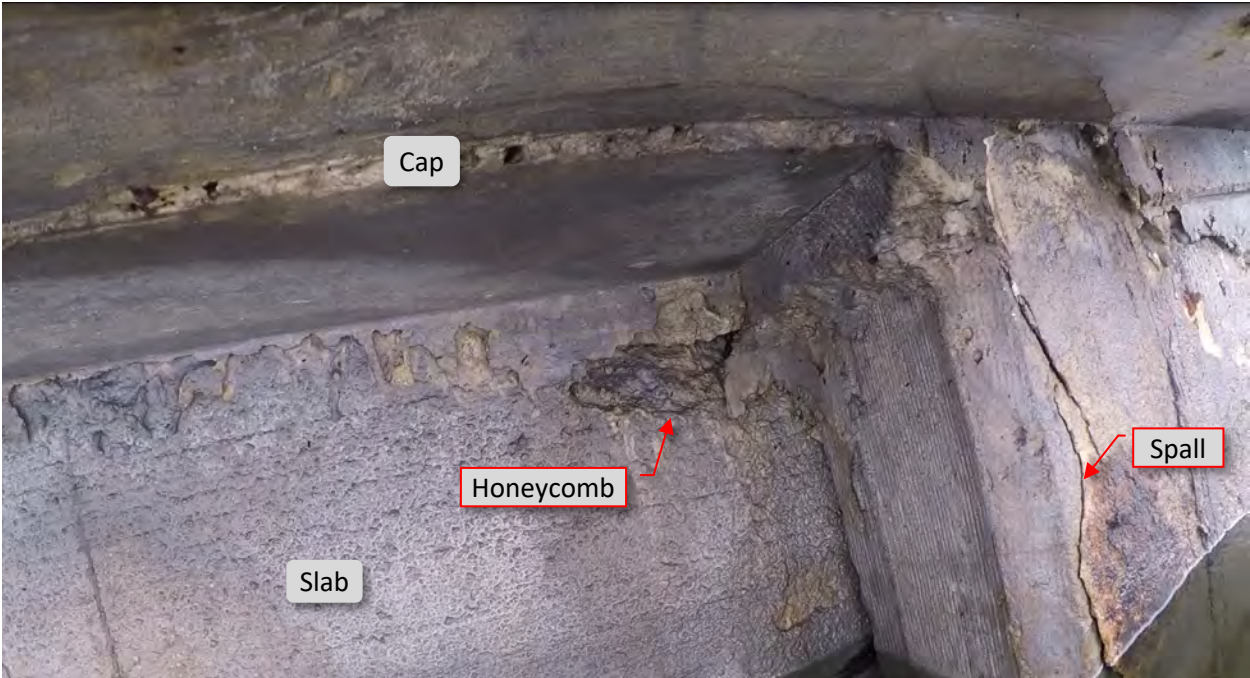
Figure 38: S10. 3+47. Honeycomb area at top east corner of slab. P15. STA 3+48. Crack/spall at west flange at pile.

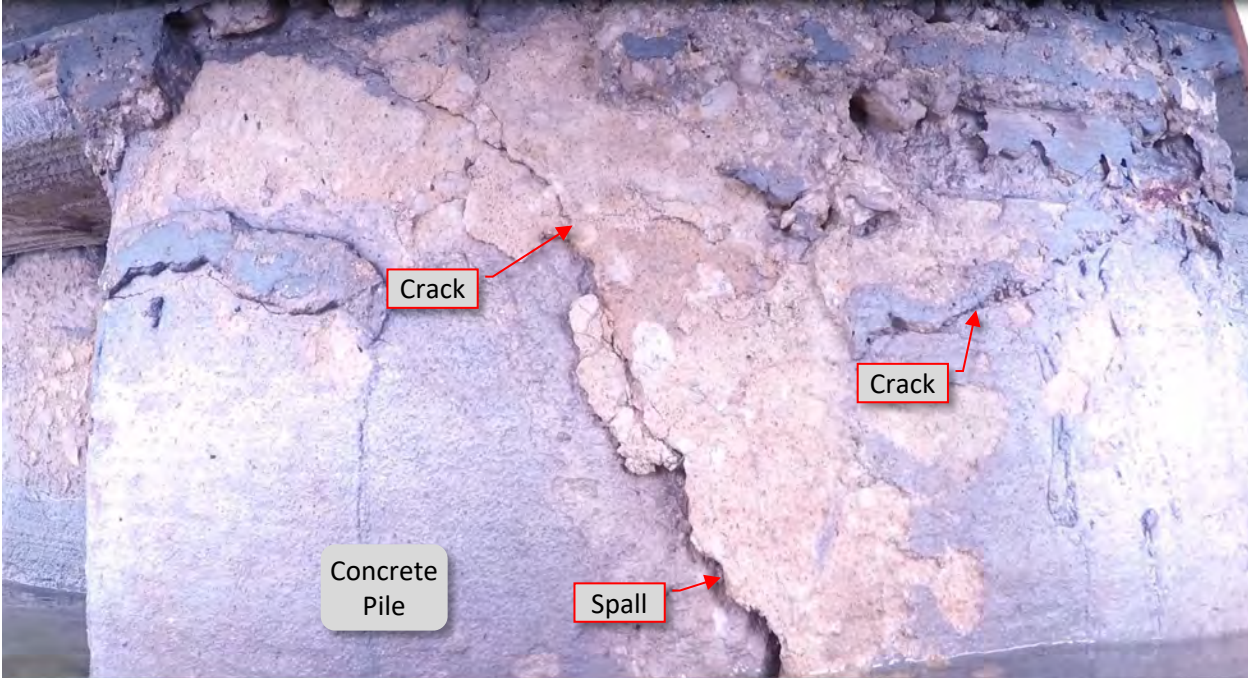
Figure 42: P16. STA 3+56. Spall/crack on south side at pile.

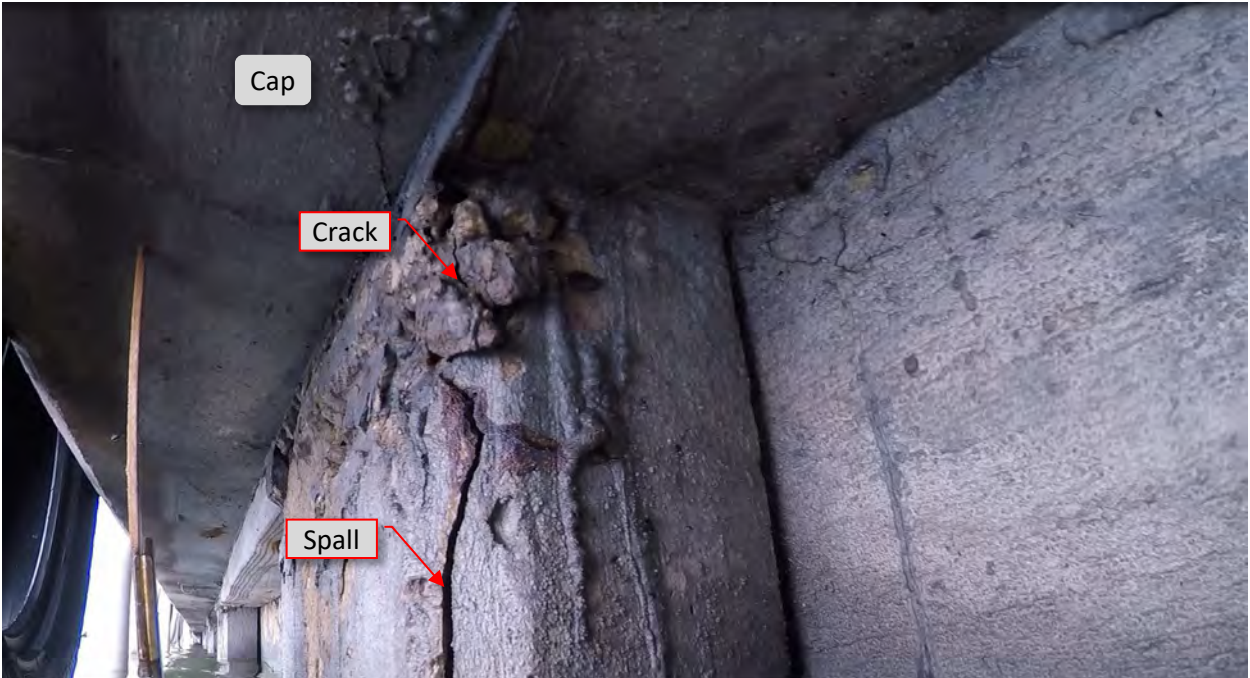
Figure 44: P16. STA 3+56. Spall/crack on south side and near east flange at pile. Honeycomb area at top of pile.

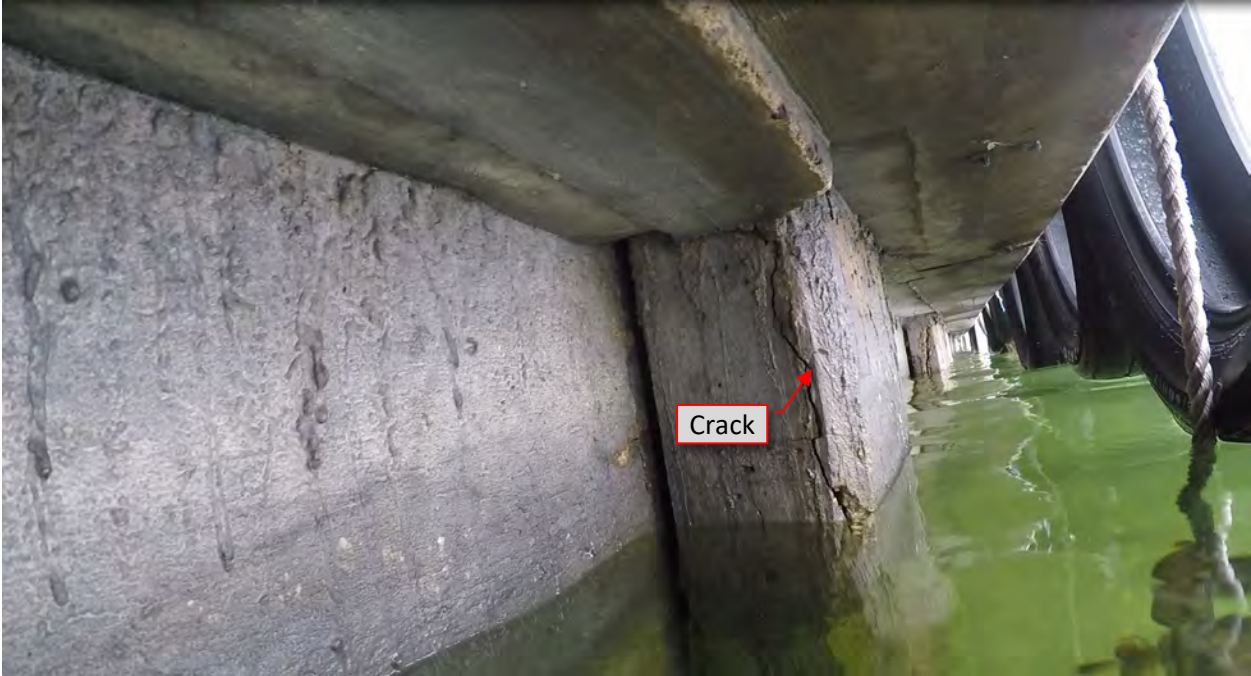
Figure 45: P17. STA 3+63. Crack at west top of flange at pile.

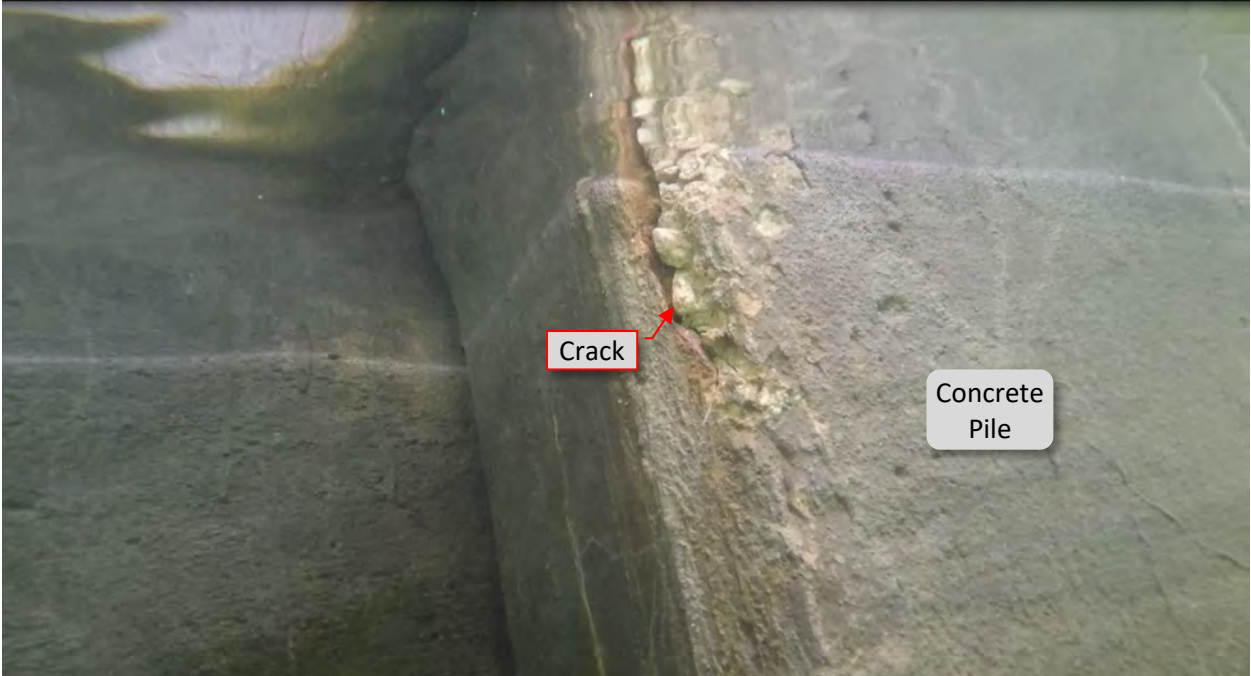
Figure 46: P17. STA 3+63. Crack at west top of flange at pile. Underwater view.

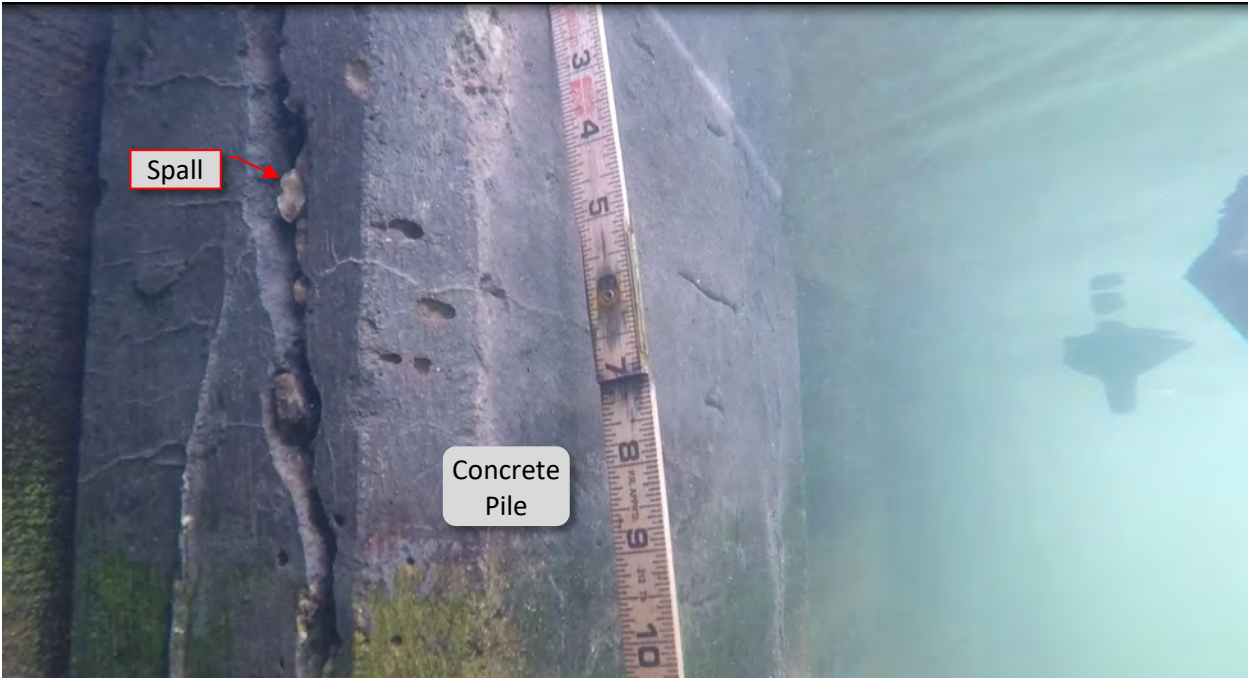
Figure 48: P18. STA 3+71. Spall/crack at west flange at pile. Underwater view.

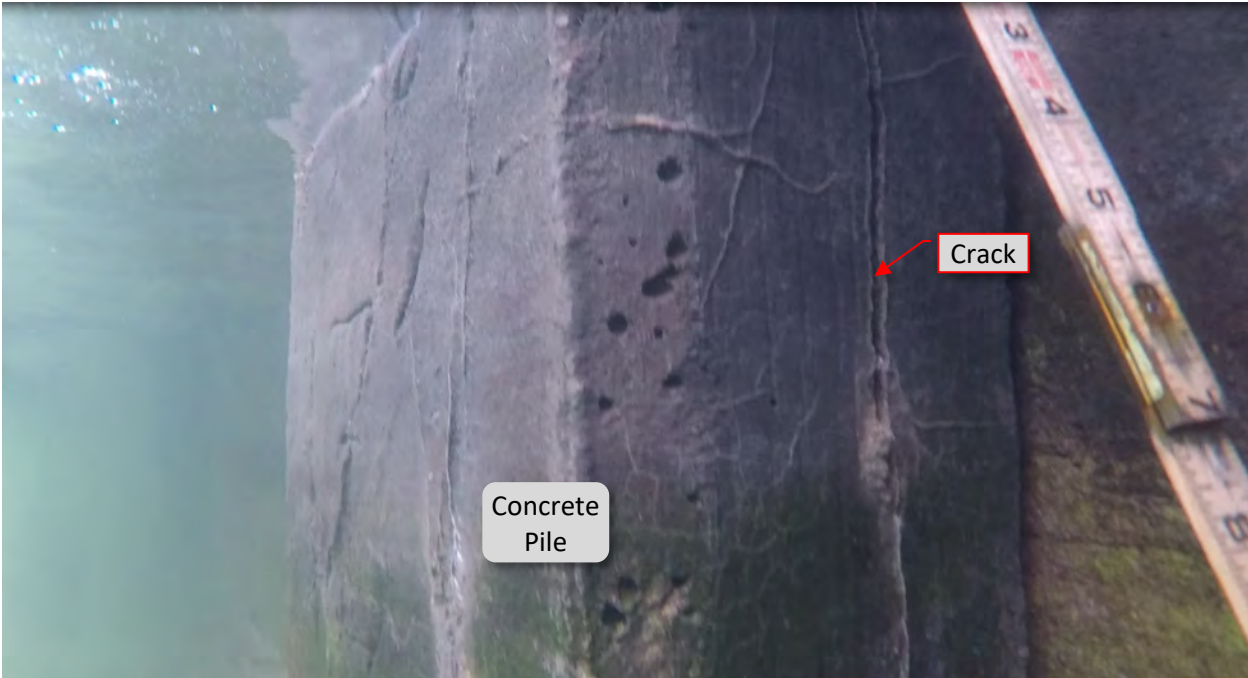
Figure 50: P18. STA 3+71. Crack at east flange at pile. Underwater view.

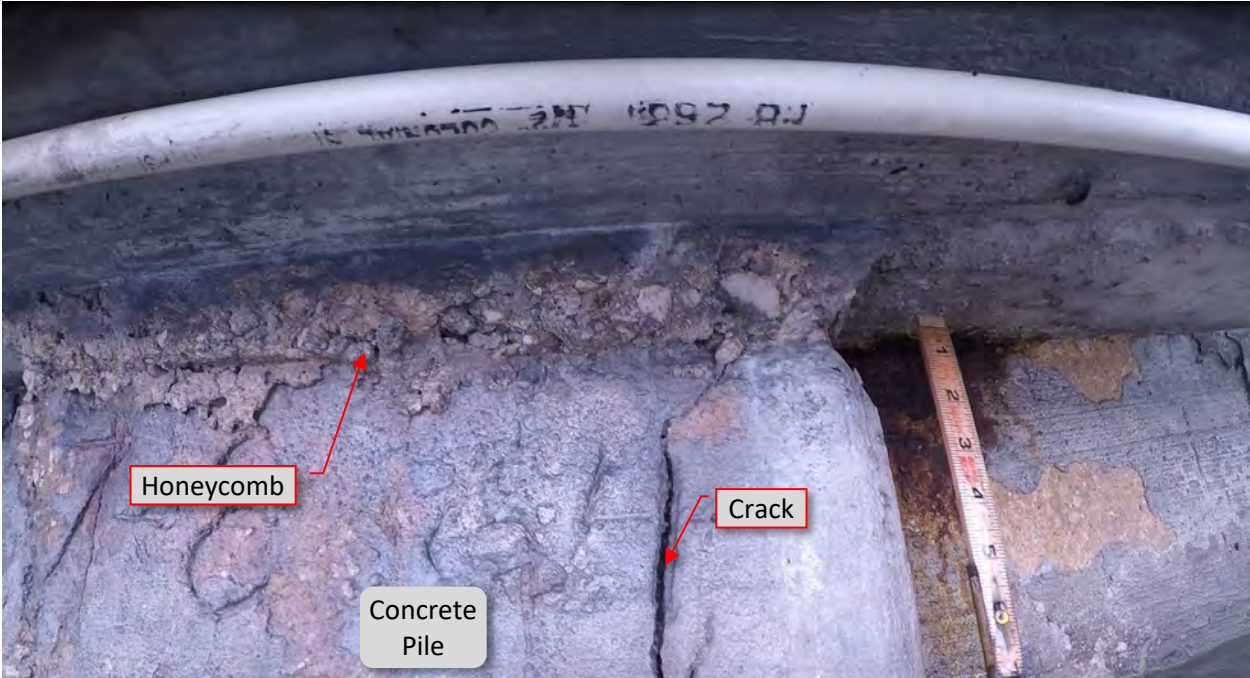
Figure 52: P19. STA 3+96. Crack at east flange at pile. Honeycomb area.

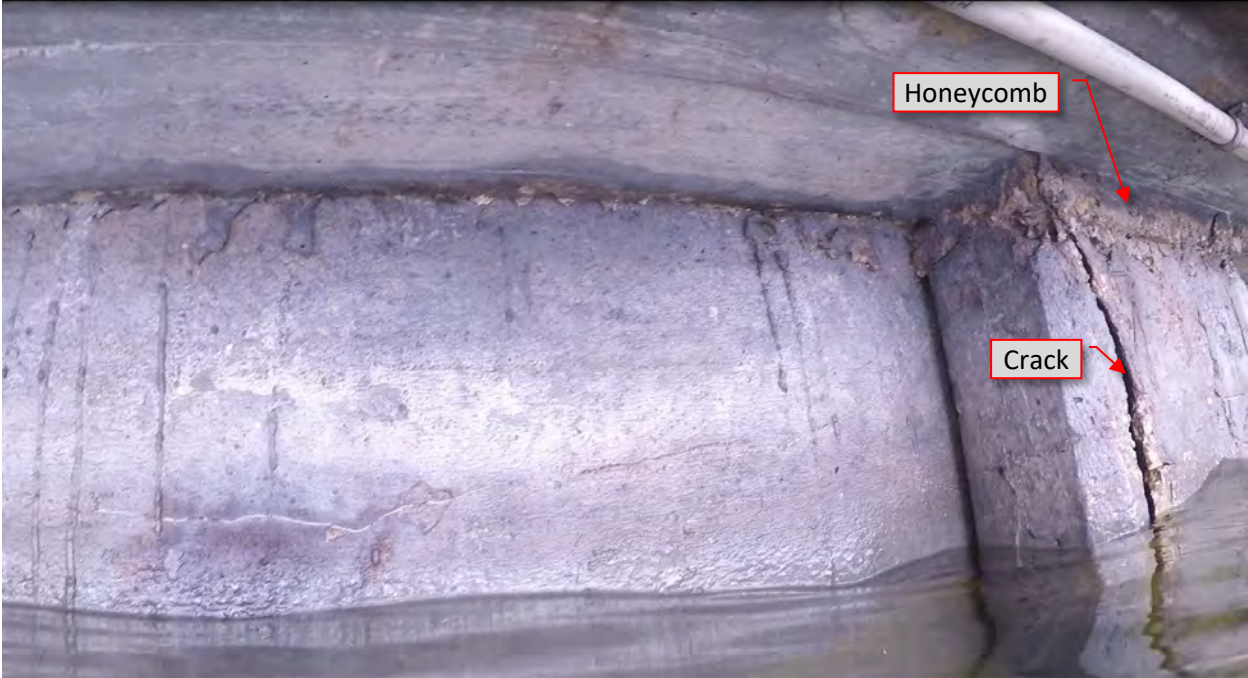
Figure 53: P19. STA 3+96. Crack at west flange at pile. Honeycomb area.

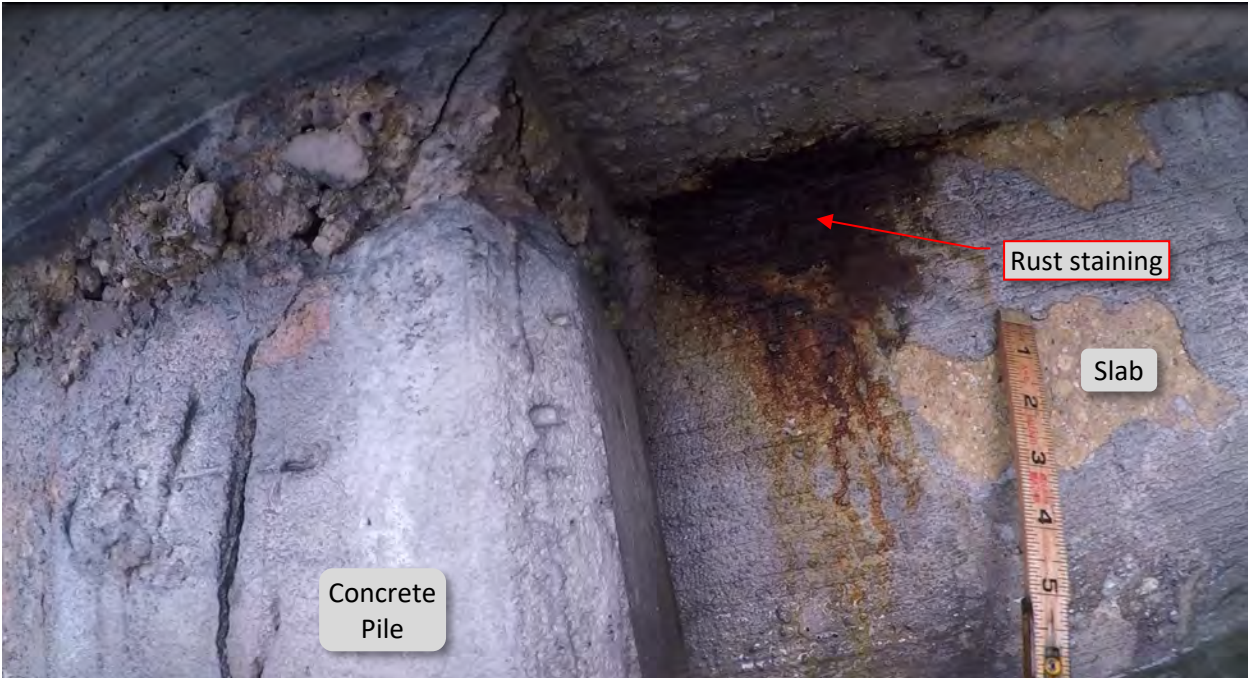
Figure 54: S13. STA 3+97. Rust staining area at top of slab west corner.

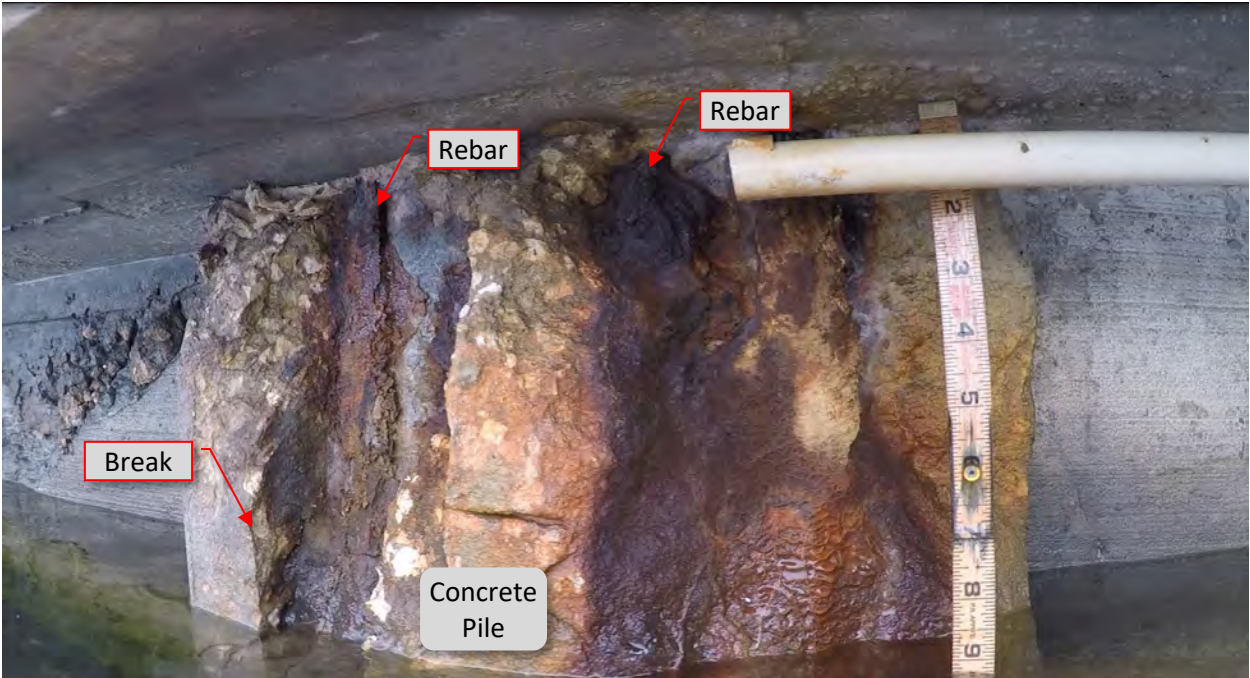
Figure 58: P21. STA 4+12. Break/spall at pile. Loss of concrete and rebar due to corrosion, and rust staining.

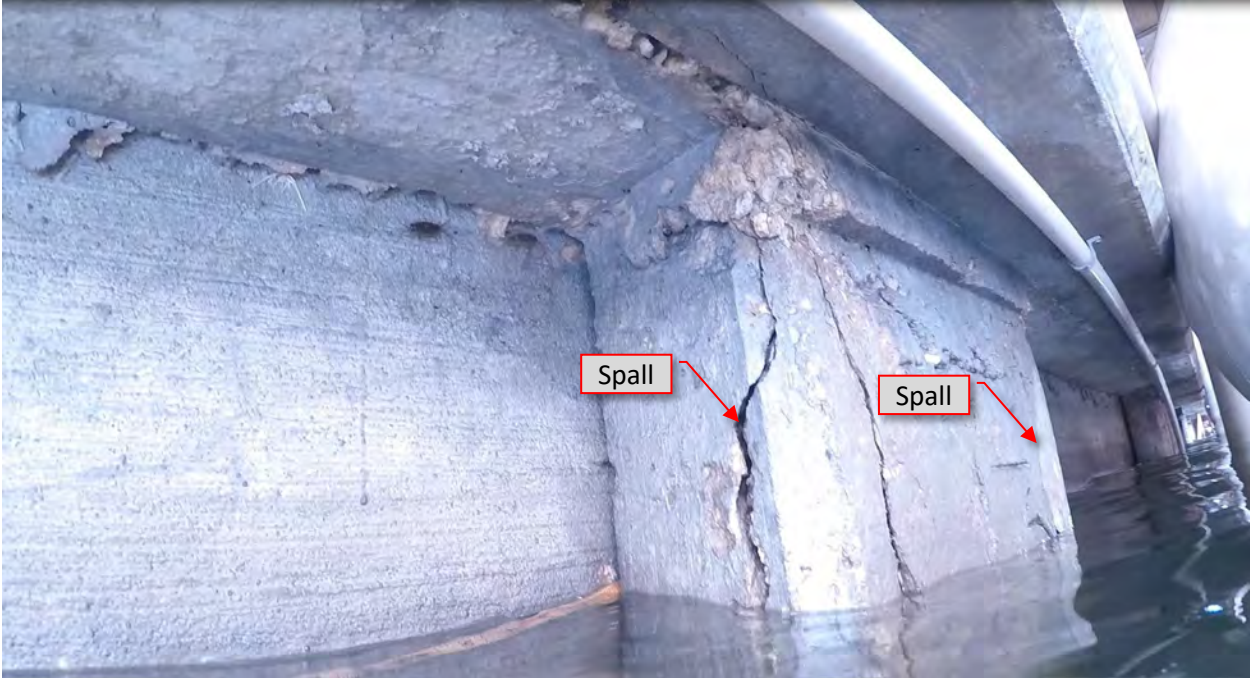
Figure 59: P22. STA 4+20. Break/spall at west and east flanges at pile.
