Subject: Key West Angelfish Pier Seawall Structural Assessment

CITY OF KEY WEST
PORT & MARINE SERVICES

KEY WEST GARRISON BIGHT MARINA
ANGELFISH PIER SEAWALL STRUCTURAL ASSESSMENT REPORT

Prepared By:
Tetra Tech, Inc.
759 South Federal Highway, Suite 314
Stuart, FL 34994

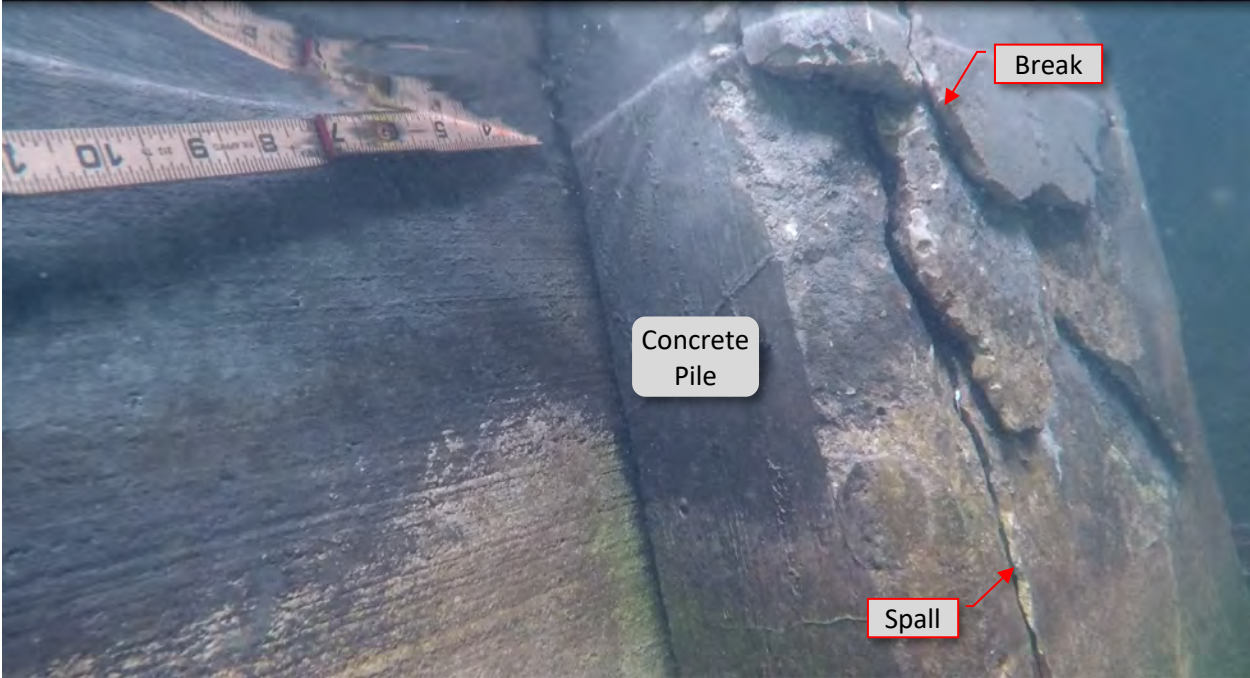
Figure 60: P22. STA 4+20. Break/spall at west and east flanges at pile. Loss of concrete. Underwater view.

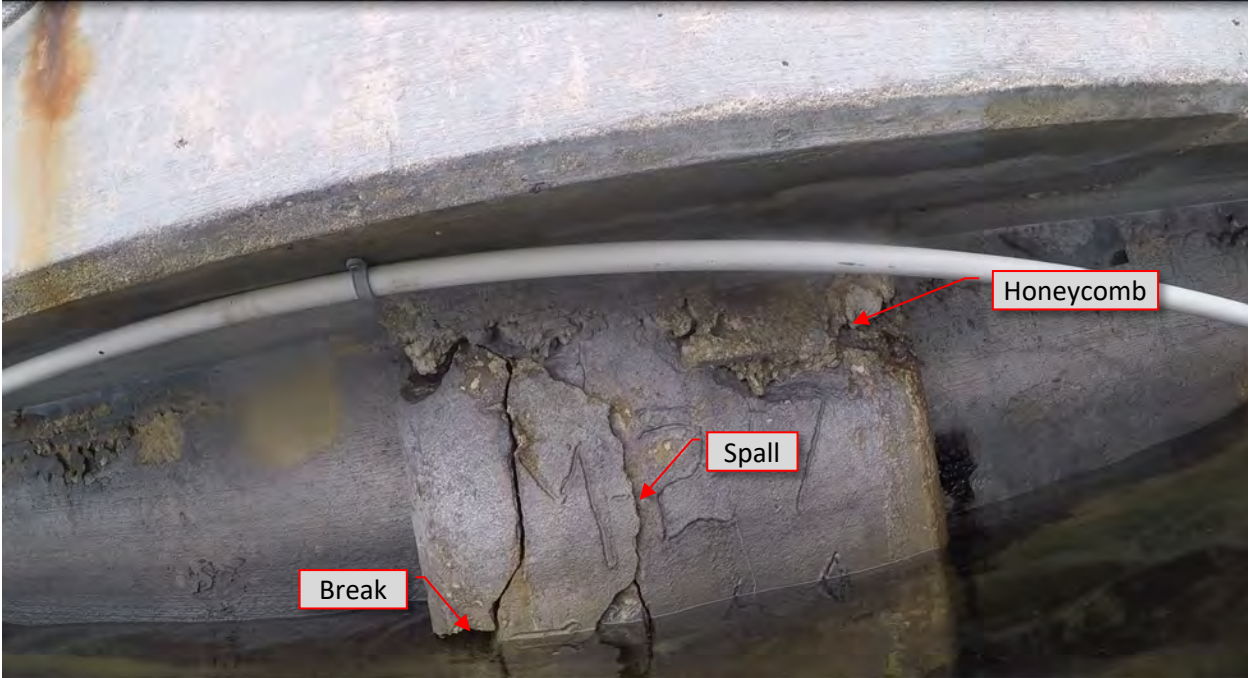
Figure 68: P25. STA 4+44. Breaks/spalls at both flanges at pile. Loss of concrete. Honeycomb area.

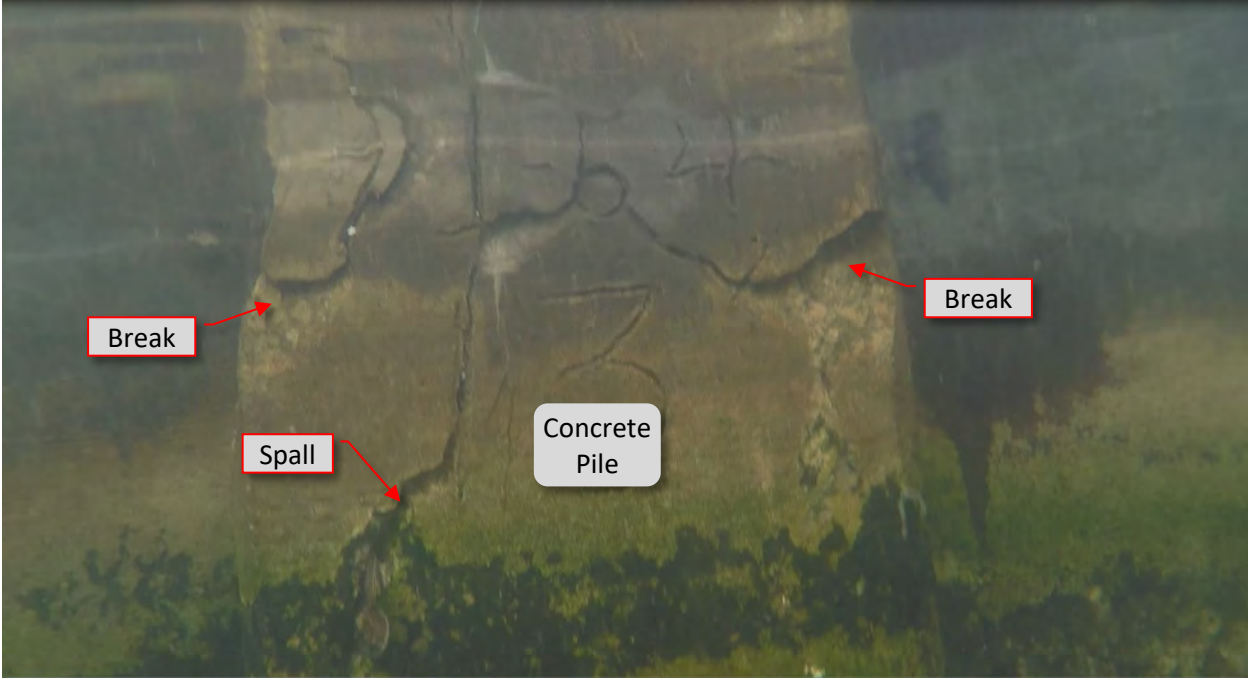
Figure 69: P25. STA 4+44. Breaks/spalls at both flanges at pile. Loss of concrete. Honeycomb area. Underwater view.

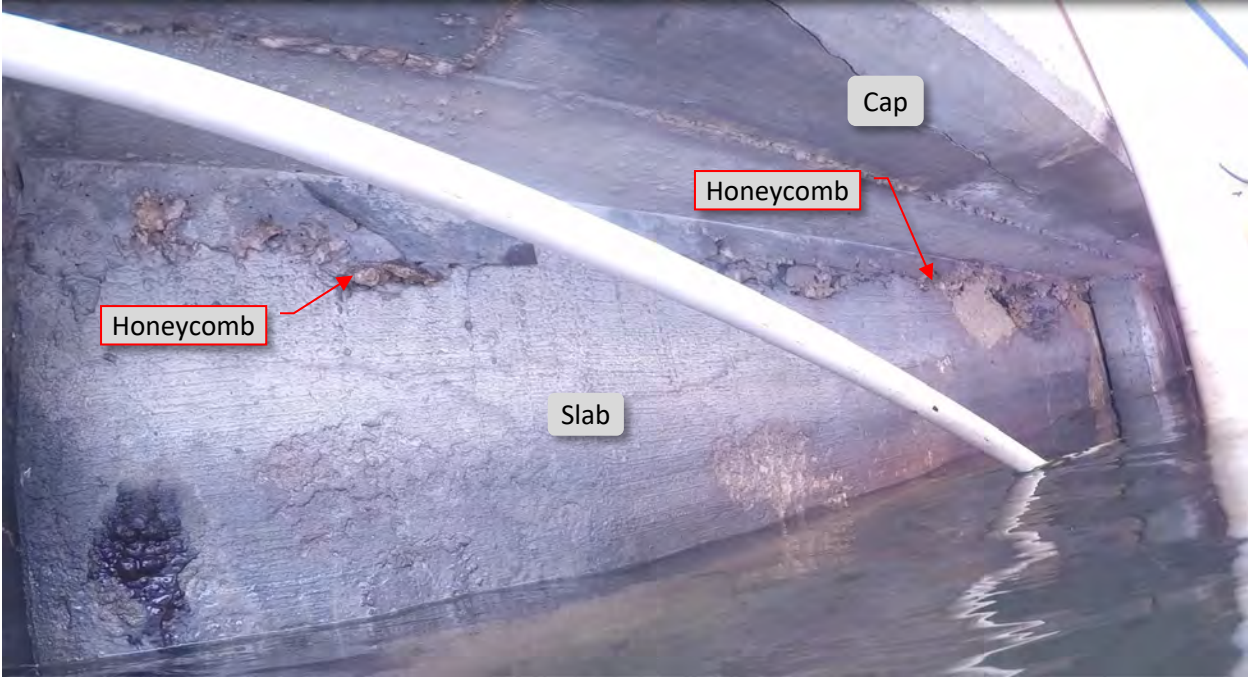
Figure 70: S17. STA 4+45 – 4+52. Honeycomb area along the top of slab.

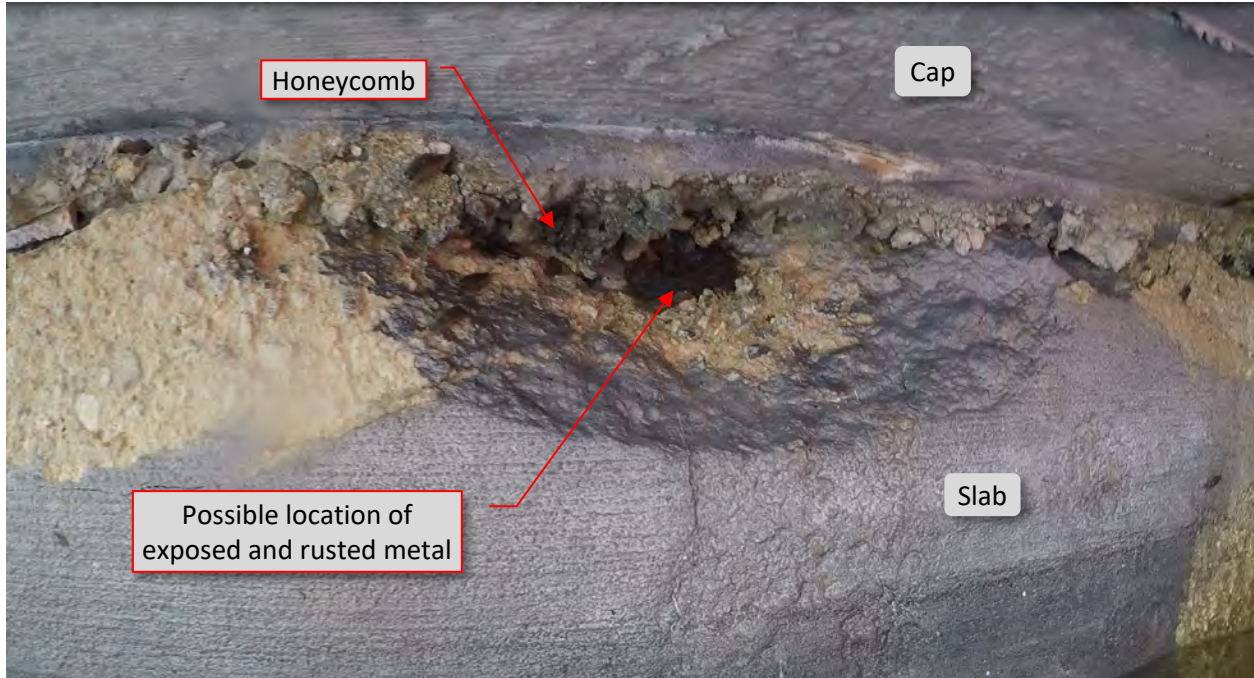
Figure 71: S17. STA 4+45 - 4+52. Honeycomb area at top of slab and presumed location of exposed metal.

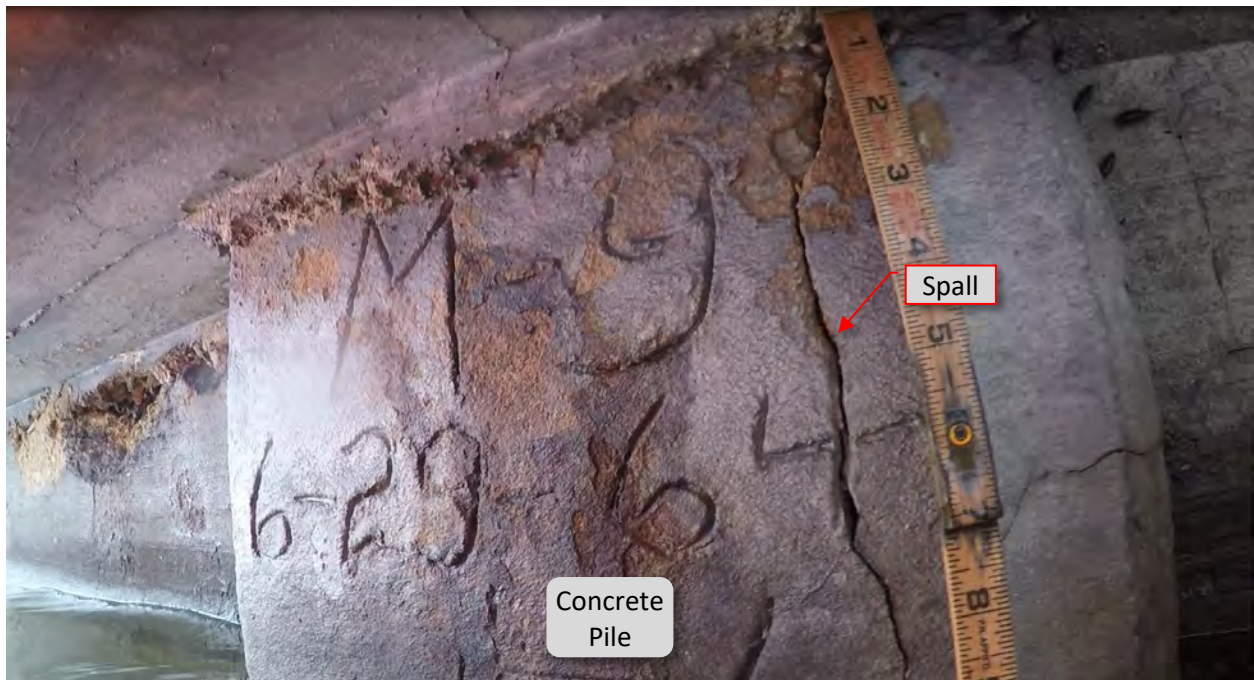
Figure 72: P26. STA 4+53. Breaks/spalls at both flanges at pile. Honeycomb area.

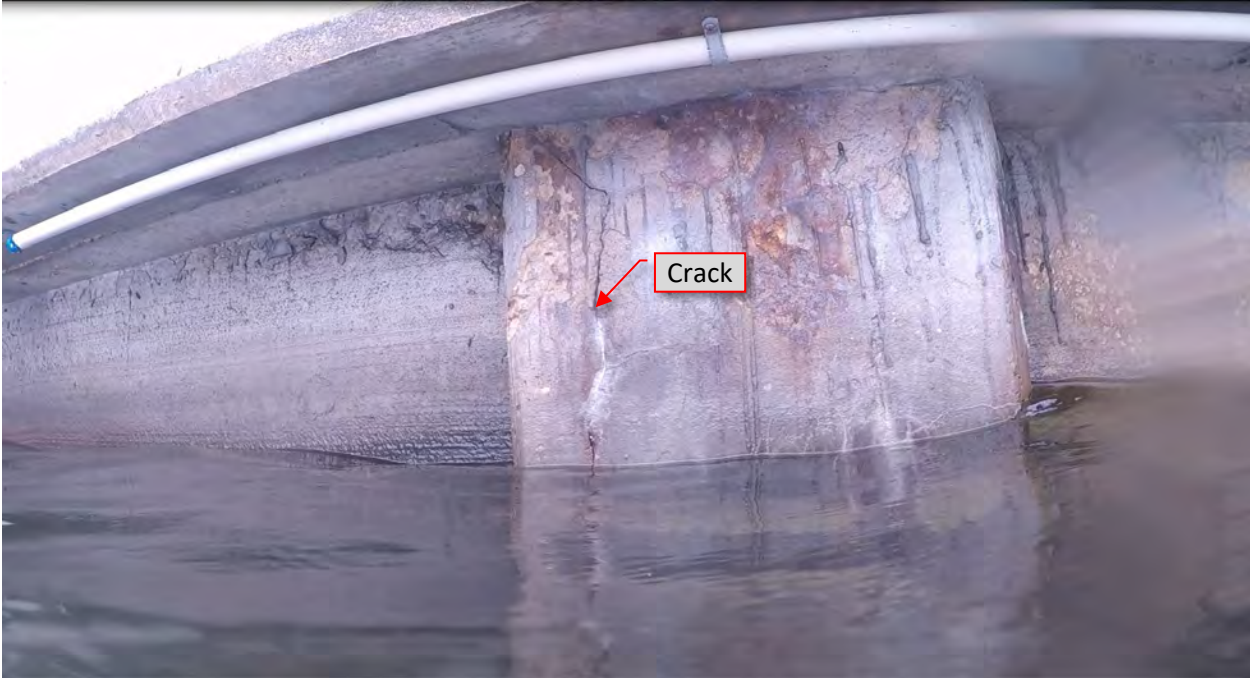
Figure 77: P28. STA 4+67. Crack at top of west flange with rust staining.

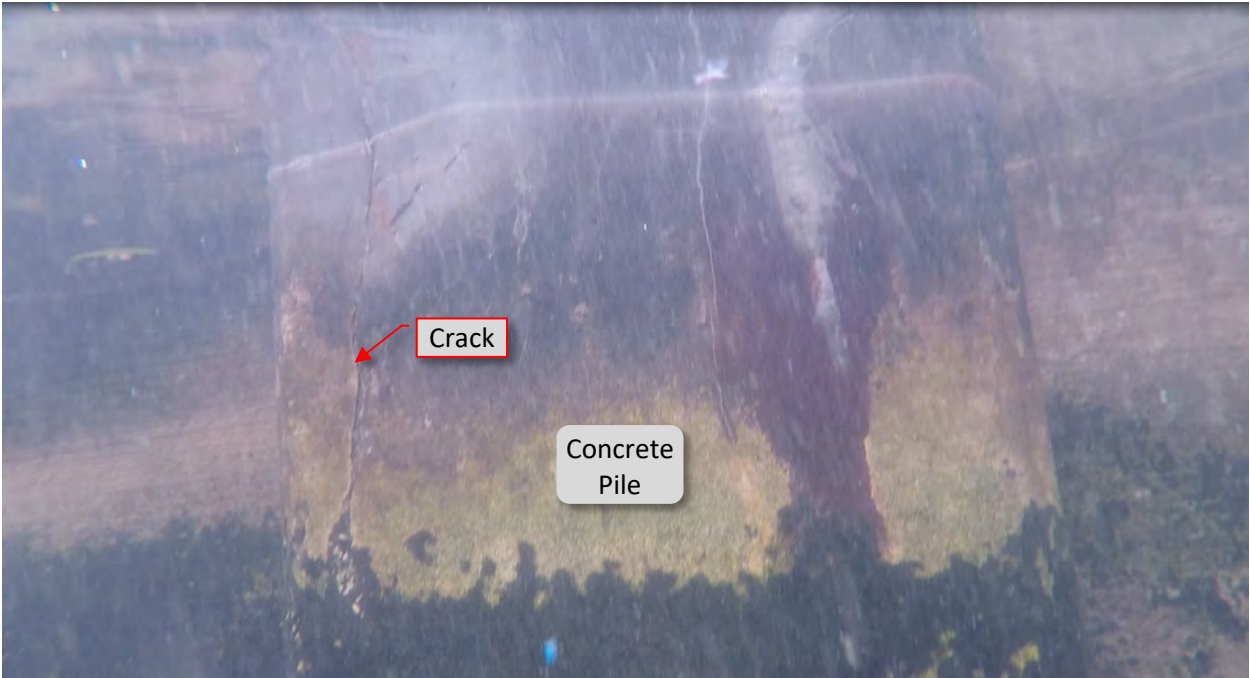
Figure 78: P28. STA 4+67. Crack at top of west flange with rust staining. Underwater view.

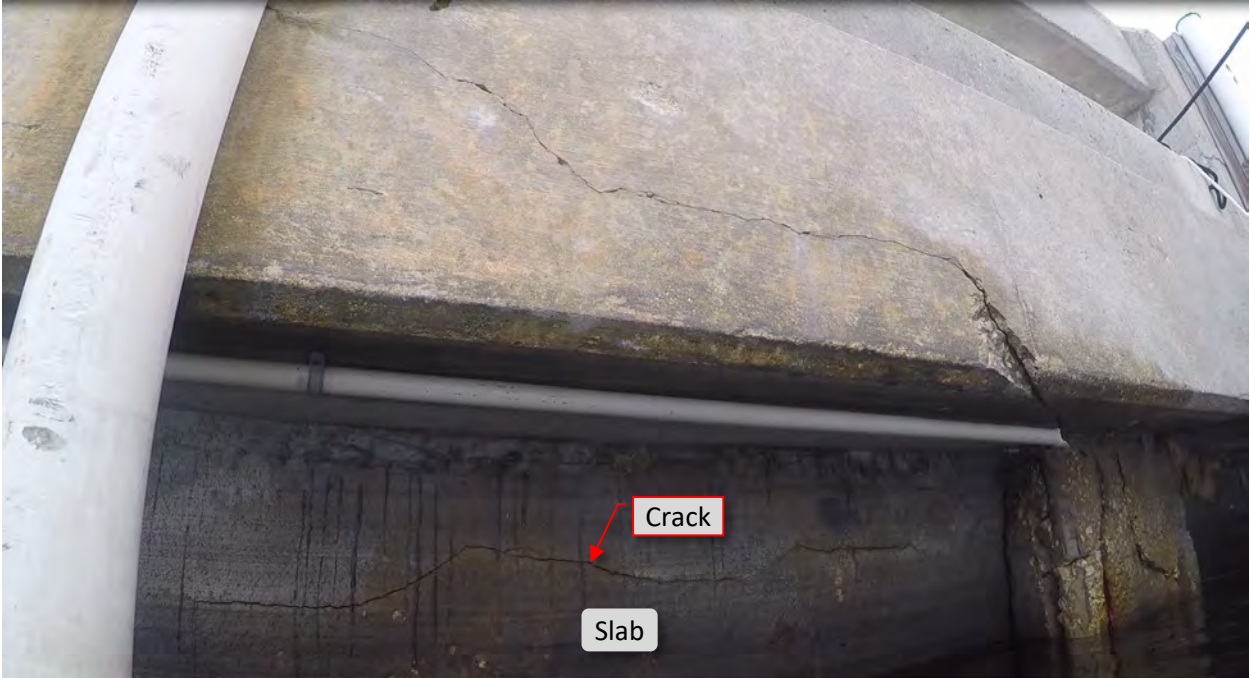
Figure 80: S20. STA 4+84 - 4+90. Crack at top of slab. View of mid to east span of slab.

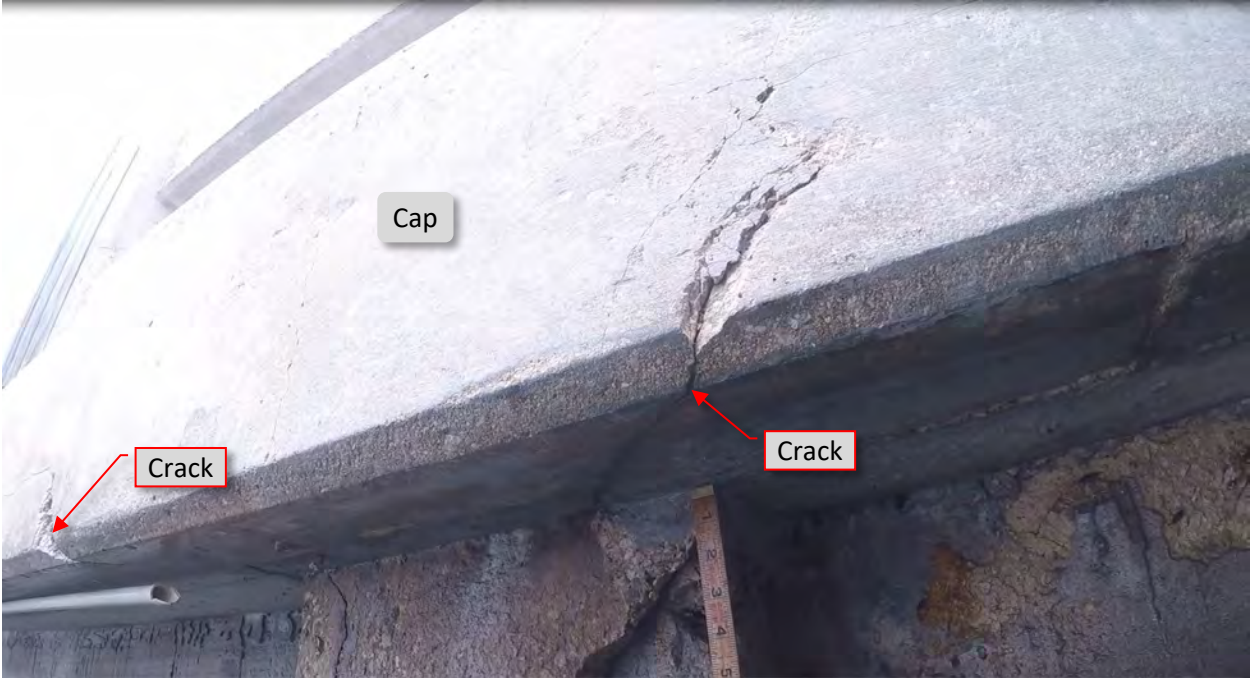
Figure 81: C1. STA 4+84 - 4+93. Two cracks spalled west and east direction on cap from pile's top.

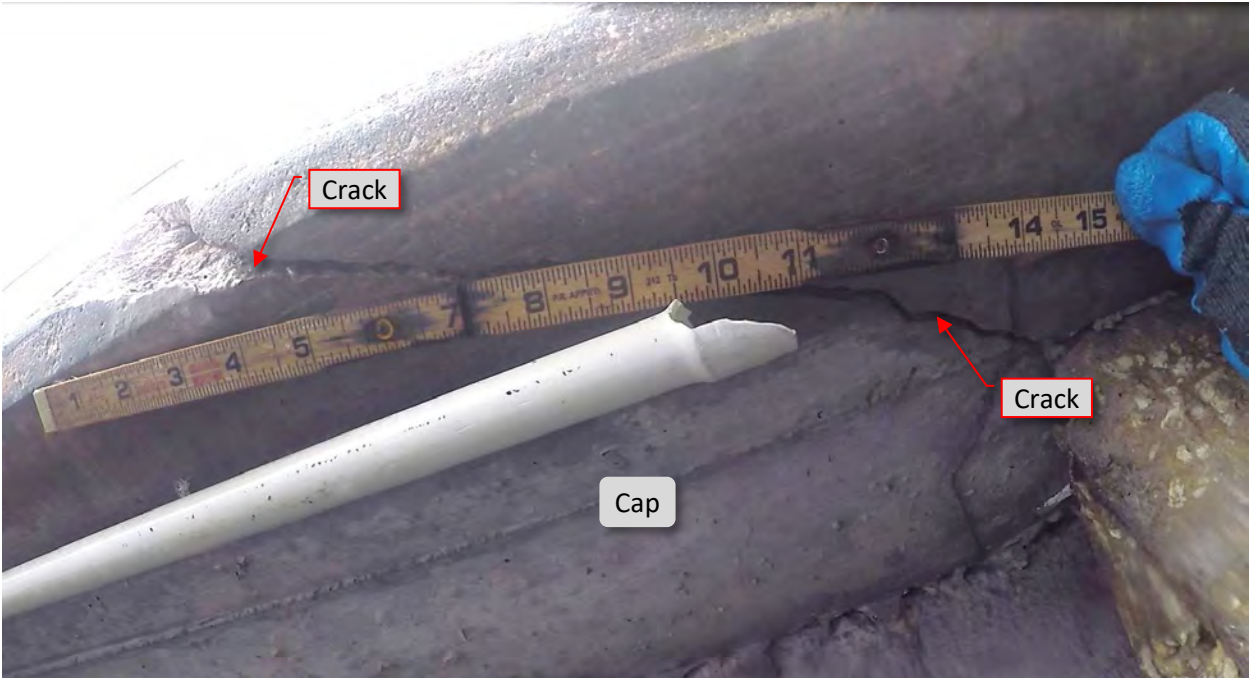
Figure 82: C1. STA 4+84 - 4+93. One crack spalled west direction on cap from pile's top.

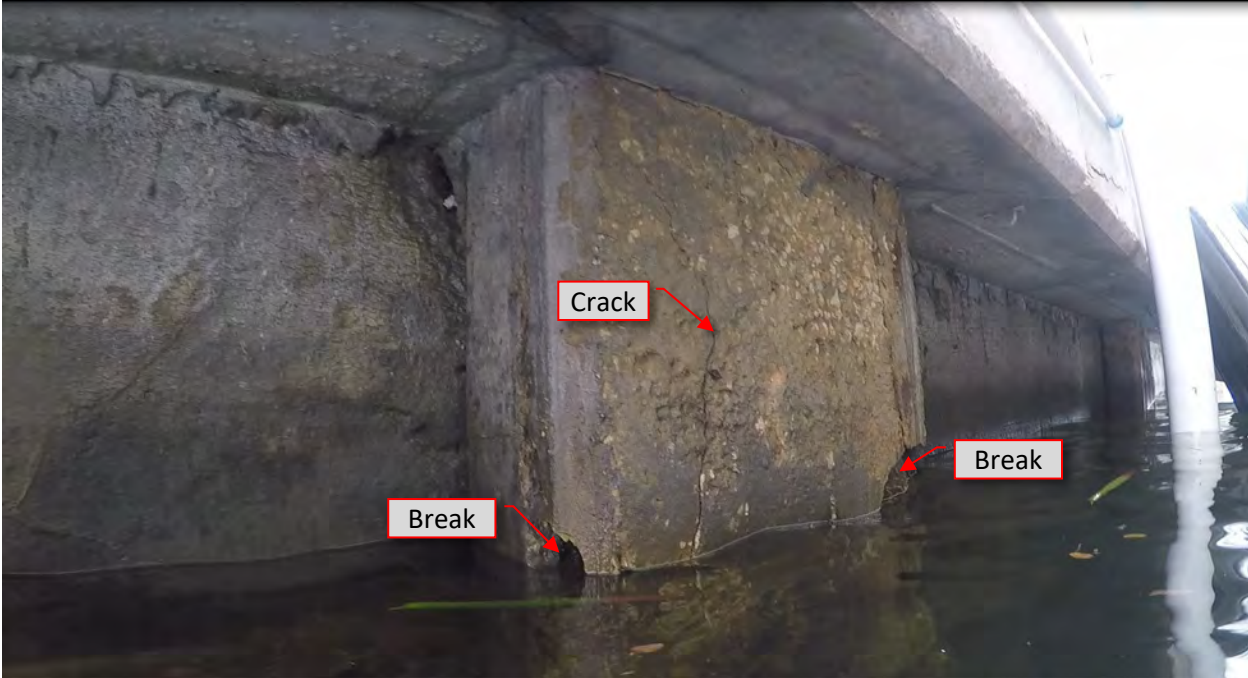
Figure 88: P30. STA 5+00. Cracks/spalls at both flanges at pile and loss of concrete.

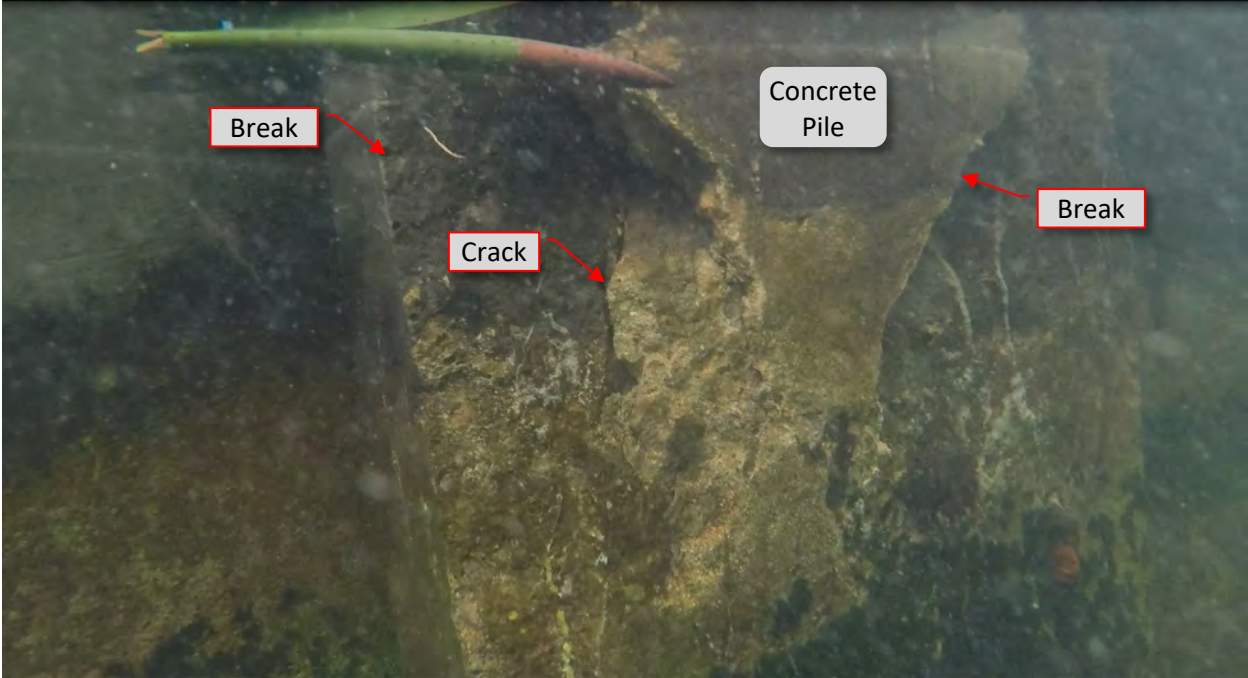
Figure 89: P30. STA 5+00. Cracks/spalls at both flanges and loss of concrete. Underwater view.

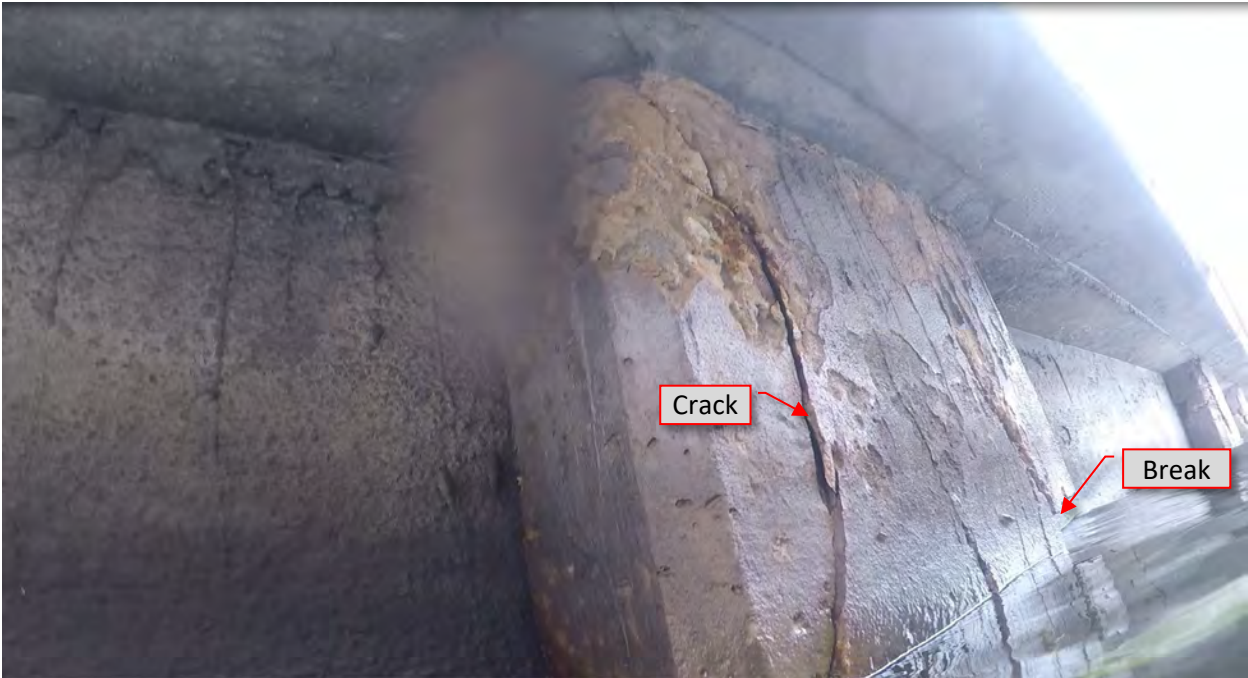
Figure 90: P31. STA 5+08. Cracks/spalls at both flanges at pile and loss of concrete.

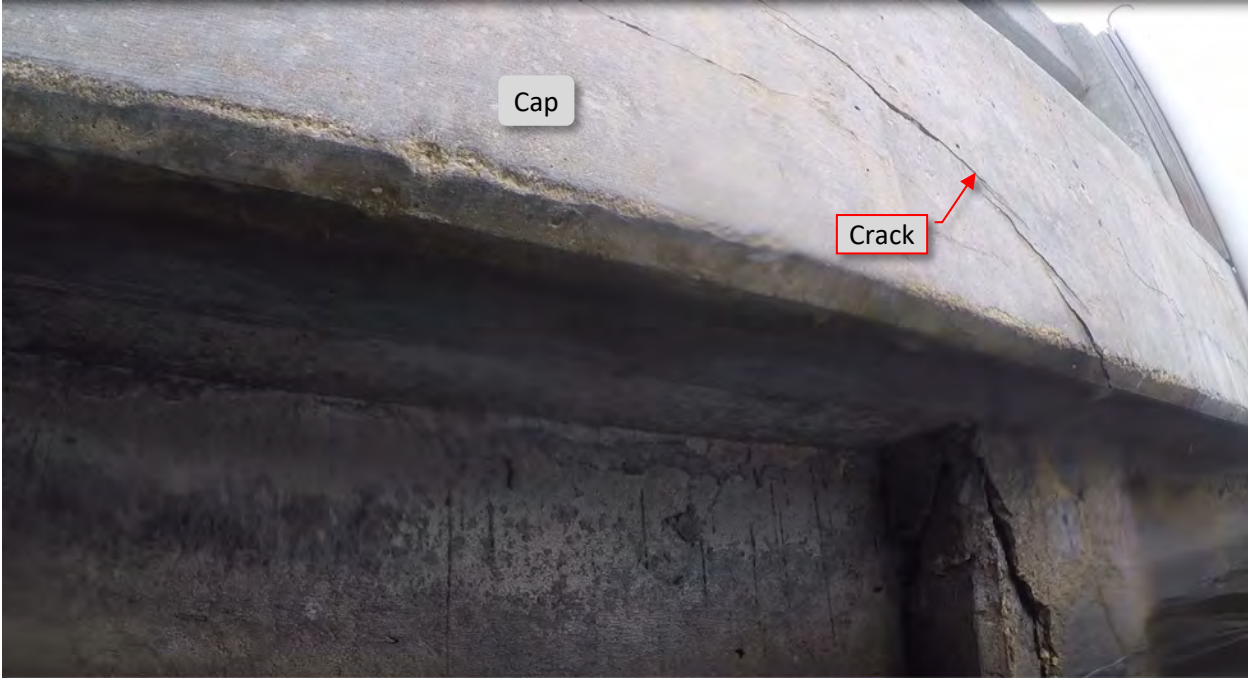
Figure 92: C4. STA 5+11 - 5+16. Crack on cap's south face.

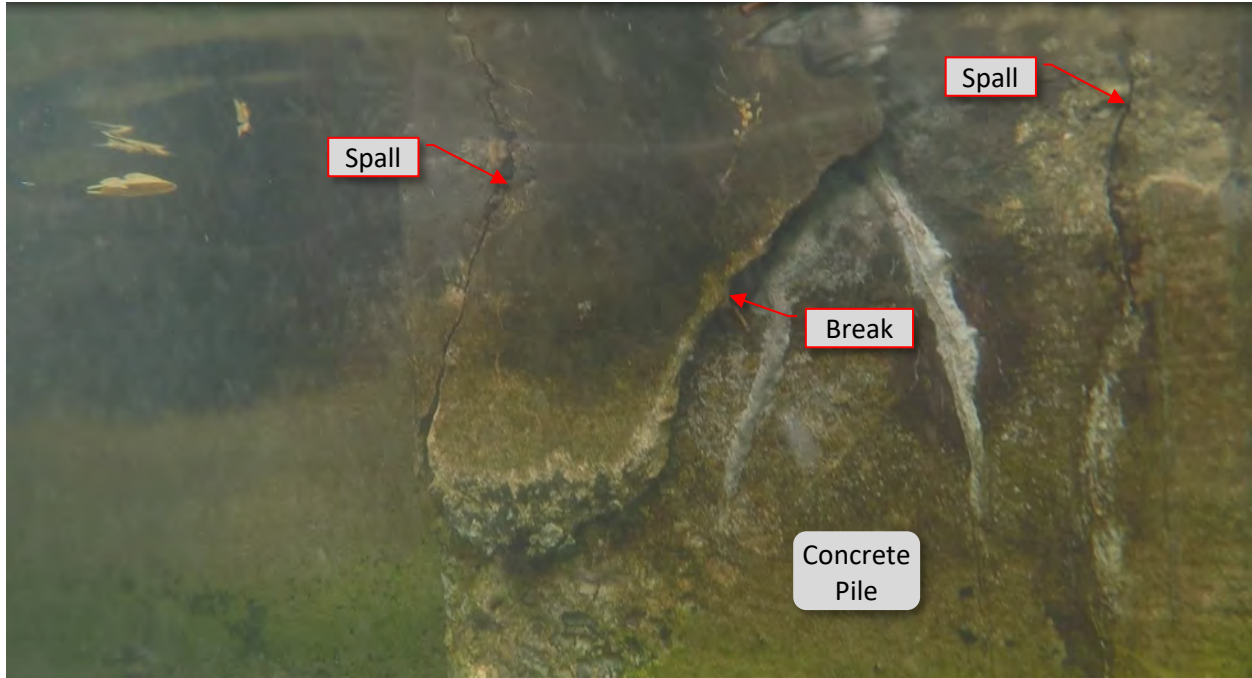
Figure 95: P32. STA 5+16. Cracks/spalls at west flange and south face, loss of concrete, and rust staining. Underwater view.

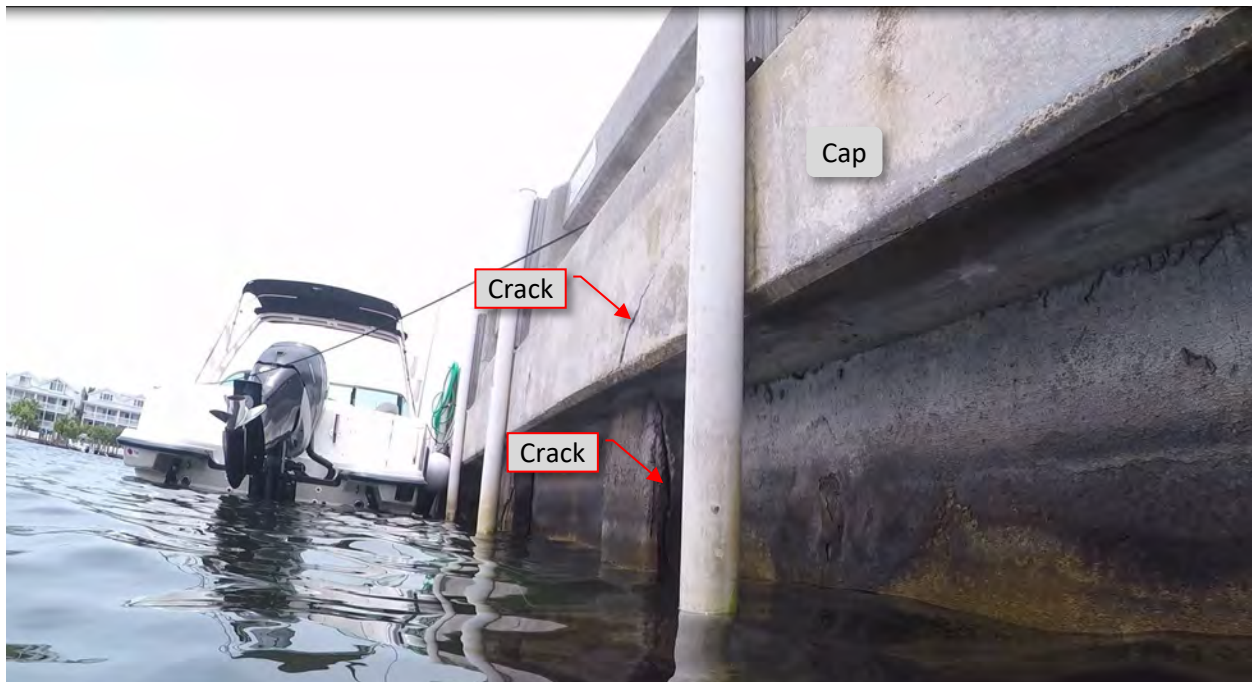
Figure 96: P33. STA 5+24. Crack/spall at top east flange with rust staining. C5. STA 5+24 – 5+26. Crack at cap south face.

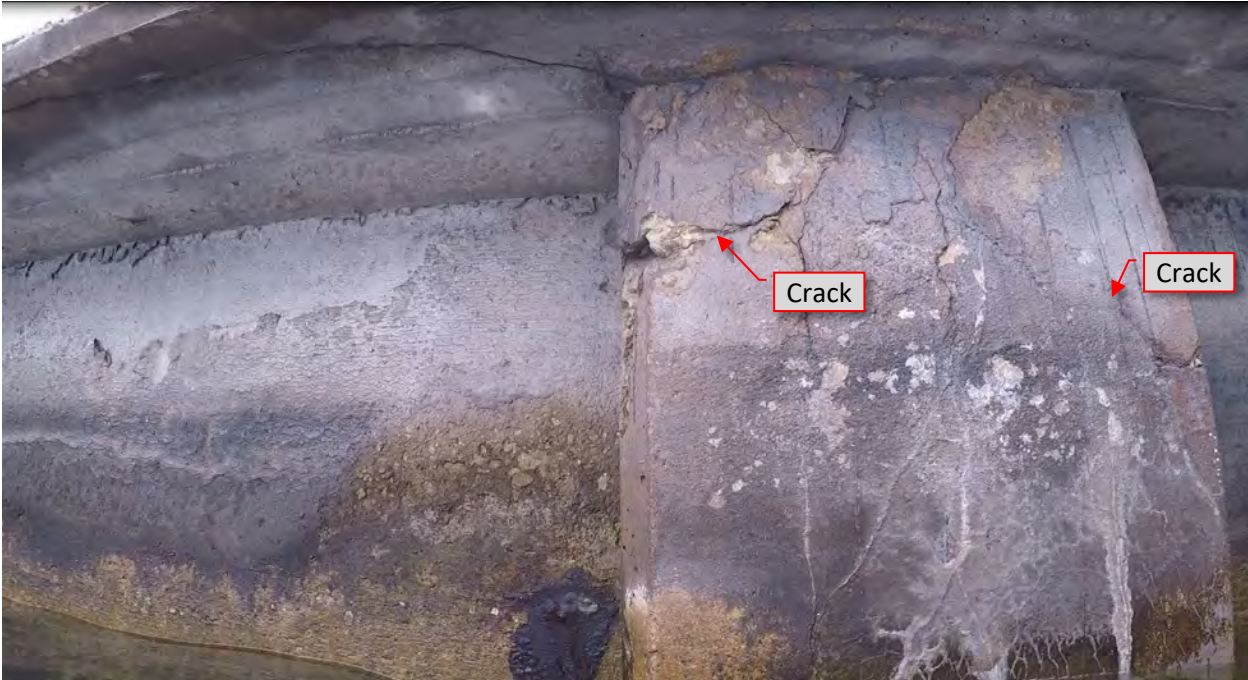
Figure 98: P34. STA 5+30. Cracks/spalls at top of pile west and east flanges, loss of concrete, and rust staining.

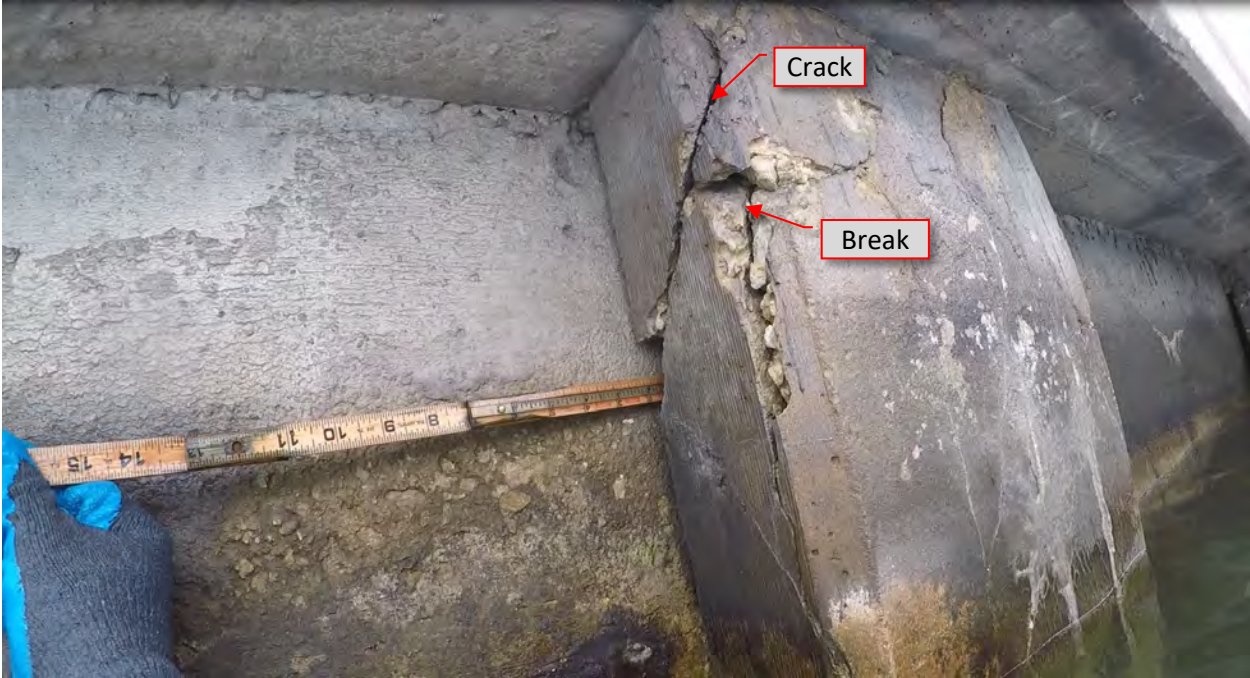
Figure 99: P34. STA 5+30. Cracks/spalls at top of pile west flange and loss of concrete.

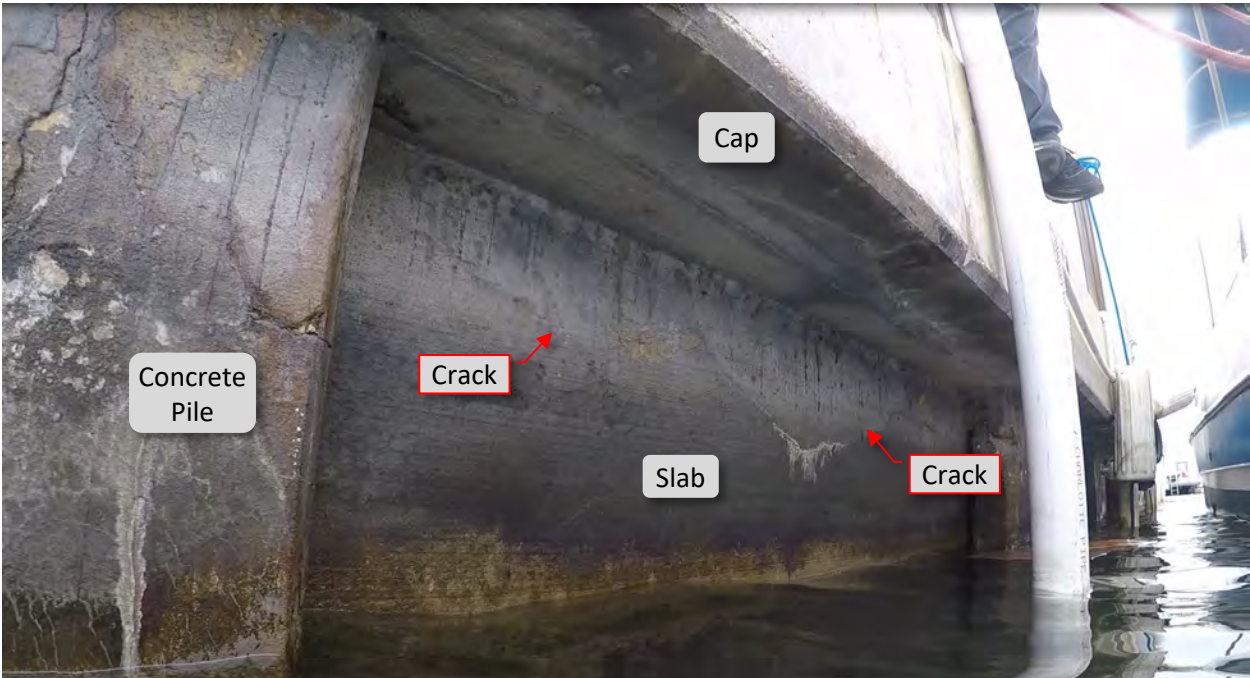
Figure 100: S21. STA 5+31 - 5+37. Crack at top of slab.

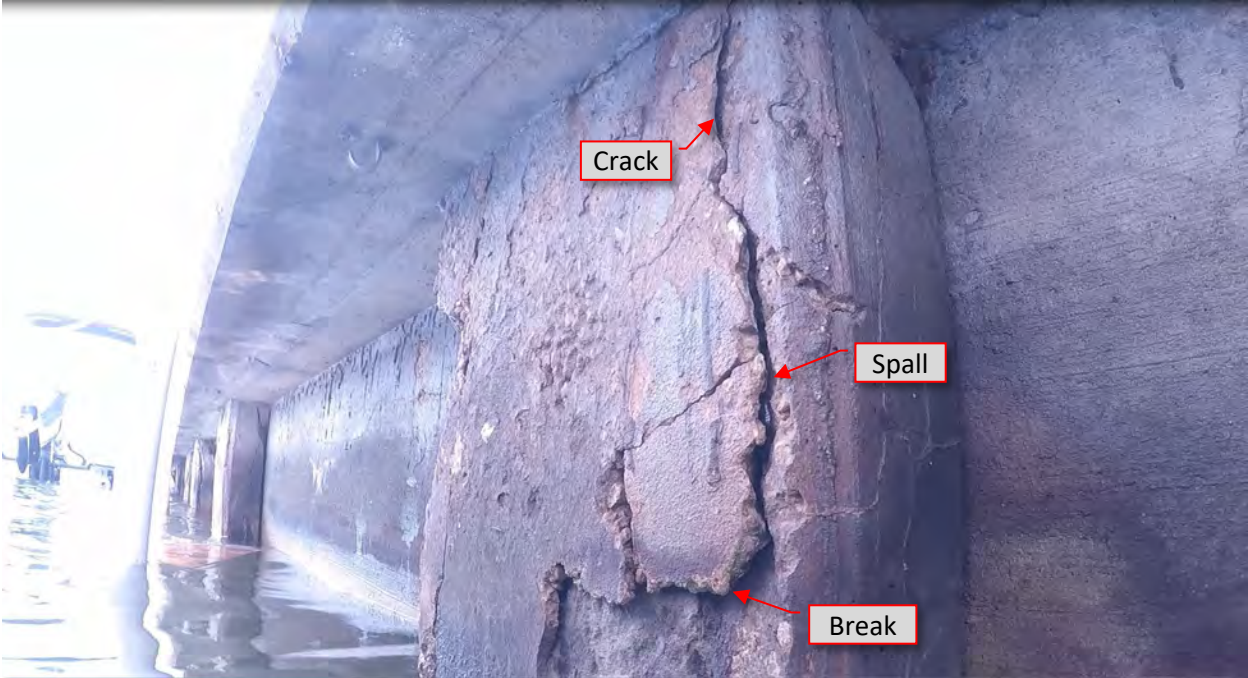
Figure 101: P35. STA 5+40. Cracks/spalls at both flanges and loss of concrete. View of east flange.

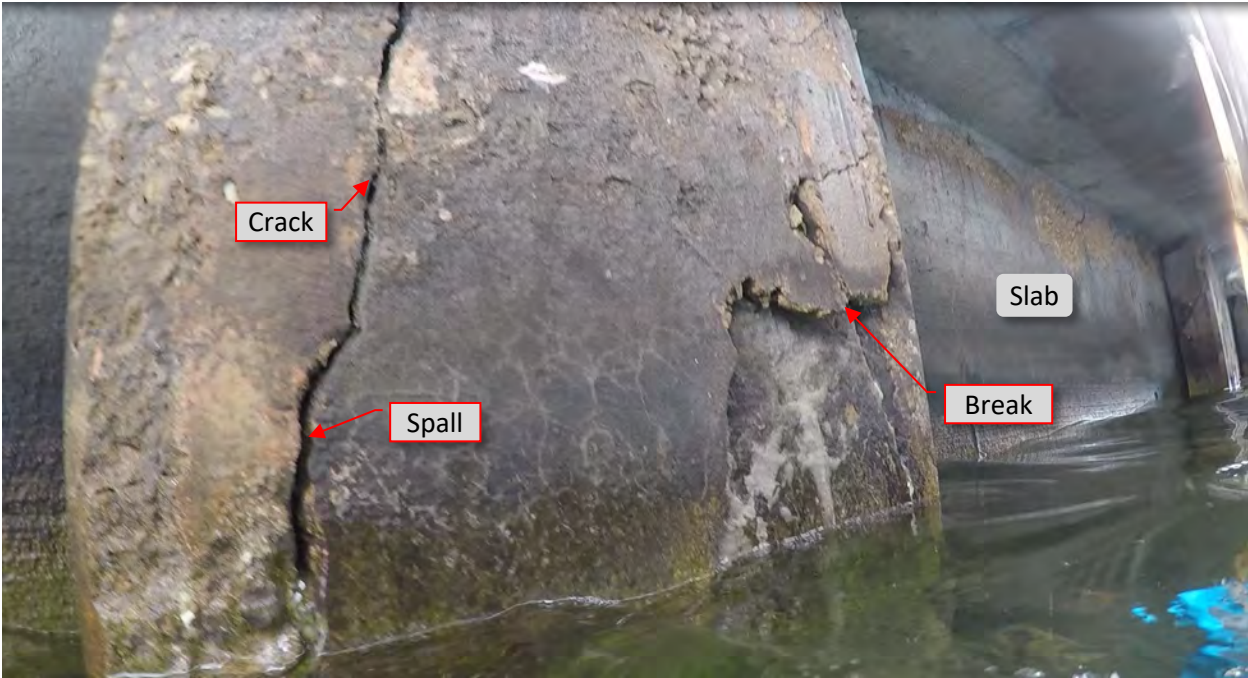
Figure 102: P35. STA 5+40. Cracks/spalls at both flanges at pile and loss of concrete. View of west flange.

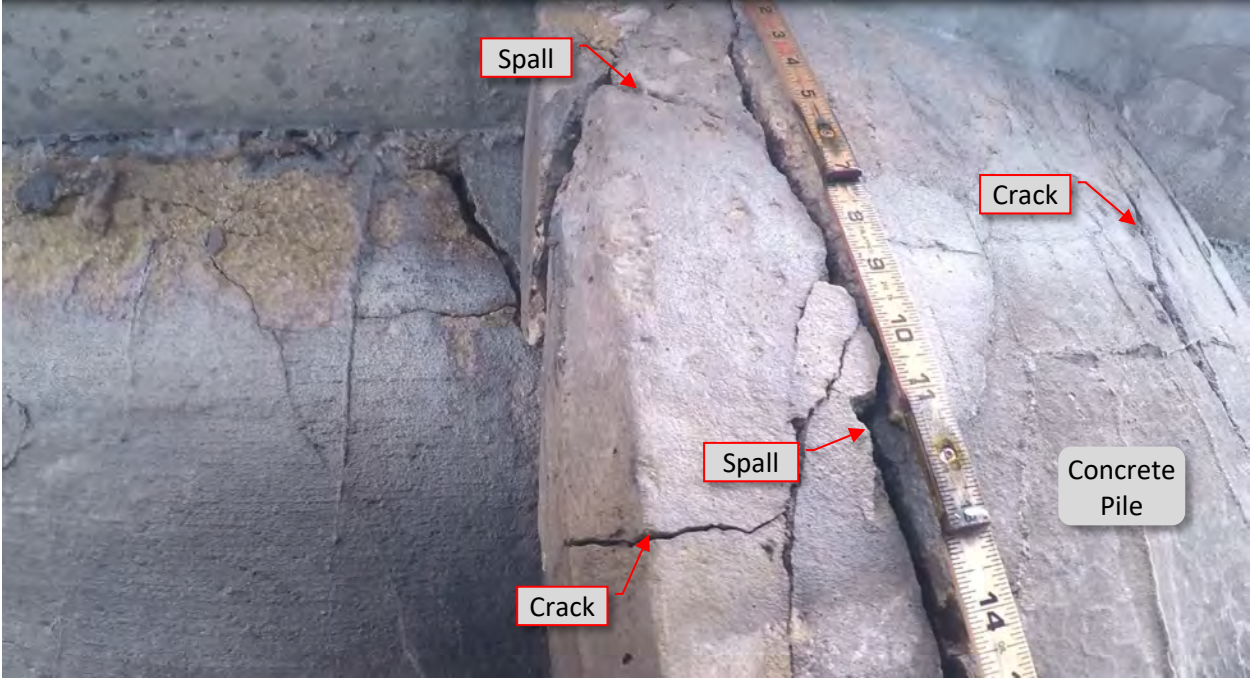
Figure 105: P36. STA 5+48. Cracks/spalls at both flanges at pile and loss of concrete. View of west flange.

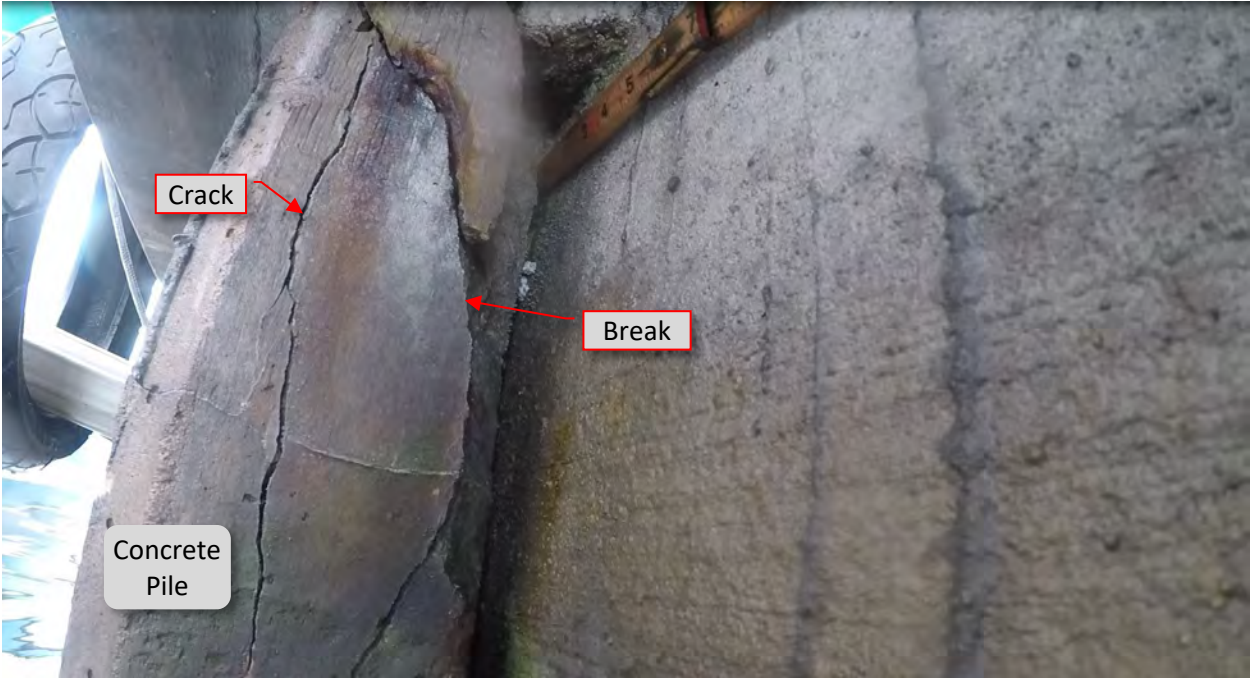
Figure 106: P36. STA 5+48. Cracks/spalls at both flanges at pile and loss of concrete. View of east flange.

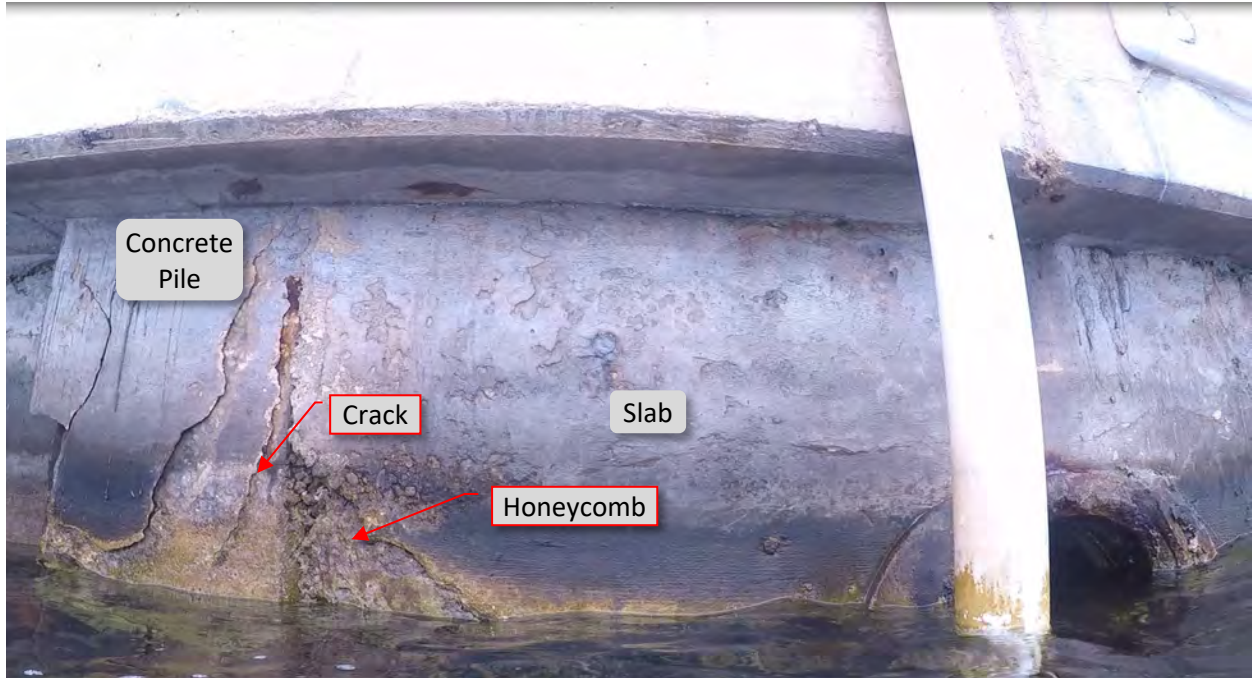
Figure 113: HW2. STA 5+66. Honeycomb area at headwall west side. P38. STA 5+64. Spall/crack at east flange at pile.

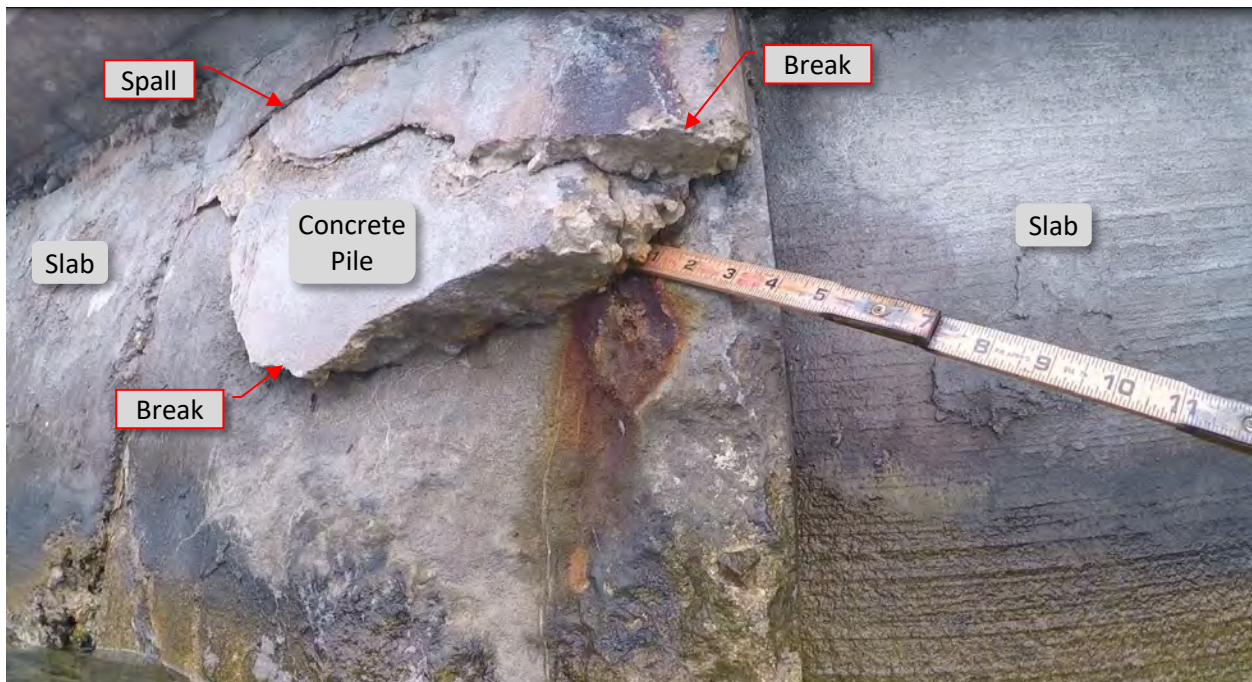
Figure 114: P39. STA 5+72. Cracks/spalls at both flanges at pile with rust staining at east flange, and loss of concrete.
