Subject: Key West Angelfish Pier Seawall Structural Assessment

CITY OF KEY WEST
PORT & MARINE SERVICES

KEY WEST GARRISON BIGHT MARINA
ANGELFISH PIER SEAWALL STRUCTURAL ASSESSMENT REPORT

Prepared By:
Tetra Tech, Inc.
759 South Federal Highway, Suite 314
Stuart, FL 34994

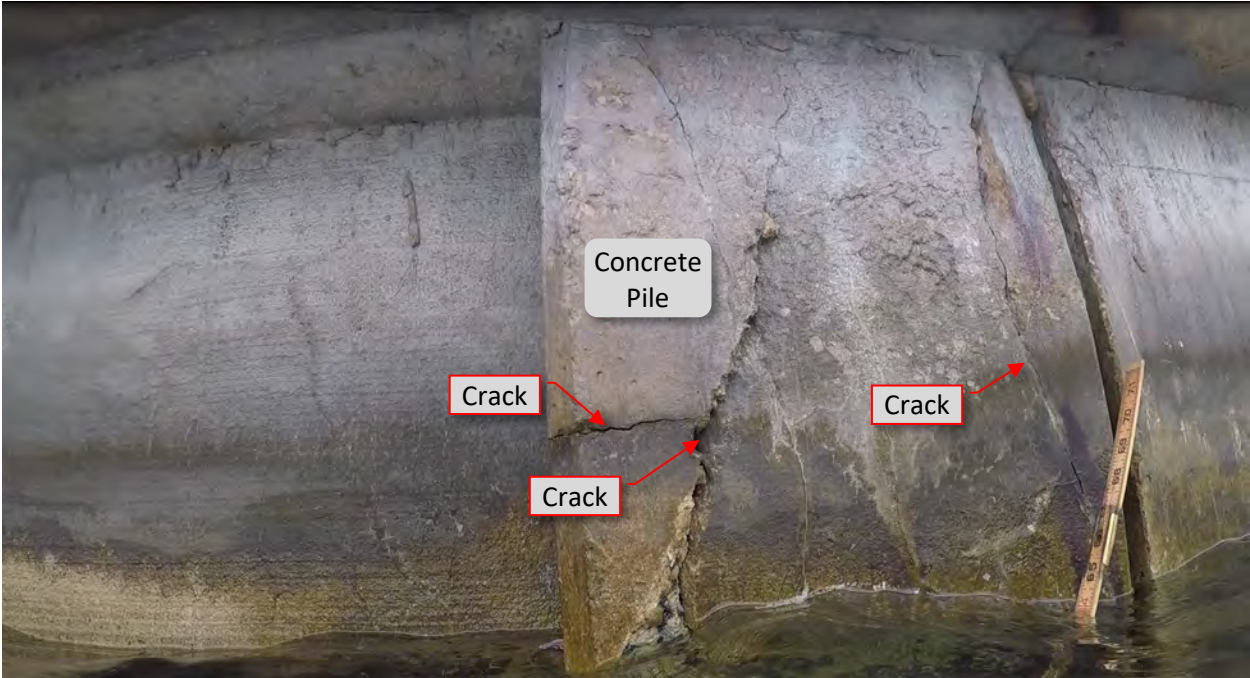
Figure 118: P40. STA 5+80. Cracks/spalls at both flanges at pile and loss of concrete. Gap at construction/expansion joint.

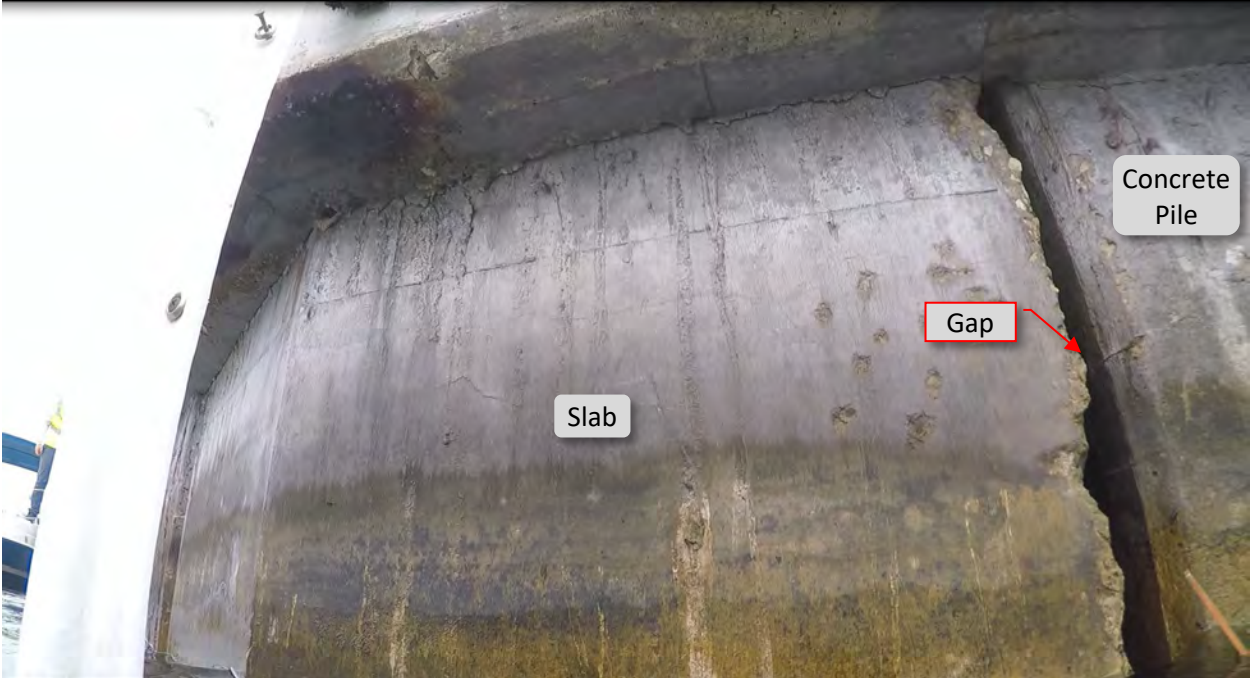
Figure 120: P40. STA 5+85. Gap at construction/expansion joint.

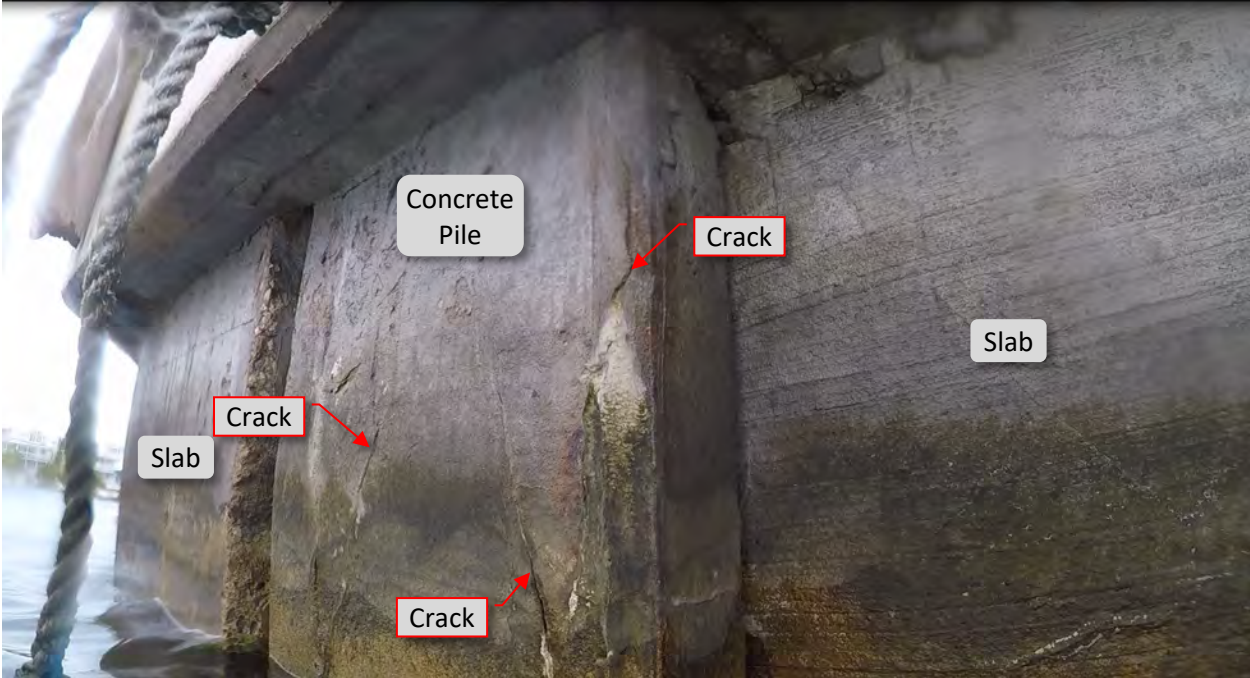
Figure 121: P41. STA 5+85. Crack/spalls at both flanges at pile.

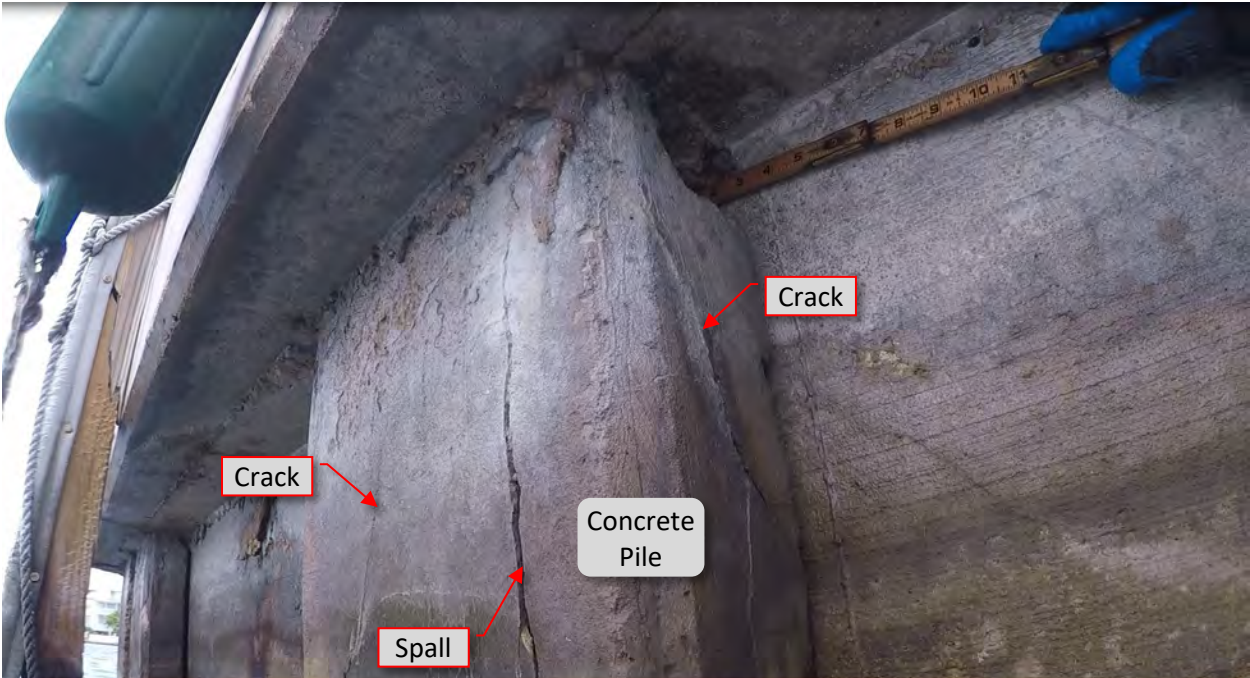
Figure 122: P42. STA 5+93. Crack/spalls at both flanges at pile and loss of concrete.

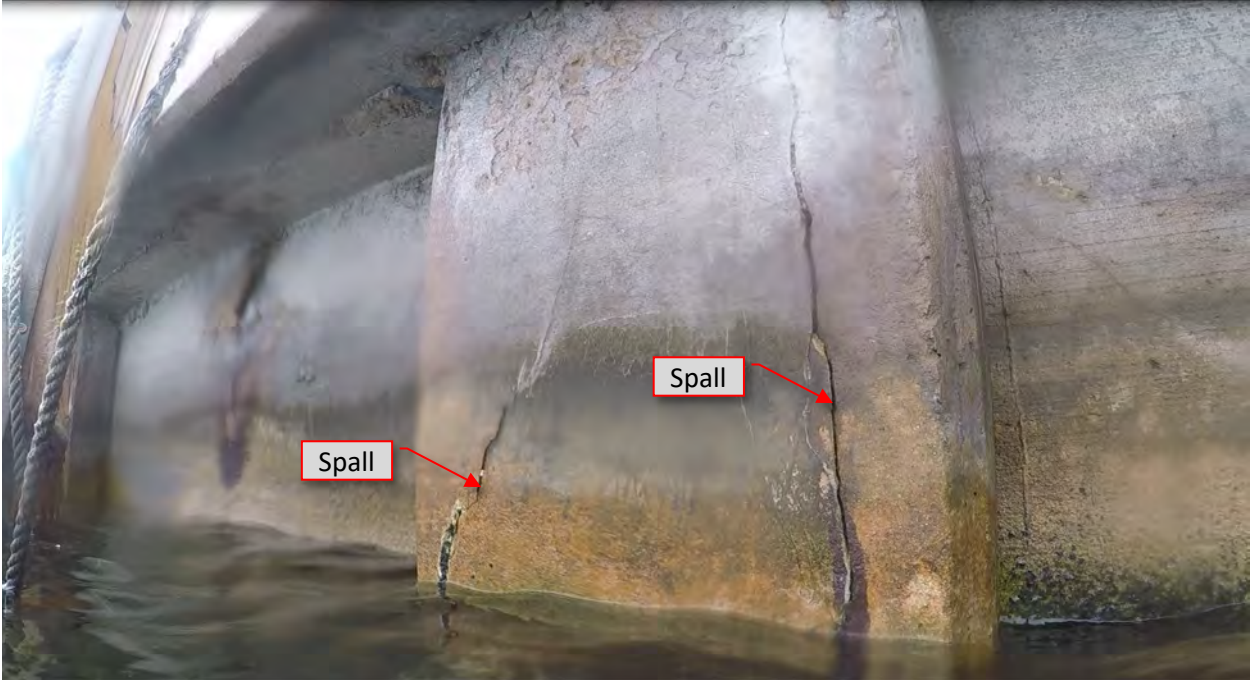
Figure 123: P42. STA 5+93. Crack/spalls at both flanges at pile.

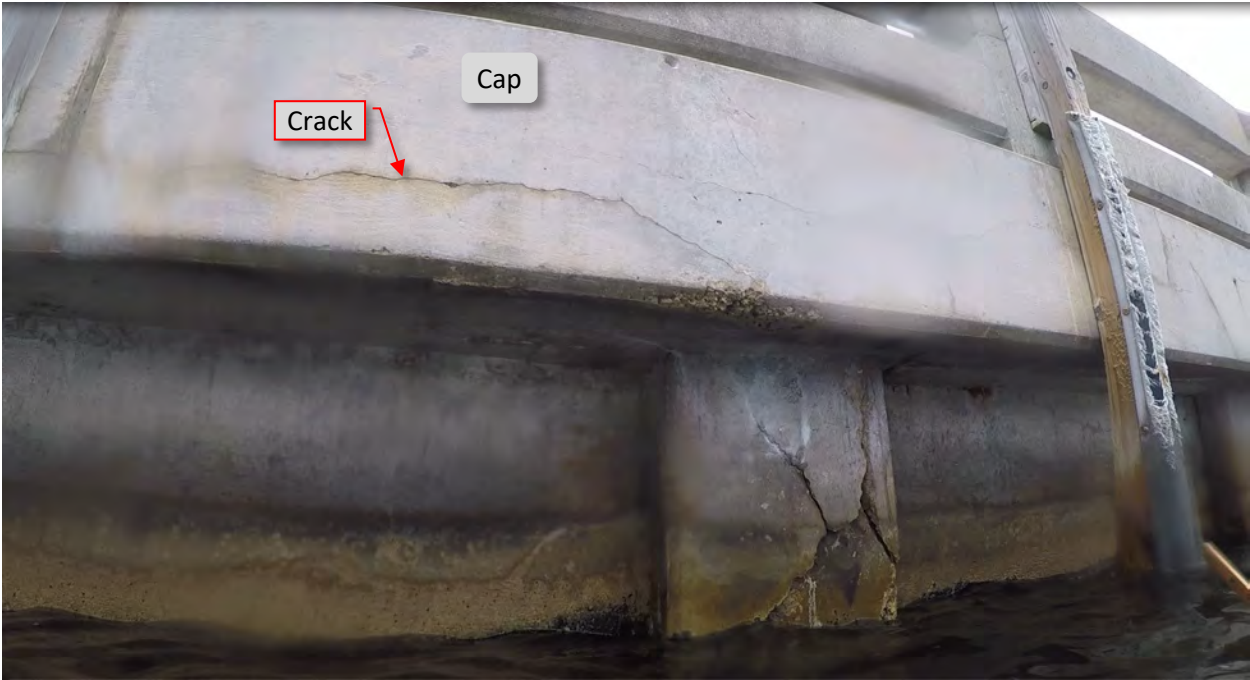
Figure 124: C10. STA 5+93 - 6+00. Crack at vertical face of cap.

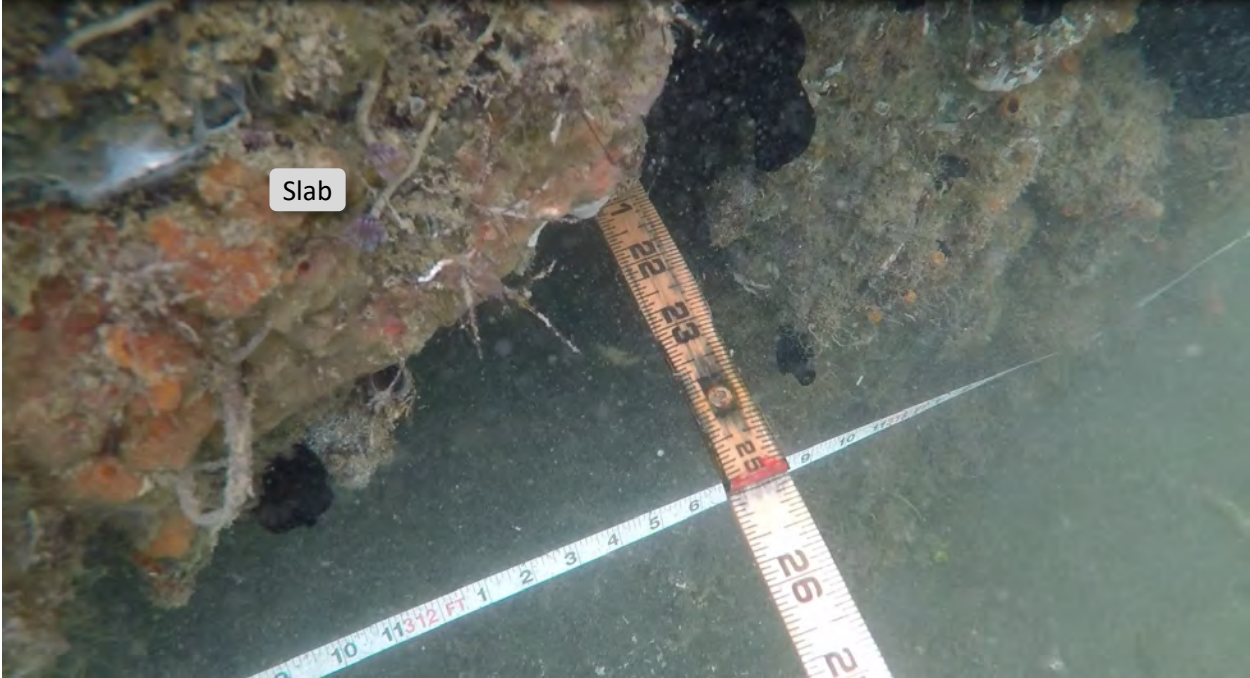
Figure 131: S24. STA 6+11. Depth of the undermining at the bottom of the slab.

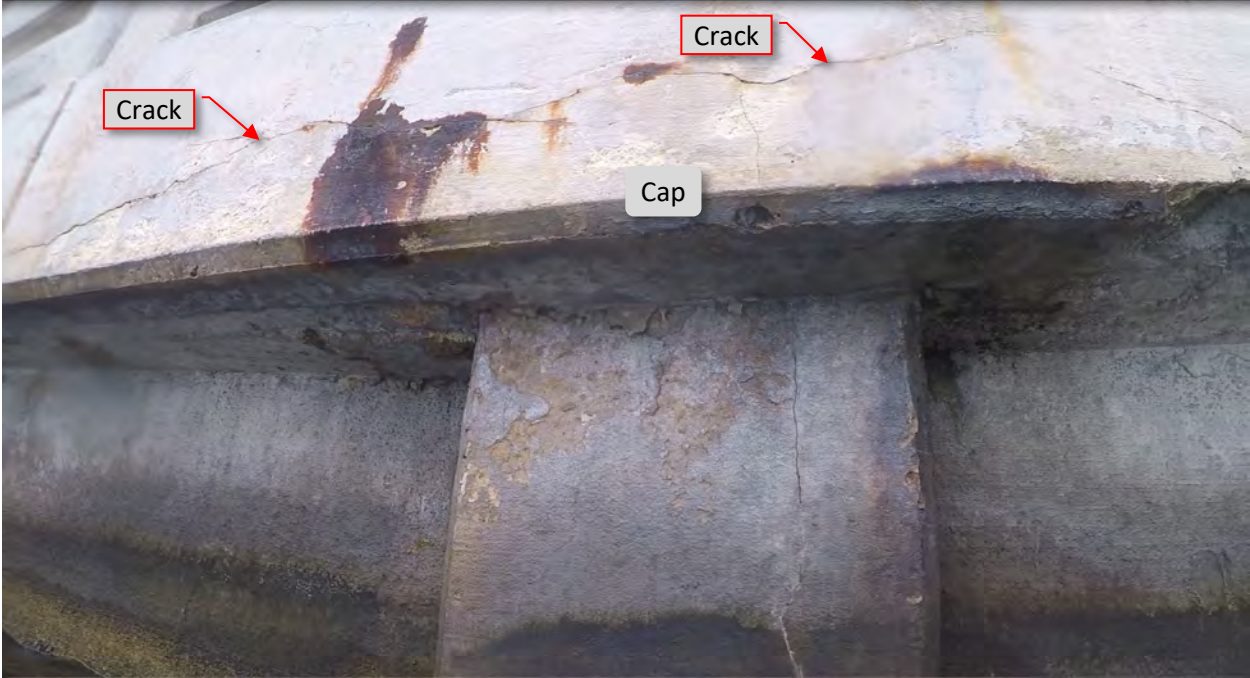
Figure 139: C14. STA 6+22 - 6+40. Crack at cap's vertical face.

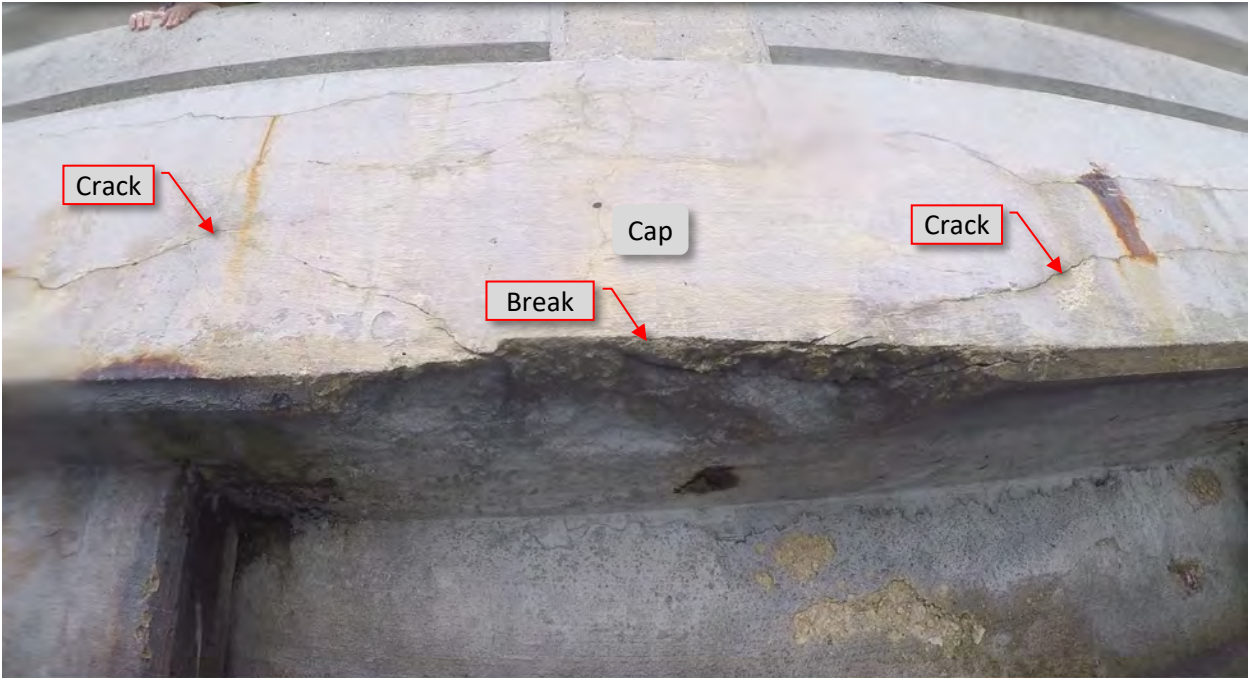
Figure 140: C14. STA 6+22 - 6+40. Crack at cap's vertical face and break of concrete at cap's bottom edge.

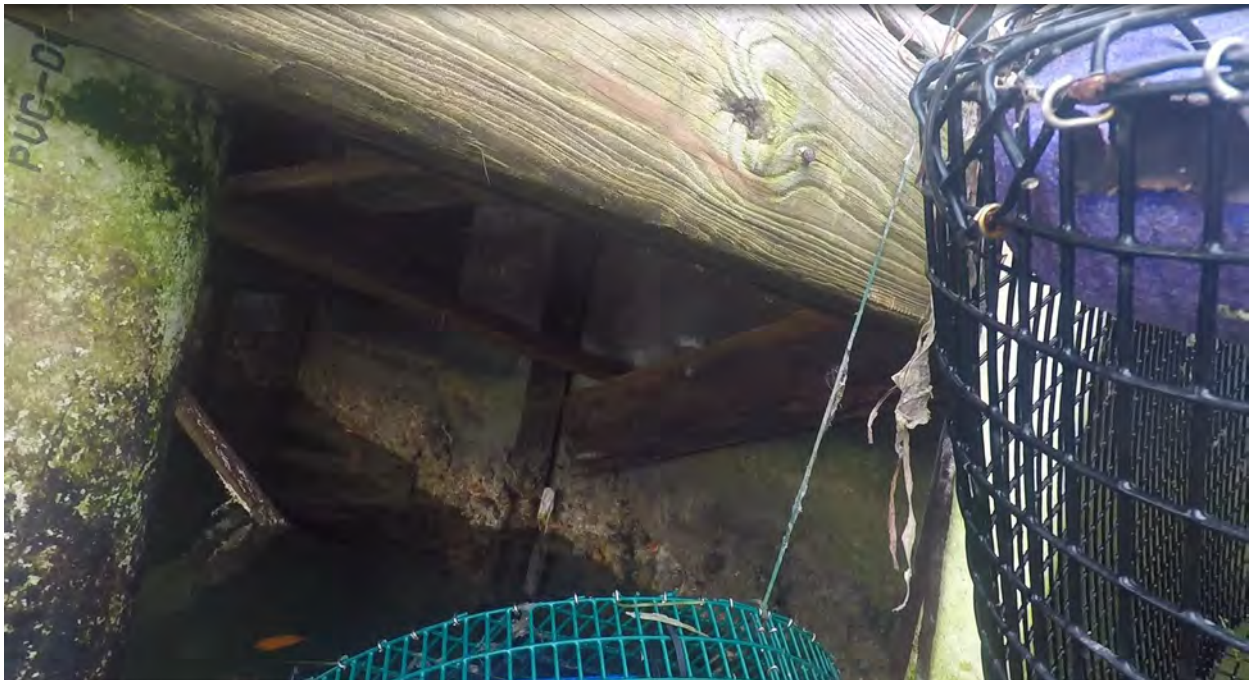
Figure 16: STA 1+20. Northwest direction view. Seawall partial view with present overhead and in the water hazard.

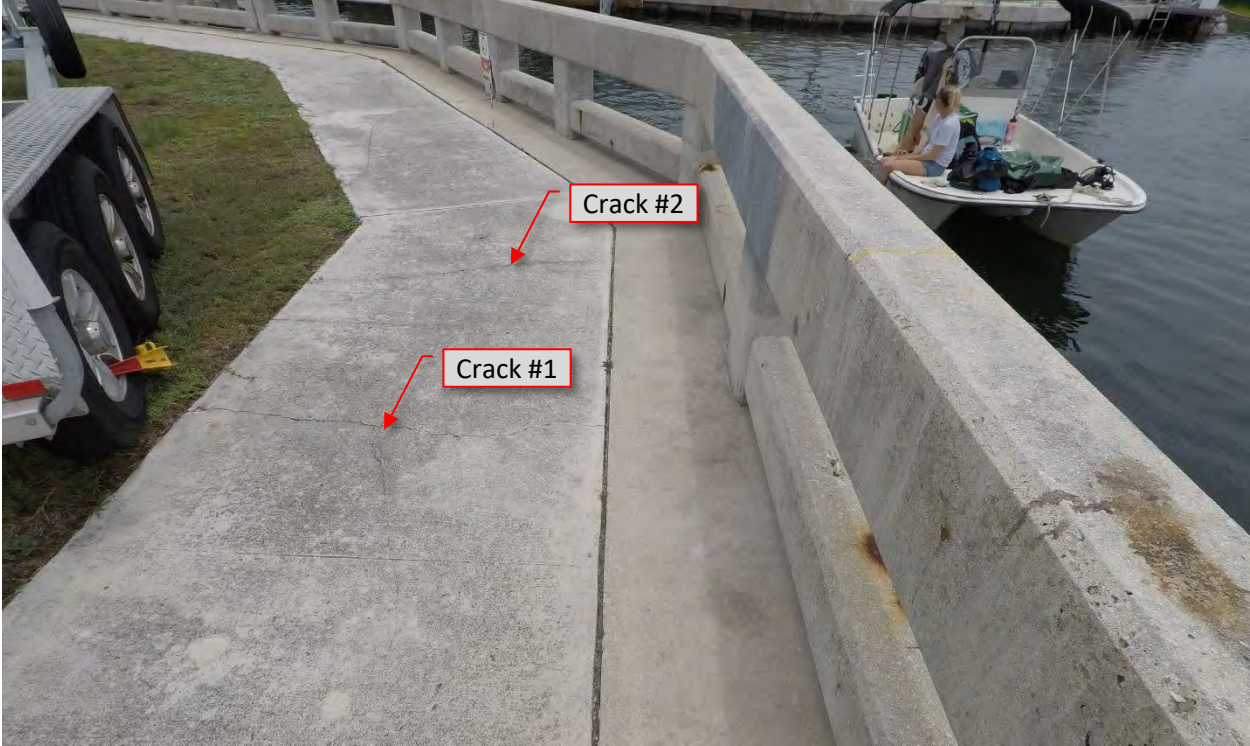
Figure 1: STA 6+00 - 6+10. Cracks in concrete slab to sidewalk.

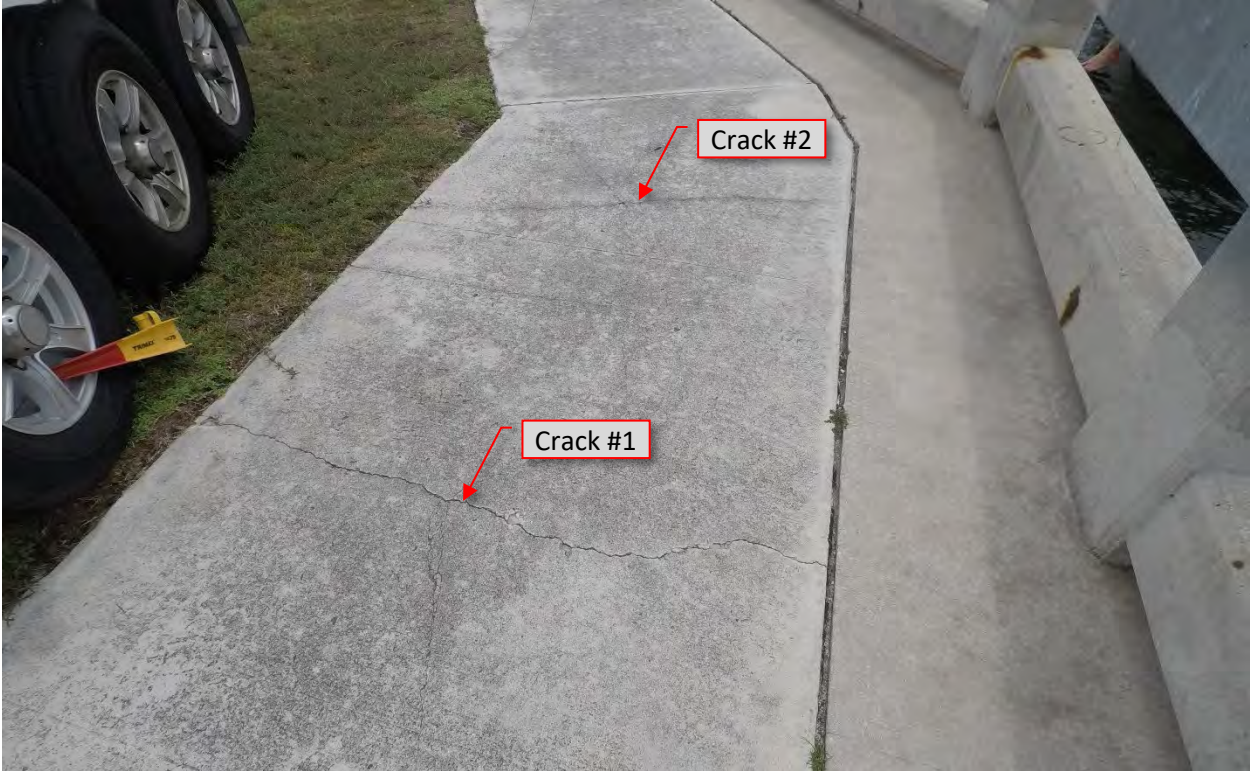
Figure 2: STA 6+00 - 6+10. Cracks in concrete slab to sidewalk. Closer view of the cracks.

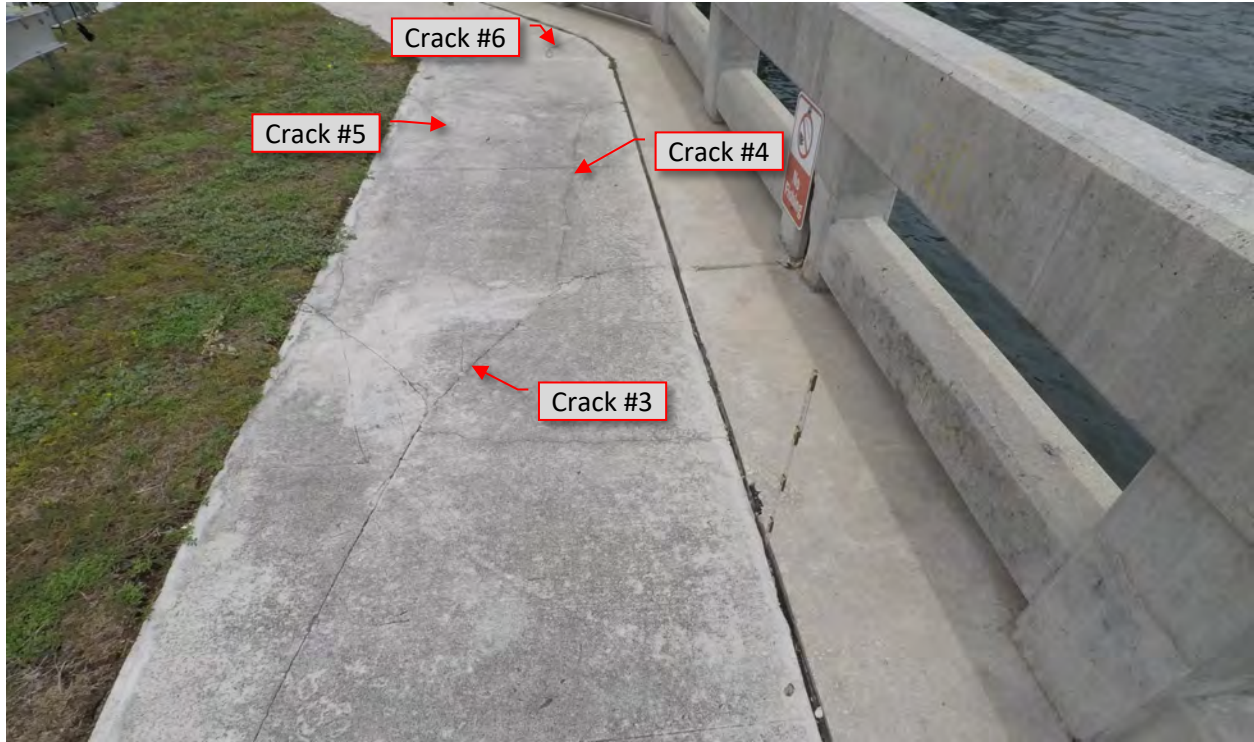
Figure 3: STA 6+15 - 6+25. Cracks in concrete slab to sidewalk.

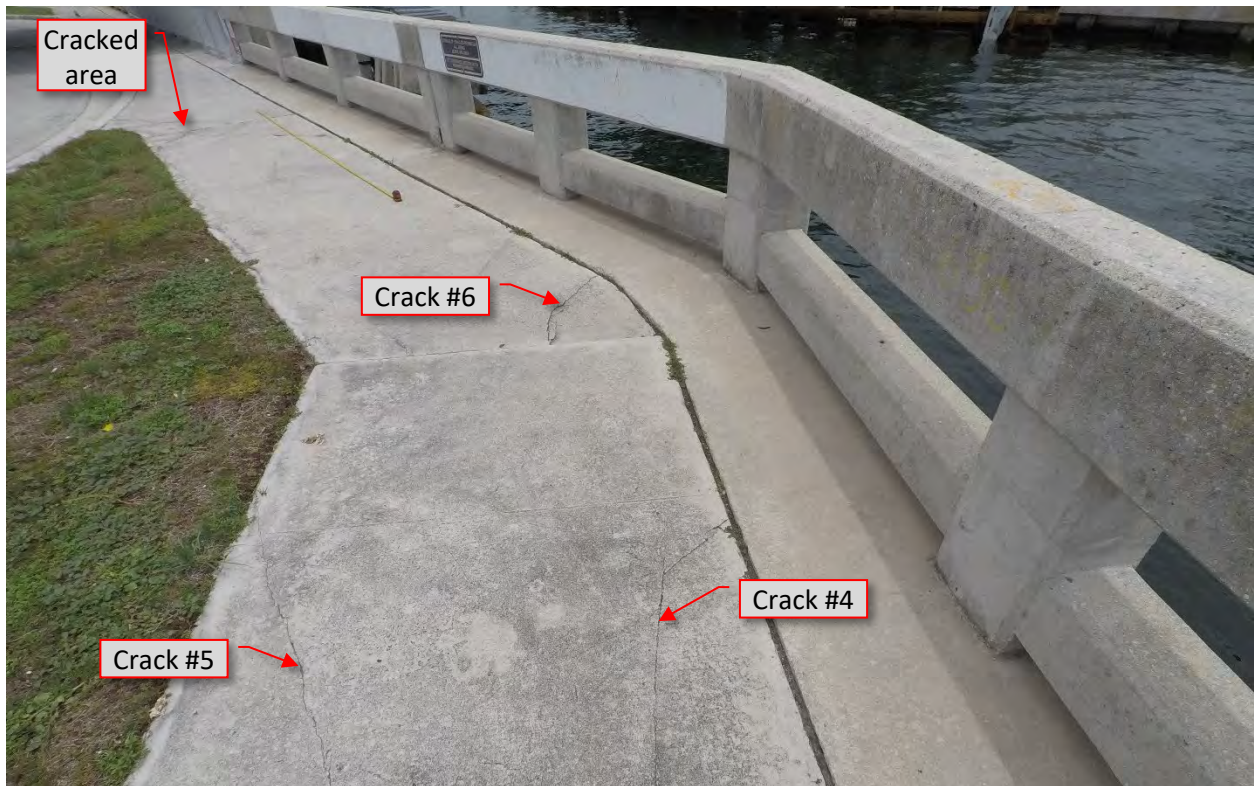
Figure 4: STA 6+25 - 6+50. Cracks in concrete slab to sidewalk.

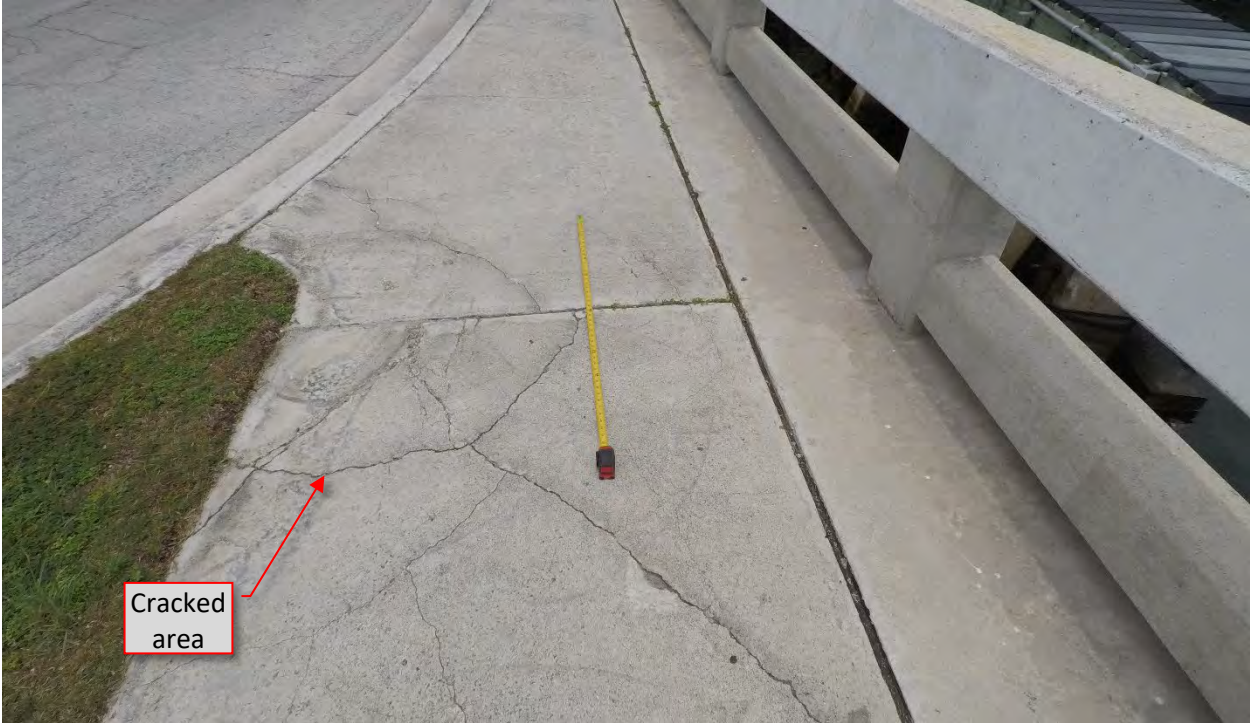
Figure 5: STA 6+50 - 6+60. Cracks in concrete slab to sidewalk.

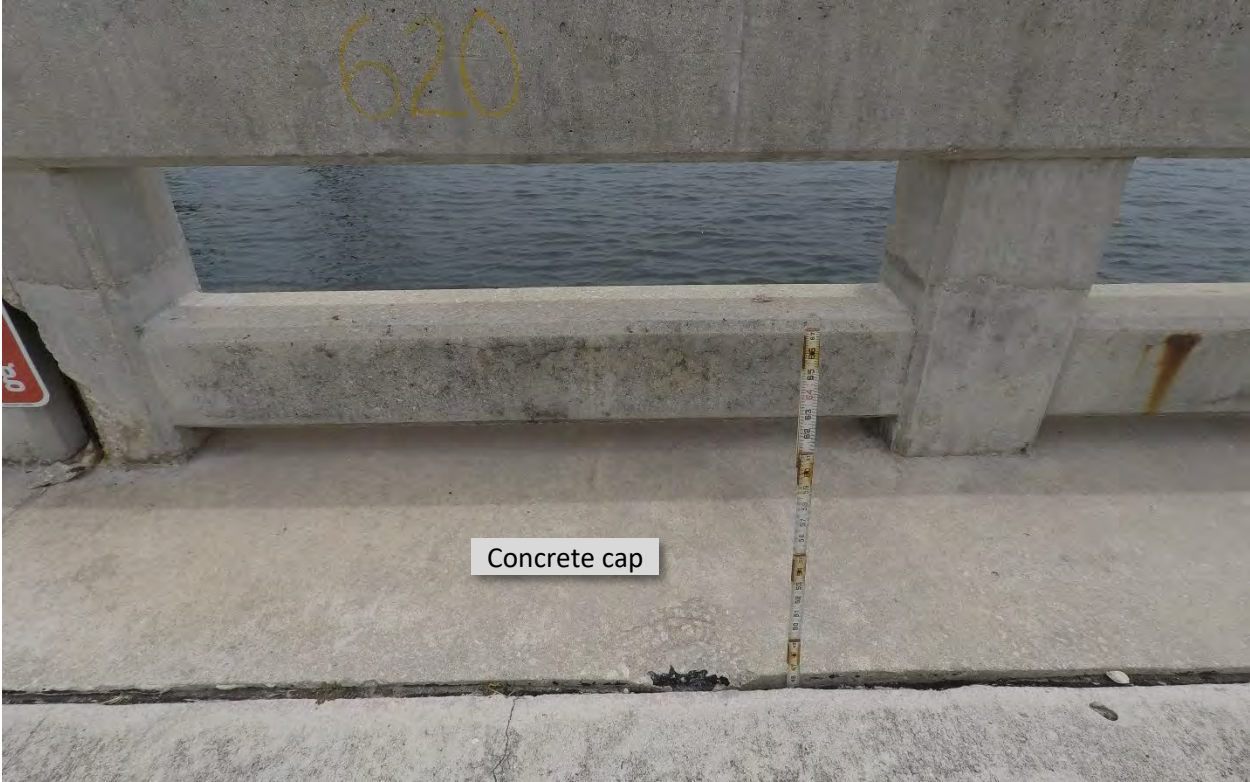
Figure 6: STA 6+20. 48-Inch void at gap between seawall cap and concrete slab at sidewalk.
