FREDERICK DOUGLASS COMMUNITY CENTER Gymnasium Structural Assessment

111 Olivia Street
Key West, Florida

August 8, 2025

Re: Frederick Douglass Community Center
 Gymnasium Building Structural Assessment

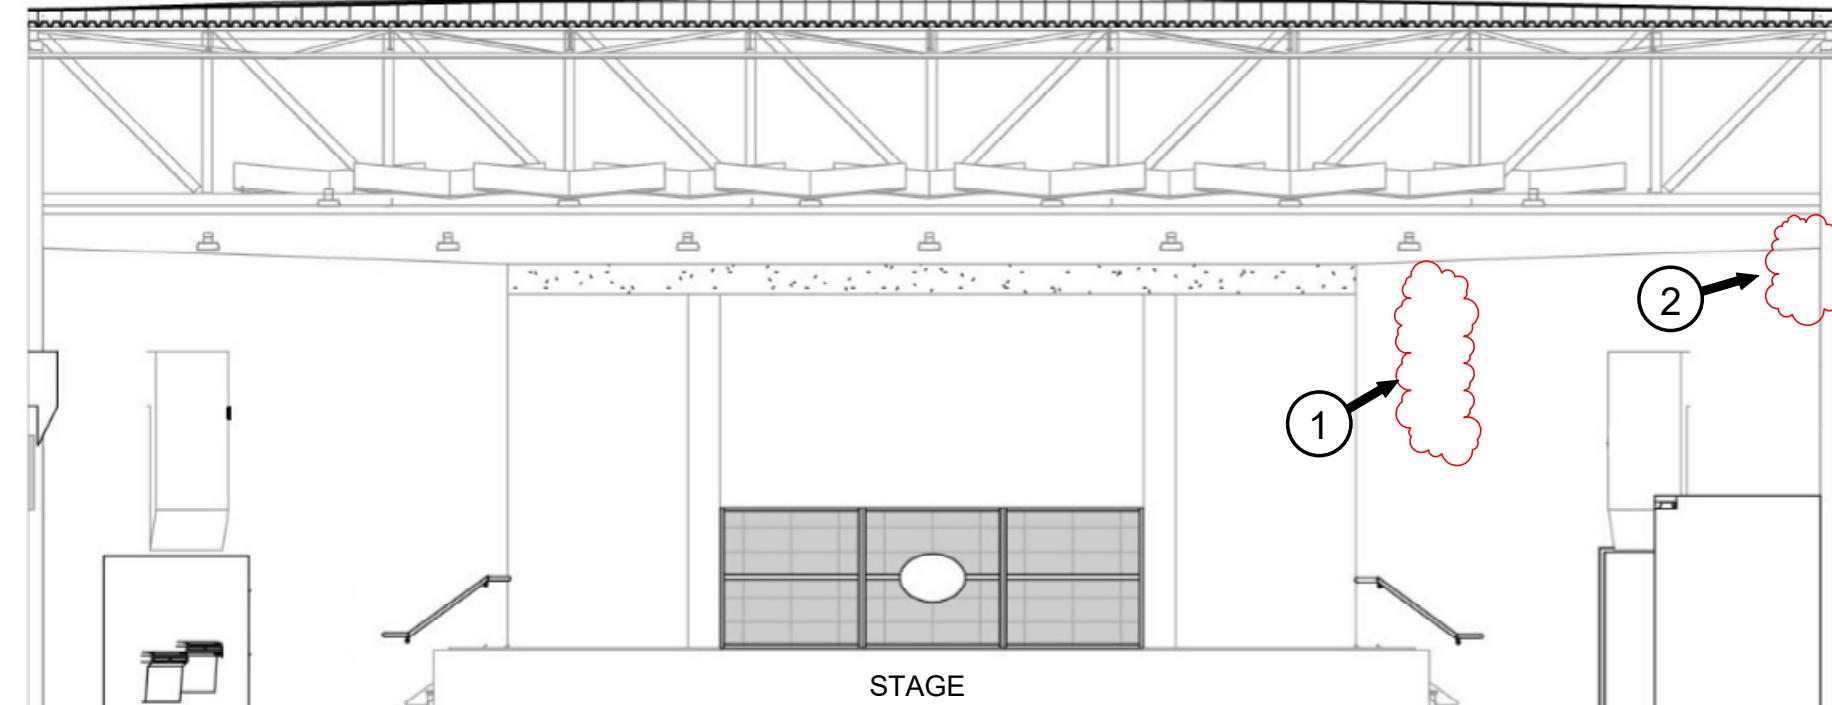
NORTH WALL INTERIOR

= AREA OF SPALLING CONCRETE

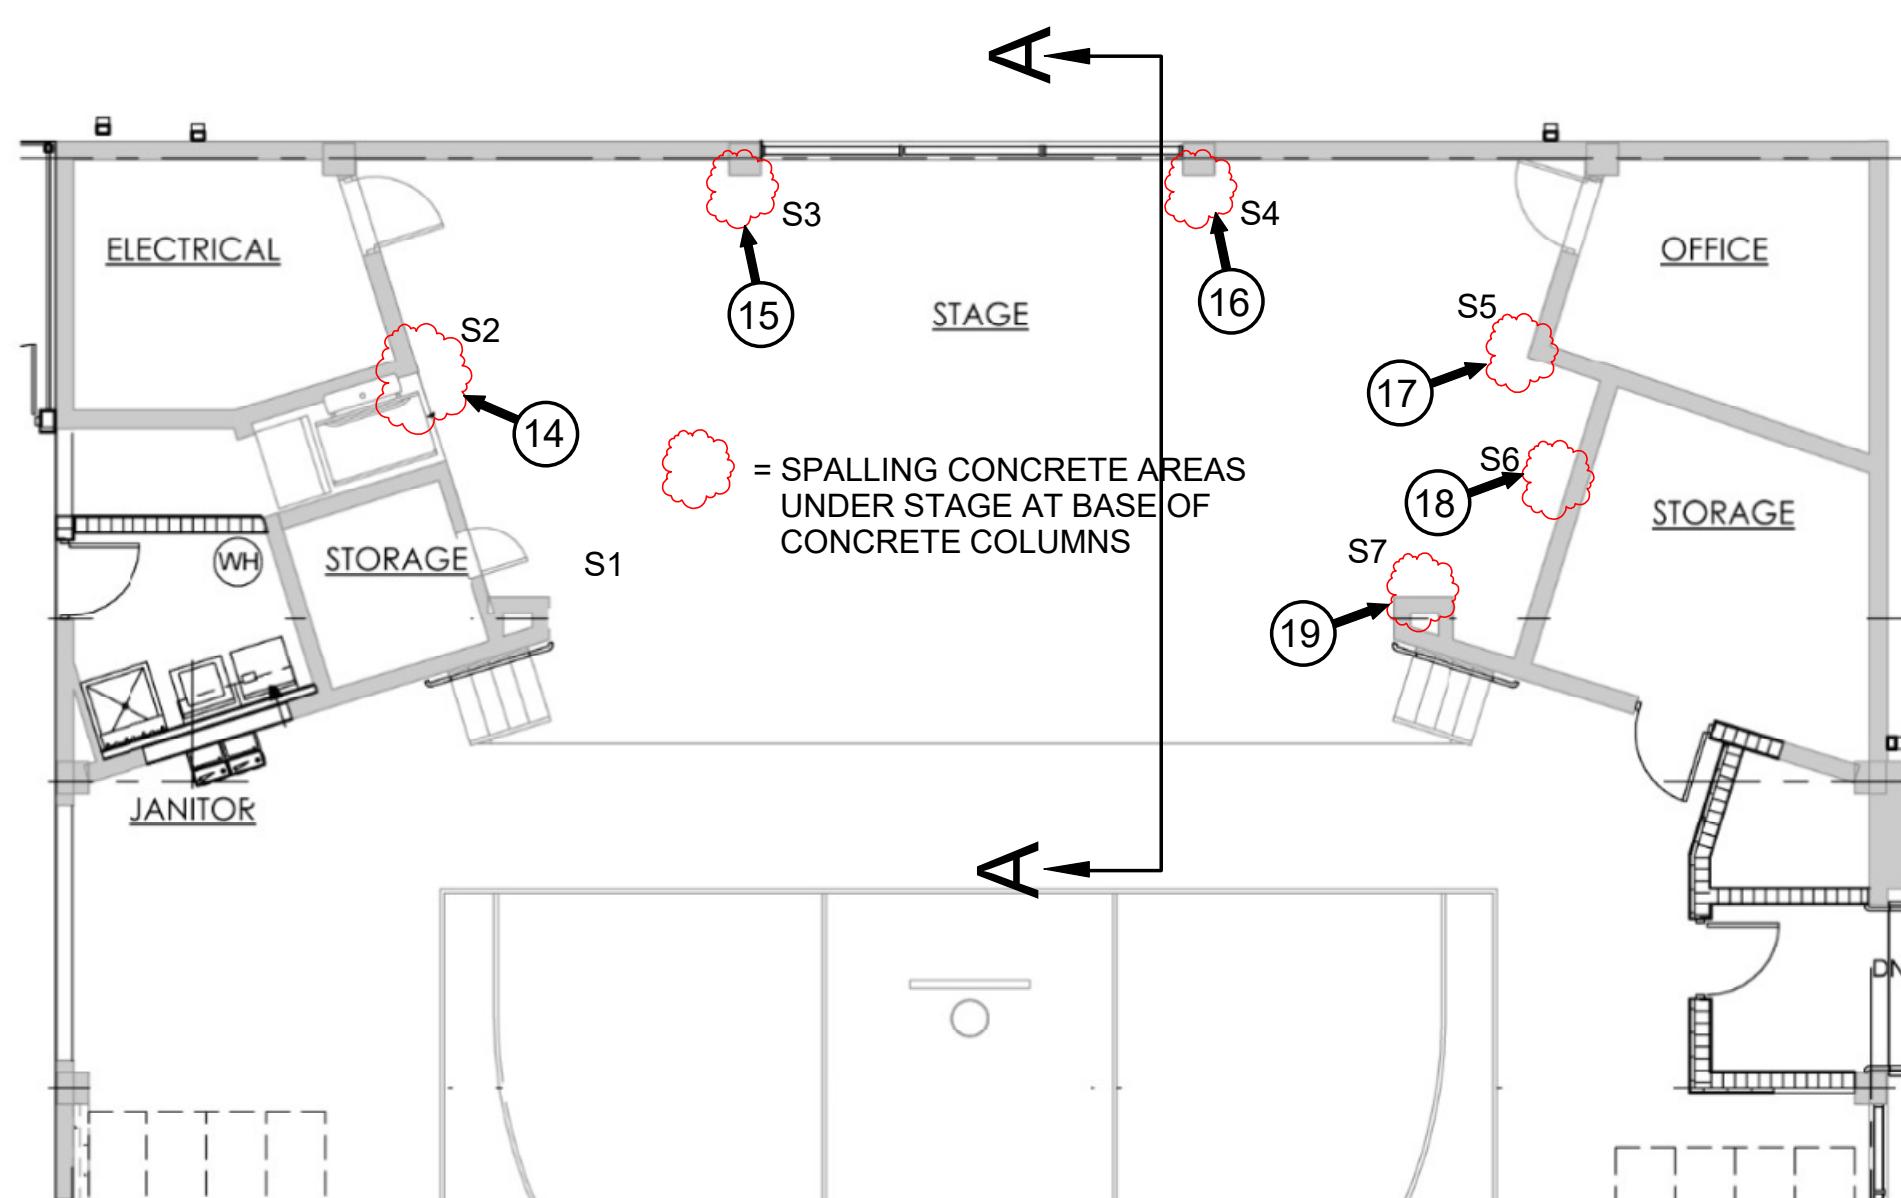
STAGE FLOOR PLAN

The stage floor framing is suffering active termite damage with evidence of termite droppings throughout the underside of the stage floor framing. Although the stage appears to be safe for continued use, a termite control specialist should be contacted as soon as practical to prevent further deterioration. We recommend the city consider reconstructing the stage floor framing with termite resistant materials.

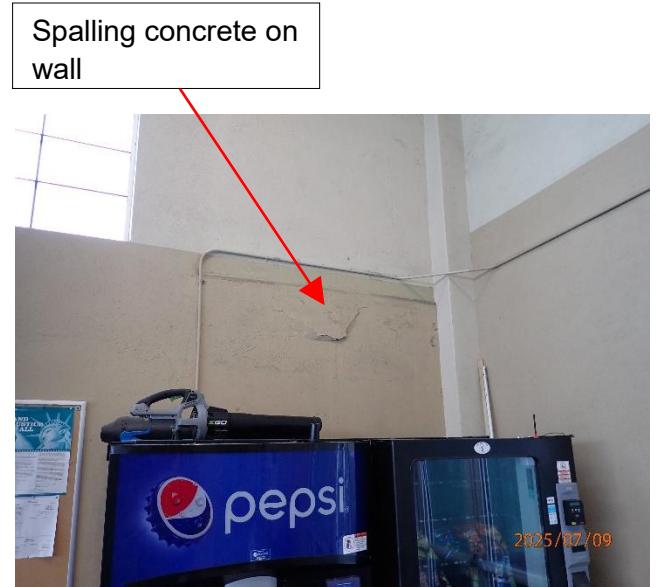
Picture #12

Spalling concrete on wall

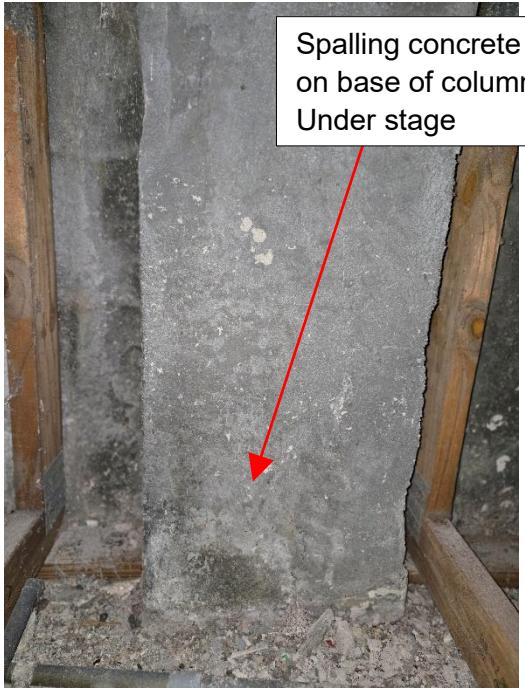
Picture #15

Spalling concrete on base of column
Under stage
