**Concrete Repair Cost Proposal Form for Fredrick Douglass Gym**

**Repair Details SK 1 – 10**

**Frederick Douglas Gym**

**McCarthy Project No. M13178**

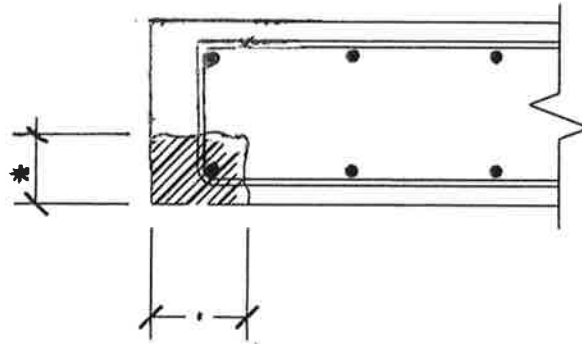
SK-4

**COLUMN OR BEAM REPAIR**

\* UNLESS TEMPORARILY SHORED,  
REPAIR AREA SHALL NOT  
EXCEED 20% OF THE CROSS  
SECTIONAL AREA OF THE COLUMN.

NOTE:  
1. REFER TO SK-5 & SK-6  
FOR PROCEDURE AND ADDITIONAL  
NOTES

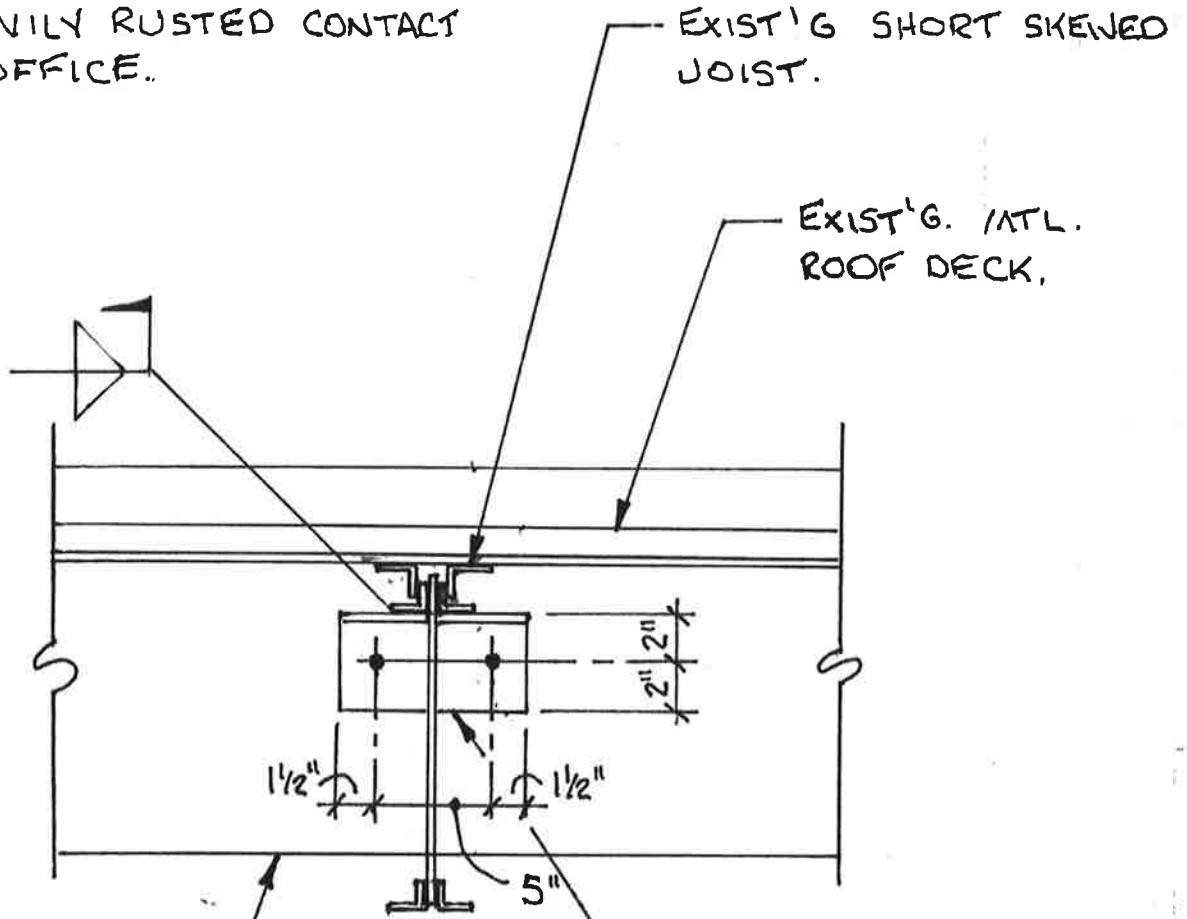
SK-10

GC NOTE:  
 FIELD VERIFY CONDITION  
 OF EXIST'G. JOIST SEAT.  
 IF HEAVILY RUSTED CONTACT  
 THIS OFFICE..

JOIST SEAT REPAIR

INSTALL L4x4x3/8x0'-8"  
 W/ (2) 3/4" Ø EPOXY BOLTS.  
 (5 1/2" EMBED)

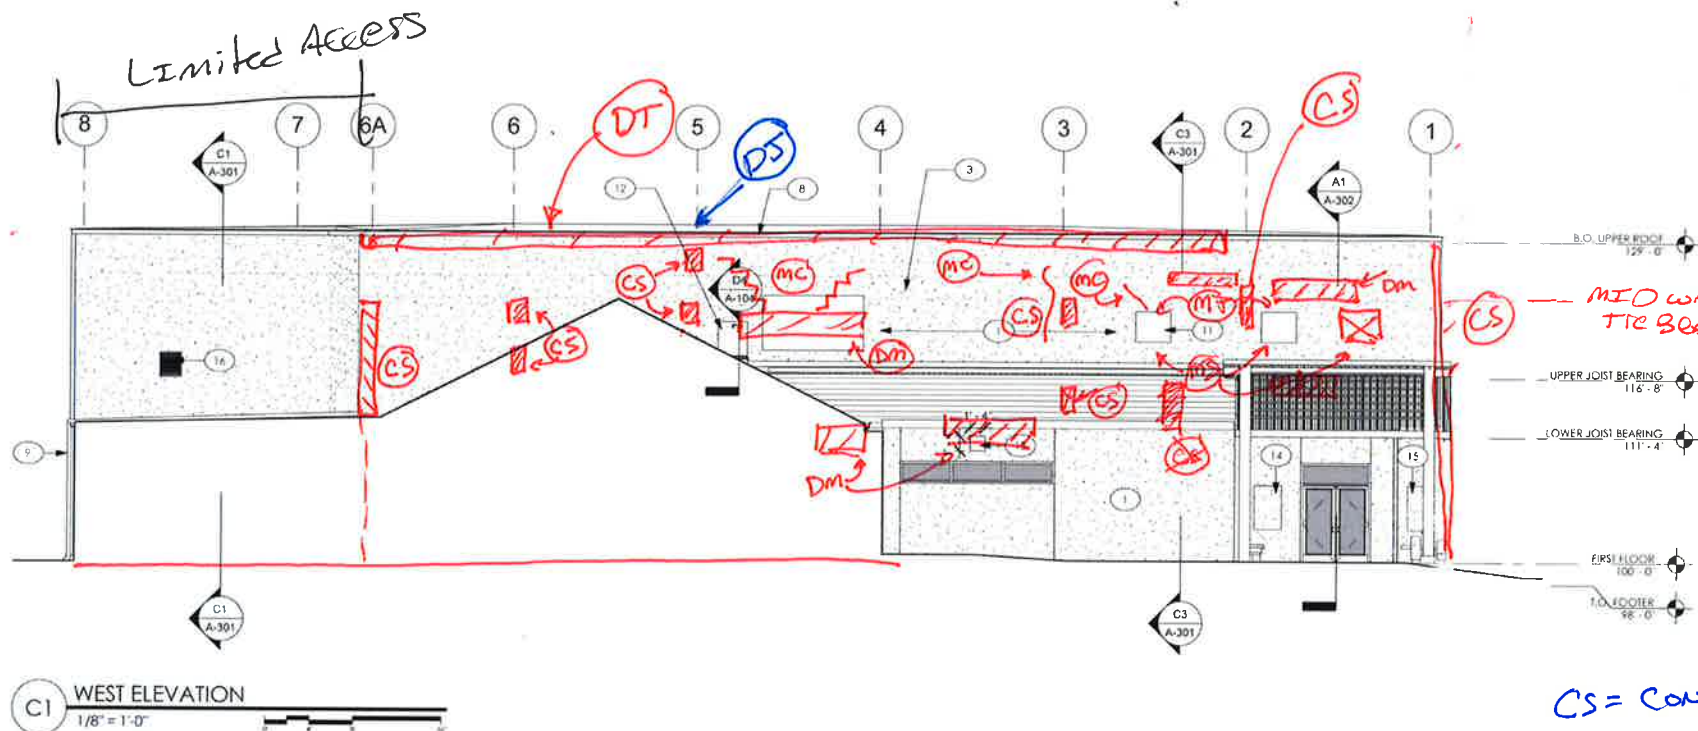
- CS = Concrete Sill  
 DH = Damaged Header  
 DS = Damaged Sill  
 MC = Masonry Crack  
 DJ = Damaged wall at Truss Tie Seat  
 DT = Damage High Roof Tie Beam  
 DM = Damaged MED Wall Tie Beam  
 MH = Missing Header  
 MS = Missing Sill

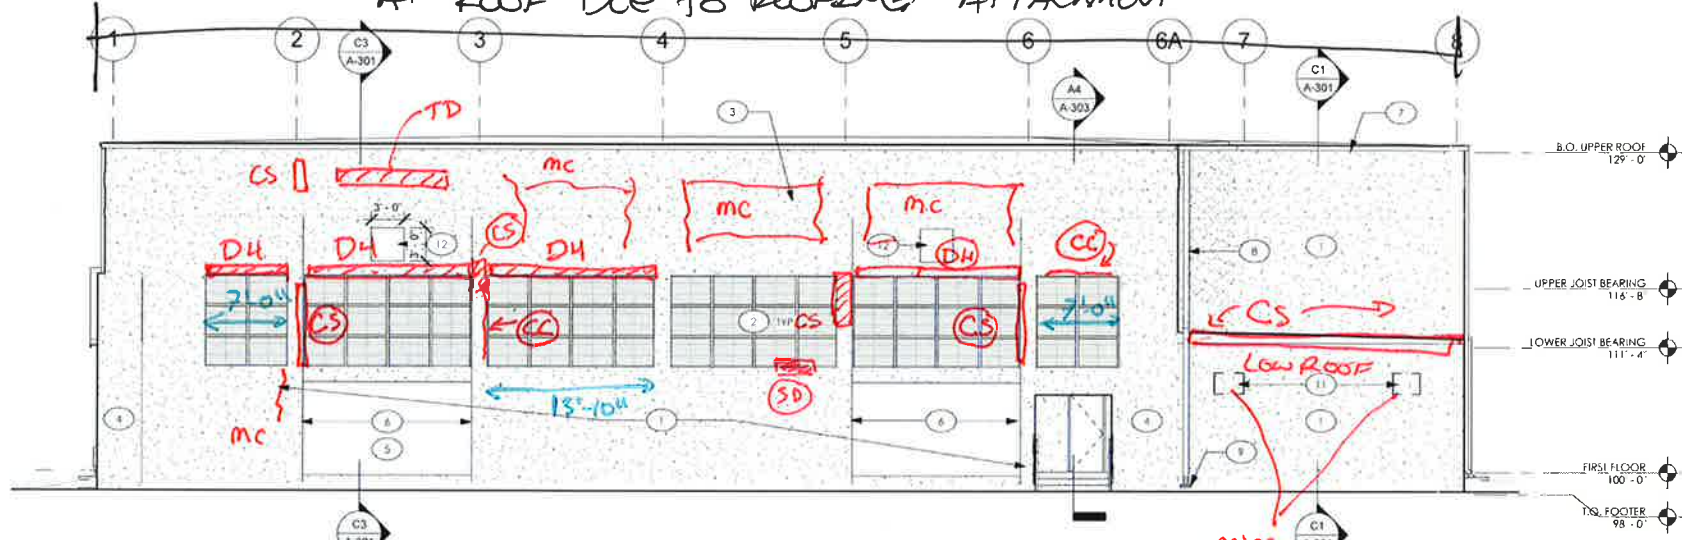
**C1** EAST ELEVATION  
 1/8" = 1'-0"

LIMITED ACCESS TO TOP OF WALL  
 AT ROOF DUE TO ROOFING ATTACHMENT

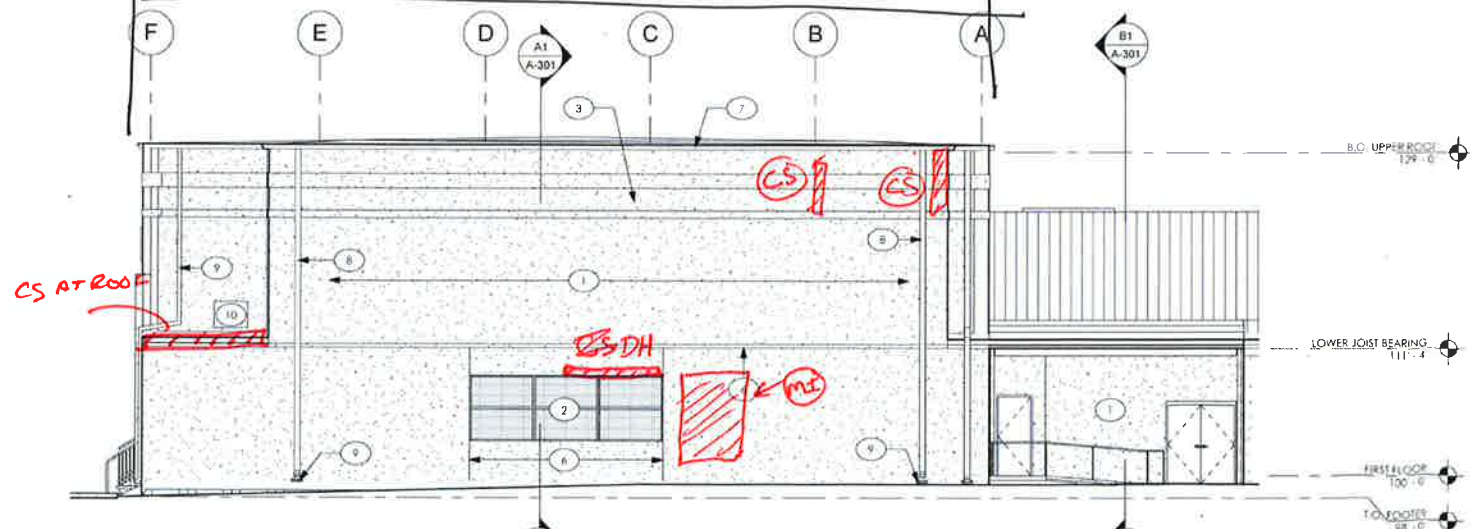
**A1** NORTH ELEVATION  
 1/8" = 1'-0"

LIMITED ACCESS OF TOP  
 OF WALL DUE TO ROOFING SYSTEM
