**Re: Frederick Douglas Recreation Center
McCarthy Project No. 12302**

FIELD REPORT

SITE VISIT #01

Project: Frederick Douglas Recreation Center Temporary Shoring
McCarthy Project No.12302

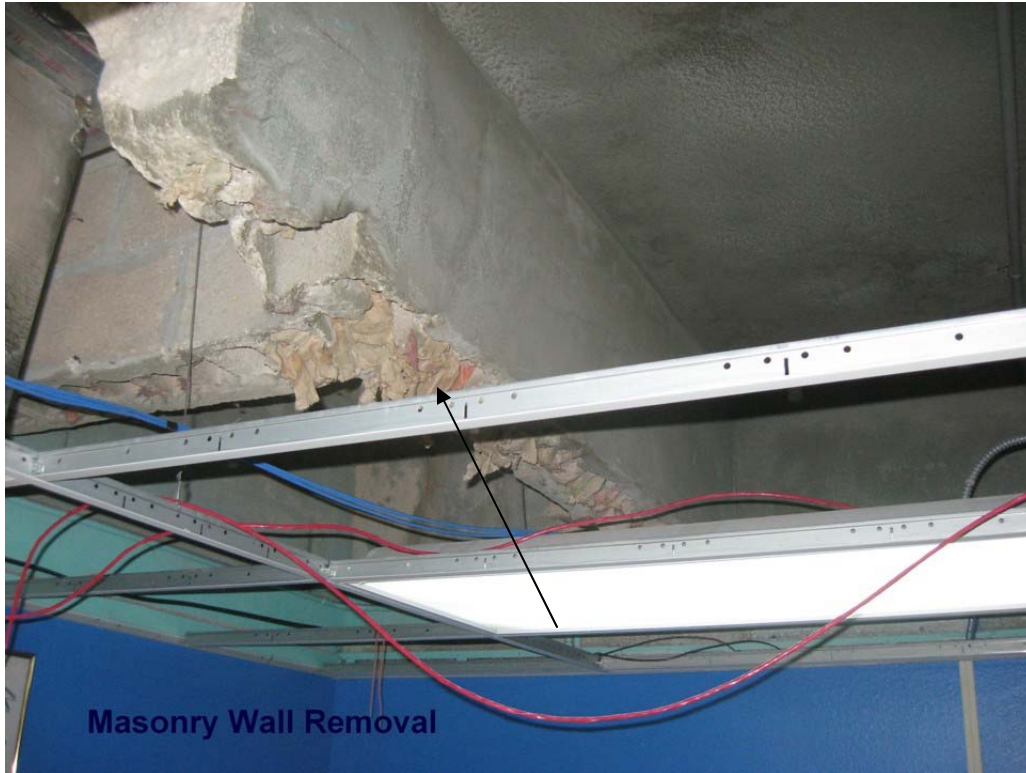
Photo #3

3. There are numerous locations where original load bearing masonry walls have been removed that were supporting the concrete roof slab. The only portion of the existing walls that remain is the top of wall tie beams. These beams were obviously not designed as clearspan beams.

Masonry Wall Removal

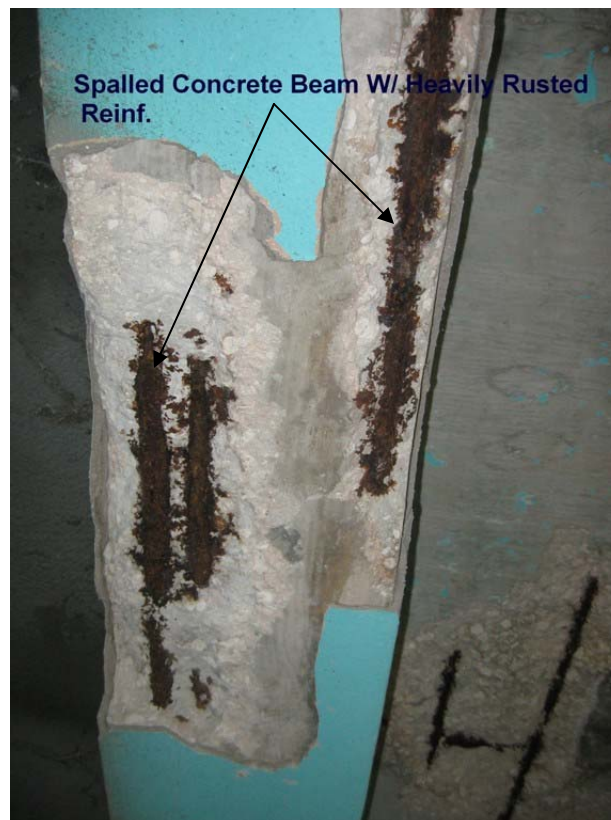
Photo #4

6. There are many locations where concrete/tie beam reinforcing is exposed at the bottom of the beams and is also heavily rusted.
7. The worst case of exposed beam reinforcing is over the men's room where what was apparently a 28" deep concrete beam spanning the entire width of the building has had 5" \pm of concrete chipped off for the entire span exposing the bottom reinforcing. This condition has seriously compromised the structural integrity of the beam and possibly transferred stresses/damage into the gymnasium wall concrete beam and column.

Spalled Concrete Beam W/ Heavily Rusted Reinf.
