Tree Permit Application **EMERGENCY**

Tree Address 711 FRANCES ROW

**Certified Arborist Tree Risk Assessment
711 Frances Street, Key West, Florida
NLE Project No. 52524001**

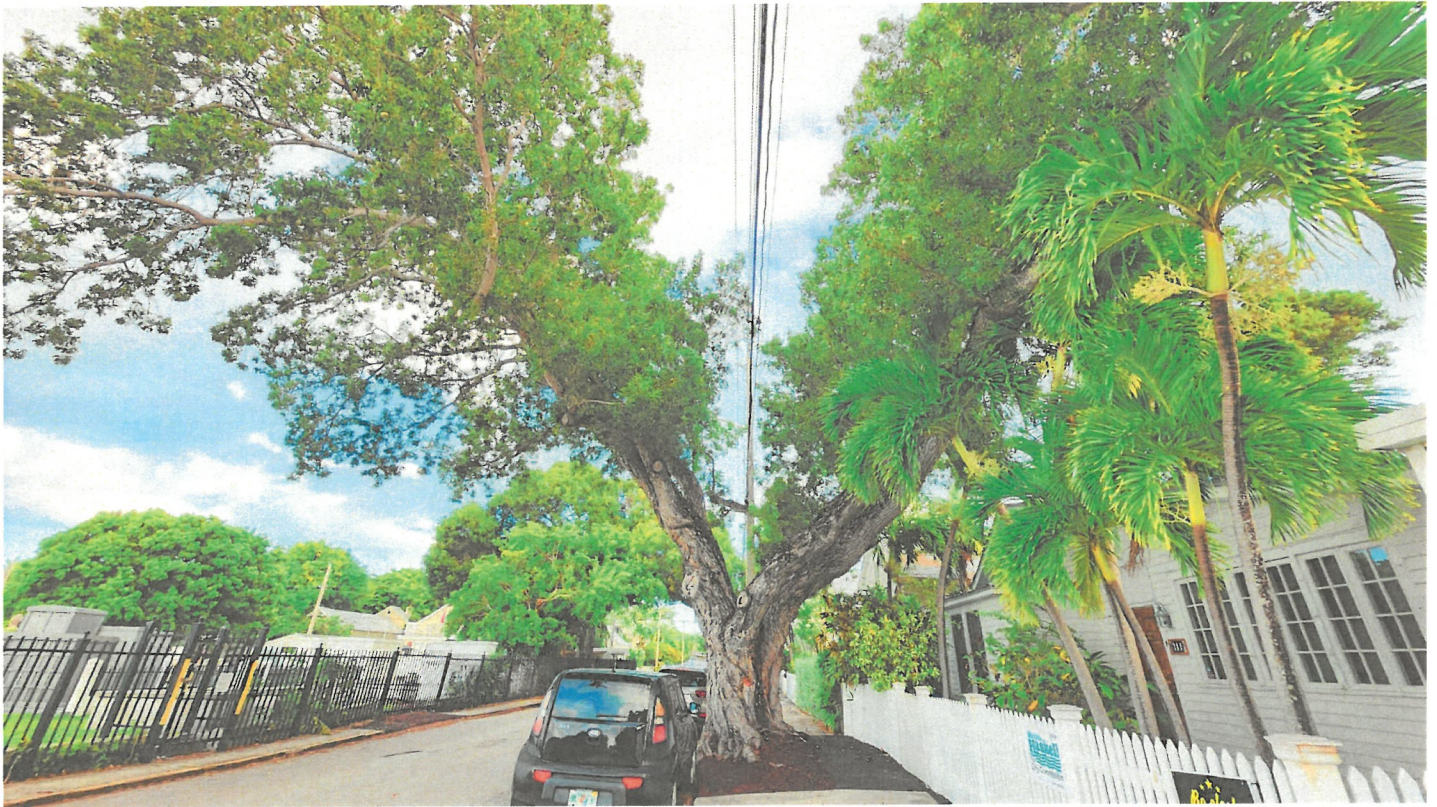
Defects and conditions of concern: This tree has two primary stems which appear to be separate (with included bark) to a point at or near the base. After many years of substantial growth of the canopy with the middle section of the canopy continually being pruned back for utility clearance, this tree has become heavily weighted toward the northeast and southwest sides, with the canopy on each side primarily growing from one of the two stems. During my field investigation, I observed a vertical crack and associated cavity which originates near the base of the tree on the side facing the roadway and proceeds approximately five feet vertically. The crack does not appear to have broken the grain of the wood within either stem but rather appears to be a split of the bark which superficially connects the two main stems. This is evidenced by the smooth and rounded appearance of the wood within the cavity with no evidence of splintering or fractures within either stem. Wound wood has formed along the crack, indicating that the tree is responding to this condition and is still growing, and the crack is not observed on the other side of the tree.

Photo 3. View of the form of the canopy from the southeast along the line of the overhead utility lines, demonstrating the divergence of the canopy originating from each of the two main stems.

1. Remove the tree in its entirety, potentially with replacement with another tree that is appropriate for growth under utility lines
2. Reduce the likelihood for the split worsening by reducing the length and height of the branches (reducing the weight and pull on the split) and installing cabling support to help prevent the two stems from splitting substantially further. Note that with this mitigation option the risk will remain *high* but it may be further reduced over time. If this option is taken, the tree should be inspected at minimum weekly until these mitigation measures are completed and then monthly until either the tree shows substantial progression to close the cavity or until the crack progresses in width in which case removal should be the only mitigation option from that point.
