Tree Permit Application **EMERGENCY**

Tree Address 711 FRANCES ROW

**Certified Arborist Tree Risk Assessment
711 Frances Street, Key West, Florida
NLE Project No. 52524001**

Tree No. 1, 60" DBH West Indian mahogany (*Swietenia mahagoni*)

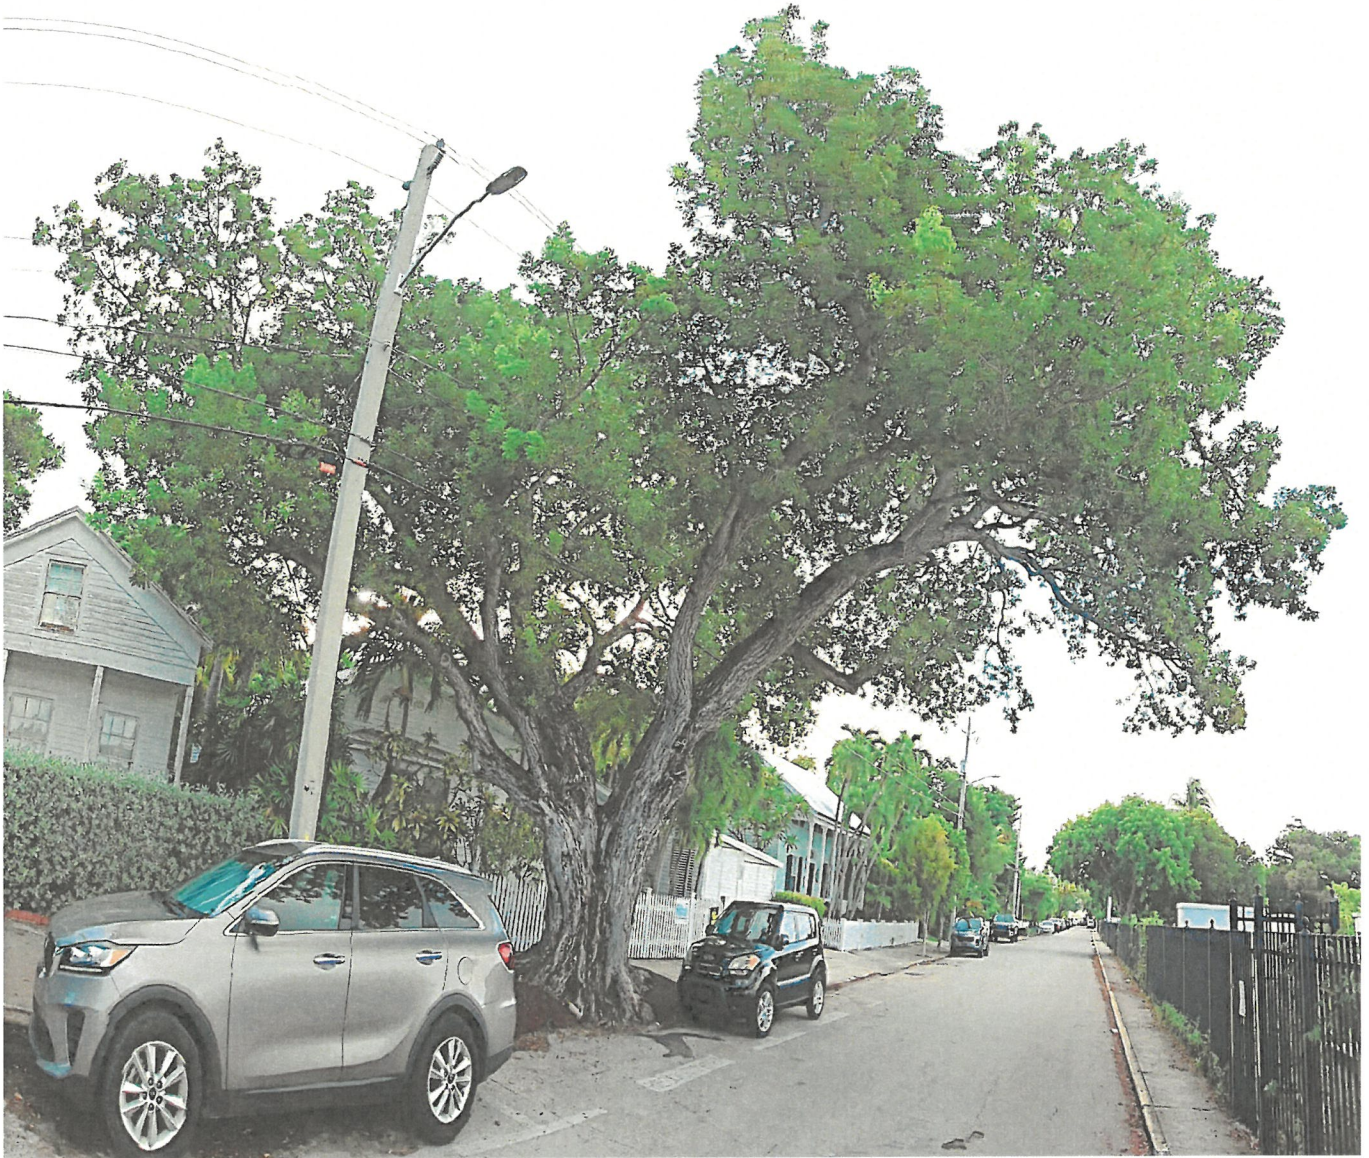
Photo 1. Overview of the tree from the north, from a point within Frances street

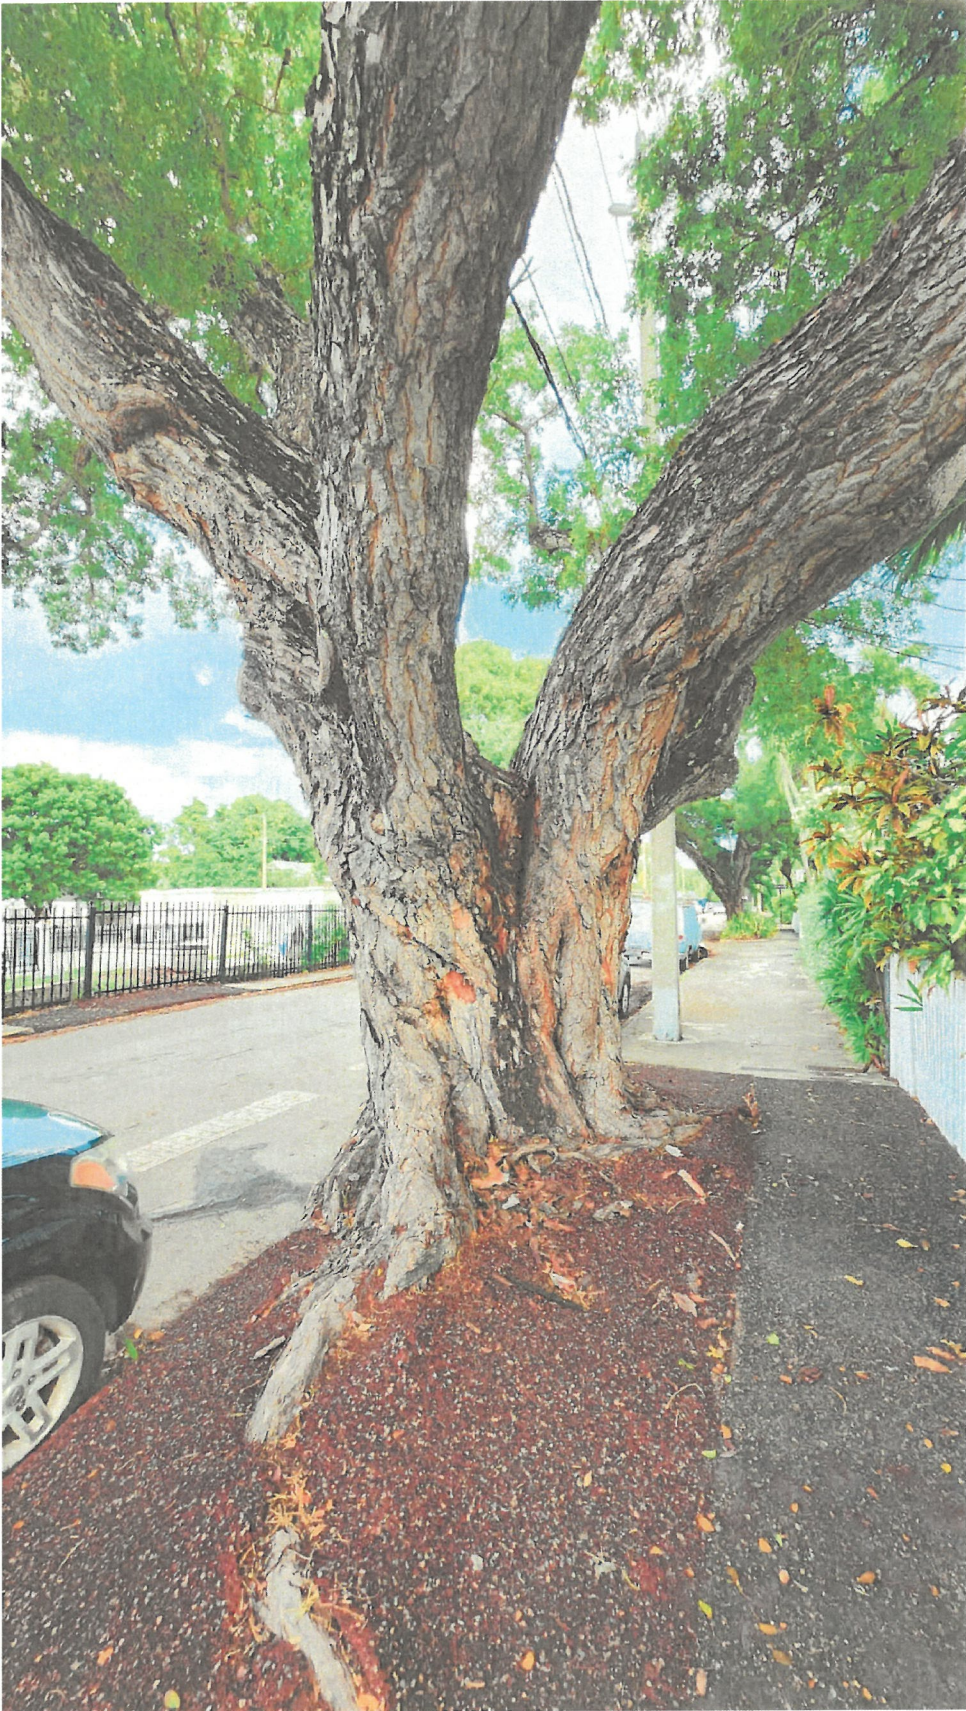
Photo 2. View of the tree from the south from within the sidewalk

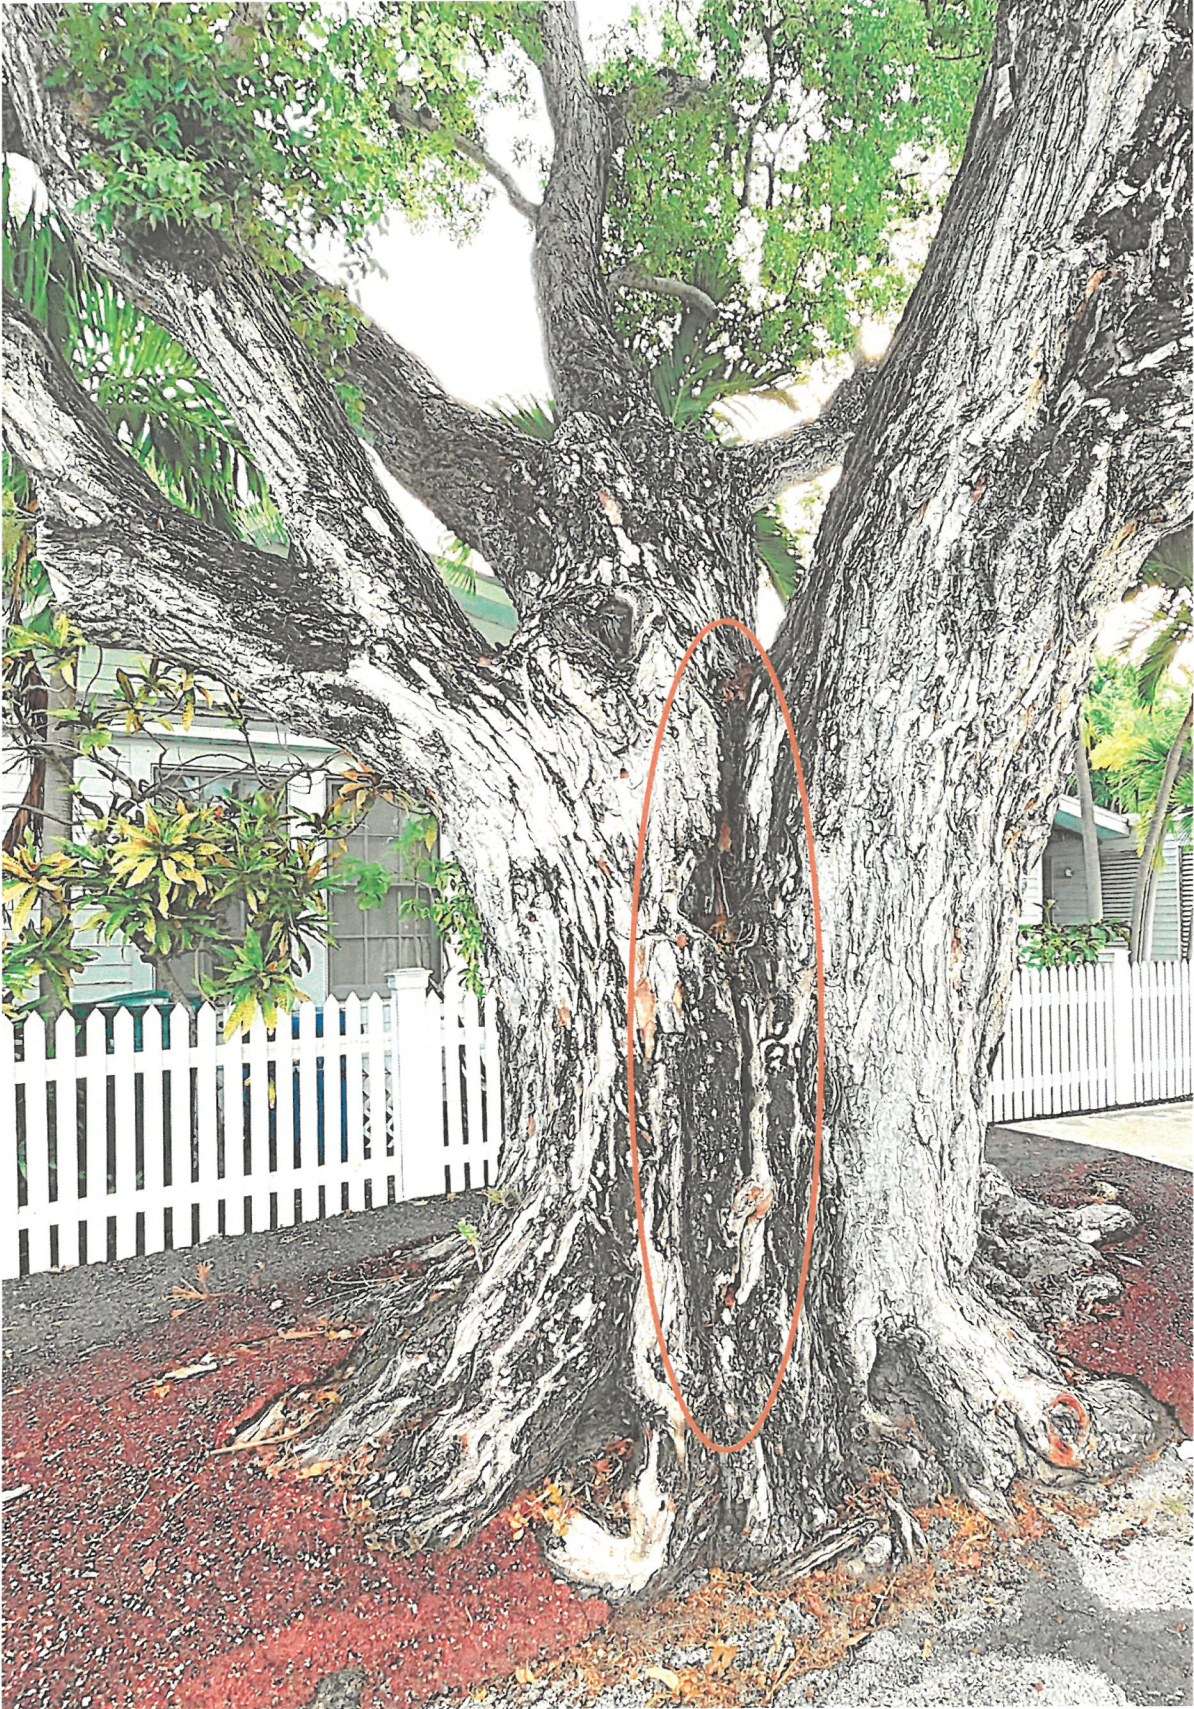
Defects and conditions of concern: This tree has two primary stems which appear to be separate (with included bark) to a point at or near the base. After many years of substantial growth of the canopy with the middle section of the canopy continually being pruned back for utility clearance, this tree has become heavily weighted toward the northeast and southwest sides, with the canopy on each side primarily growing from one of the two stems. During my field investigation, I observed a vertical crack and associated cavity which originates near the base of the tree on the side facing the roadway and proceeds approximately five feet vertically. The crack does not appear to have broken the grain of the wood within either stem but rather appears to be a split of the bark which superficially connects the two main stems. This is evidenced by the smooth and rounded appearance of the wood within the cavity with no evidence of splintering or fractures within either stem. Wound wood has formed along the crack, indicating that the tree is responding to this condition and is still growing, and the crack is not observed on the other side of the tree.

The primary concern for this tree is that this vertical crack will continue to expand in width. If this occurs it could lead to either one or both of the main stems of the tree losing structural stability and failing, i.e. falling from a point at or near the base of the tree. If the stem on the east side were to fail it would have a *high* likelihood of impacting the abutting residence. Due to the size of the stem, if it were to fail it would have *significant to severe* consequences to the house and people inside, signifying that property damage would be such that the house would require significant reconstruction to be livable and people inside could be seriously injured or killed. If the stem on the west side were to fail it would have a *high* likelihood of *significant* impacts, namely damaging parked cars on the street and blocking Frances Street for an extended period of time.

Based on the observations and analysis as described, the resulting risk rating for this tree is *High*. If no steps to mitigate this risk are taken, it is *possible* that failure could occur within the next two years. In order to reduce the risk associated with this tree, there are two main options I identified:

Photo 4. View of the vertical crack in the trunk as viewed from Frances Street.

1. Remove the tree in its entirety, potentially with replacement with another tree that is appropriate for growth under utility lines
2. Reduce the likelihood for the split worsening by reducing the length and height of the branches (reducing the weight and pull on the split) and installing cabling support to help prevent the two stems from splitting substantially further. Note that with this mitigation option the risk will remain *high* but it may be further reduced over time. If this option is taken, the tree should be inspected at minimum weekly until these mitigation measures are completed and then monthly until either the tree shows substantial progression to close the cavity or until the crack progresses in width in which case removal should be the only mitigation option from that point.
