*Final Preliminary Design Memorandum*  
(PDM)

# **Fleming Key Bridge Pipe Support Piling Repairs**

Prepared for  
**City of Key West, Florida**

November 14, 2013

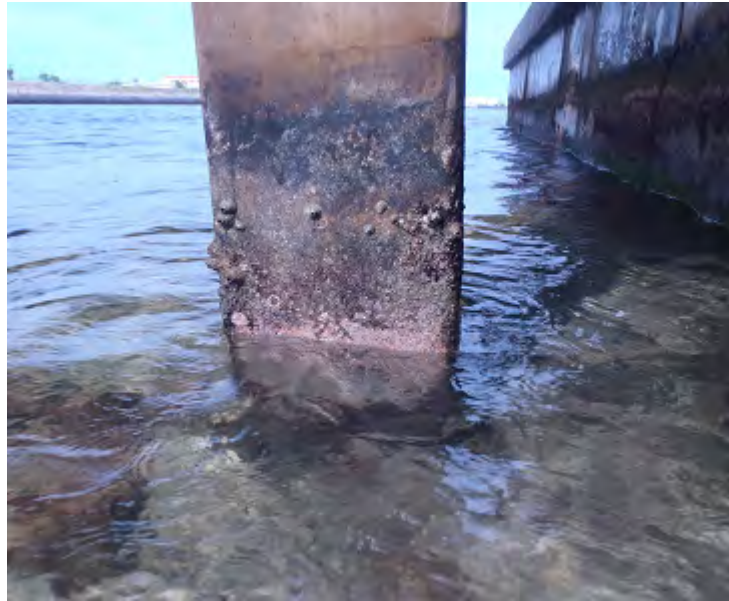
**Pile 13:** Denizens' underwater dive inspection began at the North end of the Fleming Key Bridge, with pipe support Pile Cap 12-13; following the same pile inspection order that Seamar Divers followed in 2003. Therefore, the following narrative is presented in the same order, beginning with Pile 13, which as seen in Photo No. 2 is in shallow water. No cracks were found in this pile. Pile 13 is considered to have a Condition Rating of 6 and is in Good Condition.

**Photo No. 2: East Face of Pile 13.**

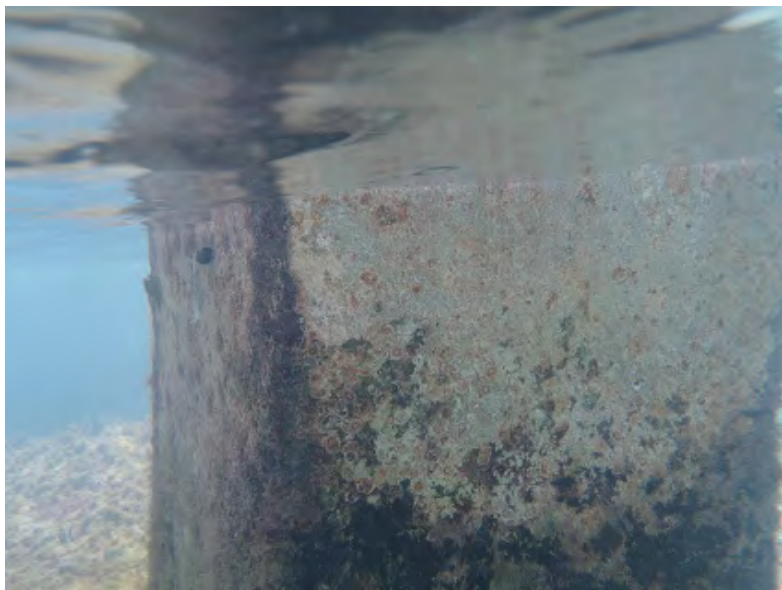
**Pile 12:** No cracks were found in this pile. Pile 12 is considered to have a Condition Rating of 6 and is in Good Condition.

**Photo No. 3: West Face of Pile 12, with no apparent pitting visible.**

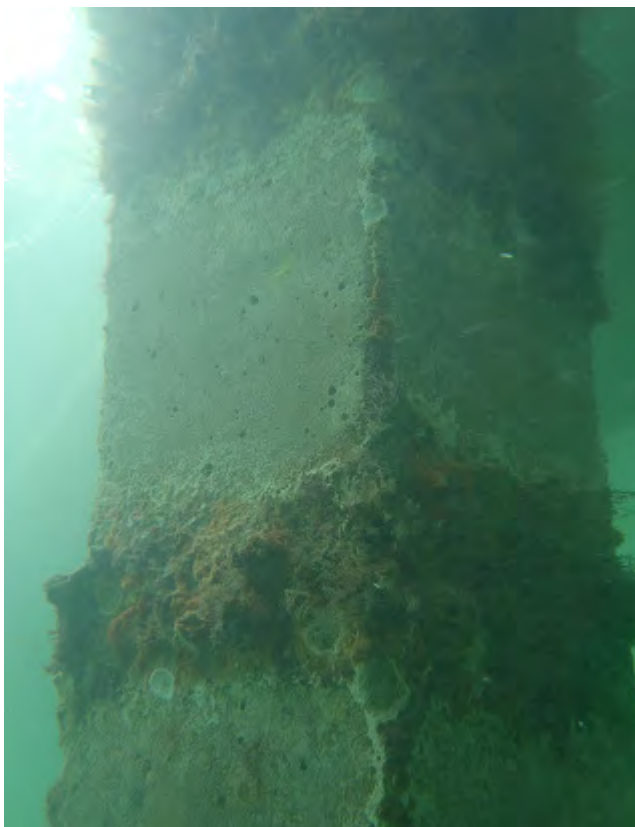
**Pile 2:** No cracks were found in this pile. Pile 2 is considered to have a Condition Rating of 6 and is in Good Condition.

**Photo No. 4: Northwest Corner of Pile 2, random pitting visible.**

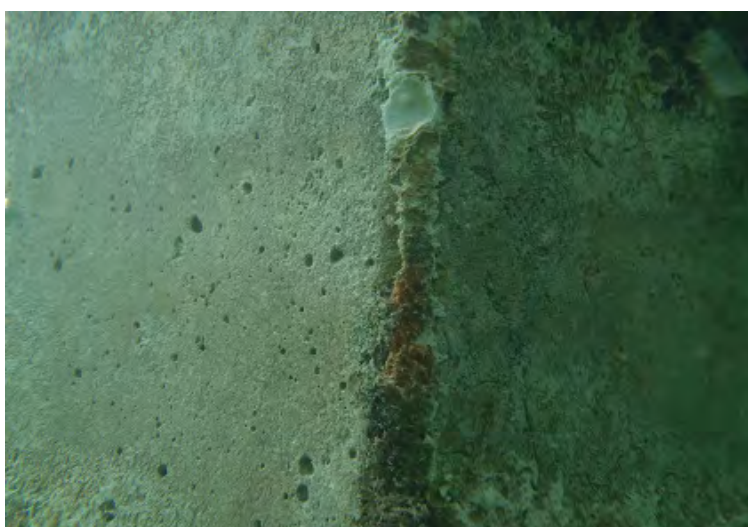
**Photo No. 5: Close-up view of Northwest Corner of Pile 2, random pitting visible.**

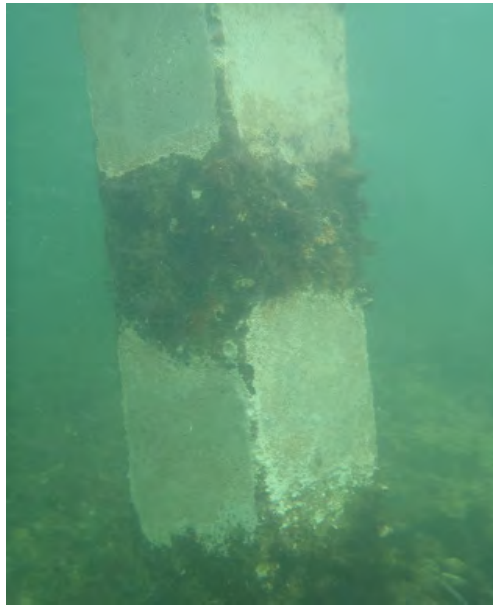
**Pile 1:** No cracks were found in this pile. There is a spall above the water line on the Southeast corner that measures 2 inches wide by 15 inches tall by 1½ inches deep with no rust observed. Pile 1 is considered to have a Condition Rating of 6 and is in Good Condition.

**Photo No. 6: South Face of Pile 1, with two 12 inch bands of marine growth removed.**

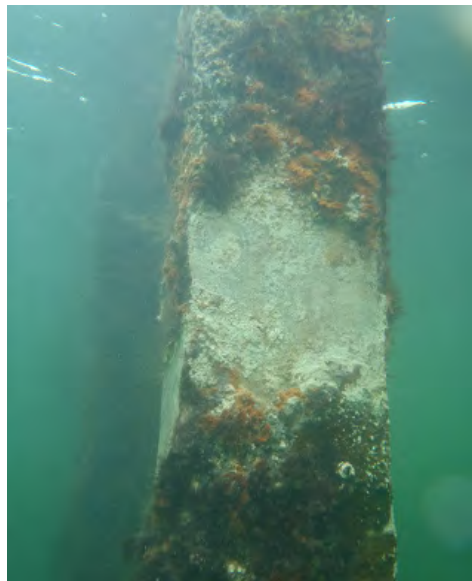
**Pile 4:** No cracks were found in this pile. Minor pitting up to 1/4 inch deep around this pile. Pile 4 is considered to have a Condition Rating of 6 and is in Good Condition.

**Photo No. 7: East Face of Pile 4, with marine growth removed and minor pitting visible.**

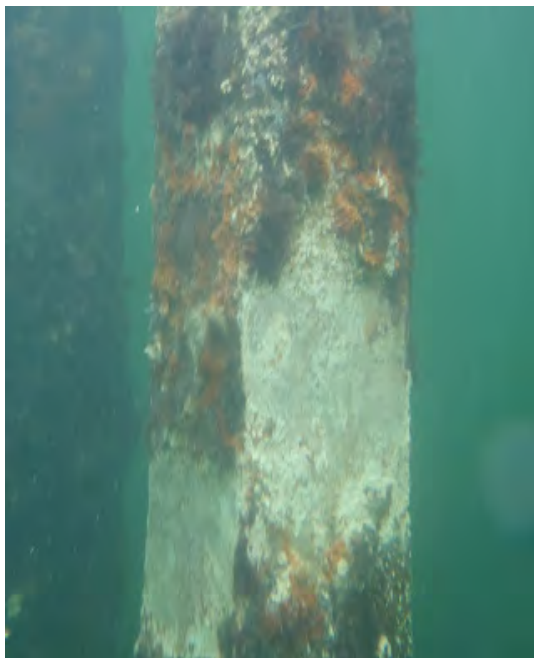
**Photo No. 8: East Face of Pile 4, upper portion of marine growth removed.**

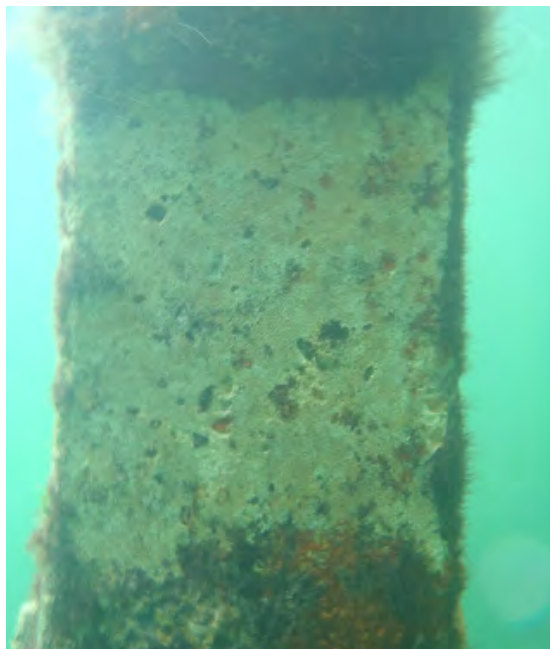
**Pile 3:** No cracks were found in this pile. Minor pitting up to 3/8 inch deep around this pile. Pile 3 is considered to have a Condition Rating of 6 and is in Good Condition.

**Photo No. 9: Close-up view of North Face of Pile 3, with marine growth removed and pitting visible.**

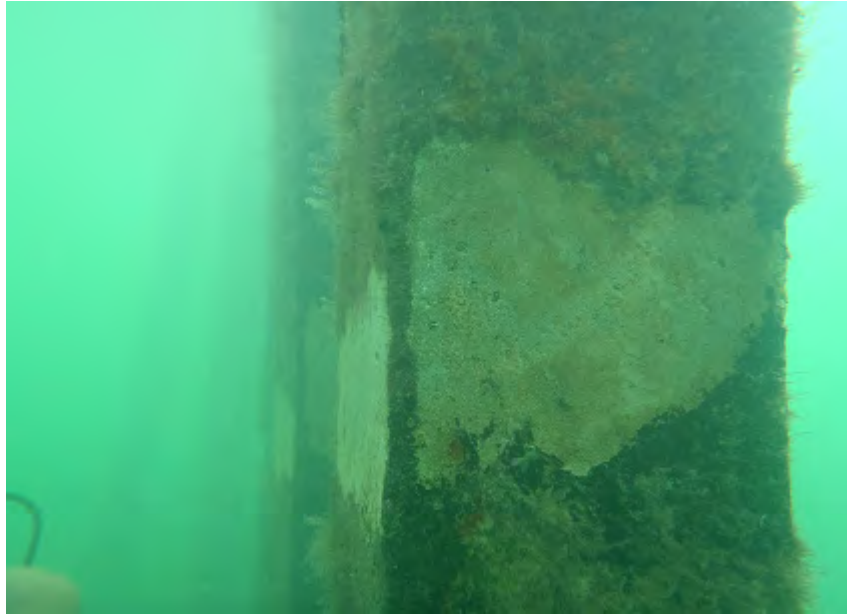
**Pile 7:** No cracks were found in this pile. Minor pitting up to 1/8 inch deep around the pile. Pile 7 is considered to have a Condition Rating of 6 and is in Good Condition.

**Photo No. 10: West Face of Pile 7, with minor pitting visible.**

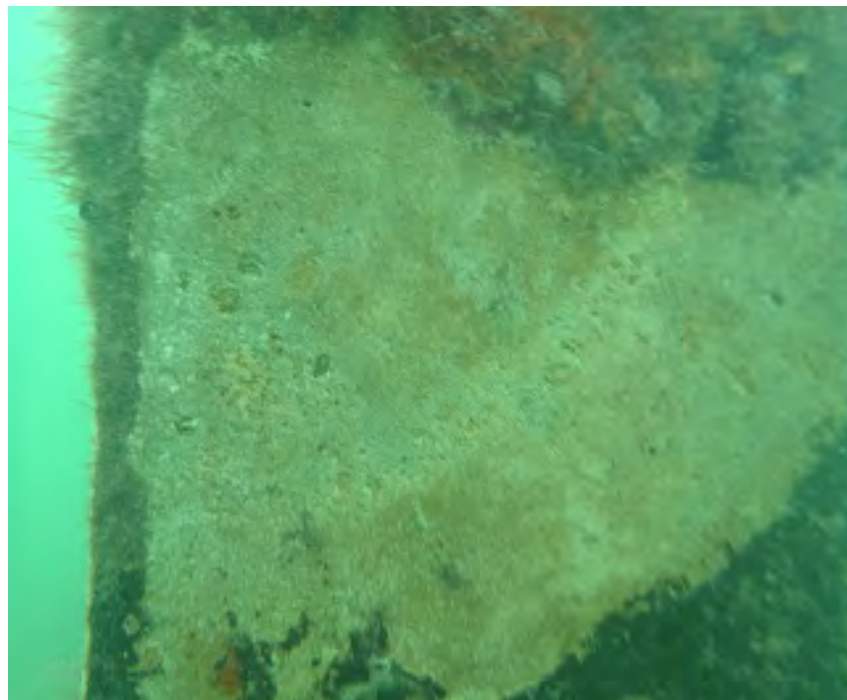
**Photo No. 11: Close-up view of West Face of Pile 7, with minor pitting visible.**

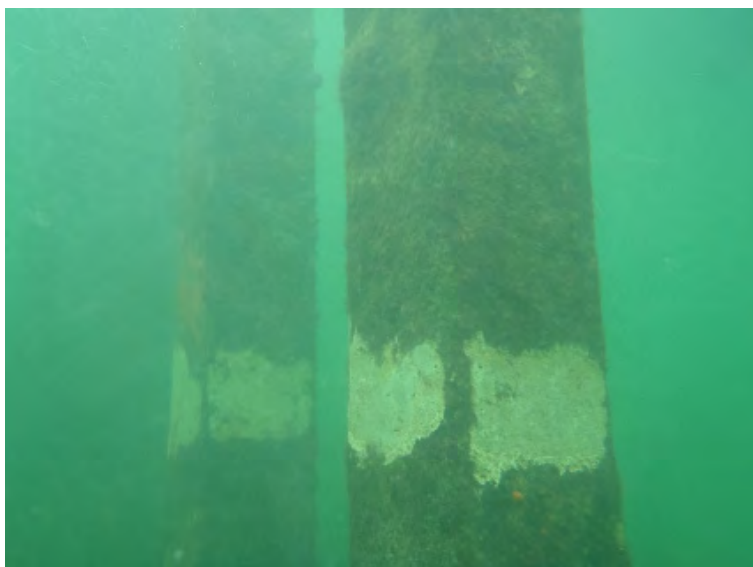
**Pile 6:** In the mid-1990s, Pile 6 was struck by a boat and sustained structural damage. To provide supplemental load capacity to Pile 6, a new pile (Pile 5) was driven to the outside of Pile 6 and the cast-in-place concrete pile cap was extended. No damage was noted to Pile 6 below the water line. However, the structural condition of Pile 6 was not determined below the mudline. The portion of Pile 6 above the water line has several cracks in both the exposed pile face and the shotcrete repair, which was made several years ago. These are mostly vertical cracks, with the exception of the West Face of the pile, where horizontal cracks were found. Although this pile had been repaired in the past with shotcrete, some of the cracks have rust bleeding through them. The largest cracks are roughly 3/8 inch wide by 4 feet long. Minor pitting below the waterline, up to 1/4 inch deep, was recorded around the pile. Pile 6 is considered to have a Condition Rating of 2 and is in Serious Condition, because of the damage caused by the boat impact.

**Photo No. 12: Southeast Corner of Pile 6, with no visible damage.**

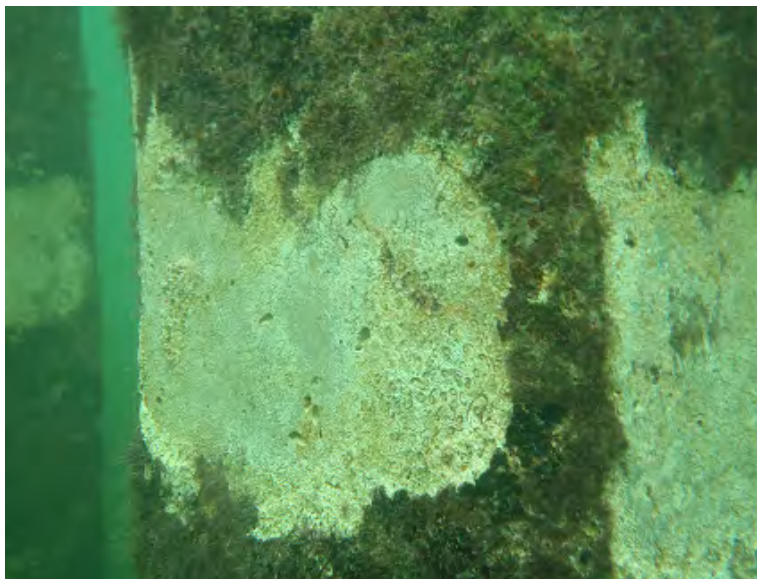
**Photo No. 13: Close-up view of Southeast Corner of Pile 6, with minor pitting visible.**

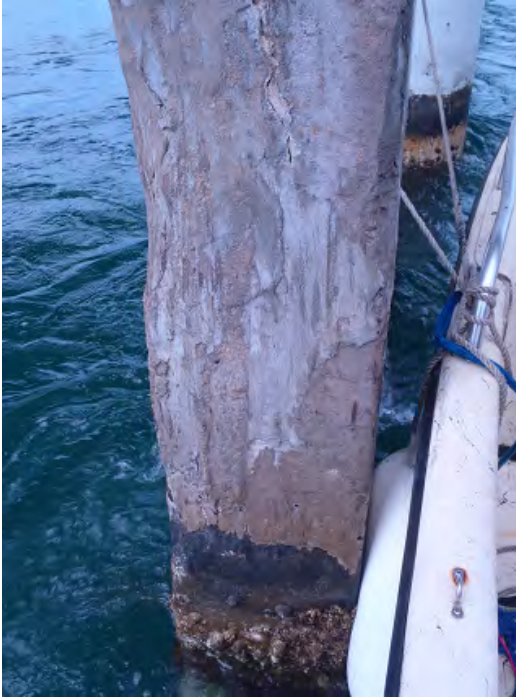
**Photo No. 14: Above water view of the East Face of Pile 6, with vertical cracks visible in shotcrete repair.**

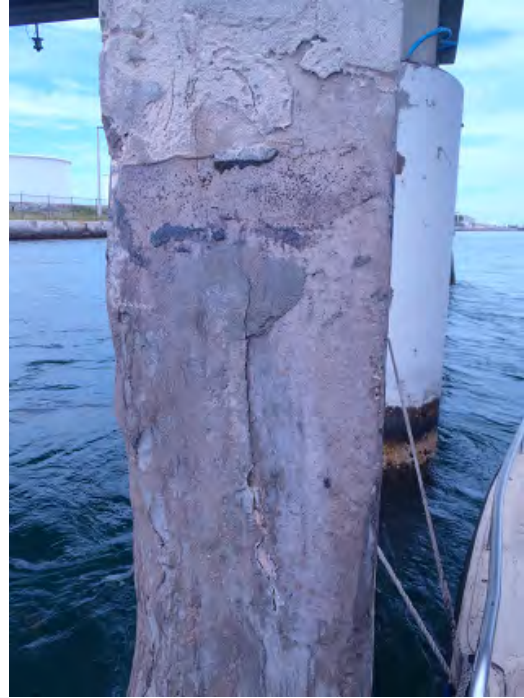
**Photo No. 15: East Face of Pile 6, with vertical cracks visible in shotcrete repair.**

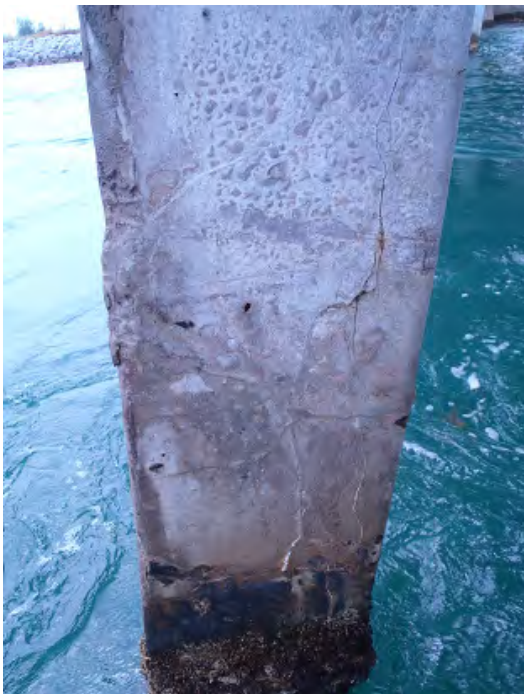
**Photo No. 16: Above water view of the North Face of Pile 6, with cracks visible in shotcrete repair.**

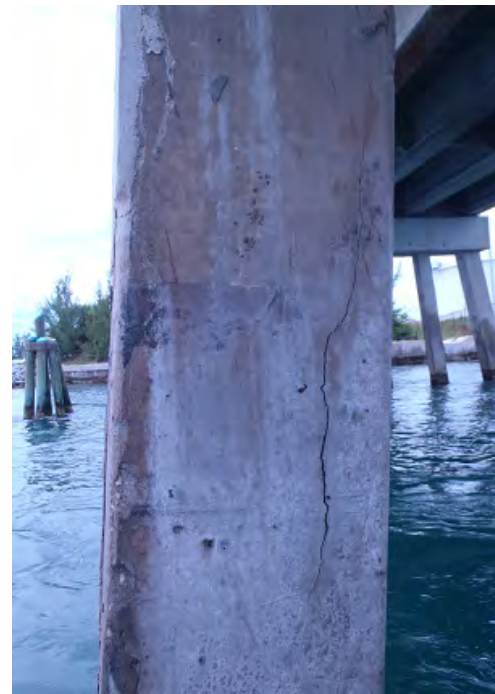
**Photo No. 17: South Face of Pile 6, with vertical cracks visible in shotcrete repair. Vertical cracks extend beyond the limits of the shotcrete repair and into the concrete pile itself.**

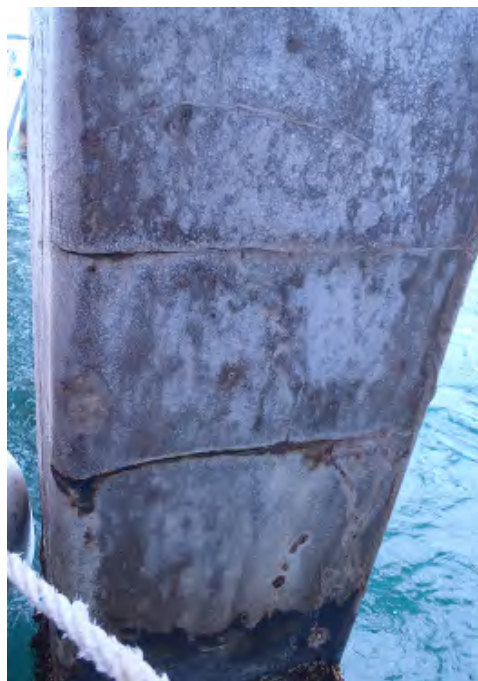
**Photo No. 19: West Face of Pile 6, with horizontal cracks visible, with rust stains bleeding through.**

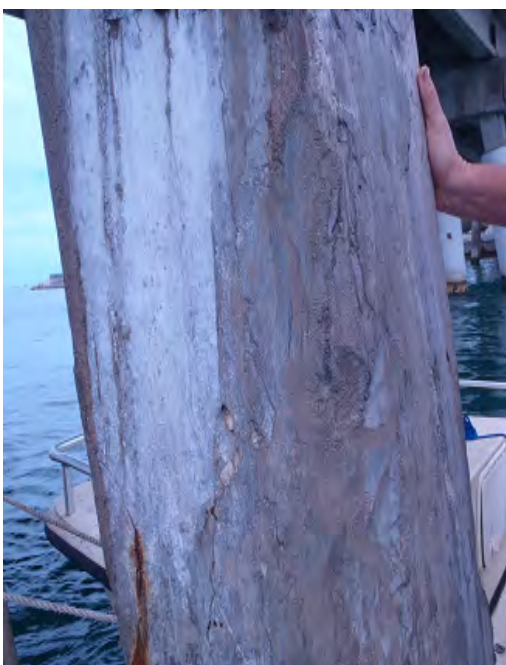
**Photo No. 20: Upper portion of South Face of Pile 6, with vertical cracks visible in shotcrete repair and rust stains bleeding through.**

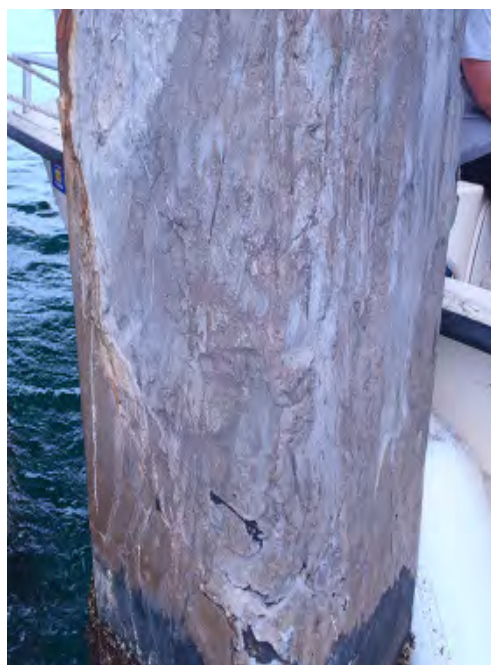
**Photo No. 21: Lower portion of South Face of Pile 6, with vertical cracks visible in shotcrete repair and rust stains bleeding through.**

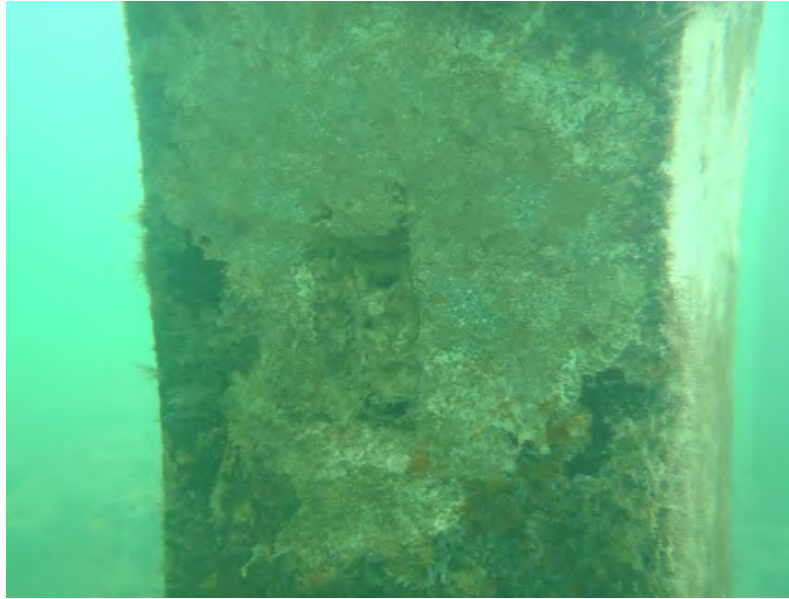
**Pile 5:** No cracks were found in this pile. Pile 5 is one of the piles that make up the only pile cap, with three piles. This pile appears to have been installed, due to the damage that has occurred to Pile 6. It appears that a block of wood or a concrete brick was part of the casting of this pile and has either deteriorated or has been removed. It has left a depression in the west face of the pile, which is approximately 3 feet above the mudline. The depressed area is approximately 3 inches wide by 6 inches long by 3/4 inch deep. Pile 5 is considered to have a Condition Rating of 6 and is in Good Condition.

**Photo No. 22: West Face of Pile 5, with the depressed area visible.**

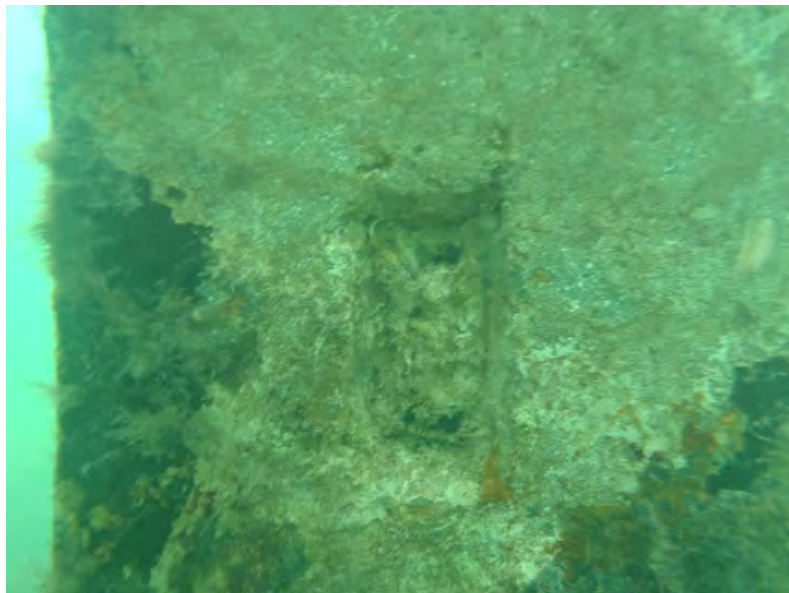
**Photo No. 23: Close-up view of the West Face of Pile 5, with the depressed area visible.**

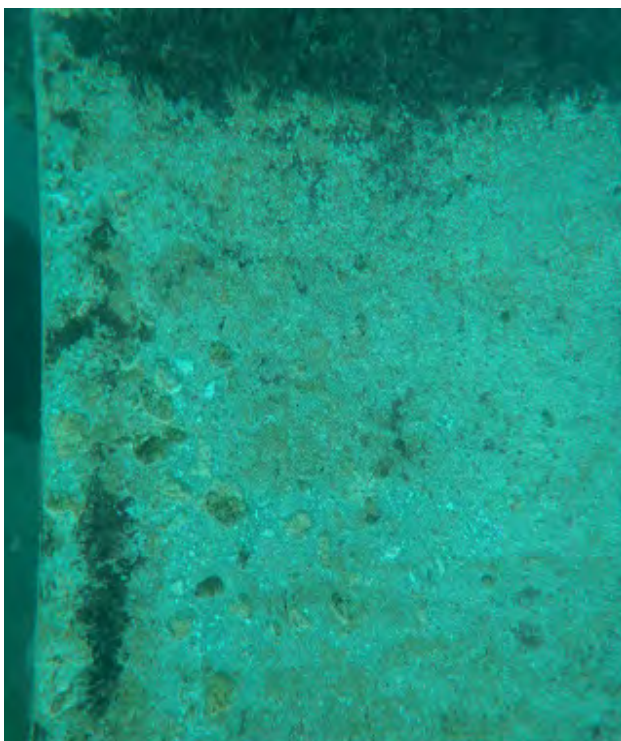
**Pile 9:** No cracks were found in the pile. Minor pitting up to 1/4 inch deep was noted around the pile. Pile 9 is considered to have a Condition Rating of 6 and is in Good Condition.

**Photo No. 25: Close-up view of the East Face of Pile 9, with minor pitting visible.**

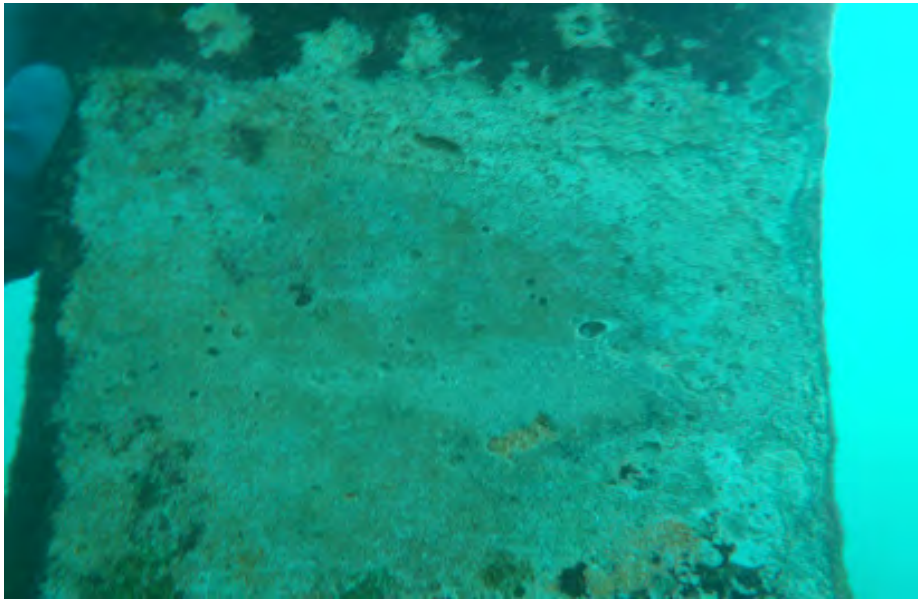
**Pile 8:** No cracks were found in this pile. The Southeast Corner is slightly eroded where the cleaning took place. The eroded area is approximately 12 inches tall by 3/4 inch deep at the corner. Pile 8 is considered to have a Condition Rating of 6 and is in Good Condition.

**Photo No. 26: Close-up view of the South Face of Pile 8, with minor pitting visible.**

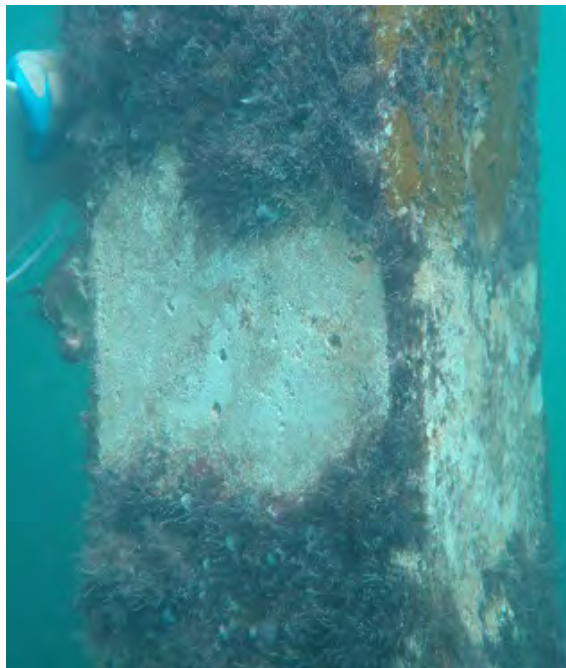
**Photo No. 27: View of South Face of Pile 11, with minor pitting visible.**

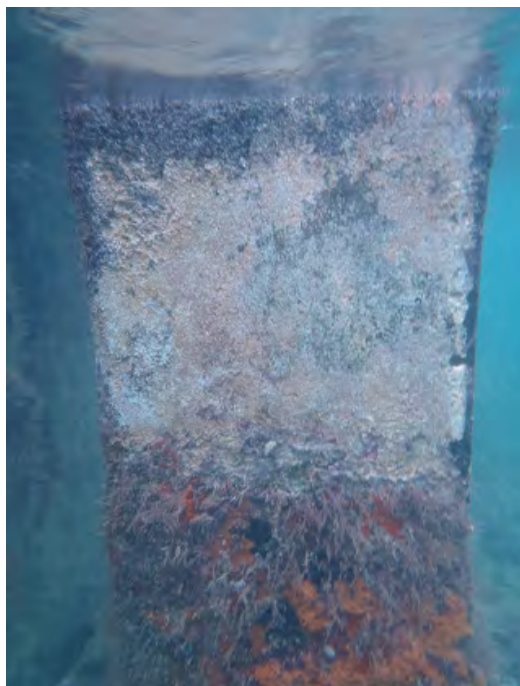
**Photo No. 29: Close-up view of East Face of Pile 15, with minimal pitting evident.**

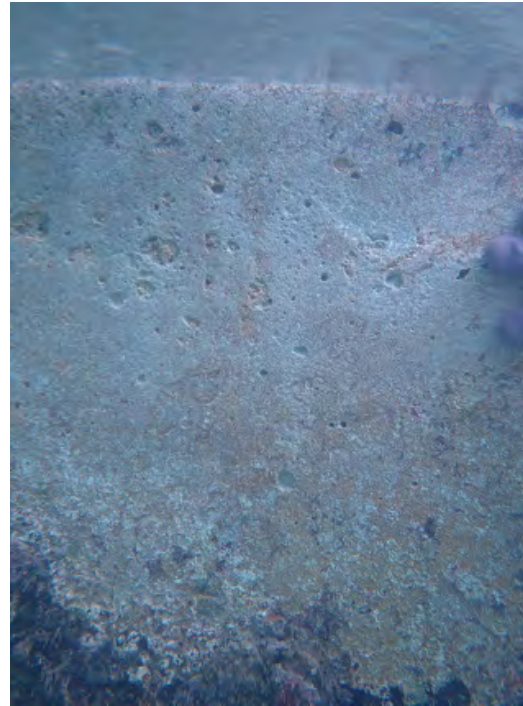
**Photo No. 31:** Close-up view of Pile 14 North Face below water, minor pitting is visible.

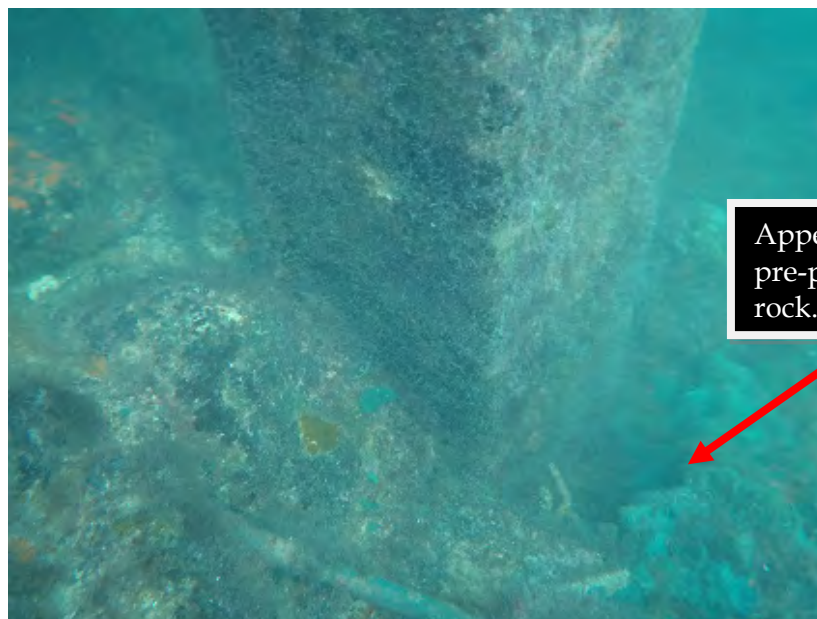
Appears to be edge of  
pre-punched hole in  
rock.

**Photo No. 32:** Typical bottom conditions at precast concrete pile, before cleaning. The bottom or mudline consists of rock, most likely coral or limestone; and it appears the rock was pre-punched before driving the pile.

As shown in Photo No. 32, the bottom or mudline beneath the Fleming Key Bridge and associated Pipe Support Pilings consists typically of coral or limestone rock. The Denizens of the Deep divers commented on the presence of rock at the mudline. Similar comments were made by the Seamar Divers, Inc.'s divers who also noted the existence of rock at the mudline.

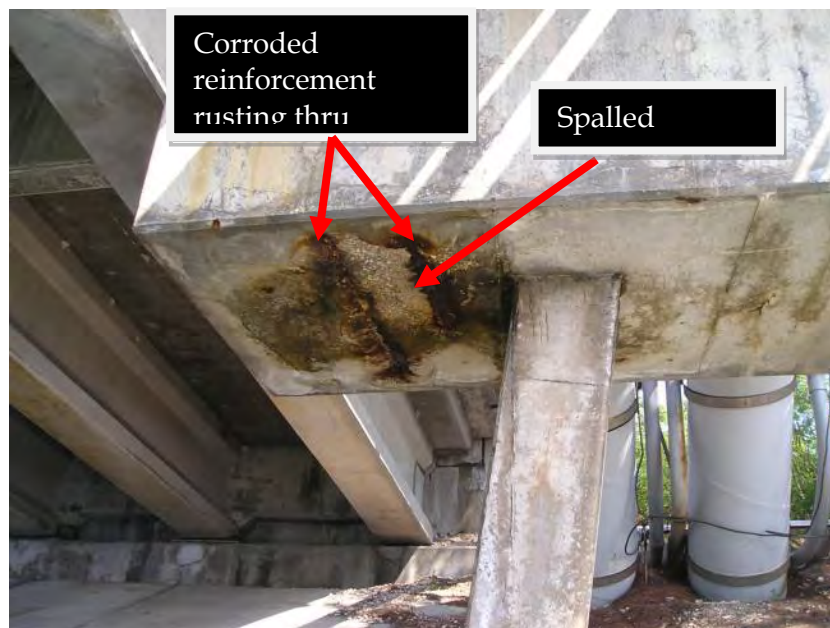
The top surface of the Pile Cap 12-13 is in good condition. A spall is visible on the underside of the pile cap above Pile 13, as may be seen in Photo No. 34. The underside and sides of the pile cap have a visible crack at Pile 12, as may be seen in Photo No. 35. Access could not be gained to the underside of the pile cap, to sound the concrete and determine the severity of the cracked and spalled section. The crack does not appear to be affecting the structural integrity of the pile

cap at this time. However, corroded reinforcement is visible at the spalled section above Pile 13. Both piles appear to be in good condition above the waterline.

**Photo No. 34: View of Pile Cap 12-13 and Pile 13, with rust stains from corroded reinforcement bleeding through pile cap soffit and spalled concrete pile cap soffit.**

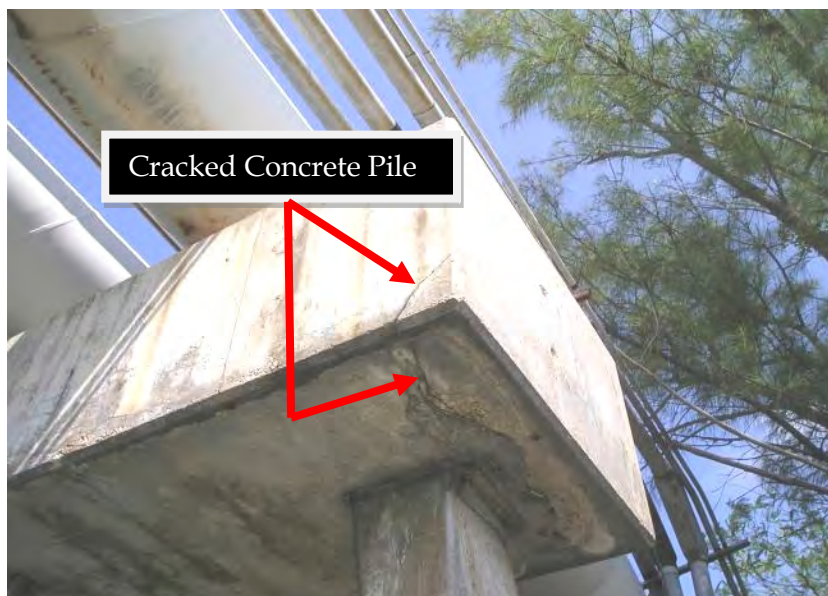
**Photo No. 35: Pile Cap 12-13 showing cracks in concrete cap at Pile 12 along the east bottom edge of the cap.**

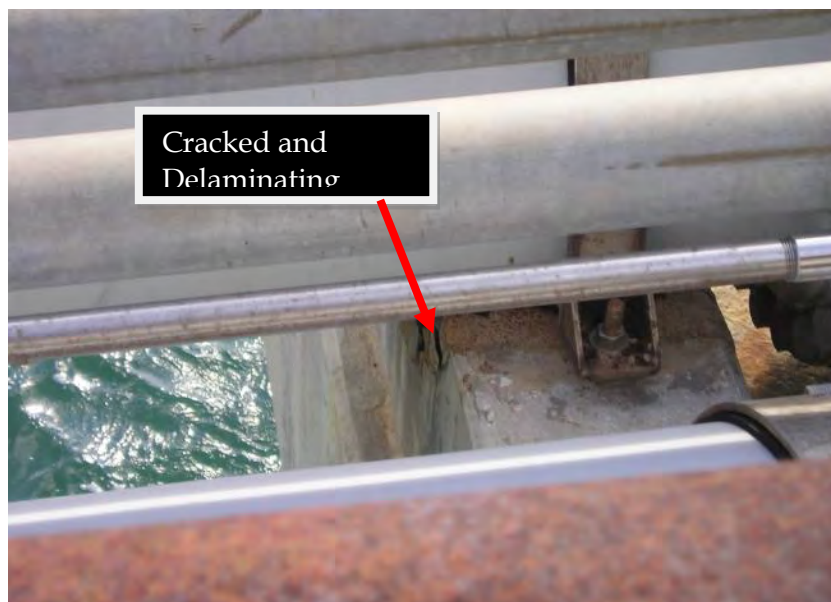
Pile Cap 3-4 appears to be in Good Condition, except for a minor delamination at the north side of the eastern pipe support saddle. Both piles, Pile 3 and Pile 4, appear to be in Good Condition above the waterline.

**Photo No. 38: Cracked and delaminating concrete visible on north side of pipe support on Pile Cap 3-4.**

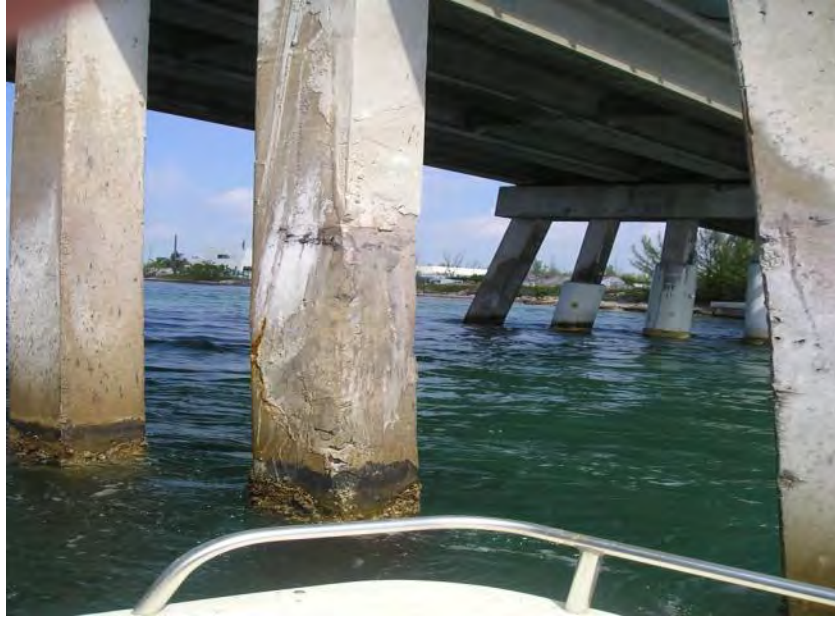
Pile Cap 5-6-7 appears to be in Good Condition. This pile cap is the only cap with three piles. The center pile (Pile 6) was damaged as the result of a mid-1990s boat impact. The pile cap was extended to the east, to accommodate a third, outer pile (Pile 5). Even though damaged Pile 6 exhibits the results of the mid-1990s boat impact, as may be seen in Photos No. 40 and No. 41, as well as Photos No. 14 through No. 21, Pile 6 continues to carry an unknown percentage of the load from the concrete pile cap. The magnitude of the load is indeterminable, because of the possibility of load sharing, by both Pile 5 and Pile 7, in addition to Pile 6. Because of this fact, it is recommended that Pile 6 be repaired by installing a pile jacket from the mudline to the pile cap. Pile 5 and Pile 7 appear to be in Good Condition above the water line.

**Photo No. 40: Damaged Pile 6, with Pile 7 to the left and Pile 5 to the right.**

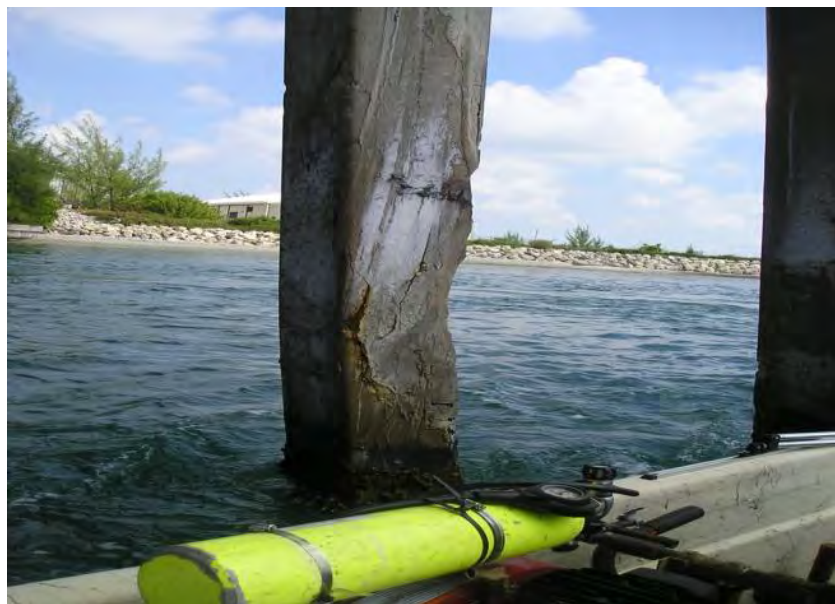
**Photo No. 41: Close-up view of damaged Pile 6, with cracked and delaminated shotcrete repair visible.**

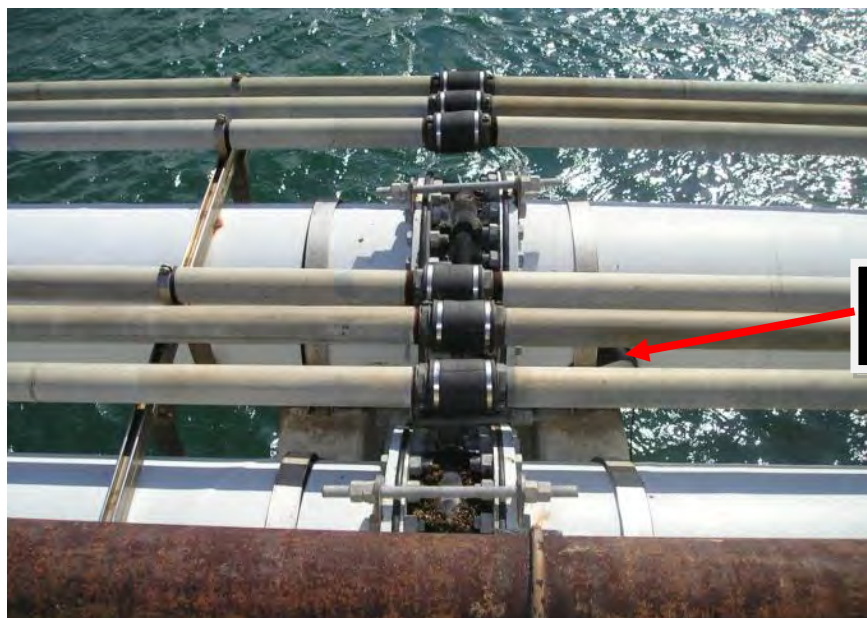
**Photo No. 43: Top view of Pile Cap 10-11.**

Pile Cap 10-11 appears to be in Good Condition. The rubber gasket between the pipe clamp and the east side pipe has been dislodged and is hanging down loose. Both piles, Pile 10 and Pile 11, appear to be in Good Condition above the waterline.

Dislodged  
Rubber Gasket

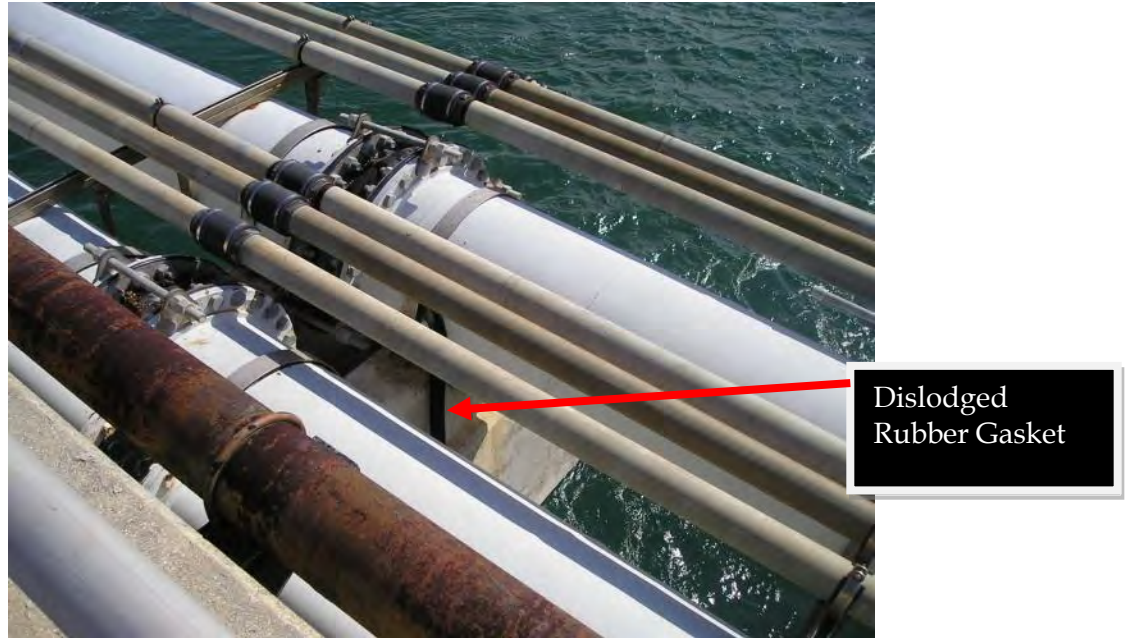
**Photo No. 44: Dislodged rubber gasket at pipe clamp at Pile Cap 10-11.**

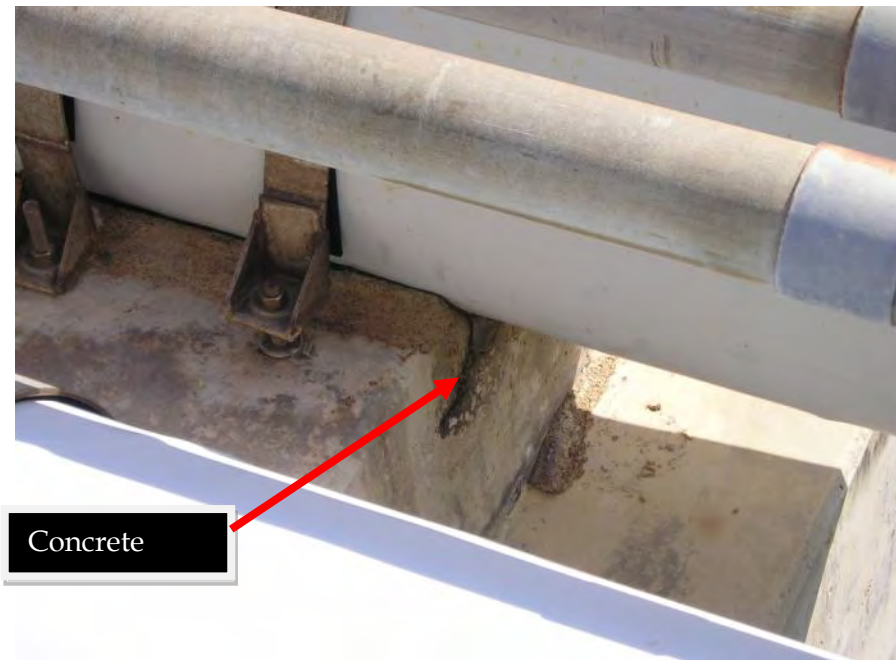
Pile Cap 14-15 appears to be in Good Condition, except for a small concrete spall on the south side of the easternmost pipe saddle and initial stage of concrete delamination on the pile cap soffit. Both piles, Pile 14 and Pile 15, appear to be in Good Condition above the waterline.

**Photo No. 46: Concrete spall on south side of pipe support on Pile Cap 14-15.**

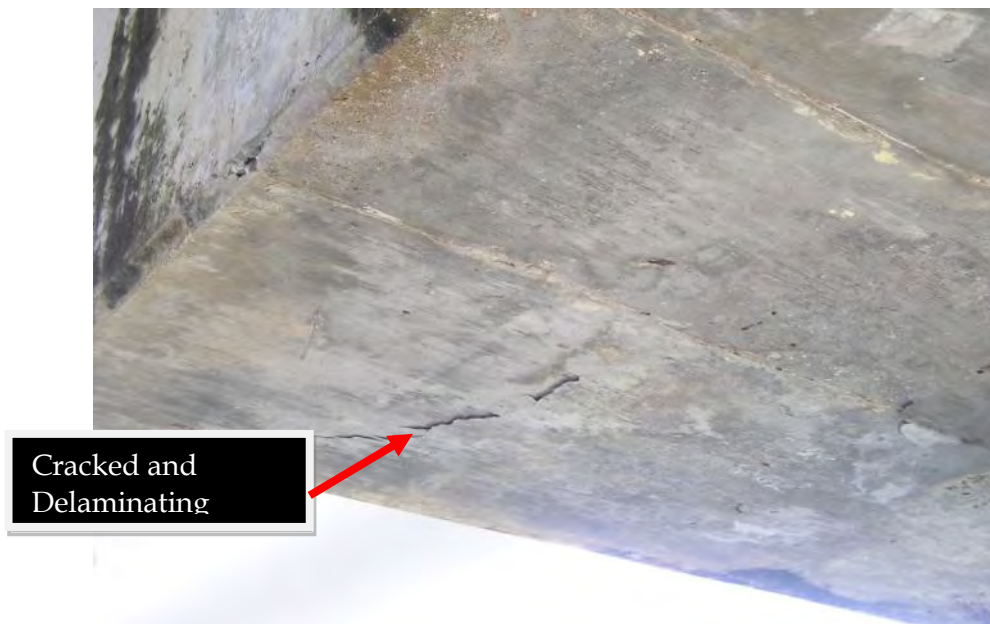
**Photo No. 47: Delaminating concrete on underside, or soffit, of Pile Cap 14-15.**

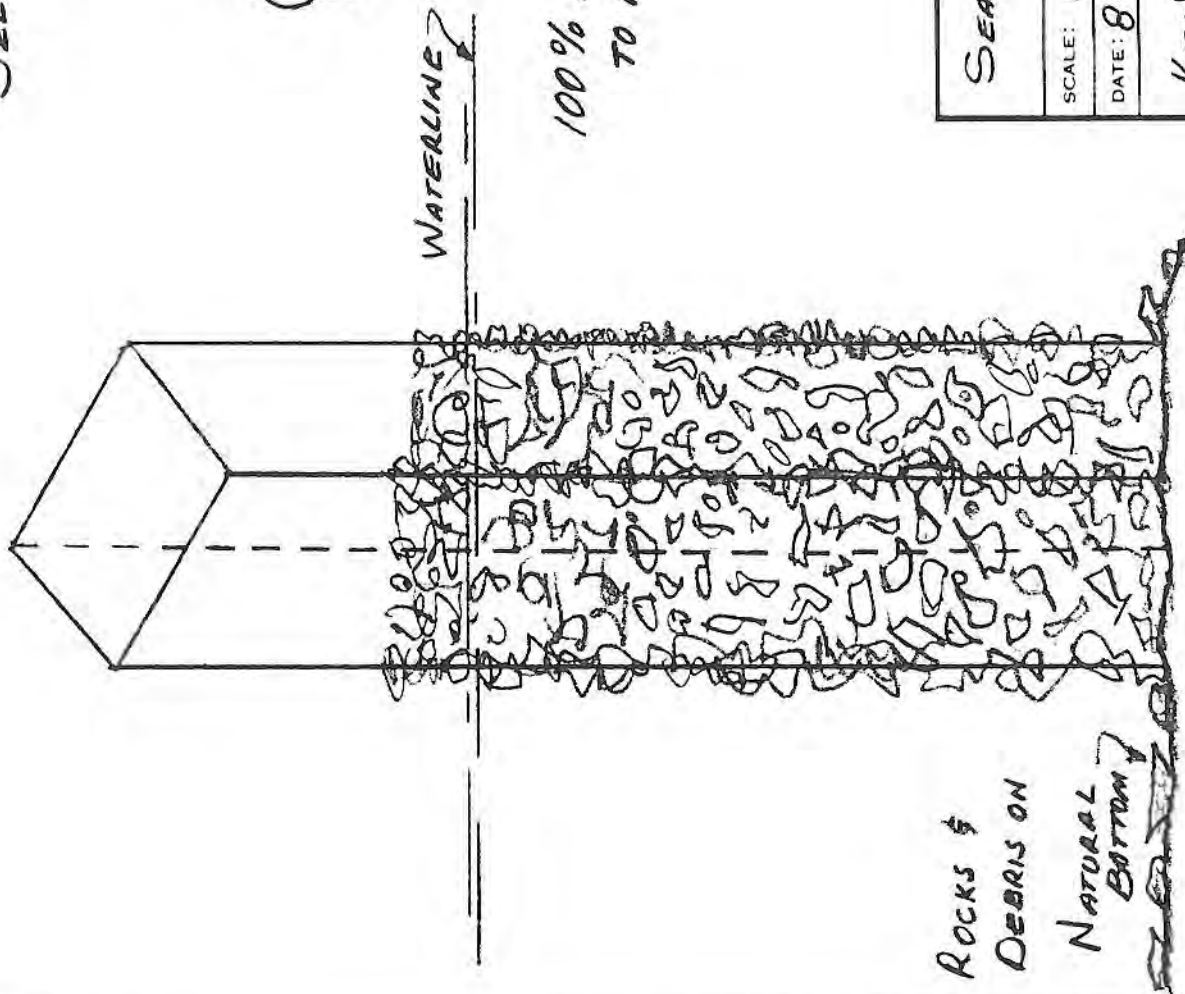
NOTE \*  
ON PILING NO. 6 EAST FACE  
THERE APPEARS TO BE MAJOR  
REPAIR ABOVE THE WATERLINE  
OF THE PILE

100% MARINE GROWTH 3' ABOVE WATERLINE  
TO NATURAL BOTTOM
