## Tree Removal Report

**PROPERTY:** 2600 Patterson Ave.

**APPLICATION NUMBER:** T2026-0132

**REQUEST:** The applicant is requesting removal of (1) Strangler Fig .

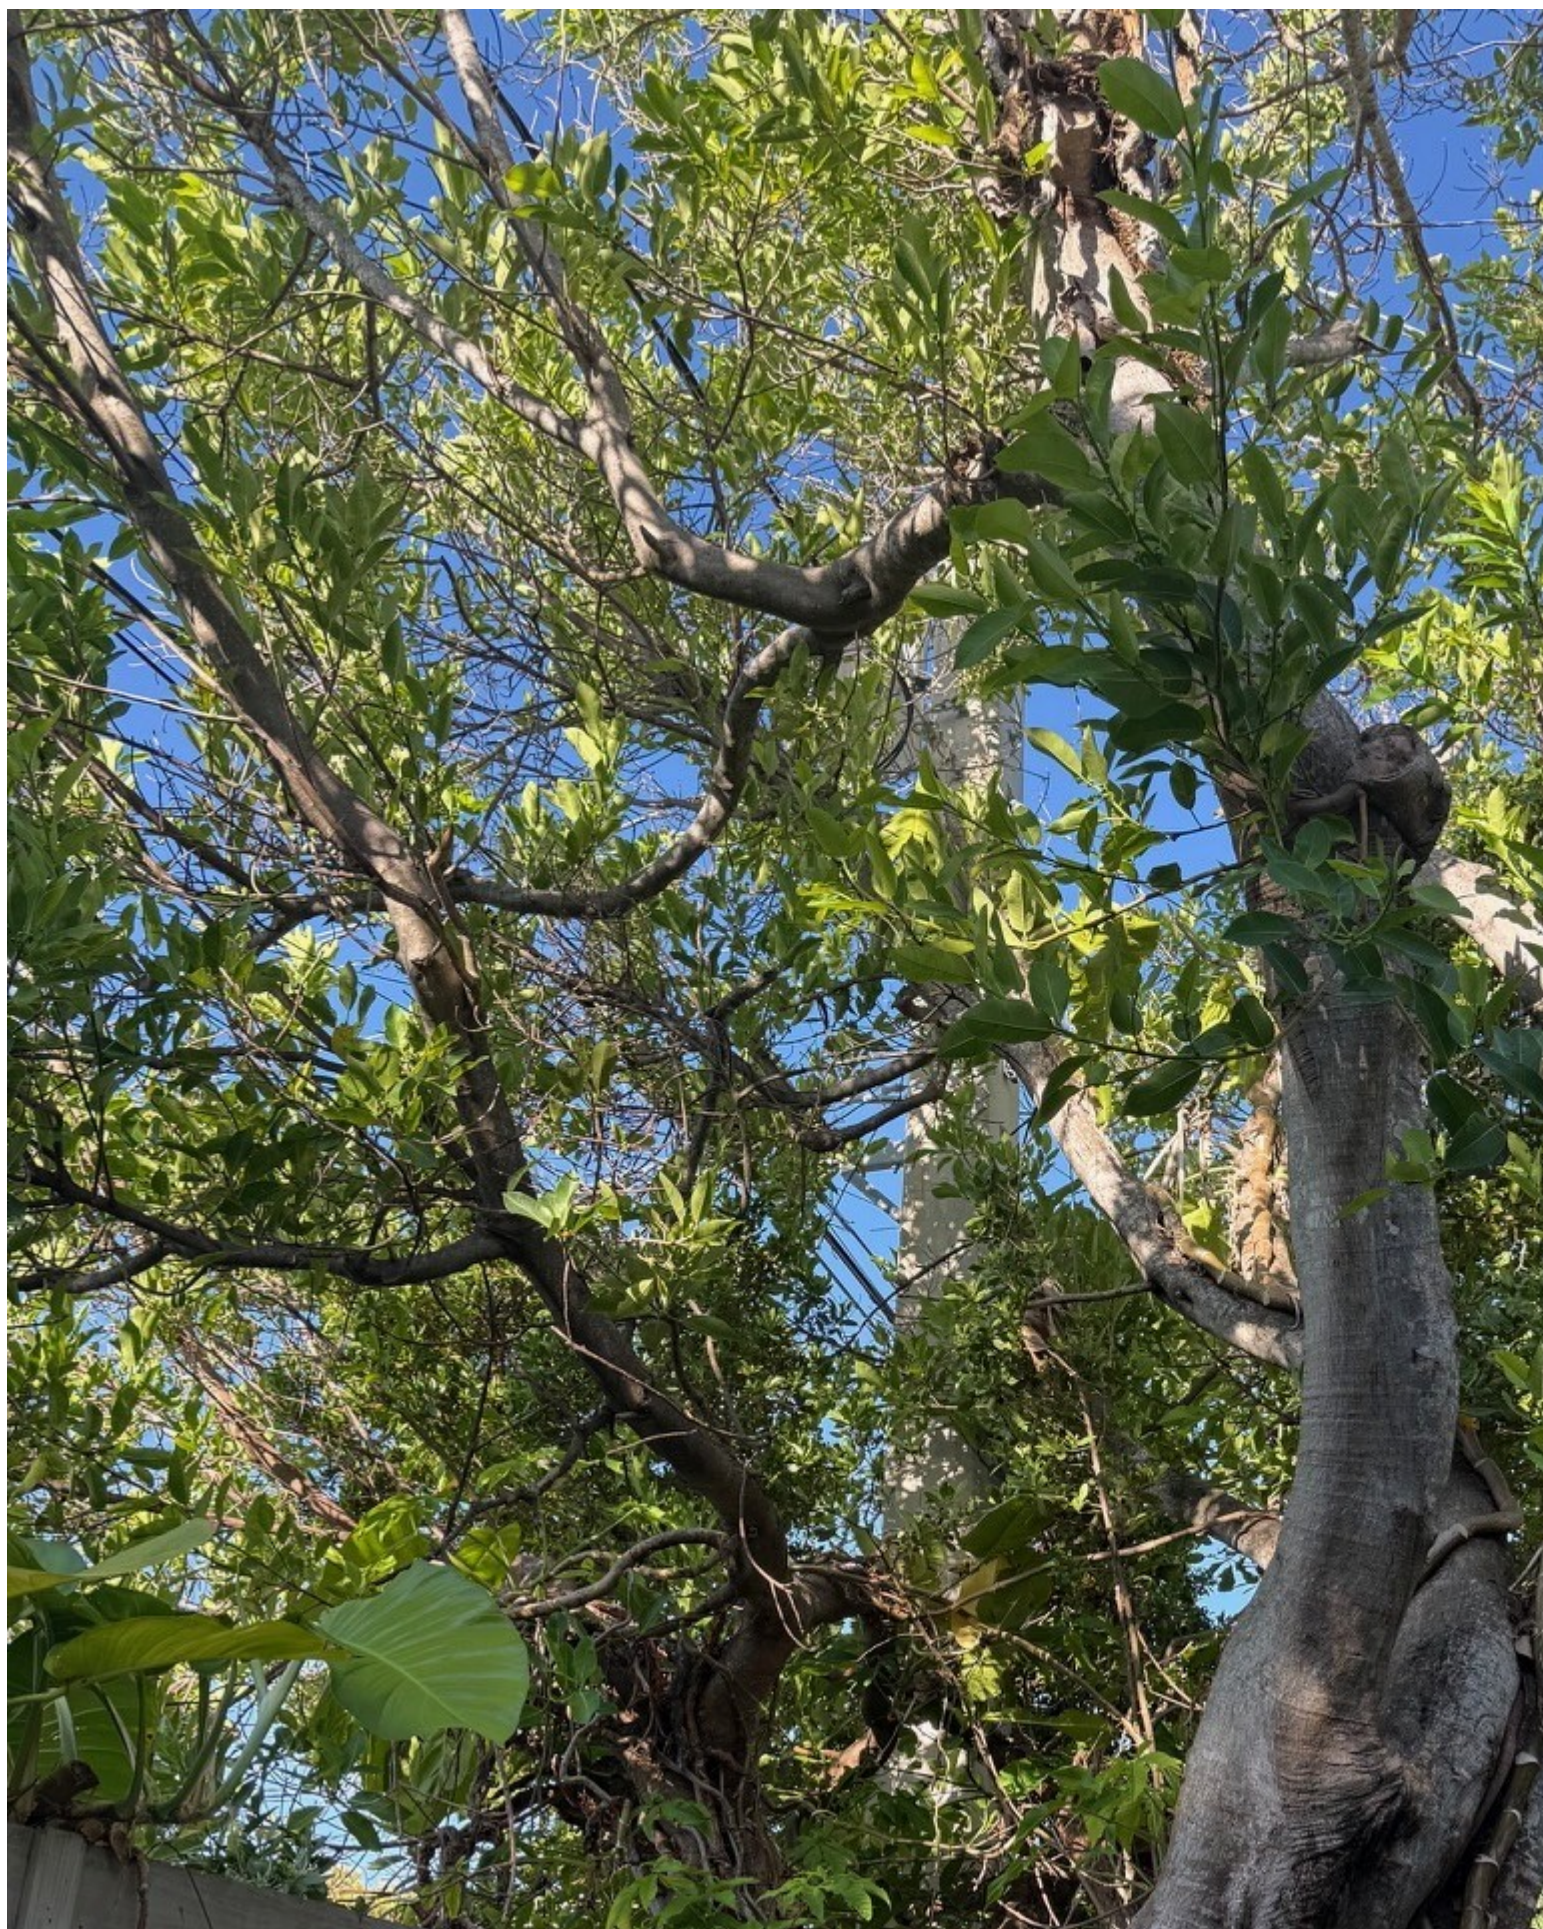
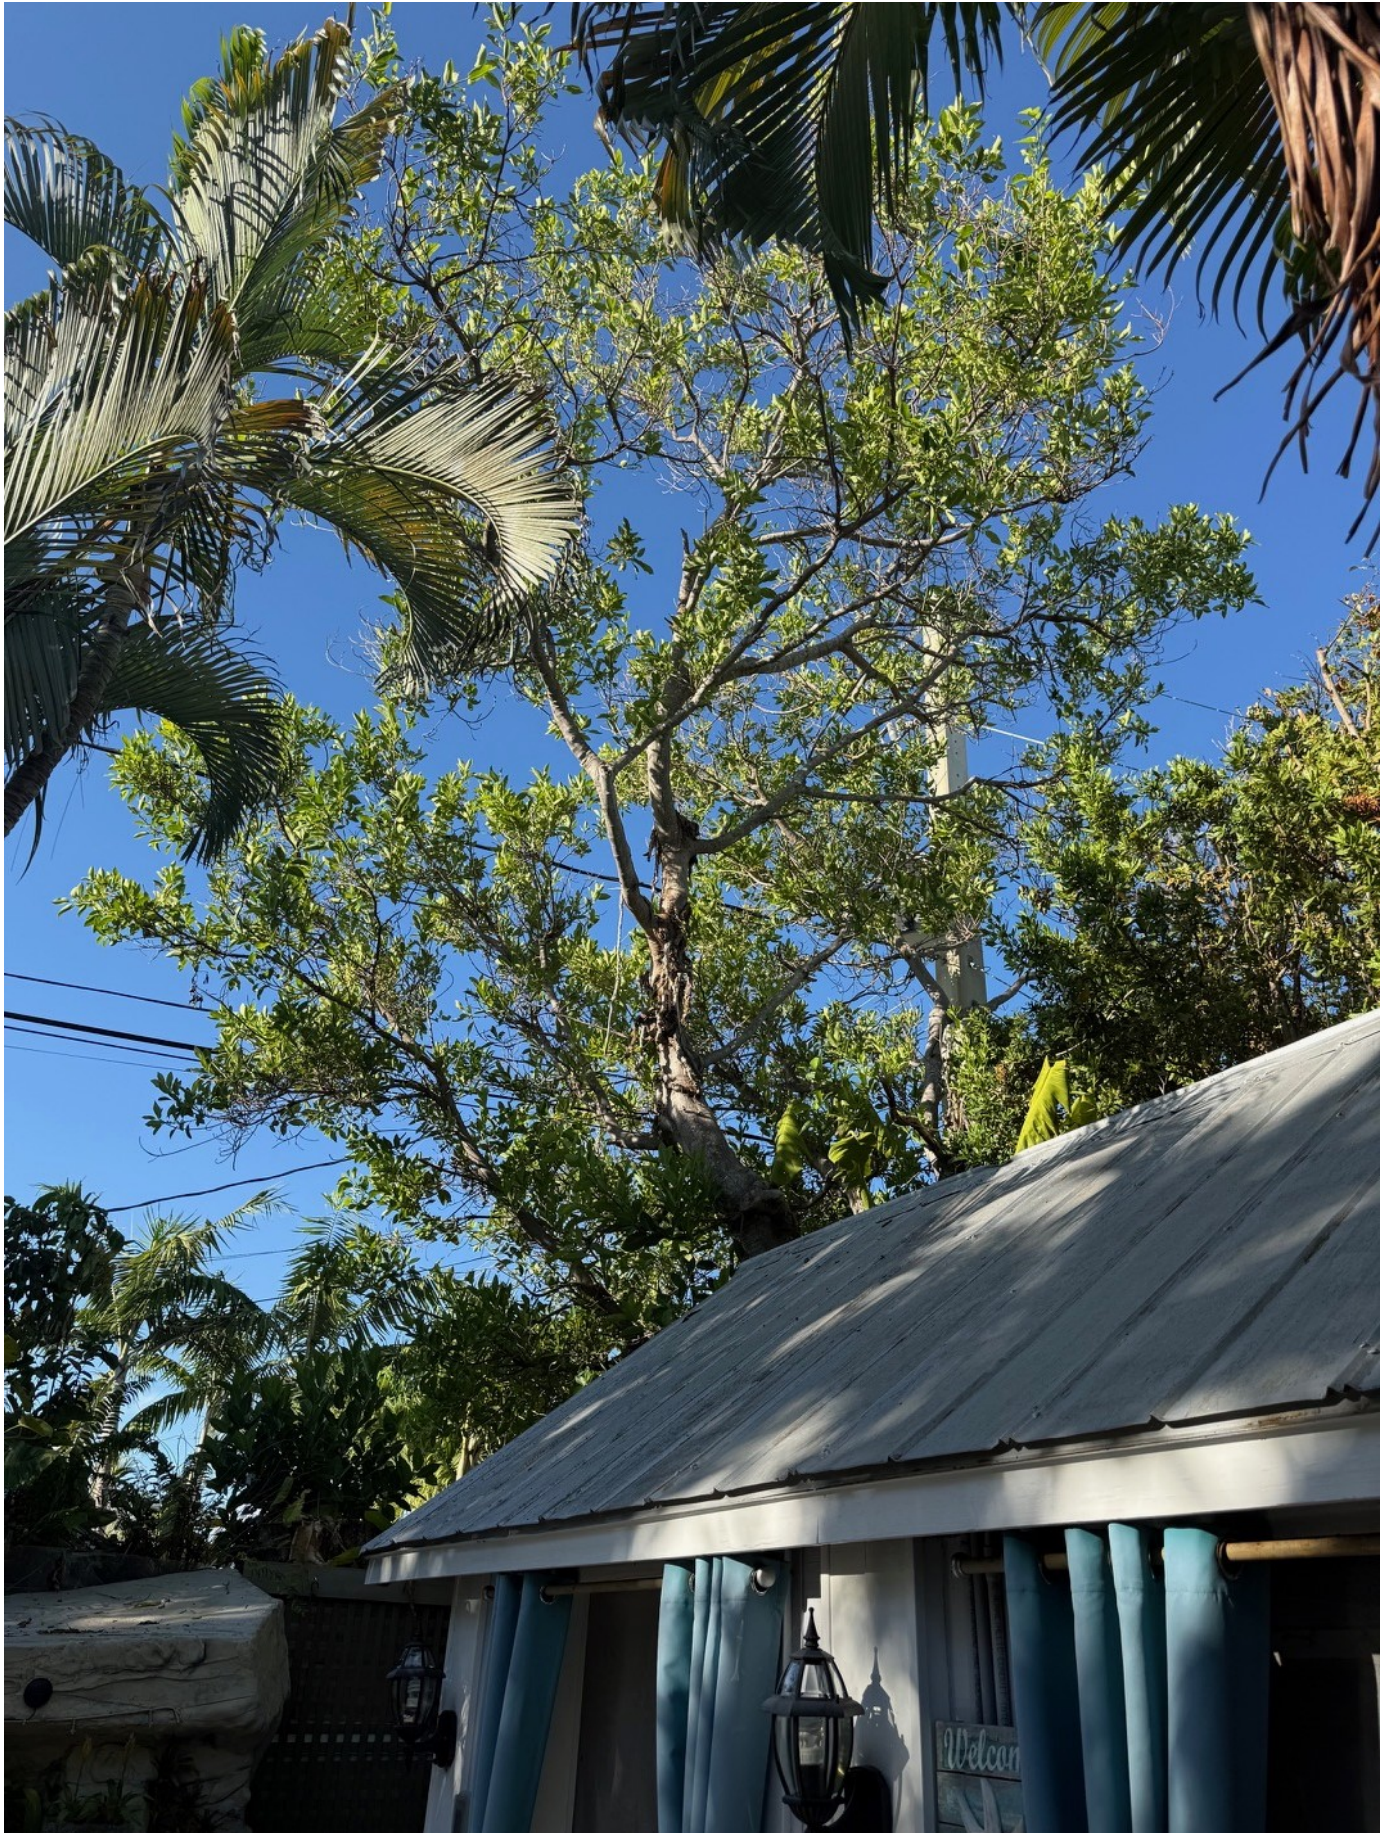
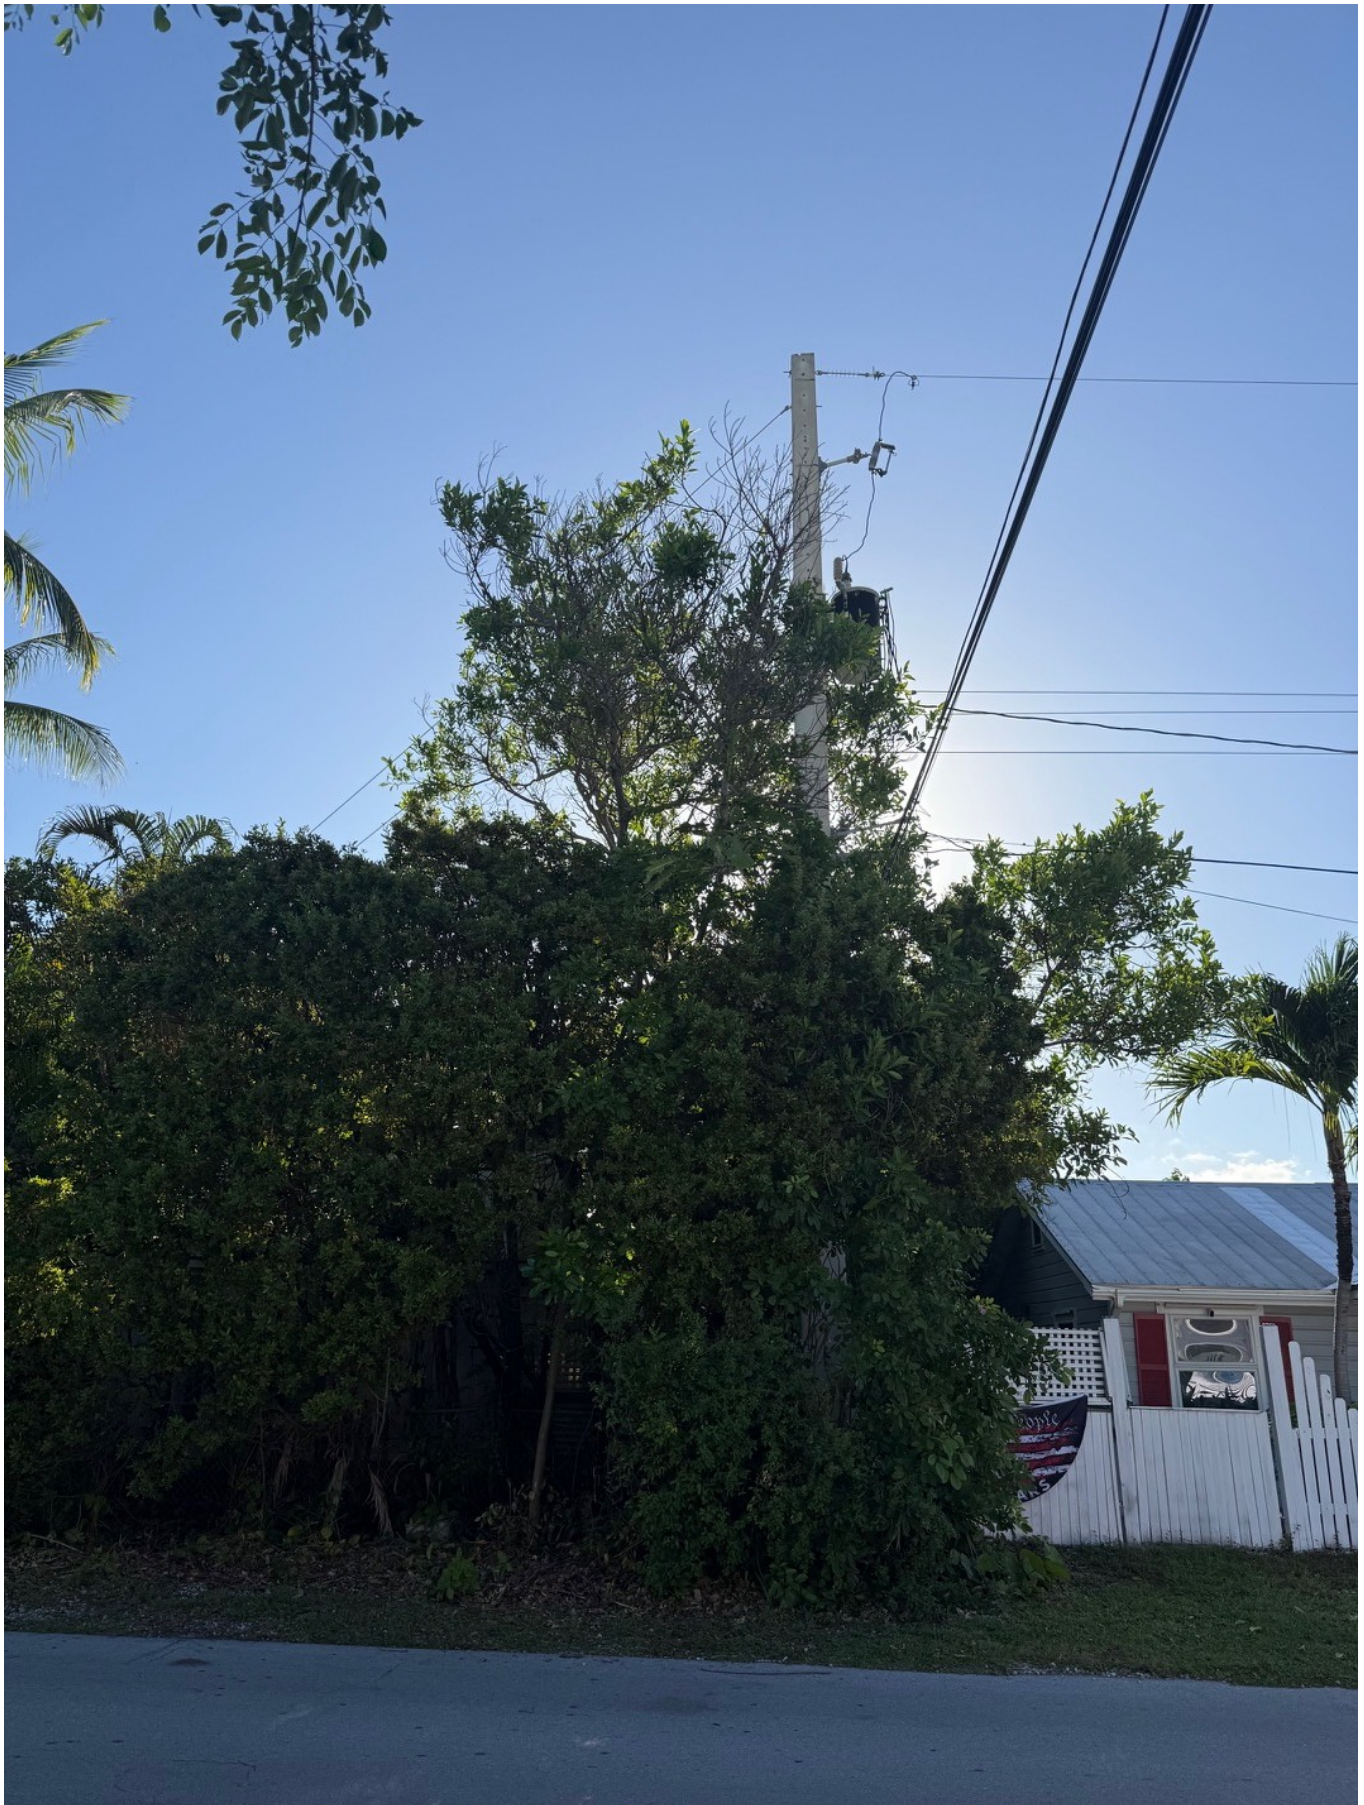
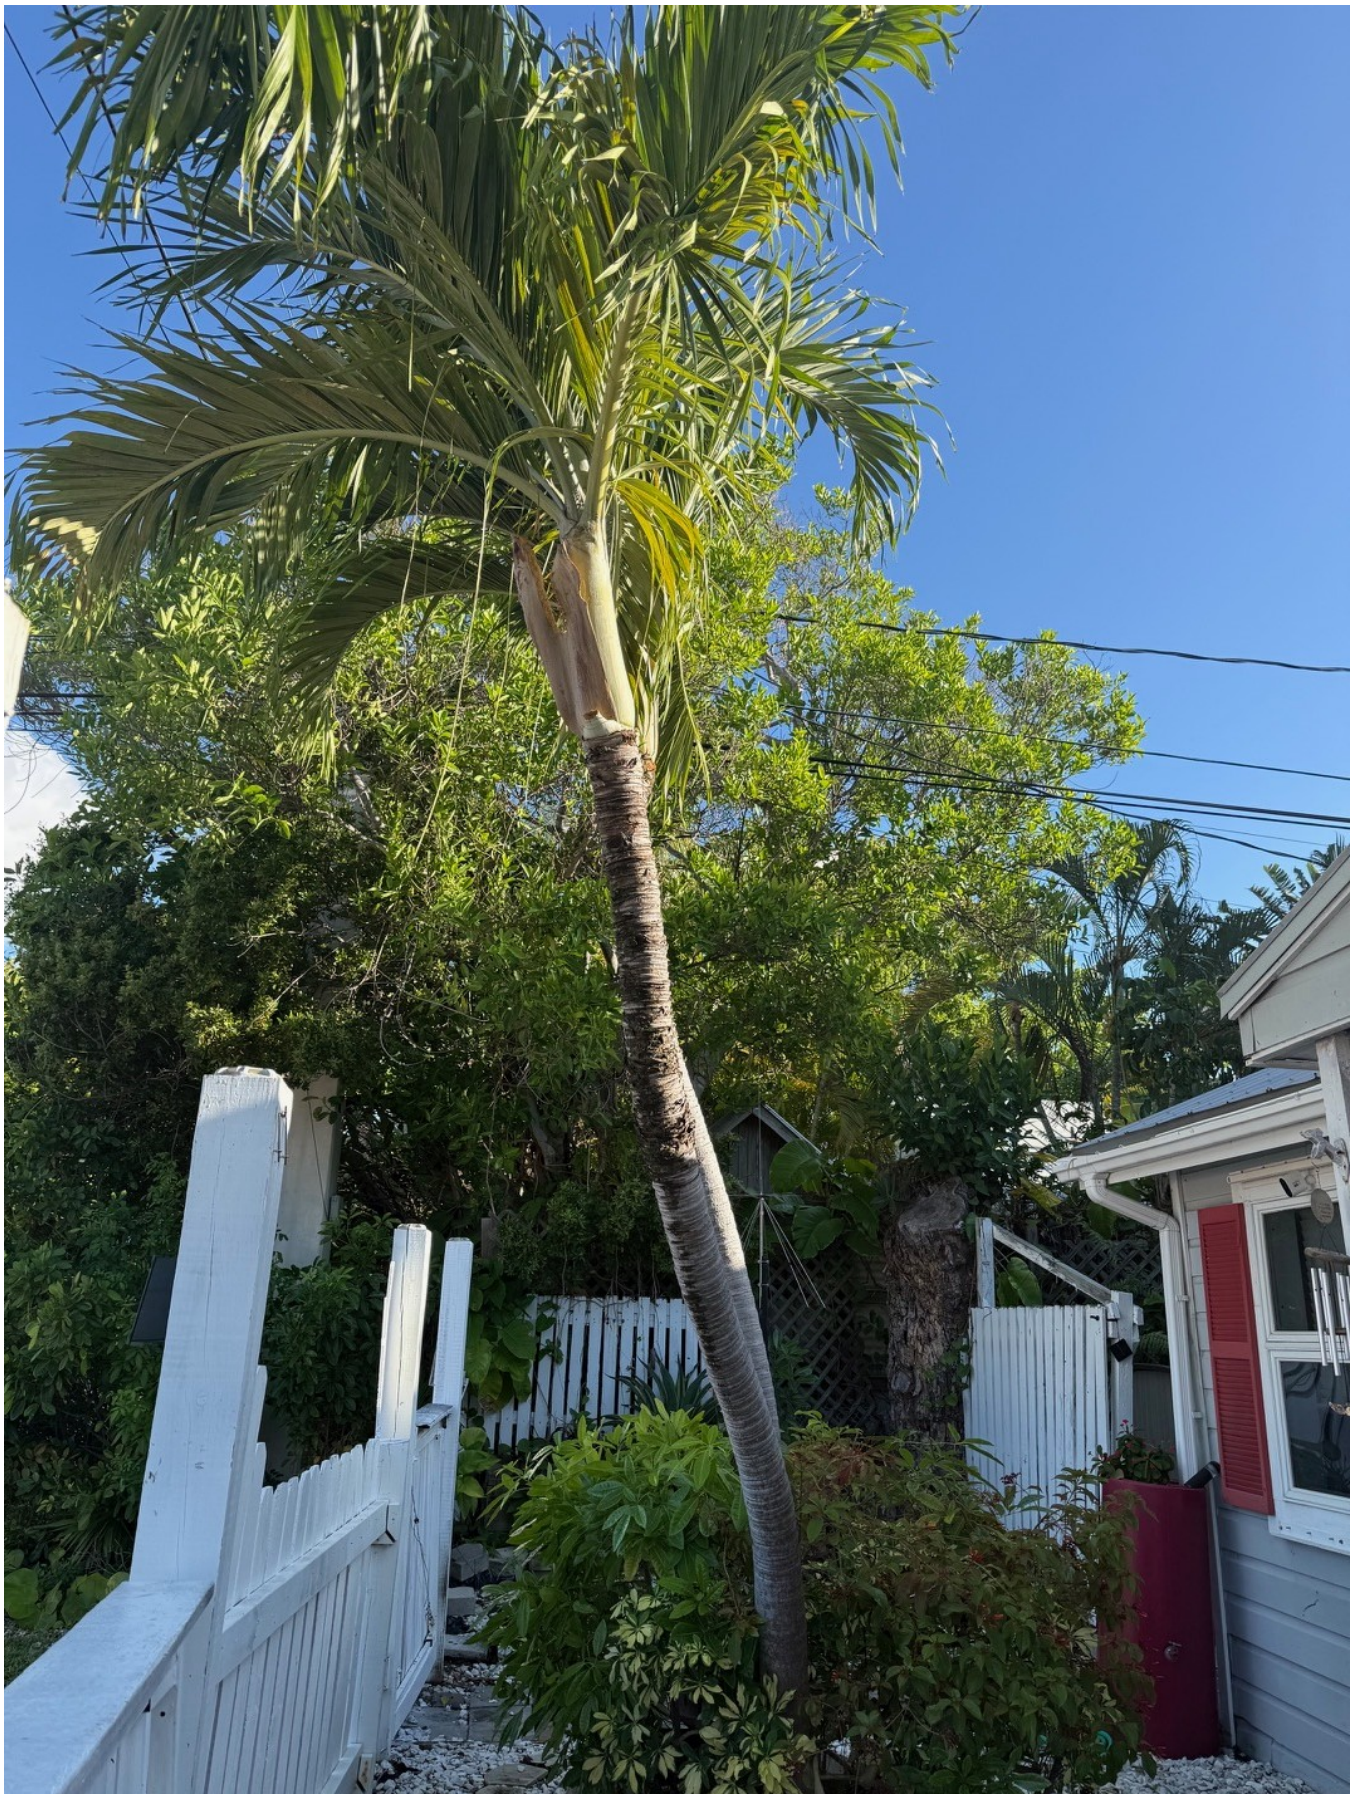
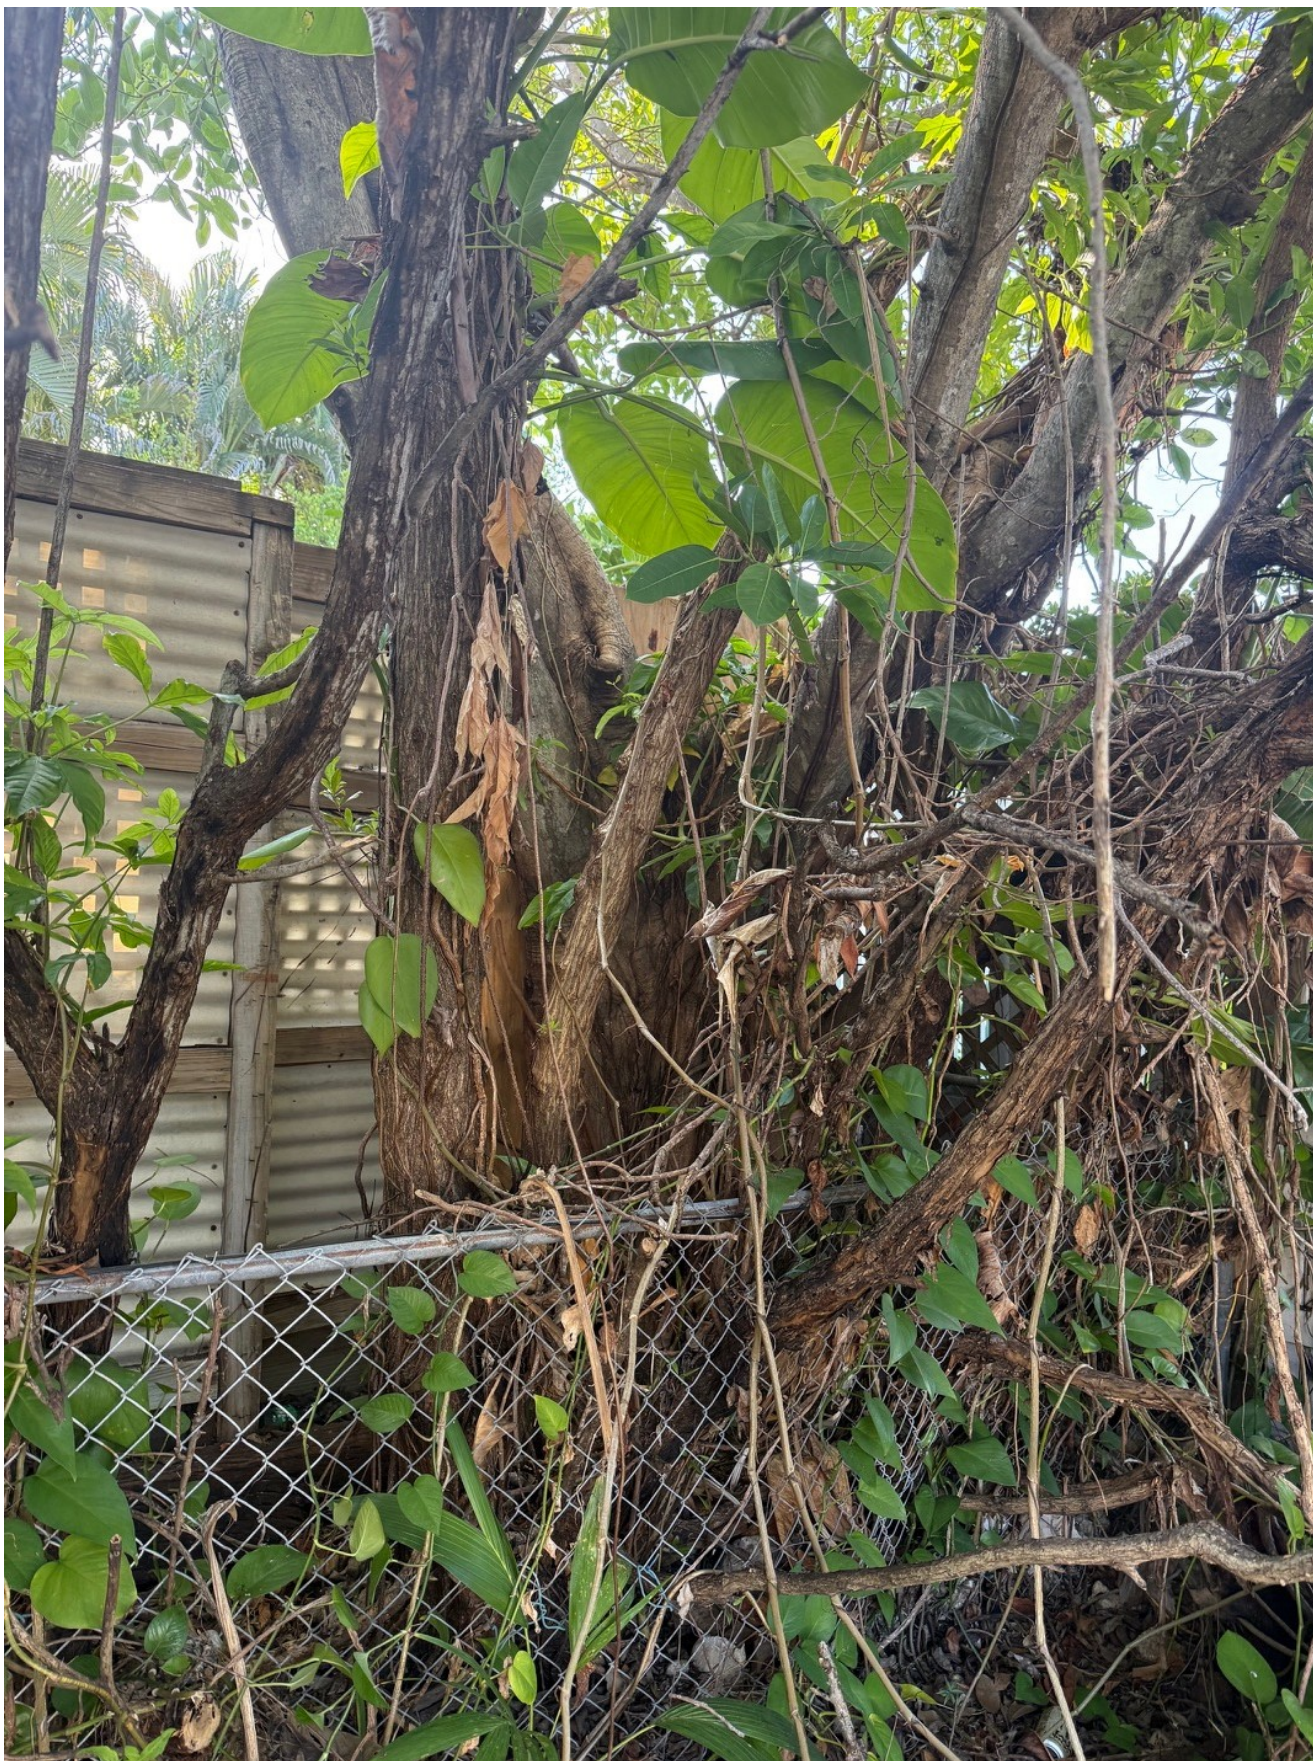
The subject tree is a Strangler Fig (*Ficus aurea*) with an approximate diameter at breast height (DBH) of 24 inches. The tree is in fair overall condition and is growing within approximately 5 feet of a utility pole carrying high-voltage electrical distribution lines. The canopy has grown into numerous communication lines, and the uppermost portions of the canopy are beginning to encroach upon the transformer and primary power lines. Additionally, a guy wire associated with the utility pole extends through the tree's growing space and will continue to interfere with the tree's future development.

The upper canopy exhibits a moderate amount of dieback, and the tree has been subjected to repeated utility clearance pruning. While these pruning operations are necessary to maintain safe electrical clearances, they are not conducive to the long-term health, structure, or natural form of the tree. Given the tree's continued growth toward critical utility infrastructure, additional utility pruning will likely be required on a recurring basis.

Numerous Green Buttonwood trees located in front of the subject tree limit photographic documentation and partially obscure the canopy. However, the overall context of the site clearly demonstrates the close proximity and ongoing conflict between the tree and the utility infrastructure.

Based on this Level 2 visual assessment, the primary concern is not an inherent structural defect within the tree itself, but rather the incompatibility of the tree's location with the adjacent utility infrastructure. The subject tree occupies a constrained growing space where future canopy development will continue to conflict with communication lines, the transformer, primary conductors, and the utility guy wire. The long-term compatibility of this tree at its current location is poor, and the ongoing need for utility clearance pruning is expected to continue for the foreseeable future.

**Recommended Mitigation: 14.4 Caliper Inches**
