STAFF REPORT

RE: 1225 Olivia Street (permit application # T2023-0118)

FROM: Karen DeMaria, City of Key West Urban Forestry Manager

An application was received requesting the removal of (2) Royal Poincianas, (1) Spanish Lime, and (1) Tamarind tree. A site inspection was done and documented the following:

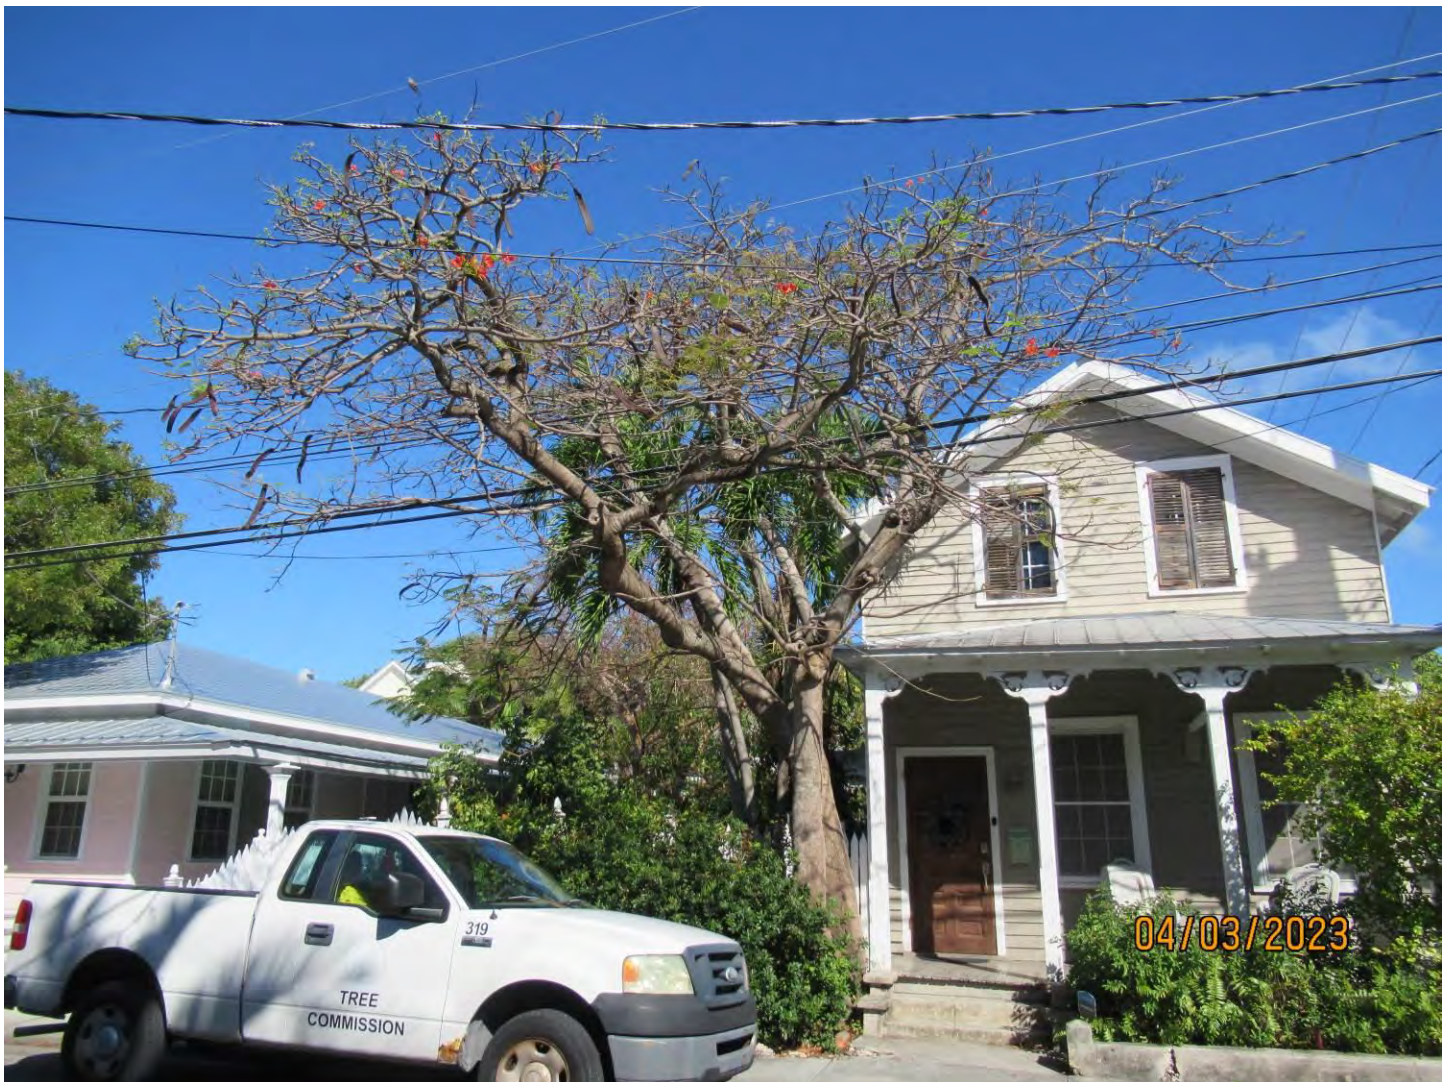
Photo showing location of tree, view 1.

Location: 40% (growing at base of stairs and porch, canopy in utility lines)

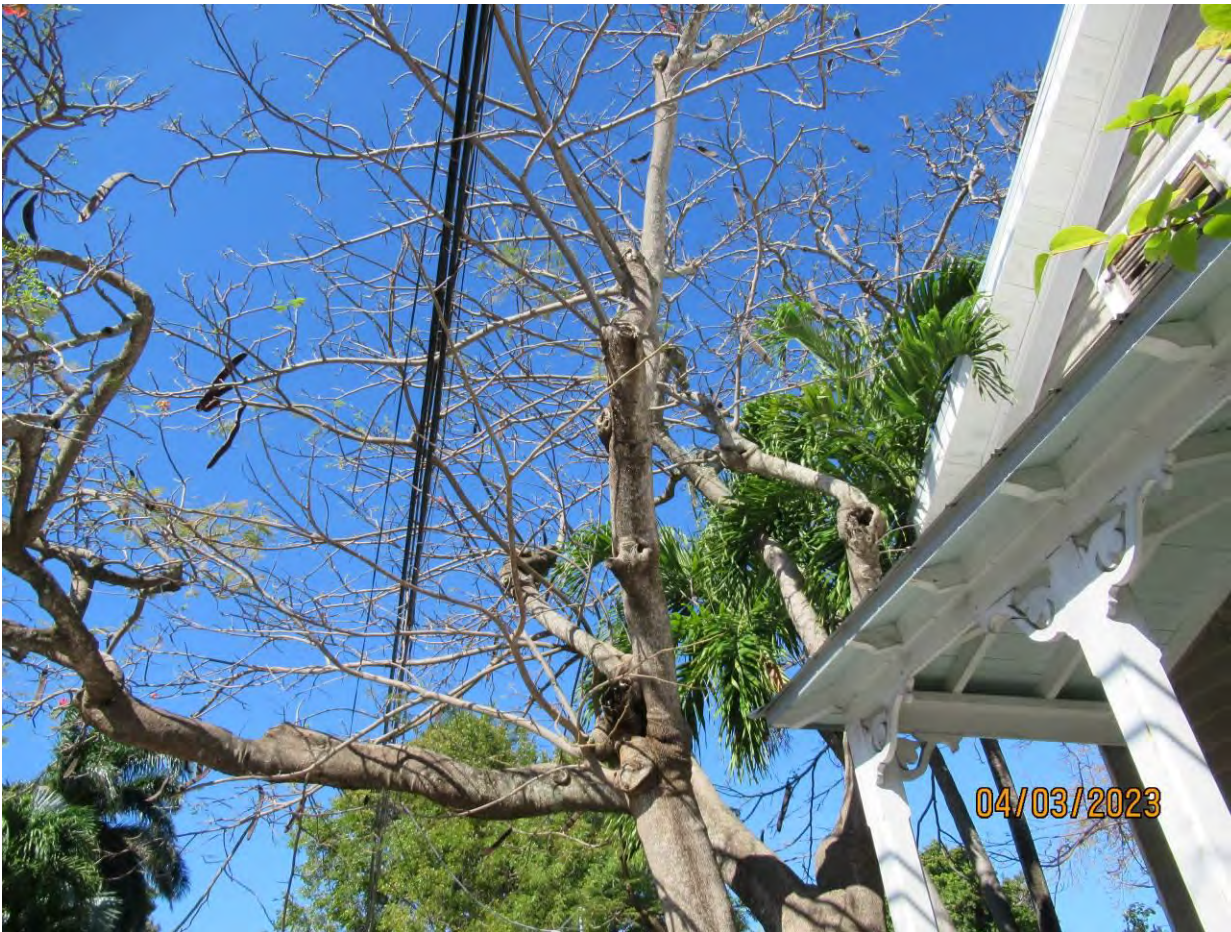
Photo showing canopy of tree, view 1.

Condition: 40% (overall condition is poor-decay in canopy, codominant trunks with termites at connection.)

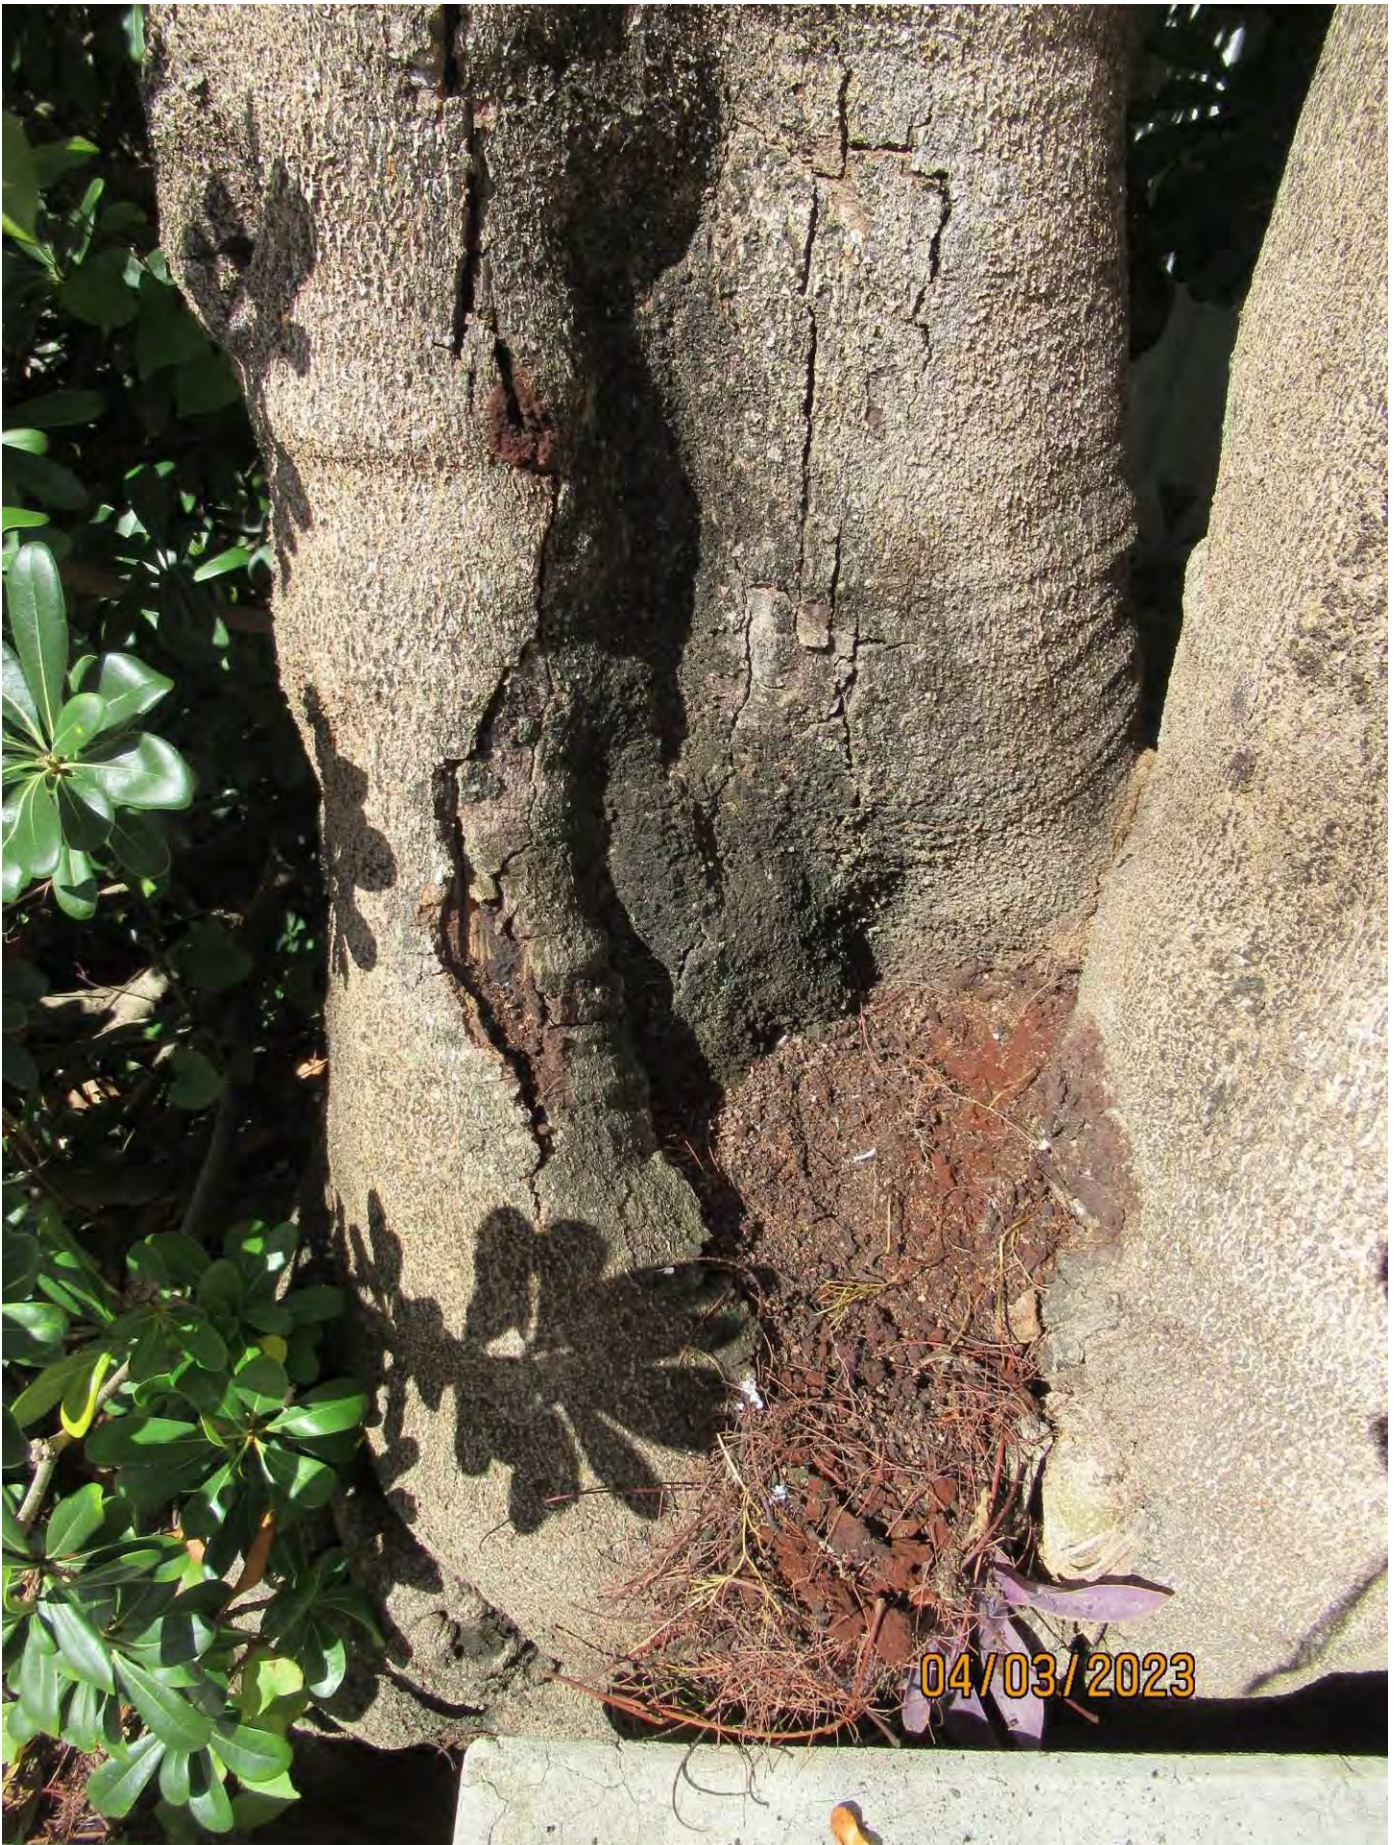
Photo of base of tree, view 2 (note presence of termite mud).

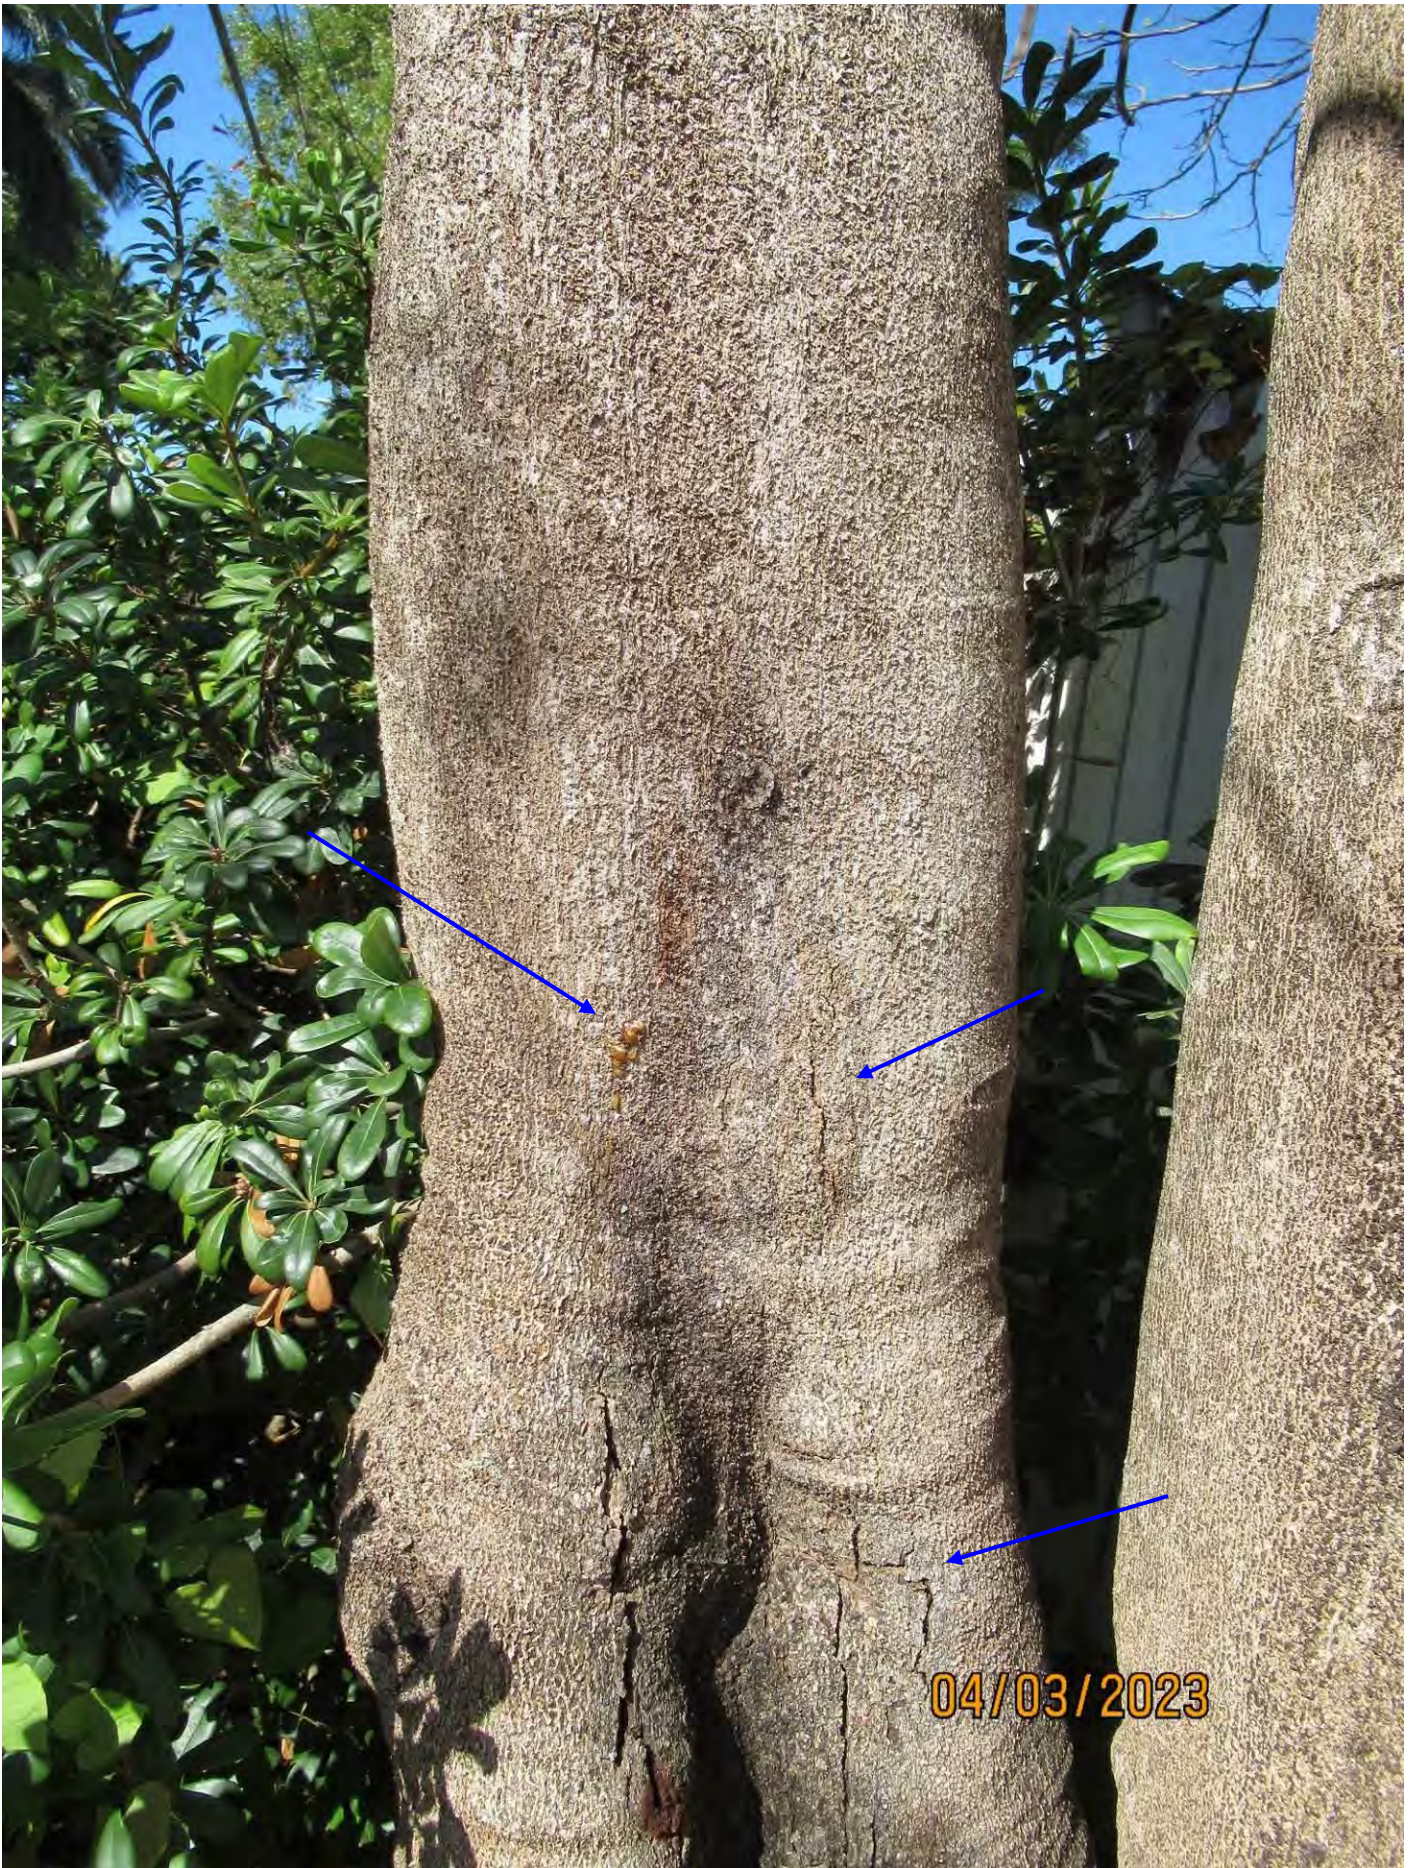
Photo of tree trunk showing oozing and cracking of bark.

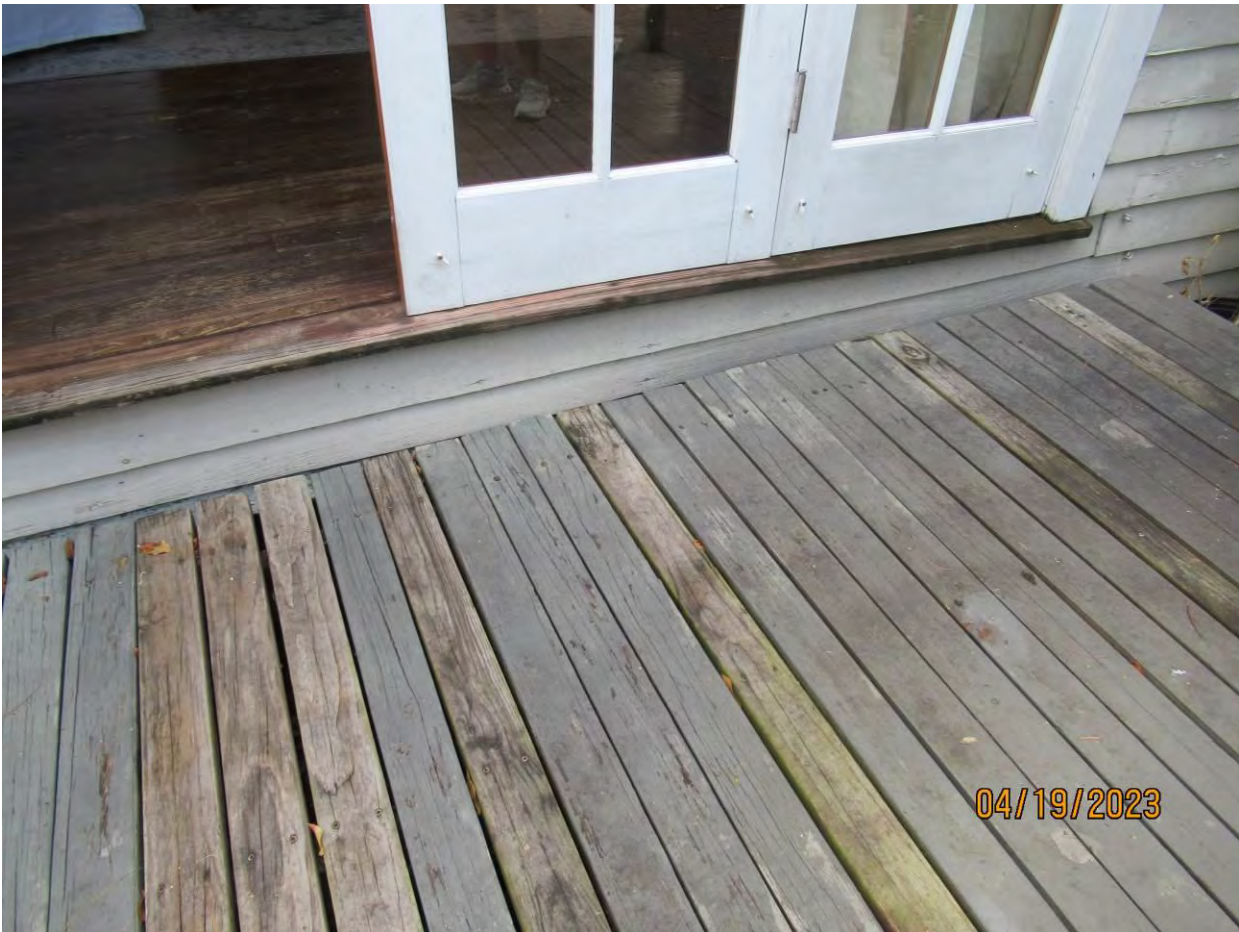
Photo showing floor raised near tree.

Diameter: 20.7"
Location: 20% (growing close to historic structure. Roots uplifting floor and porch.)
Species: 100% (on protected tree list)
Condition: 60% (overall condition is fair.)
Total Average Value = 60%
Value x Diameter = 12.4 replacement caliper inches

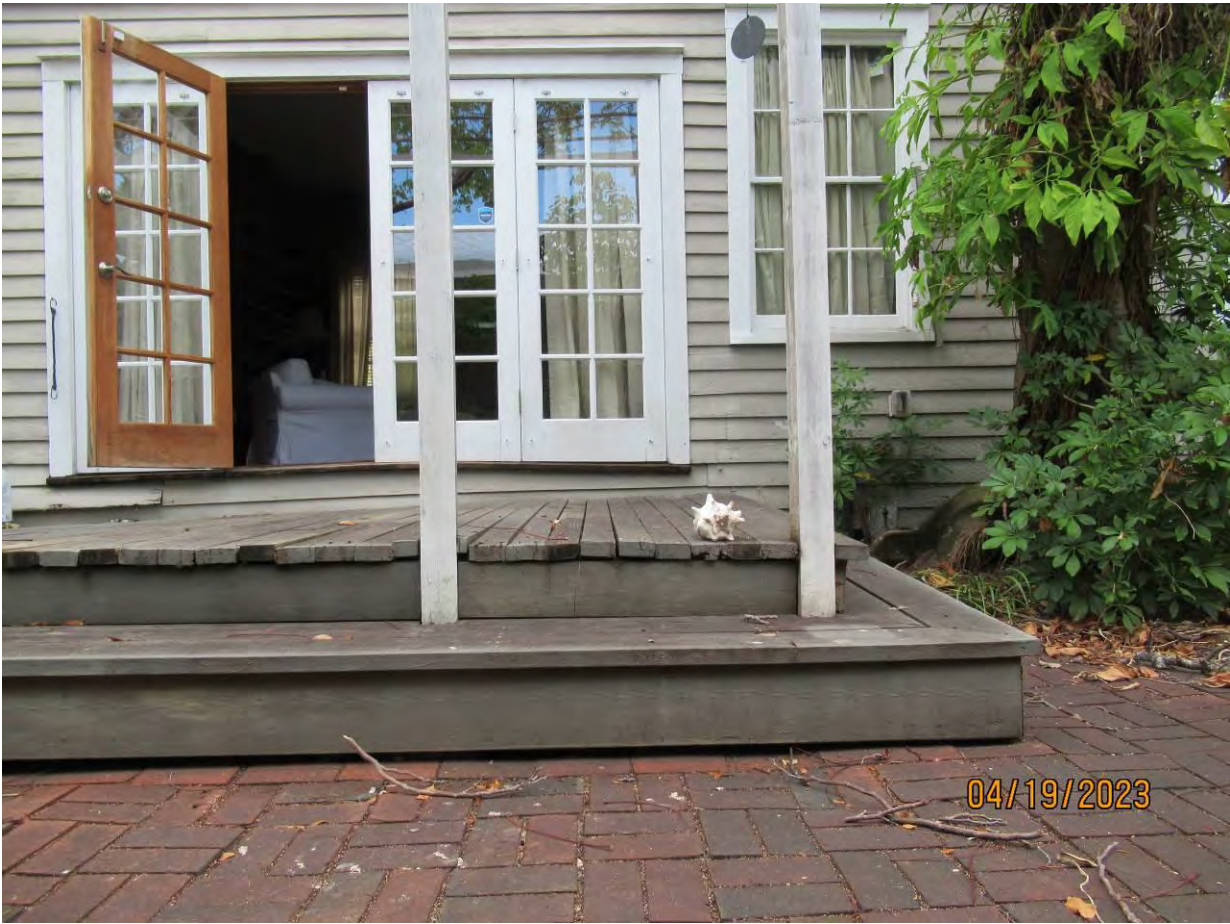
Photo showing location of tree in relation to raised floor area.

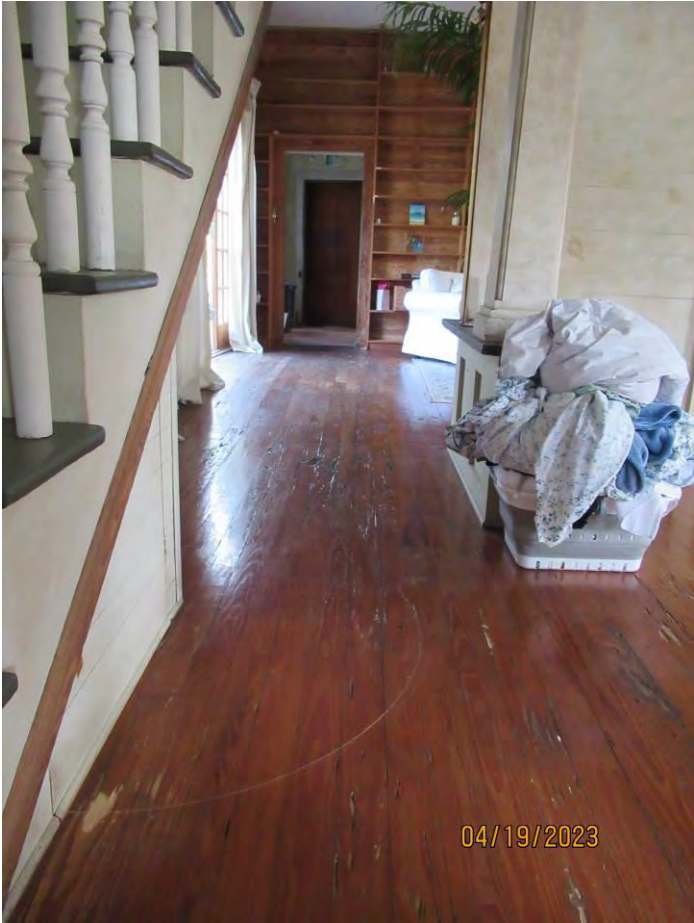
Photo of raised floor area inside the house.

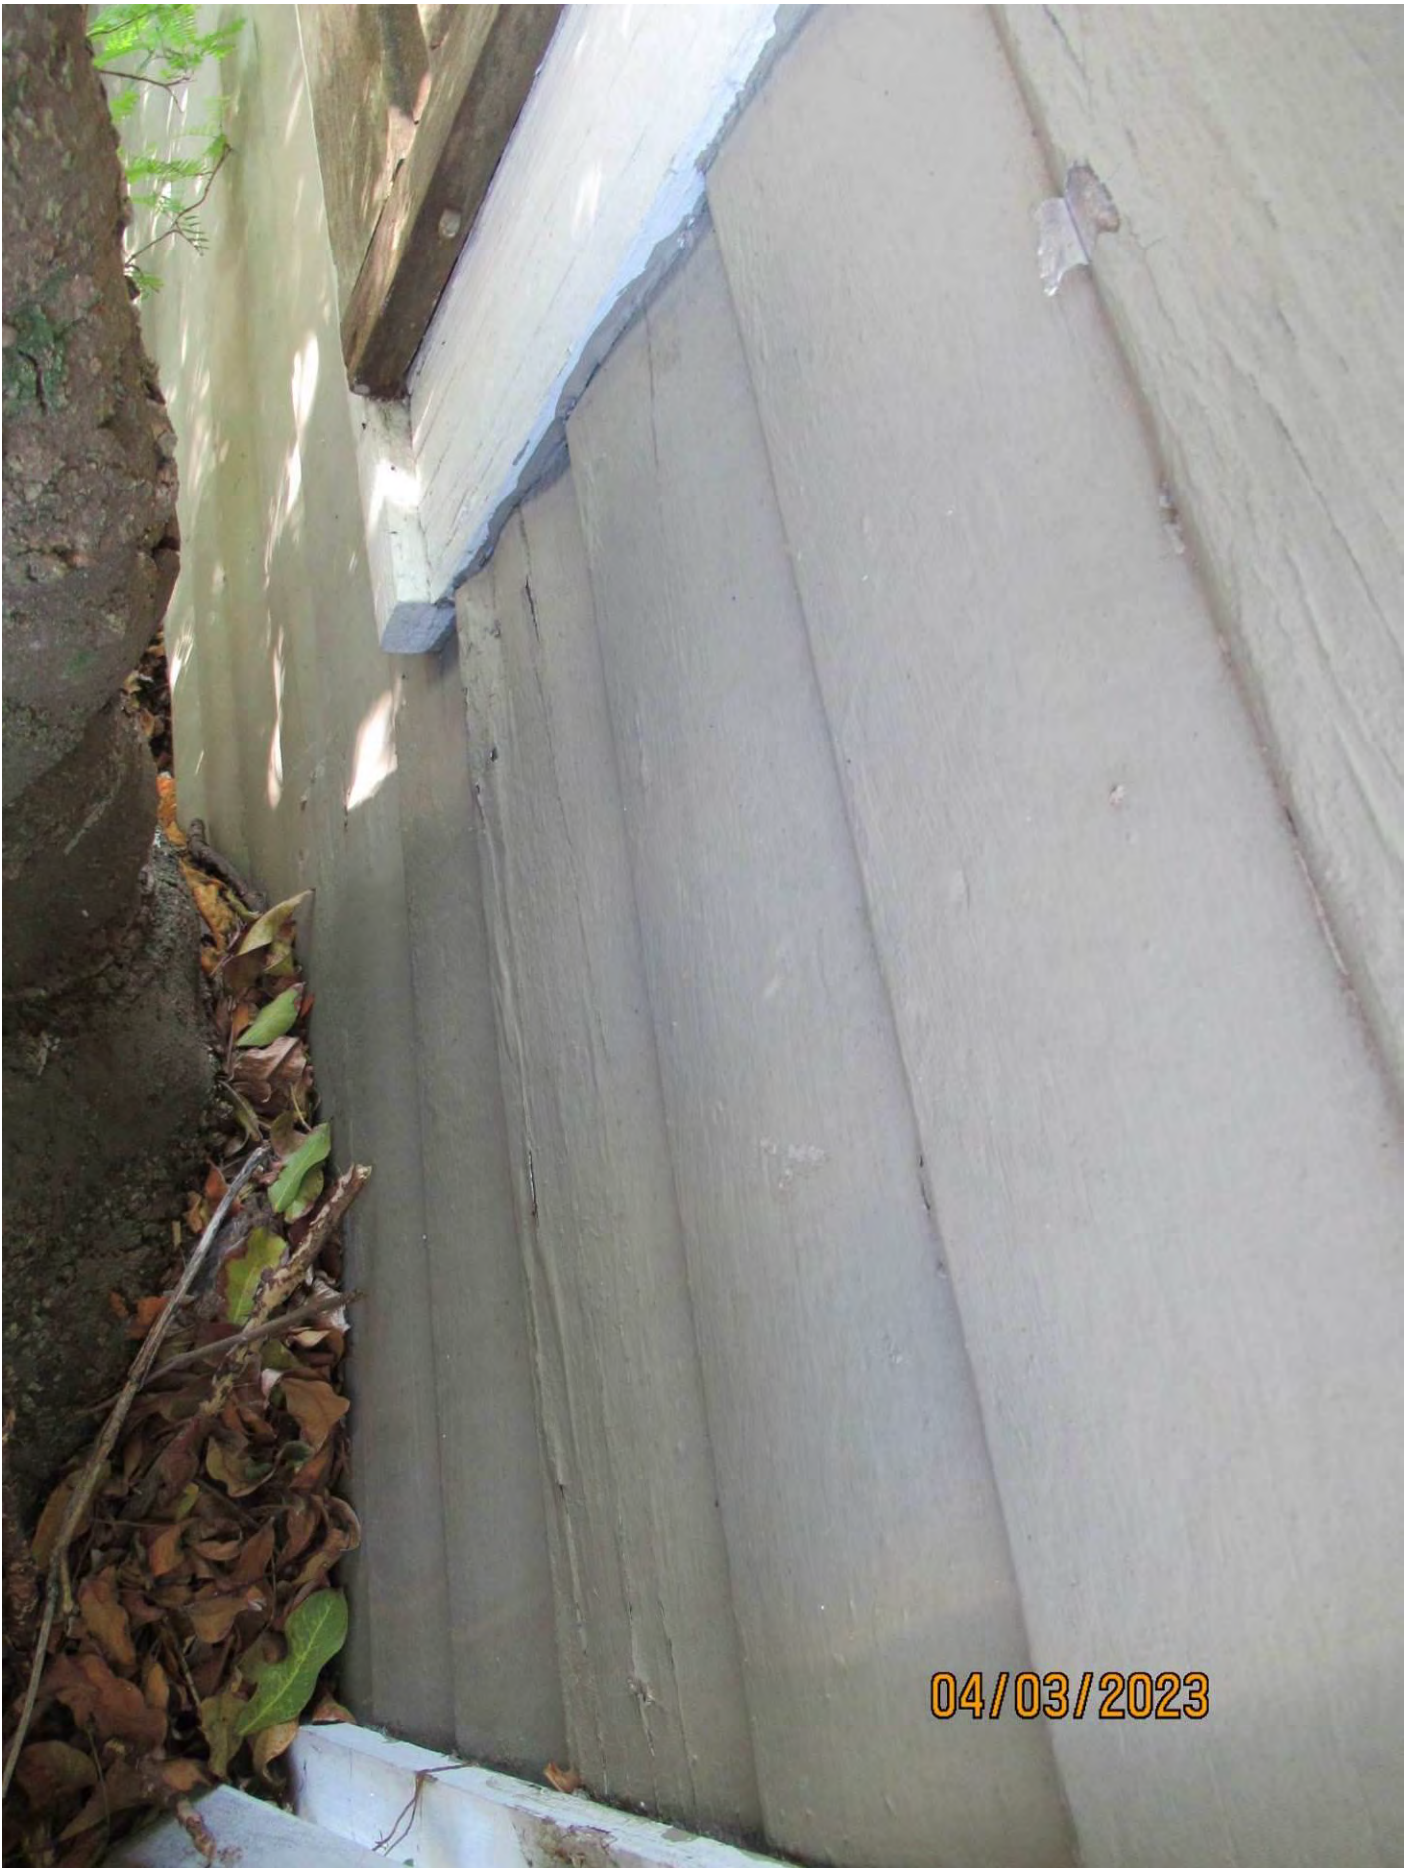
Photo of tree trunk in relation to historic structure, view 1.

Location: 20% (growing at base of historic structure-damaging structure, roots also damaged and lifted sidewalk and roadway, very visible tree.)

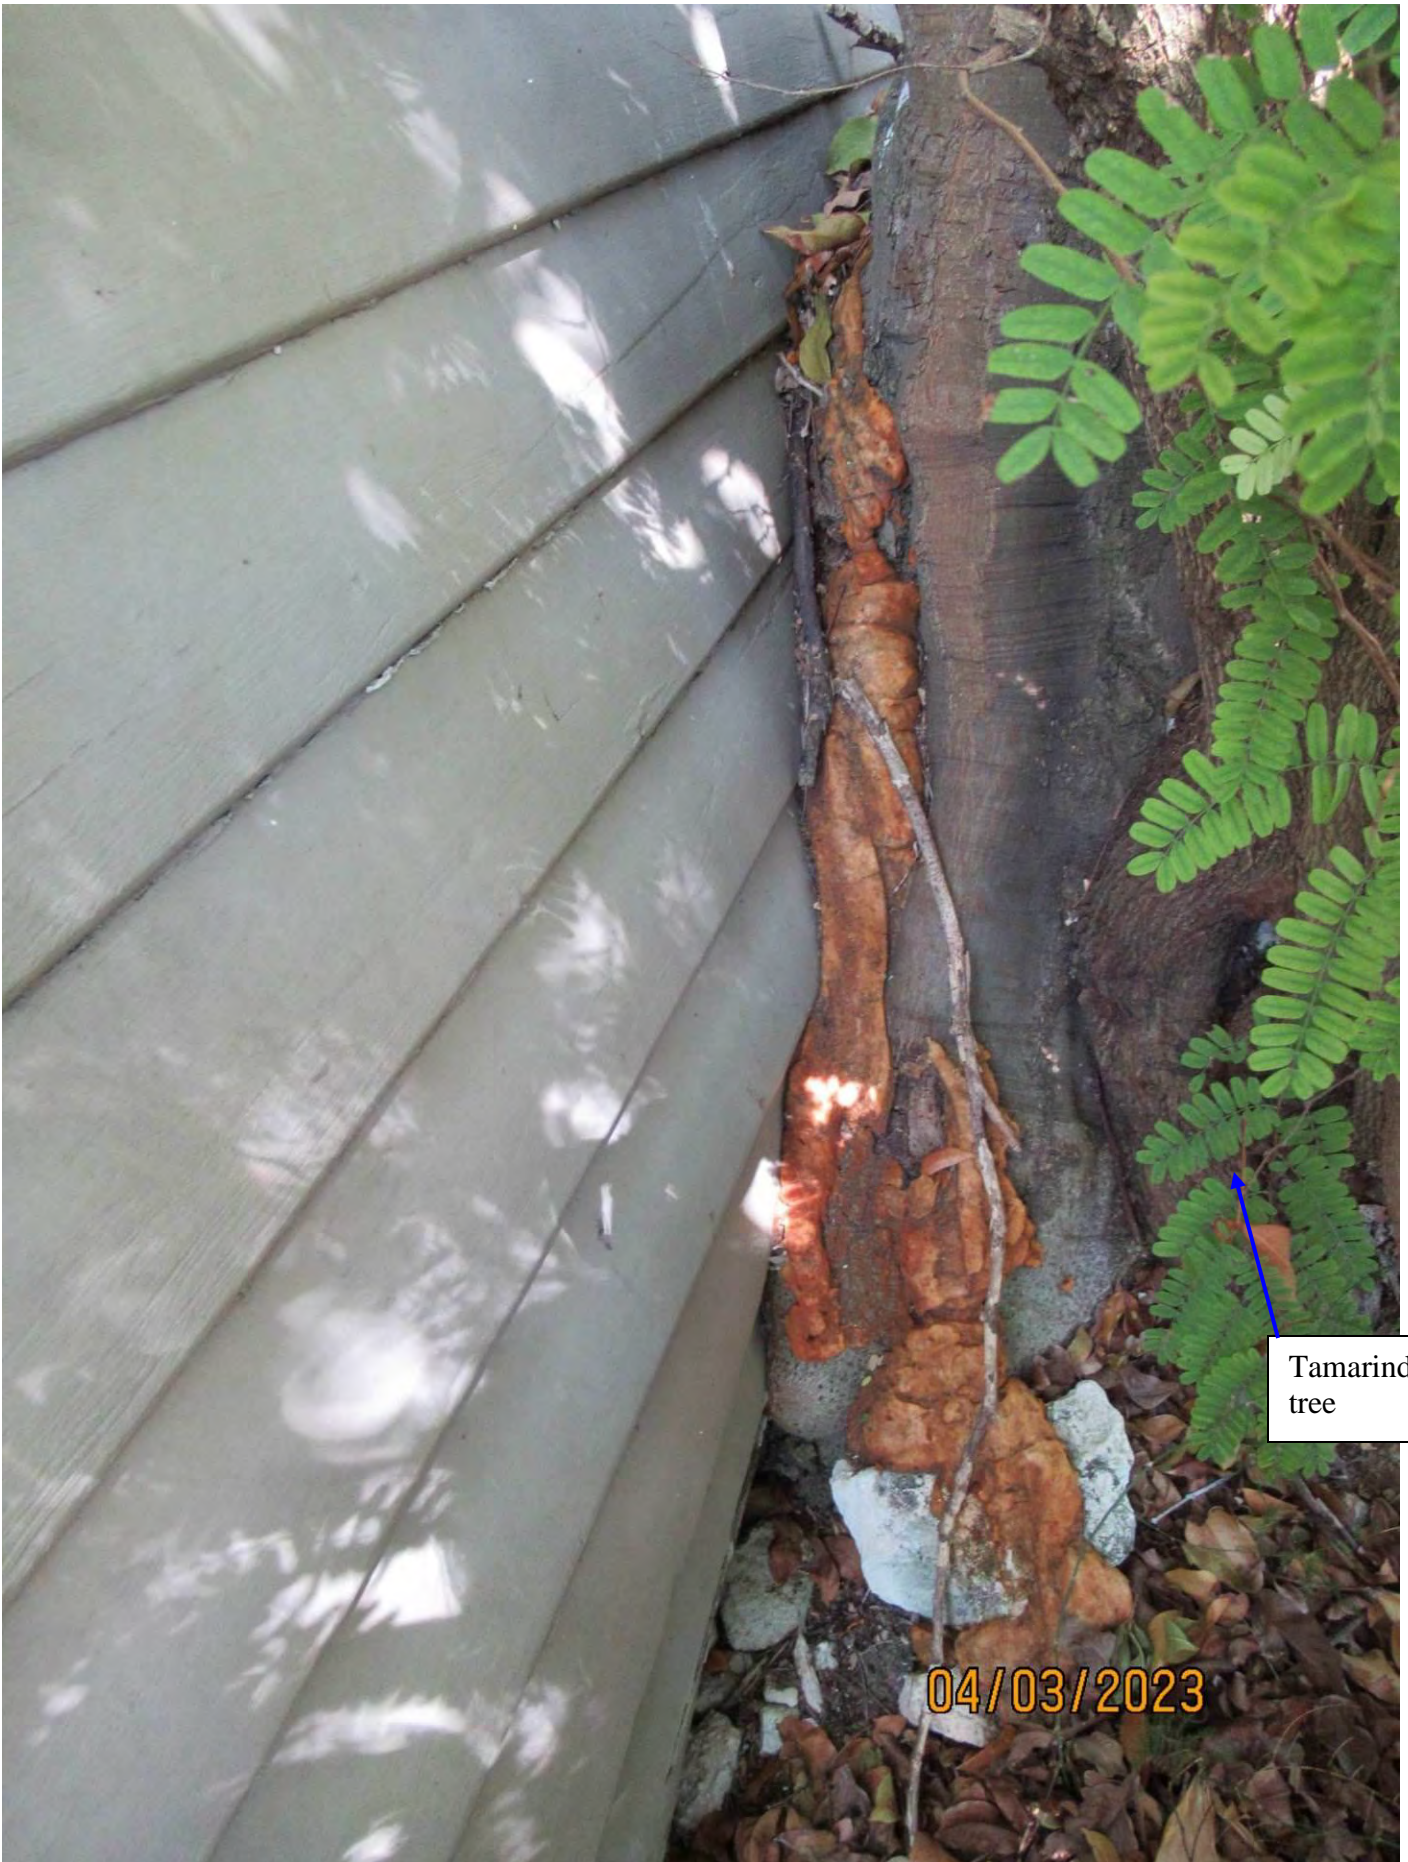
Photo of tree trunk in relation to historic structure, view 2.

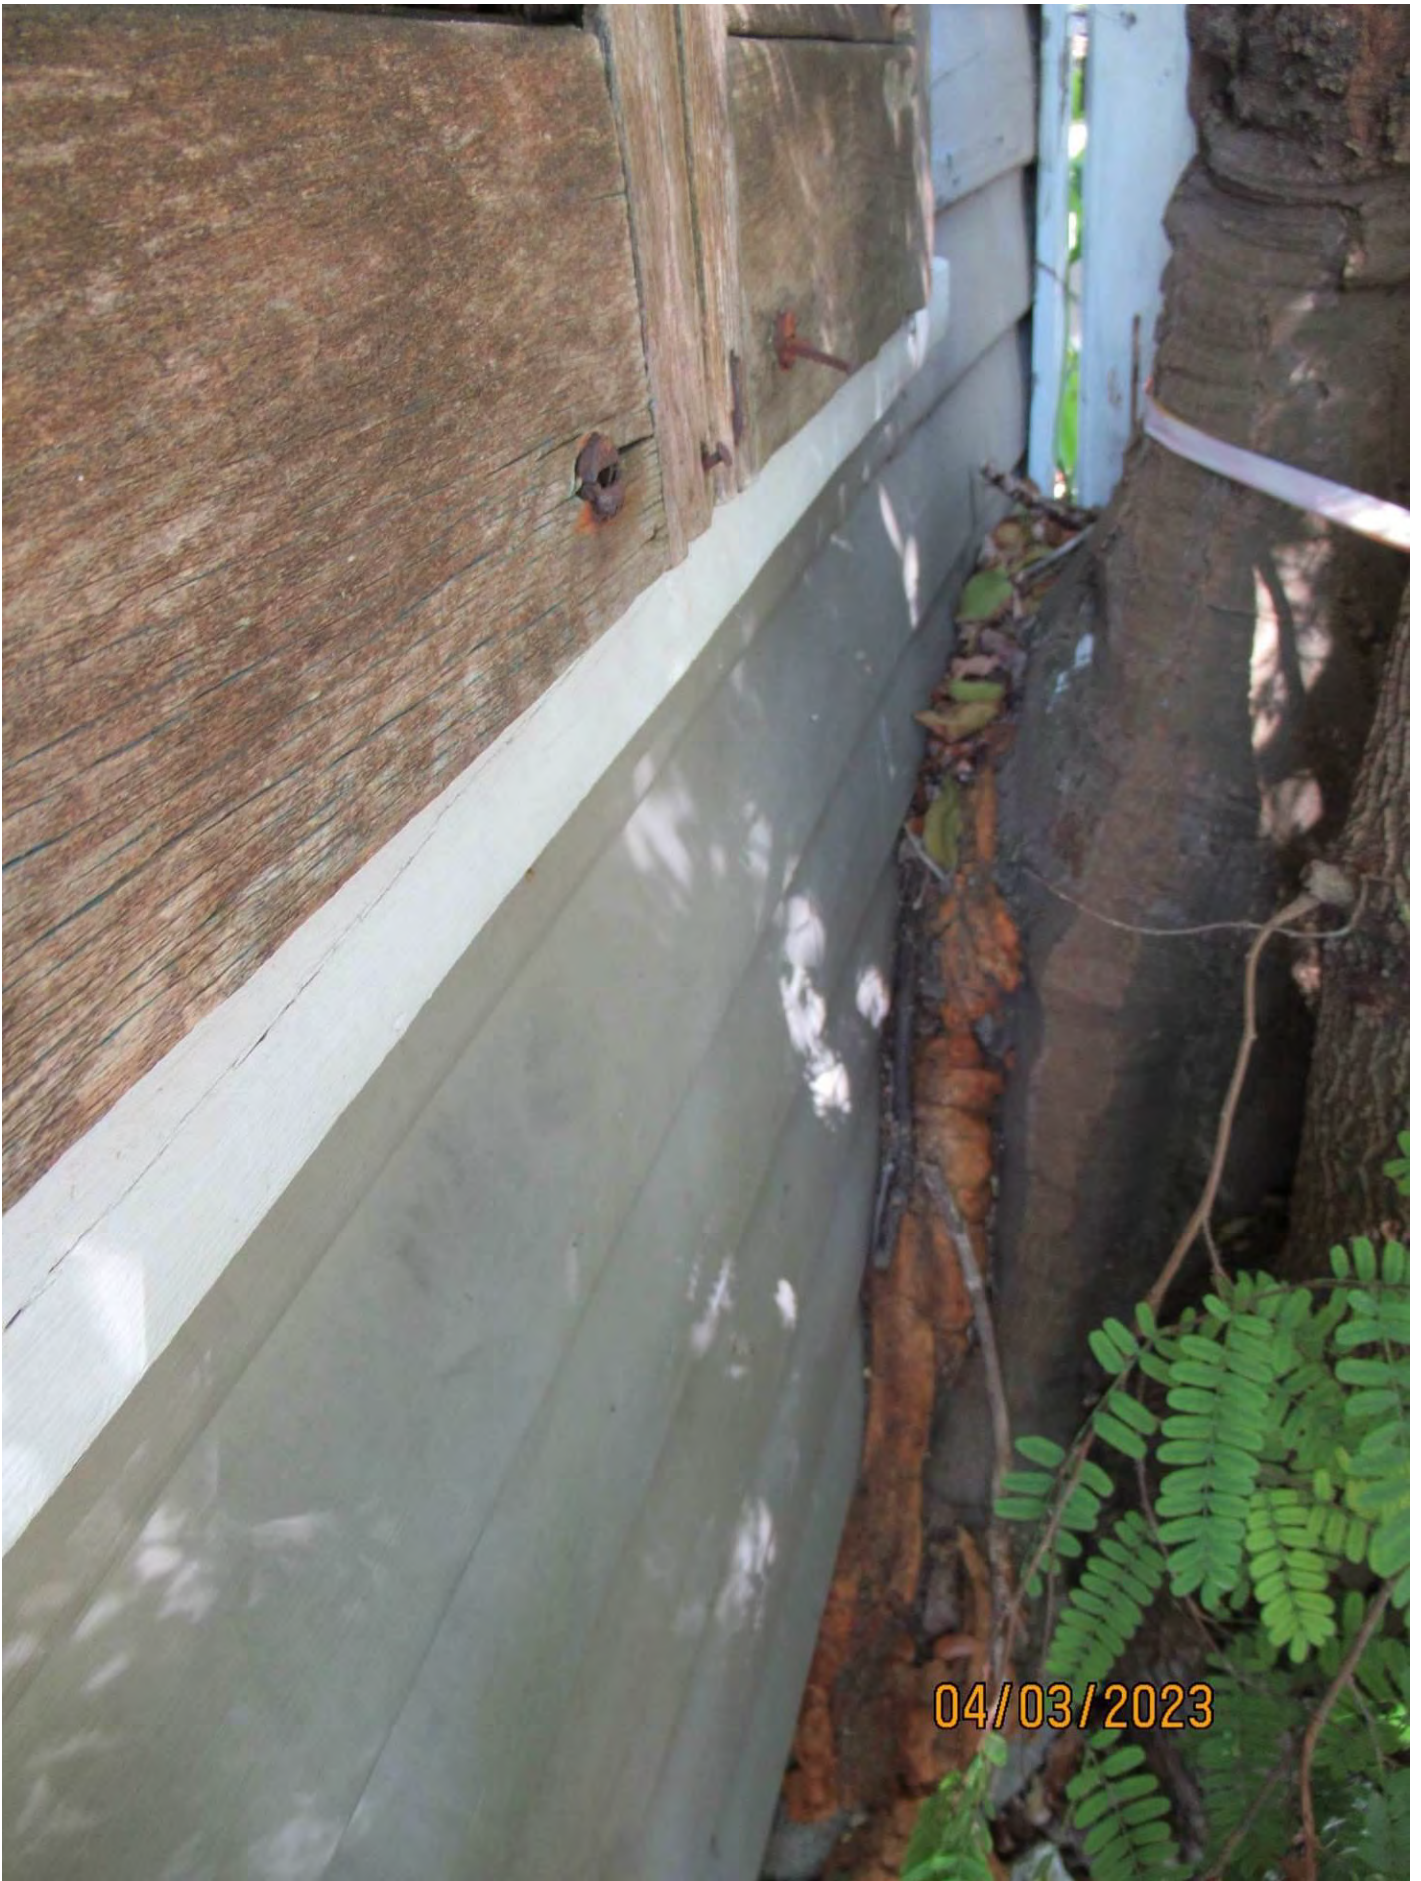
Photo of tree trunk in relation to historic structure, view 3.

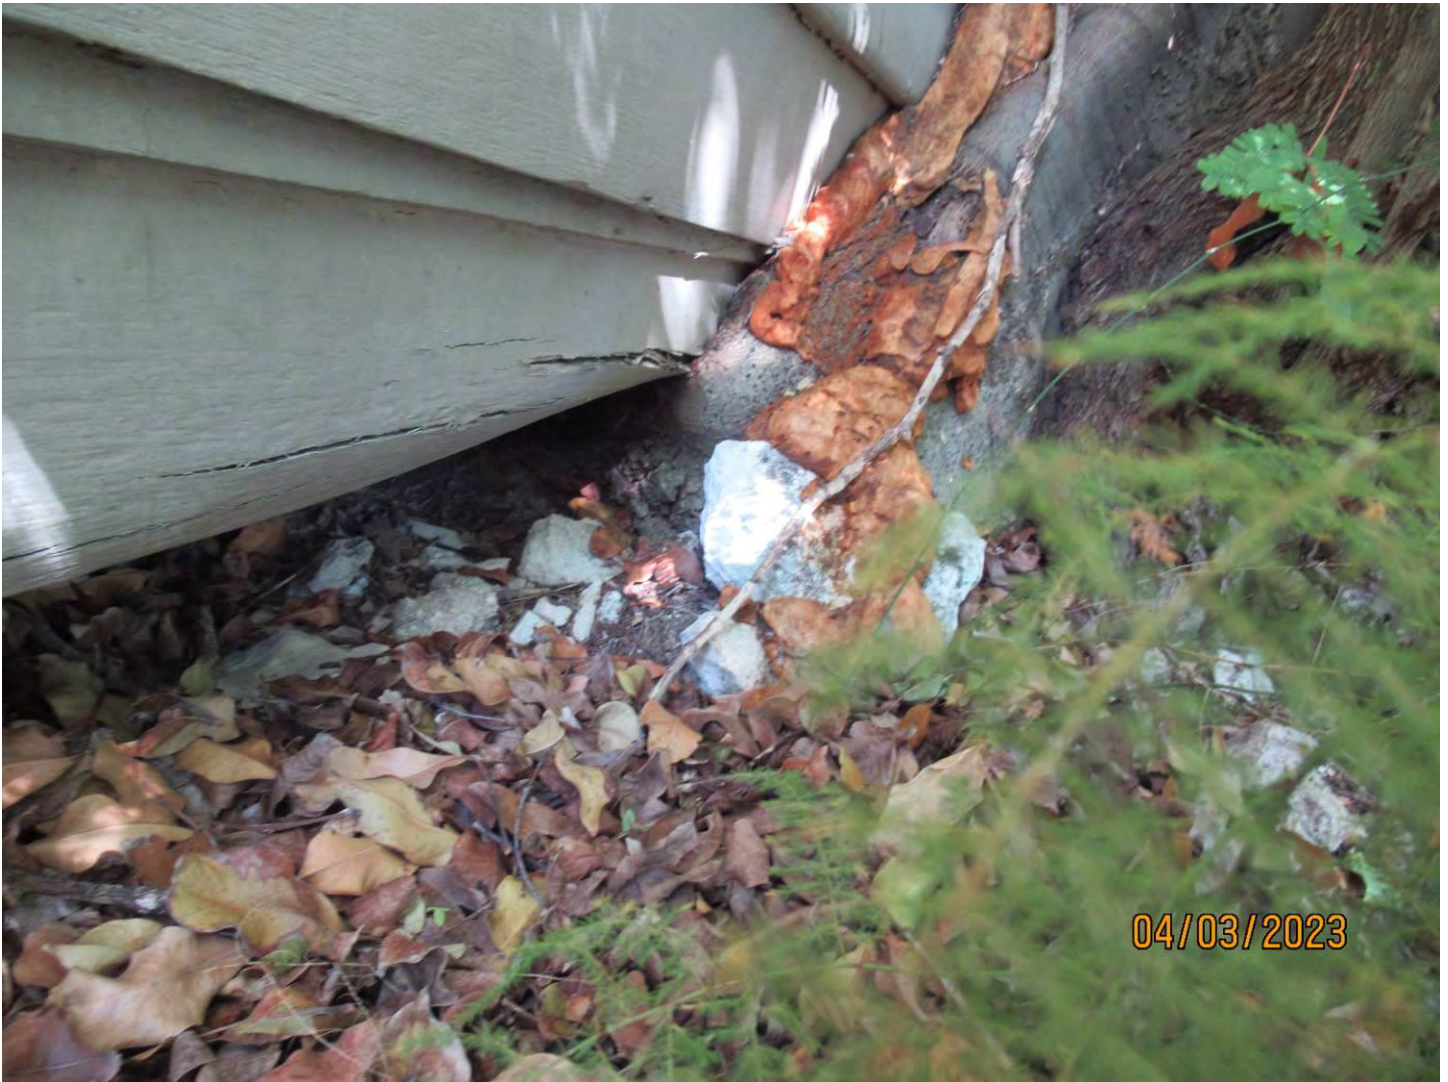
Photo showing base of tree at base of structure.

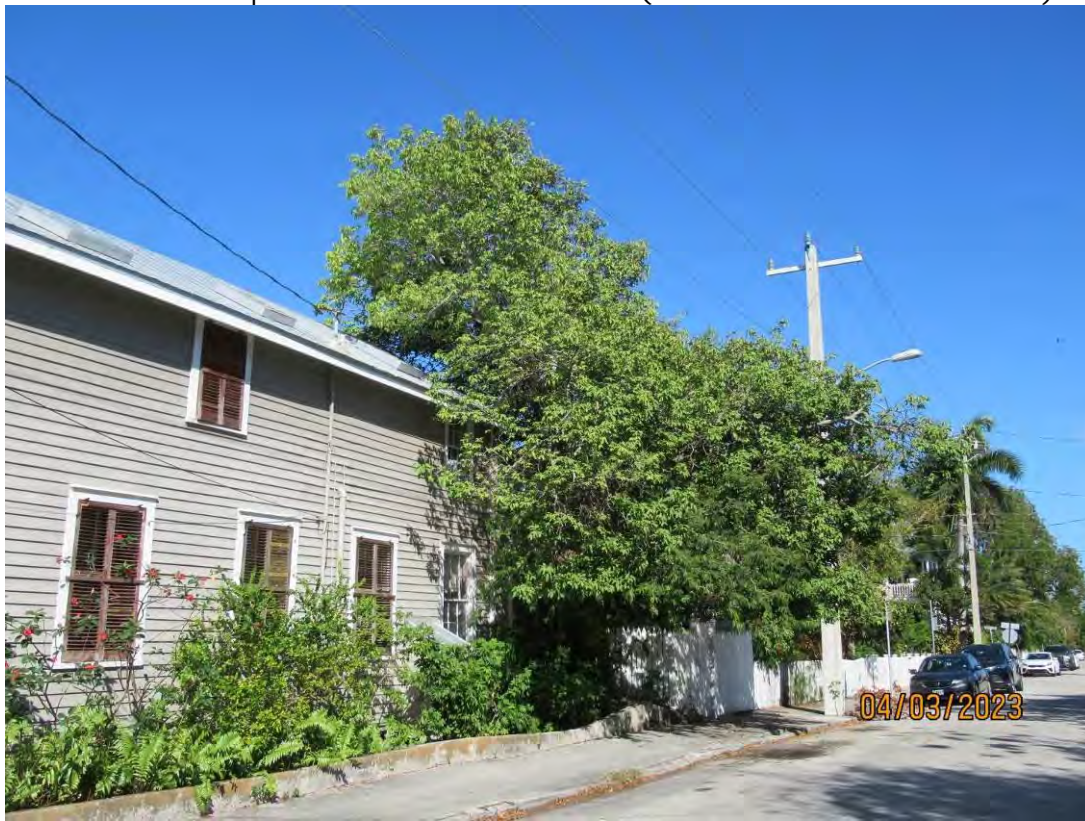
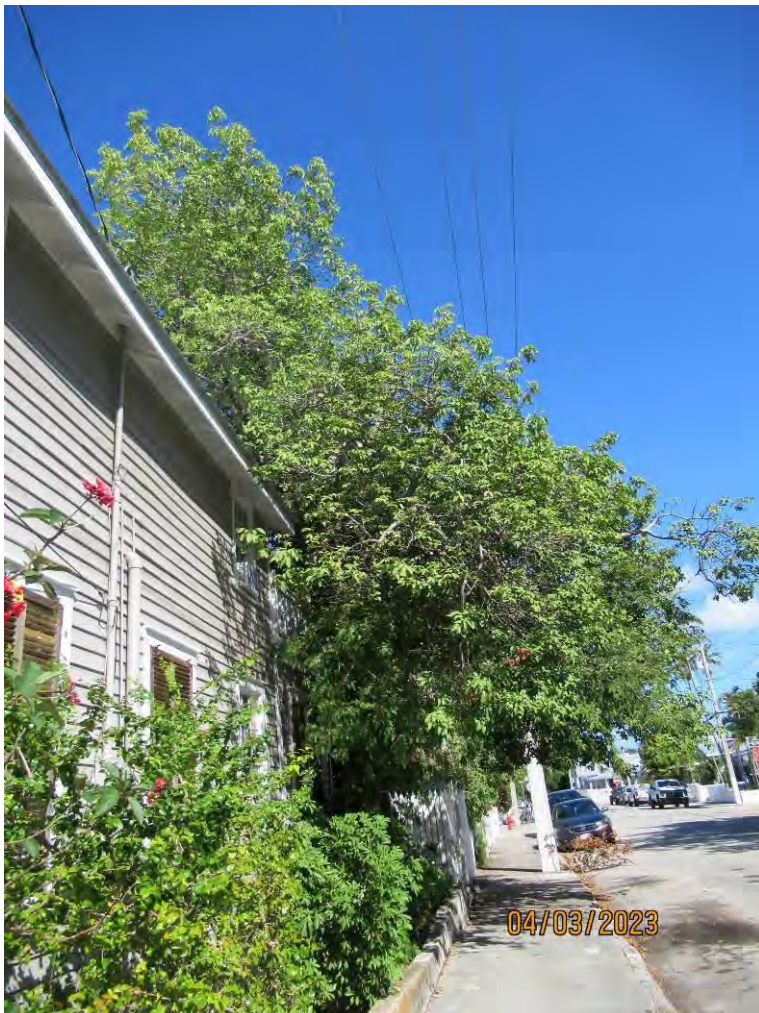
Two photos showing location
of tree-tree is growing in
Spanish Lime rootball.

Location: 20% (growing in root ball of Spanish Lime tree)

Condition: 40% (overall condition is poor, growth heavily impacted by Spanish Lime tree.)
