Structural Assessment Report:
Key West Historic Diesel Plant

Property Address:
**100 Angela St & 709 Fort St & 101 Geraldine St
Key West, FL 33040**

Serge Mashtakov, PE, FL License No. 71480

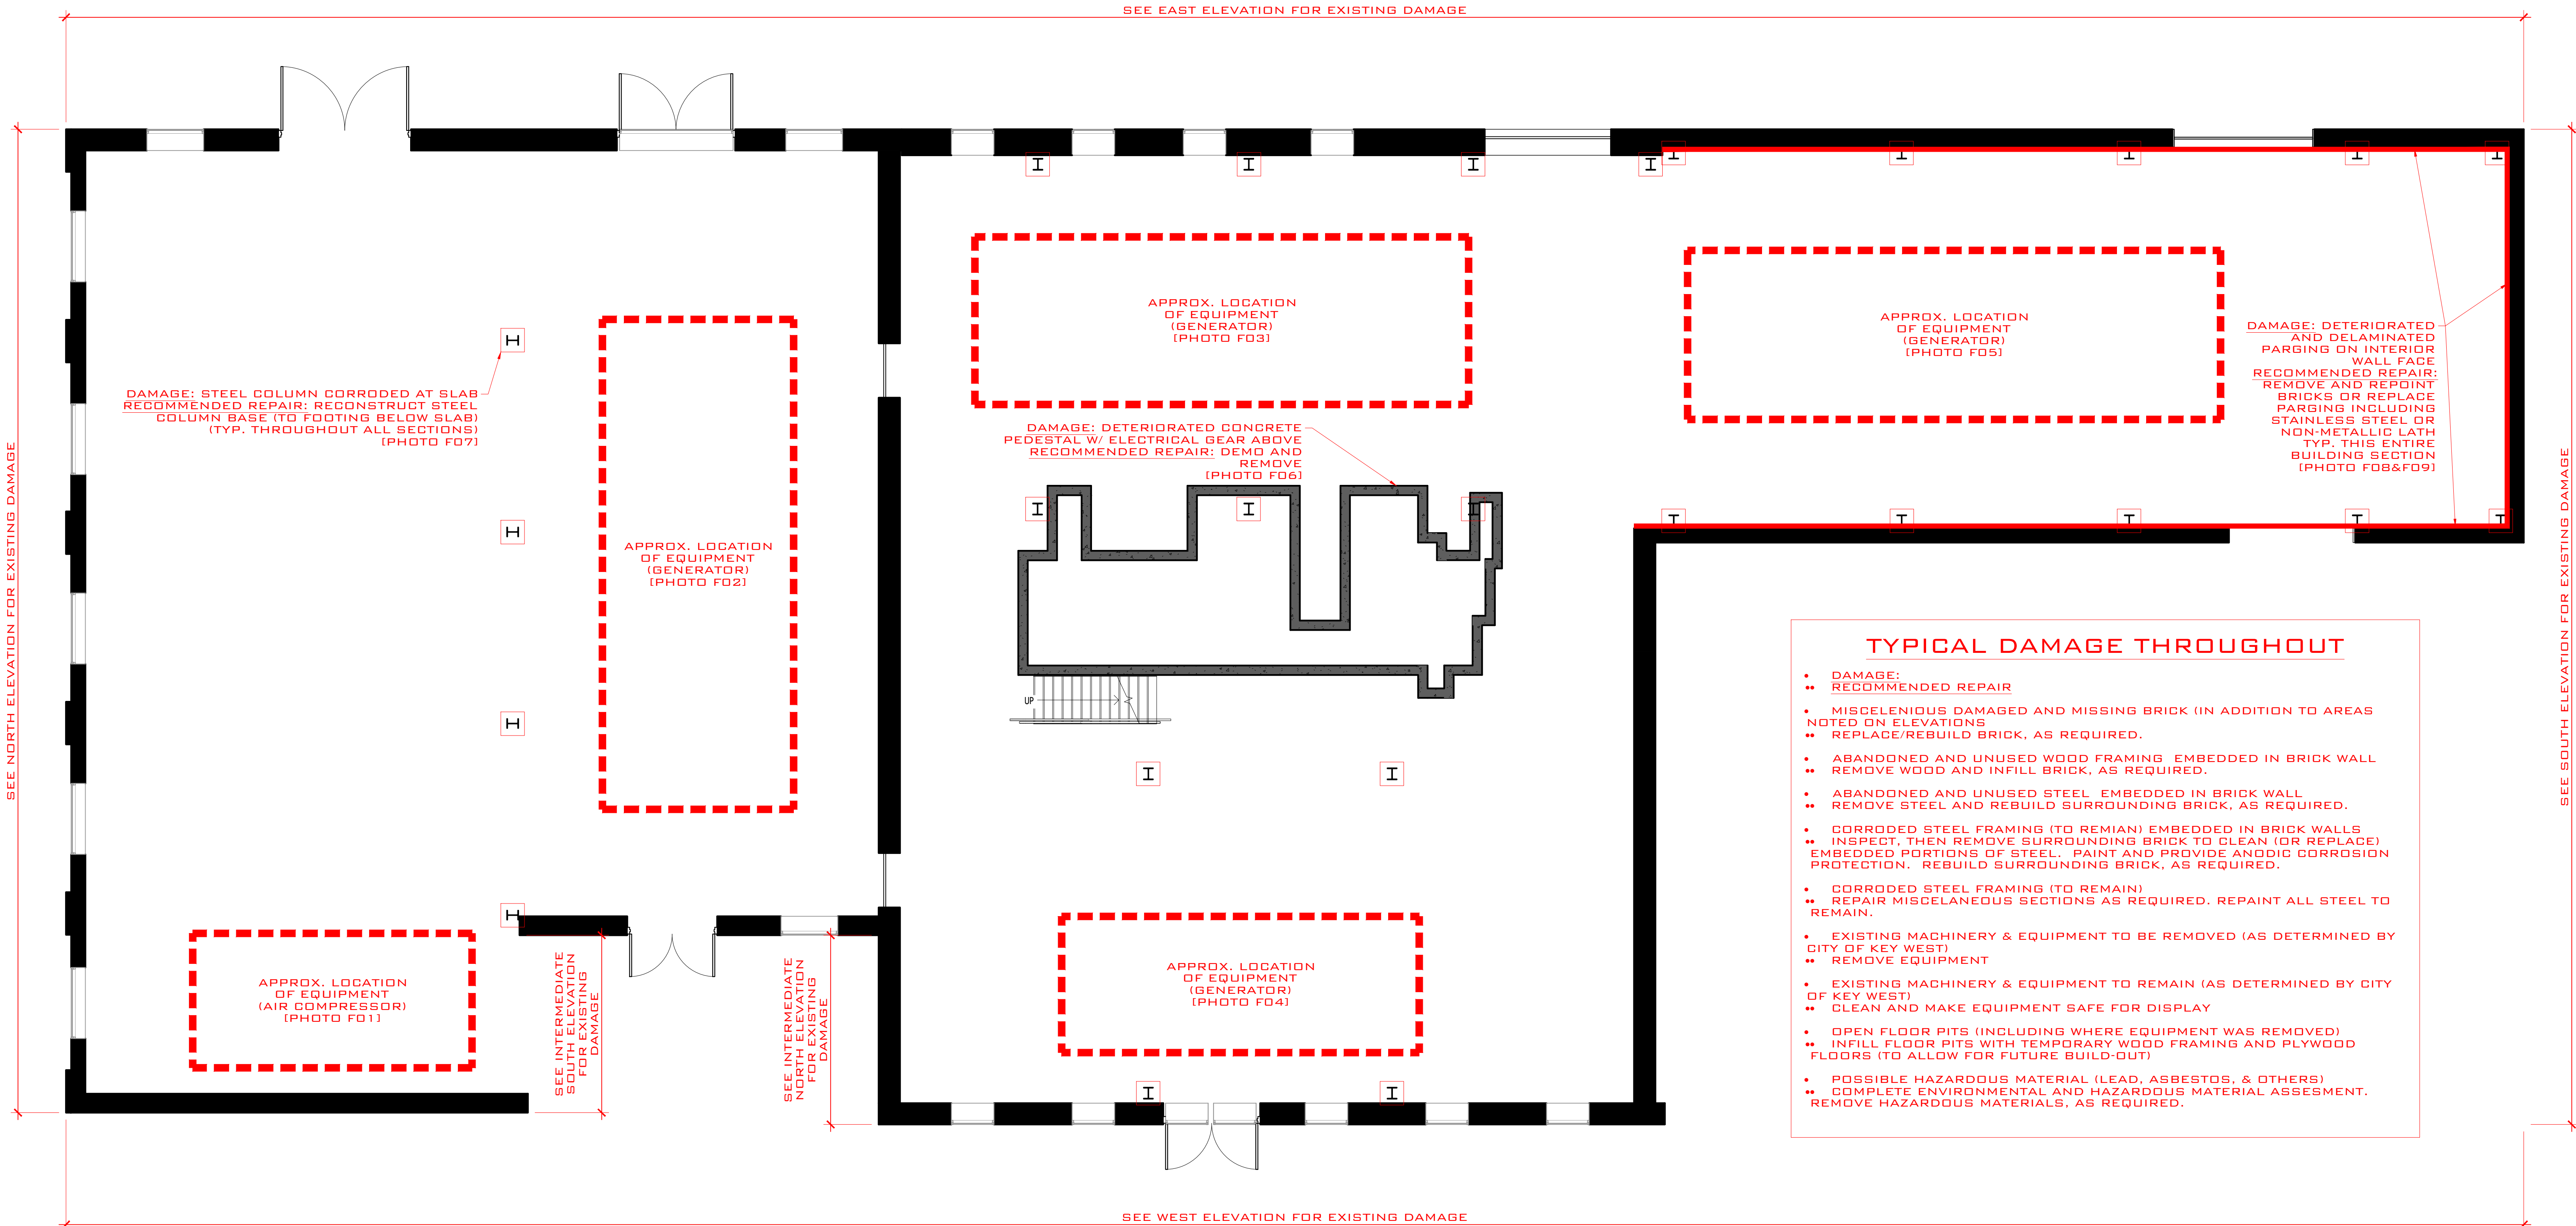
EXISTING DAMAGE - FLOOR PLAN
SCALE: 1/8" = 1'-0"

- DAMAGE: RECOMMENDED REPAIR
- MISCELLENIOUS DAMAGED AND MISSING BRICK (IN ADDITION TO AREAS NOTED ON ELEVATIONS)
- REPLACE/REBUILD BRICK, AS REQUIRED.
- ABANDONED AND UNUSED WOOD FRAMING EMBEDDED IN BRICK WALL

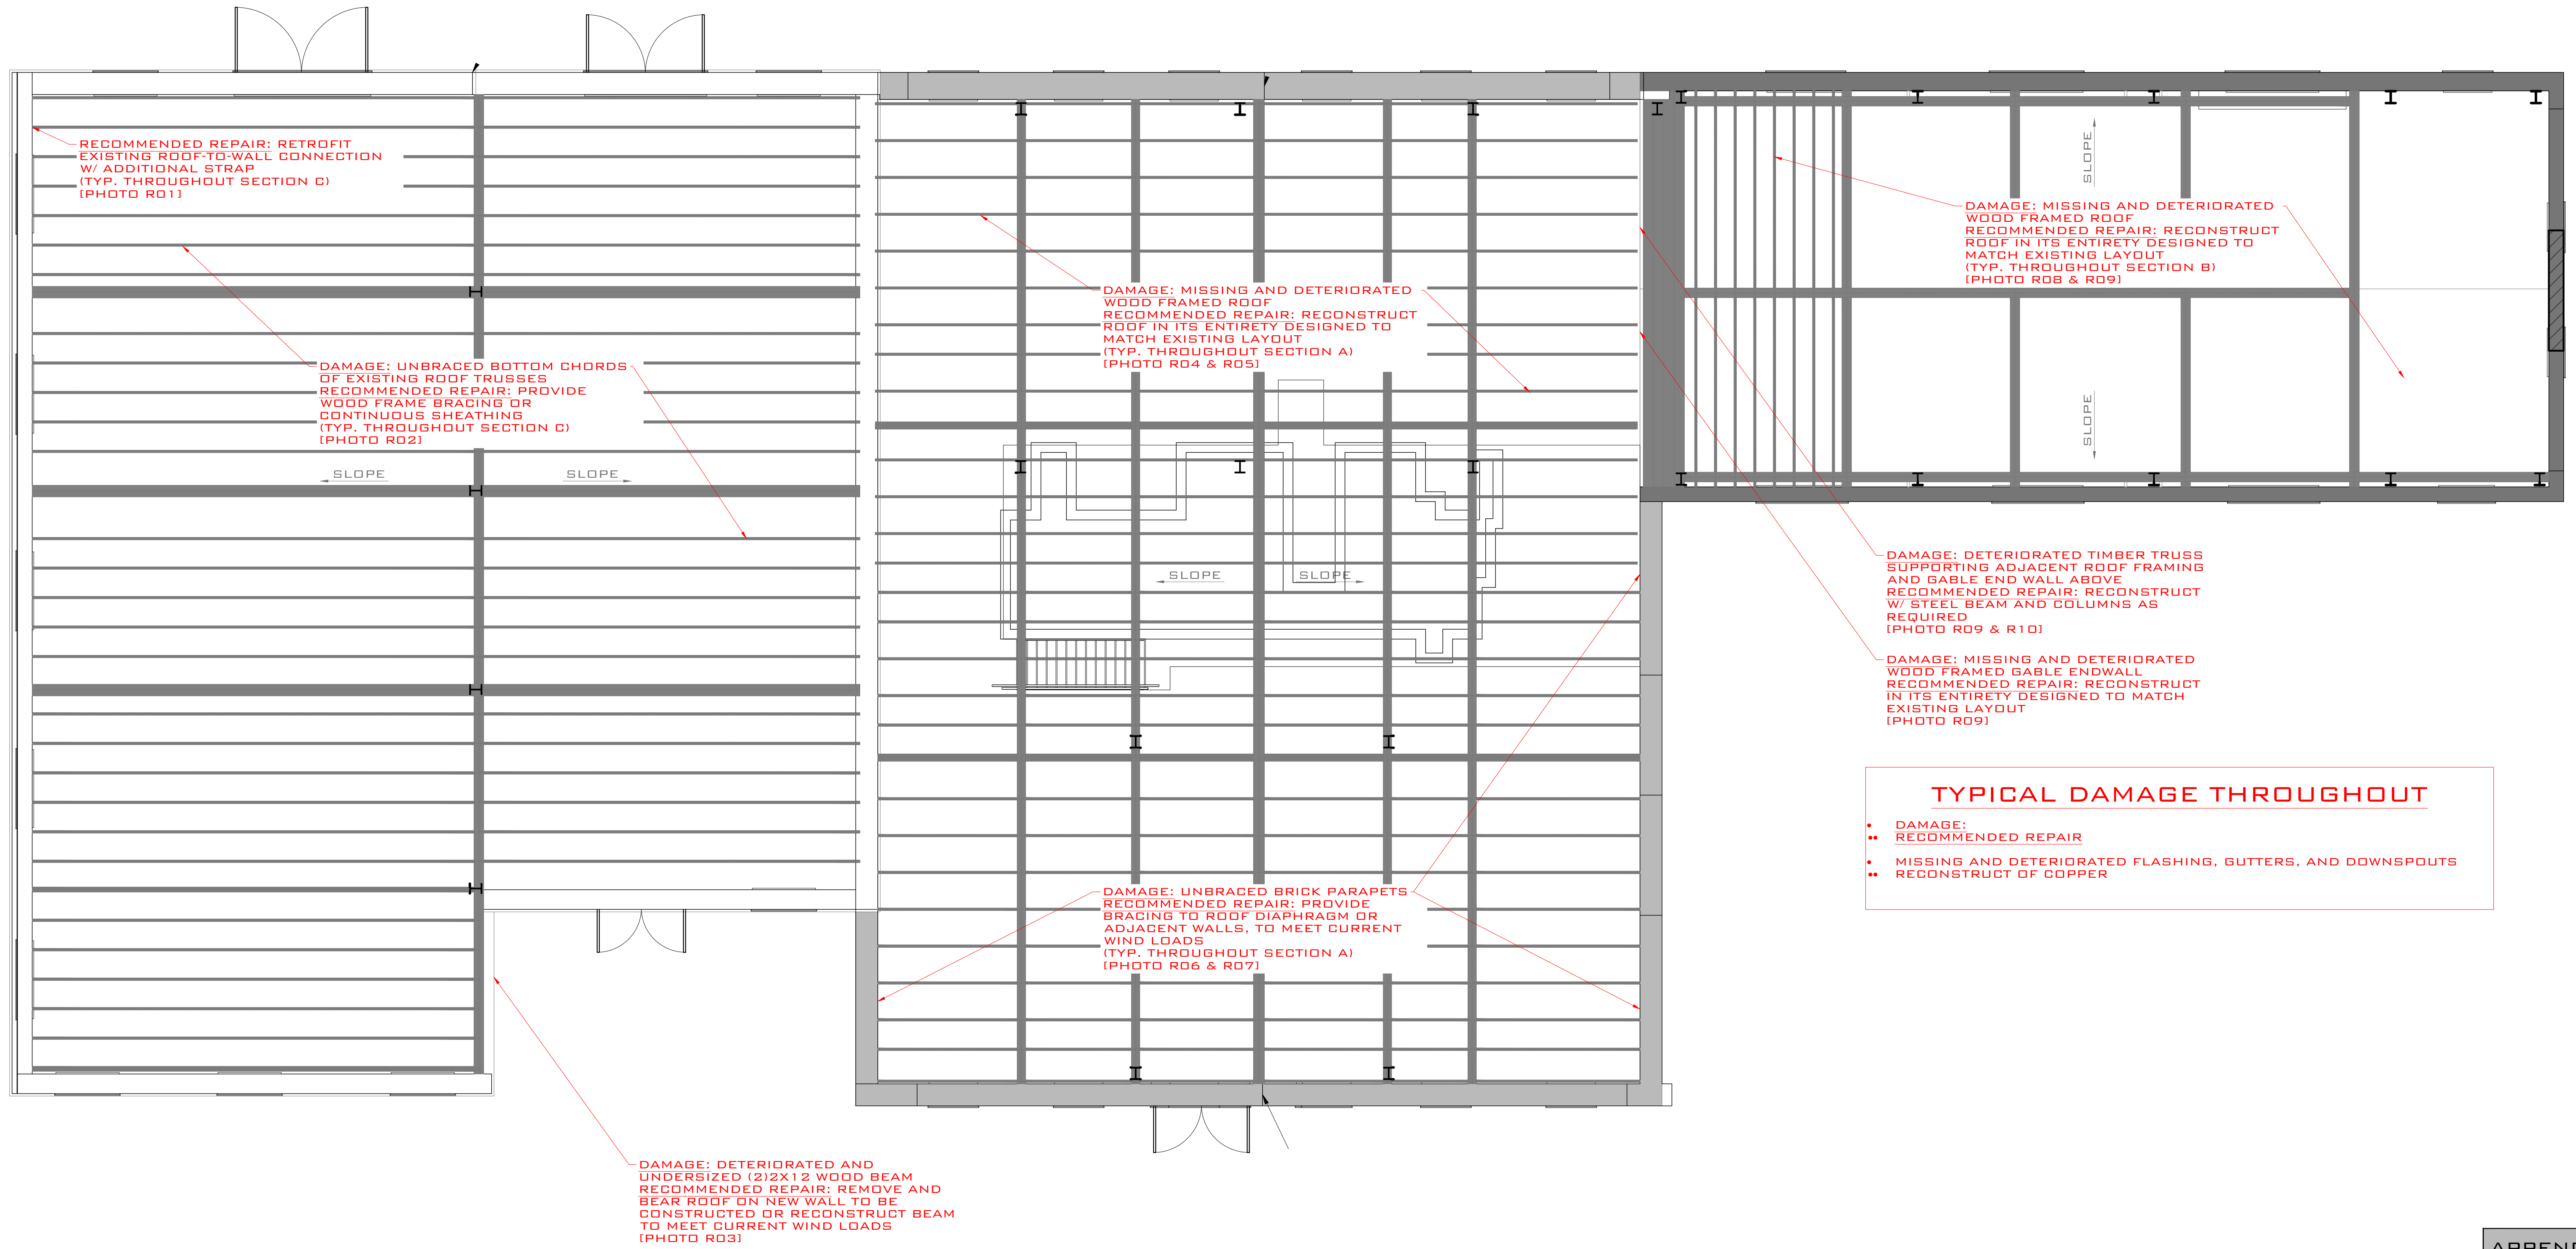
EXISTING DAMAGE - ROOF
SCALE: 1/8" = 1'-0"

- TYPICAL DAMAGE THROUGHOUT**
- DAMAGE: RECOMMENDED REPAIR
 - MISSING AND DETERIORATED FLASHING, GUTTERS, AND DOWNSPOUTS
 - RECONSTRUCT OF COPPER

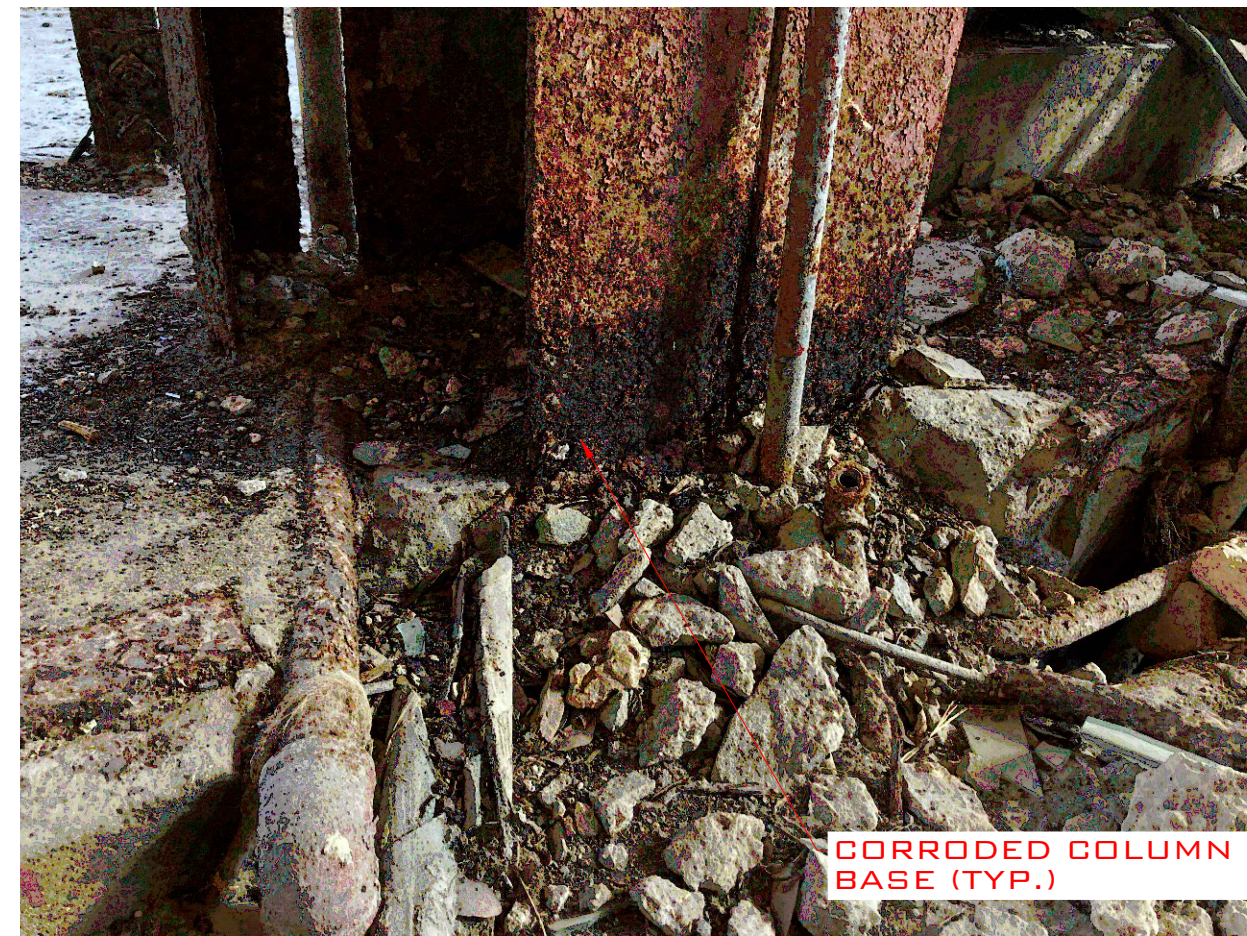
PHOTO F07

The steel framing was visually observed from the ground; however, close observation of the elevated members was not completed, due to safety concerns. All column bases (near the floor slab) are corroded. Some steel members embedded in brick walls also evidenced corrosion. The remainder of the framing did not appear to be significantly damaged; however, it is expected that some sections of steel (in addition to the column bases) will require repair or replacement.

CORRODED COLUMN BASE (TYP.)

1. Reconstructing column bases ($\pm 1'$ above slab to foundation footing below slab)
2. Reconstructing embeds in walls, where significantly damaged
3. Miscellaneous member repair or replacement, where required
4. Repaint all steel

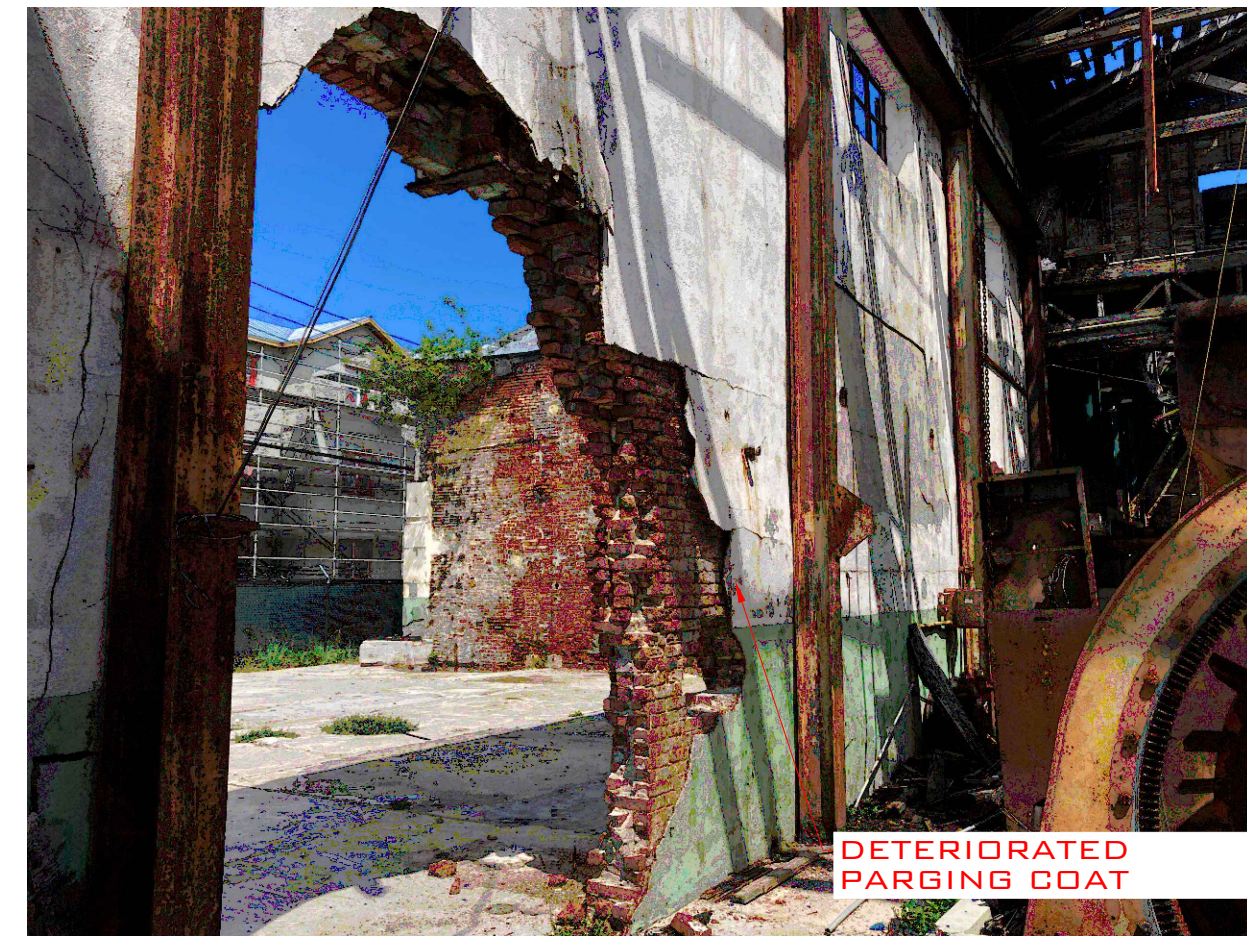
PHOTO F08

DETERIORATED PARKING COAT

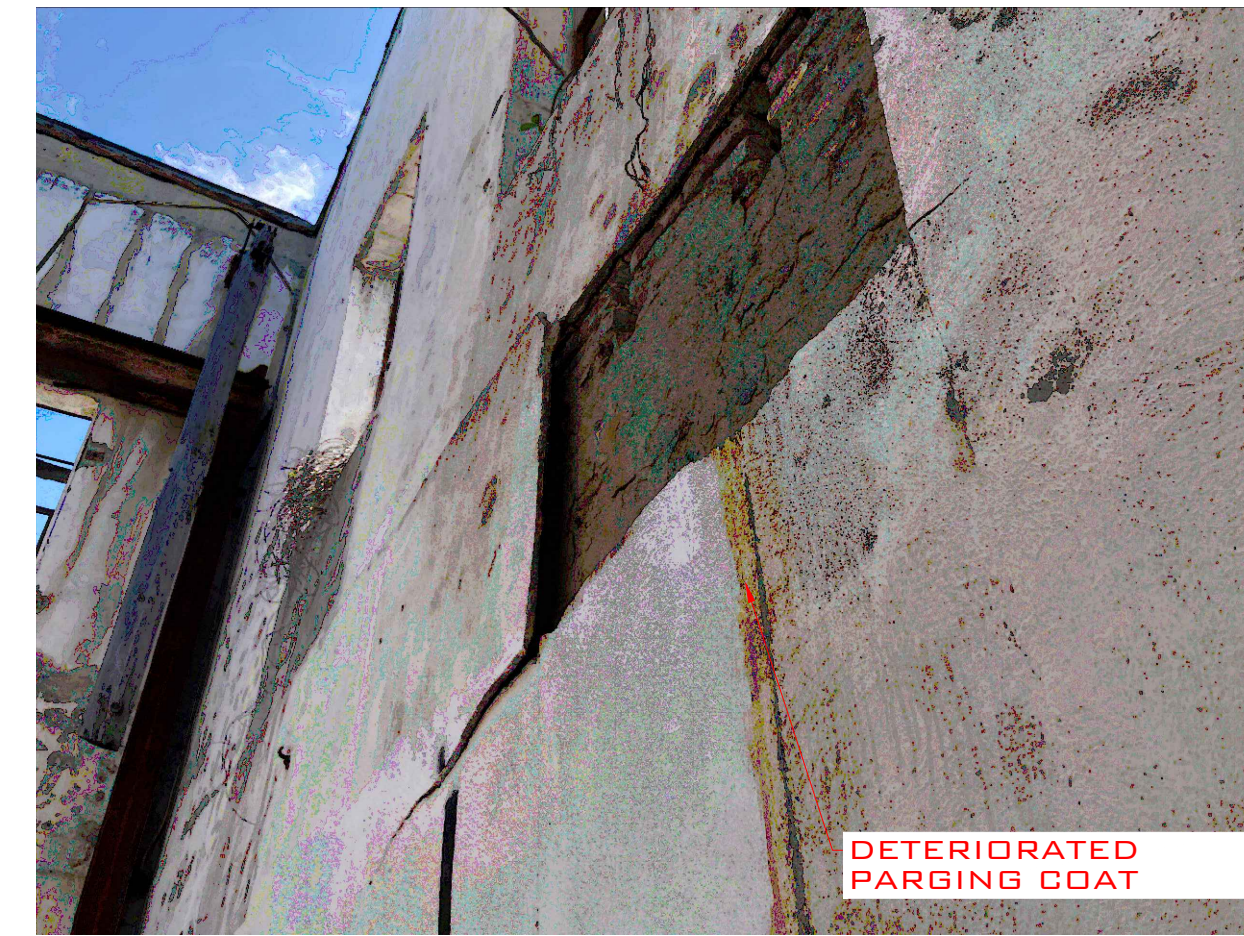
PHOTO F09

DETERIORATED PARKING COAT

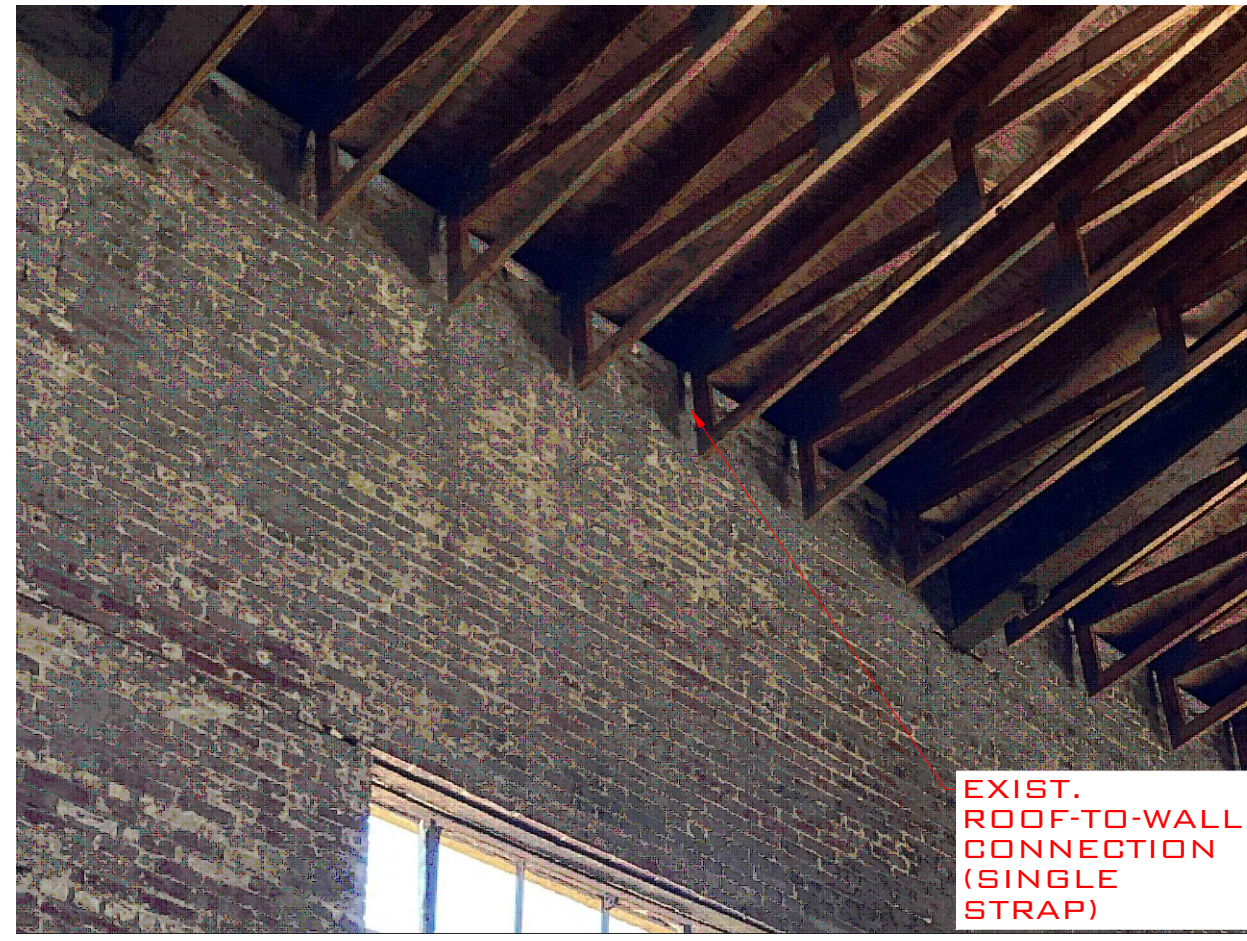
PHOTO R01

EXIST. ROOF-TO-WALL CONNECTION (SINGLE STRAP)

1. Provide bottom chord bracing by wood frame bracing or continuous sheathing (or furring & drywall)
2. Retrofit existing roof-to-wall anchors to meet current wind loads. One anchor strap currently exists; however, an additional strap may be necessary to meet current Florida Building Code loads.

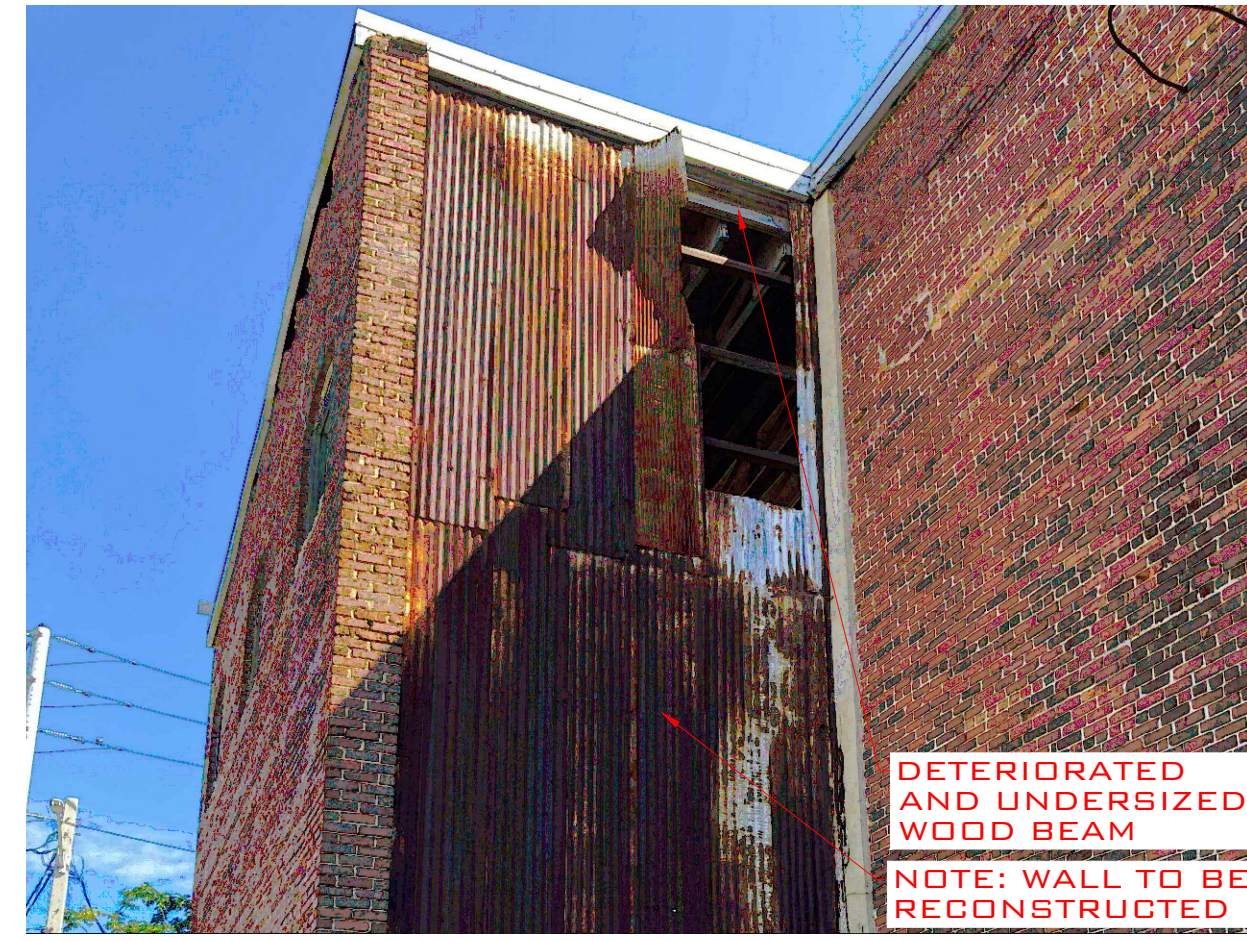
PHOTO R03

DETERIORATED AND UNDERSIZED WOOD BEAM
NOTE: WALL TO BE RECONSTRUCTED

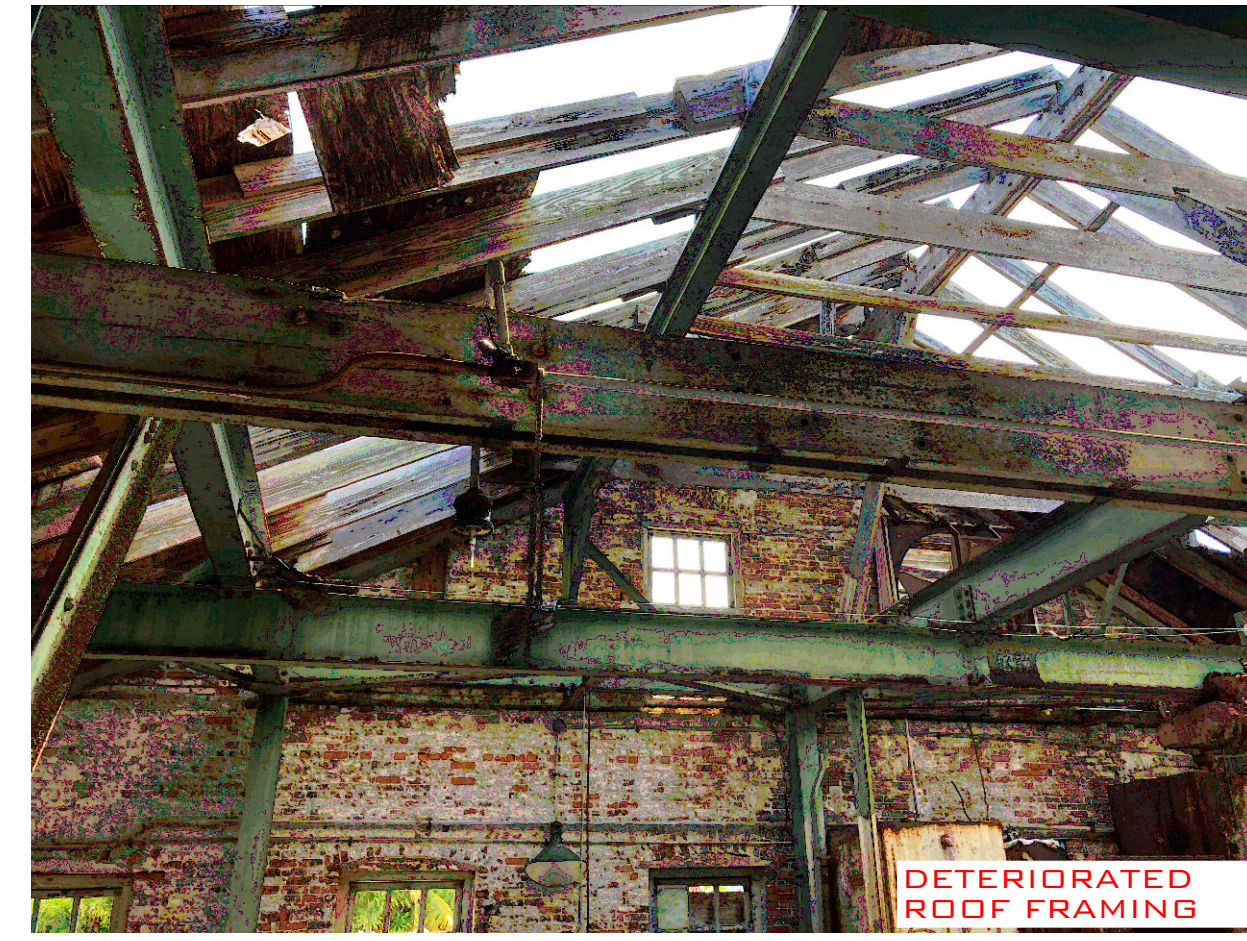
PHOTO R04

DETERIORATED ROOF FRAMING

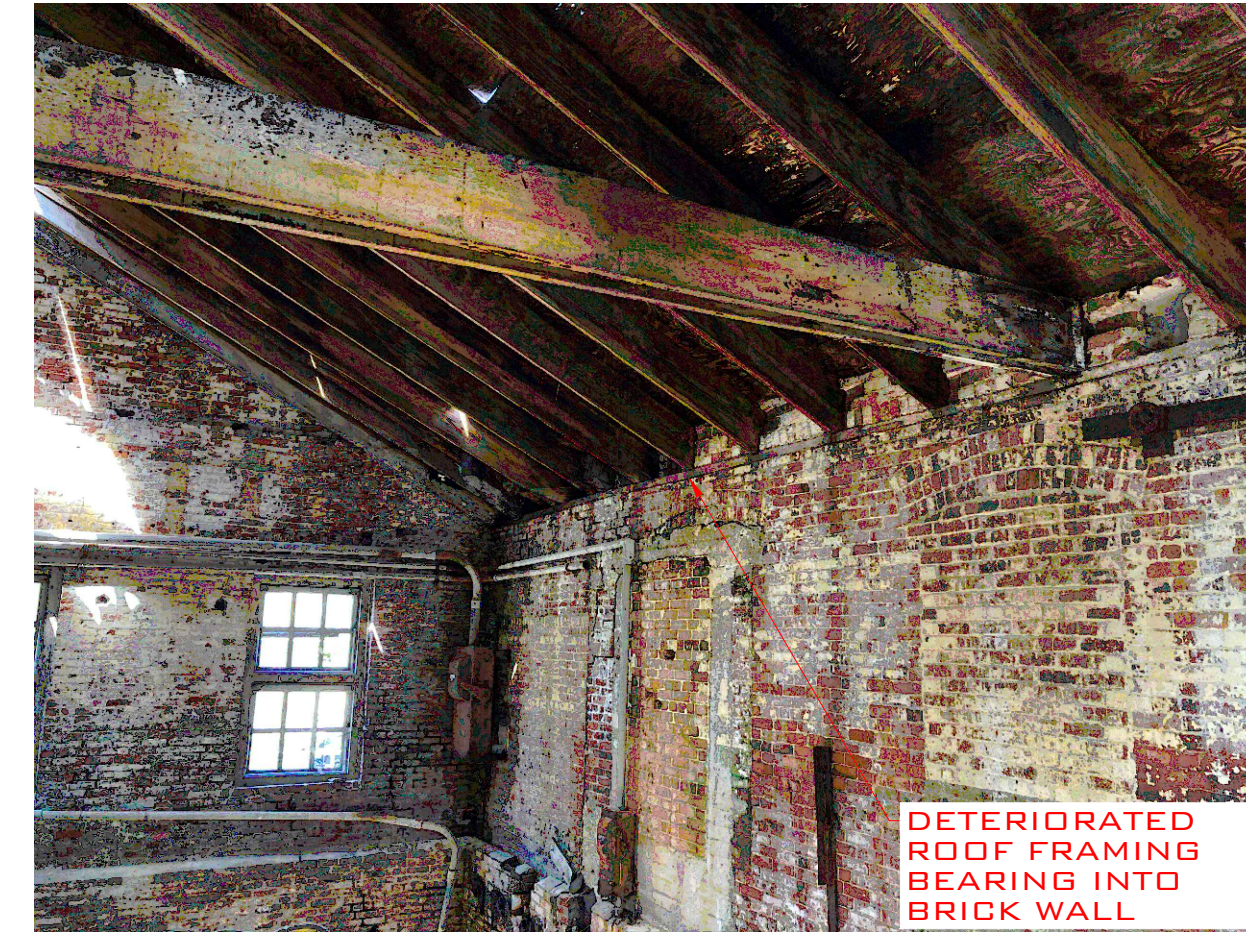
PHOTO R05

DETERIORATED ROOF FRAMING BEARING INTO BRICK WALL

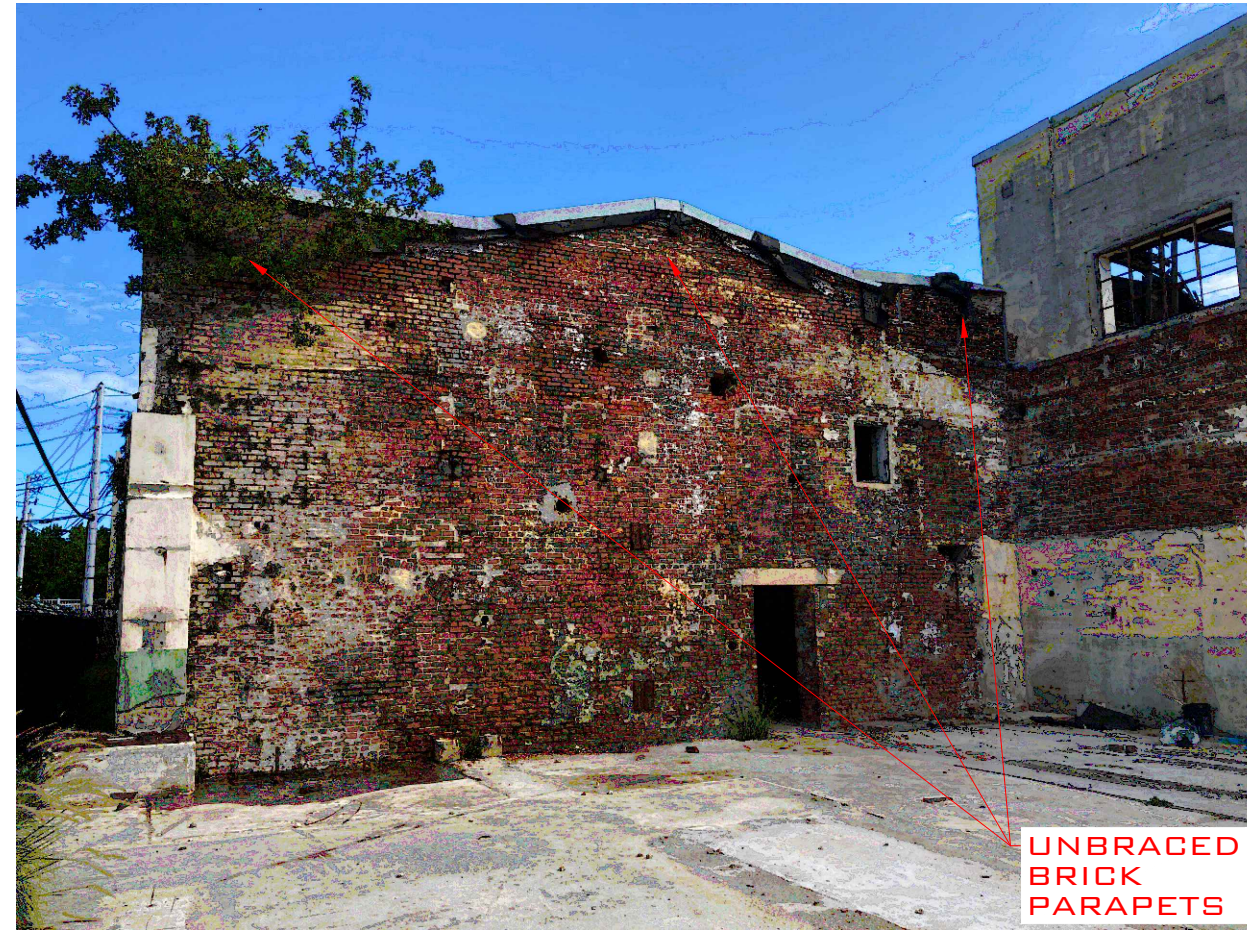
PHOTO R06

Building Section A contains parapets that are constructed of unreinforced brick. These parapets may be susceptible to failure during high wind loads.

UNBRACED BRICK PARAPETS

It is recommended that the wind loads on these parapets be analyzed during design, to determine if bracing is required. Bracing can anchor parapets to the roof diaphragm or adjacent walls. Additionally, the design of the roof crickets may be detailed to brace the parapets.

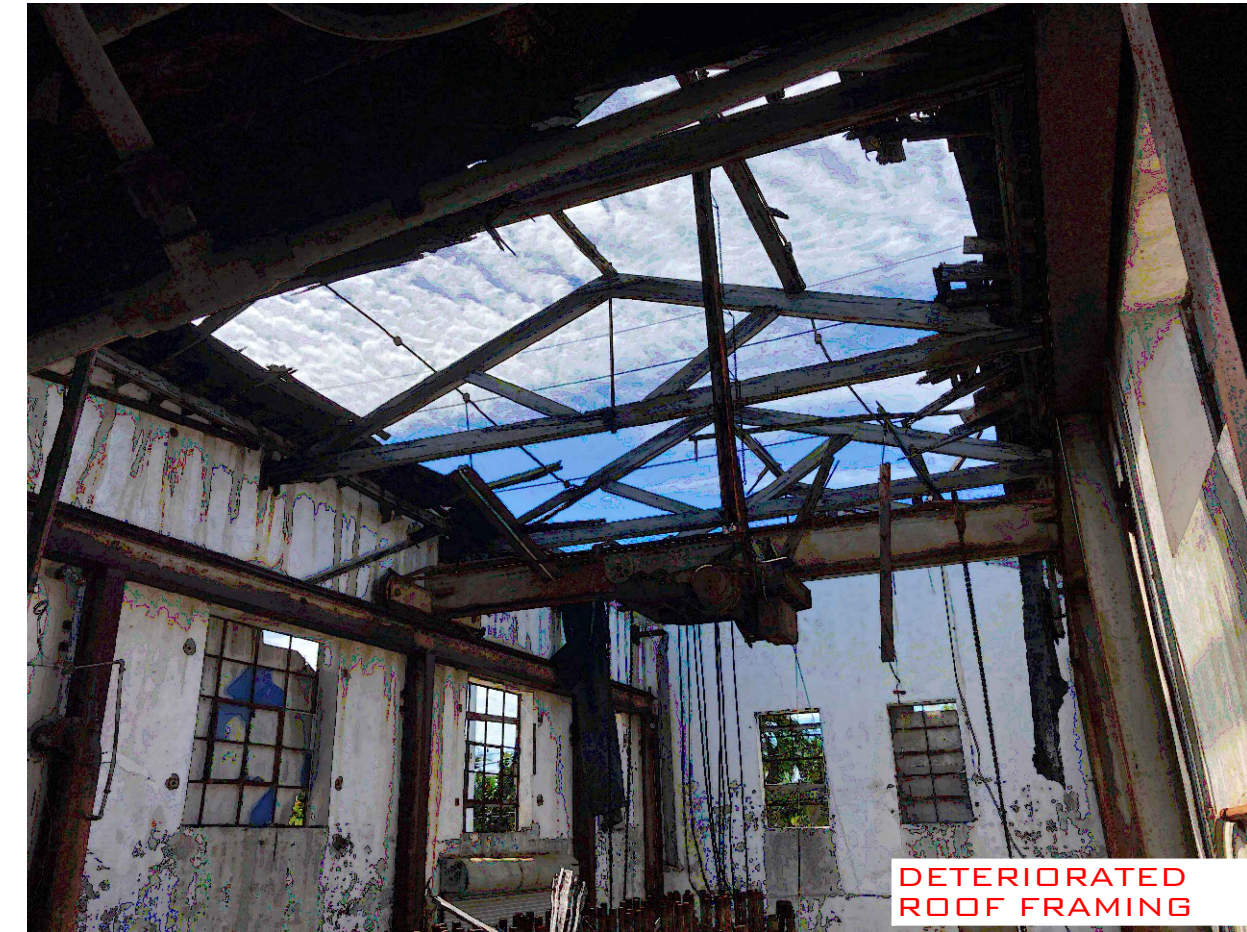
PHOTO R08

DETERIORATED ROOF FRAMING

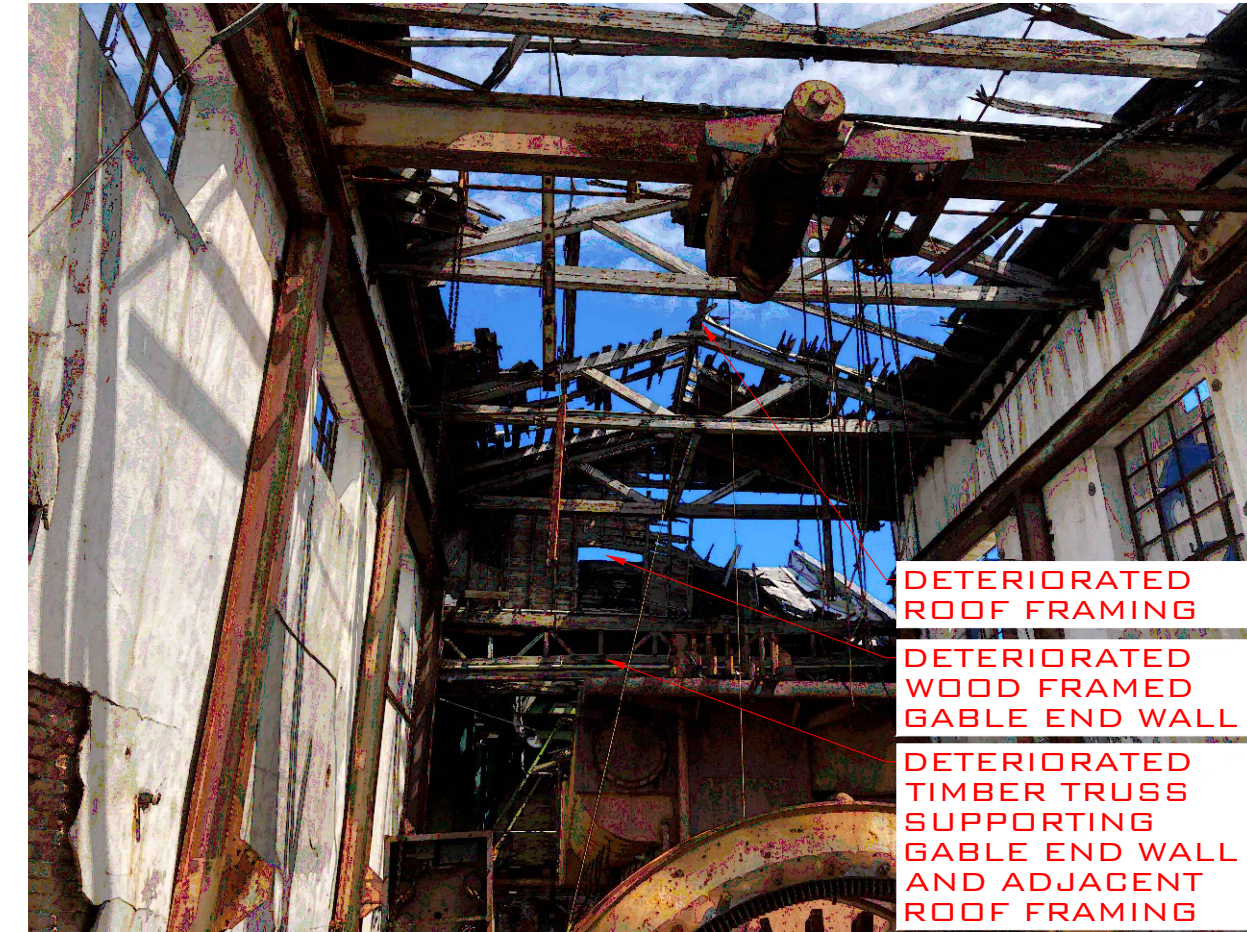
PHOTO R09

DETERIORATED ROOF FRAMING
DETERIORATED WOOD FRAMED GABLE END WALL
DETERIORATED TIMBER TRUSS SUPPORTING GABLE END WALL AND ADJACENT ROOF FRAMING

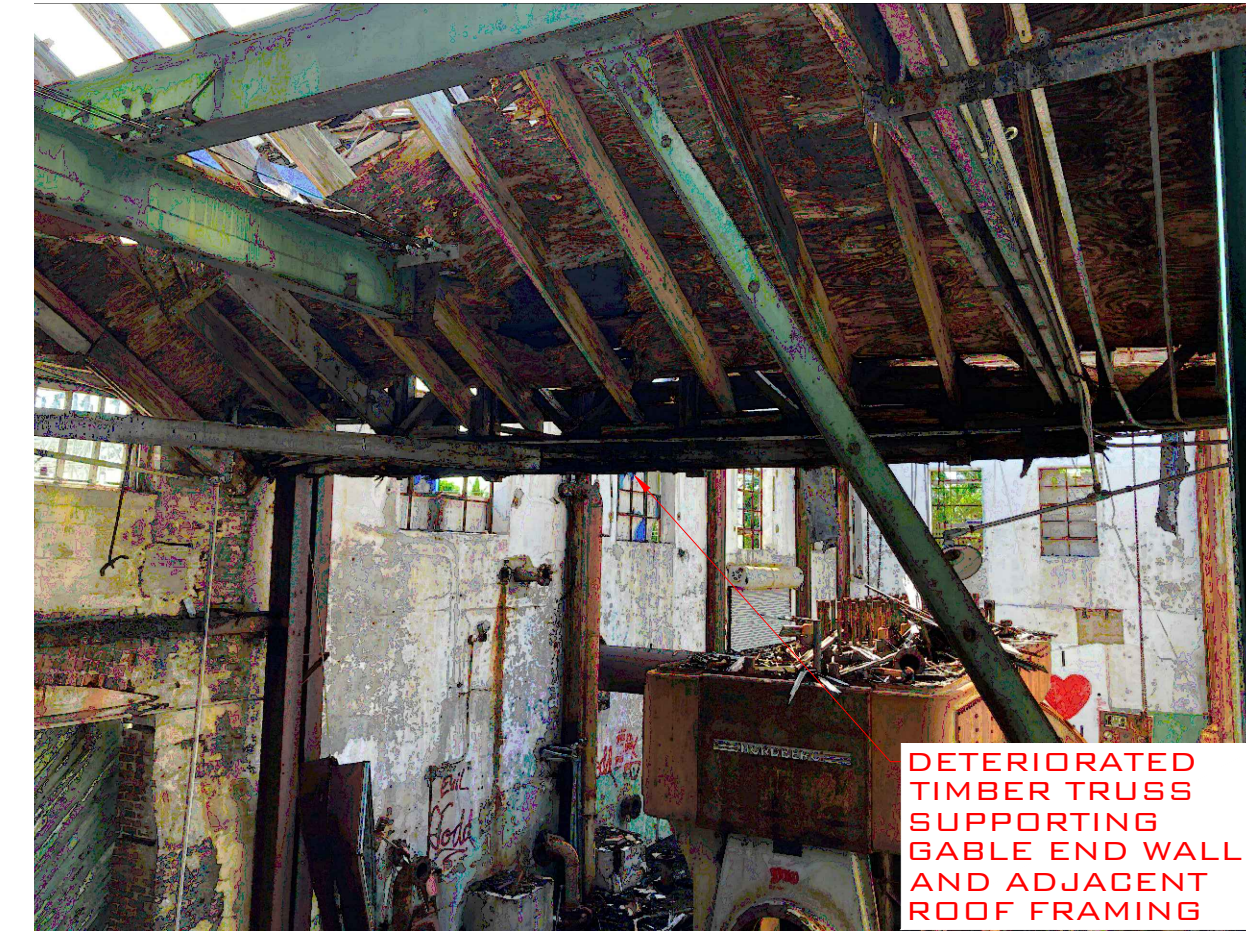
PHOTO R10

DETERIORATED TIMBER TRUSS SUPPORTING GABLE END WALL AND ADJACENT ROOF FRAMING

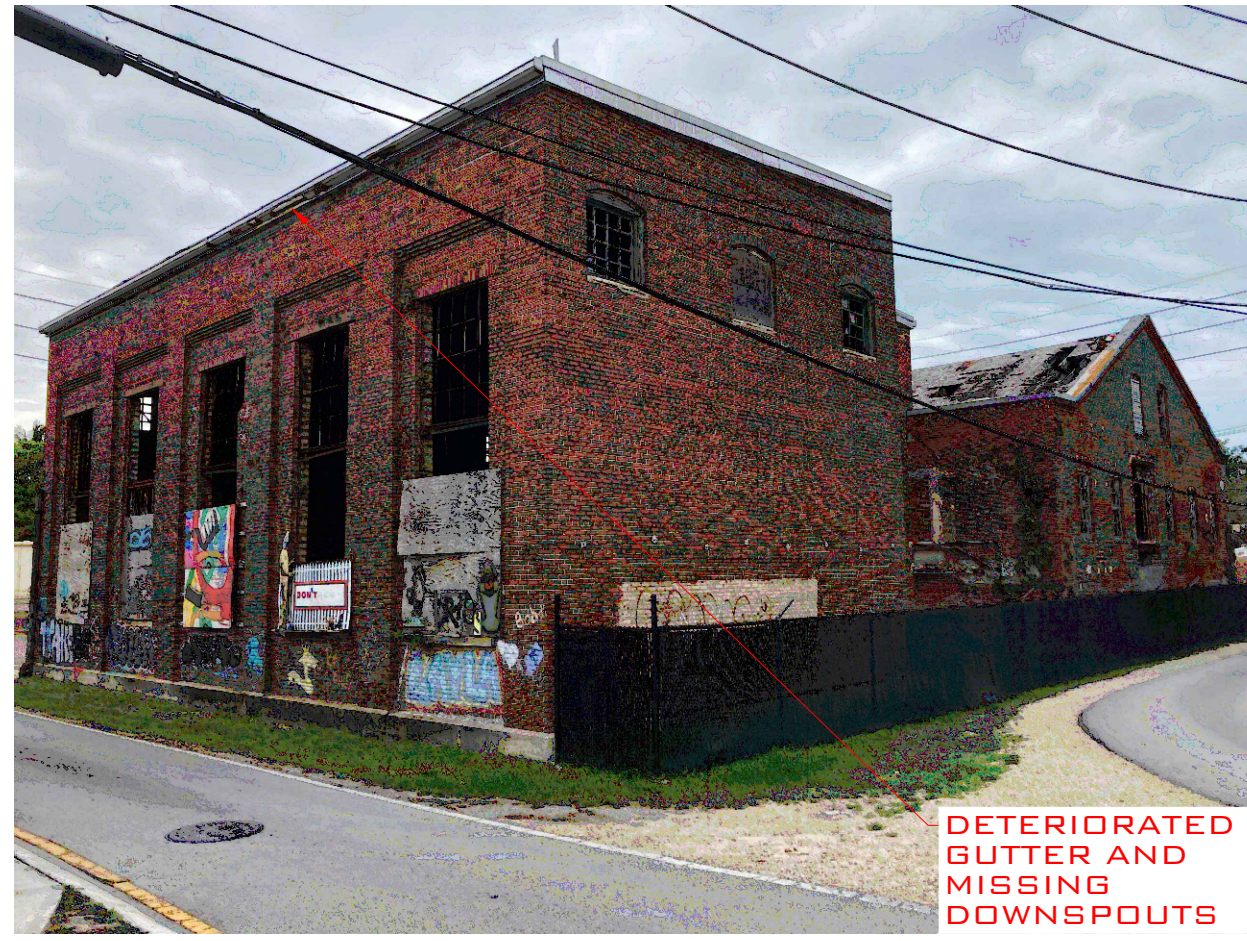
PHOTO N01

DETERIORATED GUTTER AND MISSING DOWNSPOUTS

It is recommended that new metal panel roofing be installed once roof framing is replaced. Additionally, it is critical that flashing, crickets, internal gutters, scuppers, and downspouts be constructed to efficiently remove rainwater and direct it away from the building.

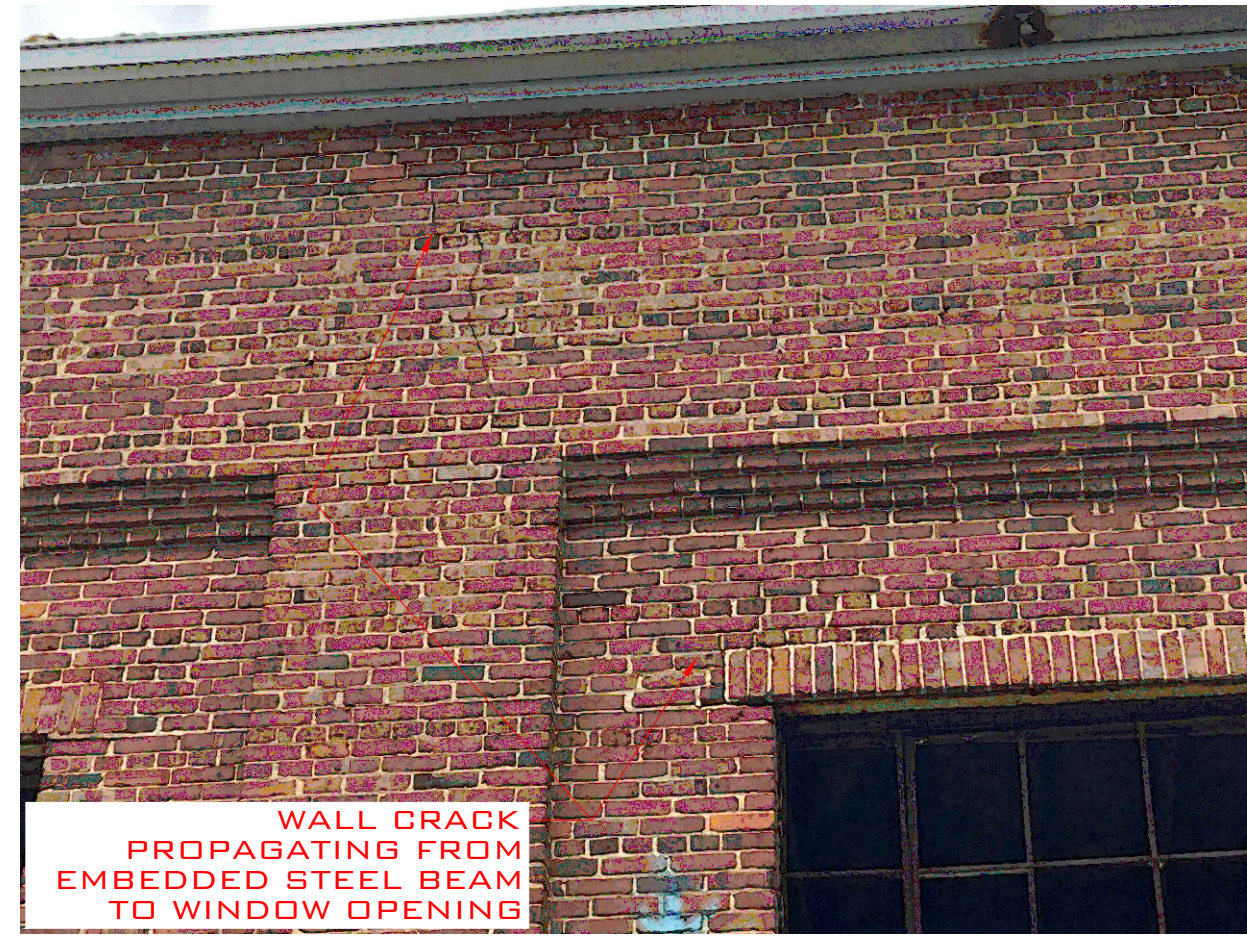
PHOTO N02

WALL CRACK PROPAGATING FROM EMBEDDED STEEL BEAM TO WINDOW OPENING

It is recommended that all abandoned embedded steel or wood be removed, and brick be replaced or rebuilt, as required.
