Structural Assessment Report:
Key West Historic Diesel Plant

Property Address:
**100 Angela St & 709 Fort St & 101 Geraldine St
Key West, FL 33040**

Serge Mashtakov, PE, FL License No. 71480

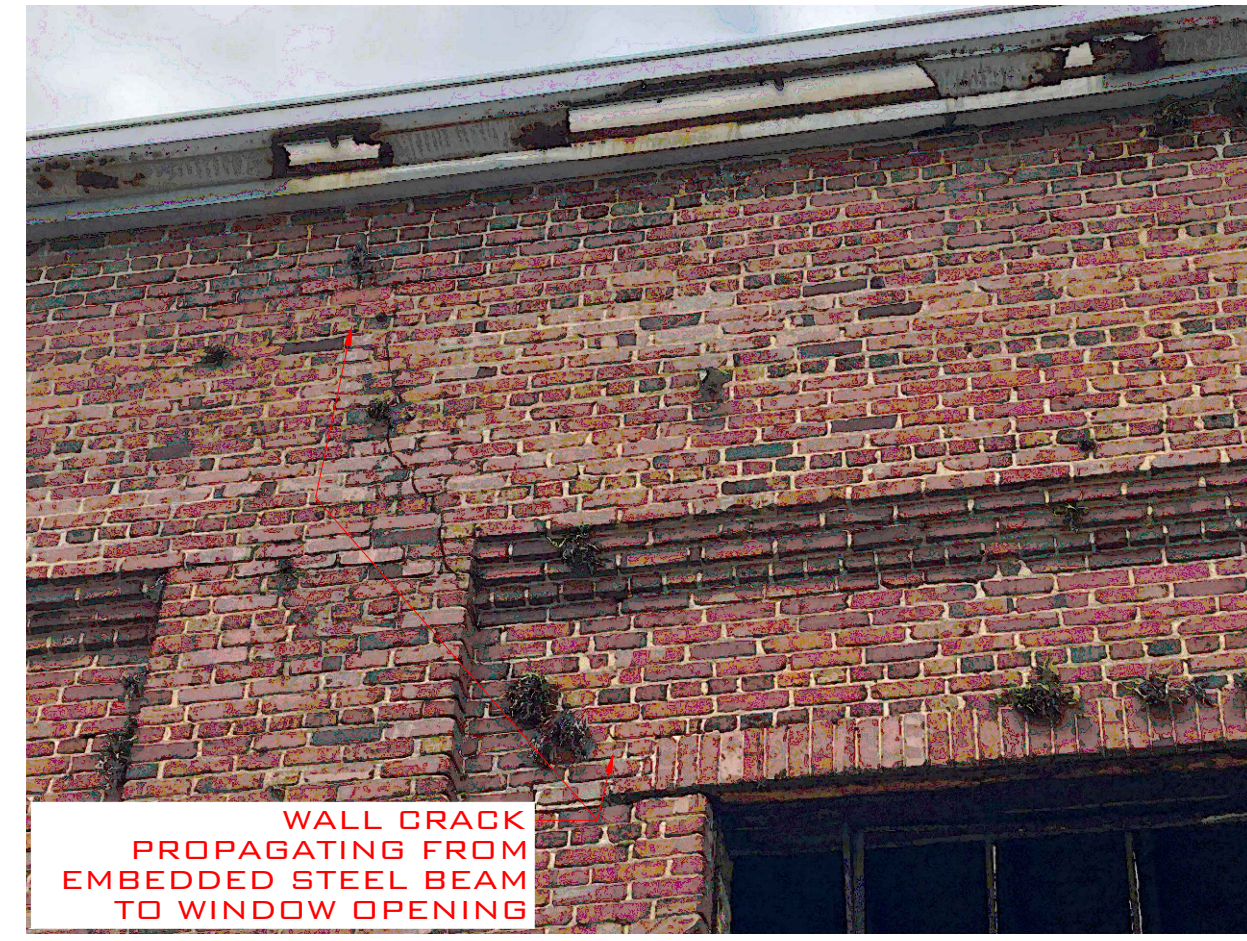
PHOTO N03

WALL CRACK PROPAGATING FROM EMBEDDED STEEL BEAM TO WINDOW OPENING

It is recommended that all abandoned embedded steel or wood be removed, and brick be replaced or rebuilt, as required.

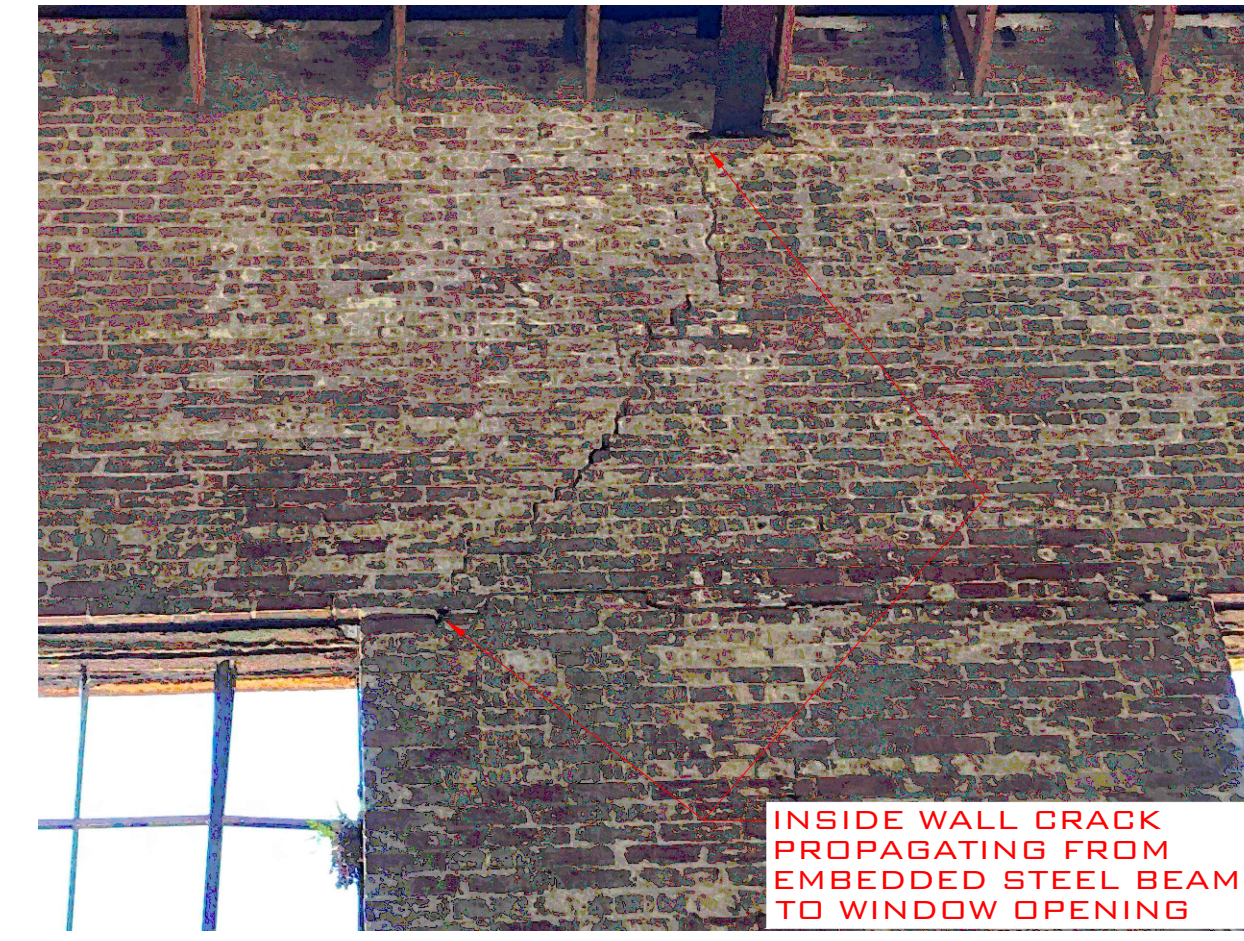
PHOTO N04

INSIDE WALL CRACK PROPAGATING FROM EMBEDDED STEEL BEAM TO WINDOW OPENING

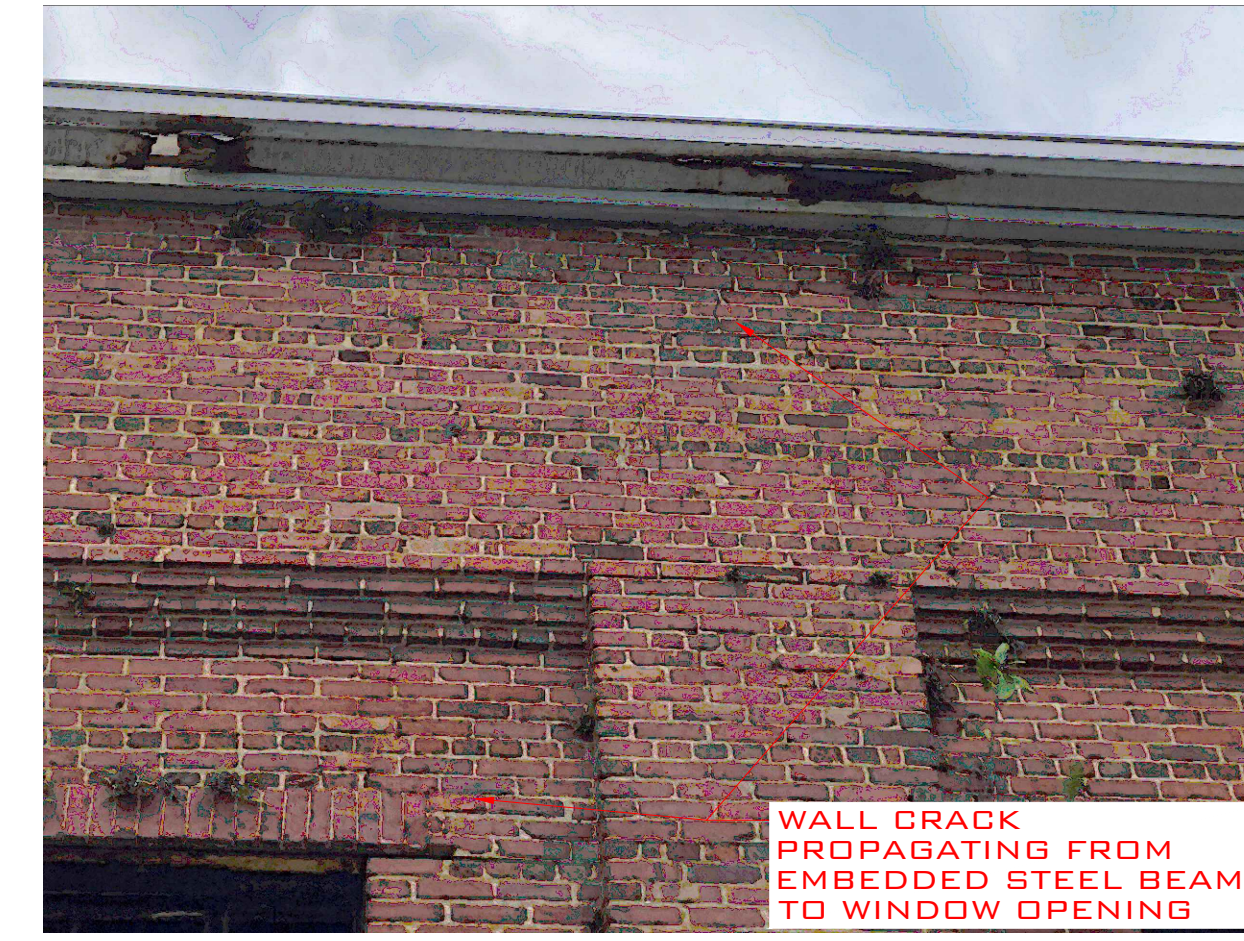
PHOTO N05

WALL CRACK PROPAGATING FROM EMBEDDED STEEL BEAM TO WINDOW OPENING

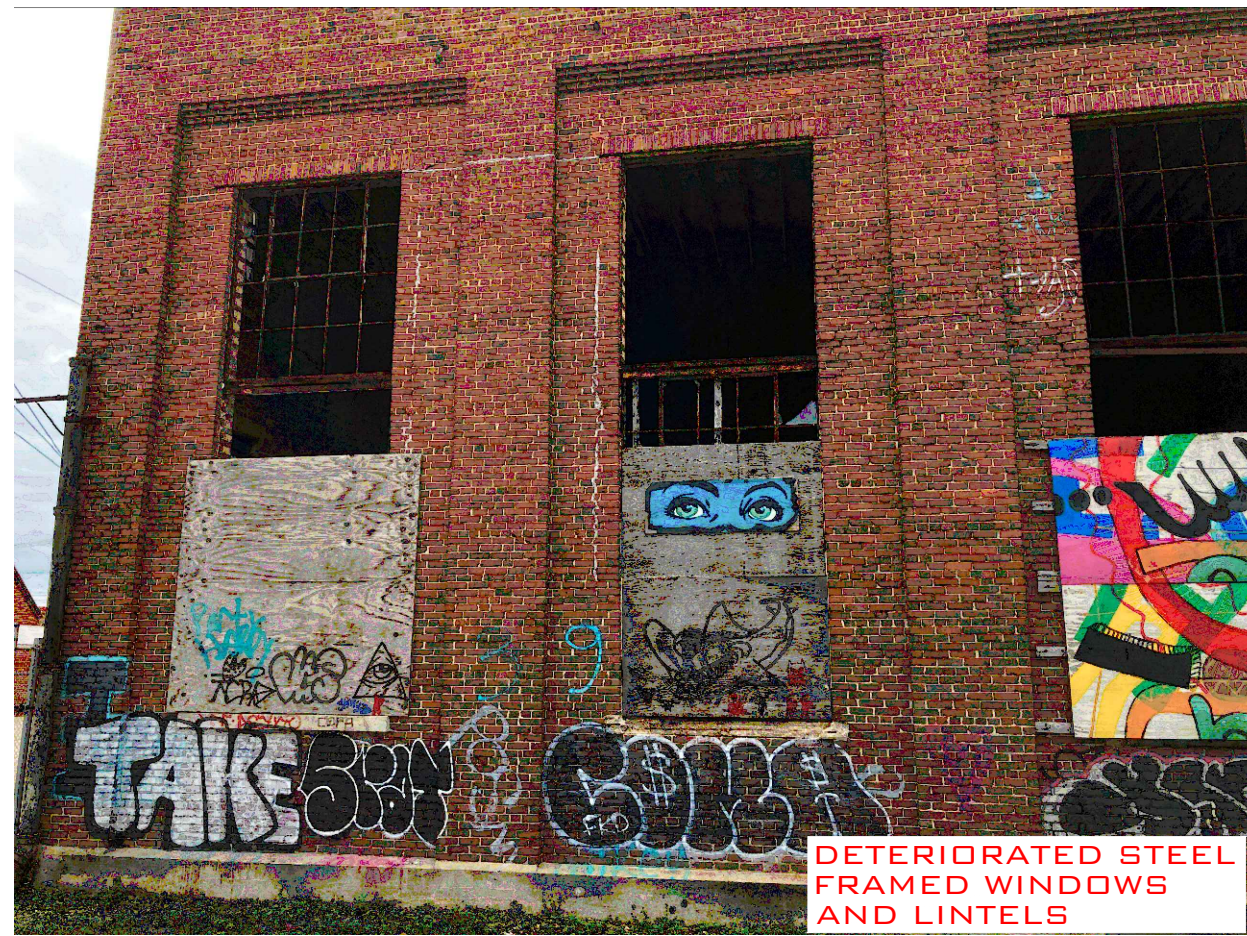
PHOTO N06

DETERIORATED STEEL FRAMED WINDOWS AND LINTELS

It is recommended that all windows be replaced with aluminum framed windows, as approved by the Key West Historic Architectural Review Commission (HARC). Aluminum framed windows provide significant performance advantages for wind loads and water intrusion. Furthermore, they are significantly more corrosion resistant than steel and require much less maintenance compared to wood or steel. Additionally, all windowsills shall be replaced to mitigate water intrusion, and steel lintels shall be reconstructed of stainless steel. This work will

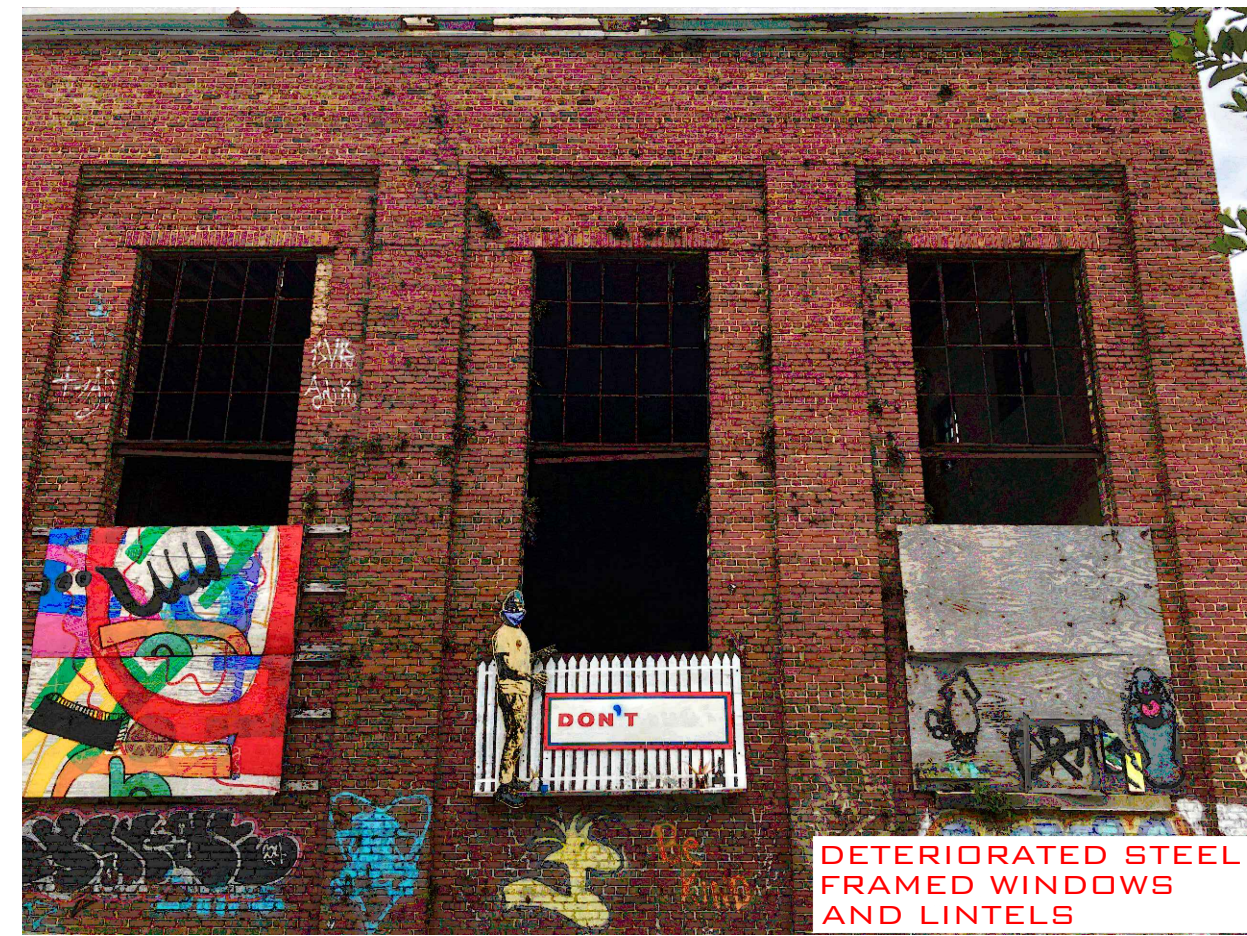
PHOTO N07

DETERIORATED STEEL FRAMED WINDOWS AND LINTELS

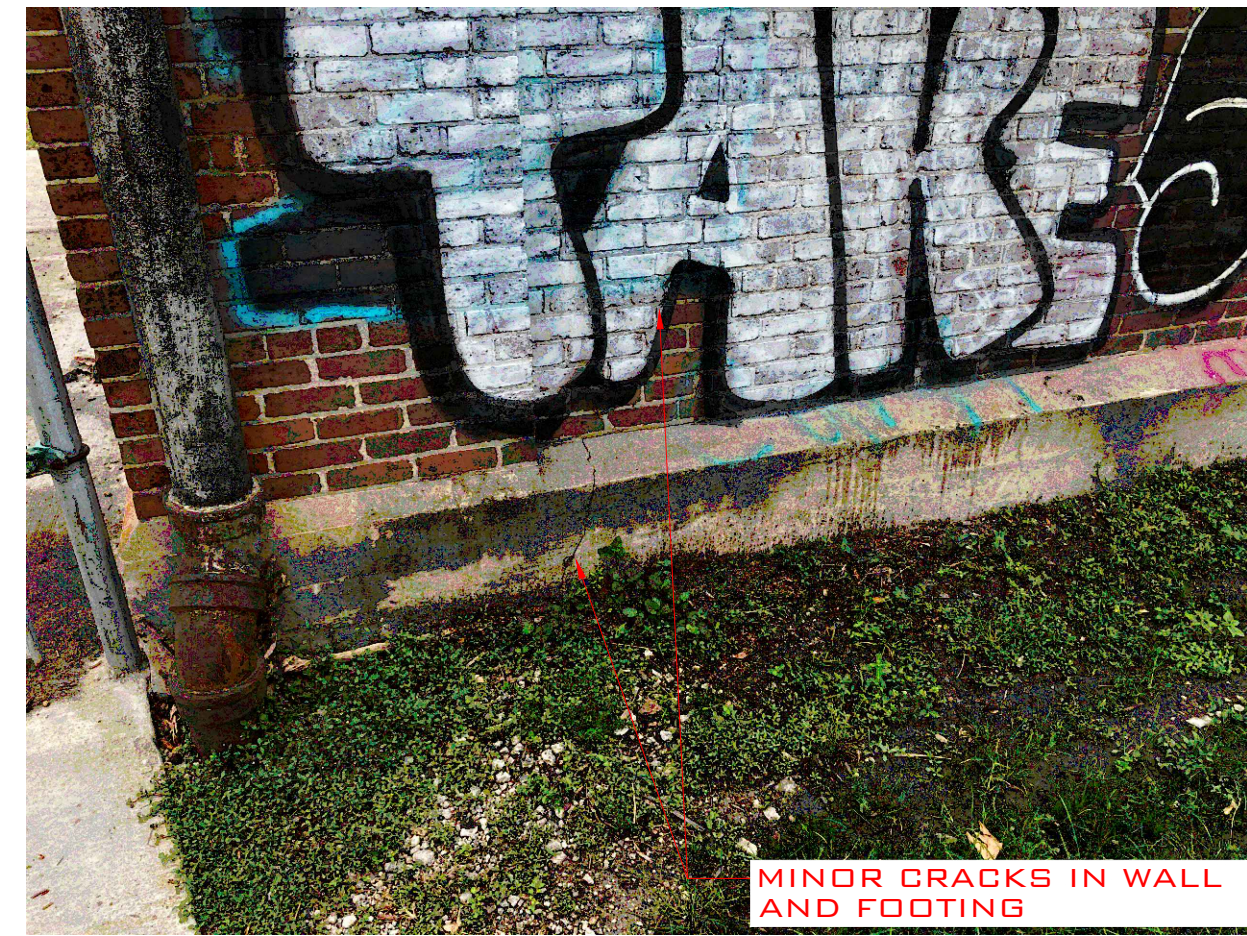
PHOTO N08

MINOR CRACKS IN WALL AND FOOTING

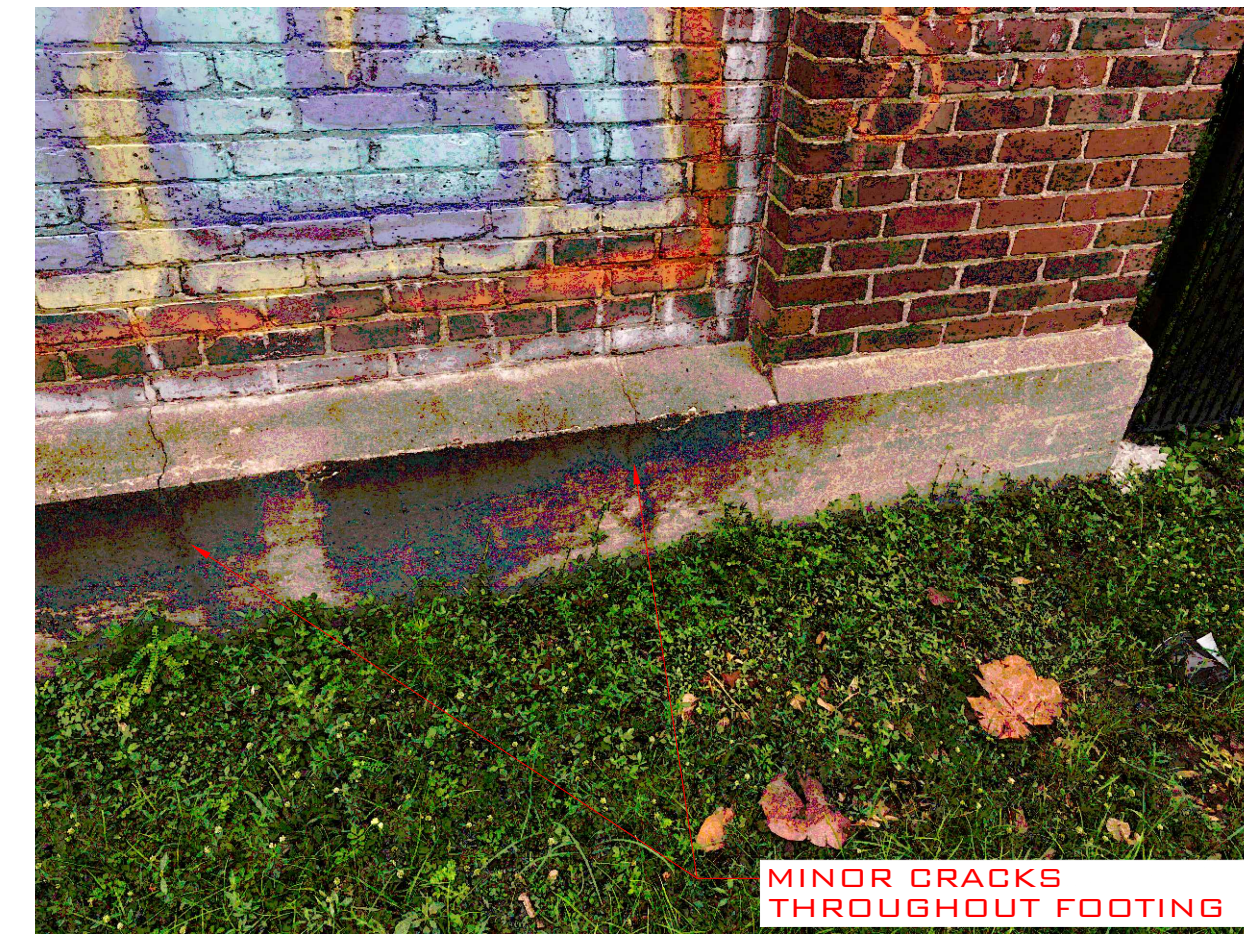
PHOTO N09

MINOR CRACKS THROUGHOUT FOOTING

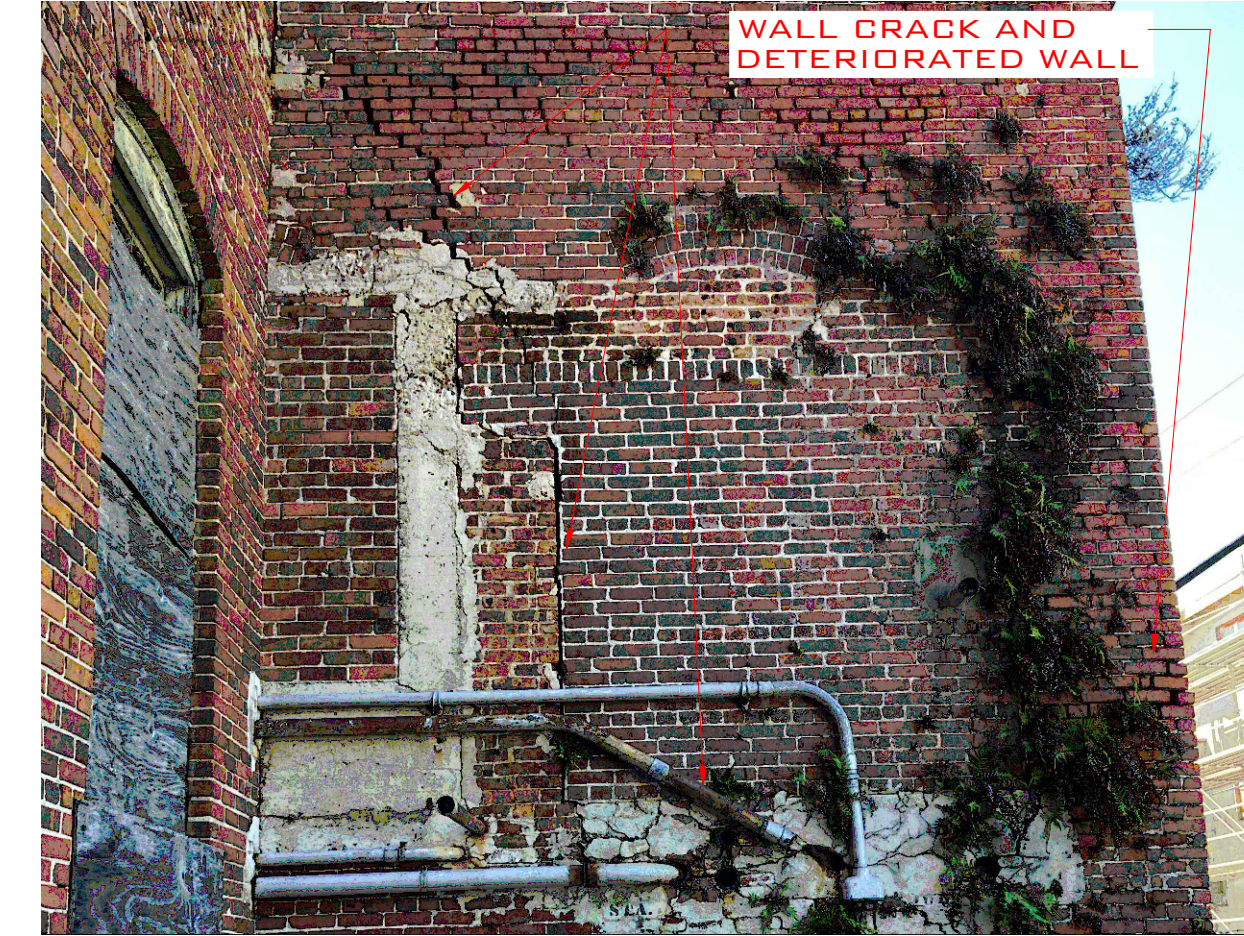
PHOTO N10

WALL CRACK AND DETERIORATED WALL

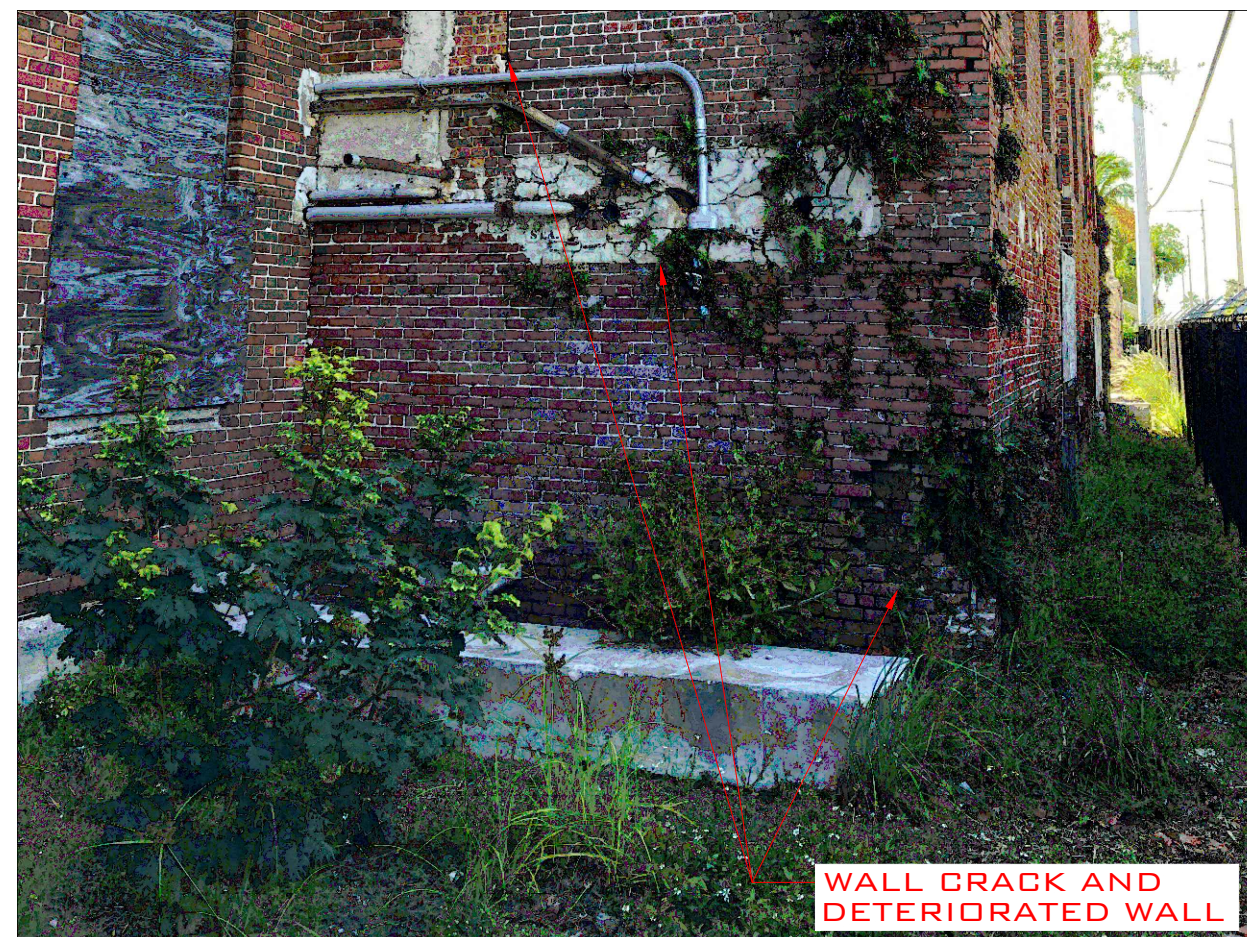
PHOTO N11

WALL CRACK AND DETERIORATED WALL

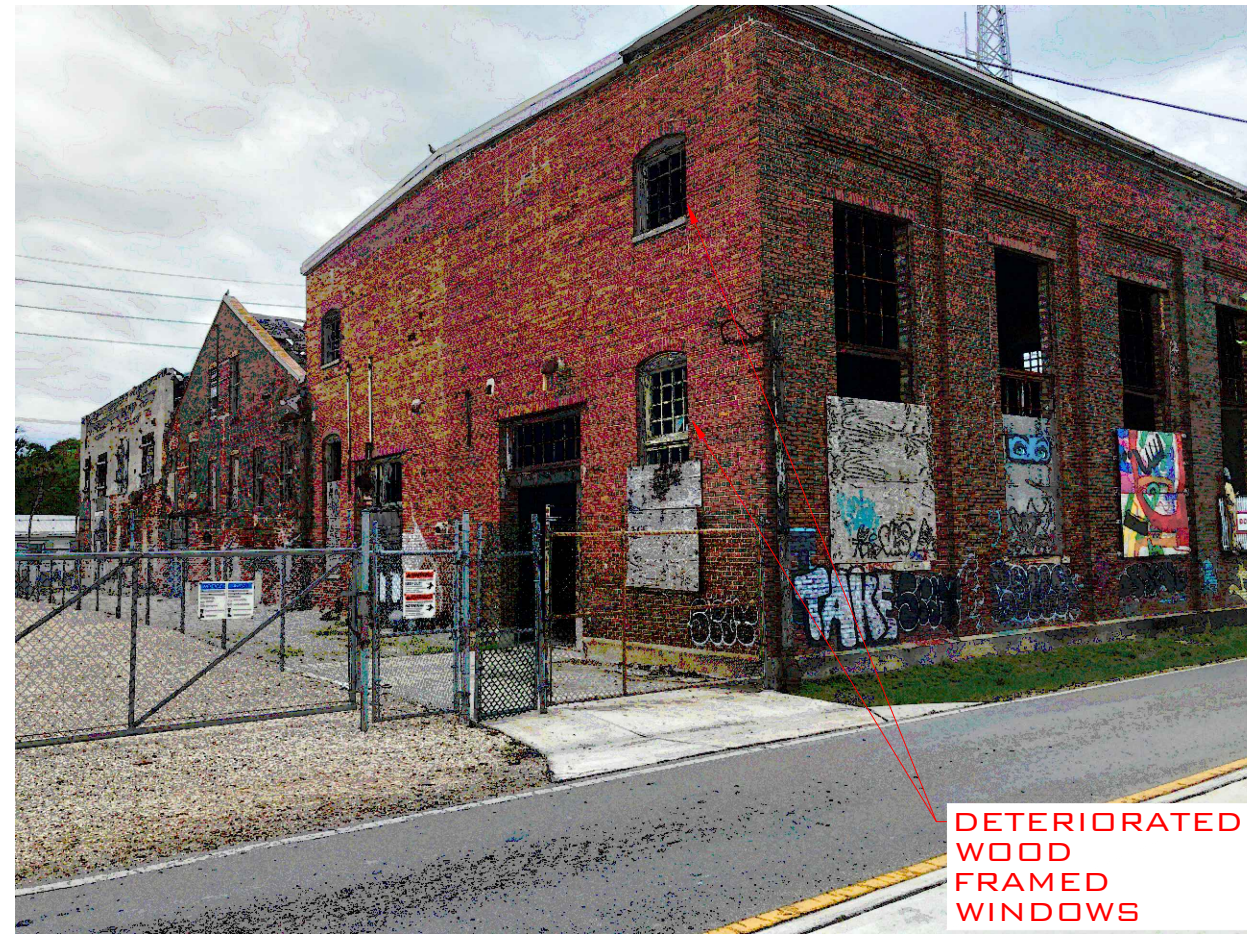
PHOTO E01

DETERIORATED WOOD FRAMED WINDOWS

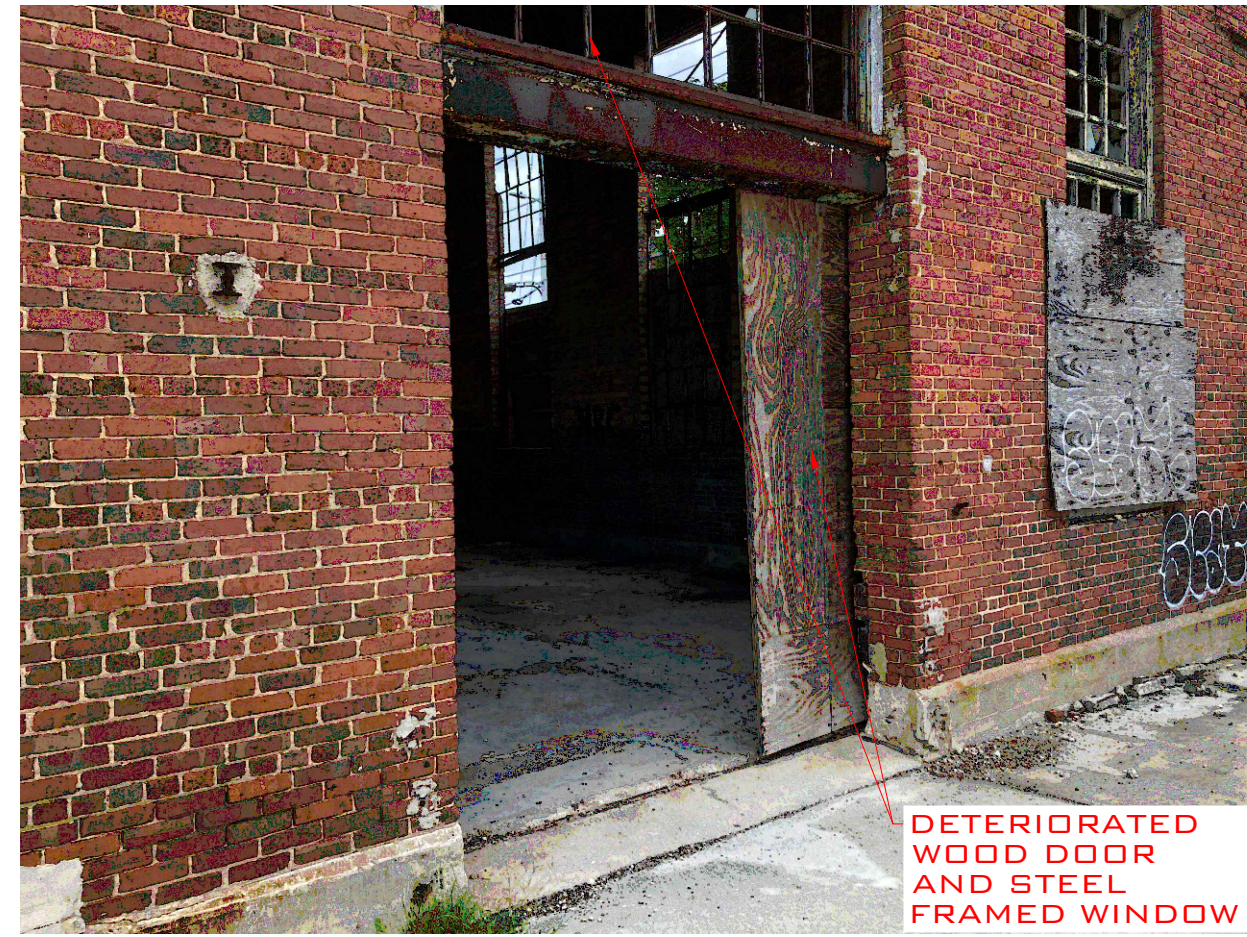
PHOTO E02

DETERIORATED WOOD DOOR AND STEEL FRAMED WINDOW

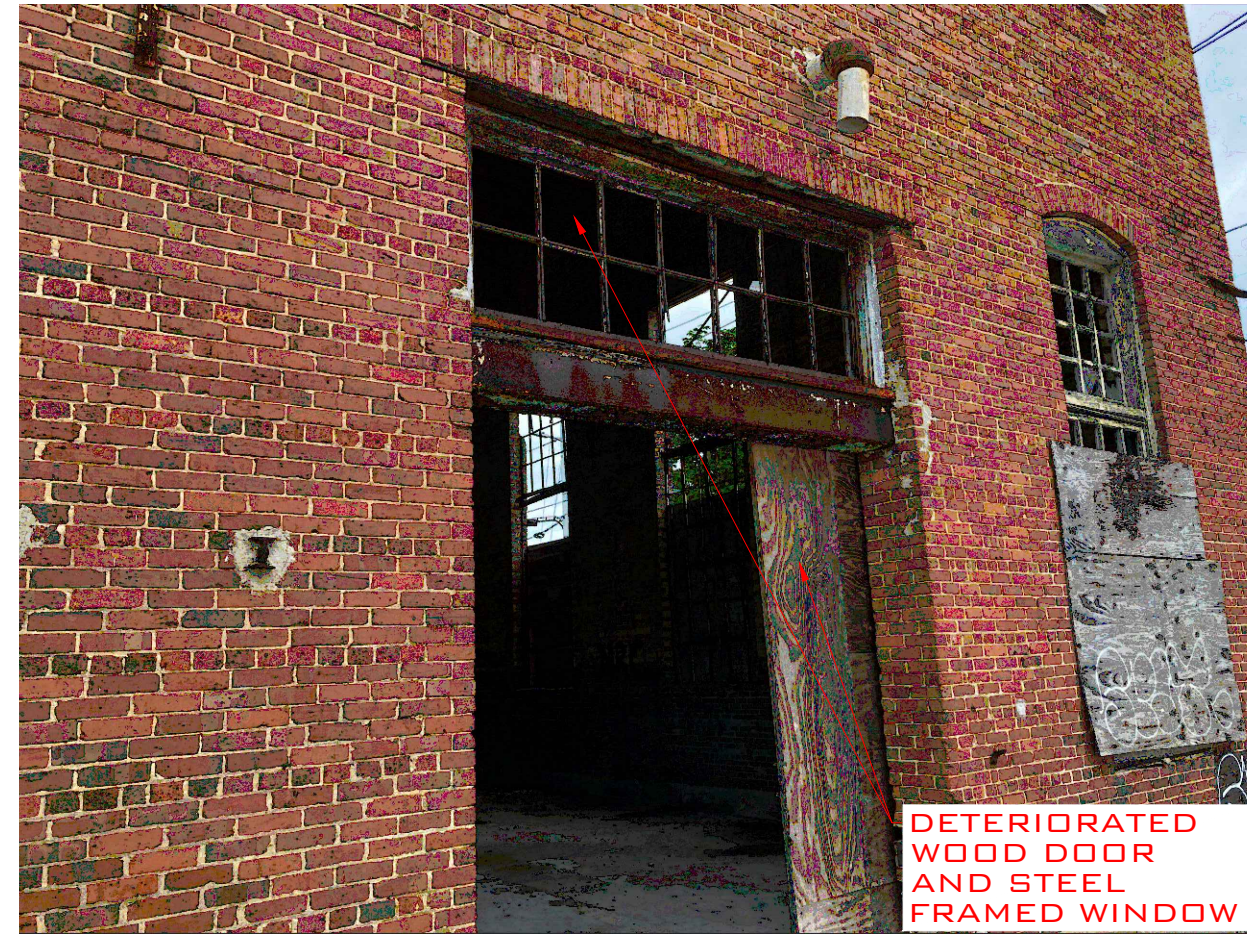
PHOTO E03

DETERIORATED WOOD DOOR AND STEEL FRAMED WINDOW

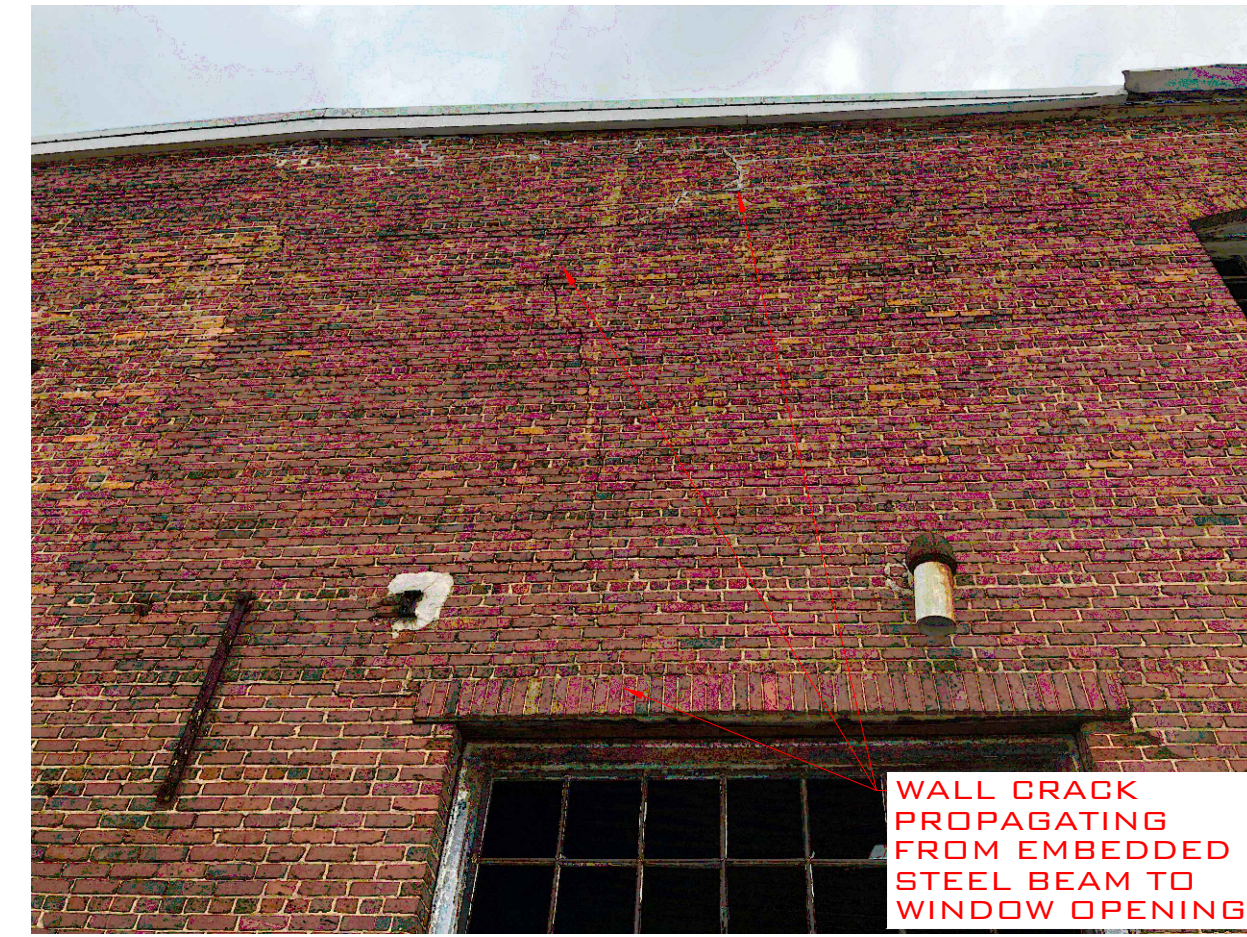
PHOTO E04

WALL CRACK PROPAGATING FROM EMBEDDED STEEL BEAM TO WINDOW OPENING

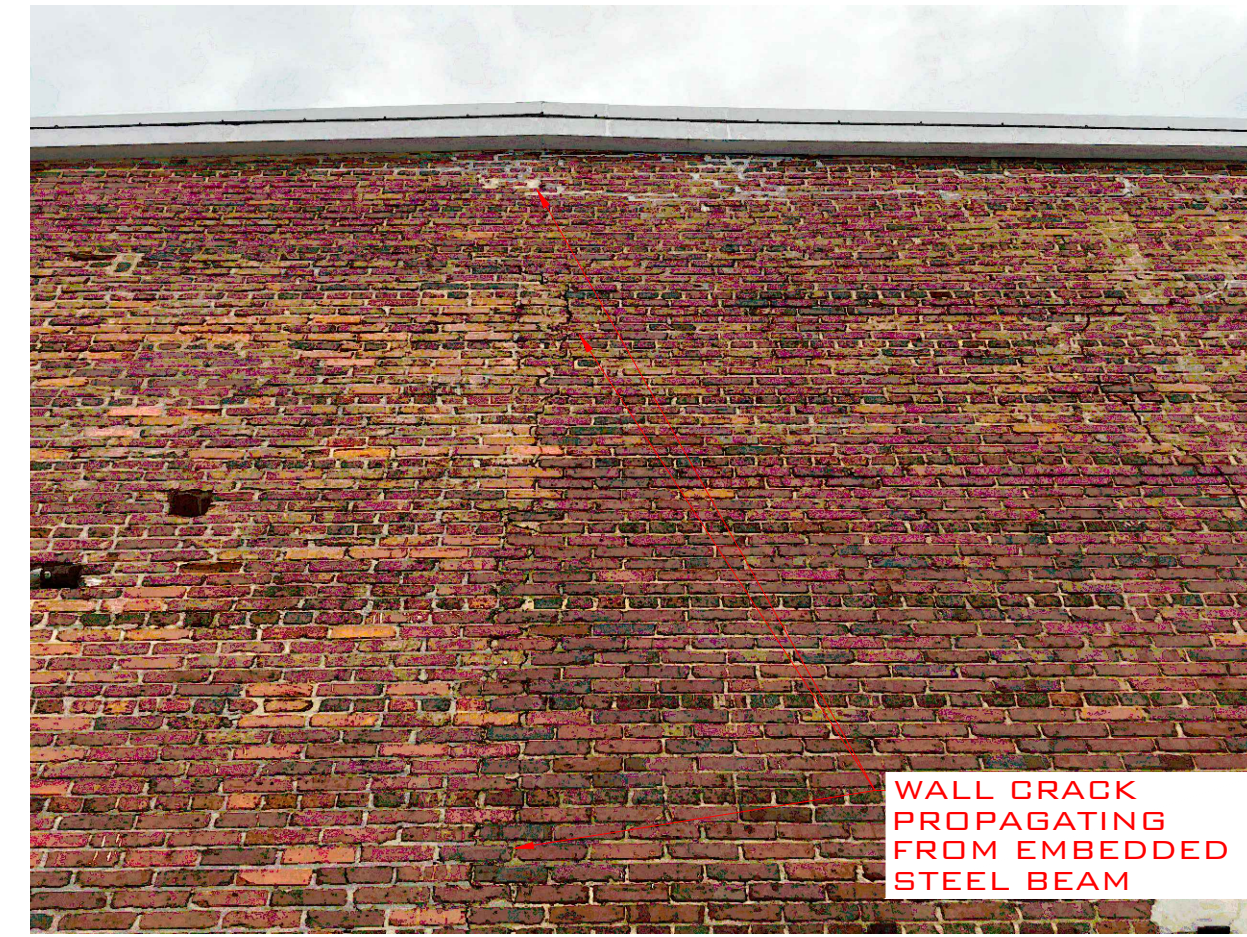
PHOTO E05

WALL CRACK PROPAGATING FROM EMBEDDED STEEL BEAM

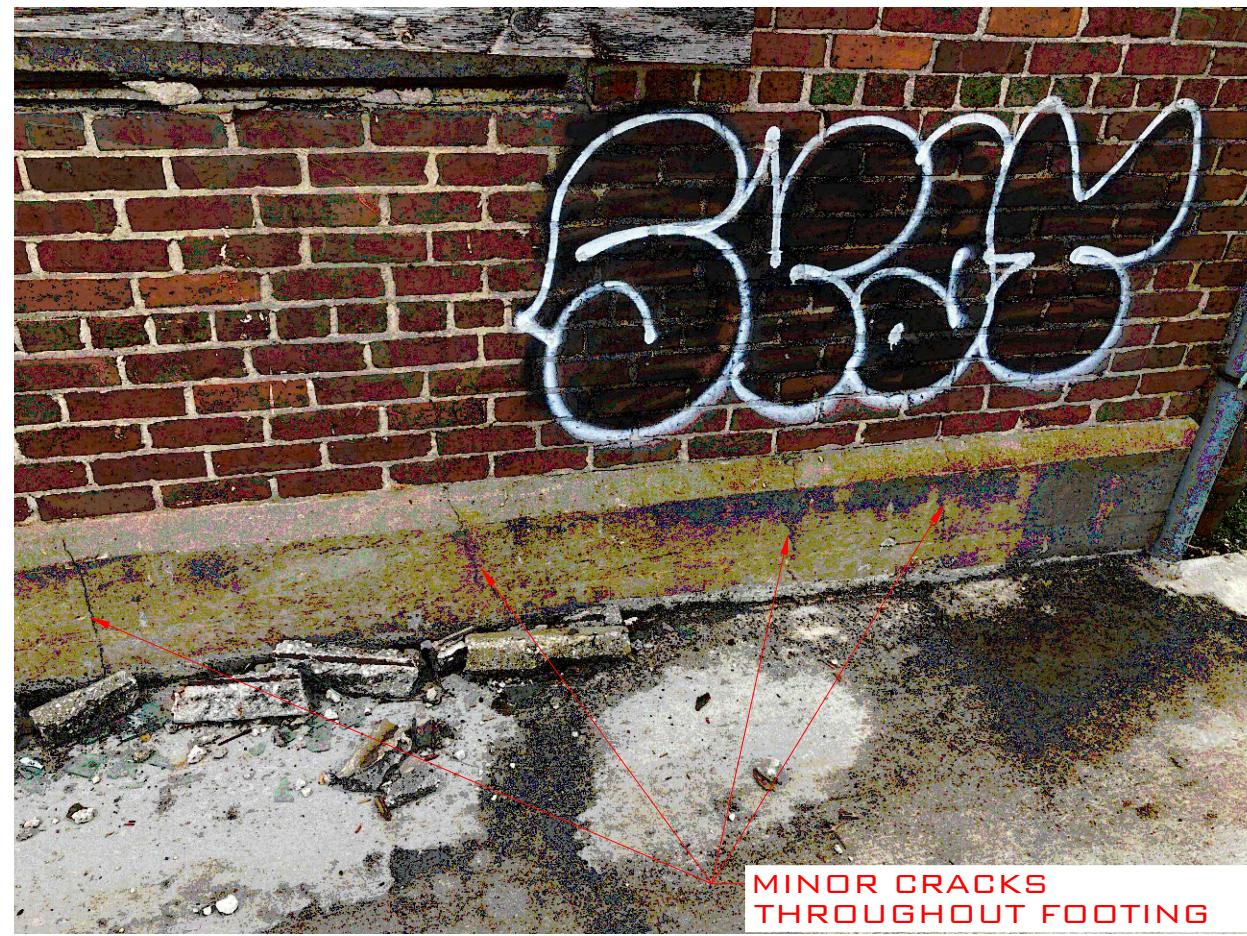
PHOTO E06

MINOR CRACKS THROUGHOUT FOOTING

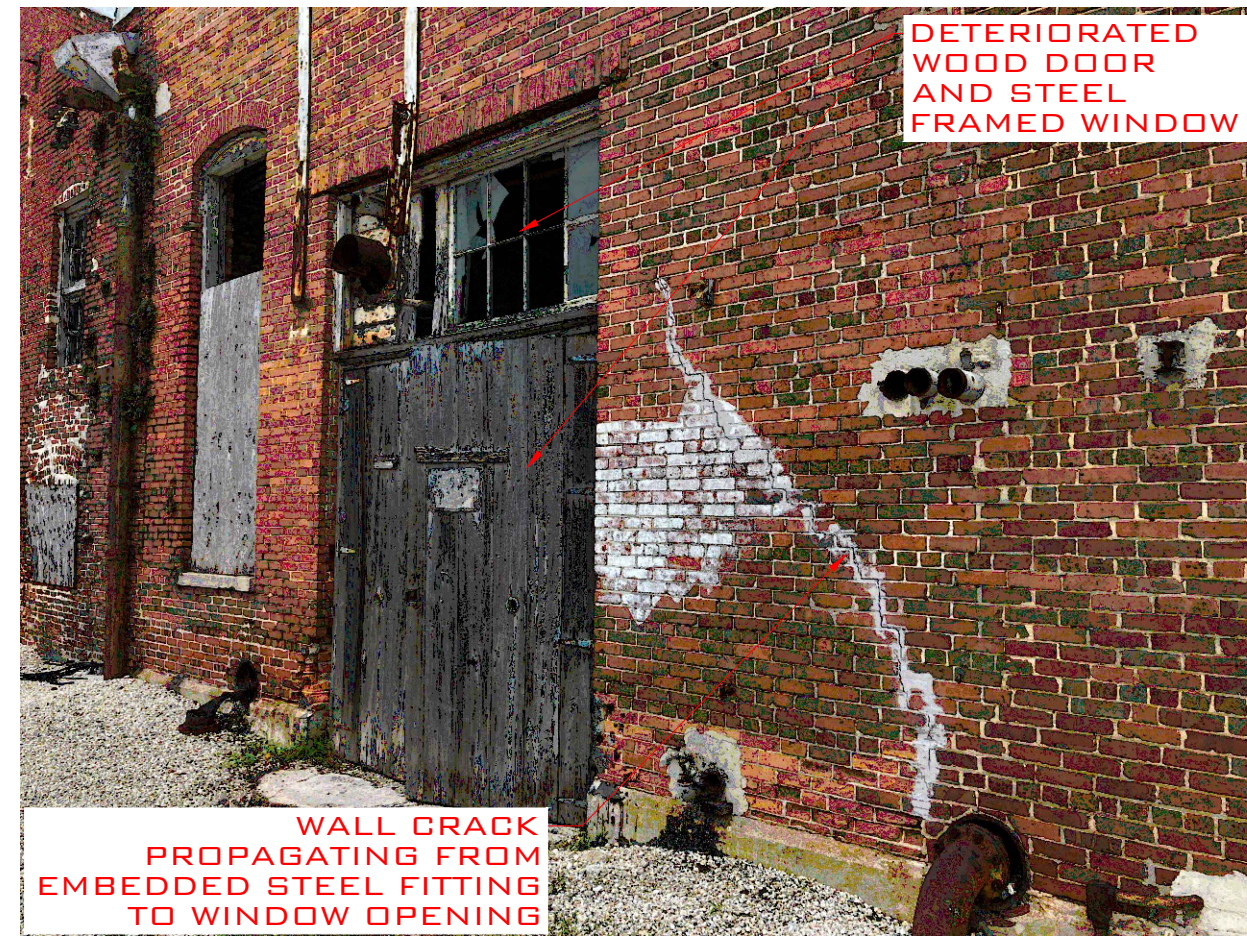
PHOTO E07

WALL CRACK PROPAGATING FROM EMBEDDED STEEL FITTING TO WINDOW OPENING

DETERIORATED WOOD DOOR AND STEEL FRAMED WINDOW

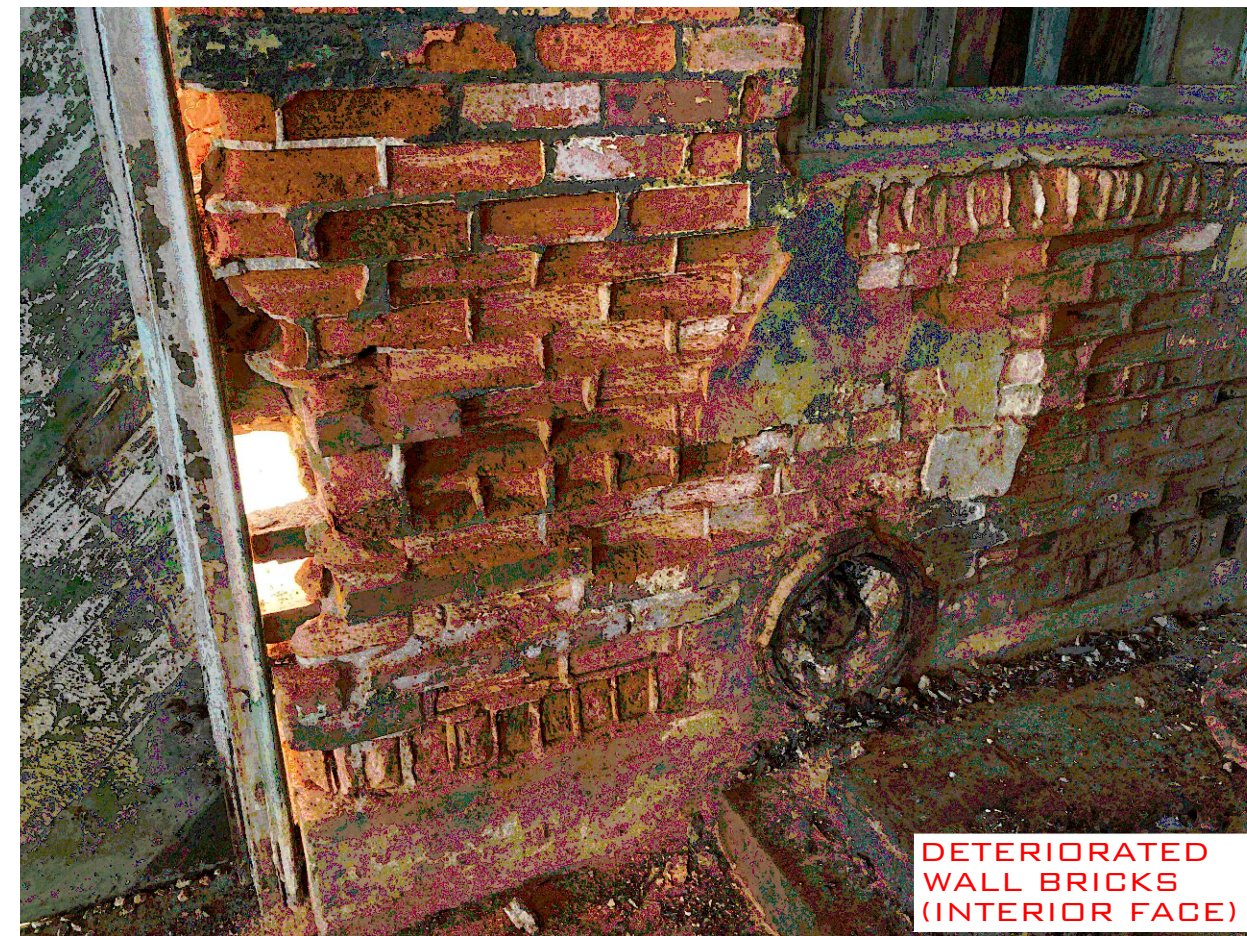
PHOTO E08

DETERIORATED WALL BRICKS (INTERIOR FACE)

It is also recommended that missing, dislodged, and damaged bricks be reconstructed. It is critical that all brick and mortar used, match the properties of the existing surrounding brick and mortar (stiffness, permeability, & aesthetics). Otherwise, it can cause further damage to structural integrity, building envelope performance, and aesthetics.

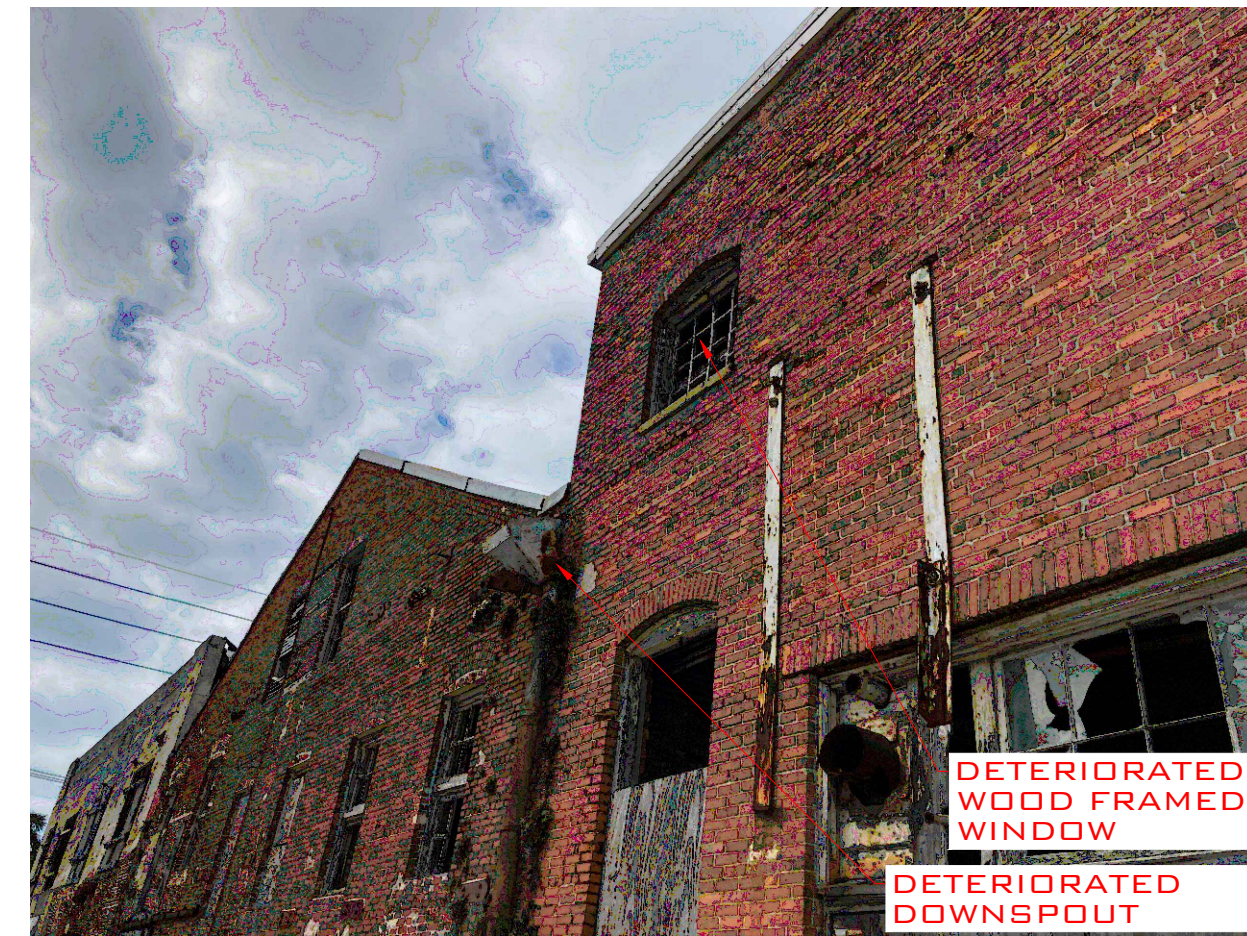
PHOTO E09

DETERIORATED WOOD FRAMED WINDOW
DETERIORATED DOWNSPOUT

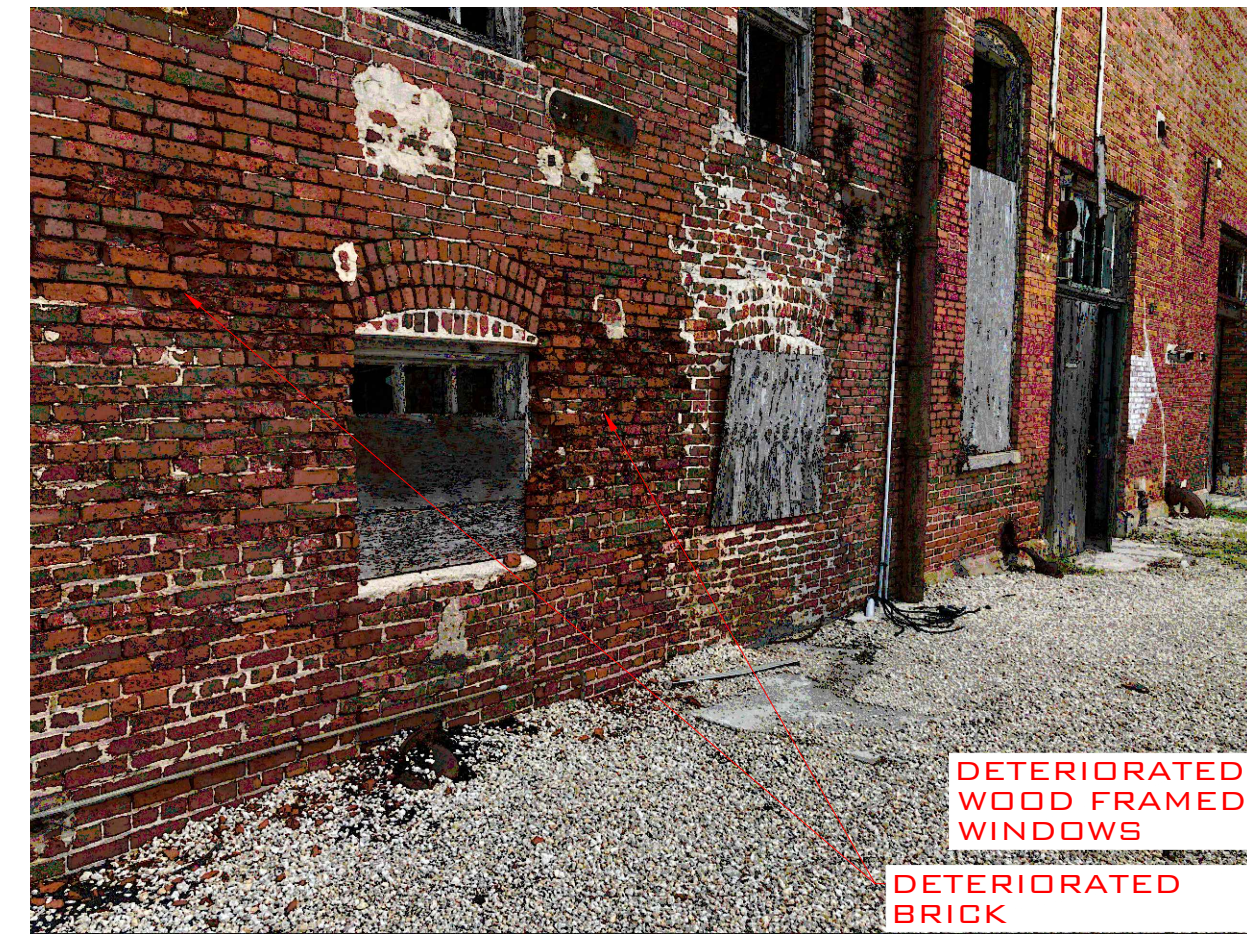
PHOTO E10

DETERIORATED WOOD FRAMED WINDOWS
DETERIORATED BRICK
