Structural Assessment Report:
Key West Historic Diesel Plant

Property Address:
**100 Angela St & 709 Fort St & 101 Geraldine St
Key West, FL 33040**

Serge Mashtakov, PE, FL License No. 71480

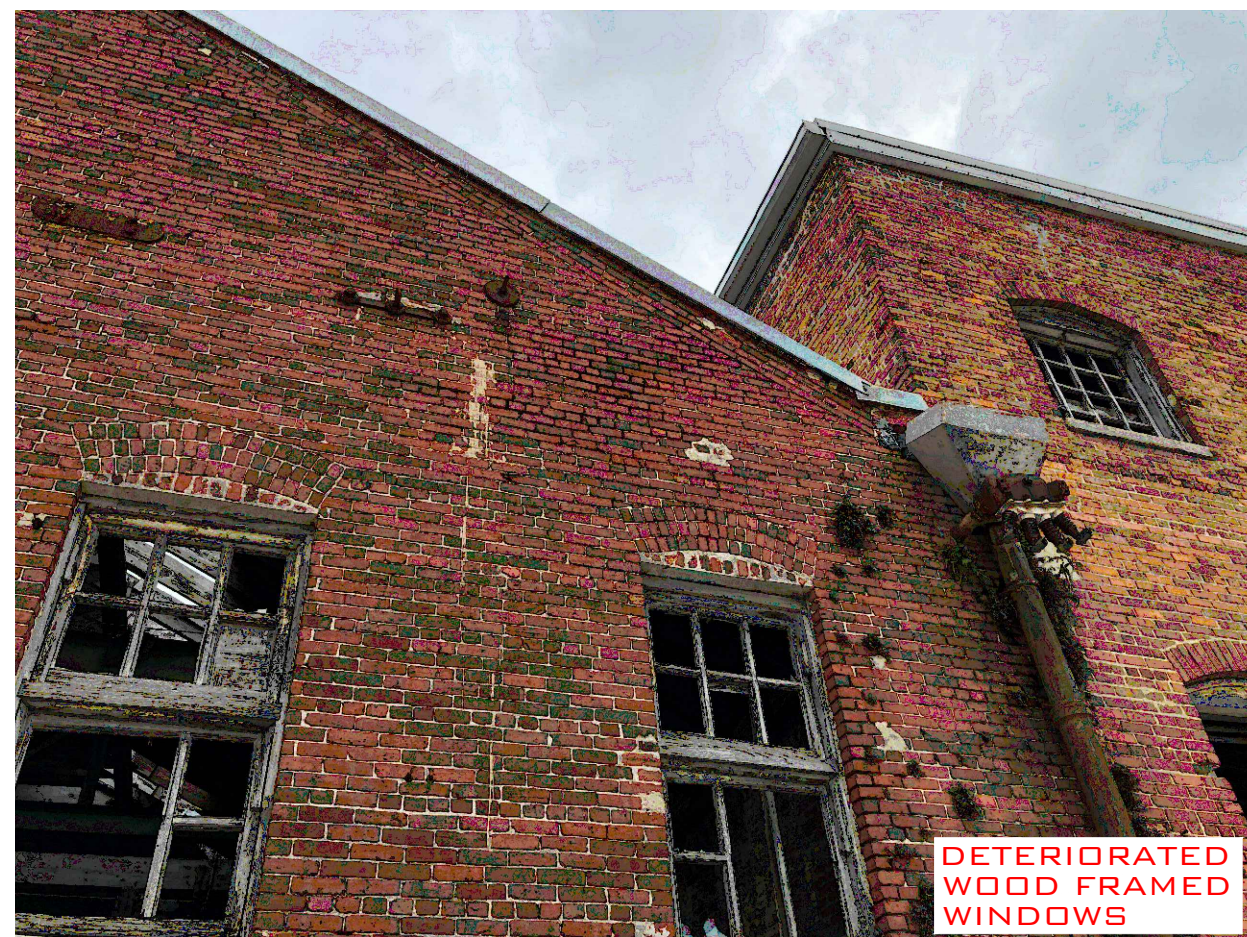
PHOTO E11

DETERIORATED WOOD FRAMED WINDOWS

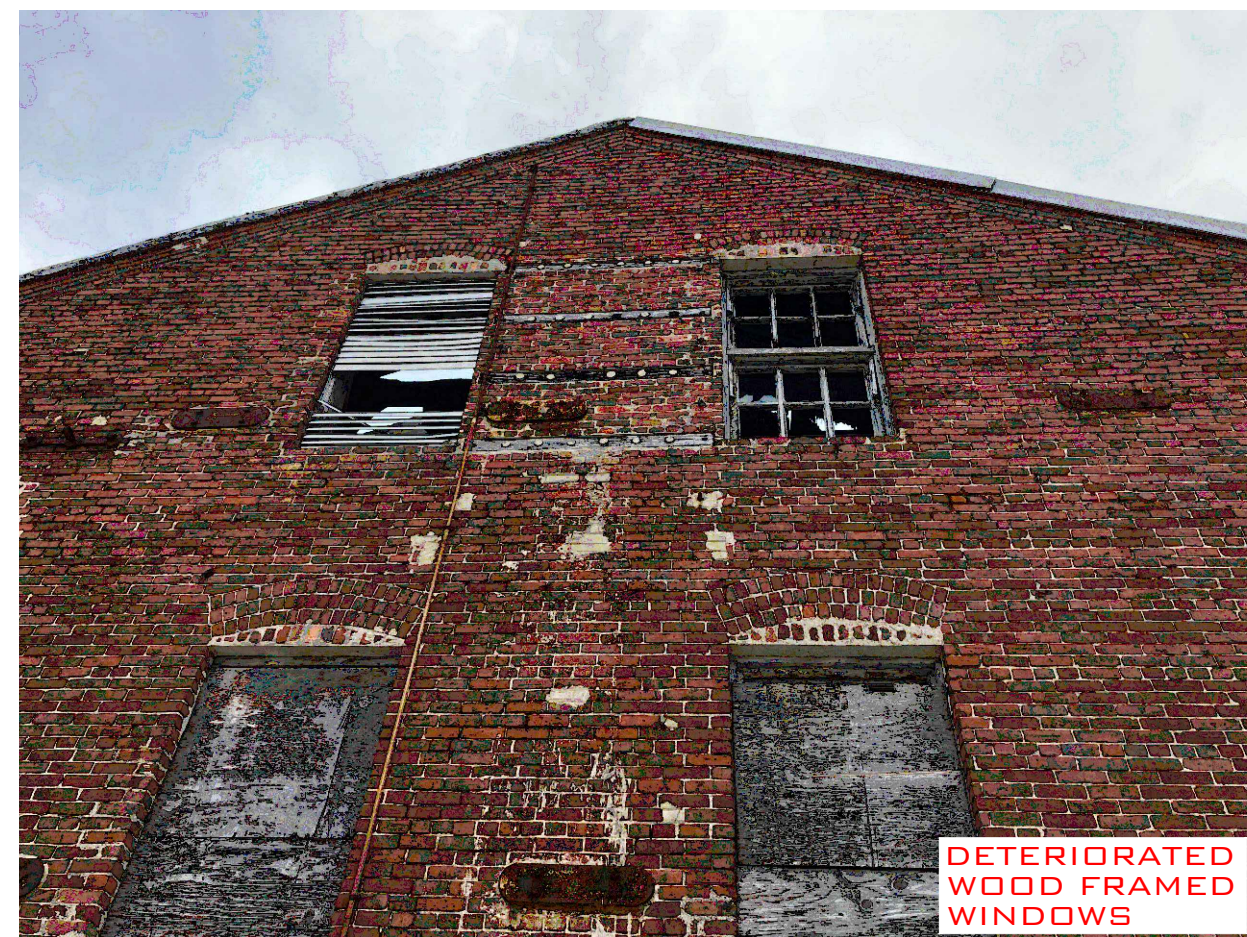
PHOTO E12

DETERIORATED WOOD FRAMED WINDOWS

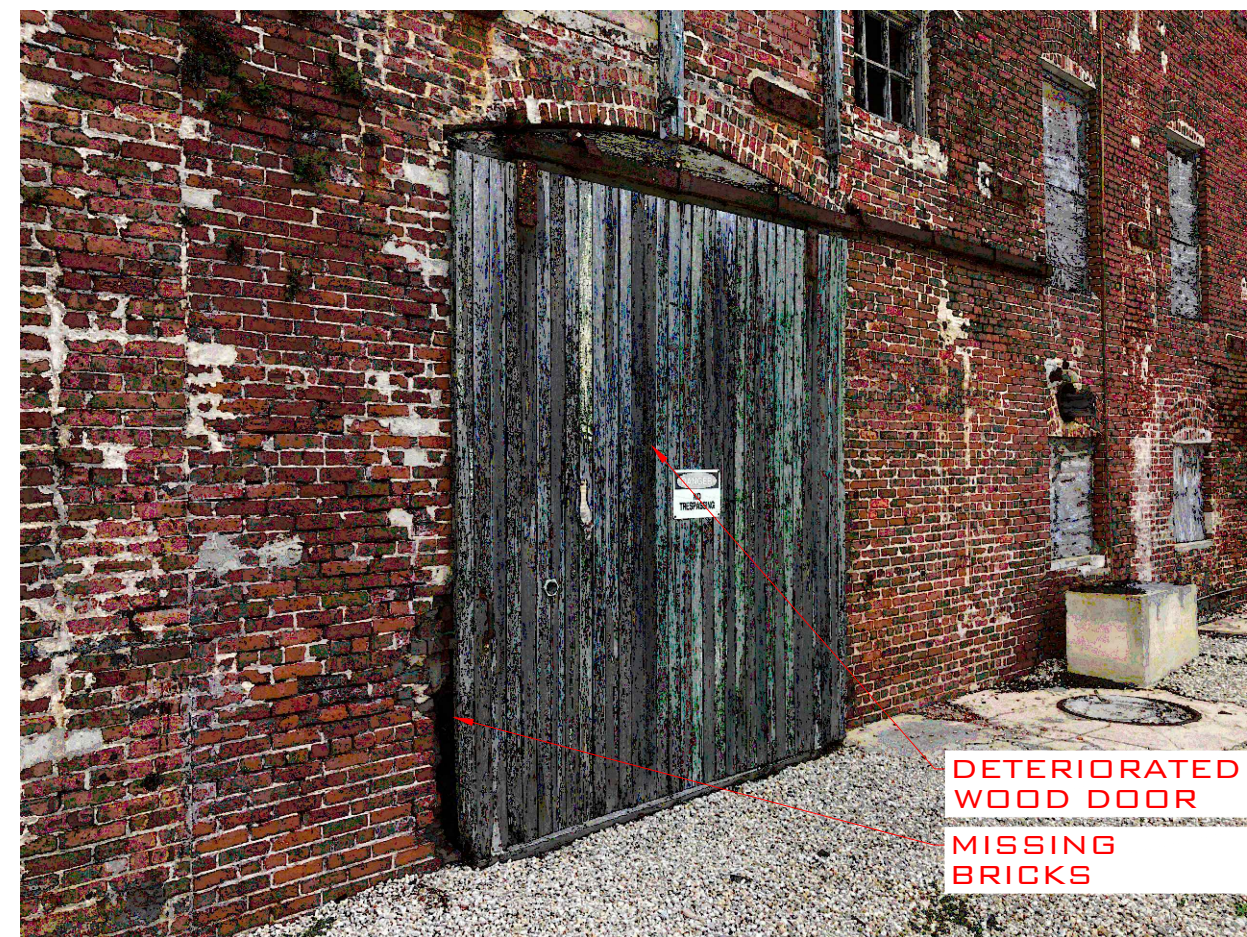
PHOTO E13

DETERIORATED WOOD DOOR
MISSING BRICKS

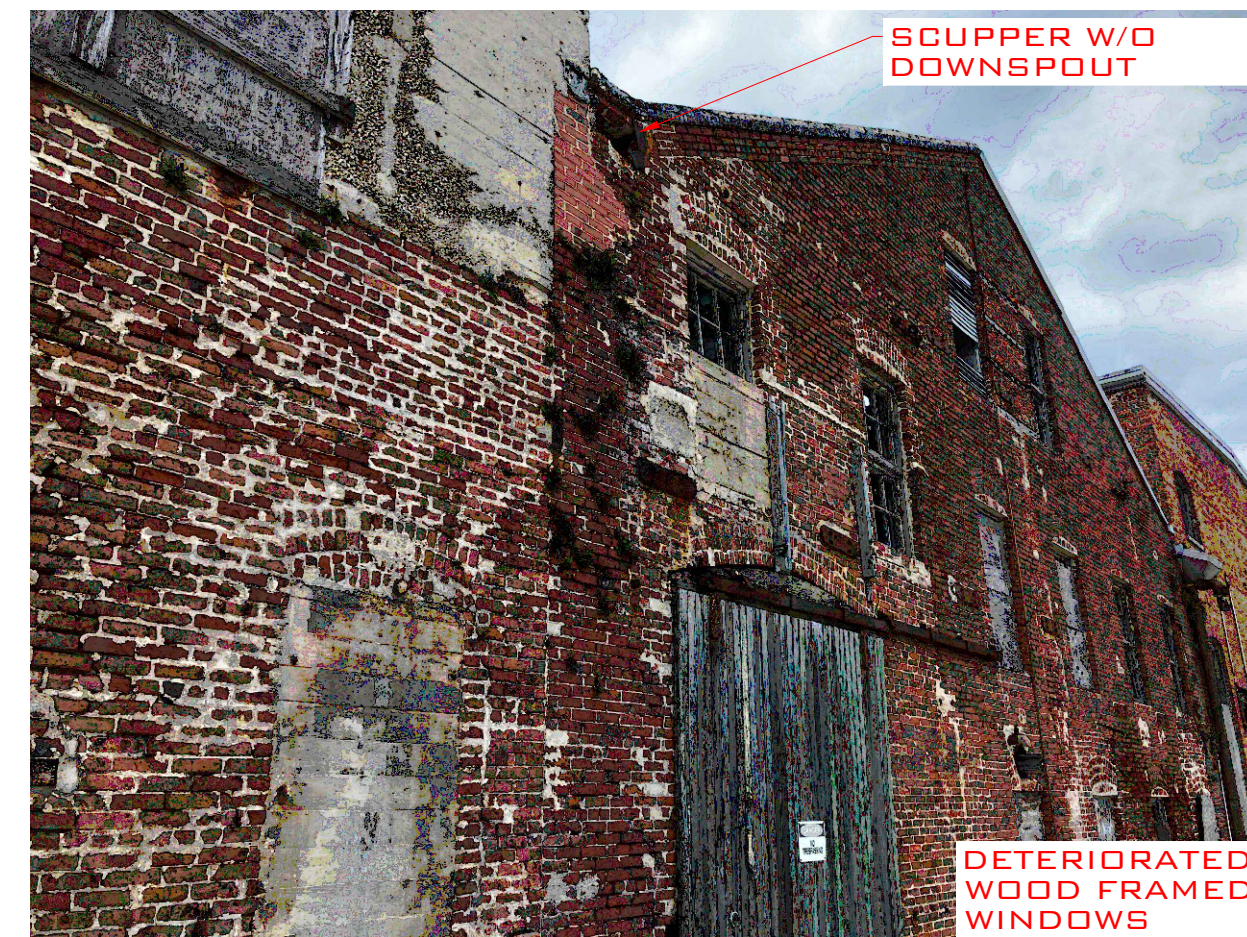
PHOTO E14

SCUPPER W/O DOWNSPOUT

DETERIORATED WOOD FRAMED WINDOWS

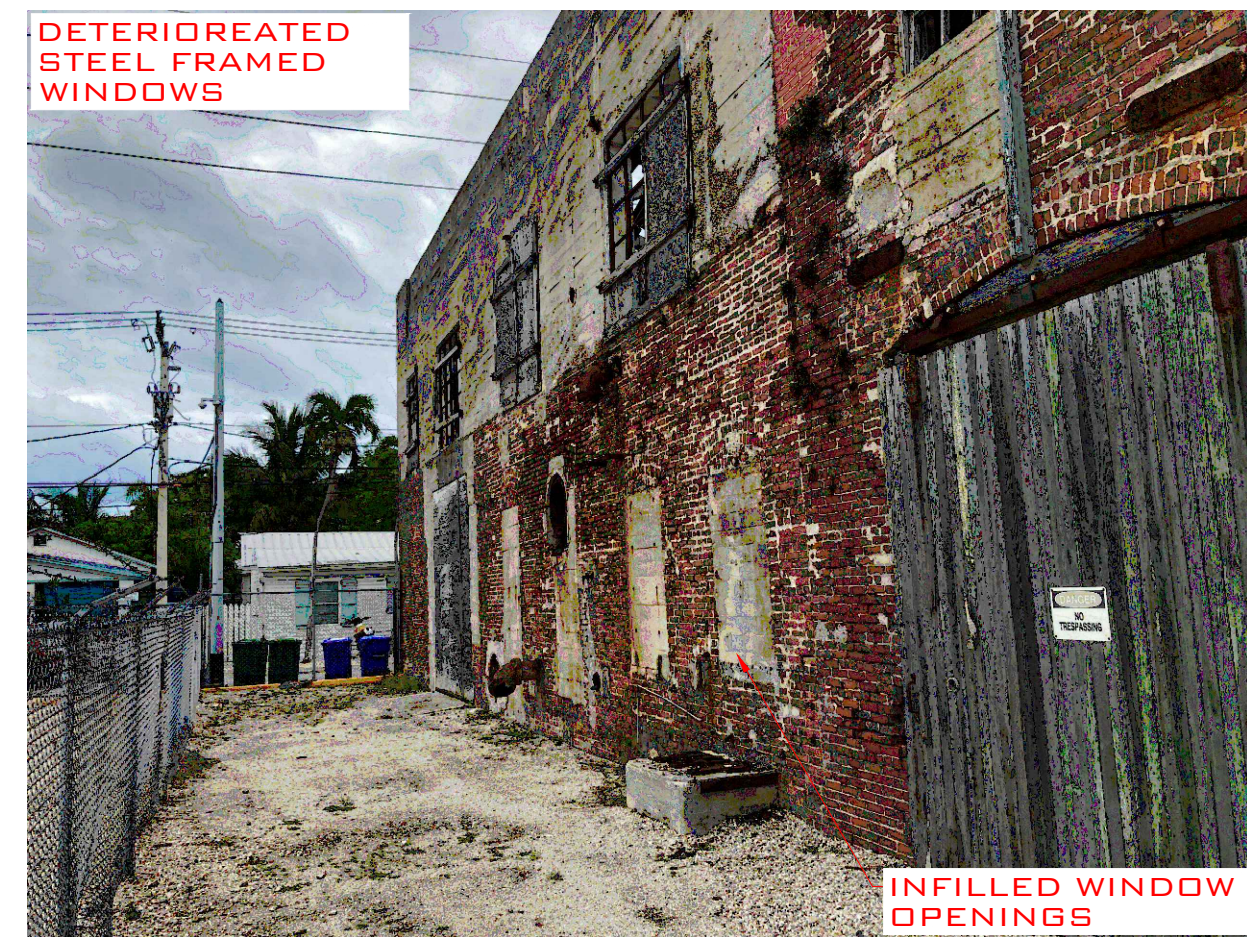
PHOTO E15

DETERIORATED STEEL FRAMED WINDOWS

INFILLED WINDOW OPENINGS

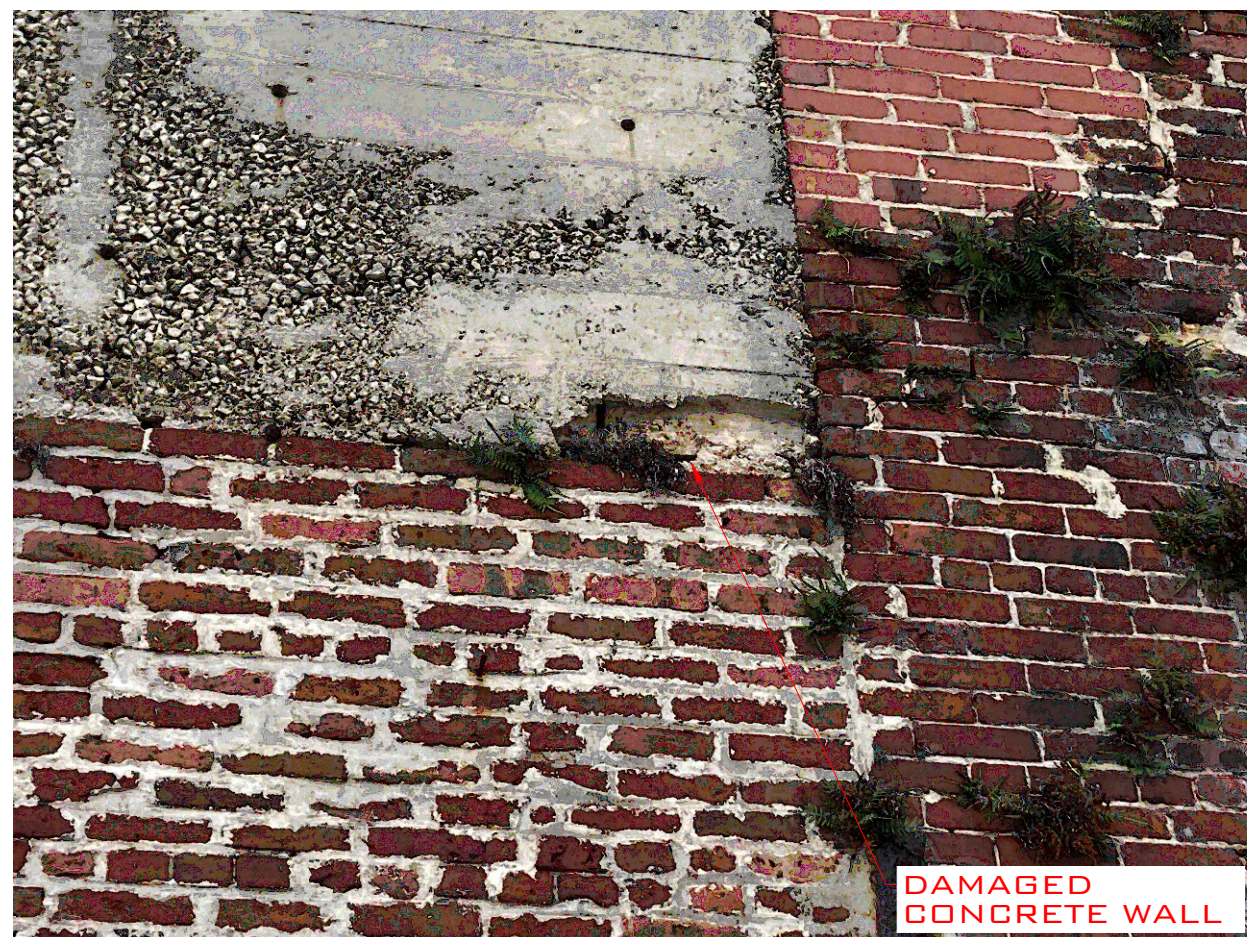
PHOTO E16

The upper half of Building Section B and some infilled wall openings are constructed of cast in place concrete, with minimal steel reinforcement bar. This wall did not evidence significant damage; however there are two locations in need of patch repairs.

DAMAGED CONCRETE WALL

It is recommended that the existing concrete wall be repaired, with partial section patch repairs.

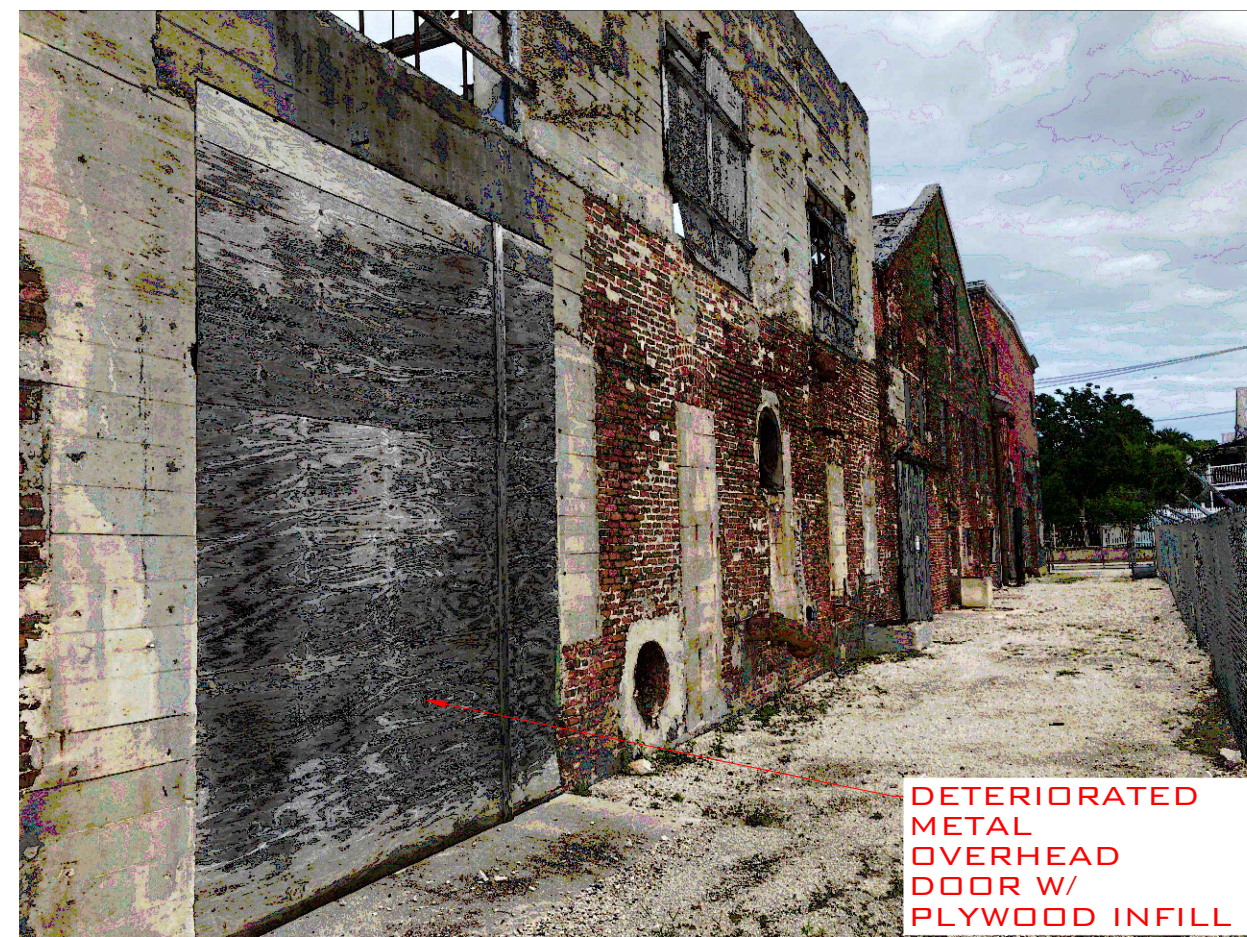
PHOTO E17

DETERIORATED METAL OVERHEAD DOOR W/ PLYWOOD INFILL

It is recommended that all doors be replaced with aluminum-framed doors, as approved by HARC. Aluminum framed doors are recommended for reasons as described for windows. It may be feasible to include decorative wood doors, fixed to adjacent walls, to achieve the desired aesthetics.

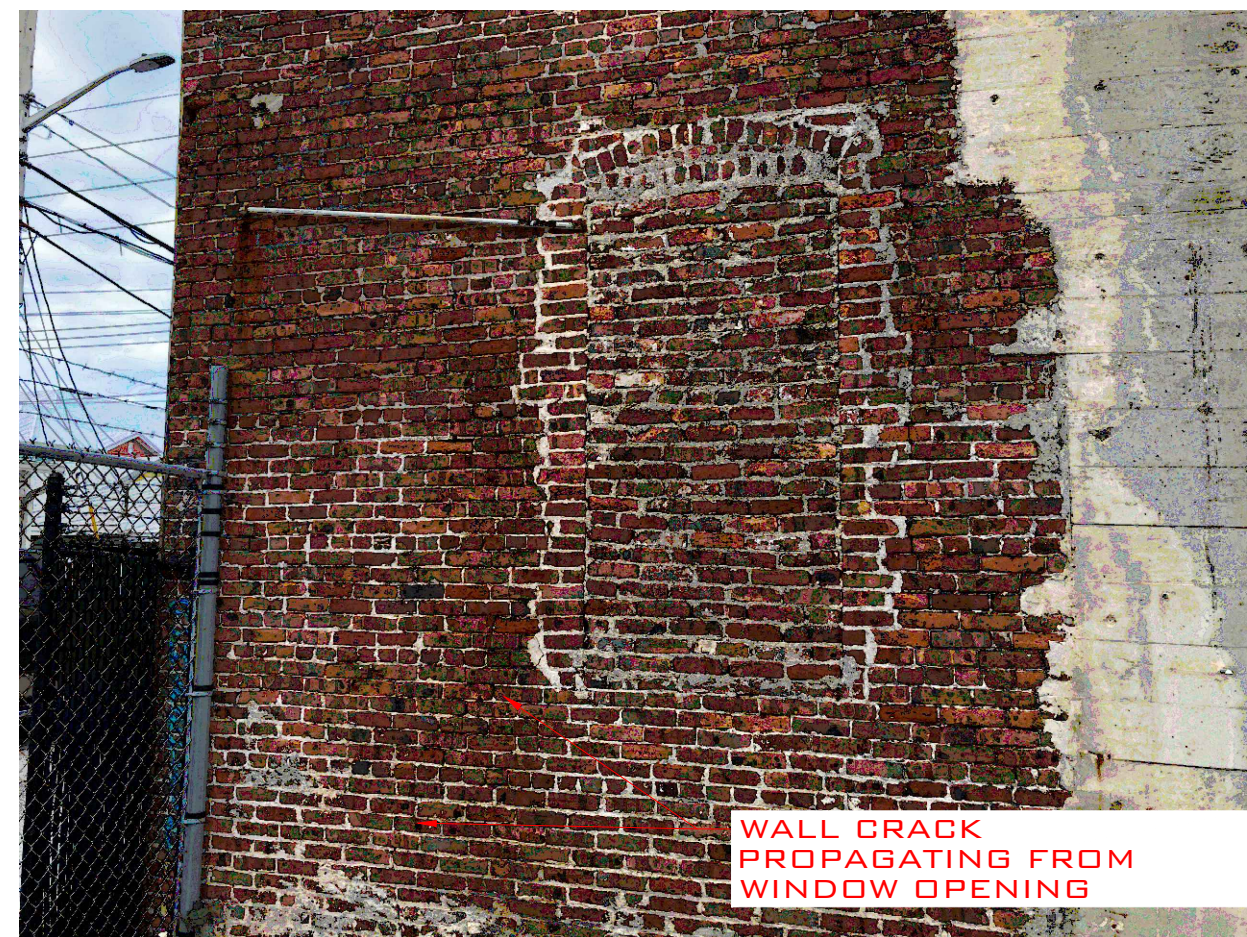
PHOTO E18

WALL CRACK PROPAGATING FROM WINDOW OPENING

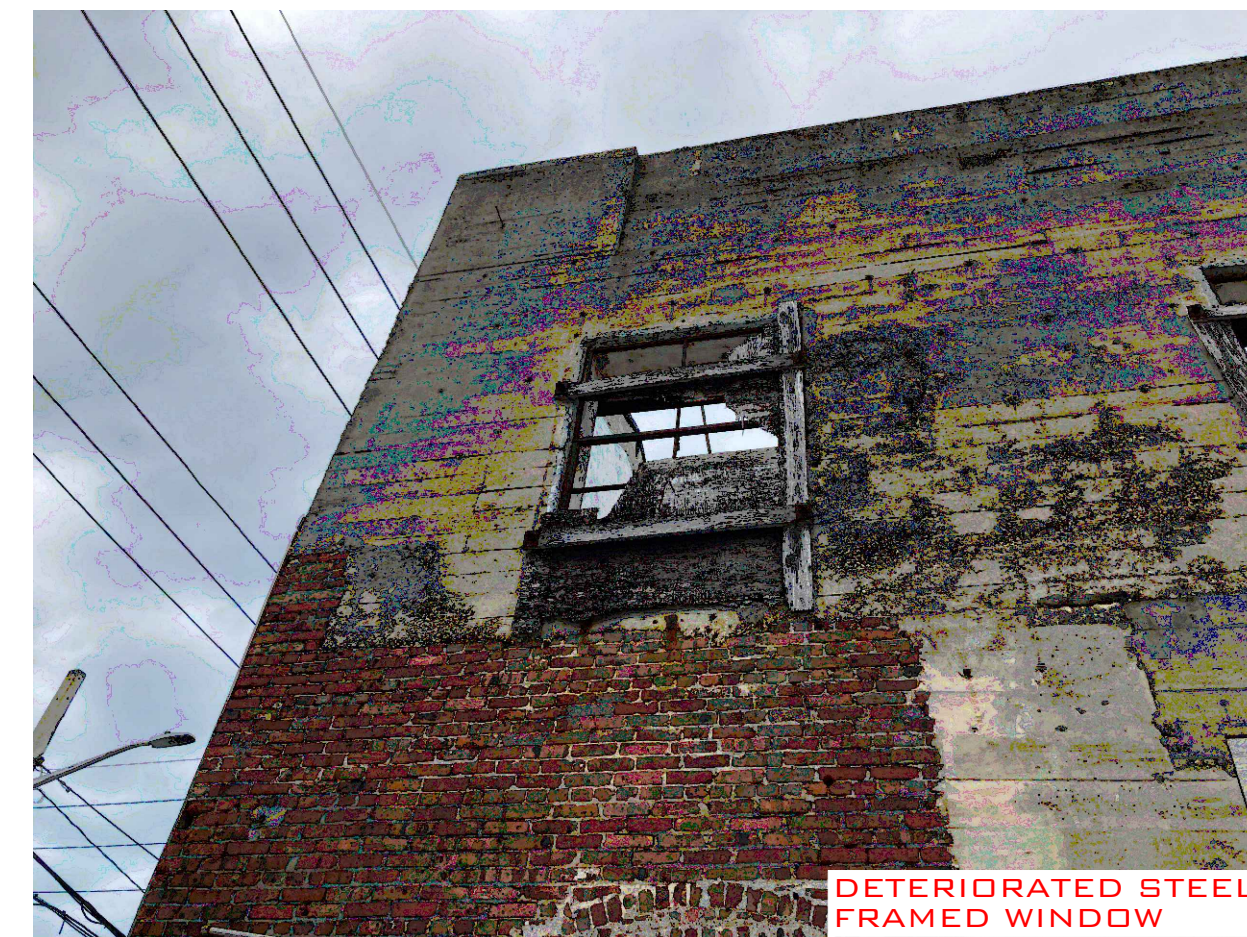
PHOTO E19

DETERIORATED STEEL FRAMED WINDOW
