**CITY OF KEY WEST  
FREDERICK DOUGLASS GYM**

**TASK 'A" – STRUCTURAL ASSESSMENT**

111 OLIVIA STREET, KEY WEST, FLORIDA

JULY 31, 2013

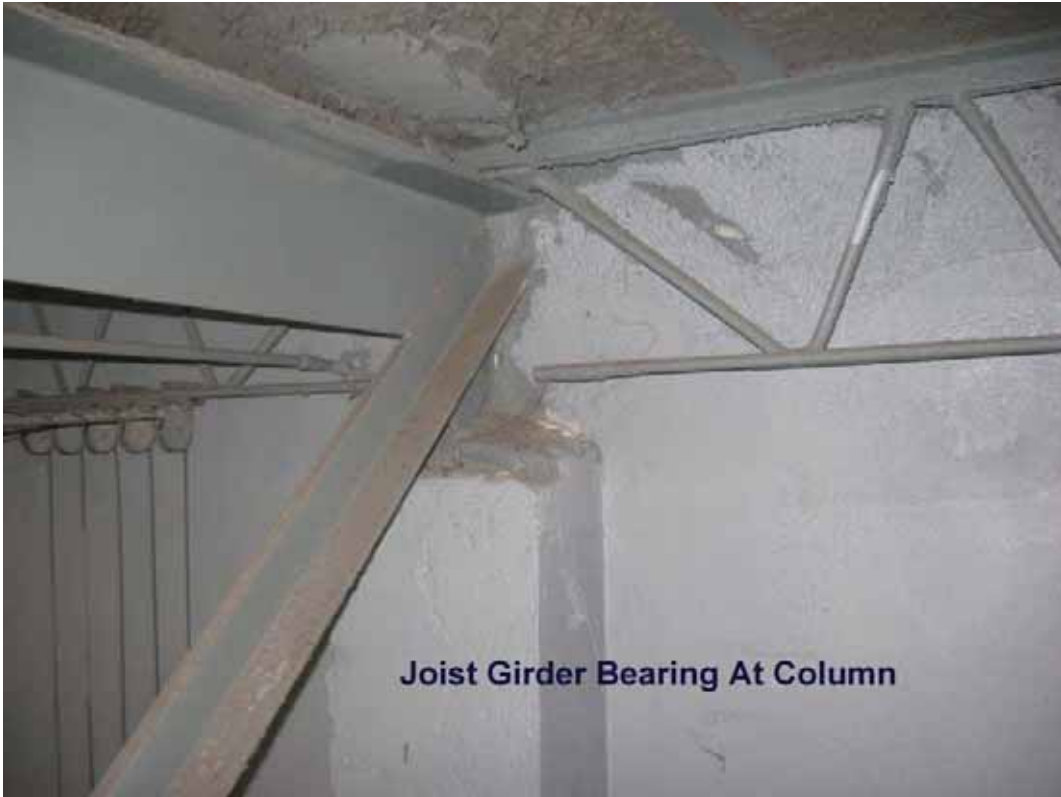
**Photo #05**

**Joist Girder Bearing At Column**

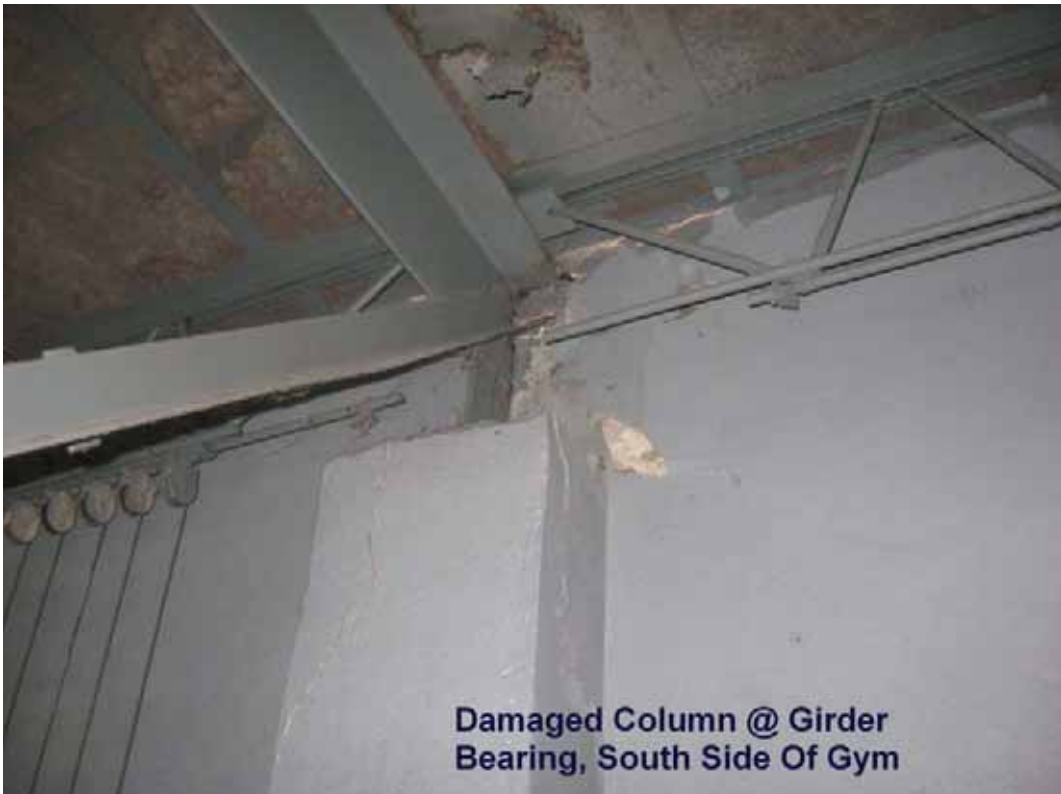
**Photo #06**

**Damaged Column @ Girder  
Bearing, South Side Of Gym**
