Staff Report for Item 9

Application Number: 16-3452

Address: #516 Bahama Street

Replacement of historic windows with new wood windows.

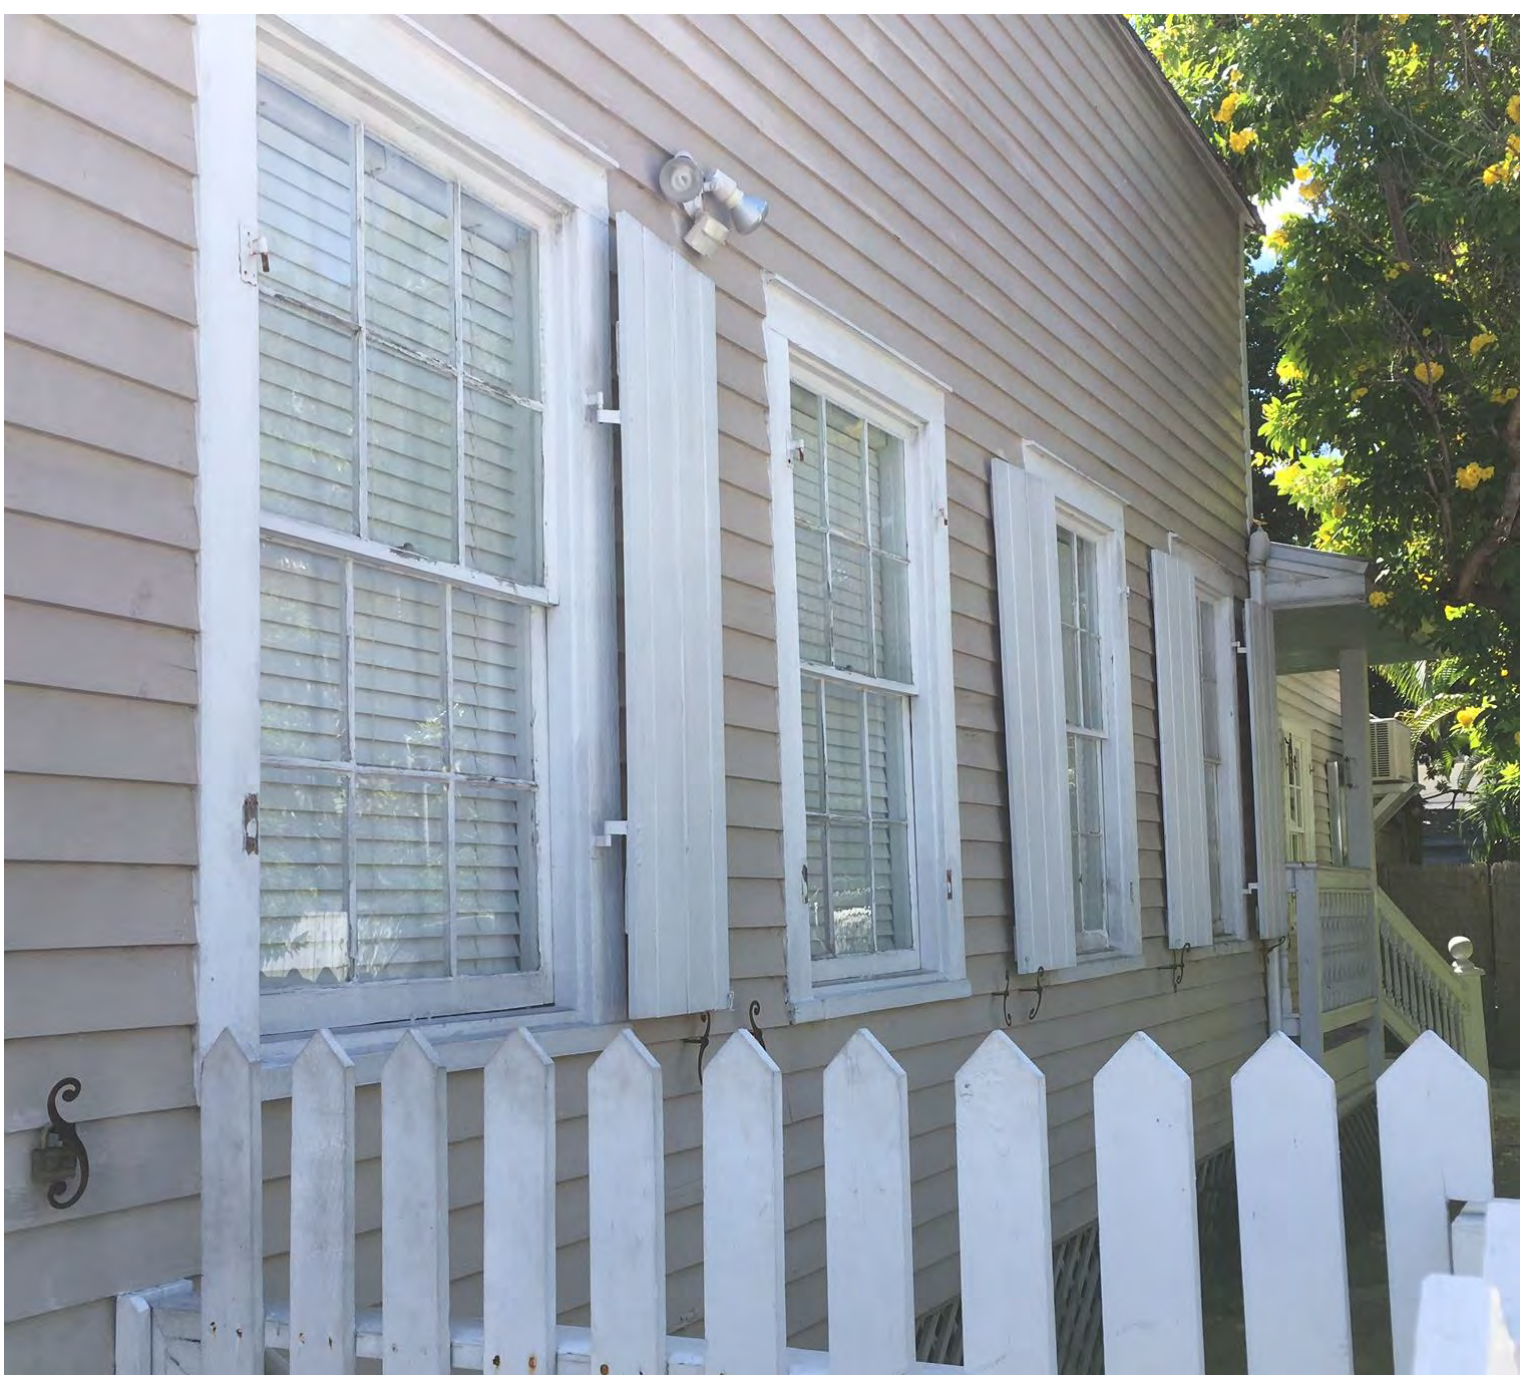
The windows need repairs, reglazing, and repainting, but those are standard repairs with historic windows. The applicant has noted that many of the window sills are rotted, which is not surprising, as the lower portion of the window is the most susceptible to water infiltration. The replacement of the window sill has no impact on the window itself. Once the windows have been removed, the wood dried, and the glazing removed, the muntins can really be evaluated for their soundness.

Four of the windows proposed to be replaced.

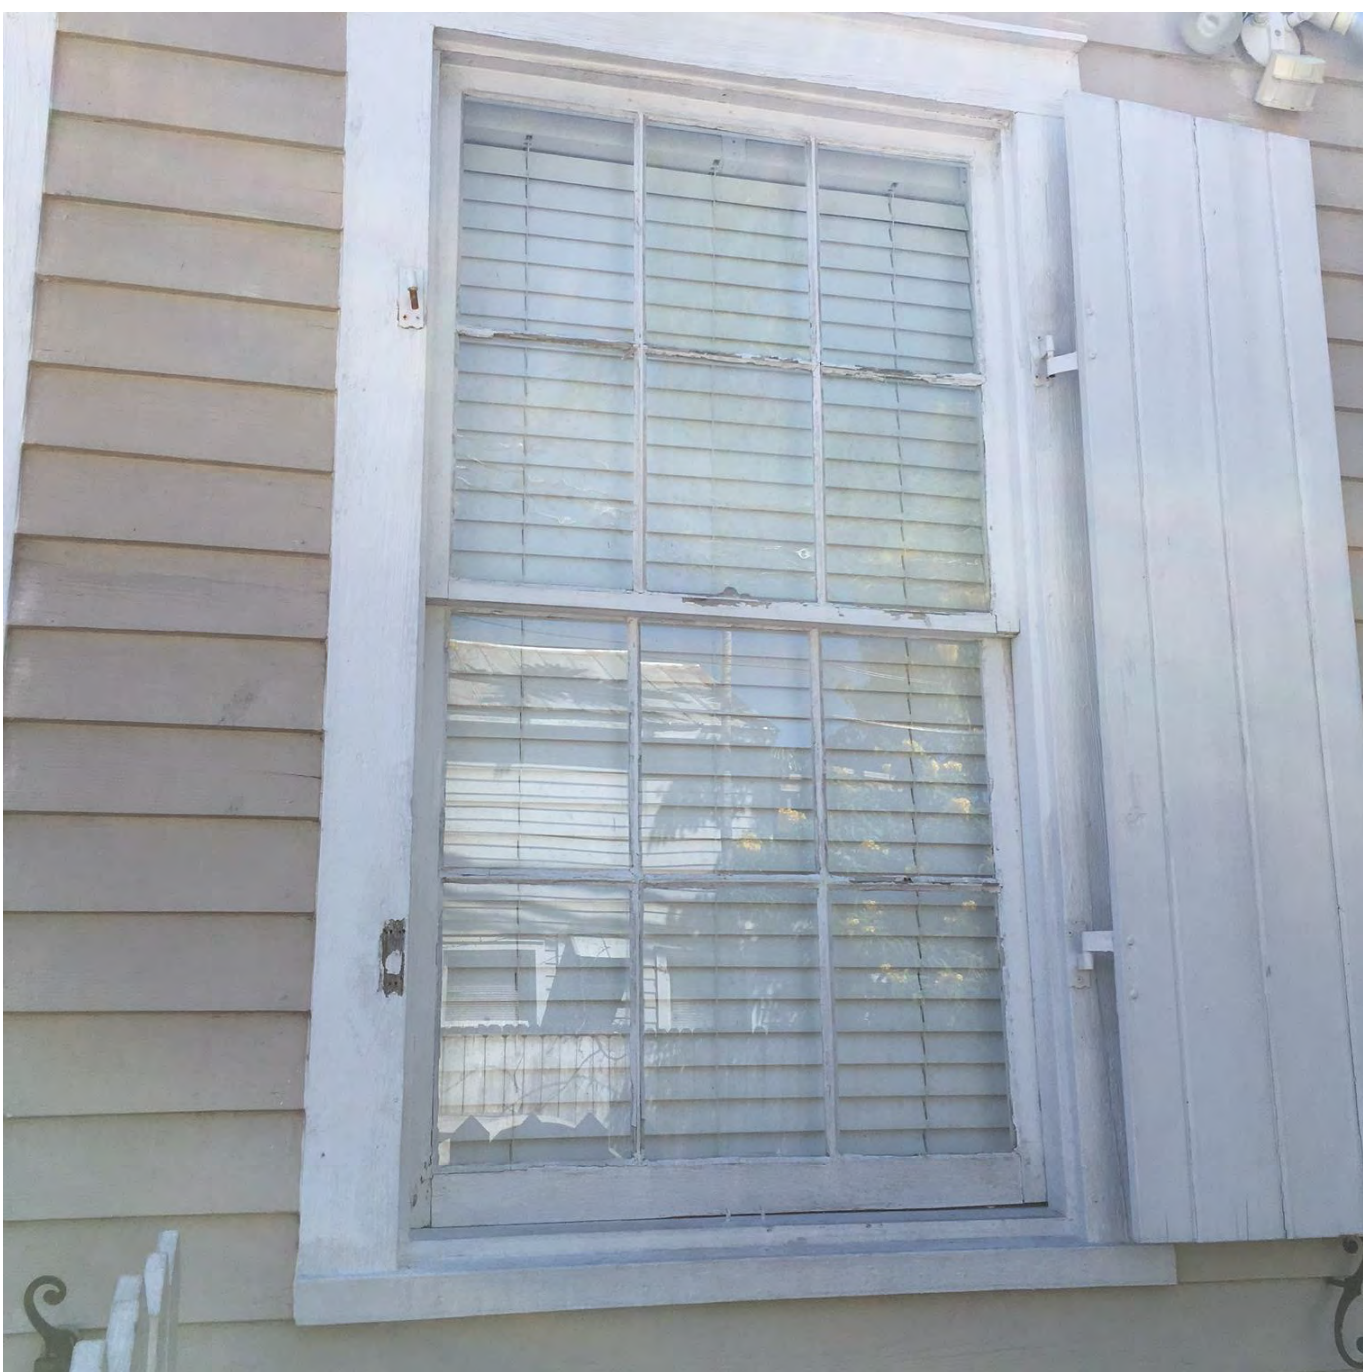
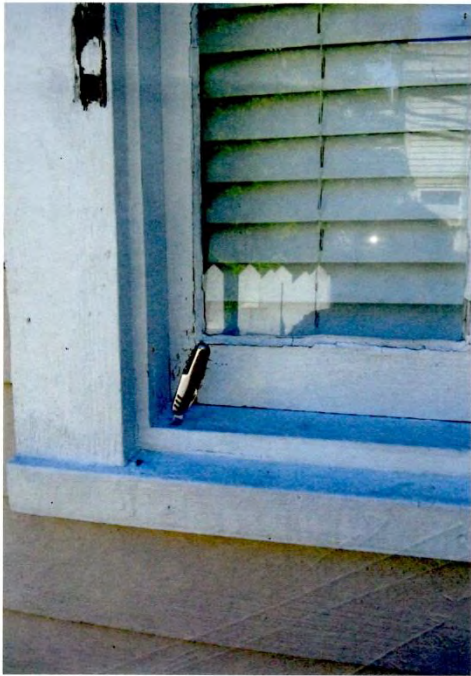
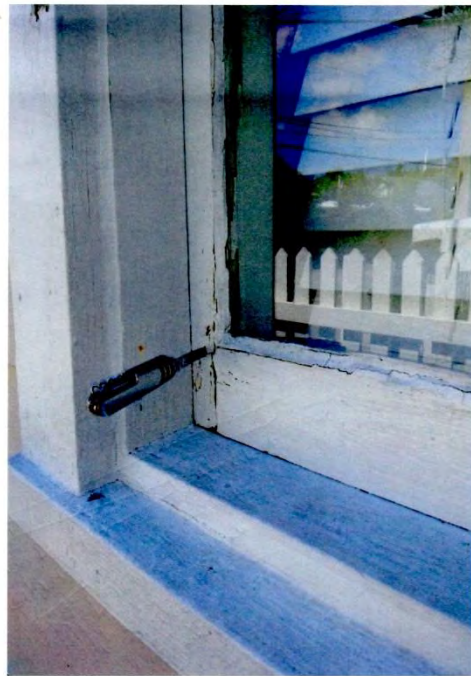
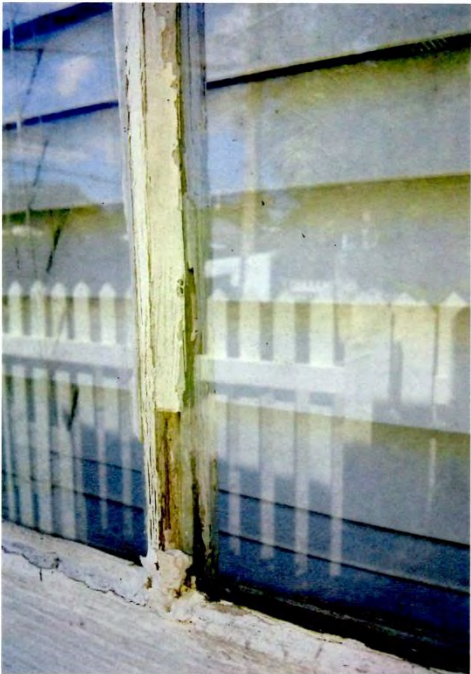
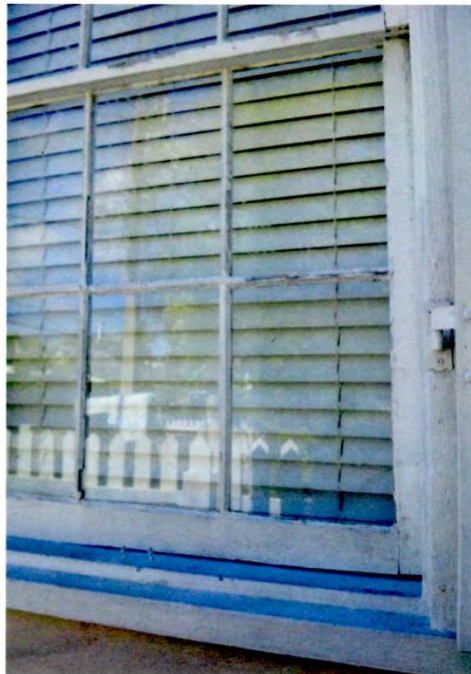
Window #1

While the applicant has claimed that many of the windows have new glass, staff has a differing opinion, concluding that window #1 has at least 4 original window panes, window #3 has all 12 original panes of glass, window #5 has 11 original windows panes. It is not surprising that a window over one hundred years old will have had some glass pane replacement.

Any rot that is found can be removed and filled in with epoxy; patch and repairs are normal for historic windows. If certain parts of the window are too far gone, such as the bottom sash, they can be replaced without needing to replace the entire window.

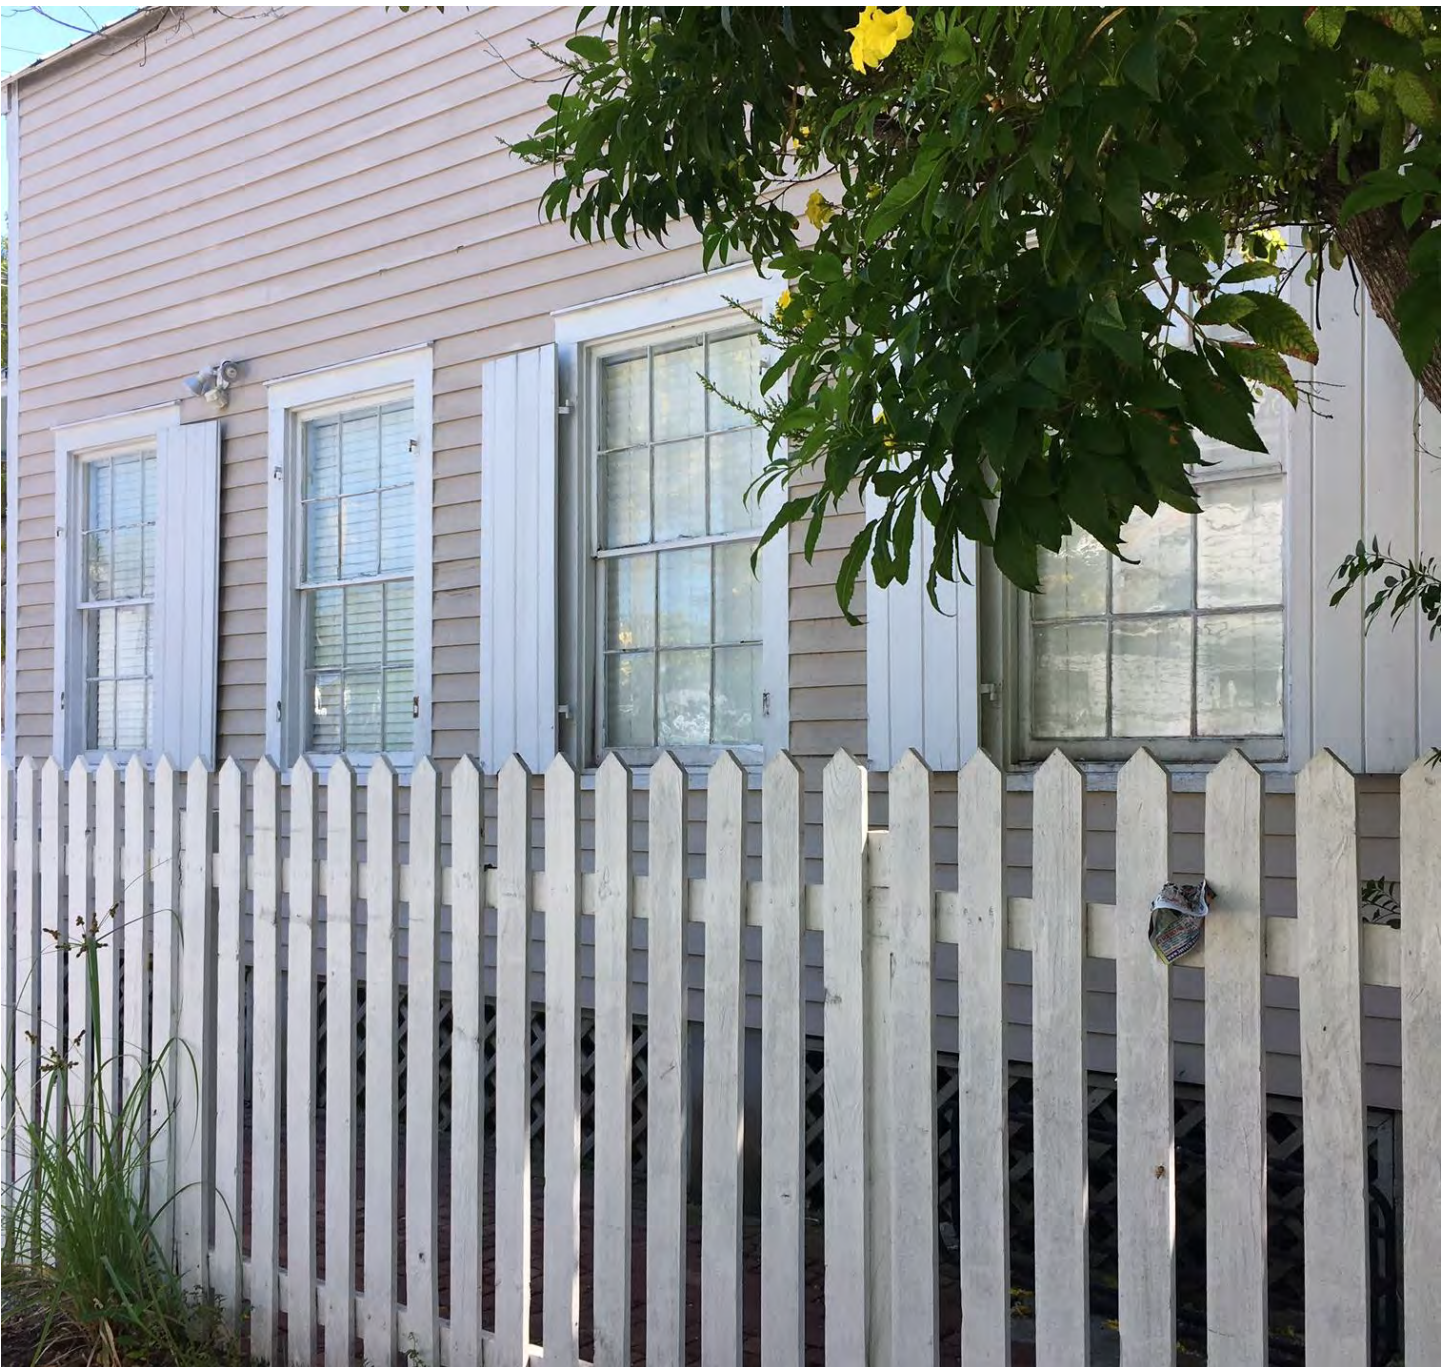
Four of the windows proposed to be replaced.
