City of Key West
Structural Visual Assessment

KEY WEST DIESEL PLANT

Project No: 6788-18-3057

Subject: Structural Visual Assessment on the
KEY WEST DIESEL PLANT
101 – 111 Geraldine Street, Key West, FL 33040

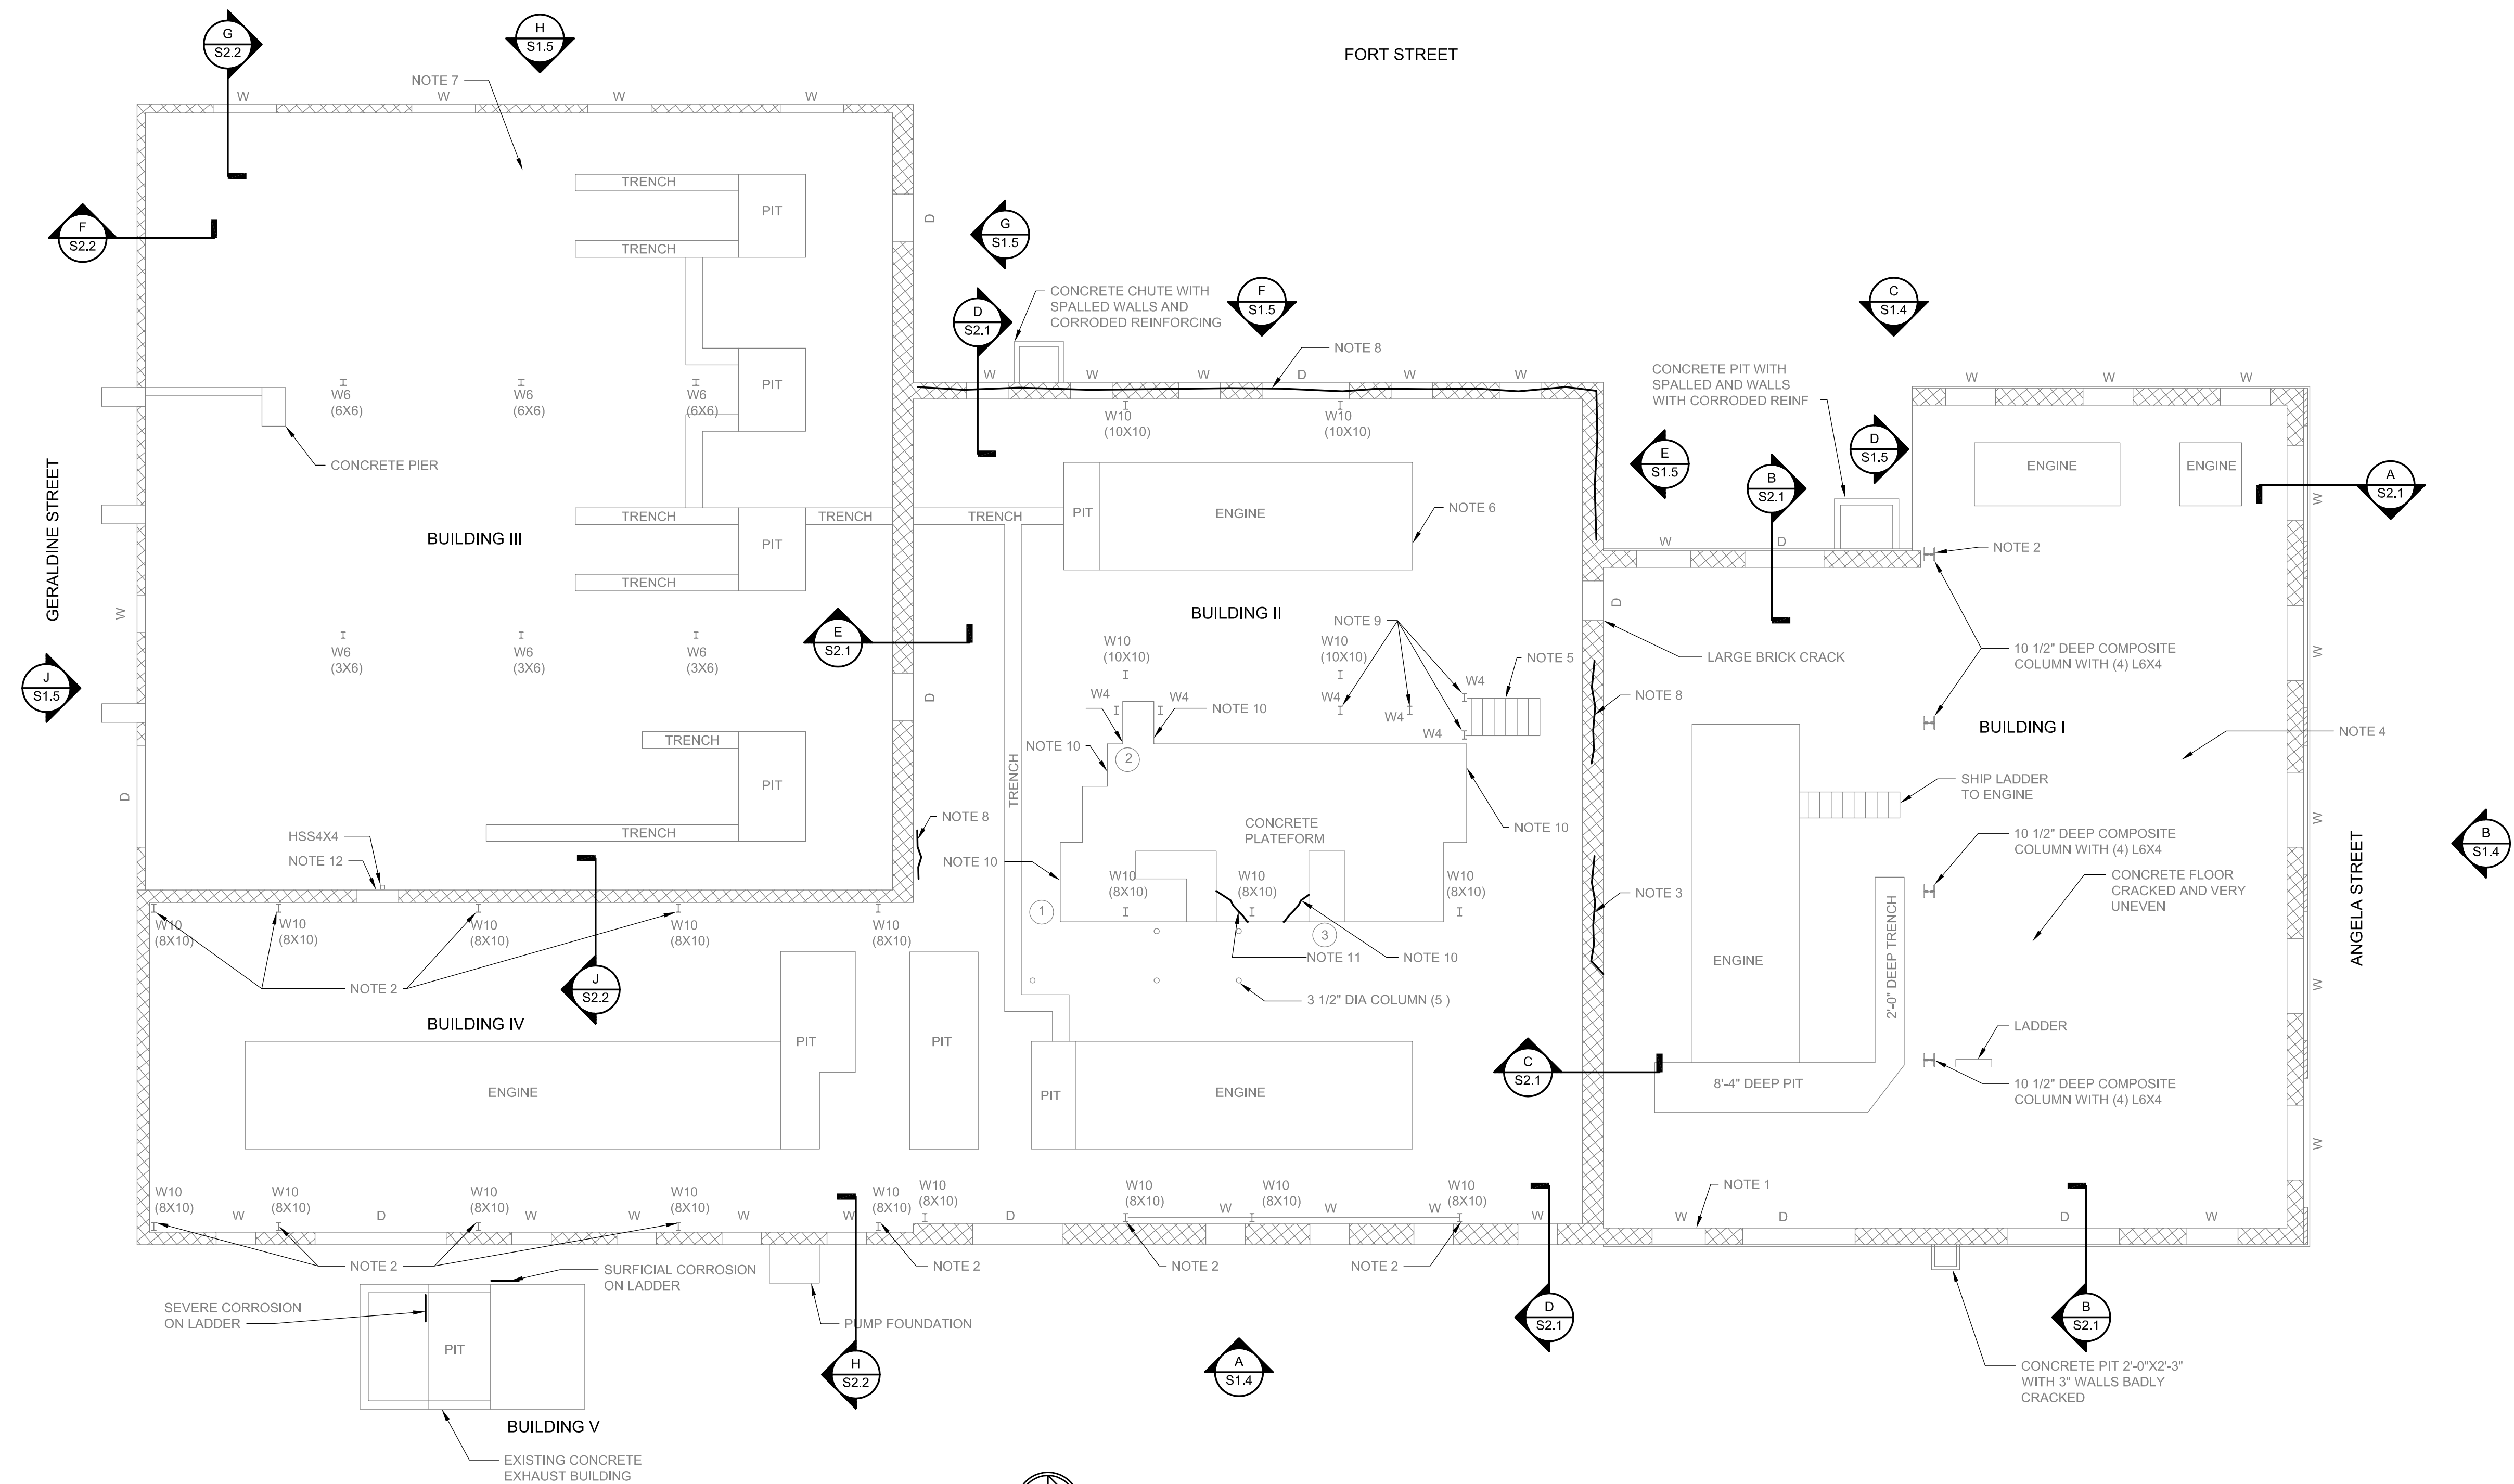
S1.1

- SURVEY NOTES:
1. DETERIORATED FACE OF BRICK
 2. BADLY CORRODED COLUMN BASE AND OR COLUMN
 3. CRACKS IN BRICK AT WALL PENETRATIONS AND ELEVATED OPENINGS
 4. CONCRETE FLOOR CRACKED AND UNEVEN
 5. BADLY CORRODED STAIR STRINGERS AT BASE OF STAIR
 6. TRENCH AND PIT EDGE ANGLE BADLY CORRODED
 7. CONCRETE FLOOR CRACKED AND UNEVEN - TRENCH AND PIT EDGE ANGLES ARE BADLY CORRODED
 8. DETERIORATED MORTAR JOINTS
 9. BADLY CORRODED POST BASE
 10. LARGE SPALL WITH EXPOSED CORRODING REINFORCING
 11. SEVERE CRACK AT CONCRETE BASE
 12. BADLY DETERIORATED BRICK AT WALL OPENING
 13. SURFICIAL CORROSION ON ALL STRUCTURAL STEEL.
- # CARBONATION AND CHLORIDE TEST

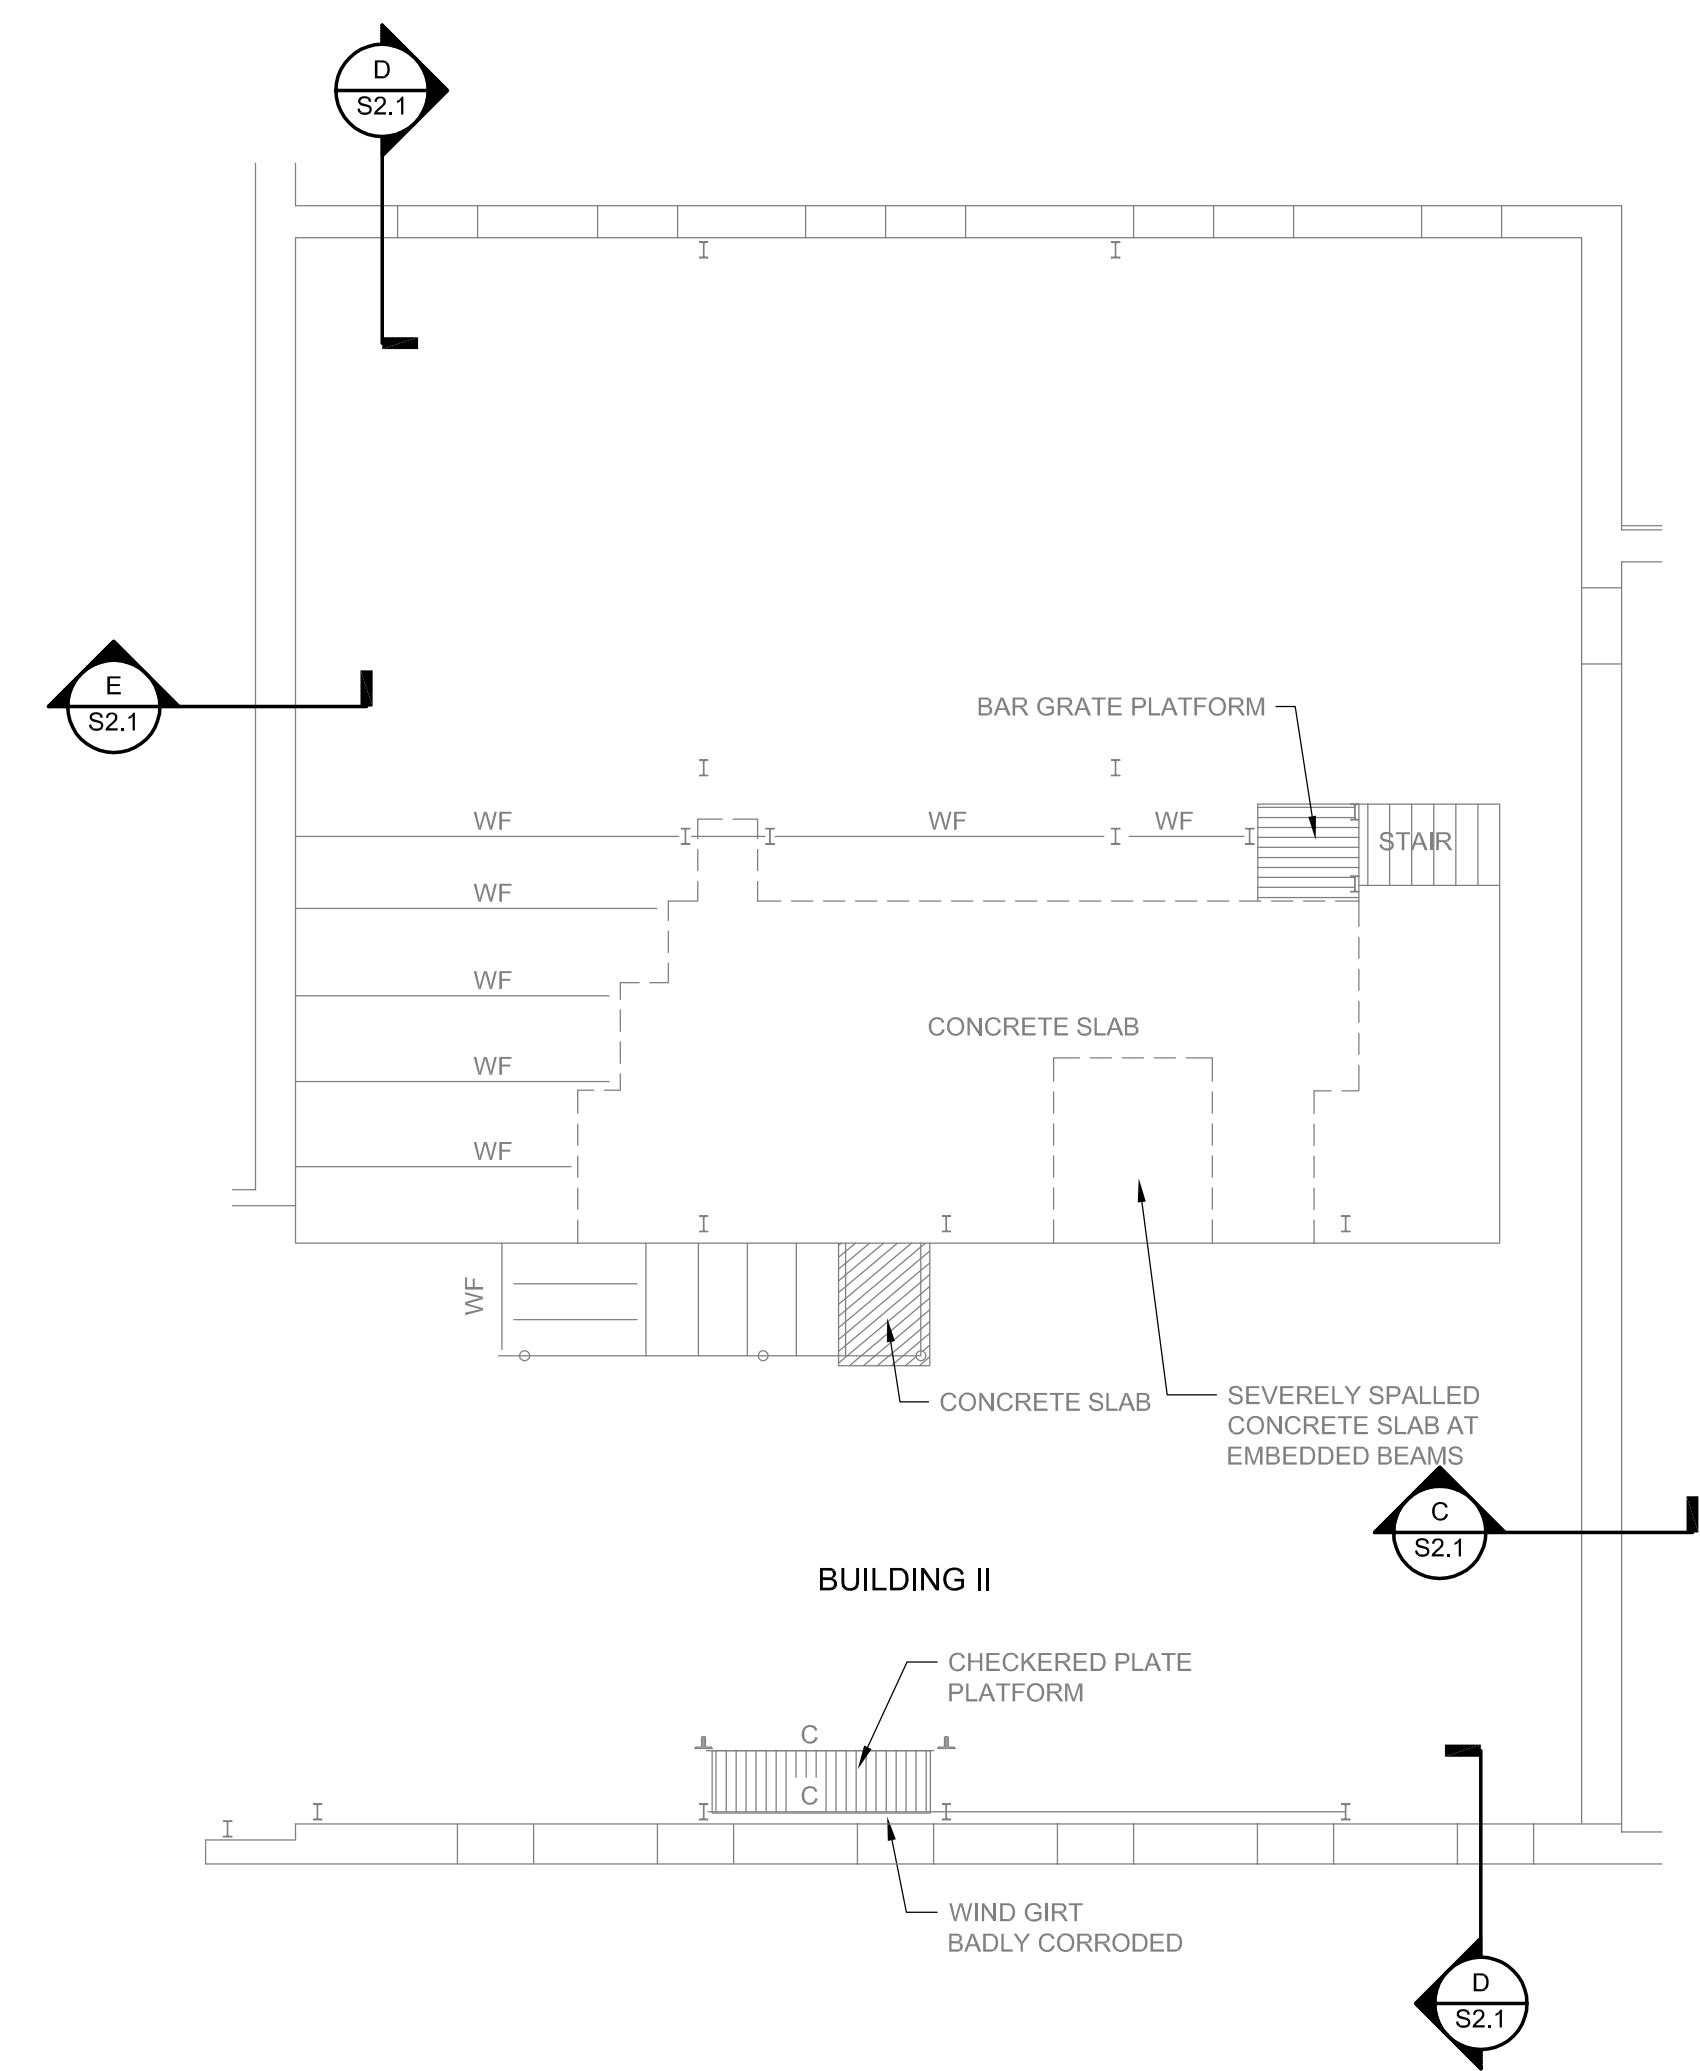
**EXISTING MEZZANINE FLOOR PLAN BUILDING II**
SCALE: 1/8"=1'-0"

SURVEY NOTES:
1. SURFICIAL CORROSION ON ALL STRUCTURAL STEEL.
