# STAFF REPORT

RE: **541 White Street-Peary Court**  
(permit application # T2023-0064)

FROM: Karen DeMaria, City of Key West Urban Forestry Manager

An application was received requesting the removal of **(2) Madras Thorn, (1) Sacred Fig, (1) Mahogany, and (1) Mango tree**. A site inspection was done and documented the following:

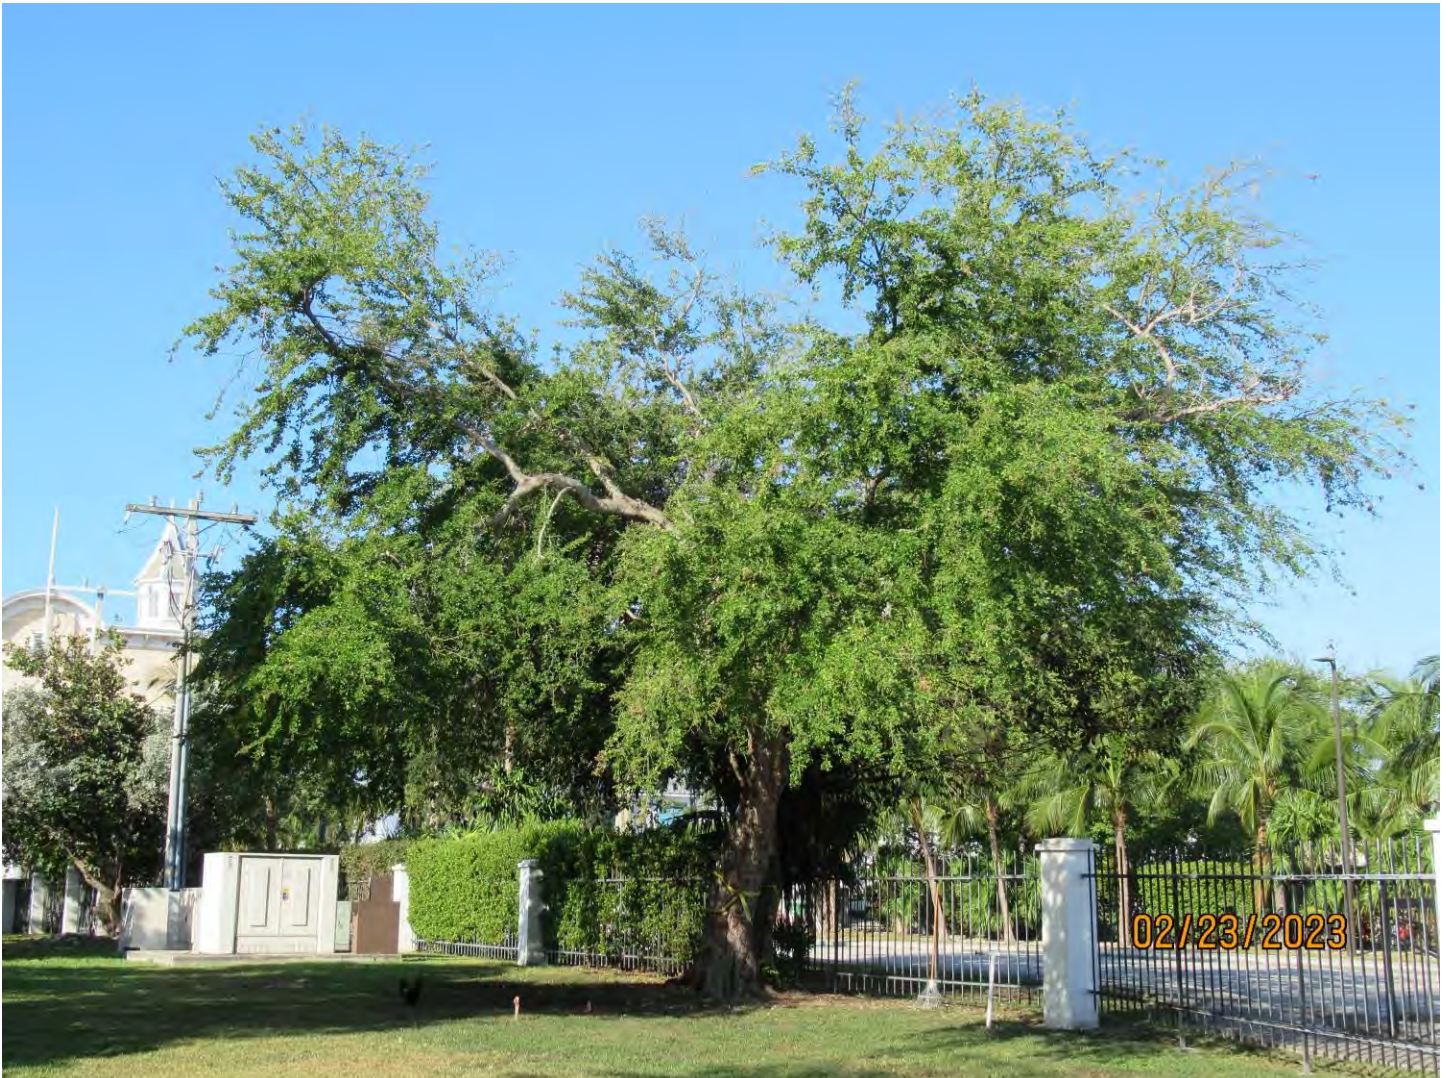
Tree #130

Photo of whole tree, view 1.

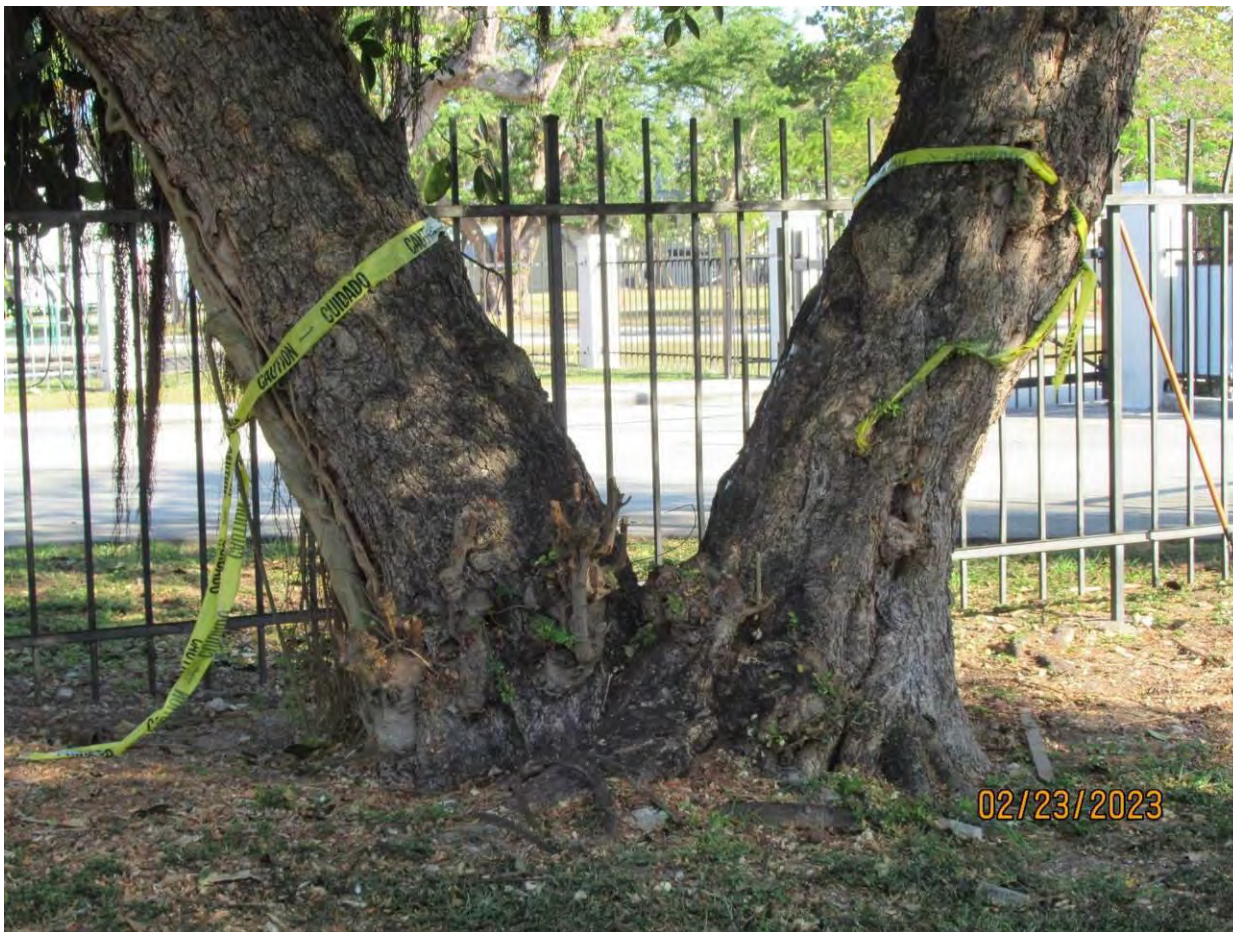
Photo showing co-dominant trunks.

Condition: 40% (overall condition is poor. Codominant trunks with poor structure. Ficus plant is growing on one of the main trunks. Large canopy branch break observed.)

**Recommend removal of tree.**

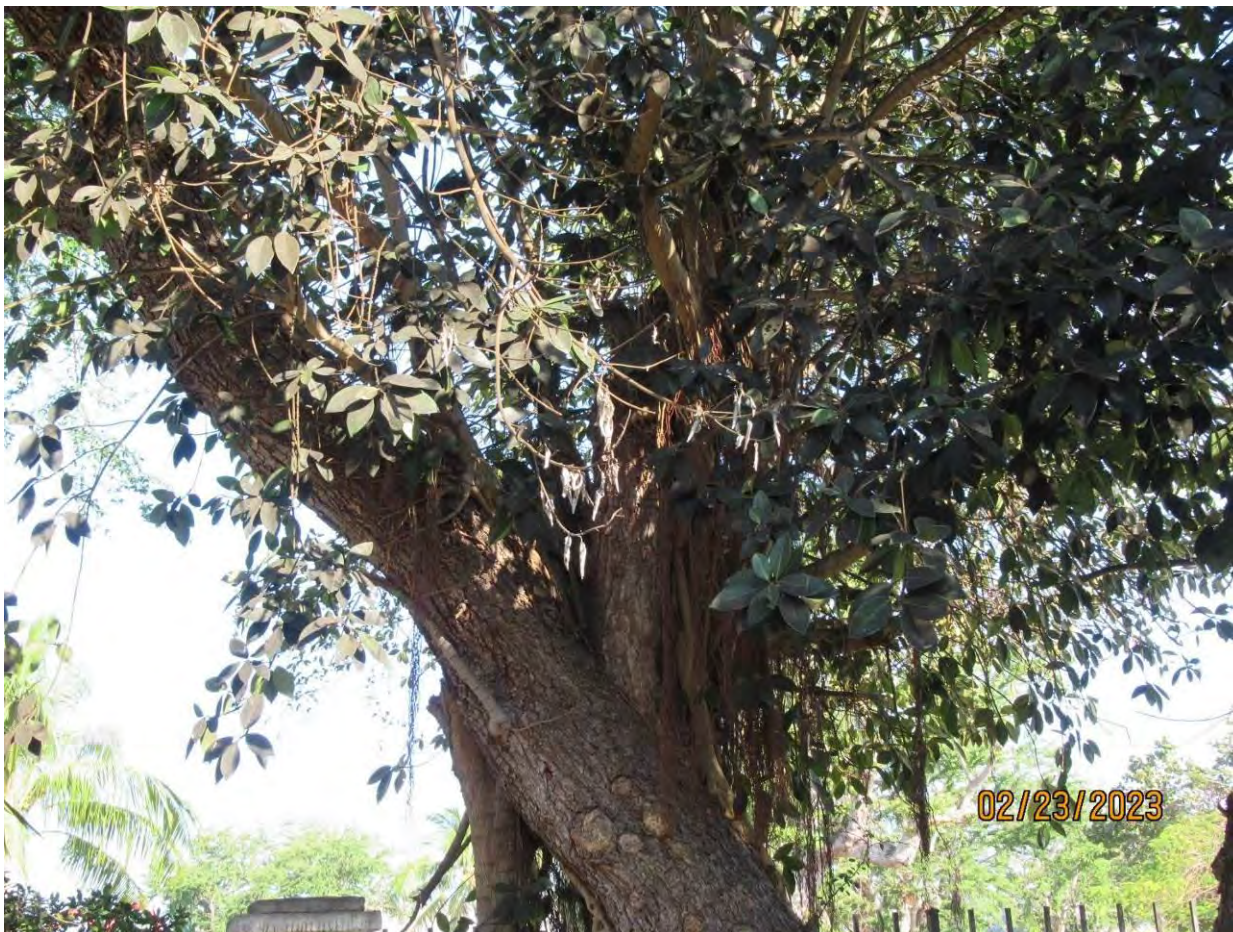
Photo of one trunk with ficus tree growing/ attached, view 1.

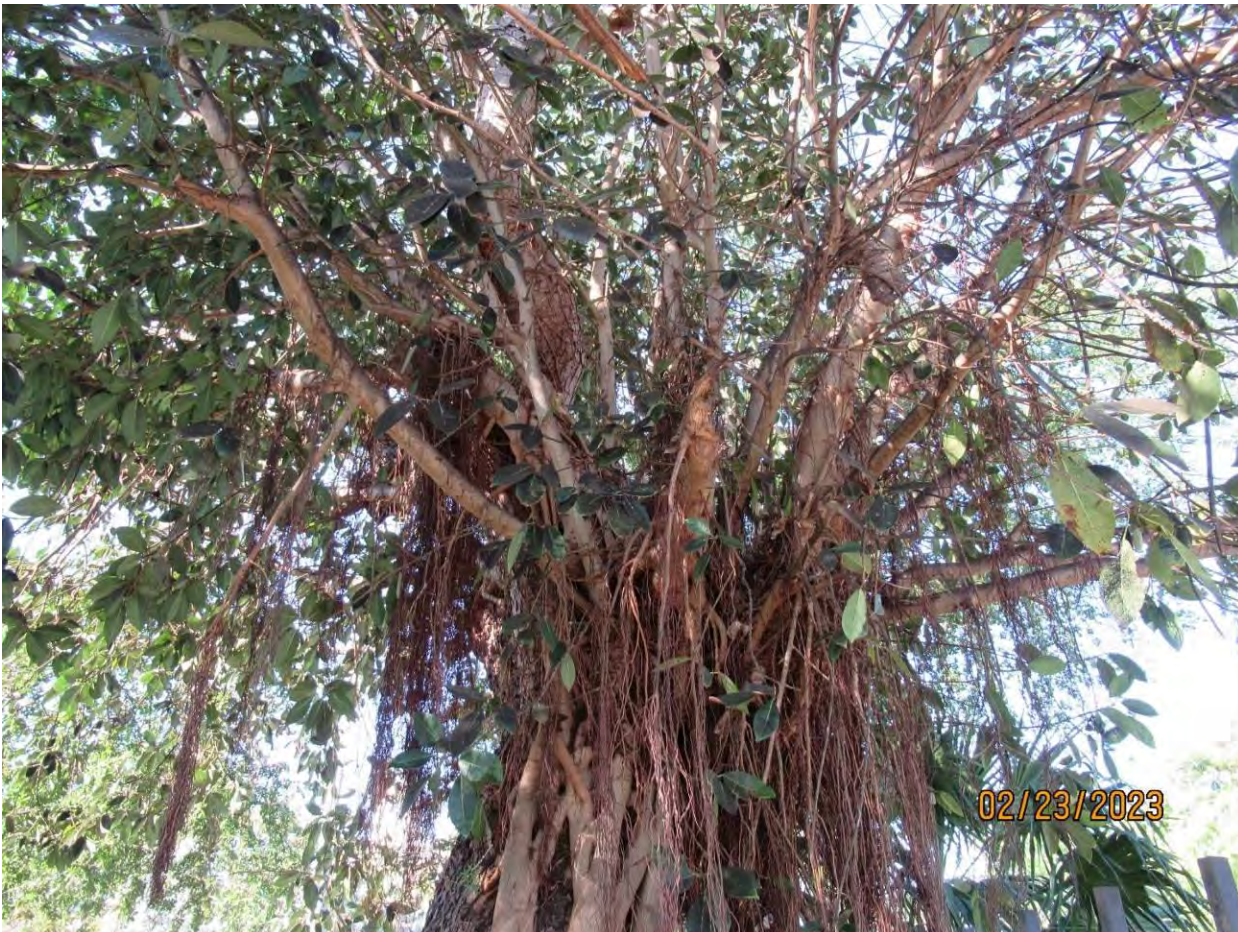
Photo of  
one trunk  
with ficus  
tree  
growing/  
attached,  
view 3.

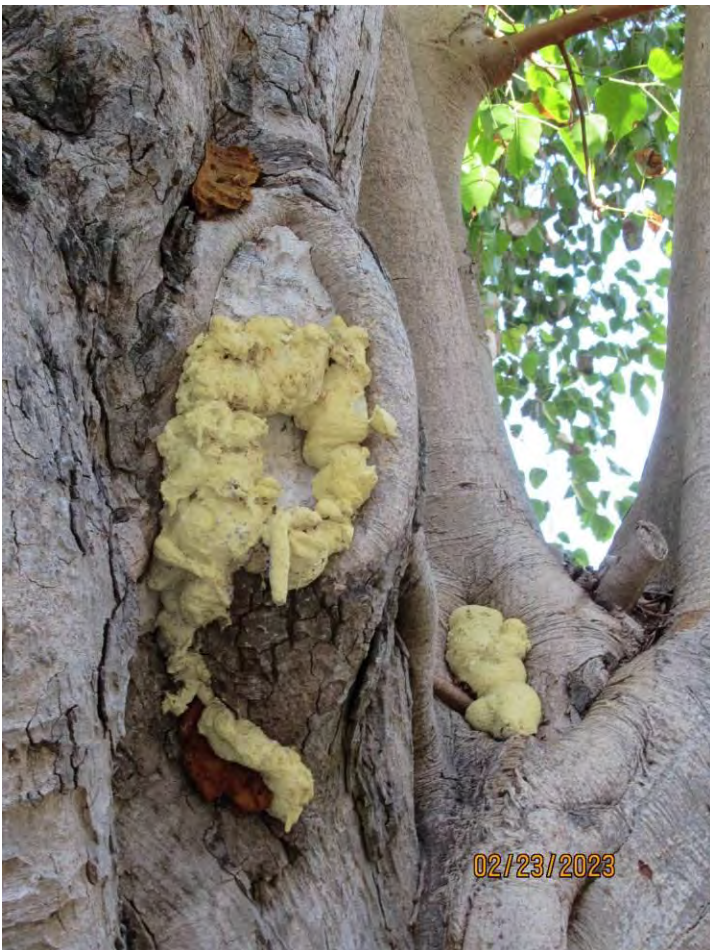
Two photos of areas of tree trunks  
with insulated foam.

Condition: 30% (overall condition is poor. Decay observed in canopy branches. Main trunk has insulation foam sprayed into hole areas. Exposed root flare area has been heavily trimmed/impacted.)

**Recommend removal of tree.**

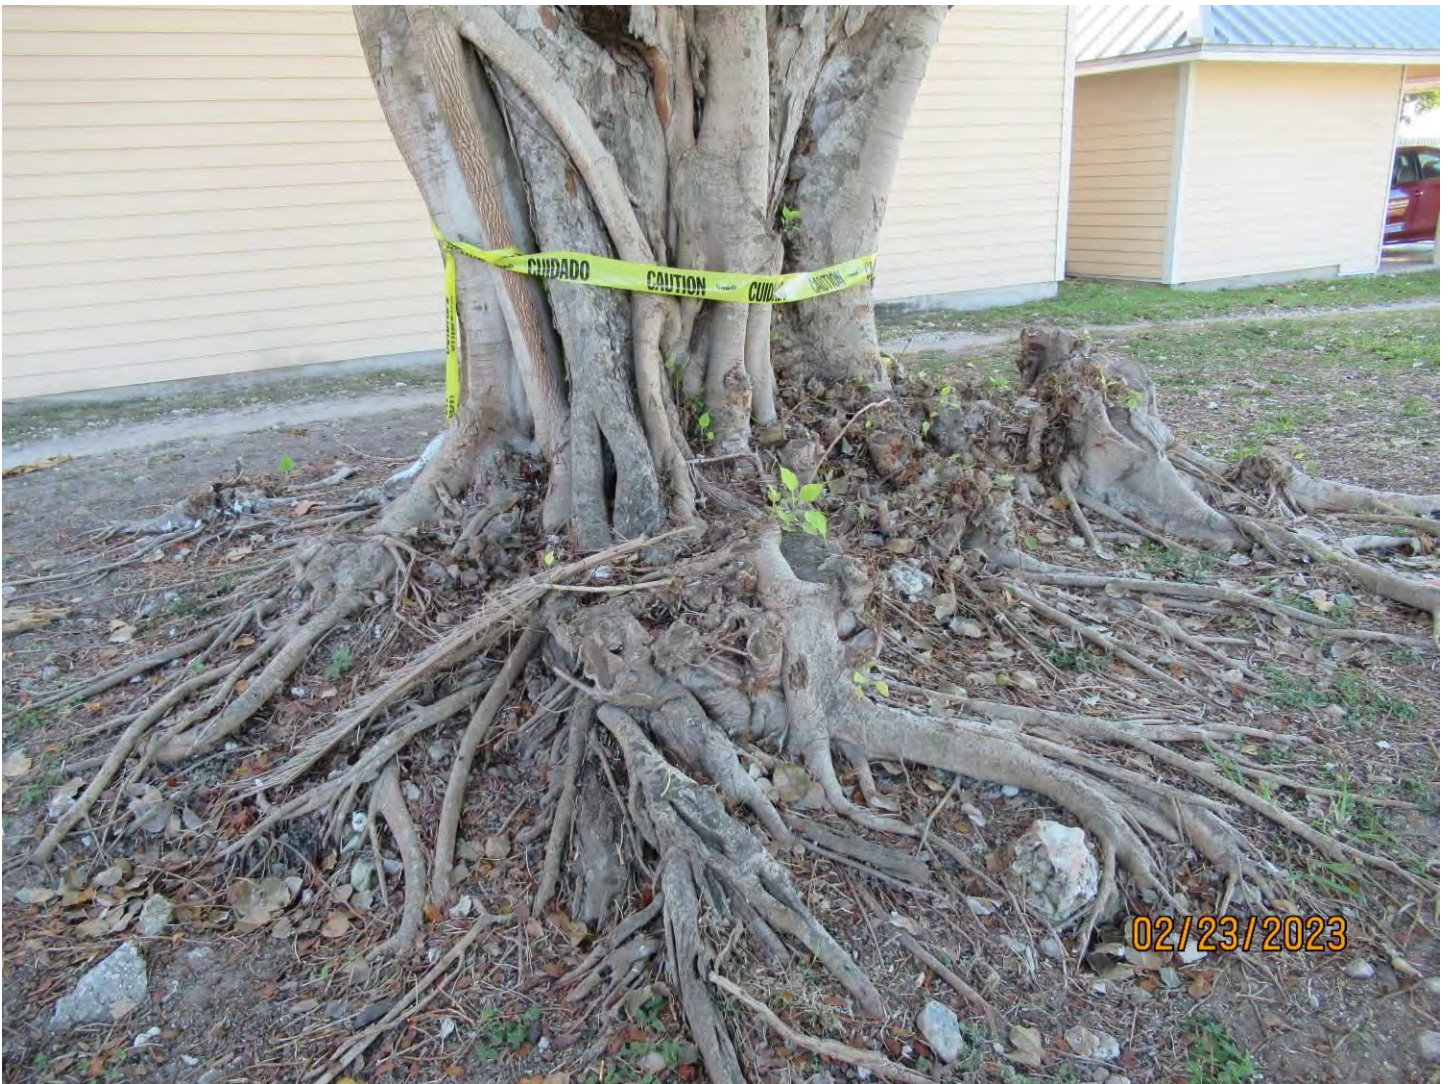
Photo of base of tree.

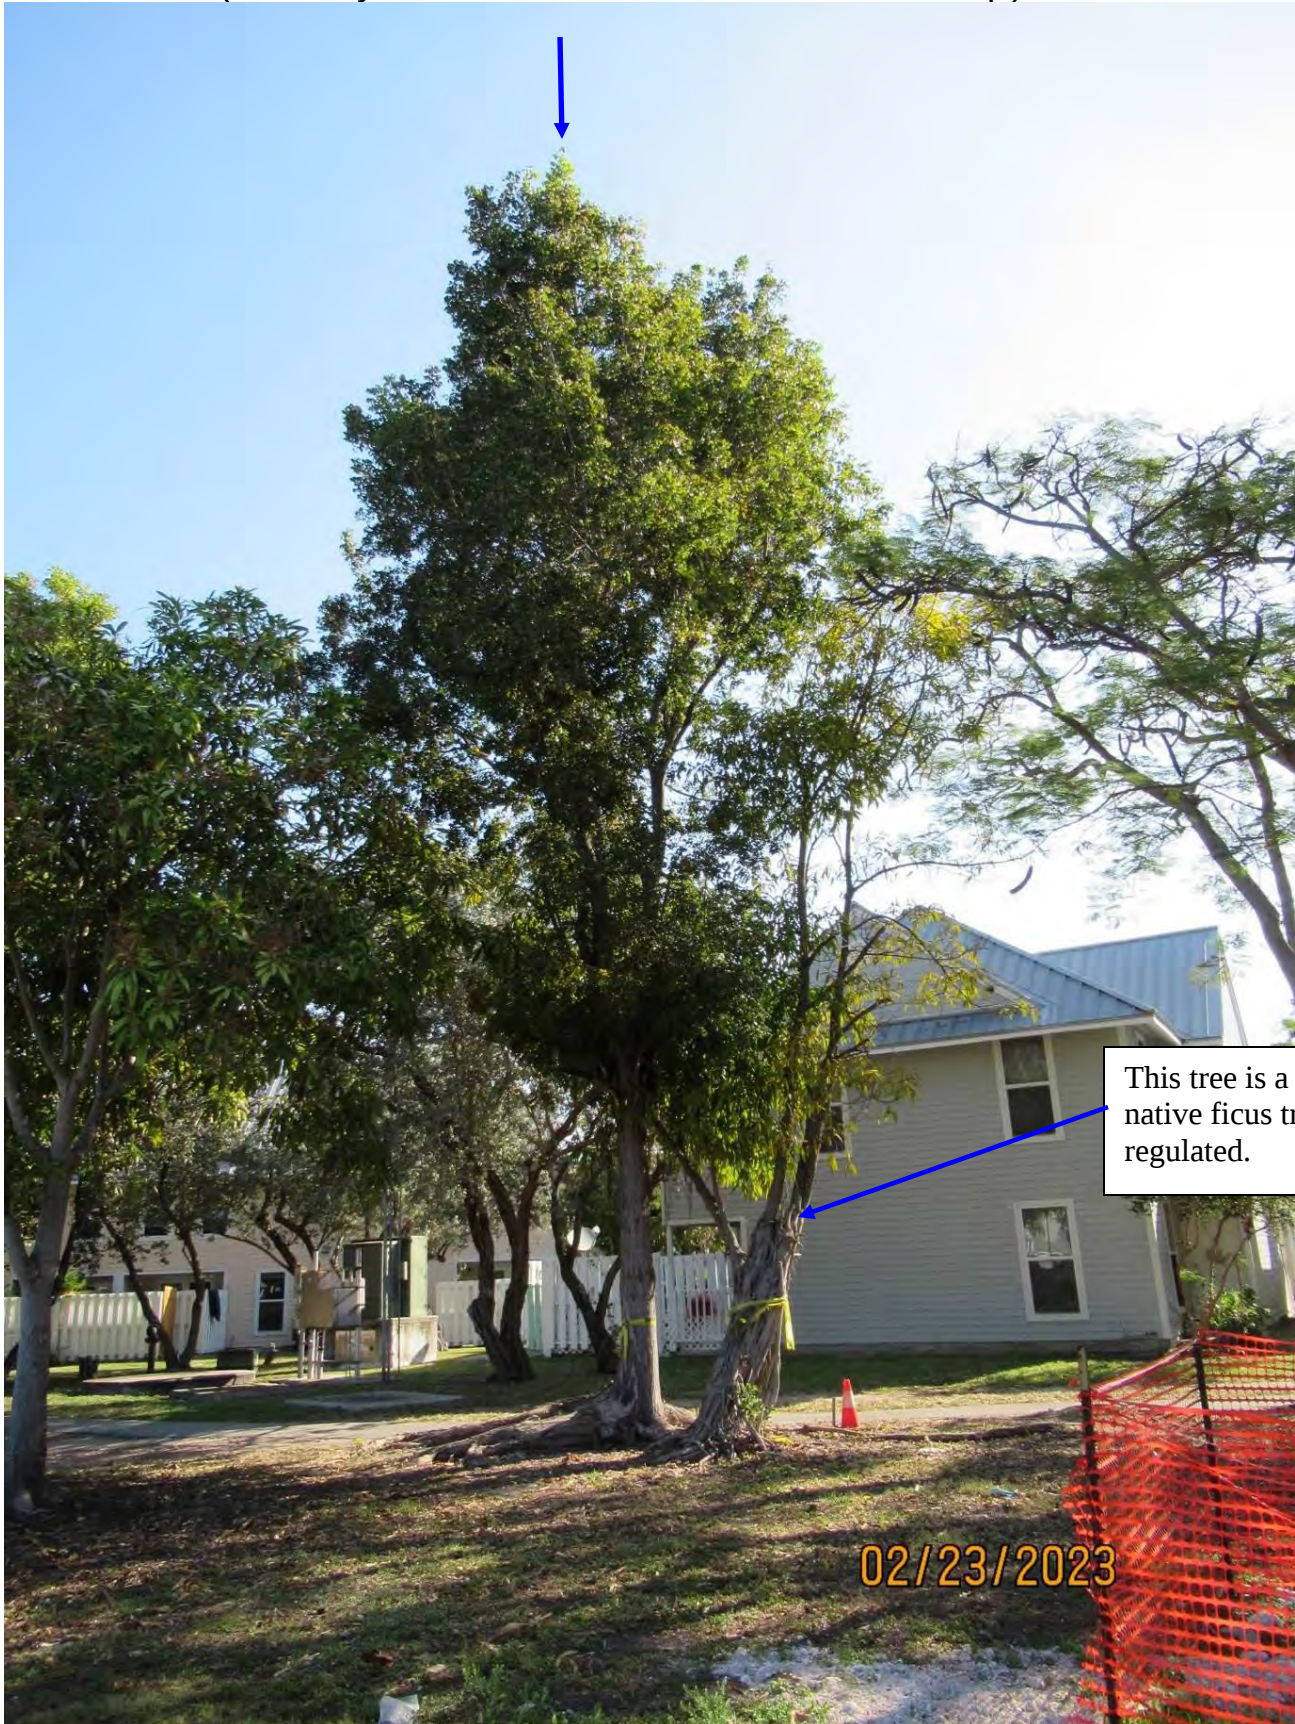
Tree #191 (actually located where 193 is on the map)

This tree is a non native ficus tree-not regulated.
