Sunset Celebration at Mallory Square: Task 1 Discovery Existing Historic Building & Restroom Needs Assessment May 2023

3.0 EXISTING HISTORIC BUILDING ASSESSMENT

3.2.h Tift and Mallory Warehouse / Waterfront Playhouse

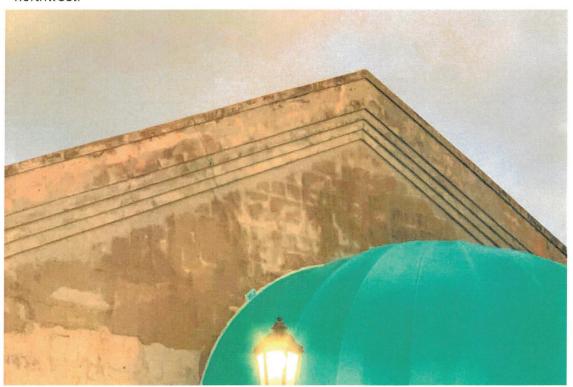
The parge coat is cracking and failing exposing sections of the limestone. The exposed sections of the limestone reveal the weathered condition of the stone and the mortar joints. There are several areas at the south elevation, where ferns and other vegetation are growing out of the wall. The stone at this location is discolored from bio growth and has mortar deterioration problems. The front (east) entry steps are also constructed of limestone finished with parge coat. The parge coat on the steps needs to be repaired.

50. Tift and Mallory Warehouse / Waterfront Playhouse, partial east elevation, camera facing northwest. Note saturation of parge coat and cracking.

- Prepare a comprehensive existing conditions assessment that includes:
 - o Structural and Mechanical, Electrical and Plumbing Engineering Reports.
 - The Structural Engineering Report should include an analysis of the roof framing and evaluation of the condition of the interior and exterior wall surfaces.
 - o An Accessibility Review to ensure compliance with the Americans with Disabilities Act.
 - A Flood Adaptation Review to ensure compliance with Chapter 34 Floods of the Key West Code of Ordinances, and the flood-resistant construction requirements of the Florida Building Code.
- Doors: Repair the doors as necessary to maintain their functionality.
- Install ADA accessible signage that directs one to an accessible entrance. The existing assessible entrance is sloped slightly downward, consider making improvements to level the surface.

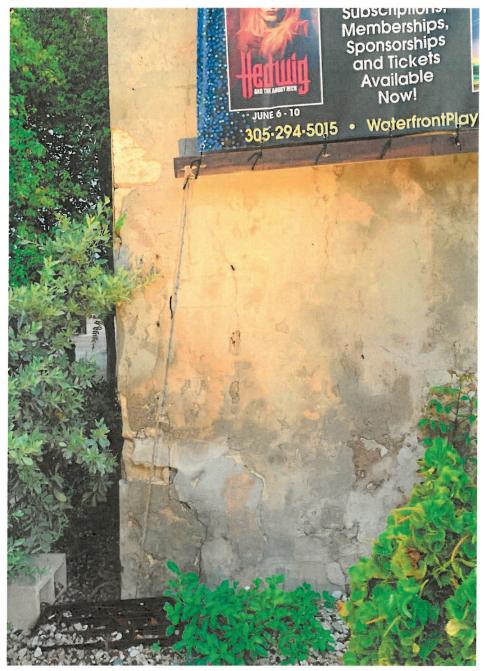
51. Tift and Mallory Warehouse / Waterfront Playhouse, partial east elevation, camera facing west. Note deterioration of parge coat and limestone.

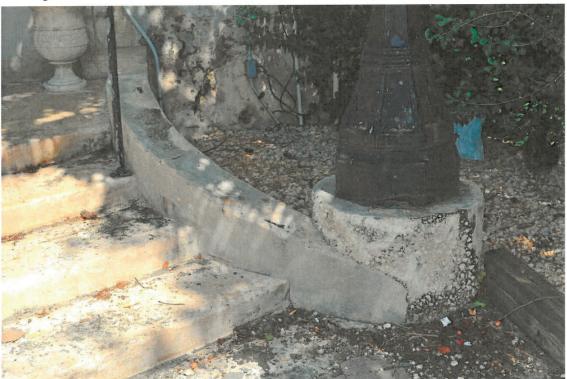
53. Tift and Mallory Warehouse / Waterfront Playhouse, front entry steps at east elevation, camera facing down and northwest. Note deterioration of steps.

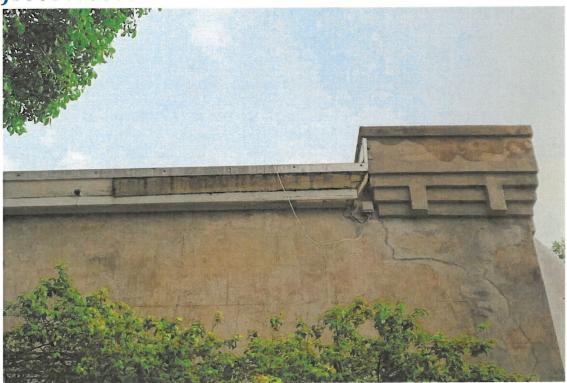
54. Tift and Mallory Warehouse / Waterfront Playhouse, partial south elevation. Note crack.

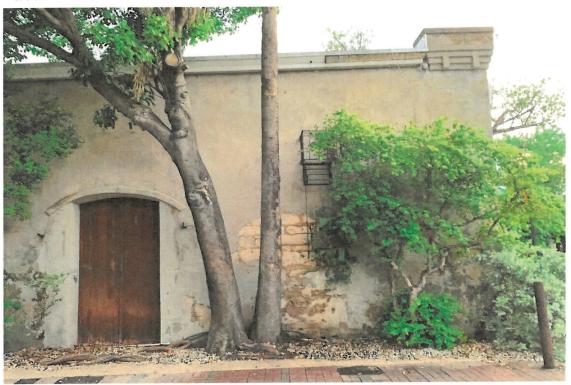
55. Tift and Mallory Warehouse / Waterfront Playhouse, partial south elevation. Note deteriorated parge coat and cracking.

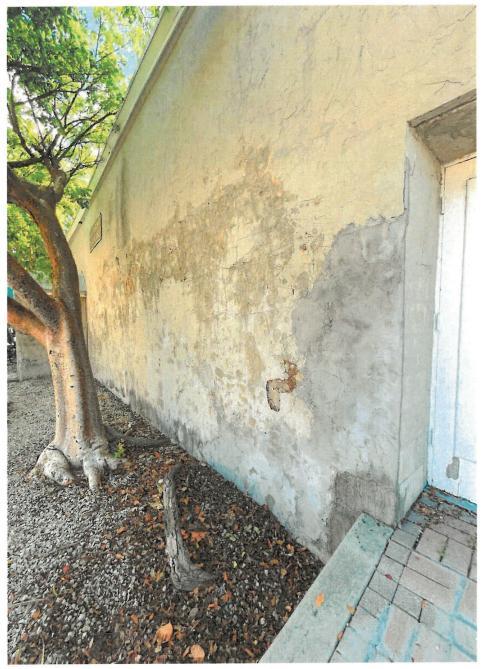
56. Tift and Mallory Warehouse / Waterfront Playhouse, partial west elevation. Note severe deterioration and failure of parge coat.

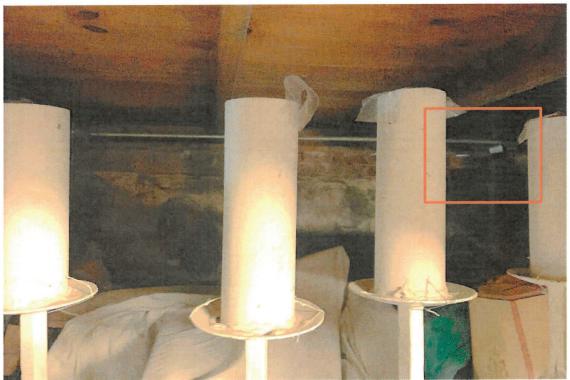
57. Tift and Mallory Warehouse / Waterfront Playhouse, attic, camera facing southwest. Note daylight along roofline.

- Inspecting the roof and roof edge for leaks.
- Repair and replace and rotted wood components like the door surrounds and frames.

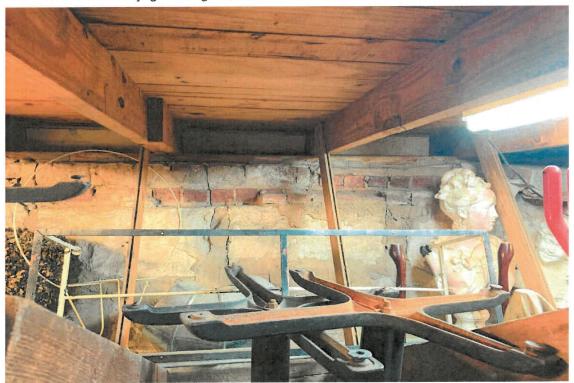
At the interior, the condition of the stone is worse than the exterior. Chunks of stone and stone dust fall to the floor and require cleaning every couple of weeks. The debris observed on the aisle carpet is about two months worth of deterioration. This is signifying an active problem that needs to be addressed immediately. Furthermore, cracks were observed along the top of the wall just below the roof framing.

58. Tift and Mallory Warehouse / Waterfront Playhouse, attic, camera facing west. Note cracks in top of wall and below roof framing.

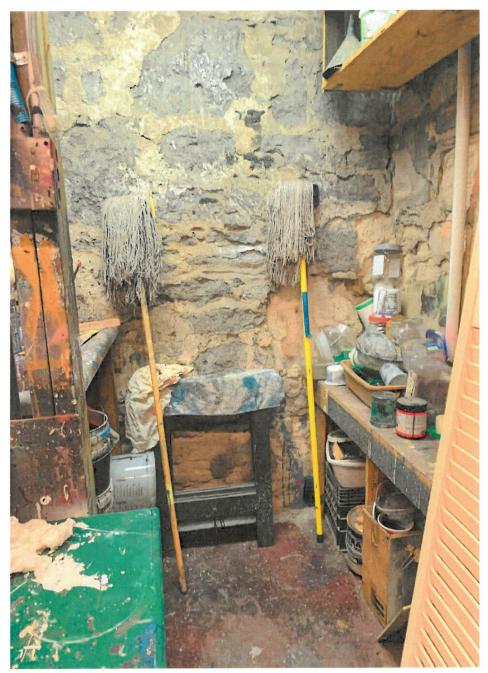
59. Tift and Mallory Warehouse / Waterfront Playhouse, interior, camera facing southwest. Example of conditions at south wall.

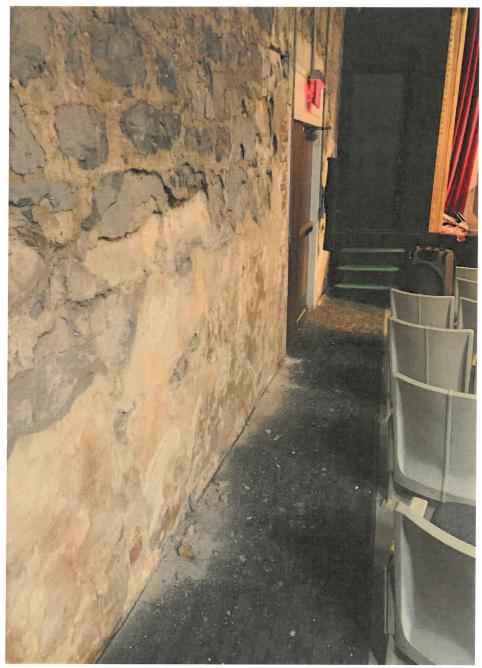
62. Tift and Mallory Warehouse / Waterfront Playhouse, south wall, camera facing down and southwest. Note deterioration of wall. Stone and mortar are on the carpet below.

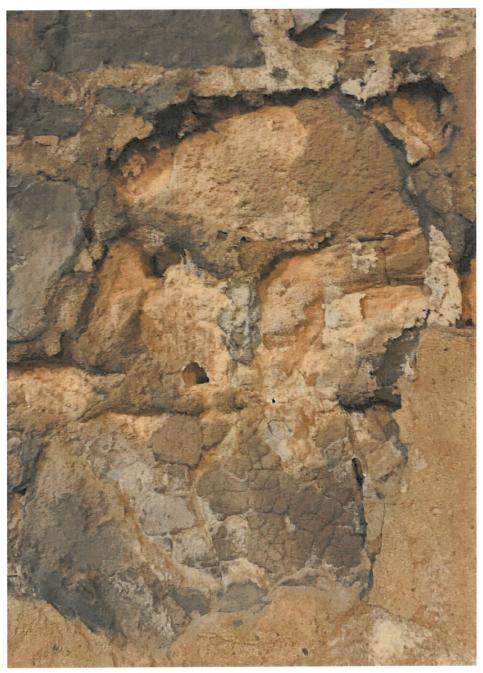
63. Tift and Mallory Warehouse / Waterfront Playhouse, south wall, camera facing south. Note severe deterioration of wall.
