# PEARY COURT PROPERTY REPORT

**ATKINS ENGINEERS, INC.**

JULY 17, 2013

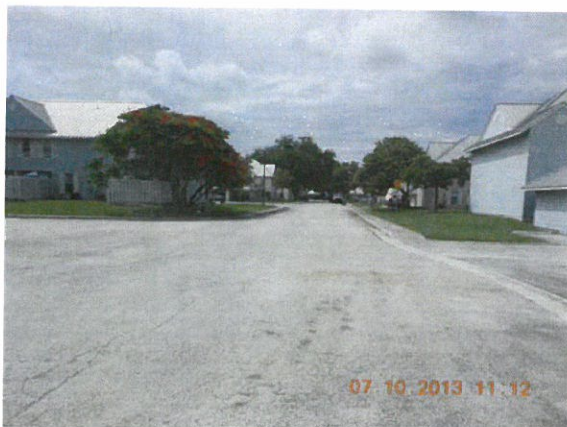
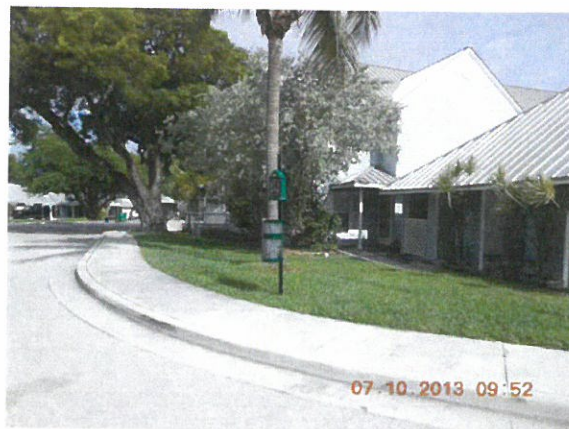
The driveway and parking areas are asphalt and these areas were in fair condition. The paved areas exhibit signs of wear and some cracking. Recoating is a normal maintenance activity and is required more frequently in south climates. The concrete curbs and sidewalks are in fair condition. Concrete sidewalks exhibit some shrinkage cracks and miscellaneous cracks when in close proximity to large trees.

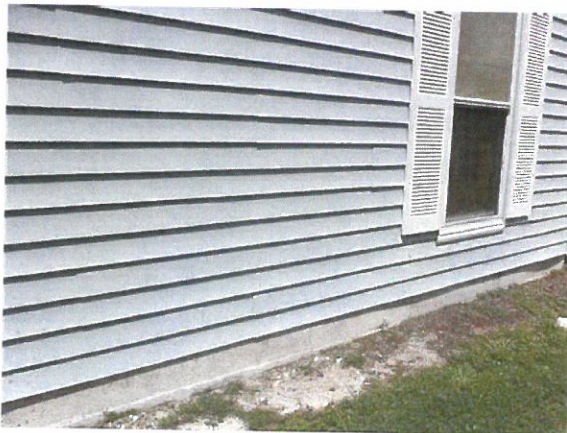
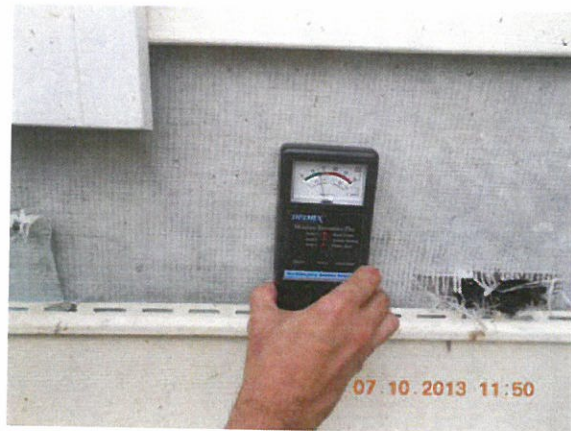
The foundation was detailed as a concrete slab on grade reinforced with welded wired mesh placed monolithically with a downturn footing. The downturn footing is anchored with 16" diameter piers embedded 3 feet minimum into lime rock. We did not verify the foundation system was as per the drawings. The buildings are performing well and we did not observe settlement or a deficient structural condition. The junction between the concrete slab on grade with the wood studs was observed and photographed at 10 townhomes and were found to be dry and in good working condition with only minor exceptions.

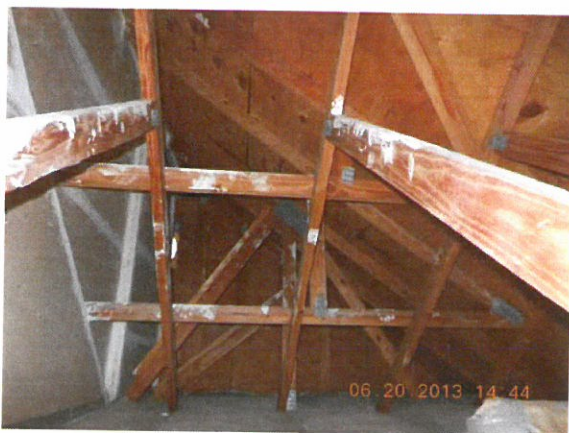
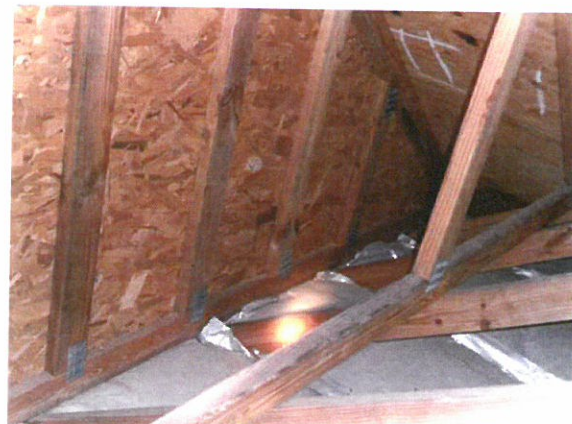
In the attic spaces we observed truss twist straps at all trusses. Rat runs and horizontal bracing was typical and nailed properly. Trusses and roof sheathing are in excellent condition with no signs of moisture or roof leaks. Roof sheathing was firmly attached although we were not able to determine the nail pattern. Shiners or nails that miss trusses that are typically found were not visible in any location.

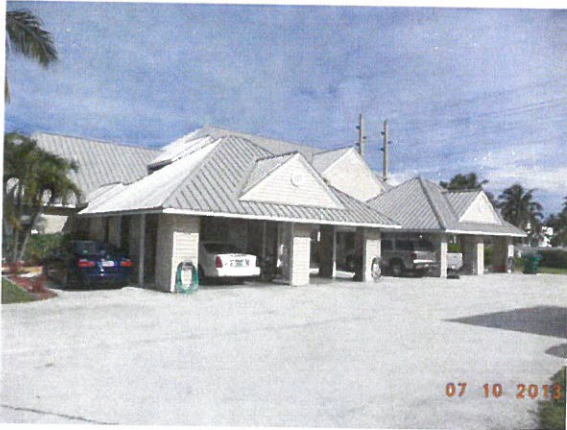
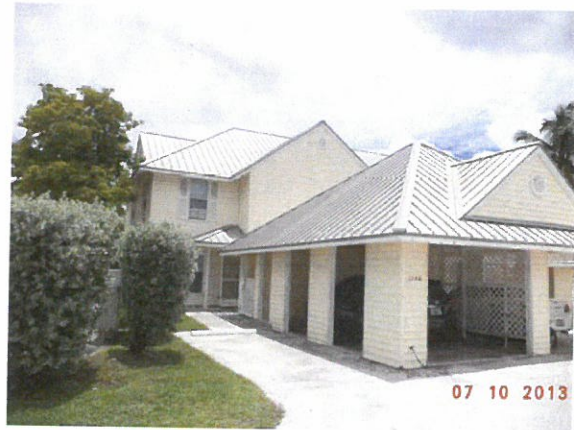
The roofs shapes consist of hips and gable ends. The gable ends were reinforced by web stiffeners nailed to flat 2x4's in lieu of diagonal bracing. The structures based on our non-destructive observations are performing well and are believed to have been constructed in general accordance with the design drawings prepared by McCall & Associates, Inc. dated 13 April 1992.

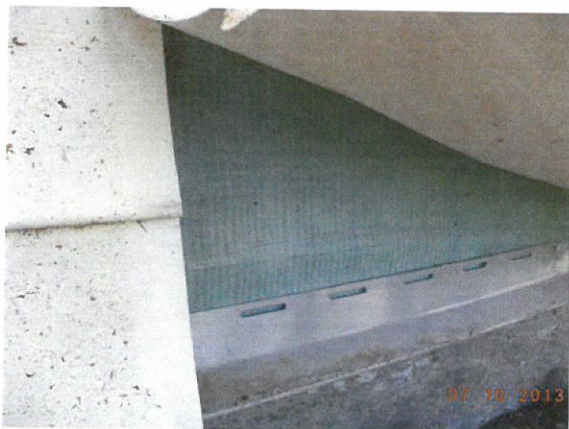
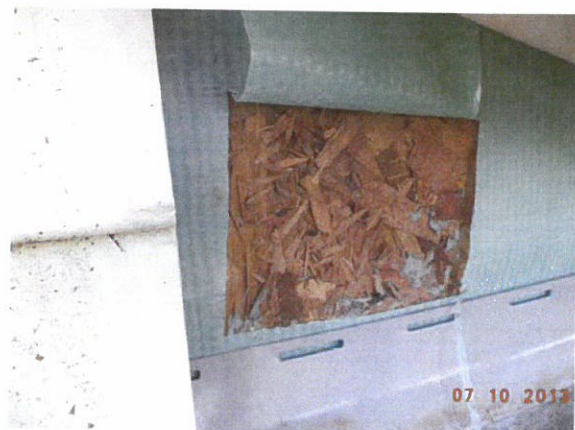
The structure of the buildings was in excellent condition with minor signs of moisture or deterioration in some isolated units. We were satisfied with the condition of the wood and particularly the OSB wall sheathing. We have observed the base plate and OSB termination at the floor line from the exterior by prying the vinyl siding up to expose the framing and find it is in good condition with only some exceptions where minor repairs are necessary.

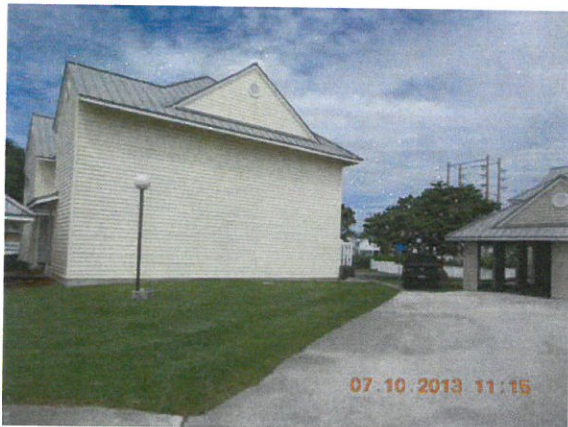
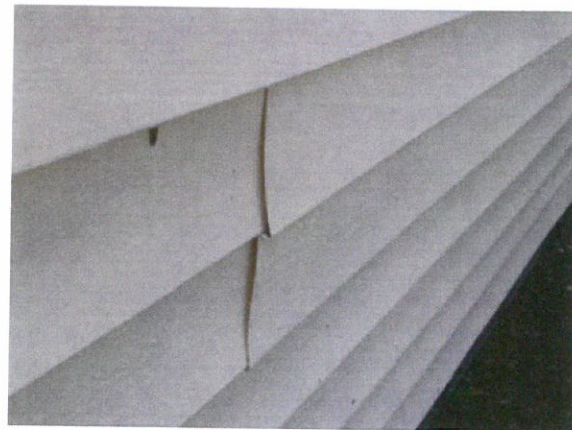
The exteriors are vinyl wall cladding that is permissible by Code in Type VI construction. Siding in some areas shows signs of aging and areas require repairs, replacement and fastening.

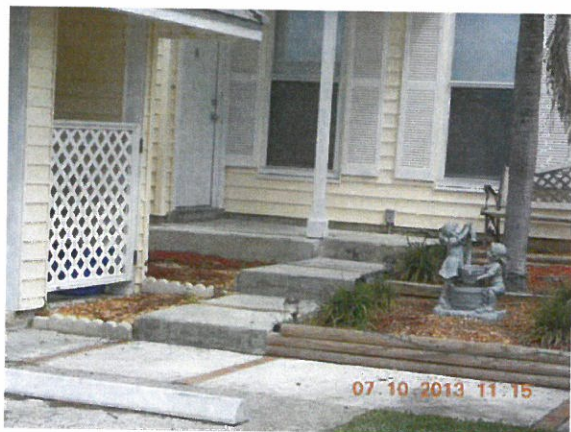
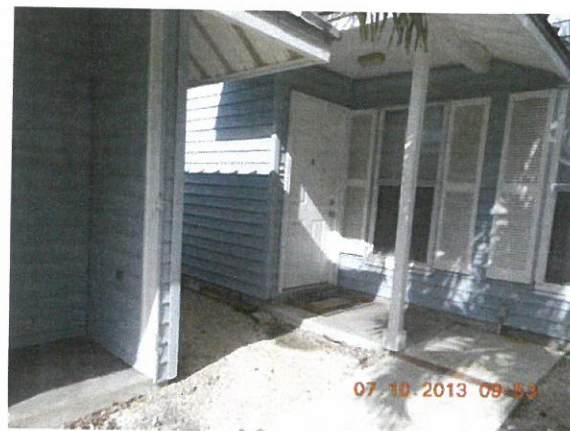
Some of the wood post framing that supports carport canopies shows signs of tenant damage, auto collisions, although this was not a typical condition. In some cases this damage has exposed the framing and sheathing and requires repairs. Some of the bottom vinyl siding panels have been damaged by the landscaper's edge trimmer.

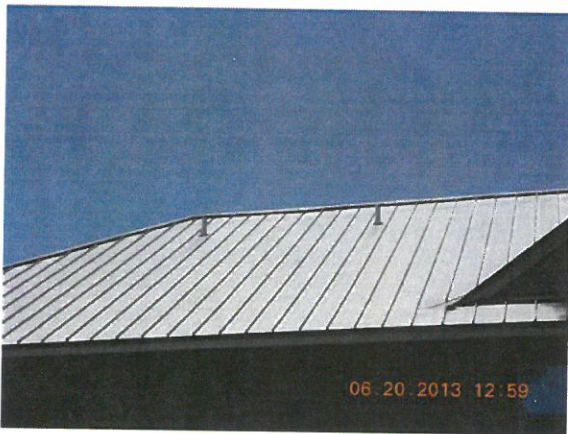
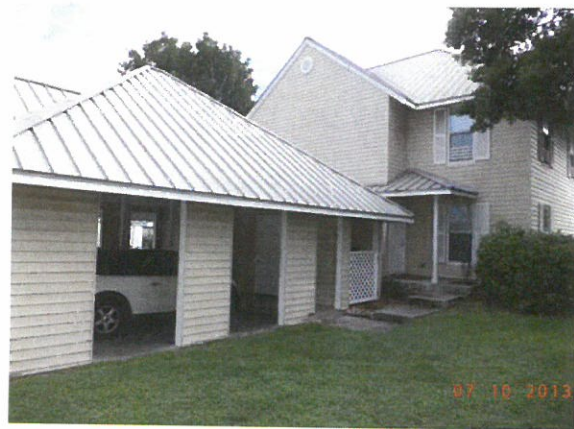
Roof construction for all buildings is metal standing seam roof system with hidden fasteners and a slope of 9 in 12. The ages of the roofs are approximately 20 years old. The roof system is in good condition with minimal observed required repairs. The standing seam metal roof appears to be the original roofing. We did not observe corrosion that would indicate the galvanizing is still providing protection to the metal and that additional useful life remains in the roofing system. The roof panels were installed tight and without waves or loose panels.

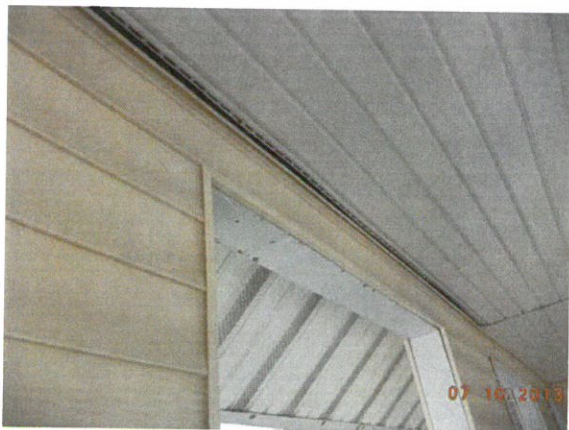
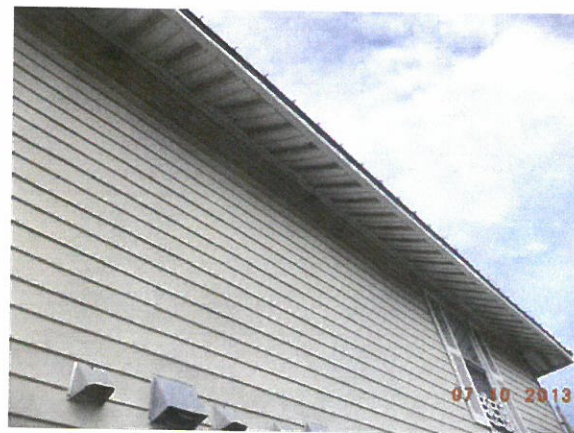
Roof attic areas meet code requirements for ventilation. Some vinyl soffits were loose and require fastening. Vinyl vented soffits are clipped to fascia and wall truss tails, a fair amount of vinyl fascia is dislodge or damaged.

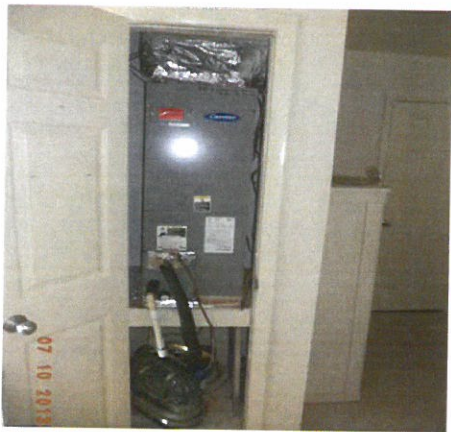
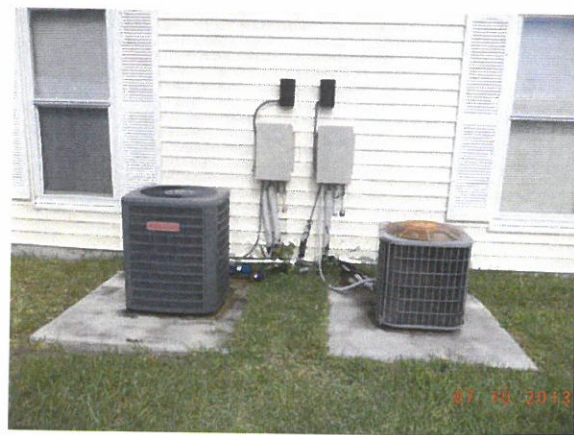
The HVAC is composed of a 2 Ton split system that serves the individual units. The compressor/heat pumps are located outside; Air Handlers with heat strips are located in ground floor closets. The ceiling drywall in the air handler closets should be patched as required, to protect the second floor framing and sealed to the plenum. Heating and air conditioning for each unit appear to be in fair condition and were in working order in the units inspected. Random samplings of the units indicate that some air handlers have been replaced as one would expect given the original construction was 20 years ago.

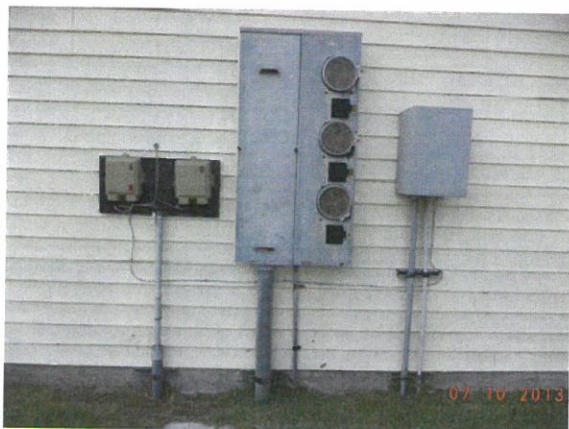
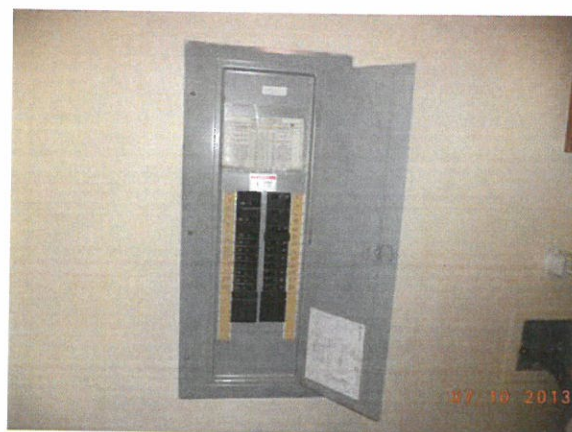
Each unit has a 150 AMP, three wire and single phase service. The Electrical breaker panel is typically located in the utility room at the 2nd floor. Panels were found to have their breakers labeled. A main breaker for each unit is located on the exterior of the building, near the meter.

The electric service is composed of 3-500MCM copper wires. The enclosure is NEMA 3R rated. The grounding wires were found to be #8 wire. NEC requires the grounding to be #1/0 wire and a ground rod and therefore should be remediated.
