Additional Information

From: Brian Olson <olsondraftingservices@hotmail.com>
Sent: Thursday, September 7, 2023 11:39 PM
To: Karen DeMaria
Cc: wrowan@gmail.com; keywestmarineassistance@yahoo.com; najagirard@yahoo.com
Subject: [EXTERNAL] 630 Eaton Street Tree Permit# T2023-0234

**RE: Proposal for Certified Arborist Support Services
630 Eaton St, Key West Monroe County, FL**

ISA CERTIFIED ARBORIST ASSESSMENT OF SPANISH LIME TREE AT 630 EATON STREET

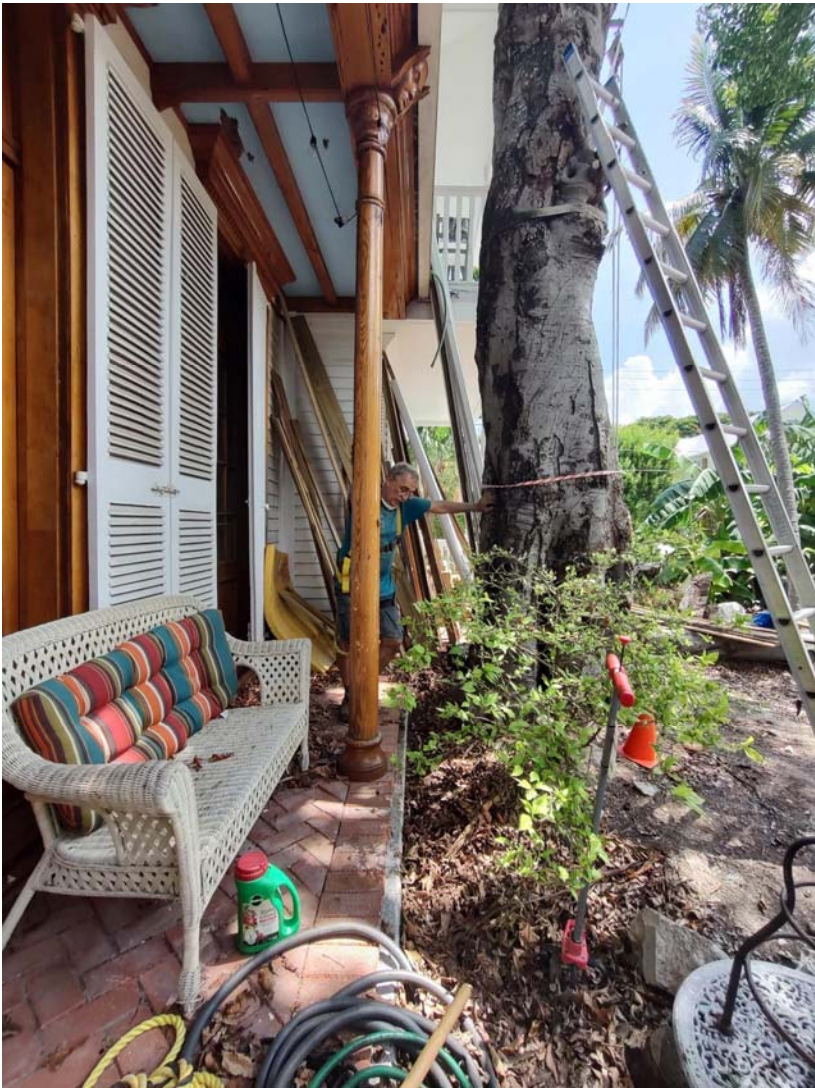
I have attached a photo of the tree that is causing problems at 630 Eaton Street.

Bill and I inspected the main structure and how the large tree in question appears to be damaging it. The root system of the tree has altered the grade beam and footer of the main structure. Specifically at the location of a main column supporting the deck at the second floor. The roots have pushed up the footing and in turn has lifted the floor framing creating voids and cracks in the deck above. Water intrusion is an issue as shown in the photo below with rotting at the ceiling. We recommend the removal of the tree because of the continued damage the root system will cause to the historic structure. If the tree in question is to be uprooted by mother nature, The damage to the main structure and other adjacent property that is easily in reach will be major.

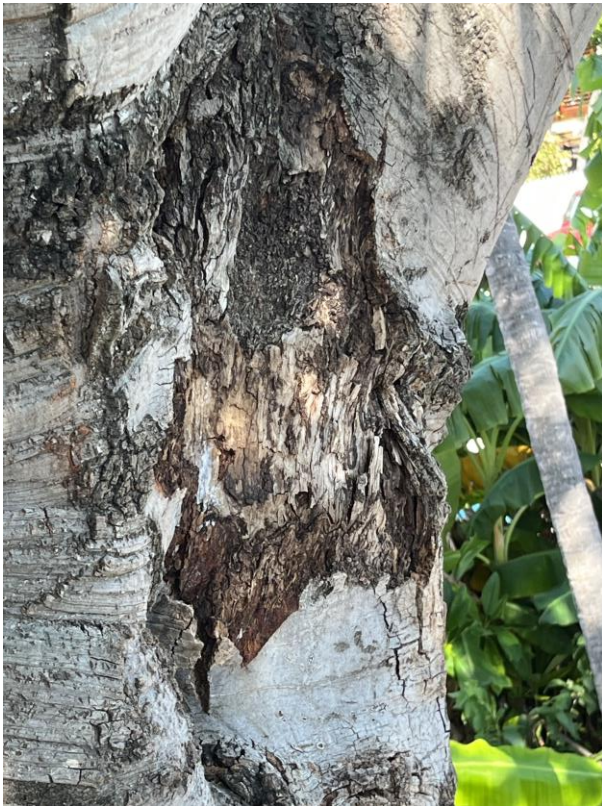
Decay on trunk

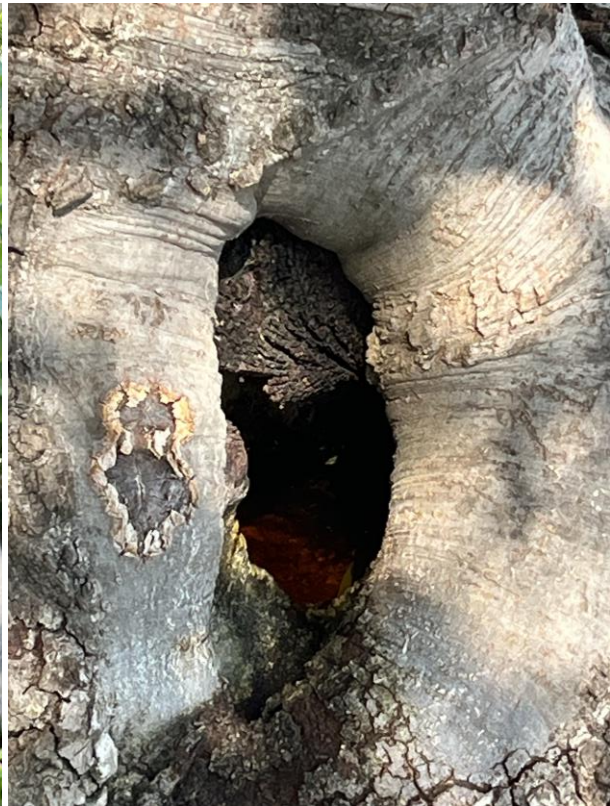
Cavity with decay

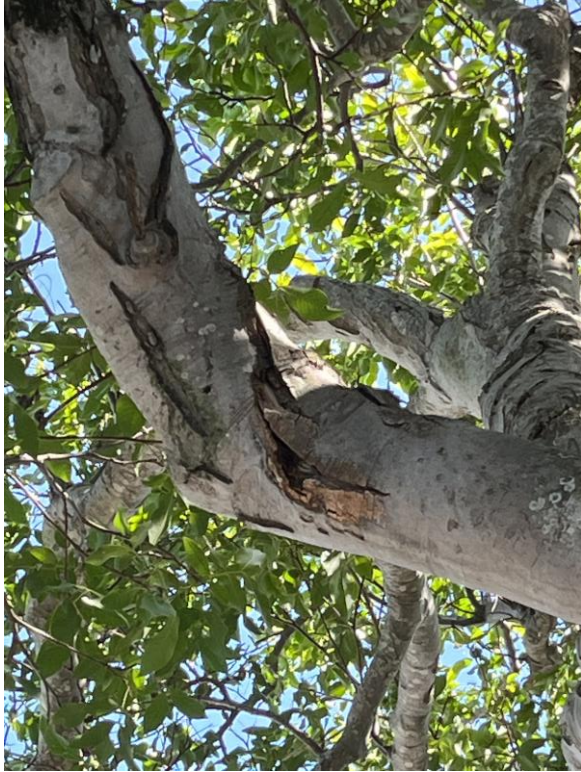
Cracking and peeling bark on major limb

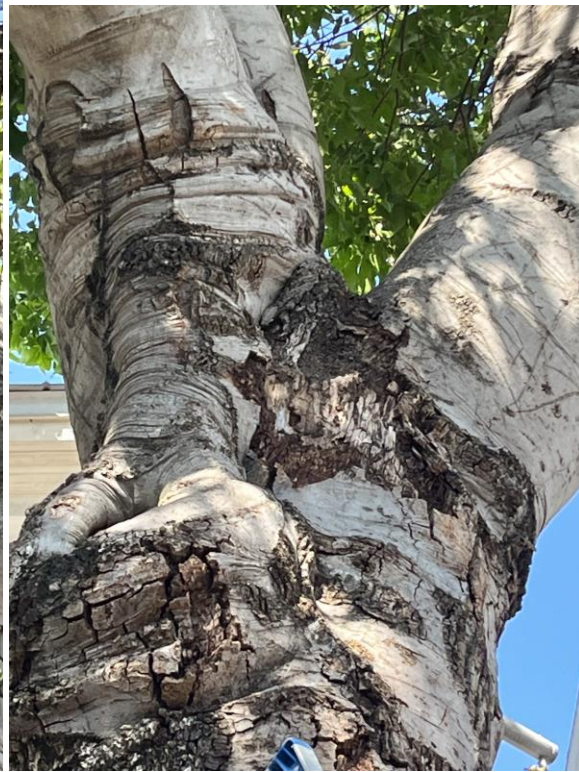
Decay and cracking a limb junction

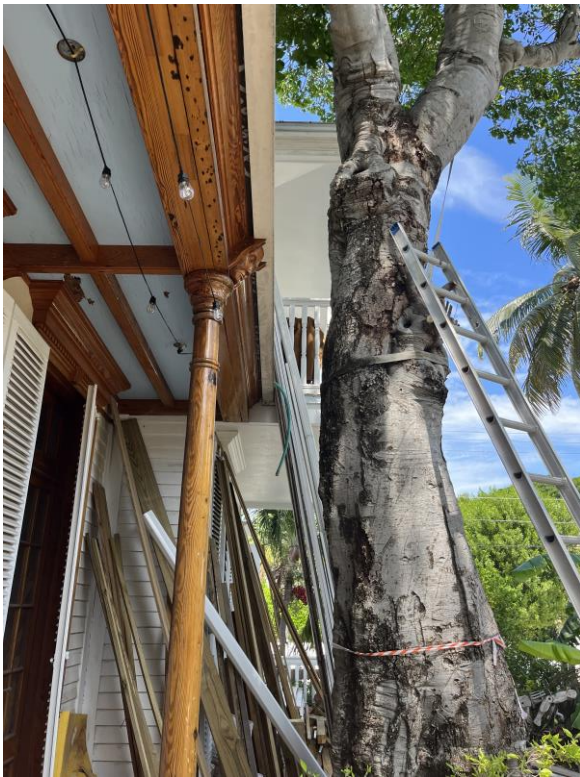
Tree Proximity to house

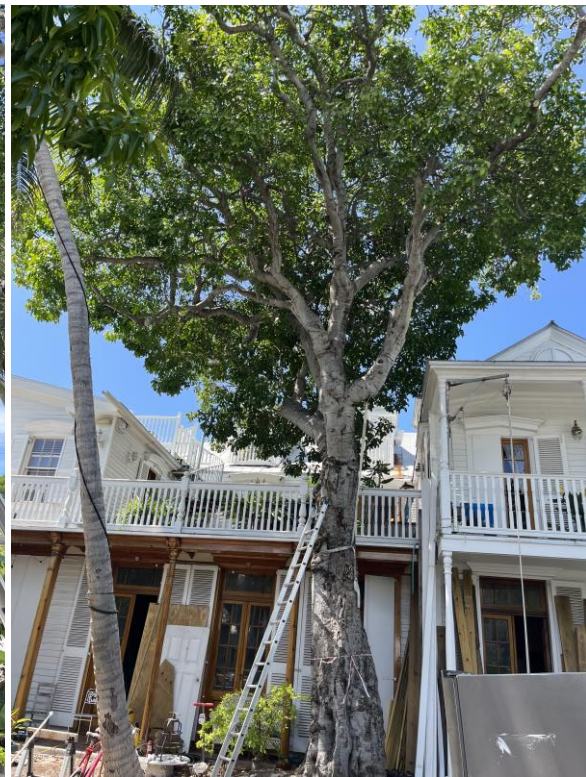
Tree No. 1: Spanish Lime (*Melicoccus bijugatus*) – 38" DBH. This tree is in **poor** condition. The tree has an actively failing major limb in the canopy that is recommended to be removed as soon as possible to mitigate risk. Overall, this tree has signs of prior wounding with some decay present. At the base of the crown of the tree, just below the limb juncture, a cavity with heartwood decay was observed. Signs of insects in the cavity were observed. This cavity with decay will likely affect the structural integrity of the tree crown. Cracks with flaking bark were observed at bends in three major limbs. The trunk of this tree is located within two feet of a building and less than a foot away from a walkway. The tree canopy covers a portion of the house and walkway. The tree appears to have been reduced by approximately fifty percent over the past five years. Further reduction of the canopy of this tree may affect the viability of the tree with minimal risk reduction. Further reduction pruning is not recommended at this time. Due to the tree's health and location, this tree is candidate for **removal**.

Overall view of the tree

The Spanish Lime is in poor condition due to decay, cracks in the canopy, and cavities with insect signs. Due to the tree's health and location, this tree is recommended for removal.
