November 16, 2023

Re: Martin Luther King Pool-Structural Shoring Inspection 11/16/2023
304 Catherine Street

On November 16, 2023 we conducted a follow-up monthly re-inspection of the concrete shoring system and the spalling concrete. The purpose of the inspection was to inspect the shoring, ensure that the shoring is secure and snug to the wood blocking, and to continue monitoring the spalling concrete.

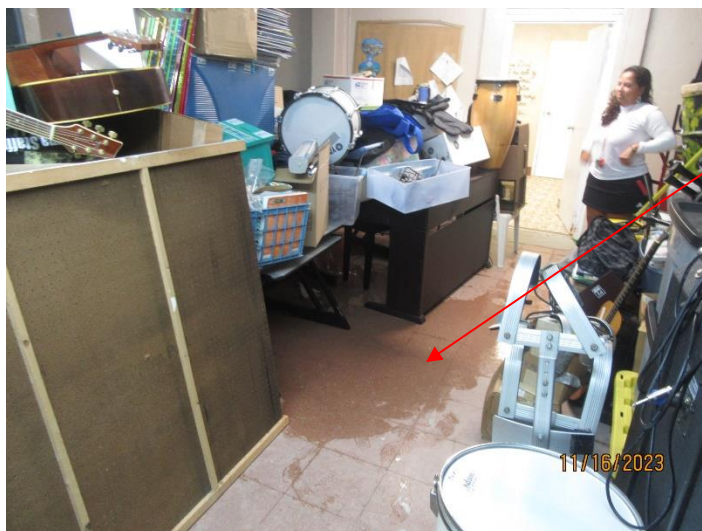
As noted in the prior inspection on 10/19/2023, the music room was again flooded due to heave rains the day before.

Flooded music equipment room.

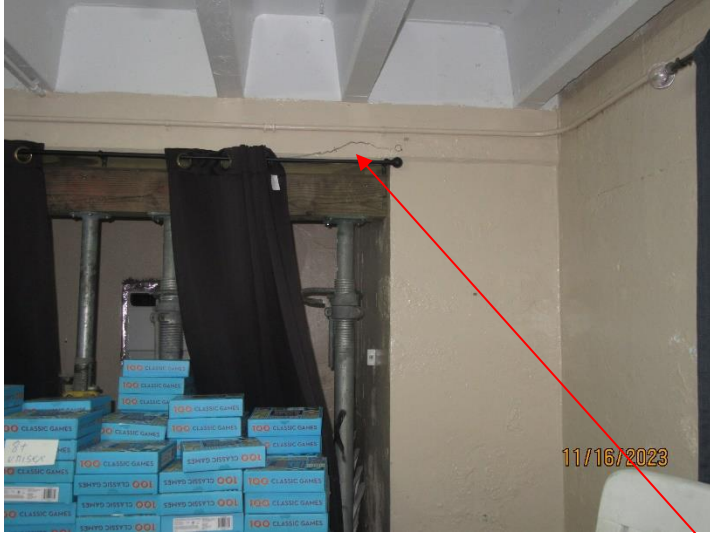
Music Room

Location of music room beam crack. Crack width no change from last inspection at 0.185"

Pole shores were snug and no adjustment was needed.

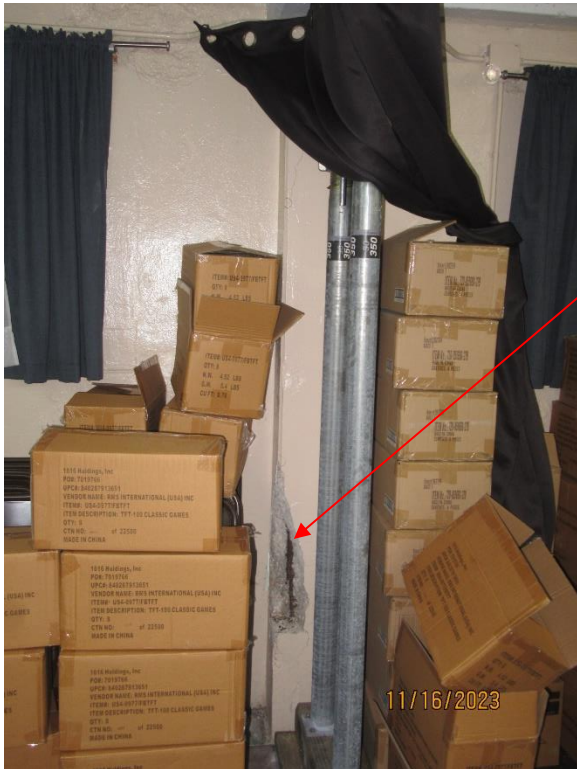
Music Equipment Room Header

The initial crack measurement on 9/28/2023 was 0.25".

During the 11/16/2023 inspection the crack measurement was slightly wider at 0.255"

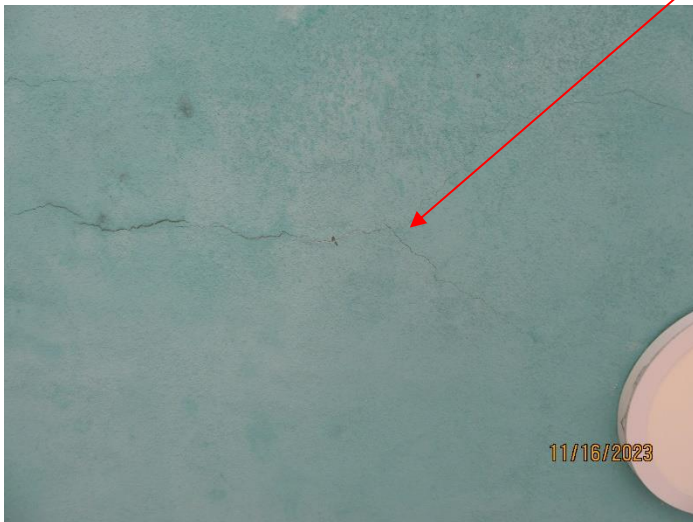
Front Entrance Roof

Concrete is beginning to delaminate from underneath the exterior front entrance roof slab.

The crack width was measured at 0.06"

This area of delaminating spalling concrete appears to be a progressing new development and should be repaired as soon as possible, or access restricted.

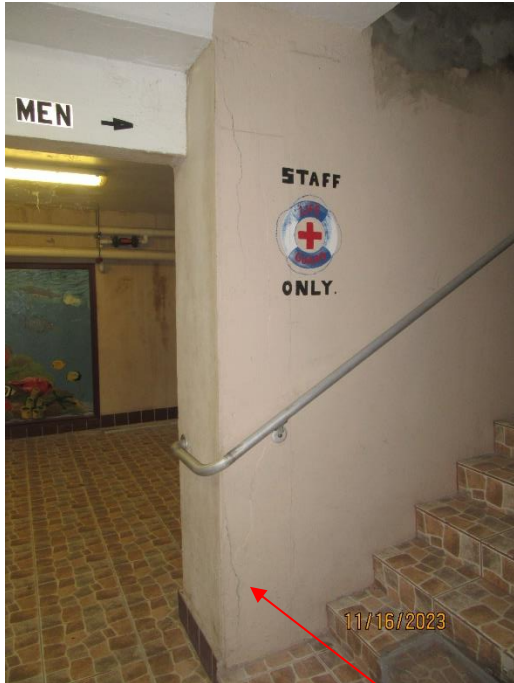
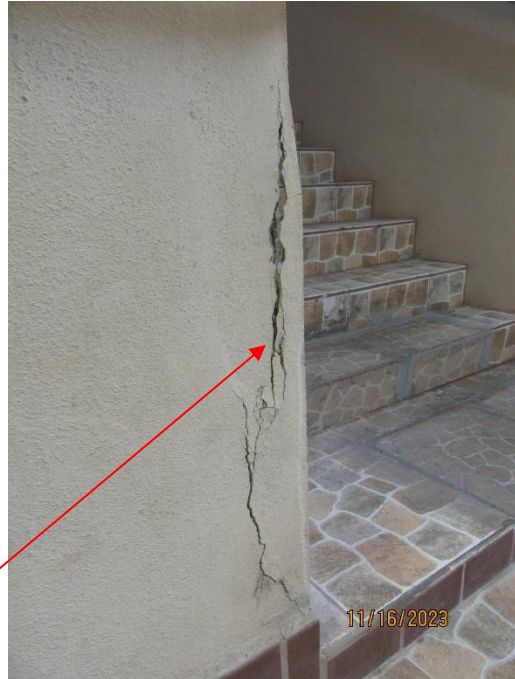
Spalling concrete at front of stairway is literally about to fall off the wall and should be removed immediately.

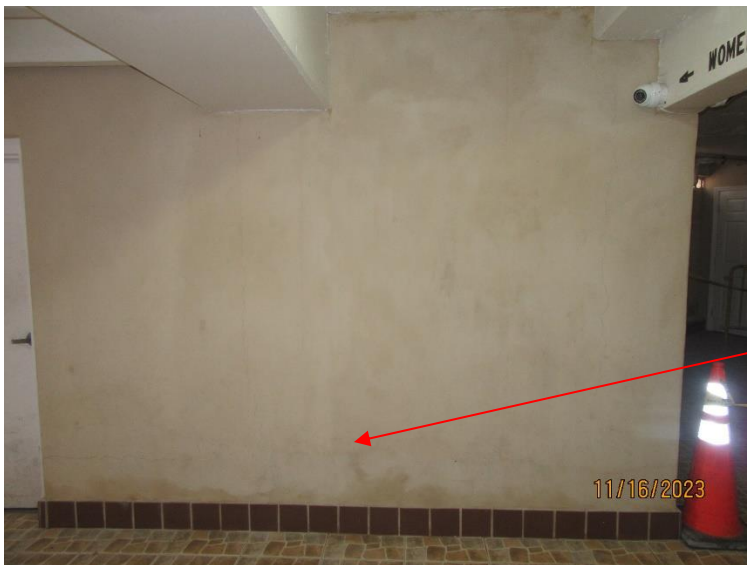
Left side wall at pool entrance. Spalling concrete is delaminating from the wall.

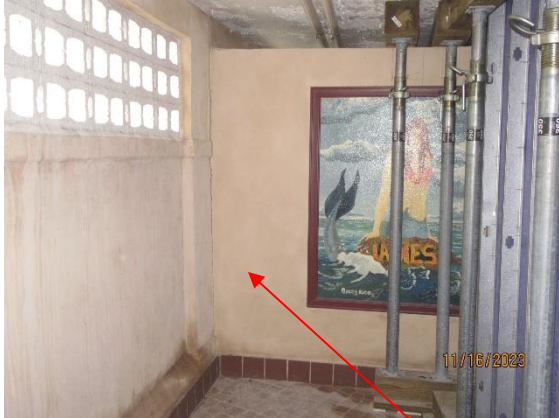
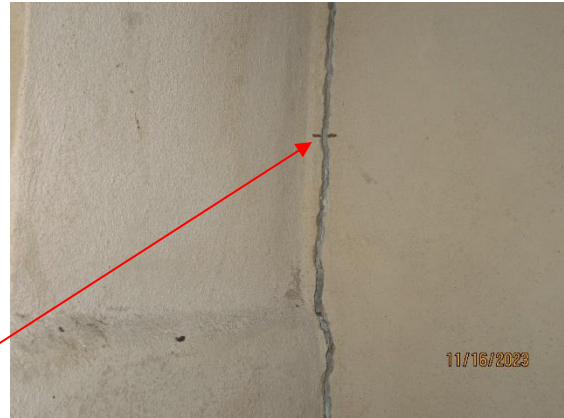
Concrete block wall in large enclosure at entrance to Men's room that butts up to exterior wall. An initial measurement of the crack was made this inspection which was 0.27". Slight adjustment needed for pole shores in this room.

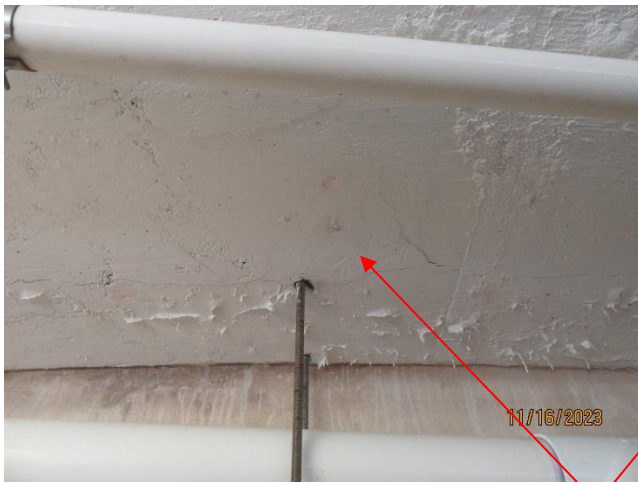
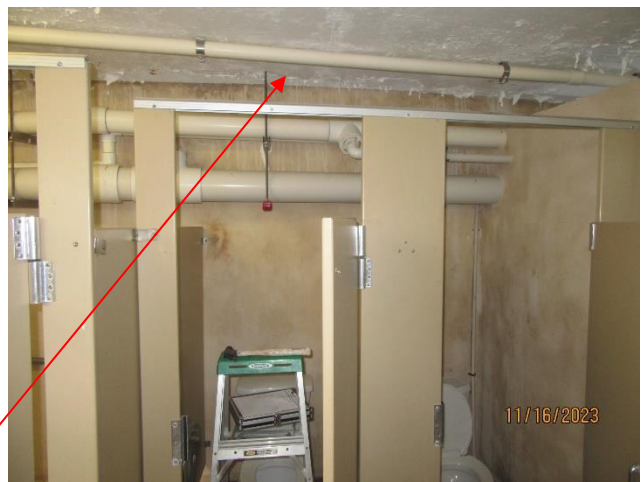
Ceiling above Women's room water closet stalls

A new development is the delamination of spalling concrete above the Women's room water closet stalls and shower area. This area should be repaired immediately or access restricted. The dressing area is currently access restricted.

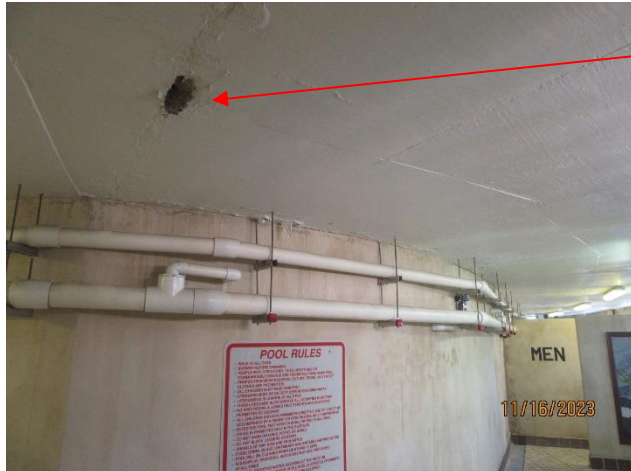
Men's Room Entrance Ceiling

Spalling concrete at entrance to men's room is progressing. Loose concrete was removed during the inspection. **This area should be repaired immediately or access restricted.**

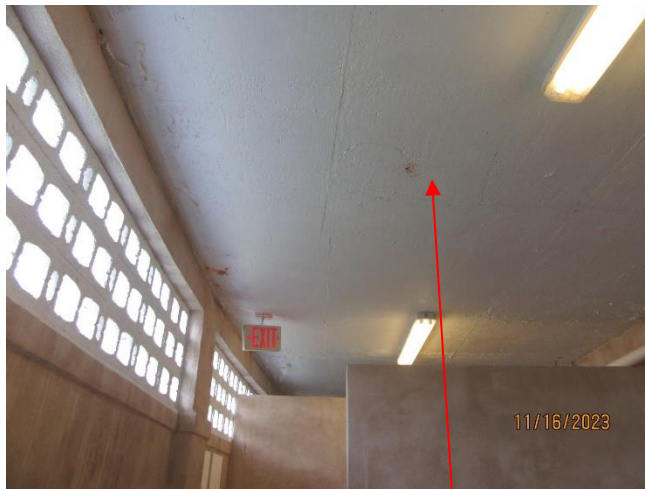
Men's Dressing Room Ceiling

Spalling concrete is delaminating from the ceiling in the Men's dressing room. This area should be repaired immediately or access restricted. The area above the water closets and showers does not exhibit delaminating concrete at this time.

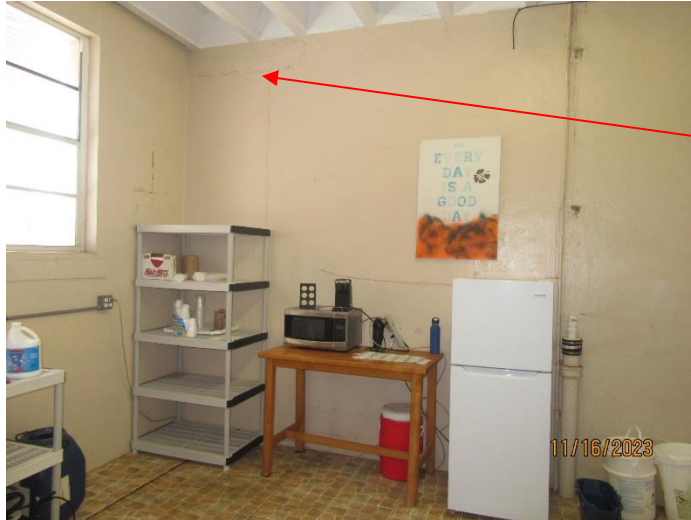
Life Guard Room

Spalling concrete delaminating from wall in Life Guard room. **This area should be repaired immediately or access restricted.**

Structural hazards that continue to develop include the ongoing spalling and delamination of loose concrete throughout the building that will fall off walls and ceilings that could injure someone. As noted above, the loose concrete in the Lifeguard room should be removed immediately and the area beneath should be cordoned off to prevent access.

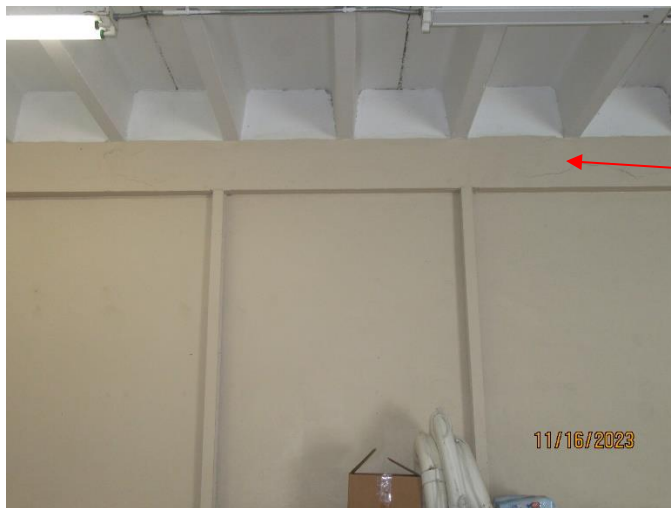
Life Guard Room

Crack on back wall tie beam of life guard room is progressing.
