# STAFF REPORT

RE: **3338 N. Roosevelt Blvd (permit application # T2019-0017)**

FROM: Karen DeMaria, City of Key West Urban Forestry Manager

An application was received requesting the removal of **(2) Gumbo Limbos (tree# 5 & 6)** and **(2) Sea Grape trees (tree# 7 & 9)** that are being impacted by the redevelopment of the Regal Cinema Movie Theater which was heavily damaged by Hurricane Irma. A site inspection was done and documented the following:

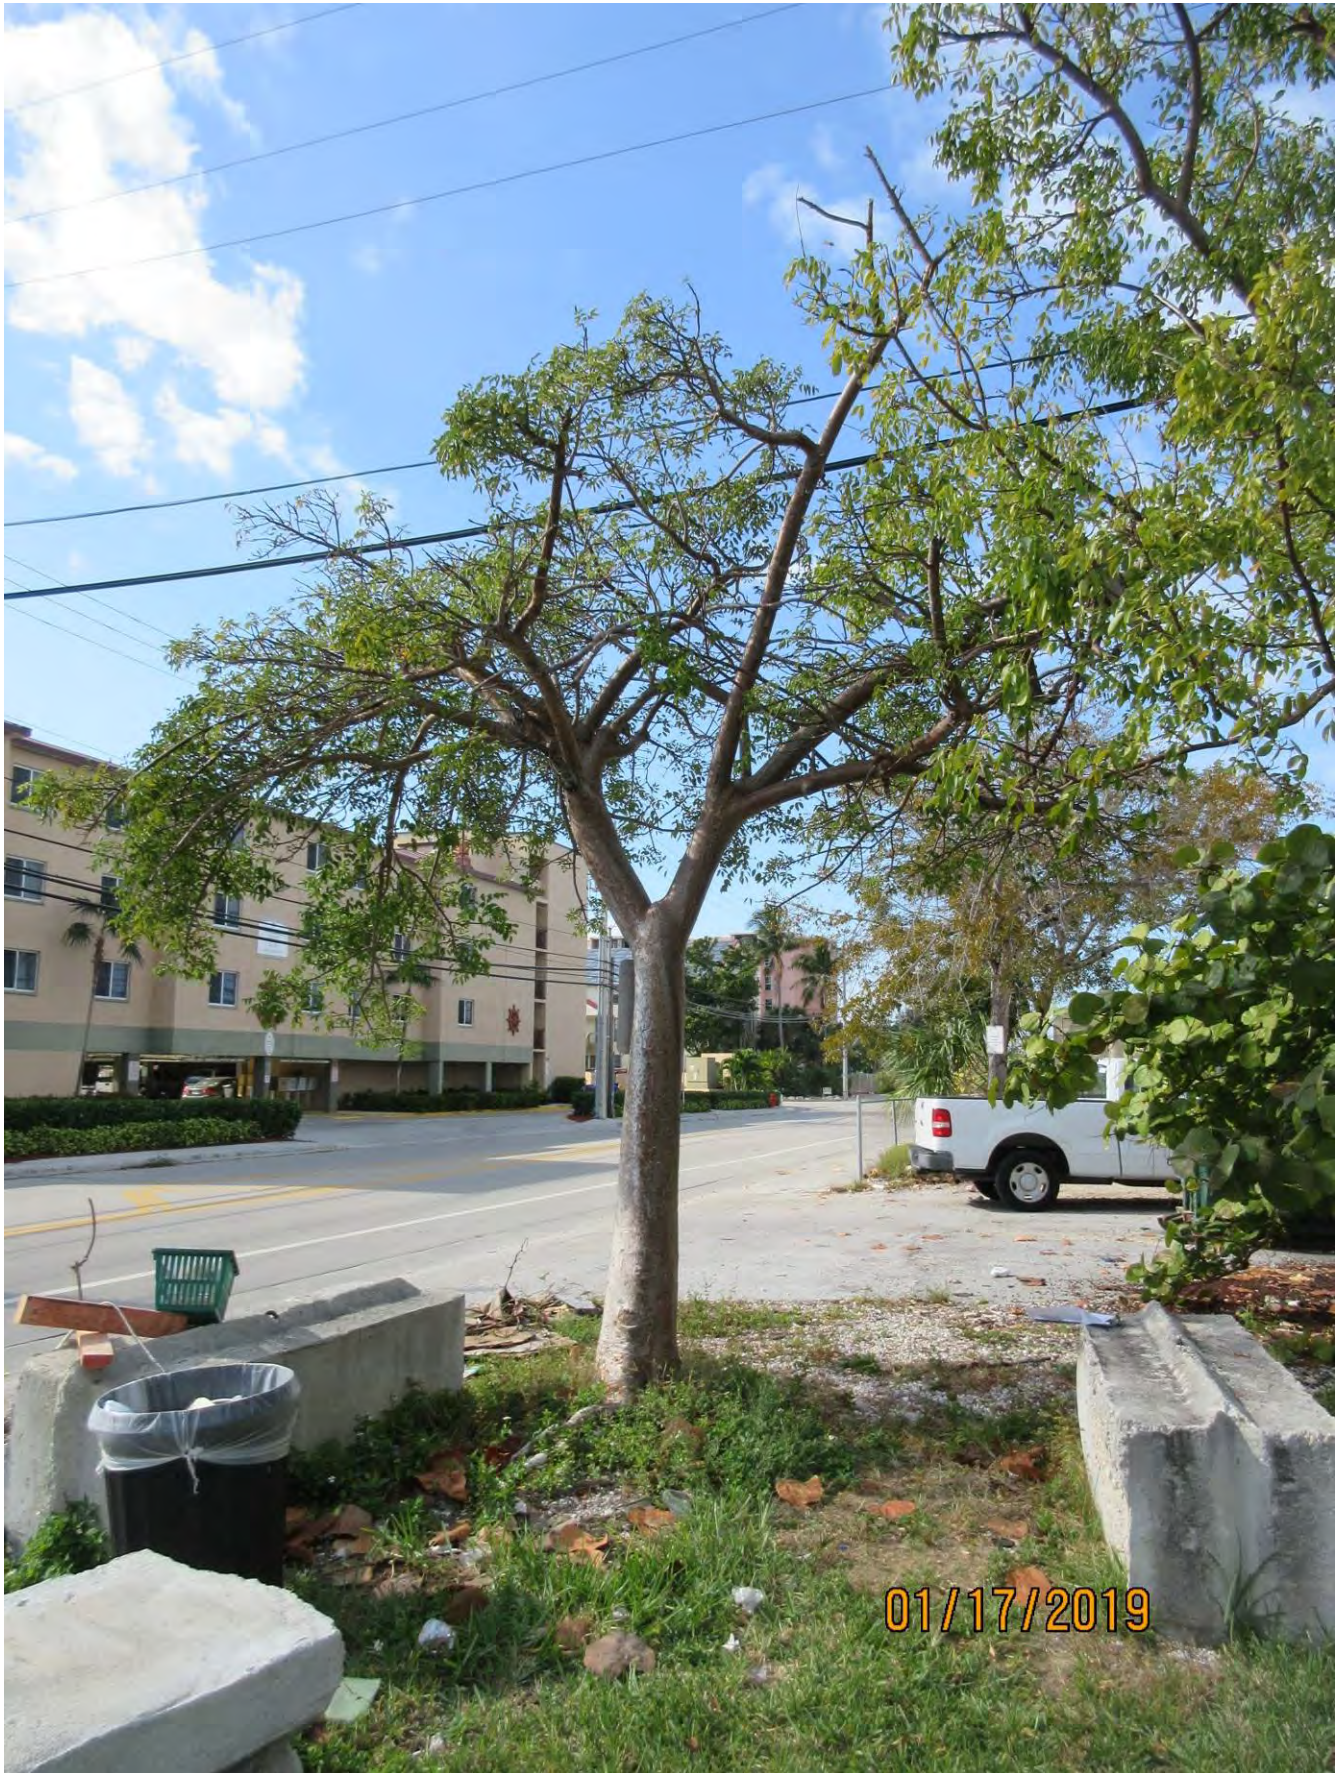
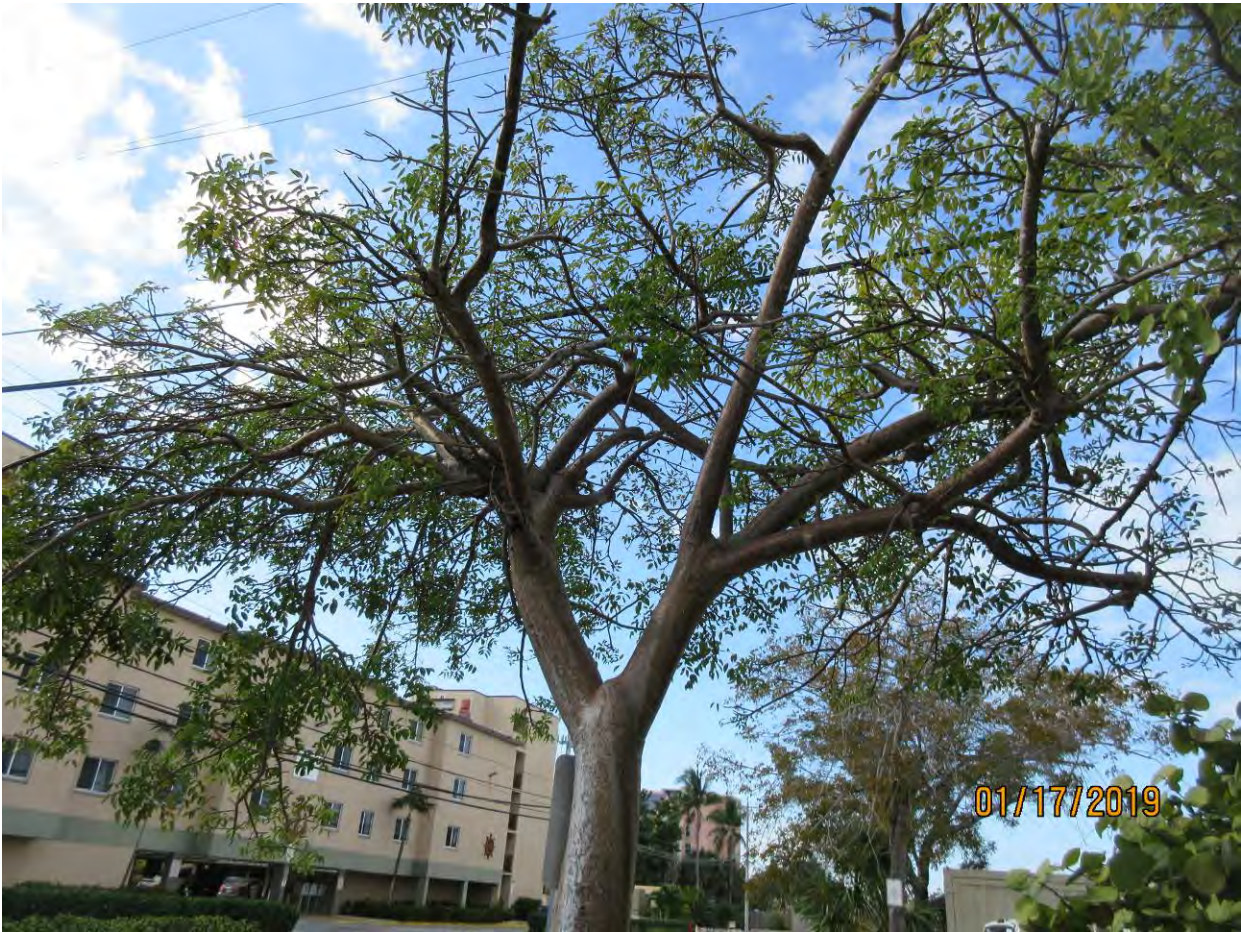
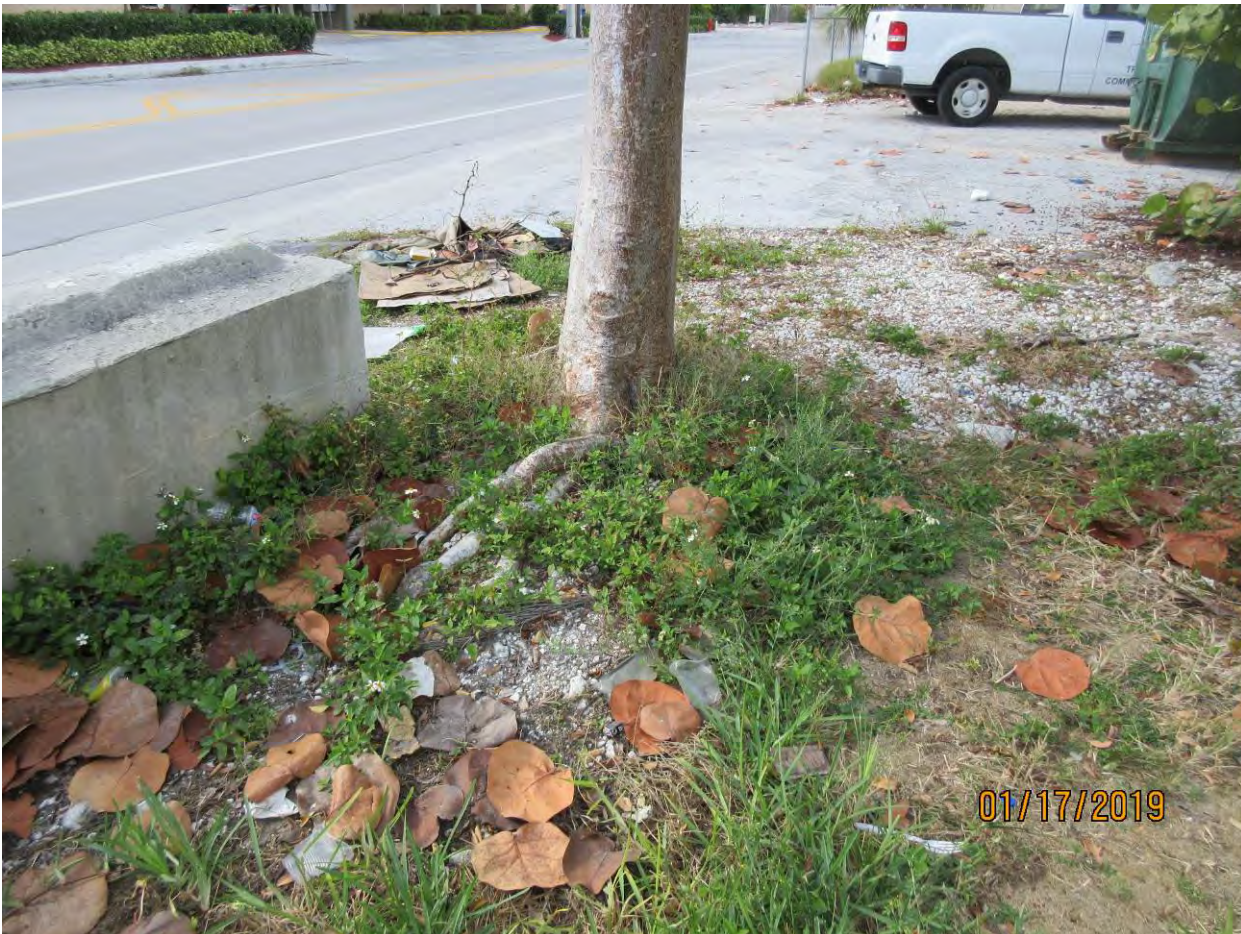
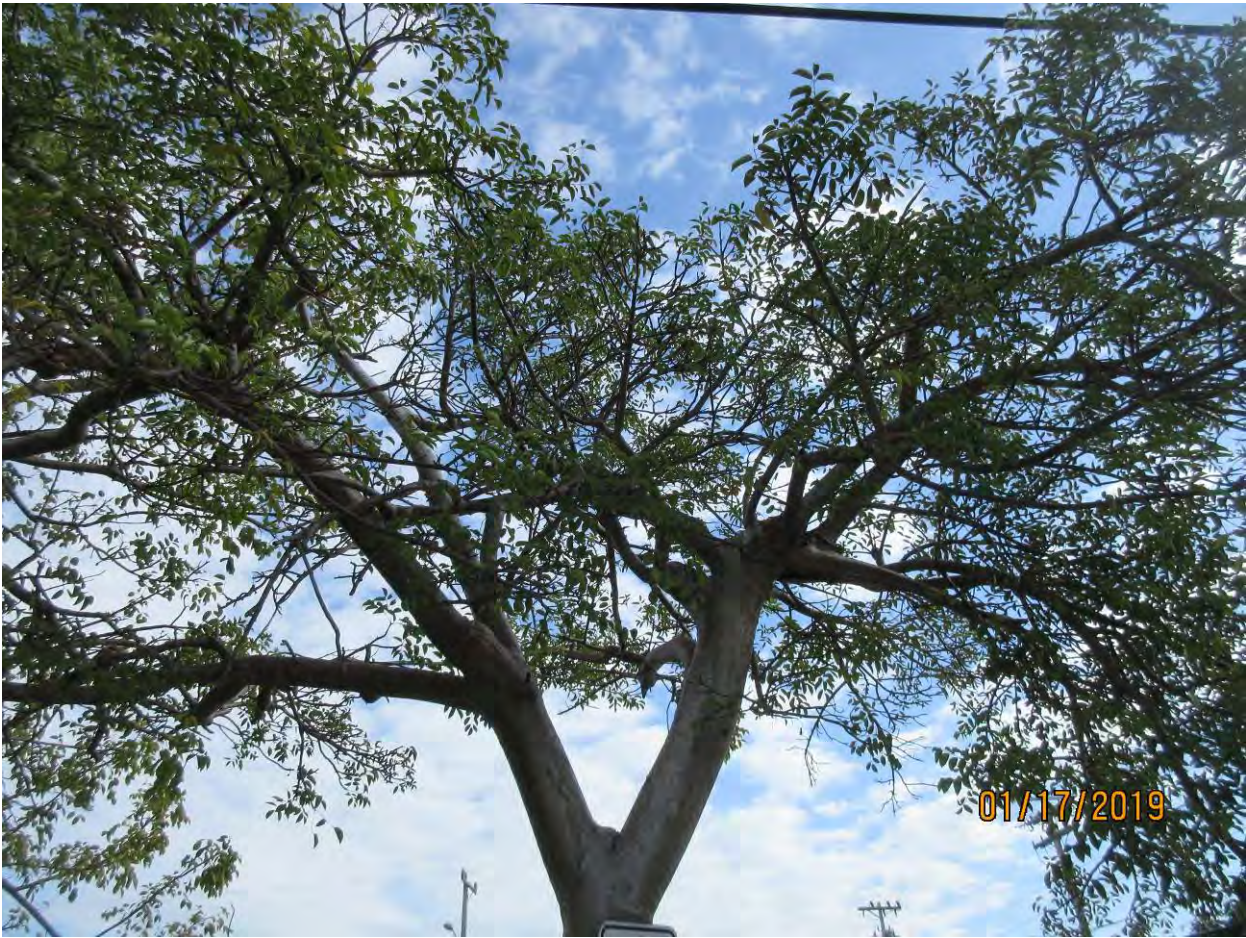
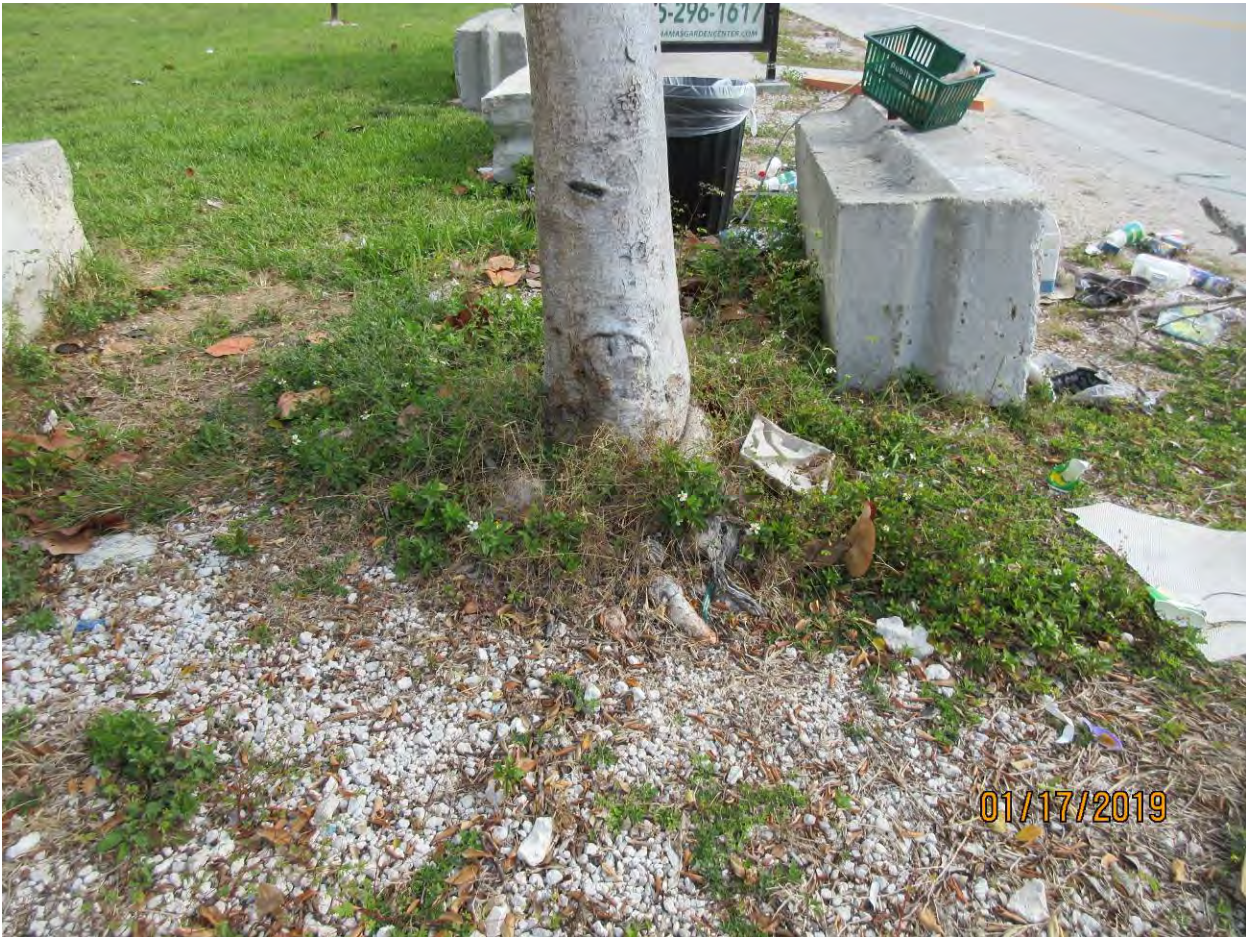
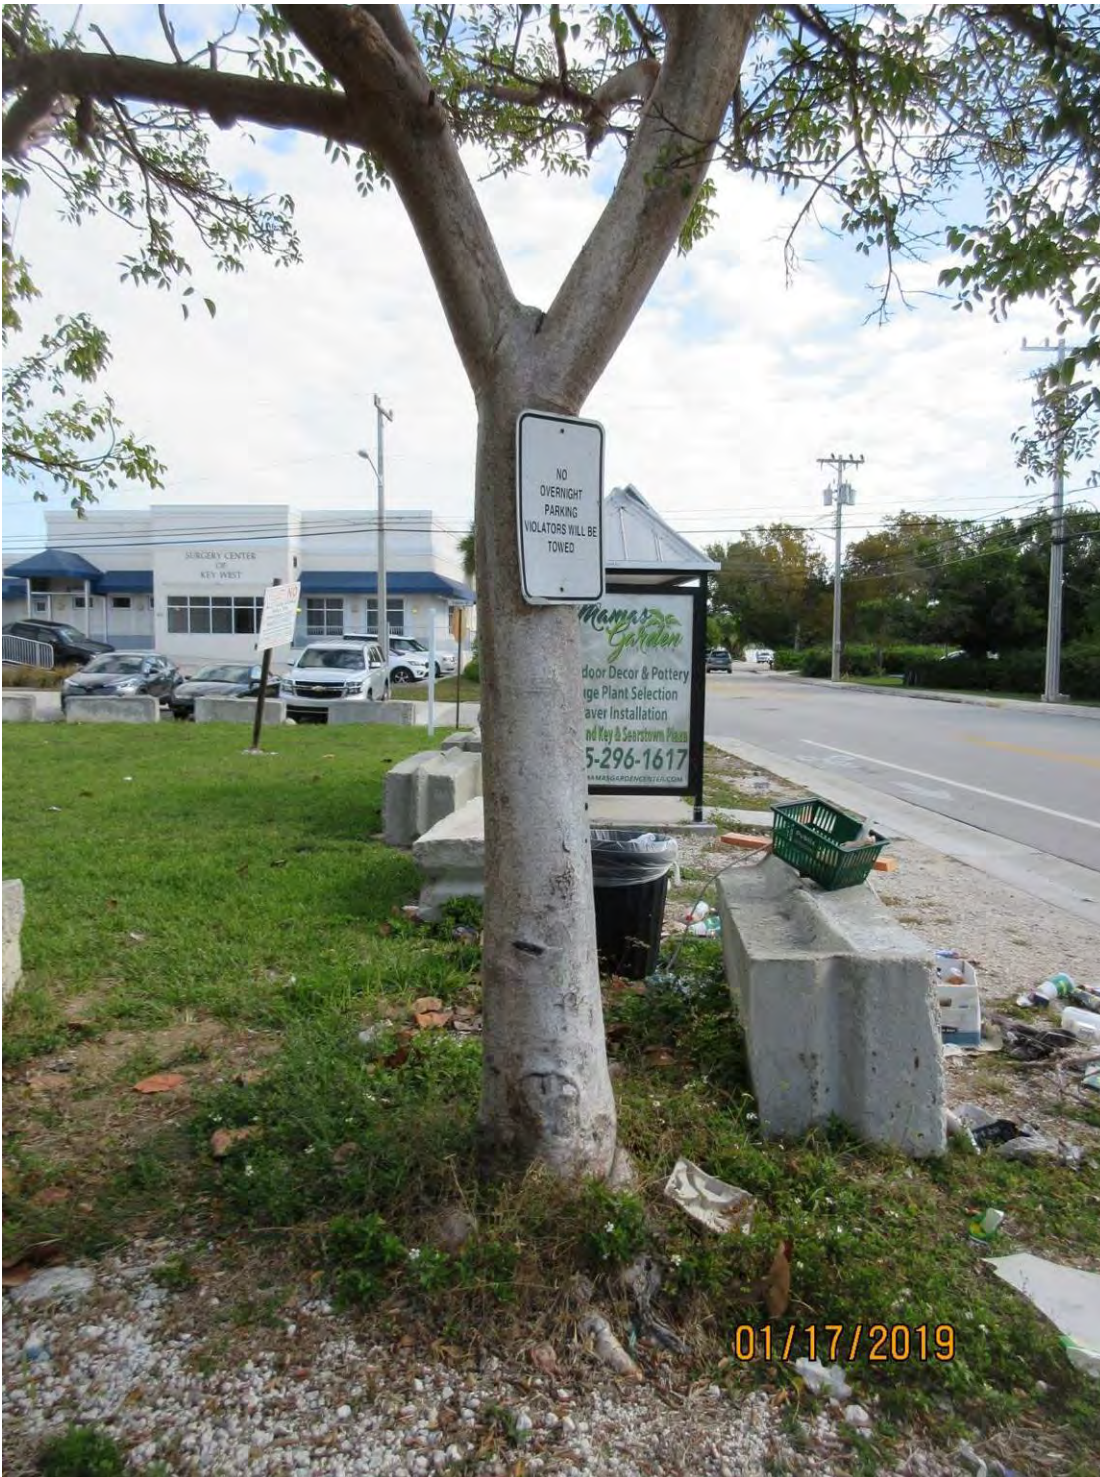
**Tree#5:**

Diameter: 10.5"

Location: 60% (tree planted under utility lines)

Species: 100% (on protected tree list)

Condition: 70% (fair to good)

Total Average Value = 76%

**Value x Diameter = 7.9 replacement caliper inches**

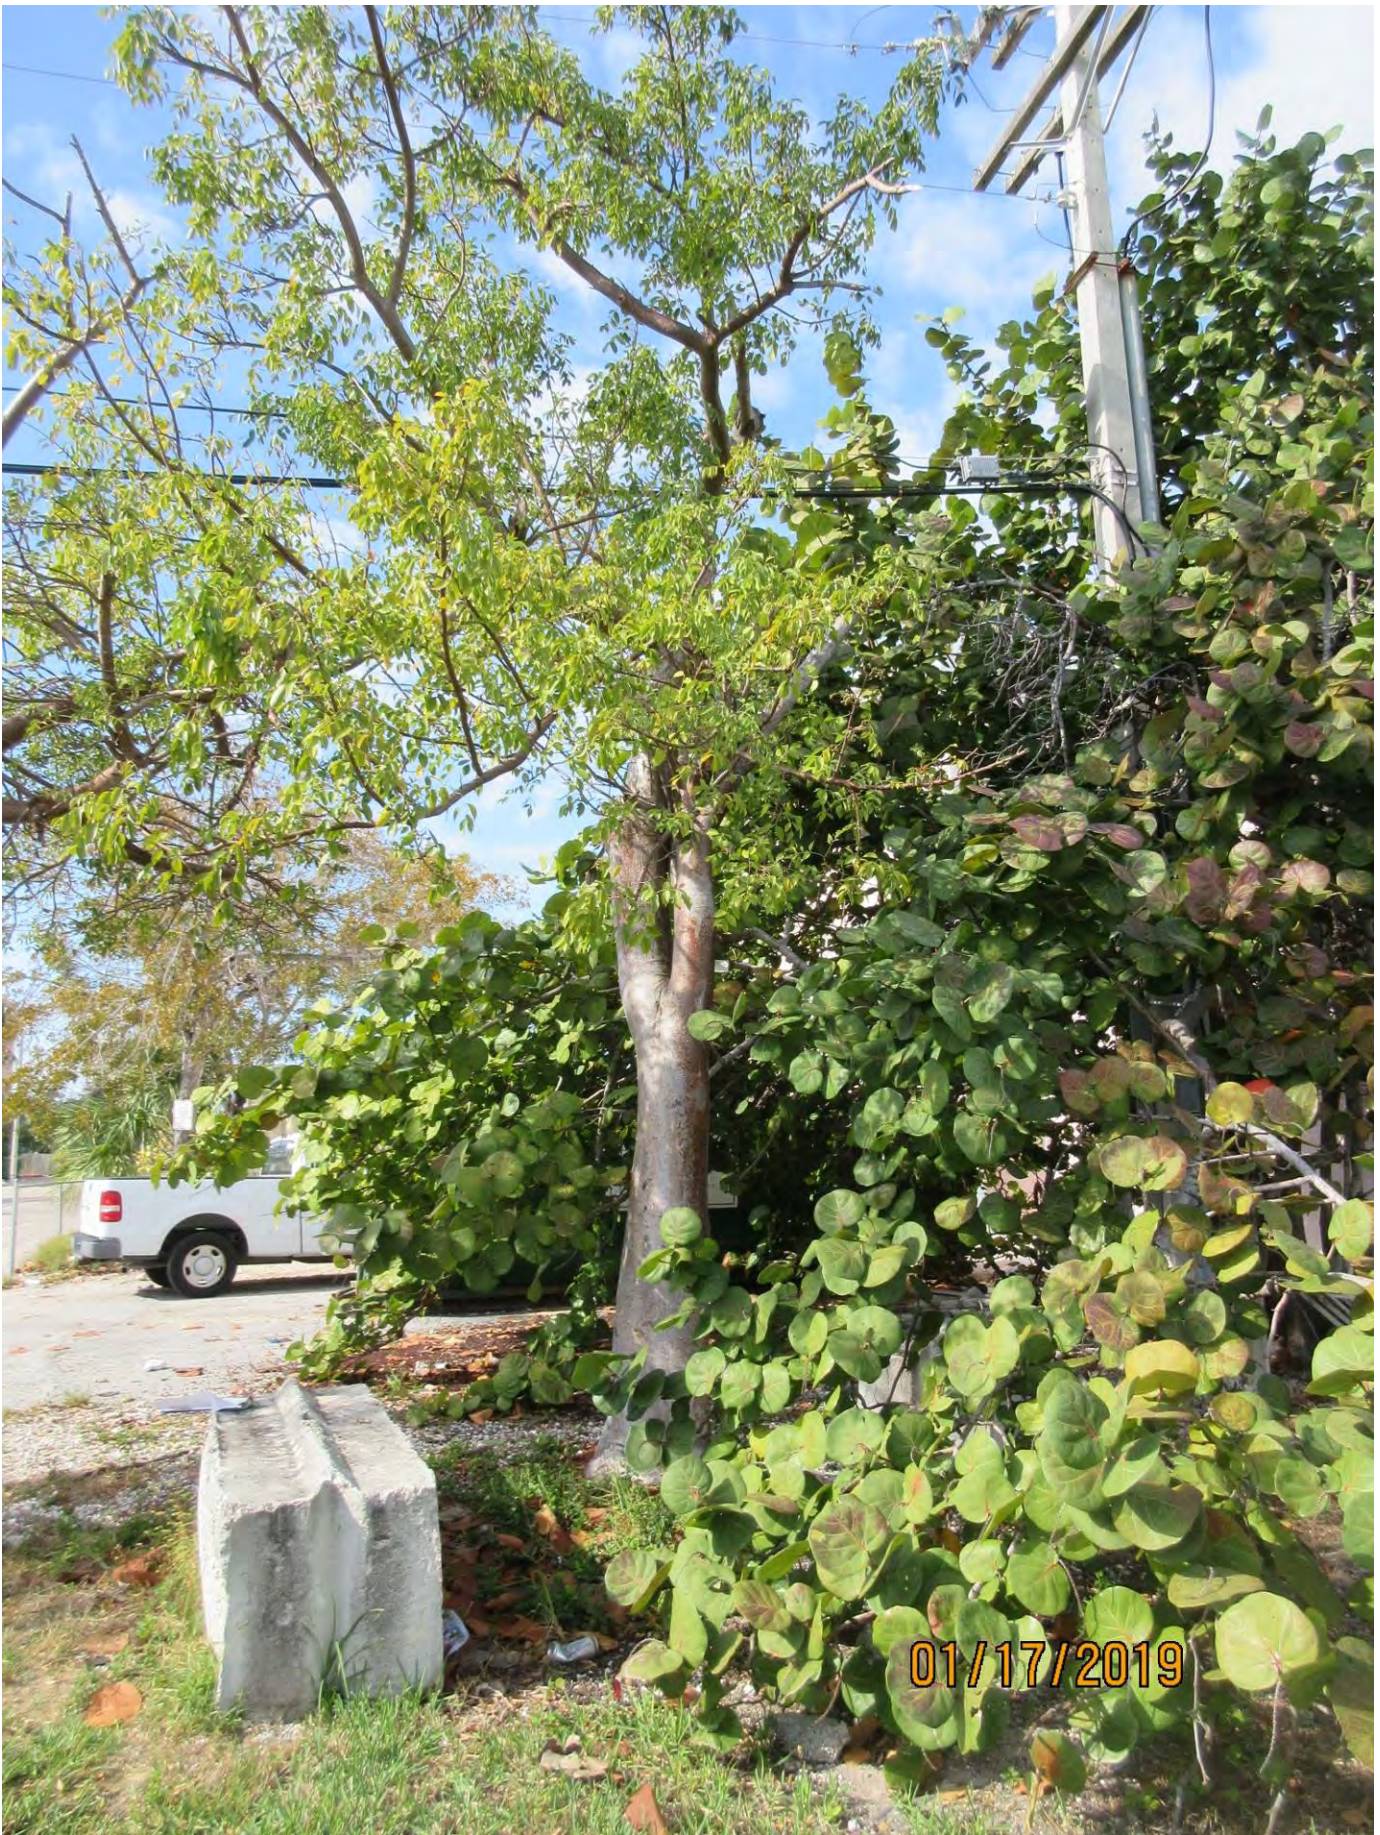
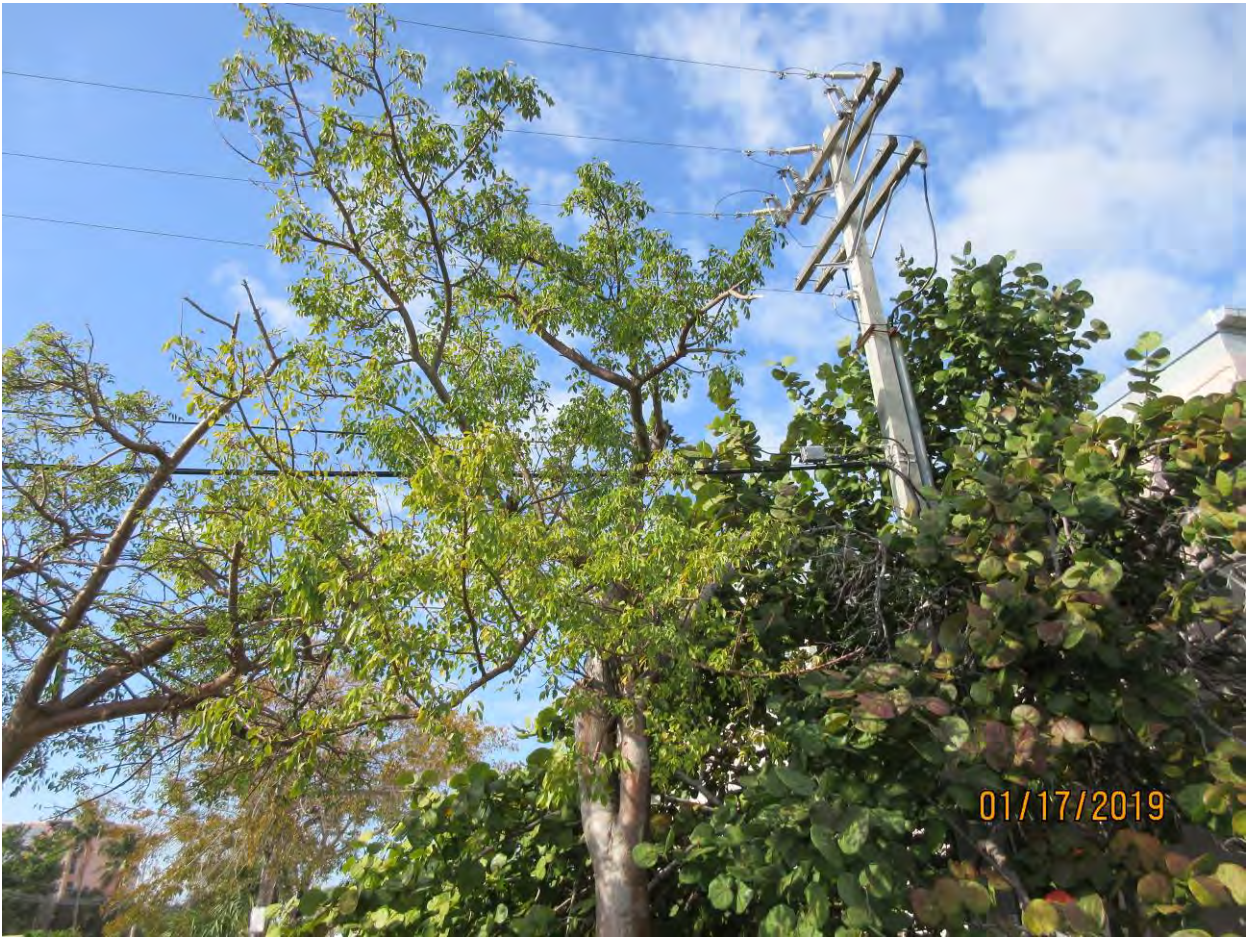
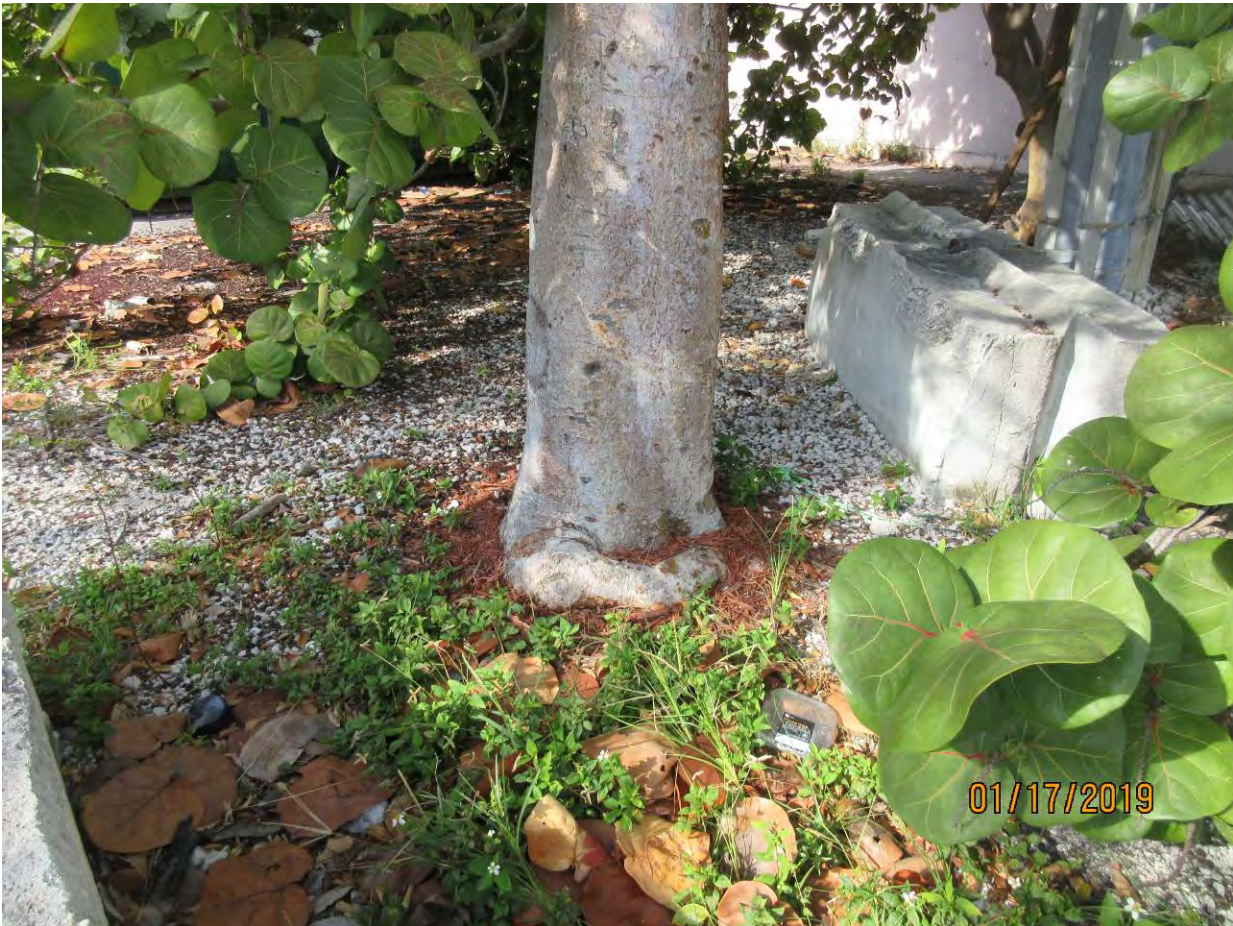
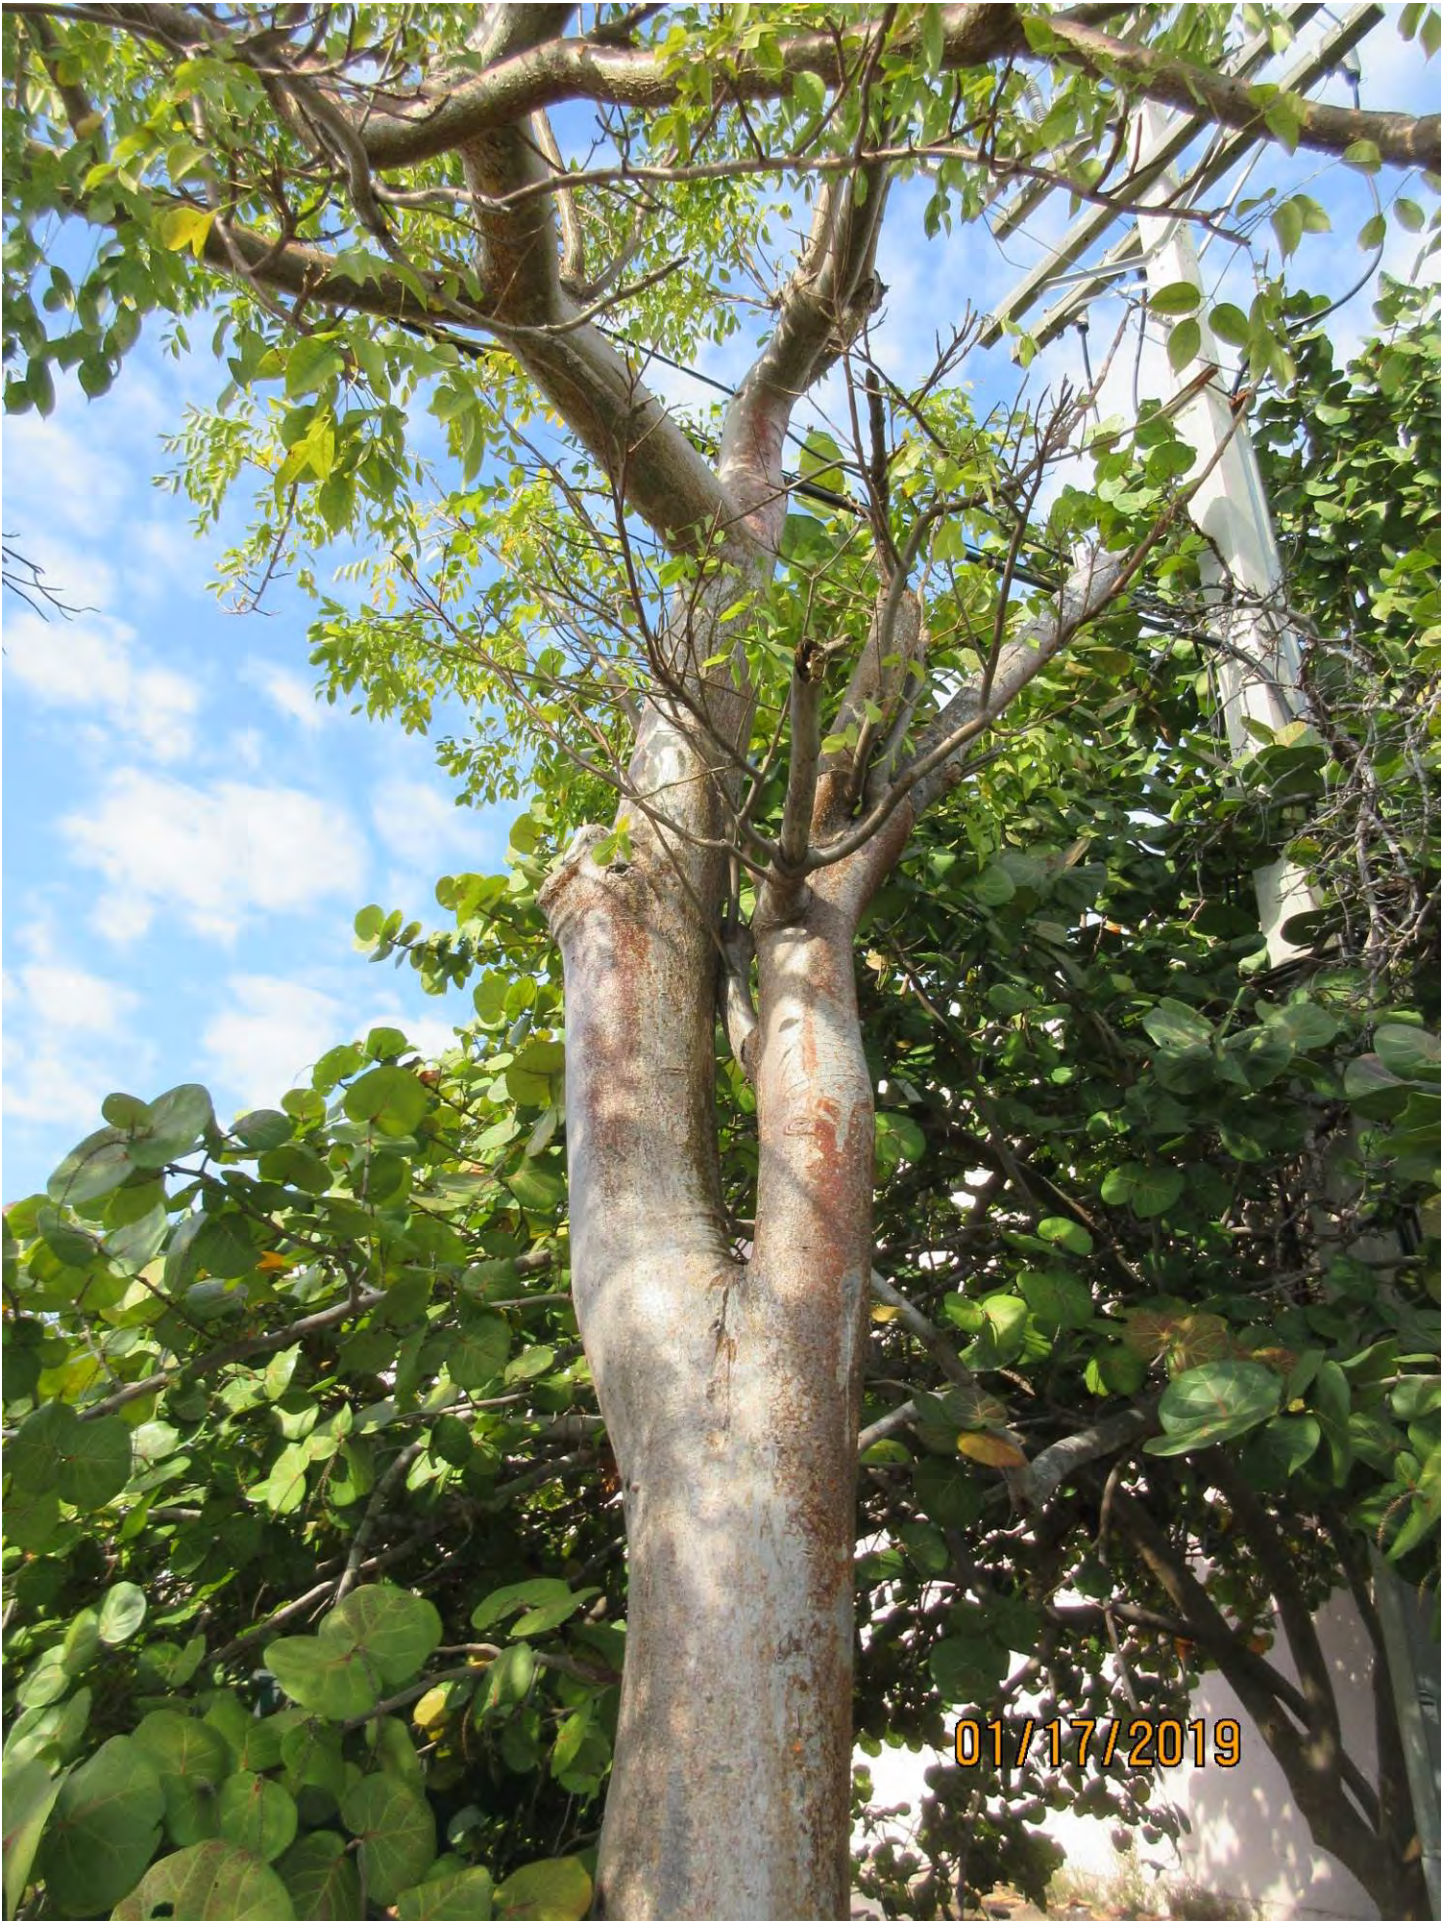
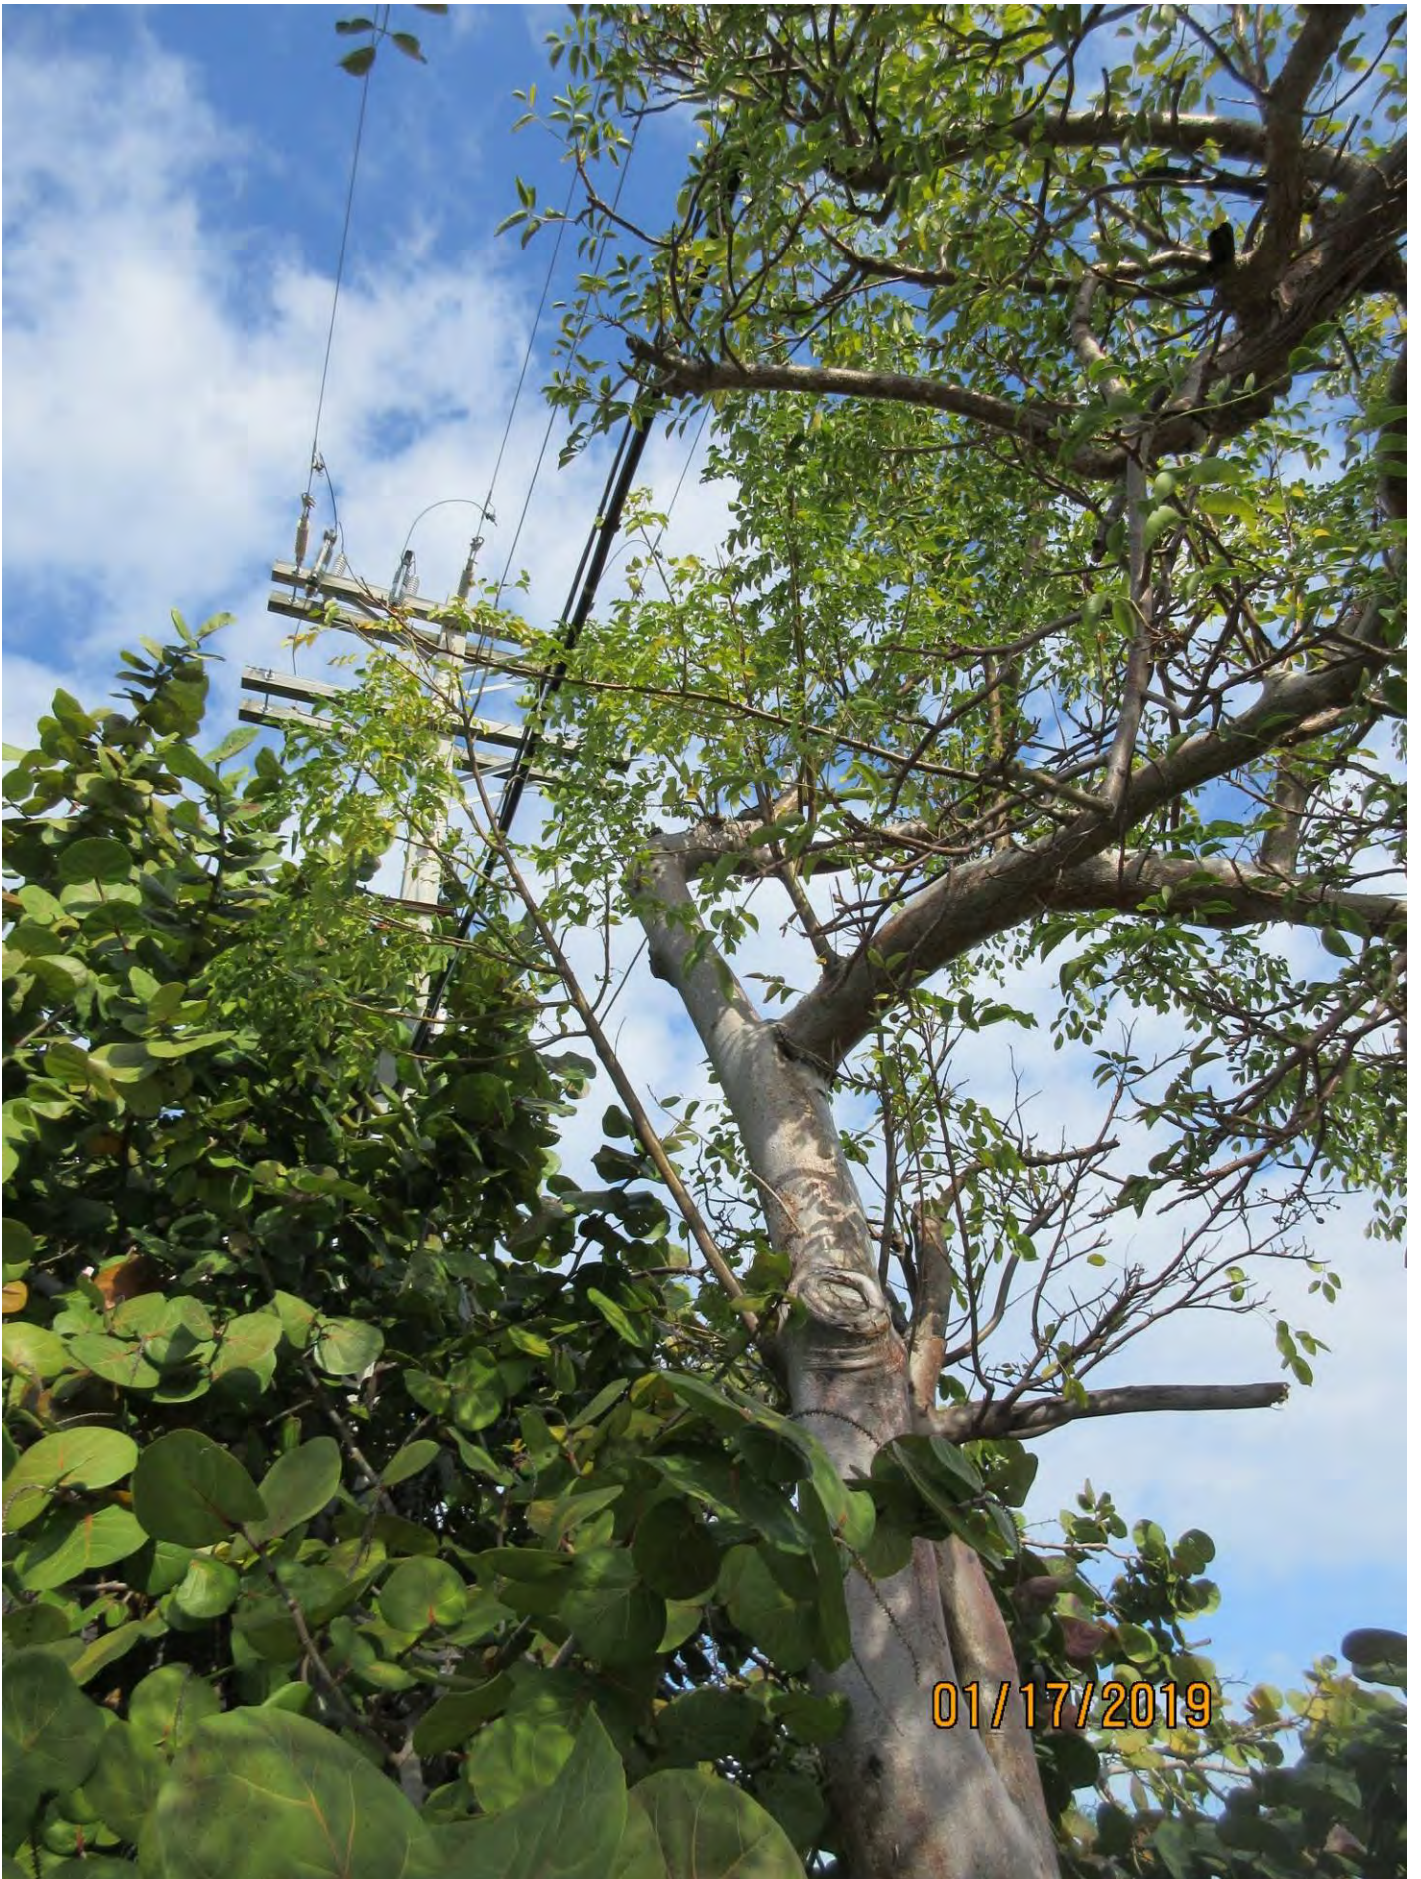
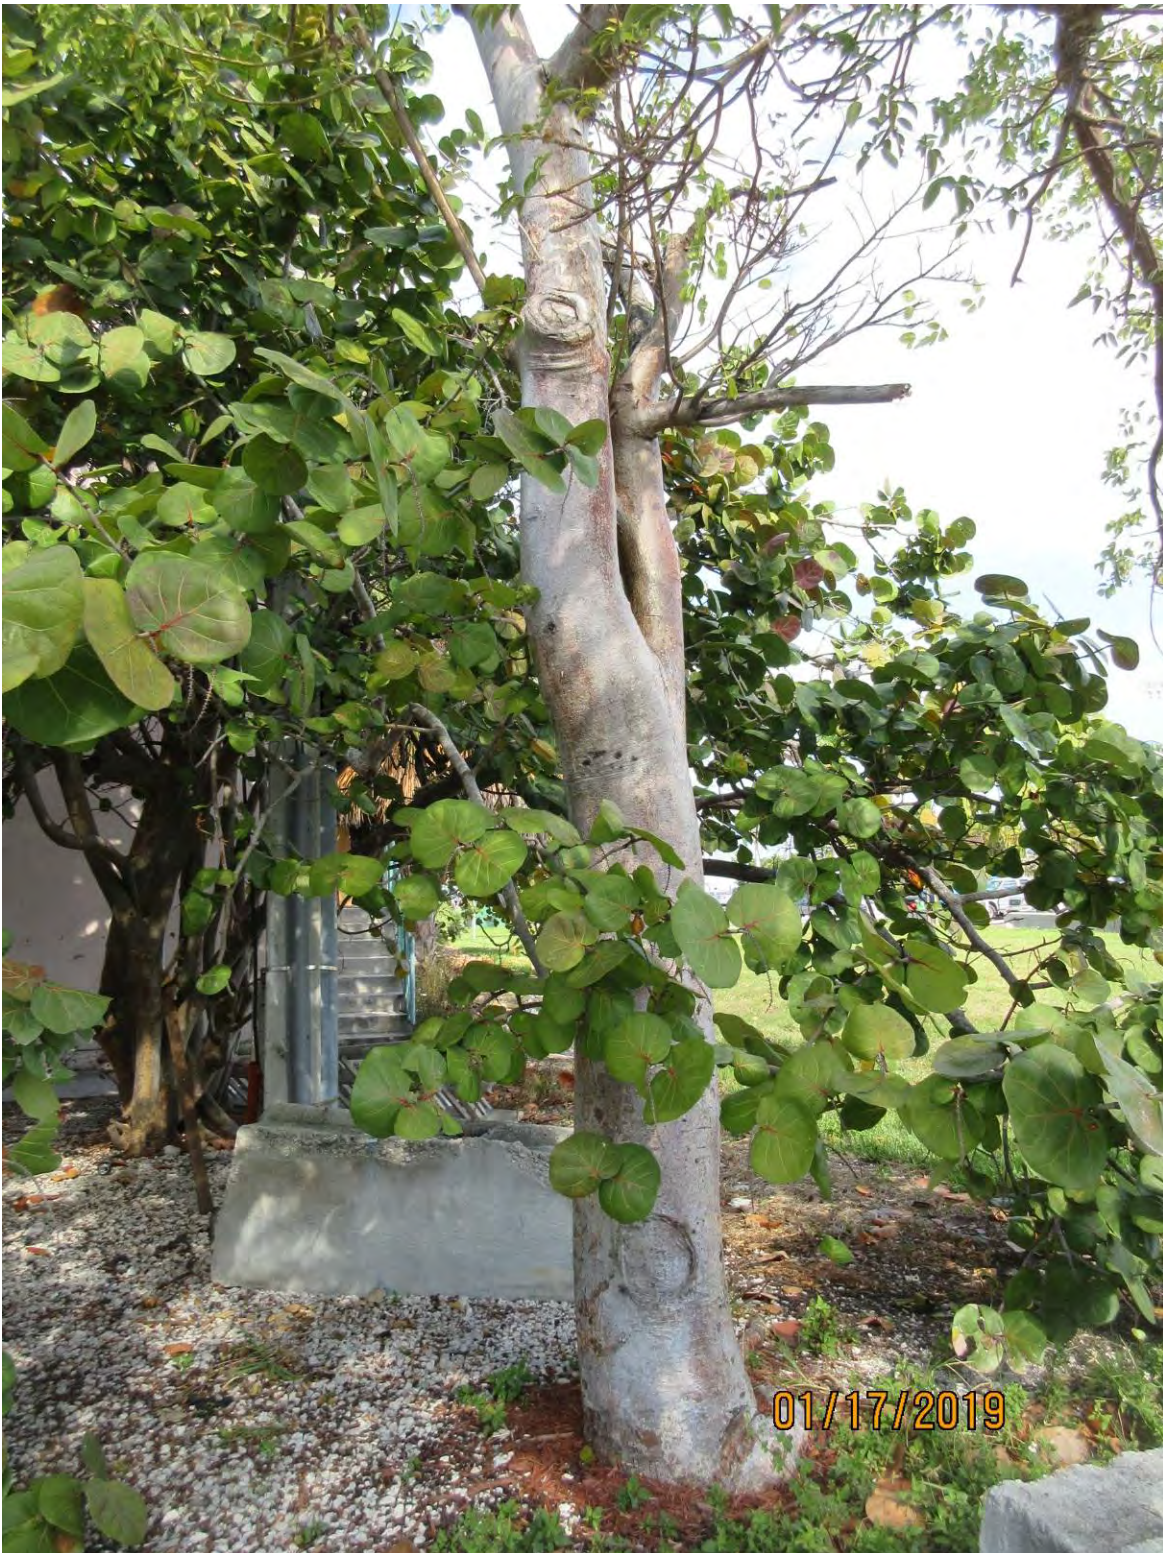
Tree# 6:

Diameter: 14.9" (multi trunked)

Location: 60% (planted under utility lines)

Species: 100% (on protected tree list)

Condition: 50% (fair to poor, poor structure, decay in canopy)

Total Average Value = 70%

**Value x Diameter = 10.4 replacement caliper inches**
