# STAFF REPORT

RE: **3338 N. Roosevelt Blvd (permit application # T2019-0017)**

FROM: Karen DeMaria, City of Key West Urban Forestry Manager

An application was received requesting the removal of **(2) Gumbo Limbos (tree# 5 & 6)** and **(2) Sea Grape trees (tree# 7 & 9)** that are being impacted by the redevelopment of the Regal Cinema Movie Theater which was heavily damaged by Hurricane Irma. A site inspection was done and documented the following:

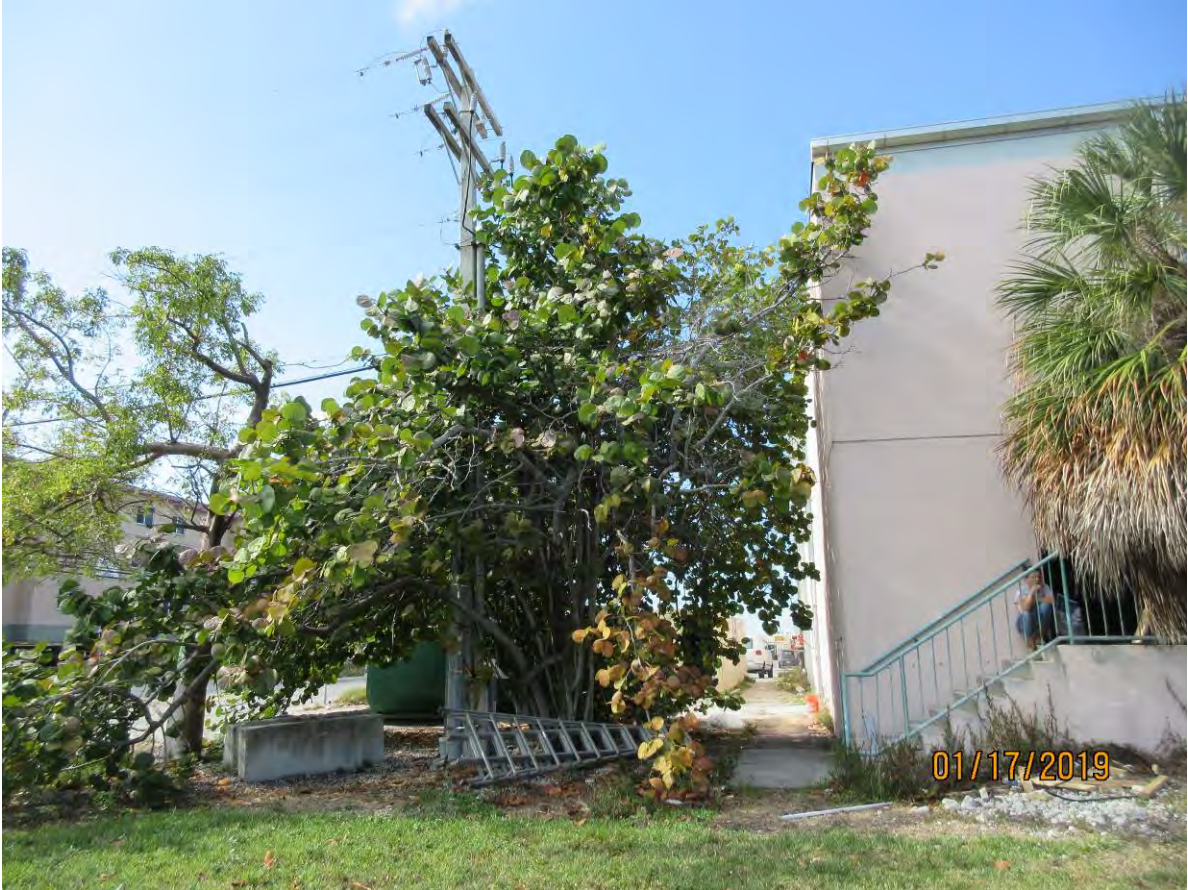
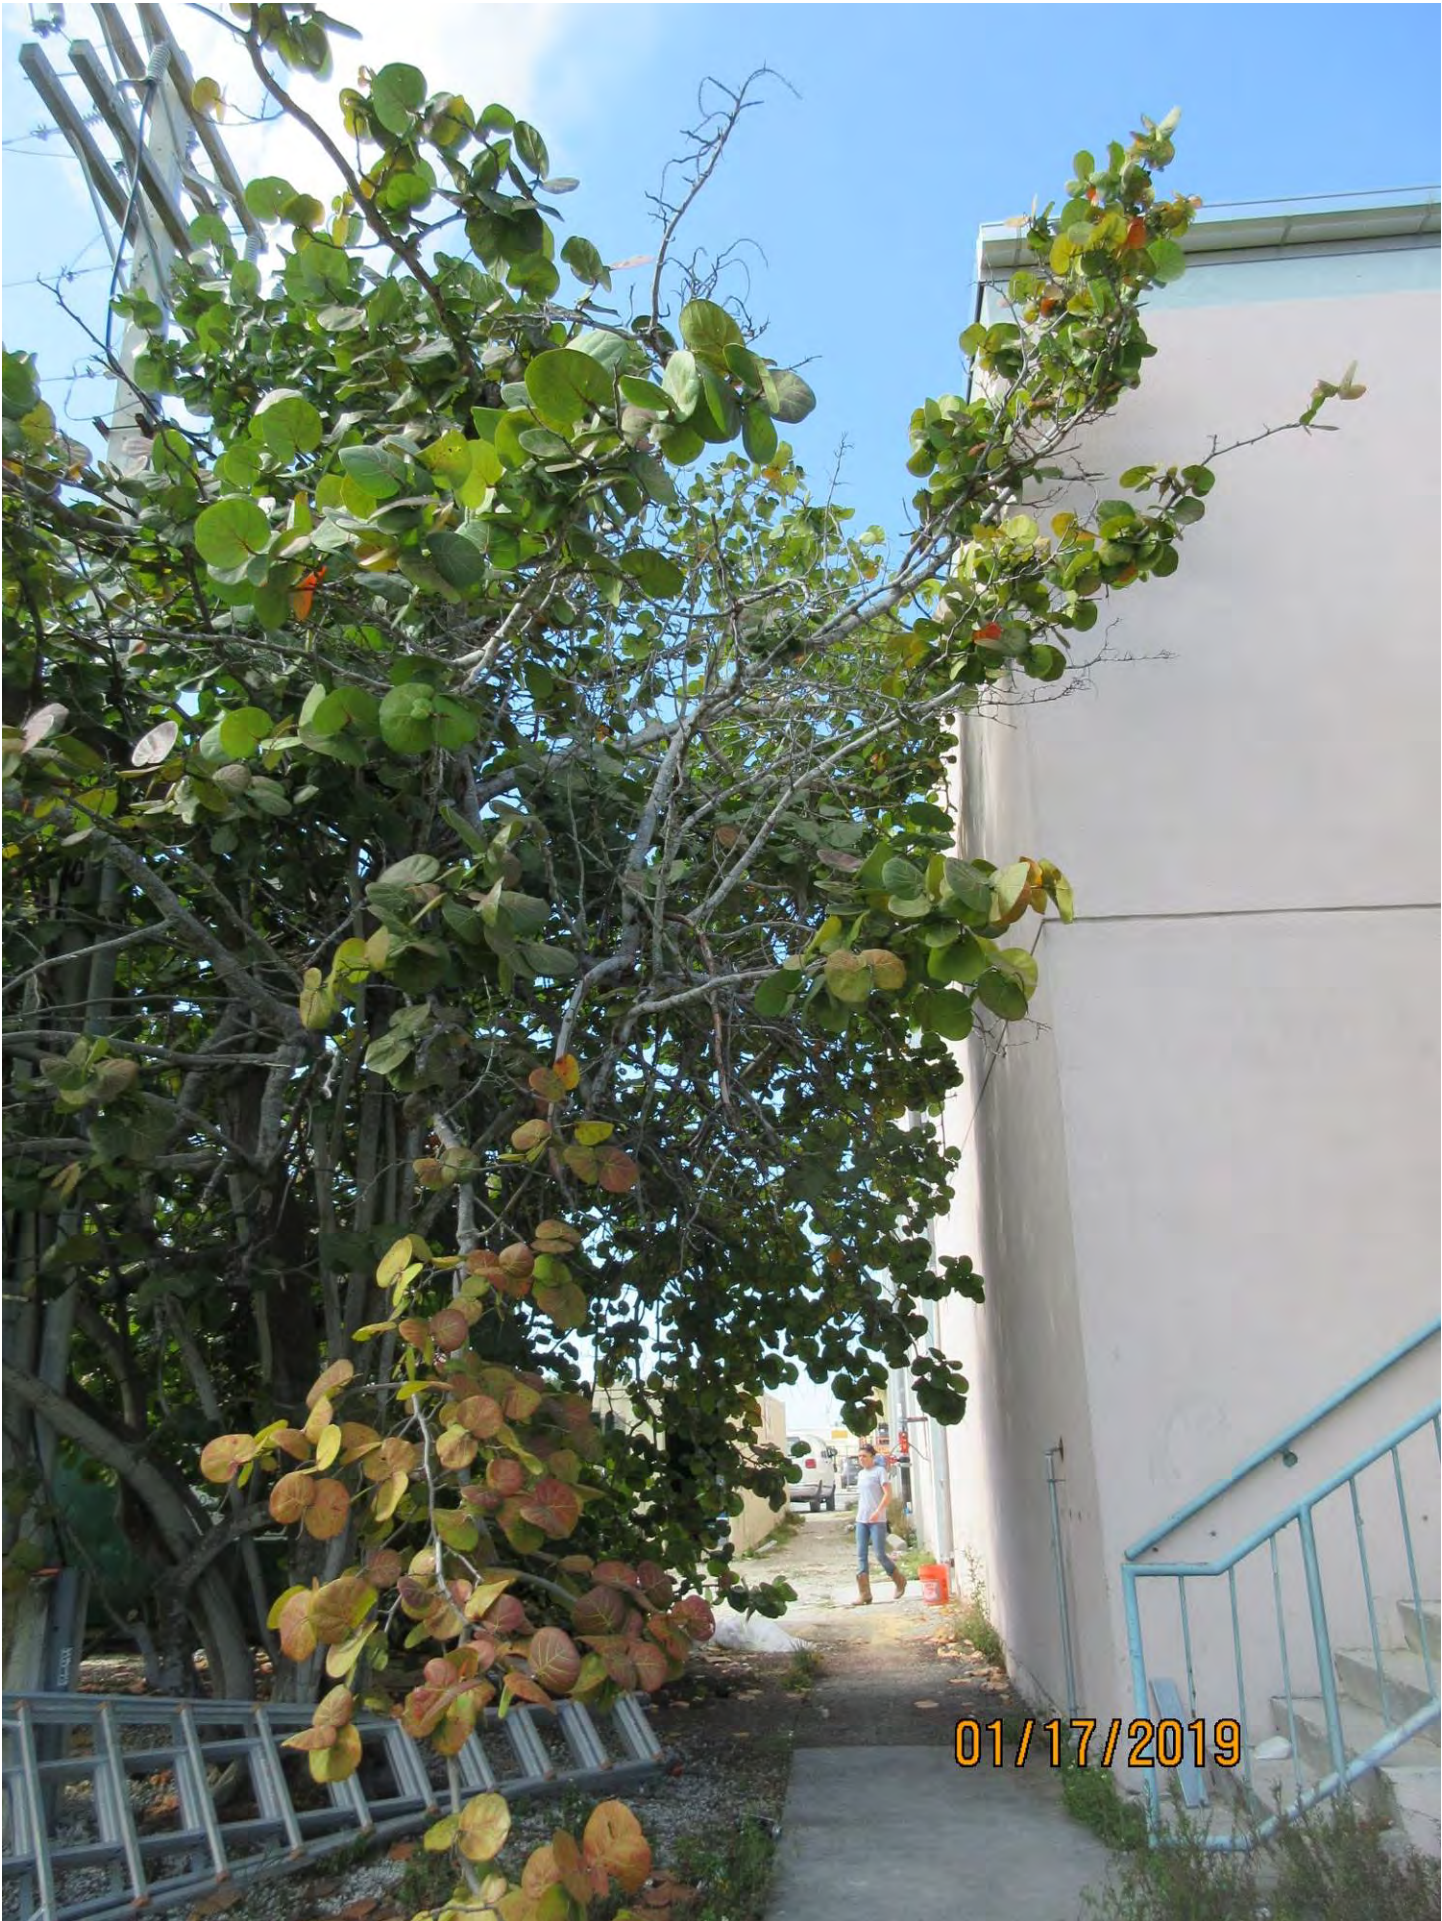
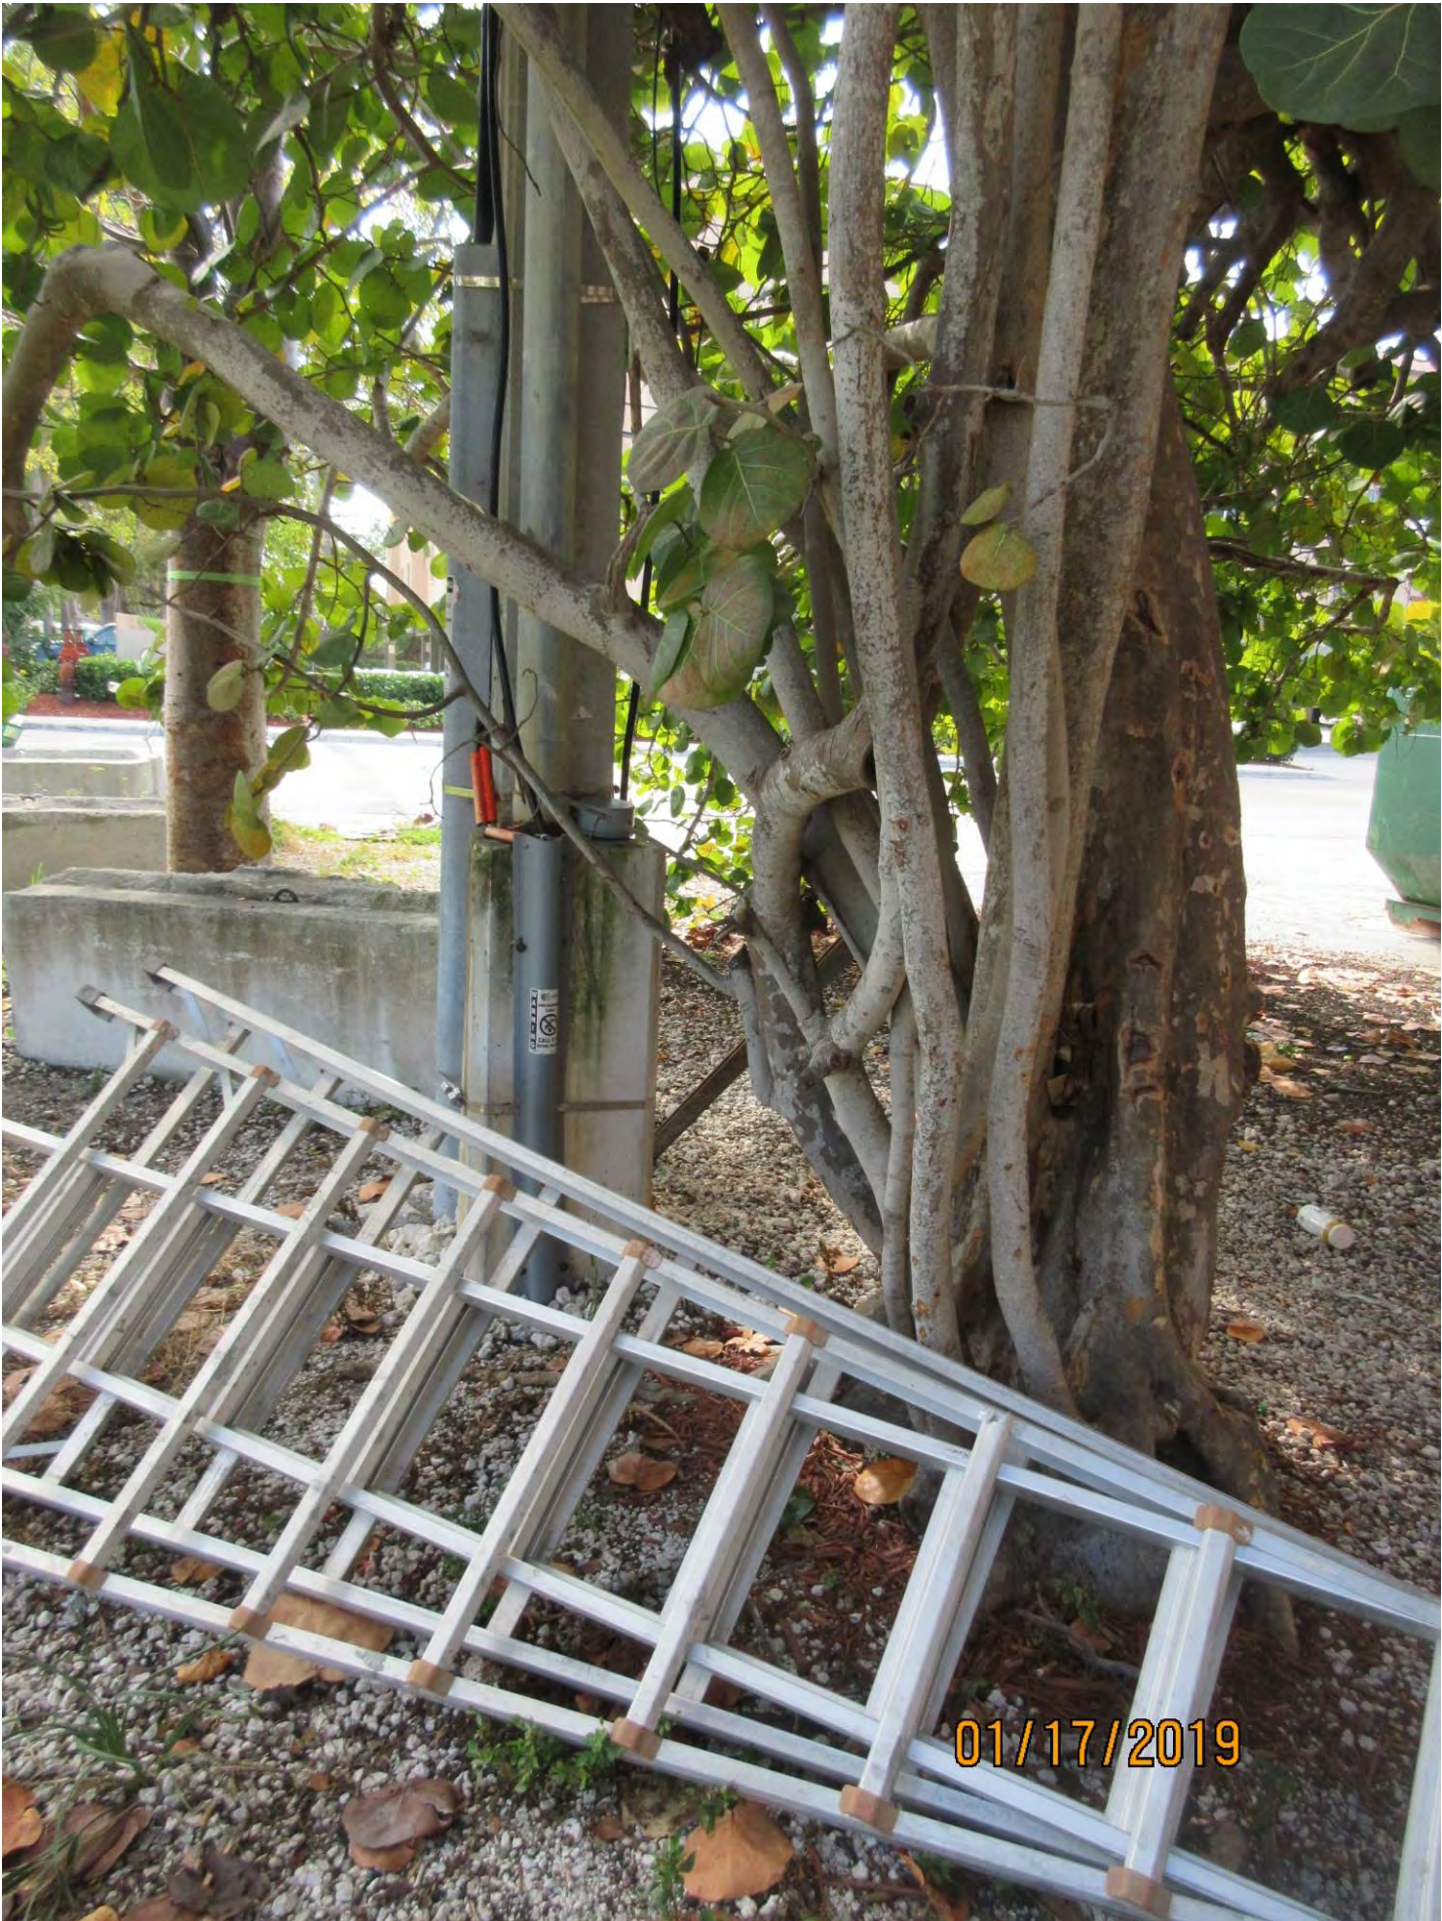
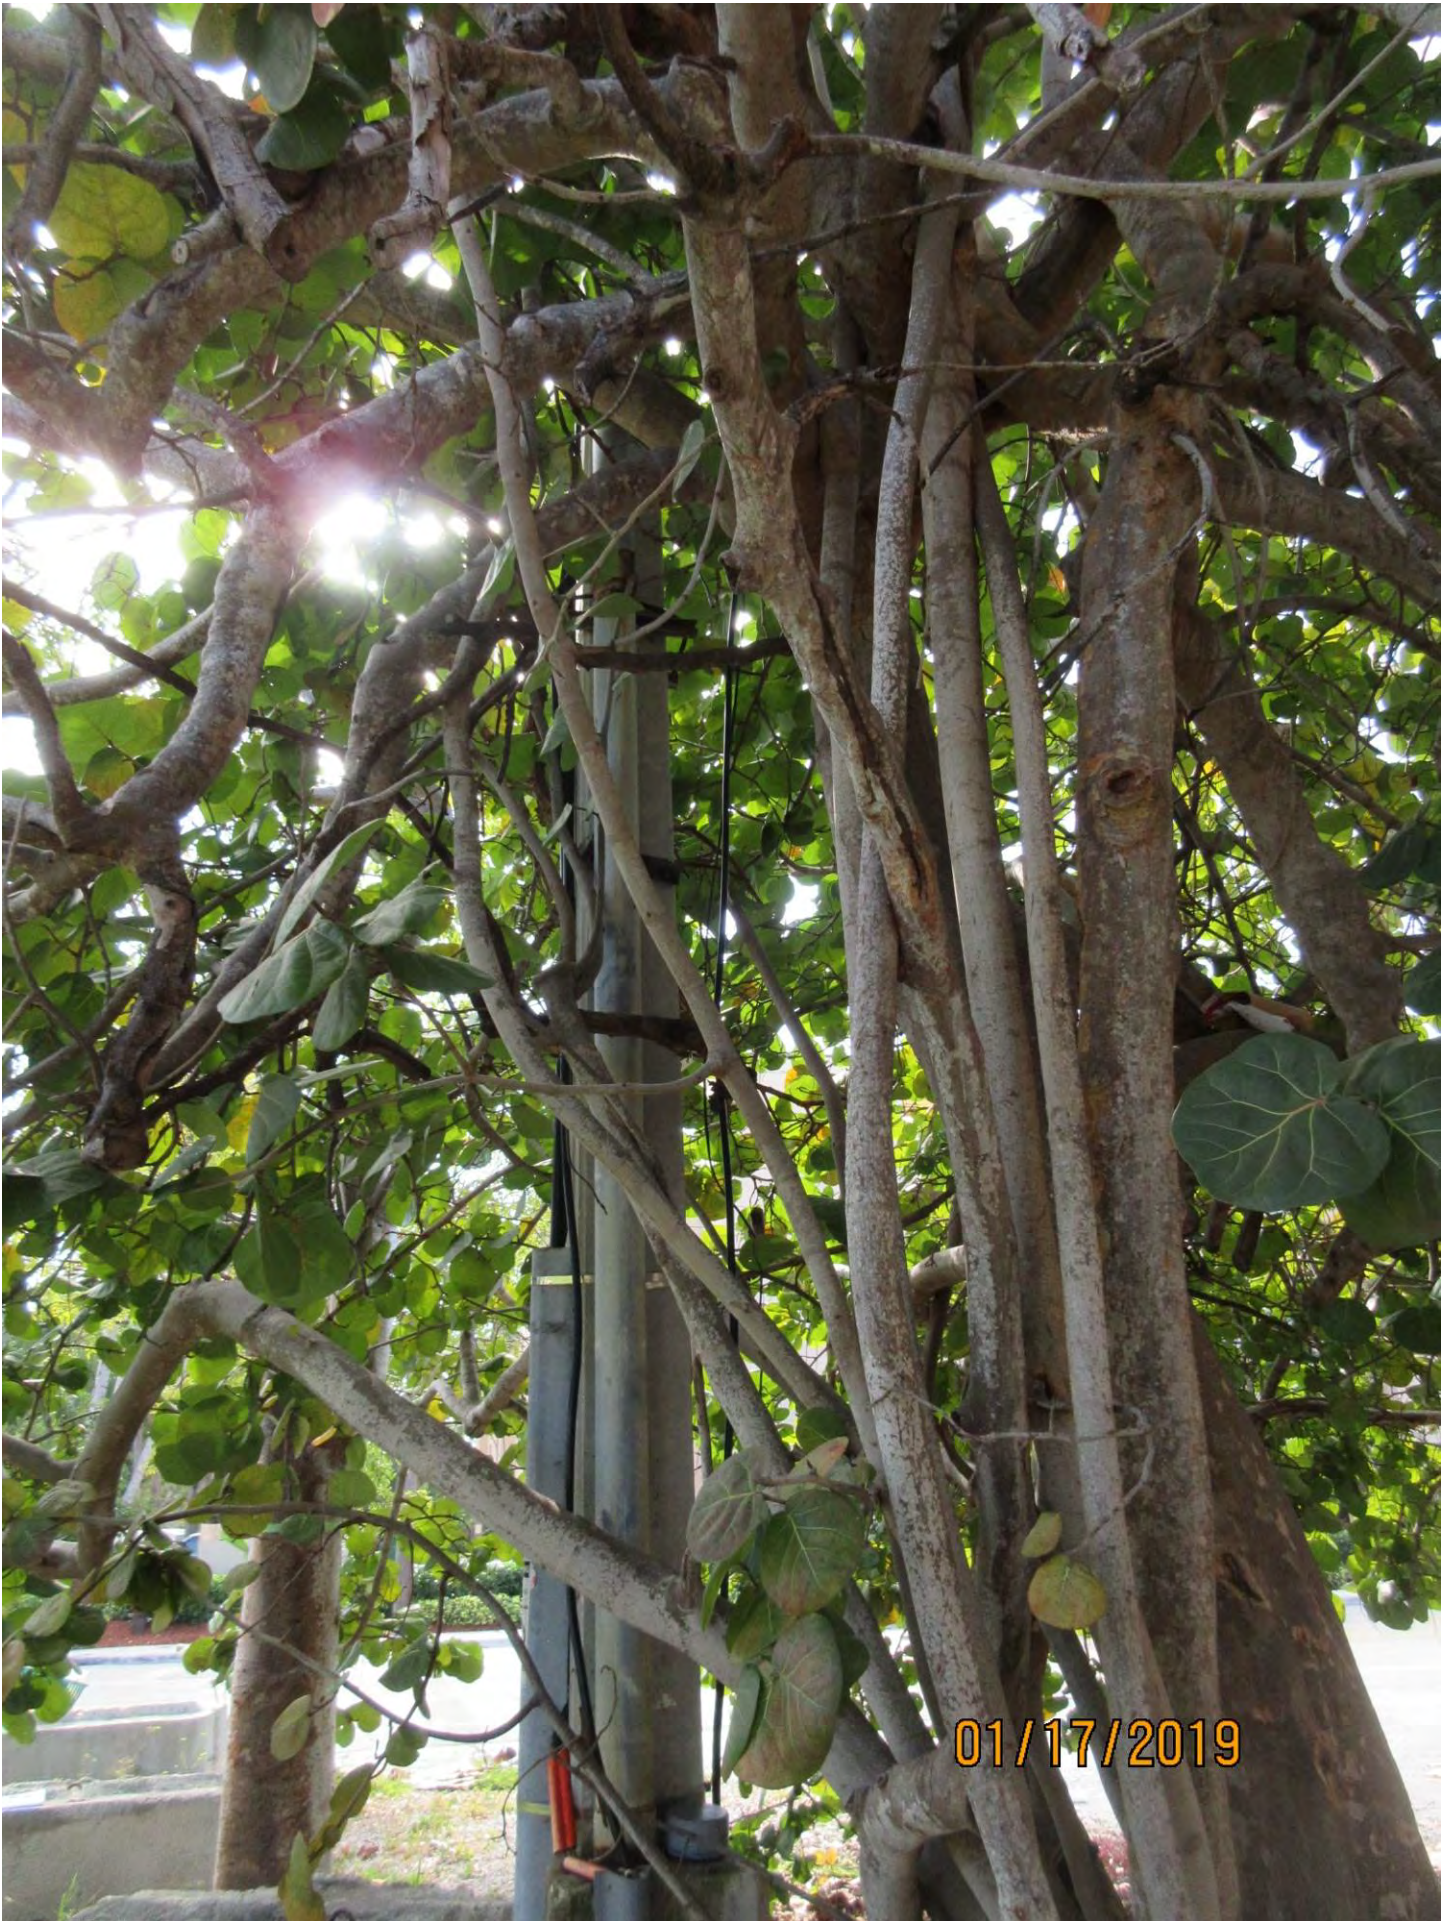
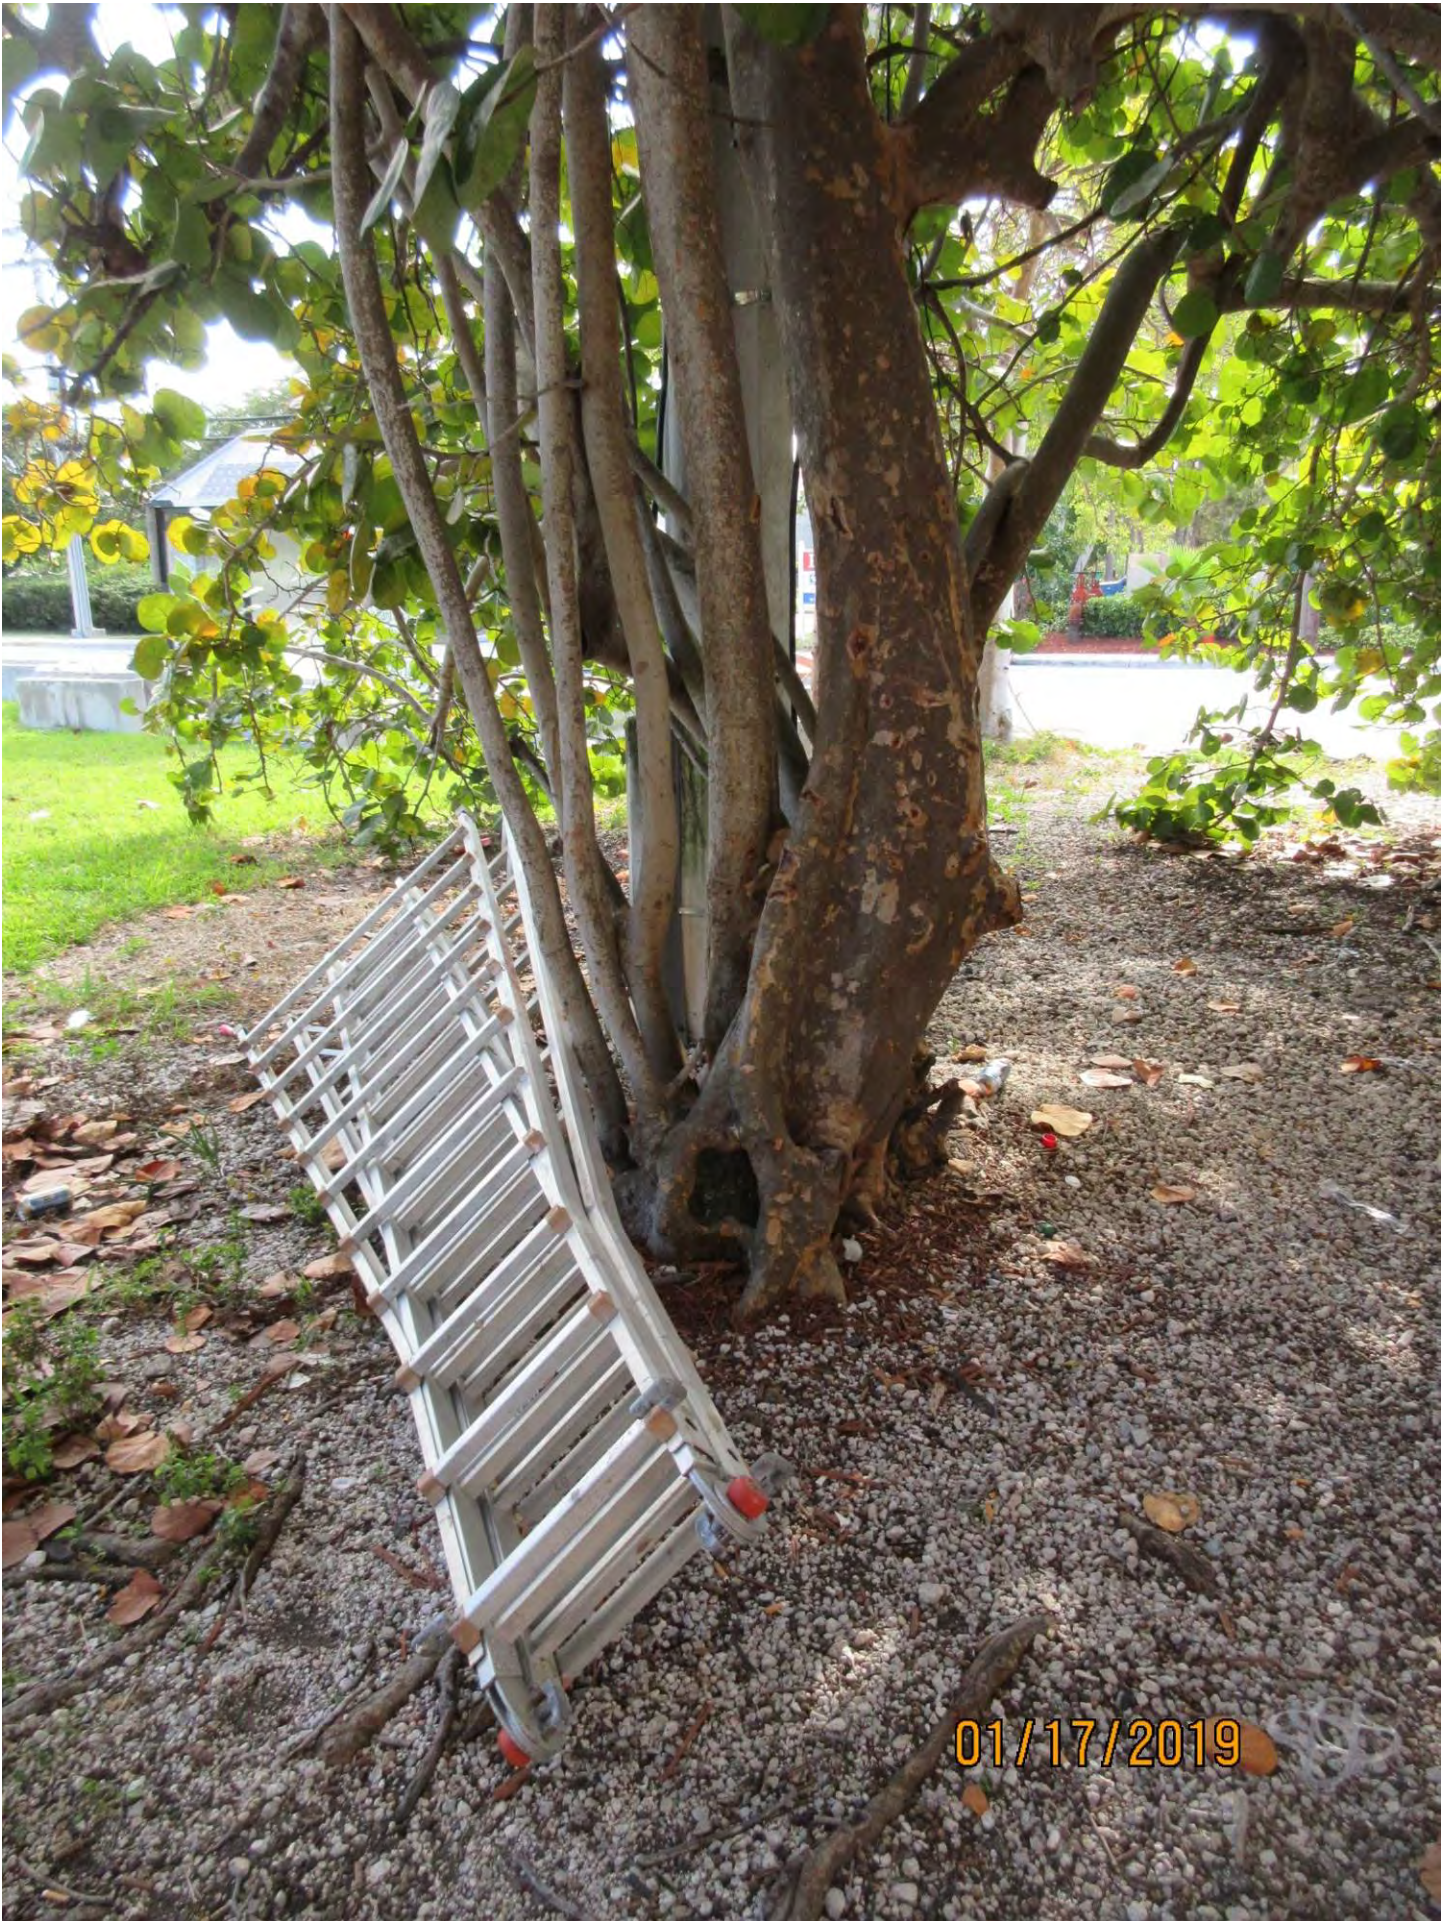
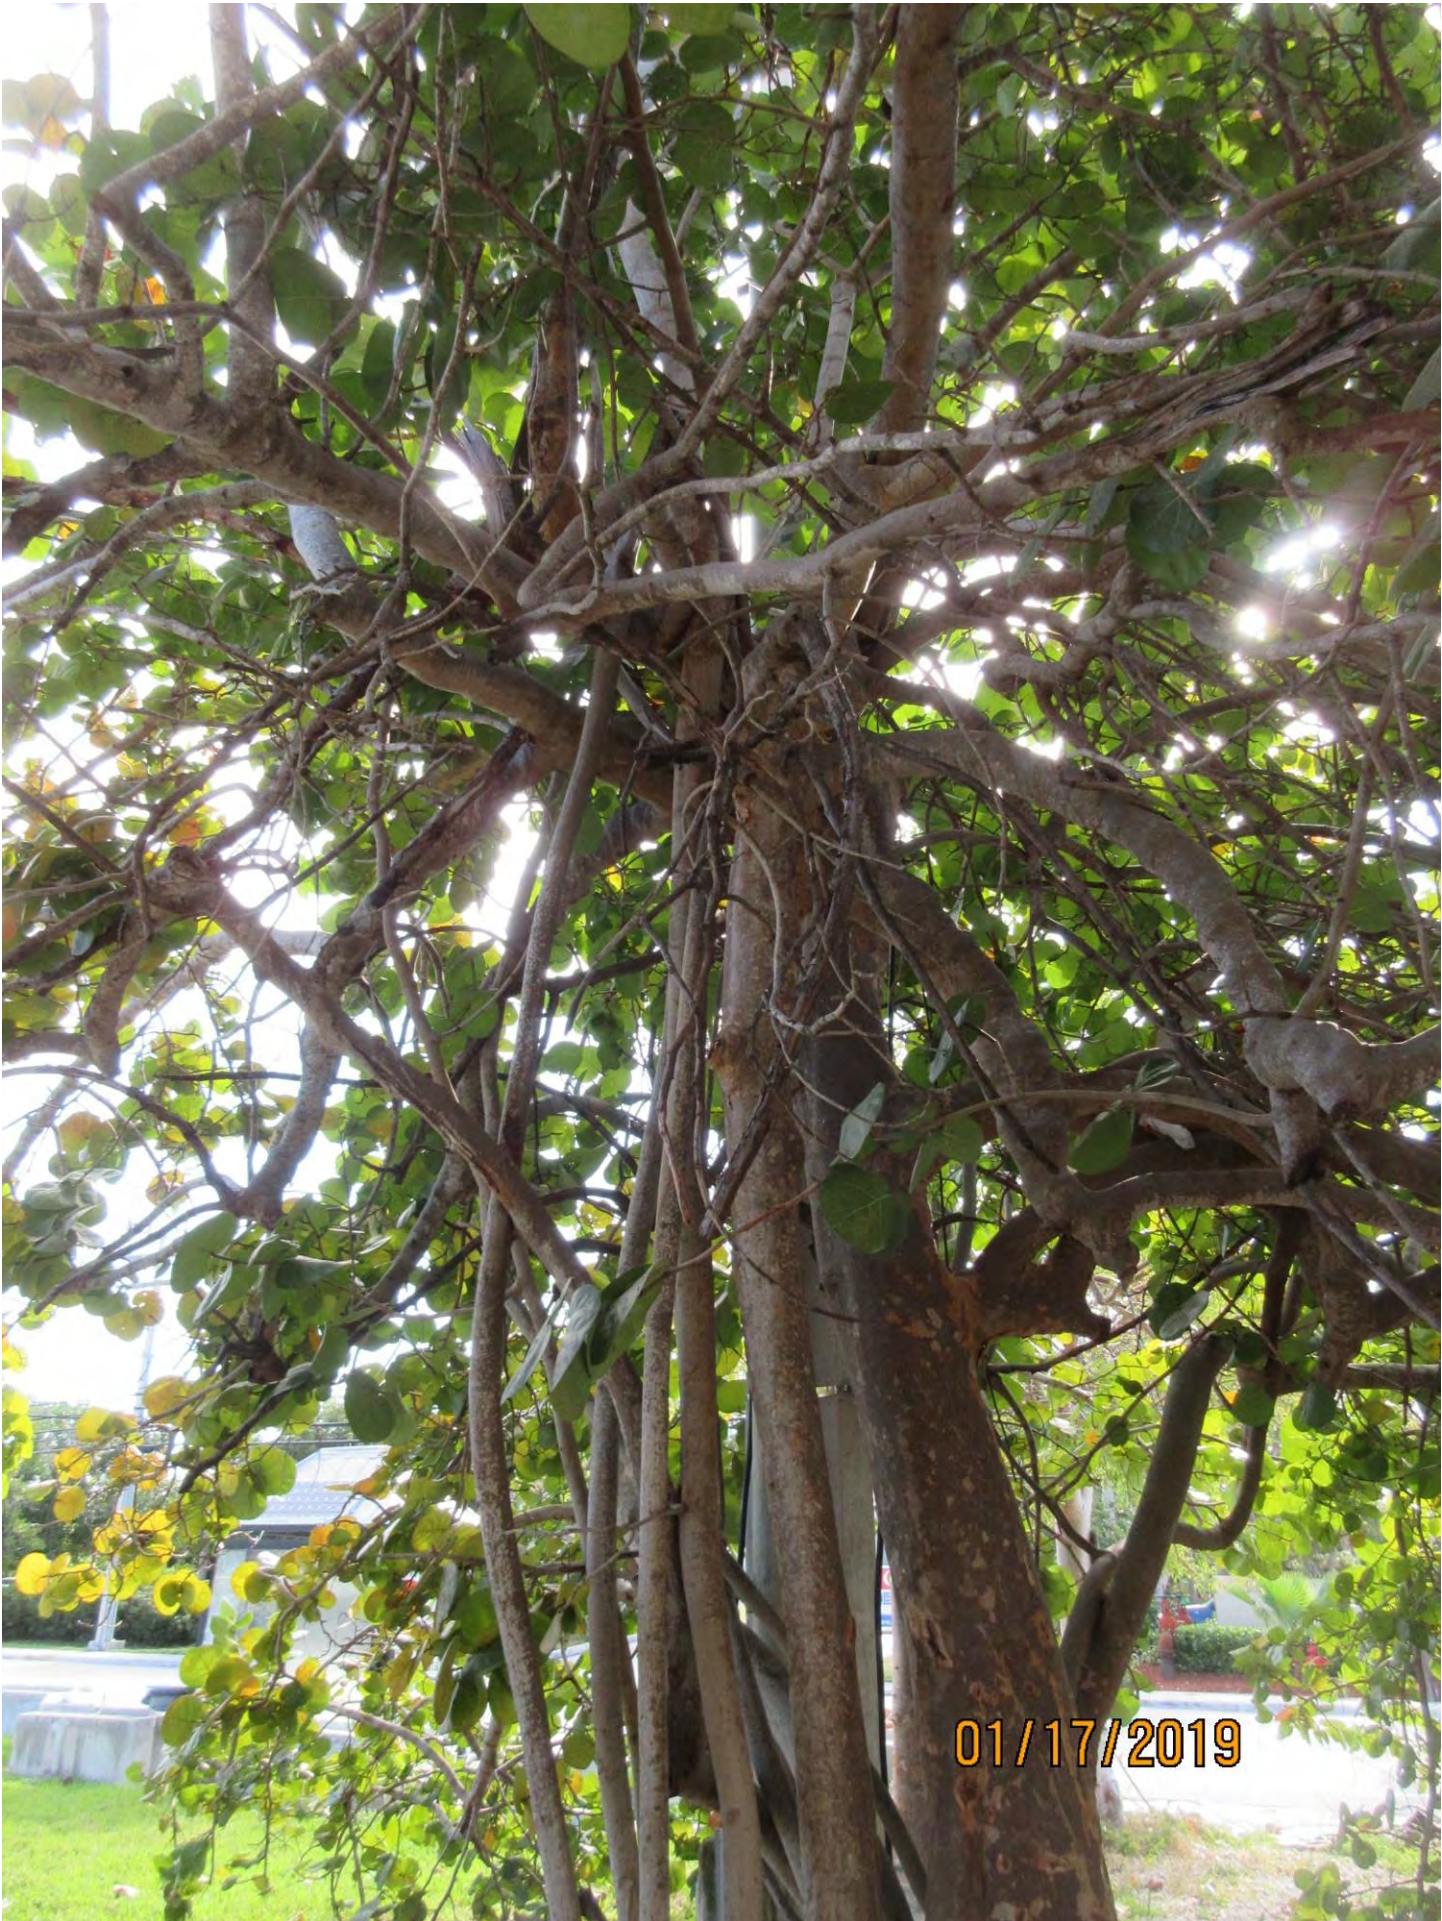
Tree# 7:

Diameter: 49" (multi trunked)

Location: 40% (planted under utility lines, impacting utility pole)

Species: 100% (on protected tree list)

Condition: 40% (poor canopy structure-lots of cross branches, decay in branches)

Total Average Value = 60%

**Value x Diameter = 20.4 replacement caliper inches**

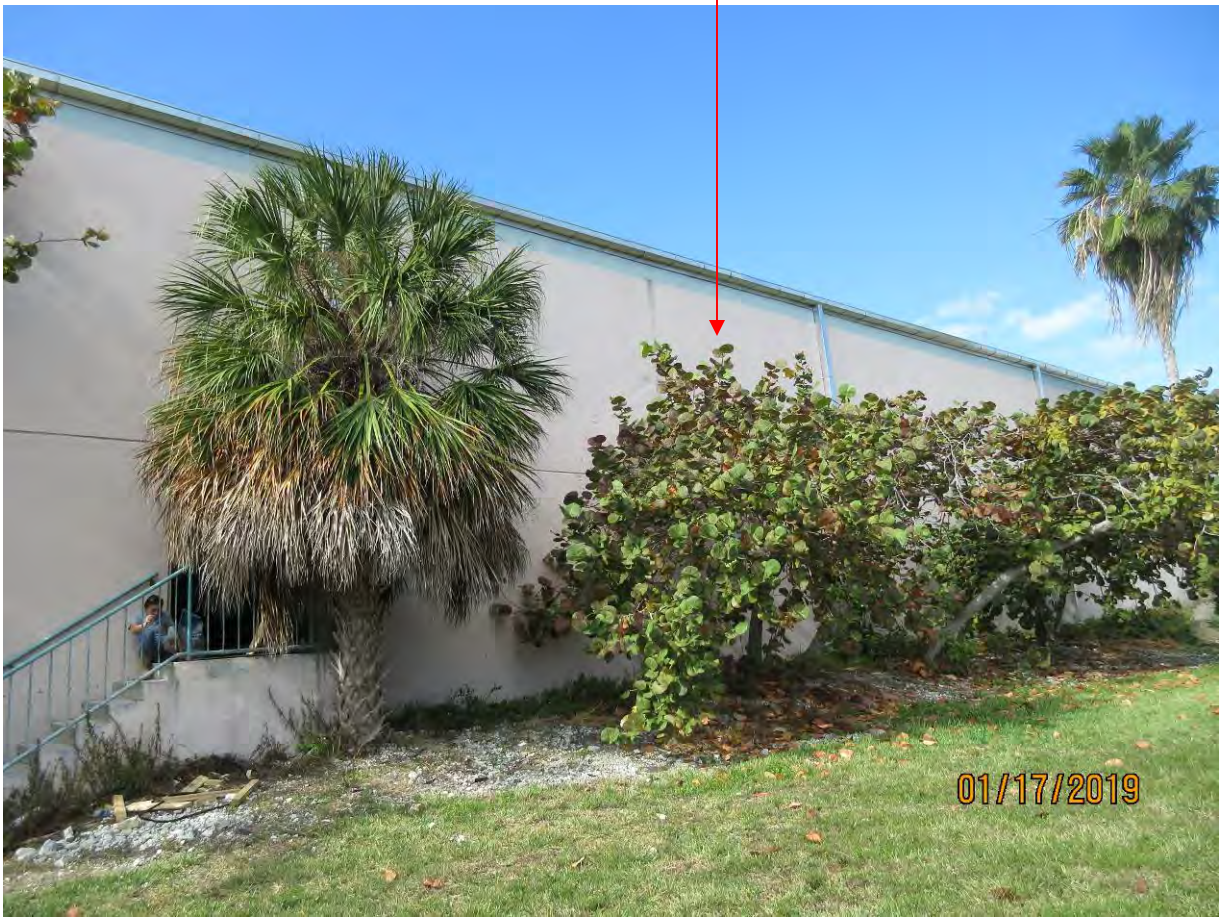
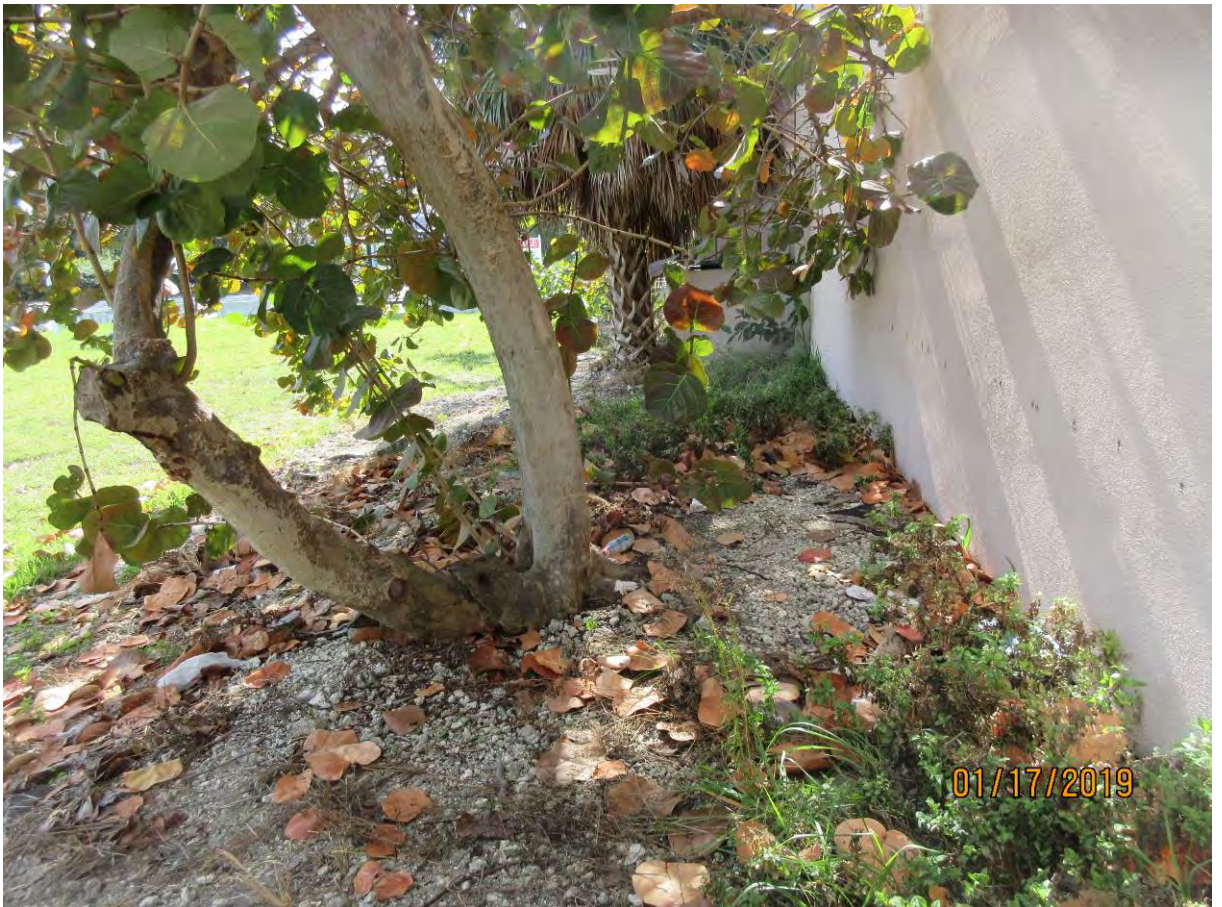
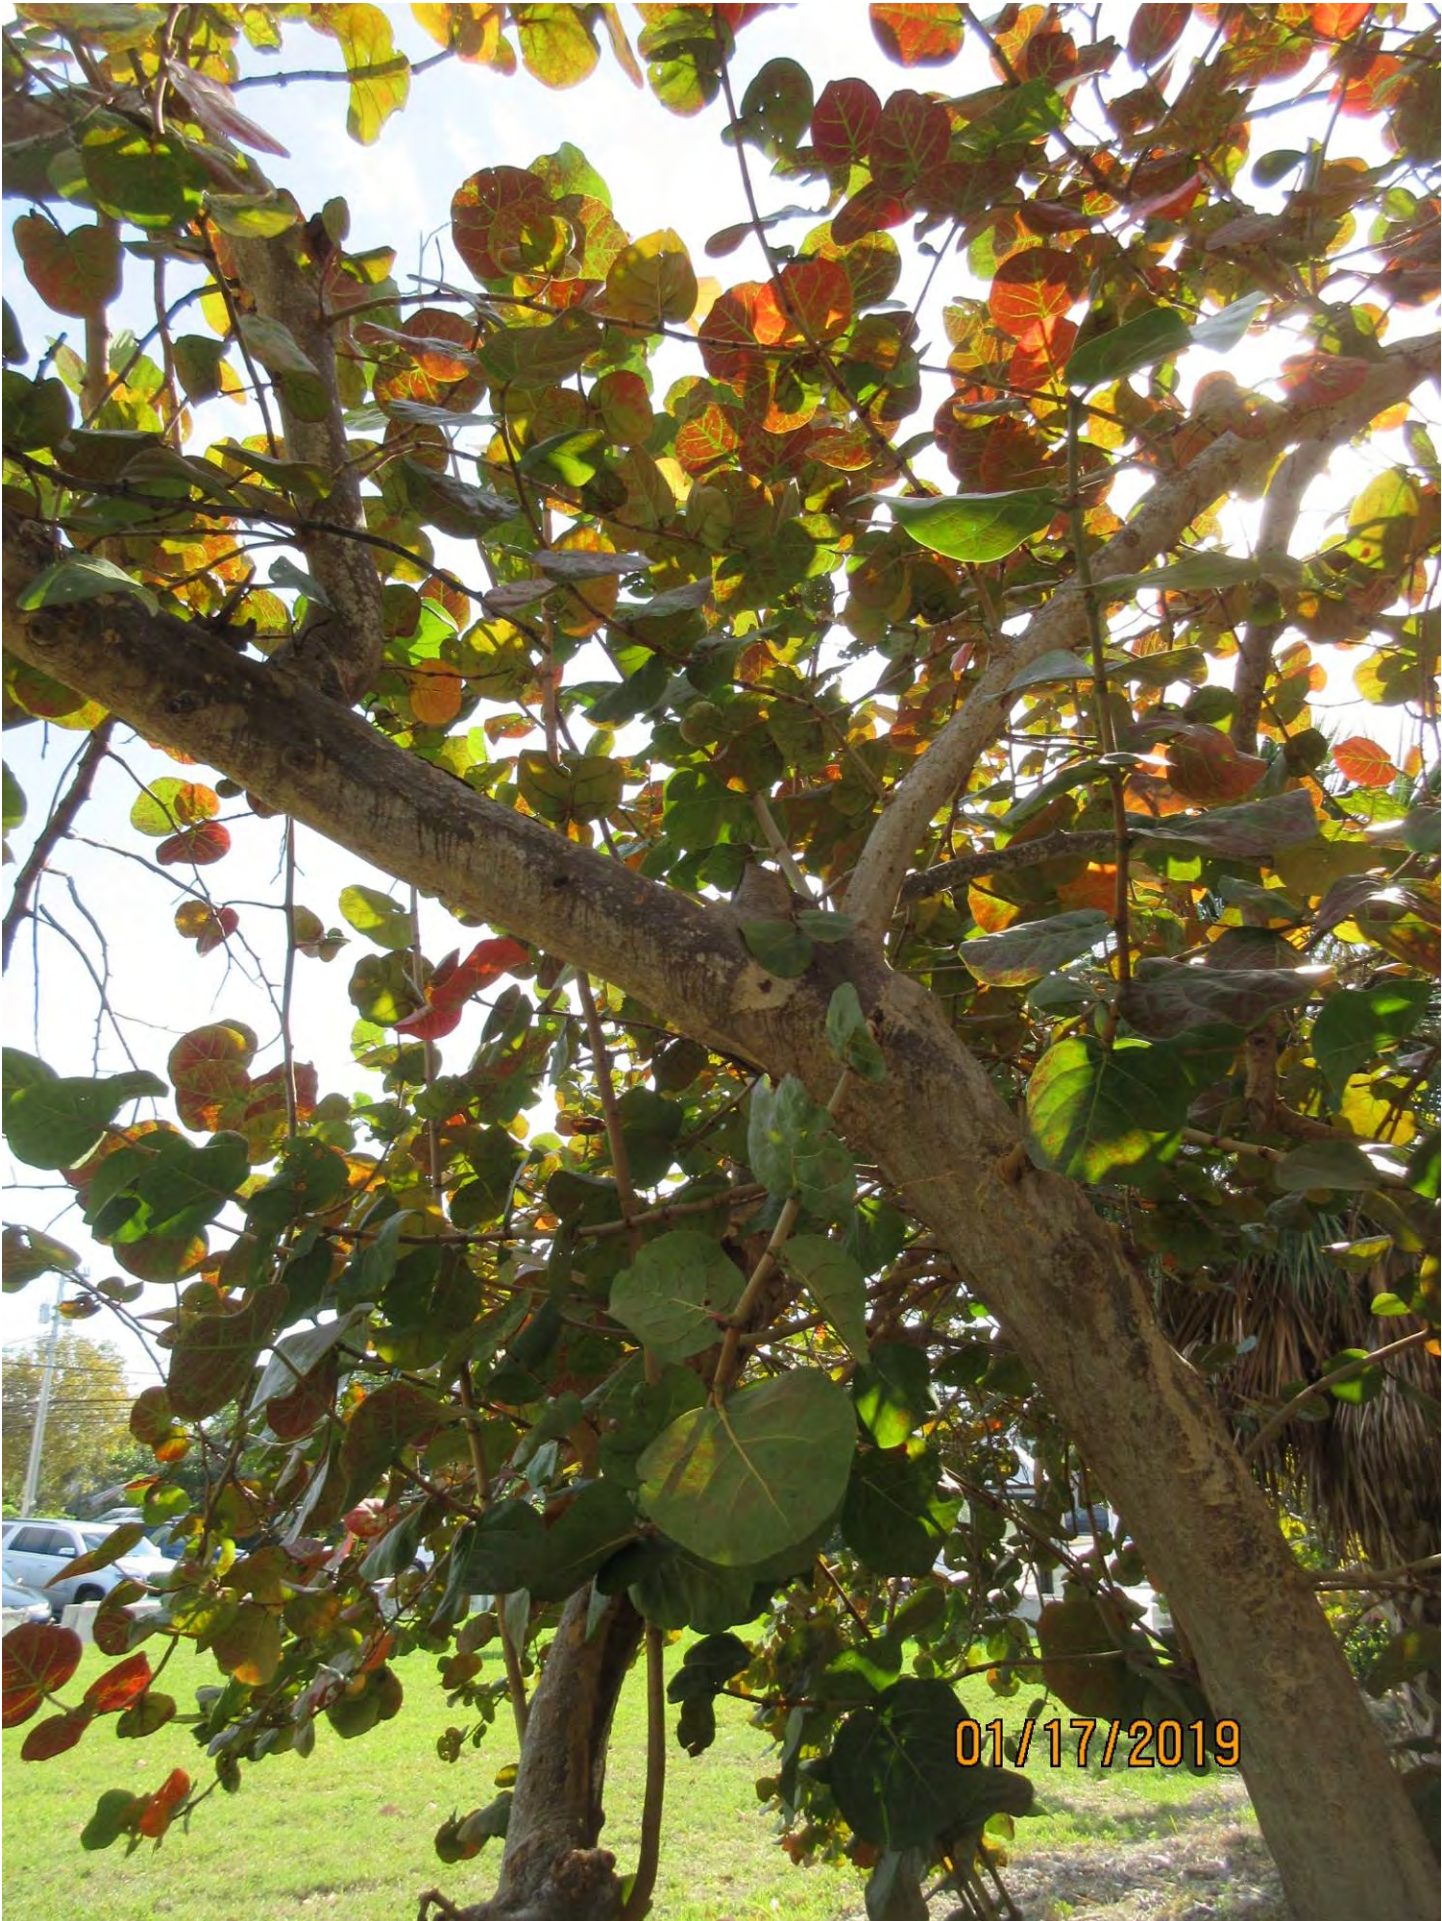
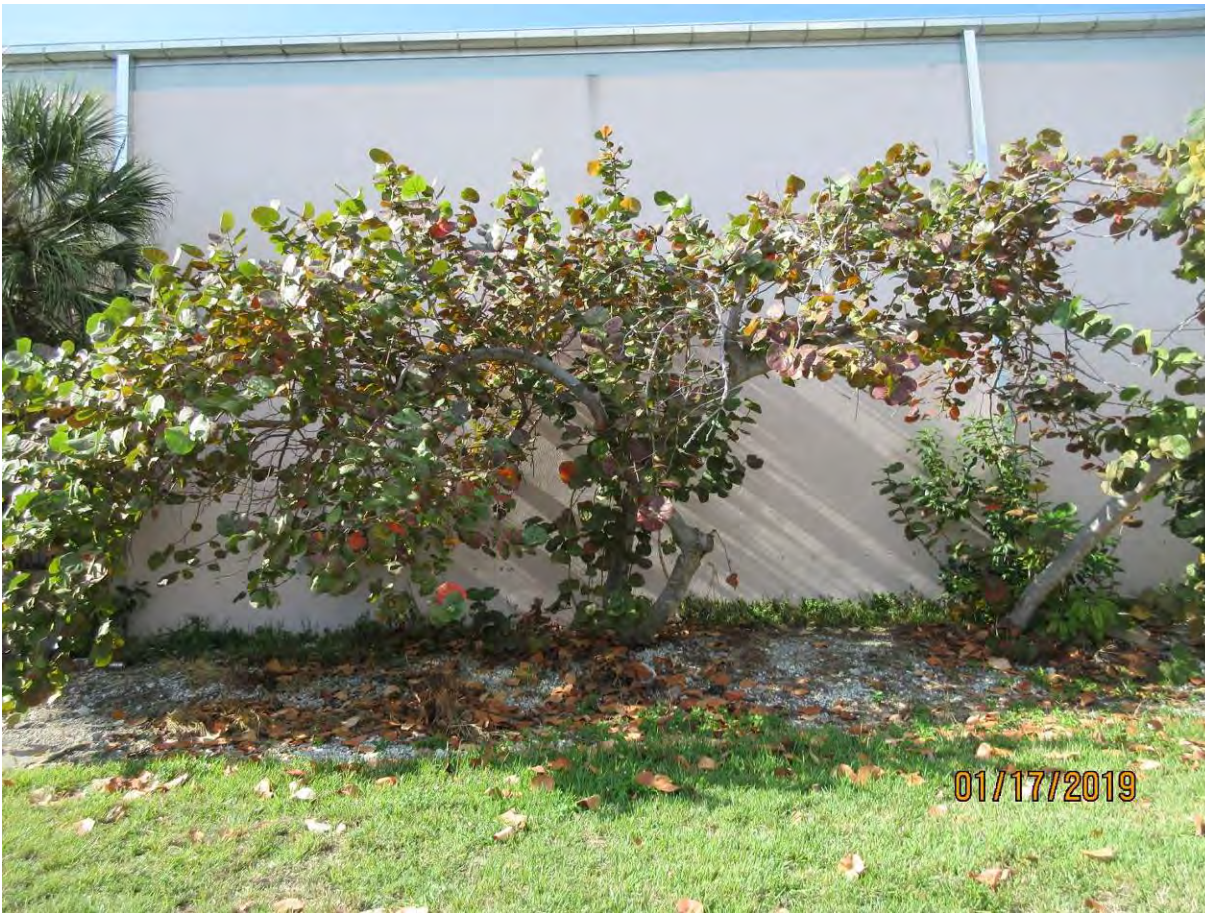
Tree# 9:

Diameter: 14.6" (two trunks)

Location: 70% (close to structure)

Species: 100% (on protected tree list)

Condition: 50% (fair, codominant trunks, canopy growth one sided due to structure, some canopy damage)

Total Average Value = 73%

**Value x Diameter = 10.6 replacement caliper inches**

Along side of theater, new emergency exit doors and walkways being installed. This work will impact Sea Grape #9 and Sea Grape shrub #13 (both to be removed). Recommend remaining trees on the property be properly trimmed by a certified arborist to correct storm damage and lack of maintenance.

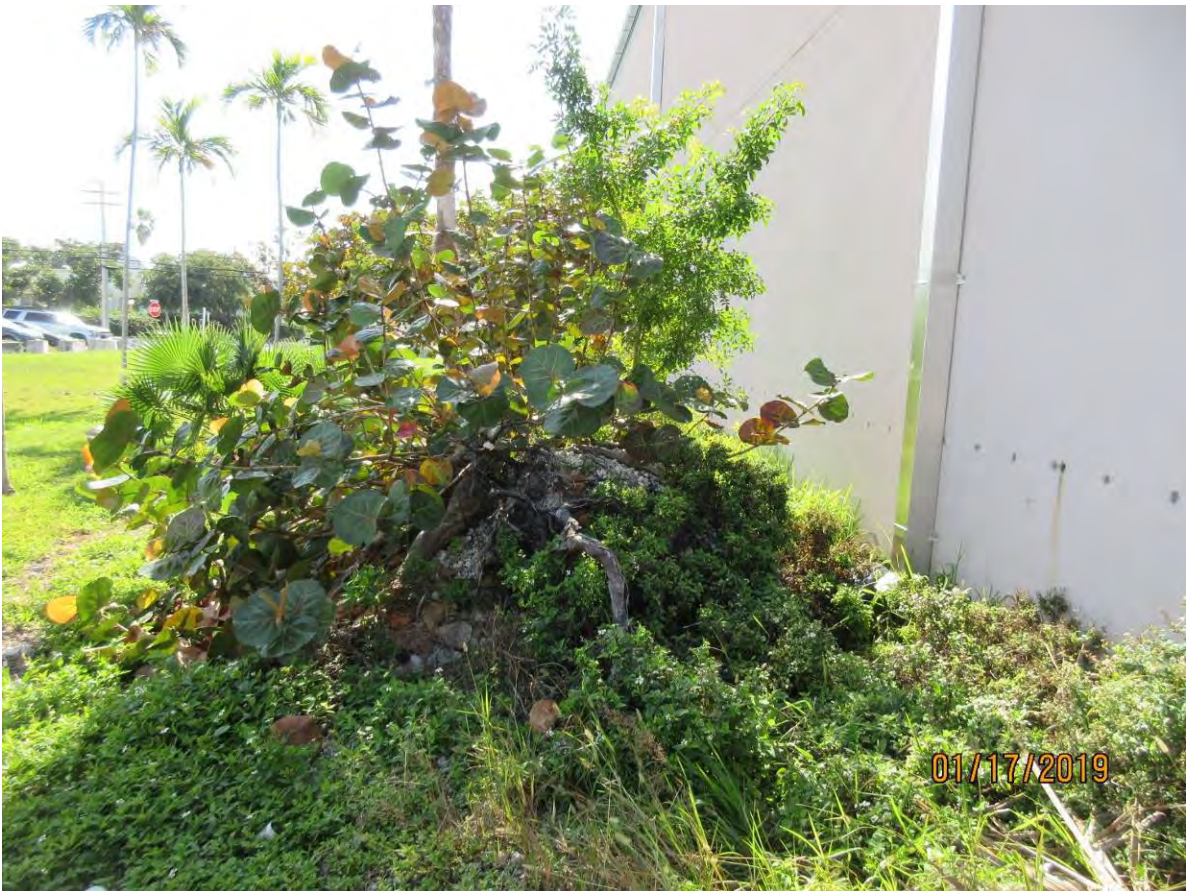
Sea Grape  
Shrub #13

Sea Grape #13:  
was once a tree but  
Hurricane Irma  
knocked over tree  
and uplified roots.  
“Tree” is now  
considered a busy  
shrub and not  
regulated.
