# STAFF REPORT

RE: **3338 N. Roosevelt Blvd (permit application # T2019-0017)**

FROM: Karen DeMaria, City of Key West Urban Forestry Manager

An application was received requesting the removal of **(2) Gumbo Limbos (tree# 5 & 6)** and **(2) Sea Grape trees (tree# 7 & 9)** that are being impacted by the redevelopment of the Regal Cinema Movie Theater which was heavily damaged by Hurricane Irma. A site inspection was done and documented the following:

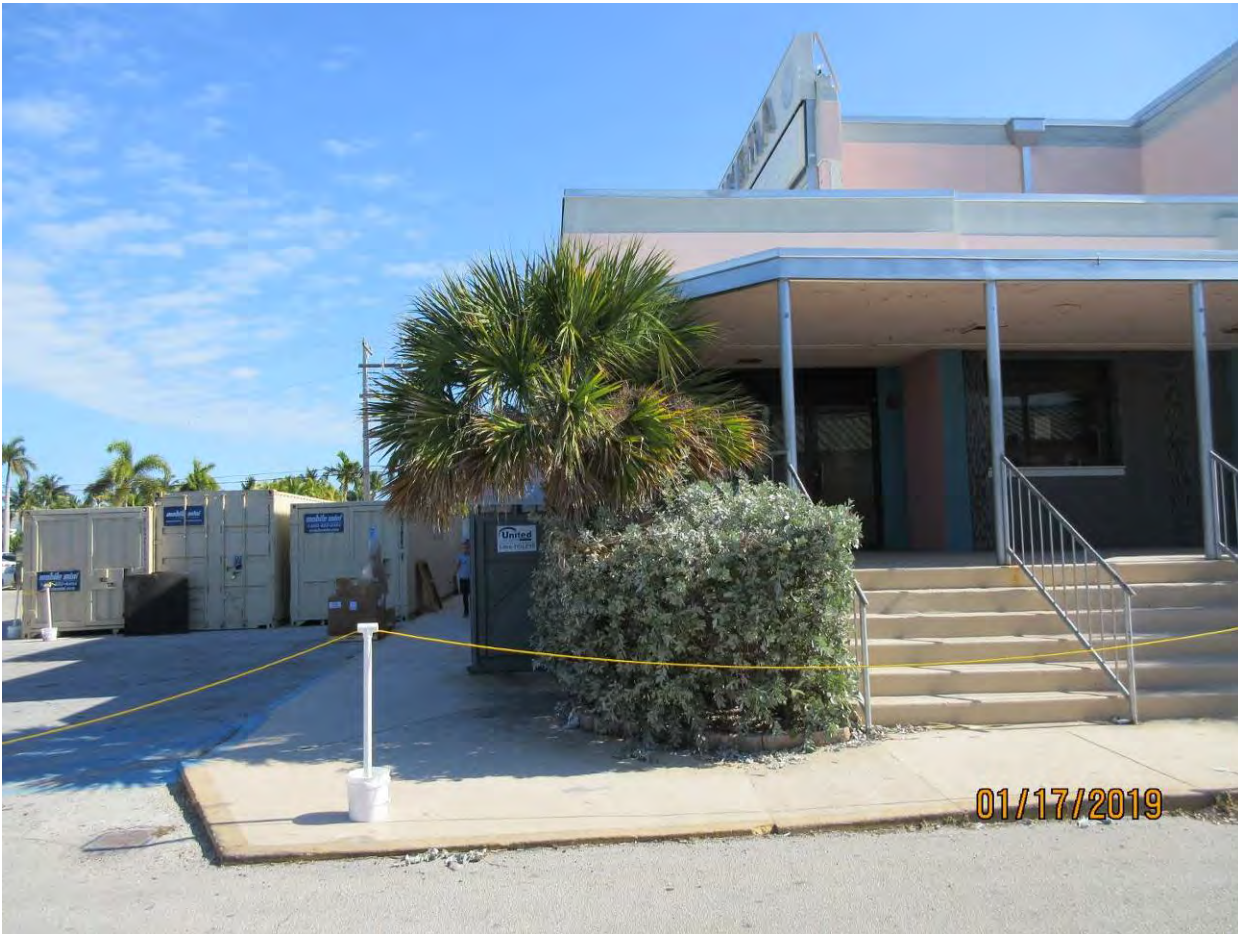
Entrance area:  
Sabal Palm to remain, silver buttonwood shrubs to be removed

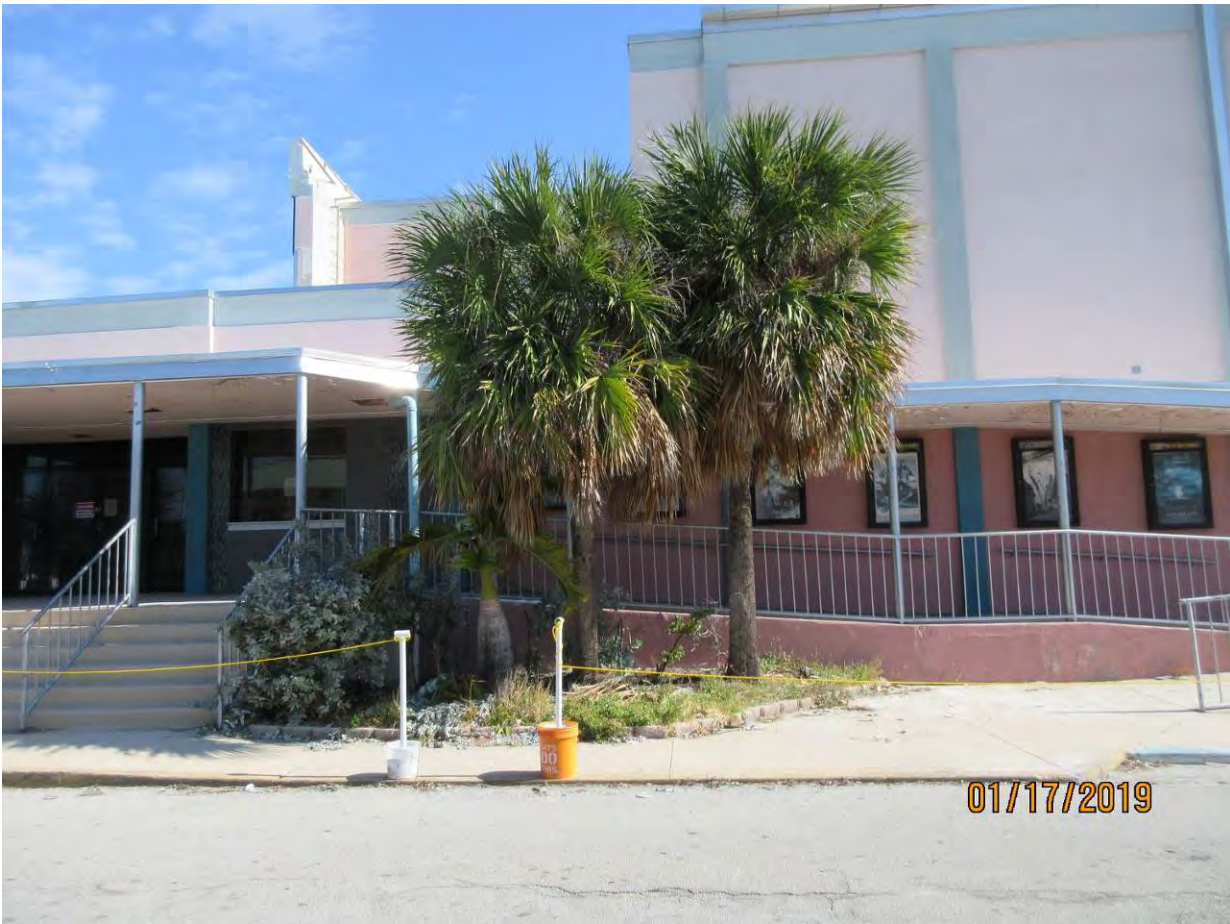
Sabal Palm on left to remain, Sabal Palm on right to be removed, silver buttonwood shrub and bottle palm also to be removed.
