Structural Evaluation Report

for existing Point Buoy

Property Address:
"Southernmost Point"
1400 Whitehead St, Key West, FL 33040

AD Job#: 2301-03
City of Key West P.O.: 097970
Artibus Design
May 2023

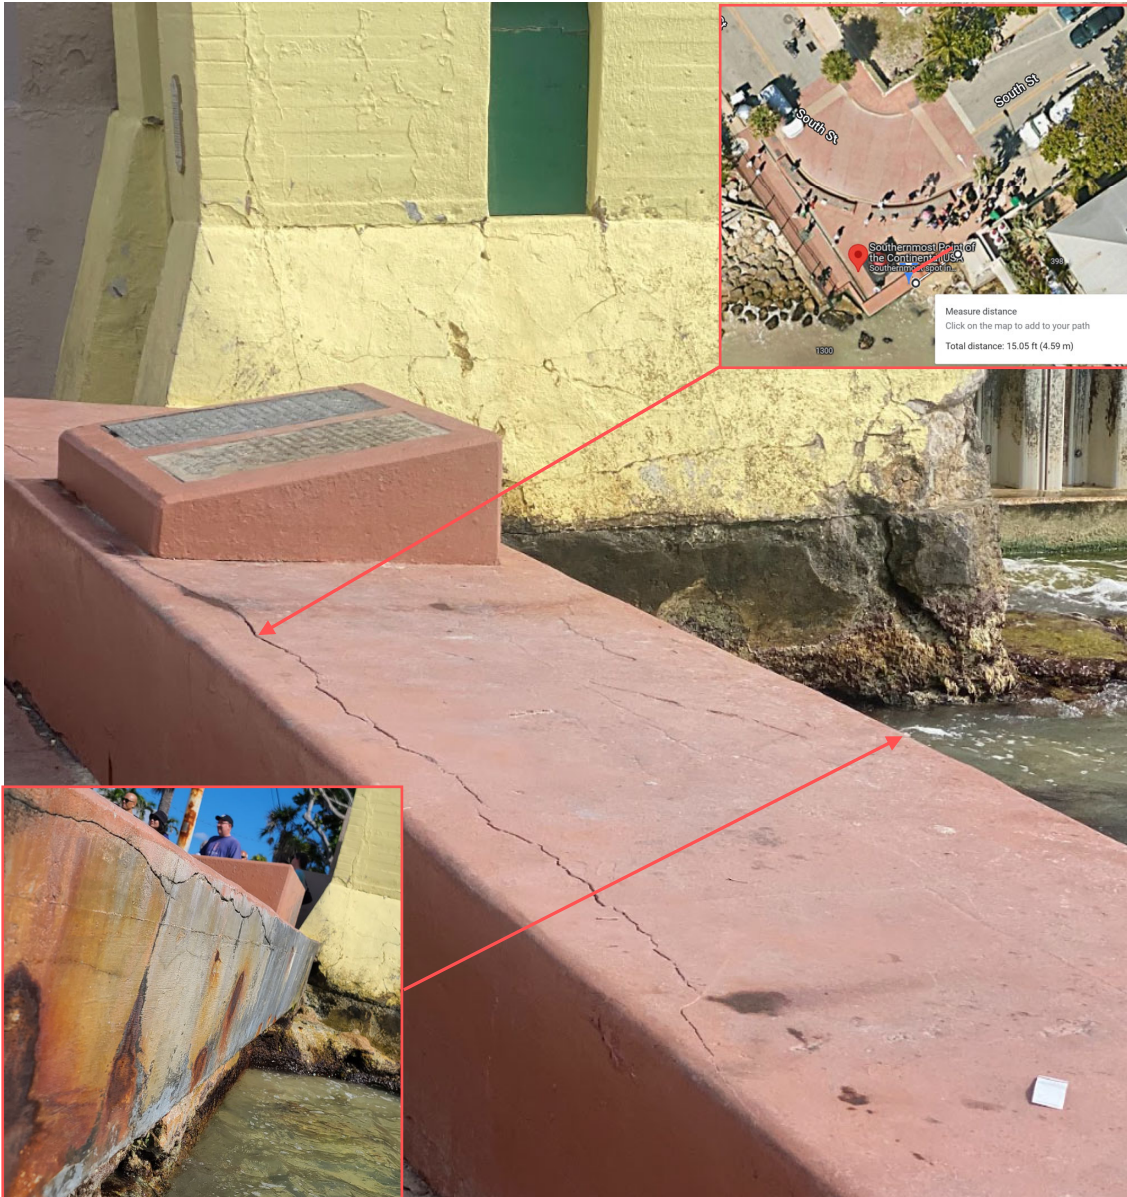
Location 1. Existing concrete seawall cap between the Cable Hut and corner point
Issue: continuous concrete spalling along the top of seawall approx. Length=15ft.
Bleeding rust stains on the outside face of the wall cap with numerous cracks.
Recommendations: A complete seawall cap replacement is recommended. The cracked and compromised chlorine impregnated concrete media no longer protects the reinforcement inside. The reinforcing oxidation products increase in volume and propagate the cracks along the bar exposing new steel surface to the elements. Any patch repairs in such cases can't be considered effective or lasting any meaningful time.

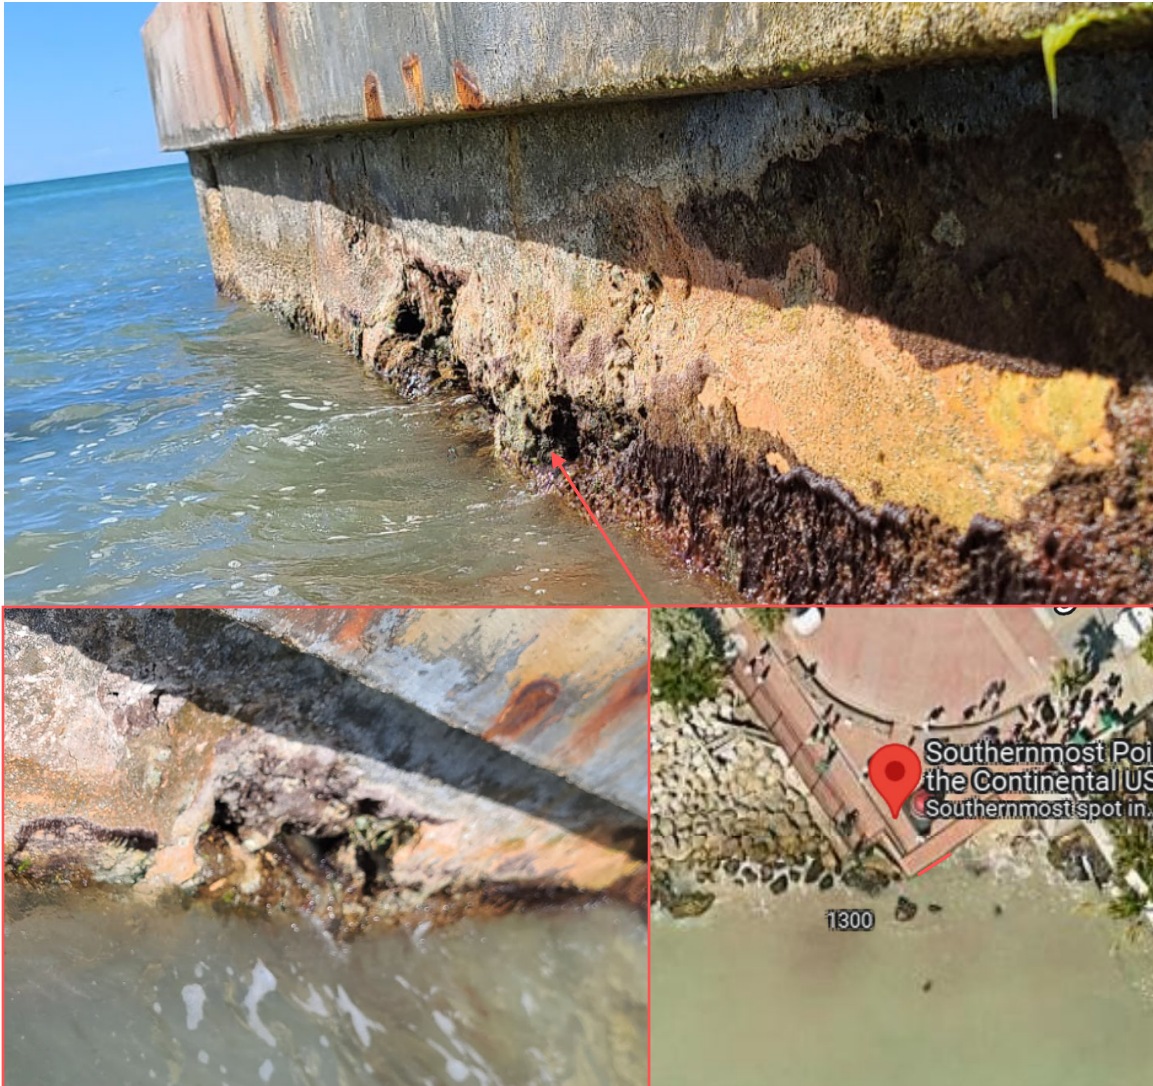
Location 2. Existing concrete seawall South-East side.

Issue: seawall surface with effects of erosion and a significant opening at the water line. The opening allows constant wave action to enter the space behind the wall and is one of the causes of the soil erosion and pavement settlement.

Recommendations: The seawall requires either complete replacement or installation of new seawall in front of the current to encapsulate any wall penetration and prevent the shoreline erosion.

Additionally, a protective Riprap is recommended to be installed in front of new seawall similarly to the installation immediately westward along the NAVY base shoreline.

The final design of the Riprap shall be based on the detailed design modeling after the bathymetric survey and geotechnical exploration for the project are completed.

Fur budget estimate purposes a 3ft deep riprap rubble over 1ft subbase and filter fabric liner installation. The estimated length is 15ft measured from the seawall face seaward with approximate 65ft of frontage including the cable hut base. Total estimated installed weight of the riprap 290 TN.

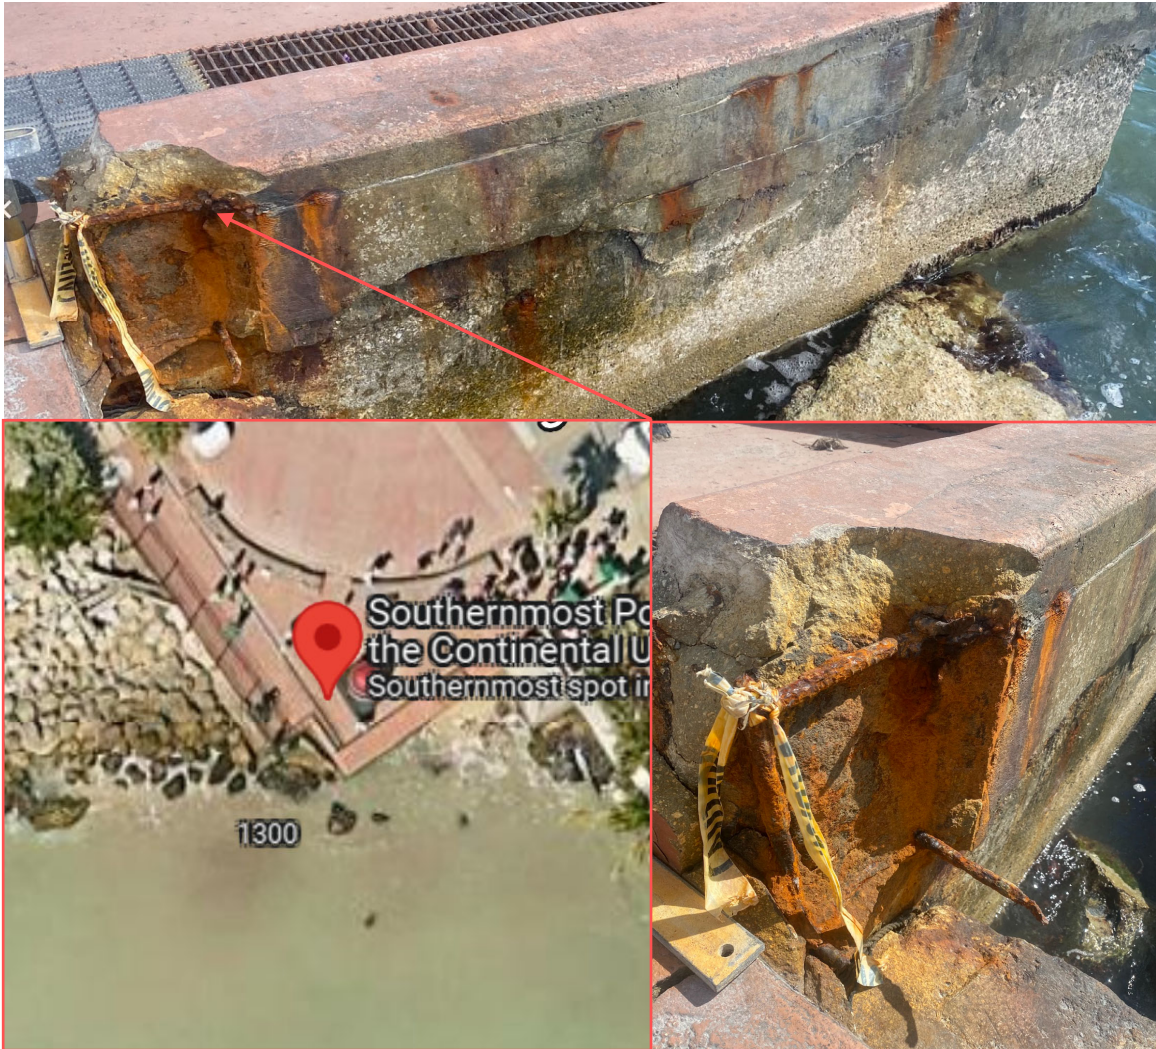
Location 3. Damaged part of existing seawall. Inner corner / return.

Issue: Complete seawall cap damage with part of the wall cap collapsed. Exposed reinforcement.

Recommendations: Complete replacement of the seawall and seawall cap. A properly designed and detailed seawall and seawall cap should be utilized in this location. Highly exposed point with routine storm events causing breaking waves can be considered highly corrosive and harsh environment. Non-corrosive and durable materials shall be used due to the nature of the location and relatively small size of the installation.

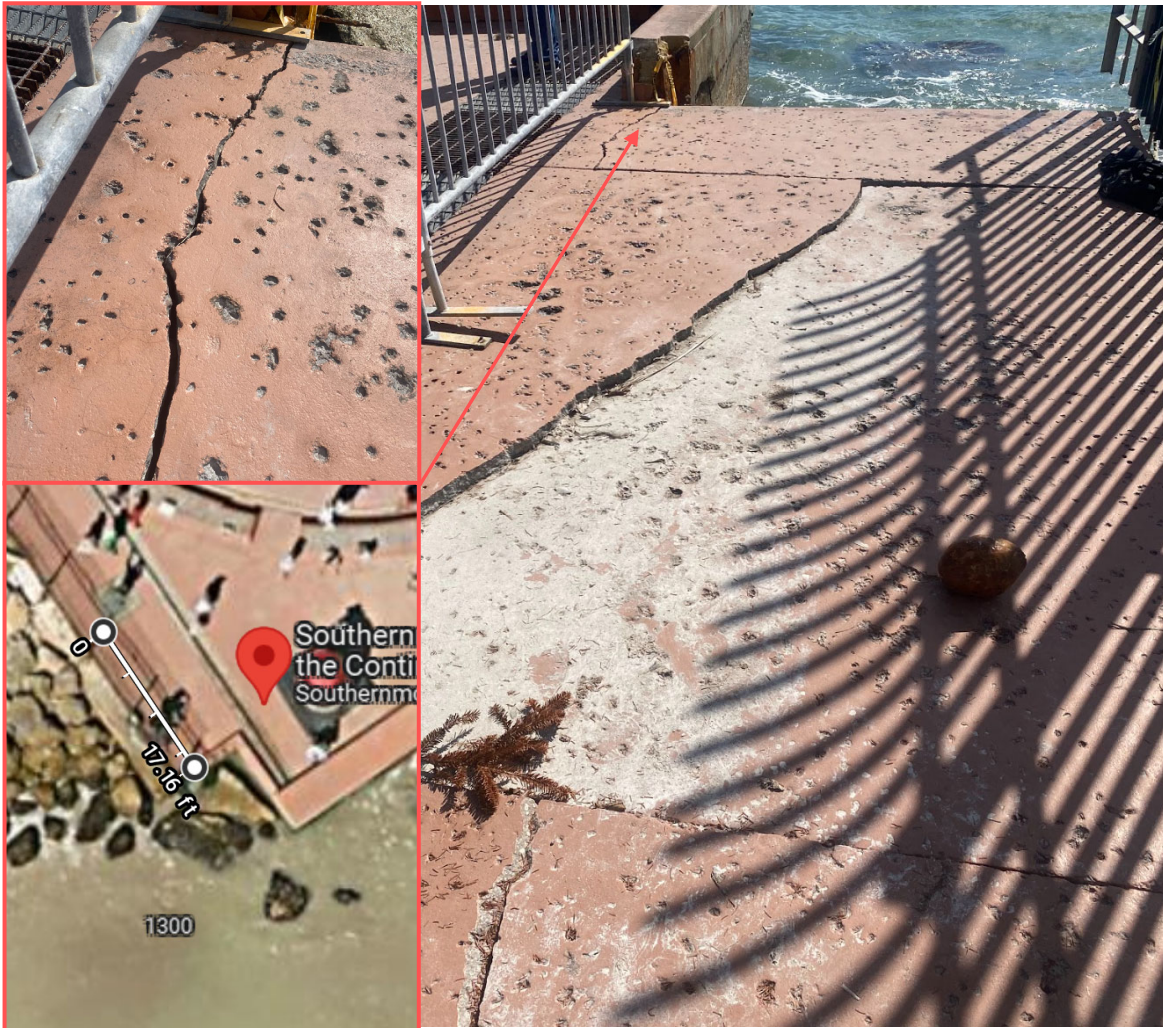
Location 4. Existing condition of concrete sidewalk.

Issue: cracked and failing concrete sidewalk beyond the failed seawall.

Recommendations: Complete replacement of the sidewalk using heavy reinforced slab design over flowable fill concrete instead of soil backfill.

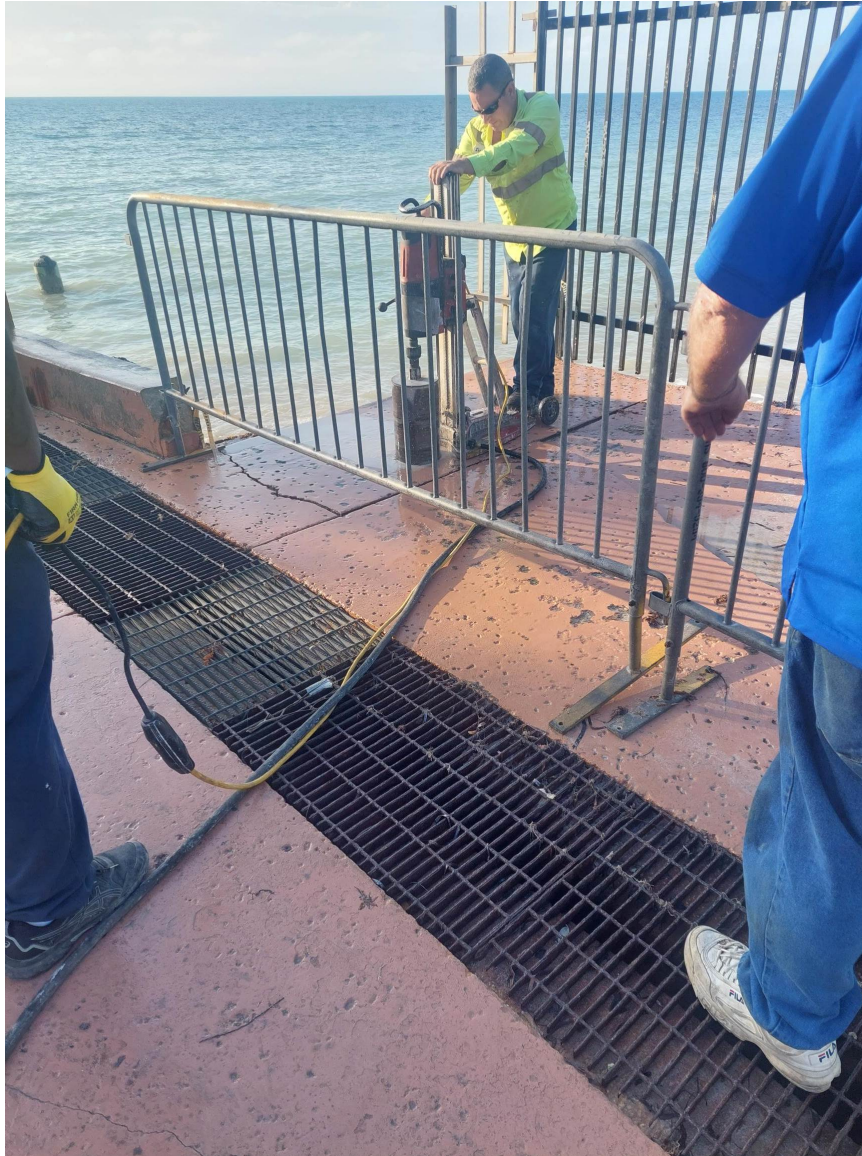
Location 4. Existing condition of concrete sidewalk.
Coring by City of Key West Community Services.

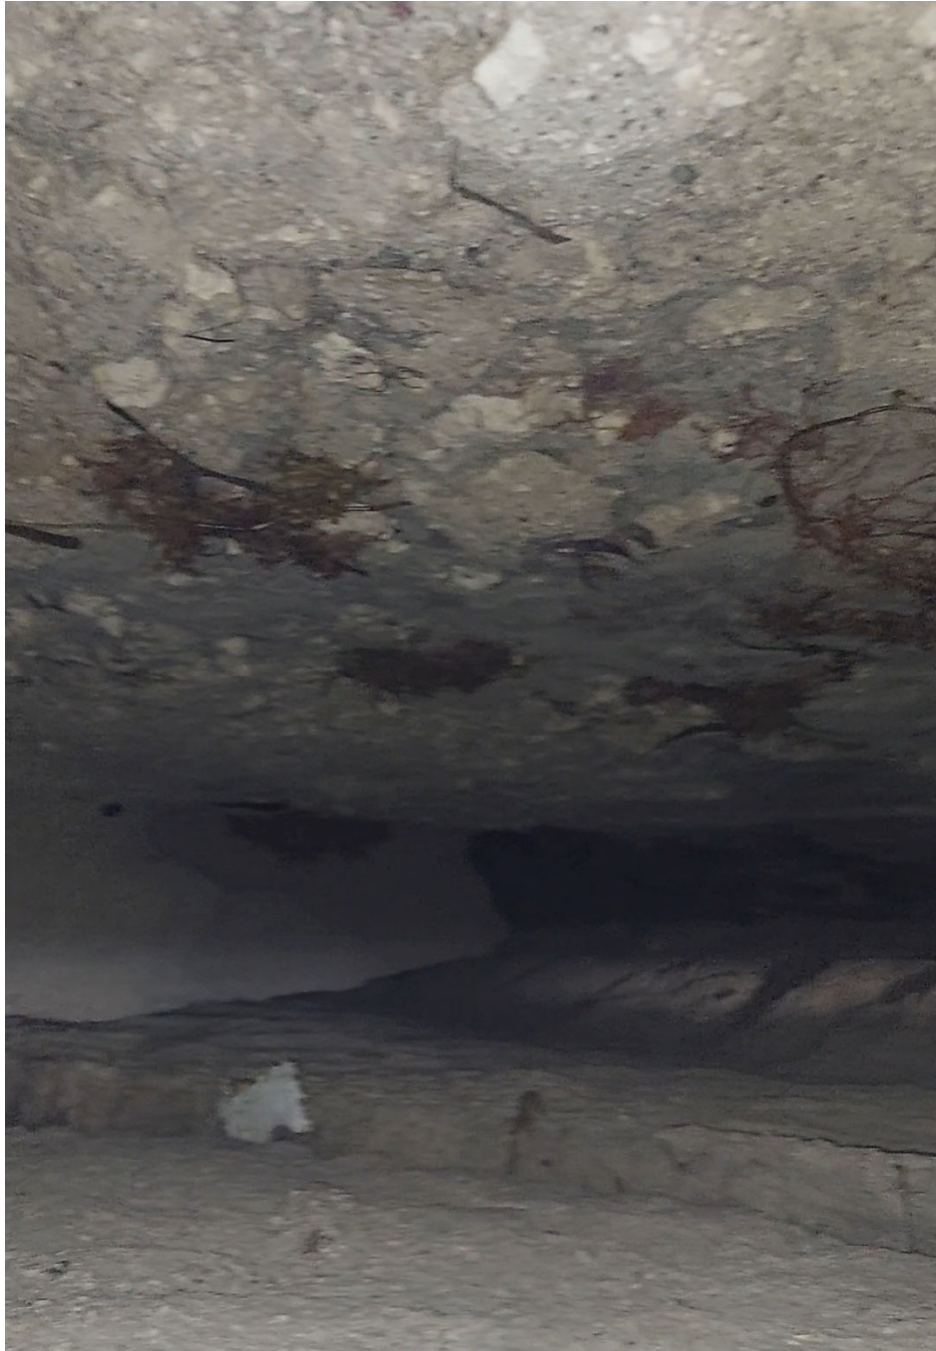
Location 4. Existing condition of concrete sidewalk.
Open void below the sidewalk slab.

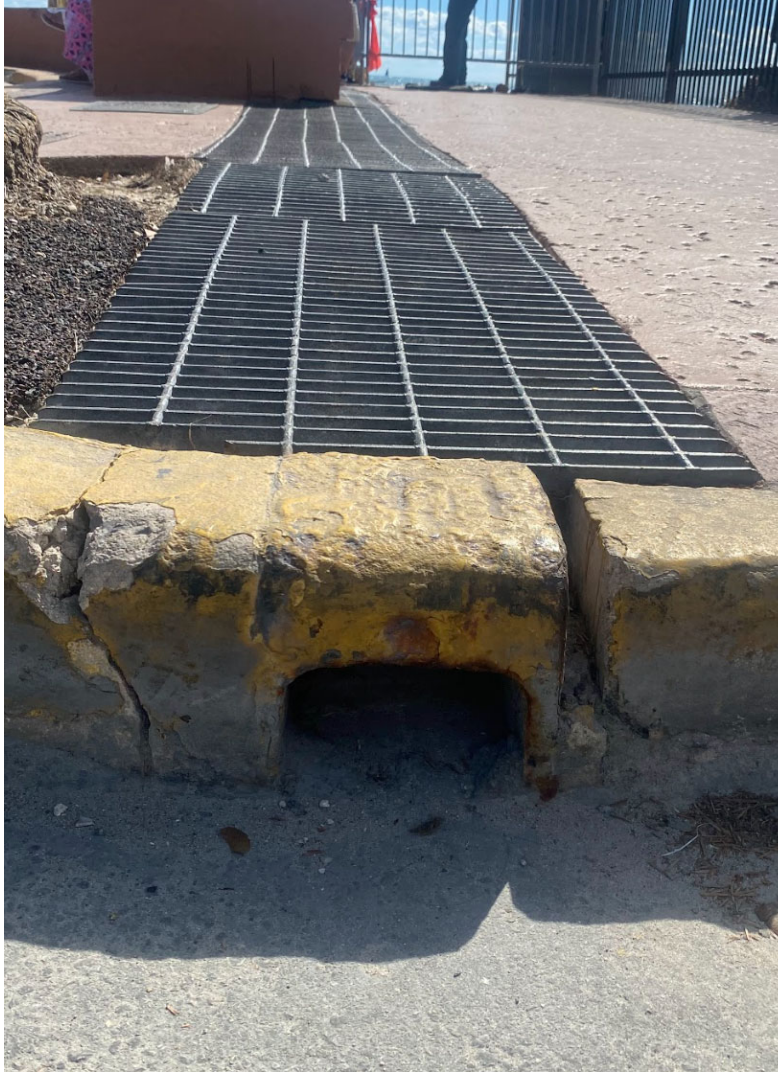
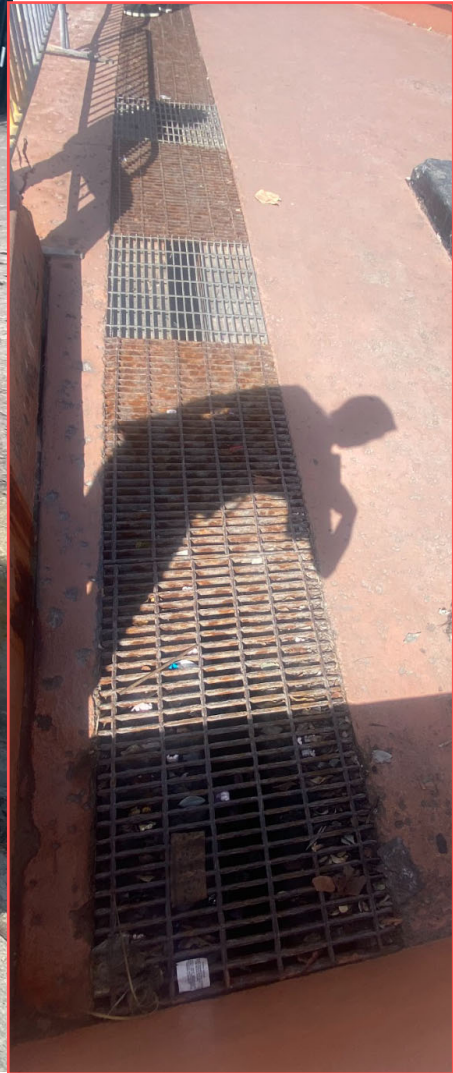
Location 5. Existing linear drain system.

Issue: Highly corroded grates

Recommendations: Replacement of the braking wave overflow trench drain and all grating using pedestrian traffic rated ADA cast iron grates.

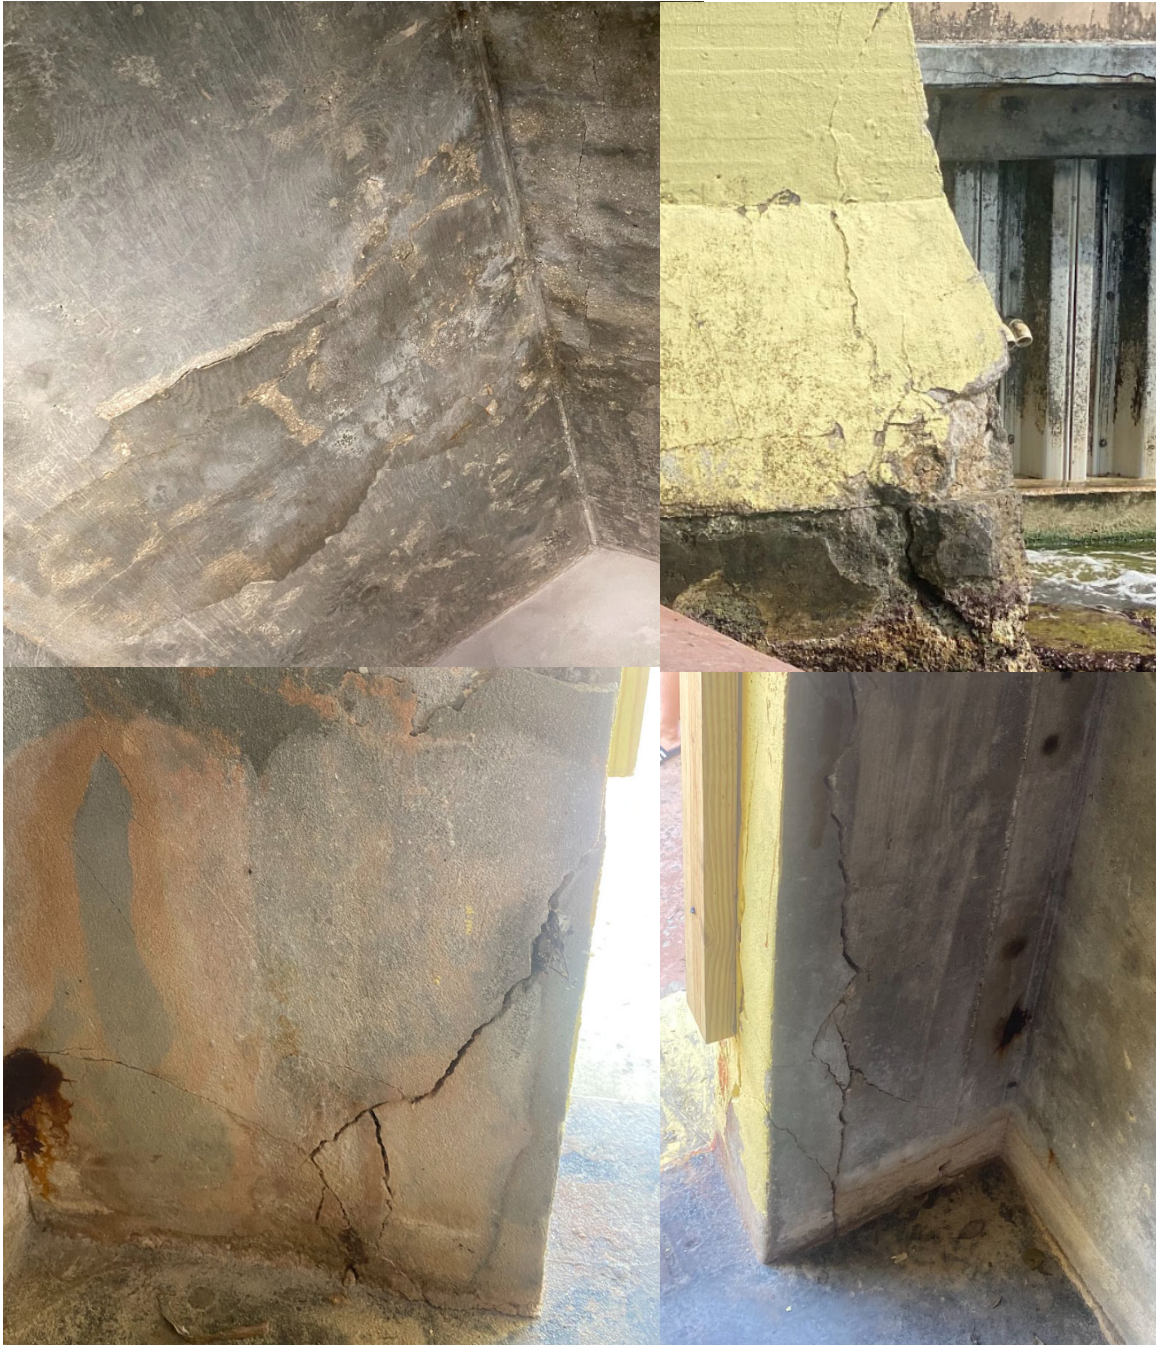
Location 6. Existing condition of The Cable Hut structure inside and outside
Issue: from inside: significant concrete spalling around entry door opening (missing door) and roof slab, visible leaking spots around cracks area;
from outside: Damaged concrete corner
Recommendations: repair spalling concrete per final structural details.

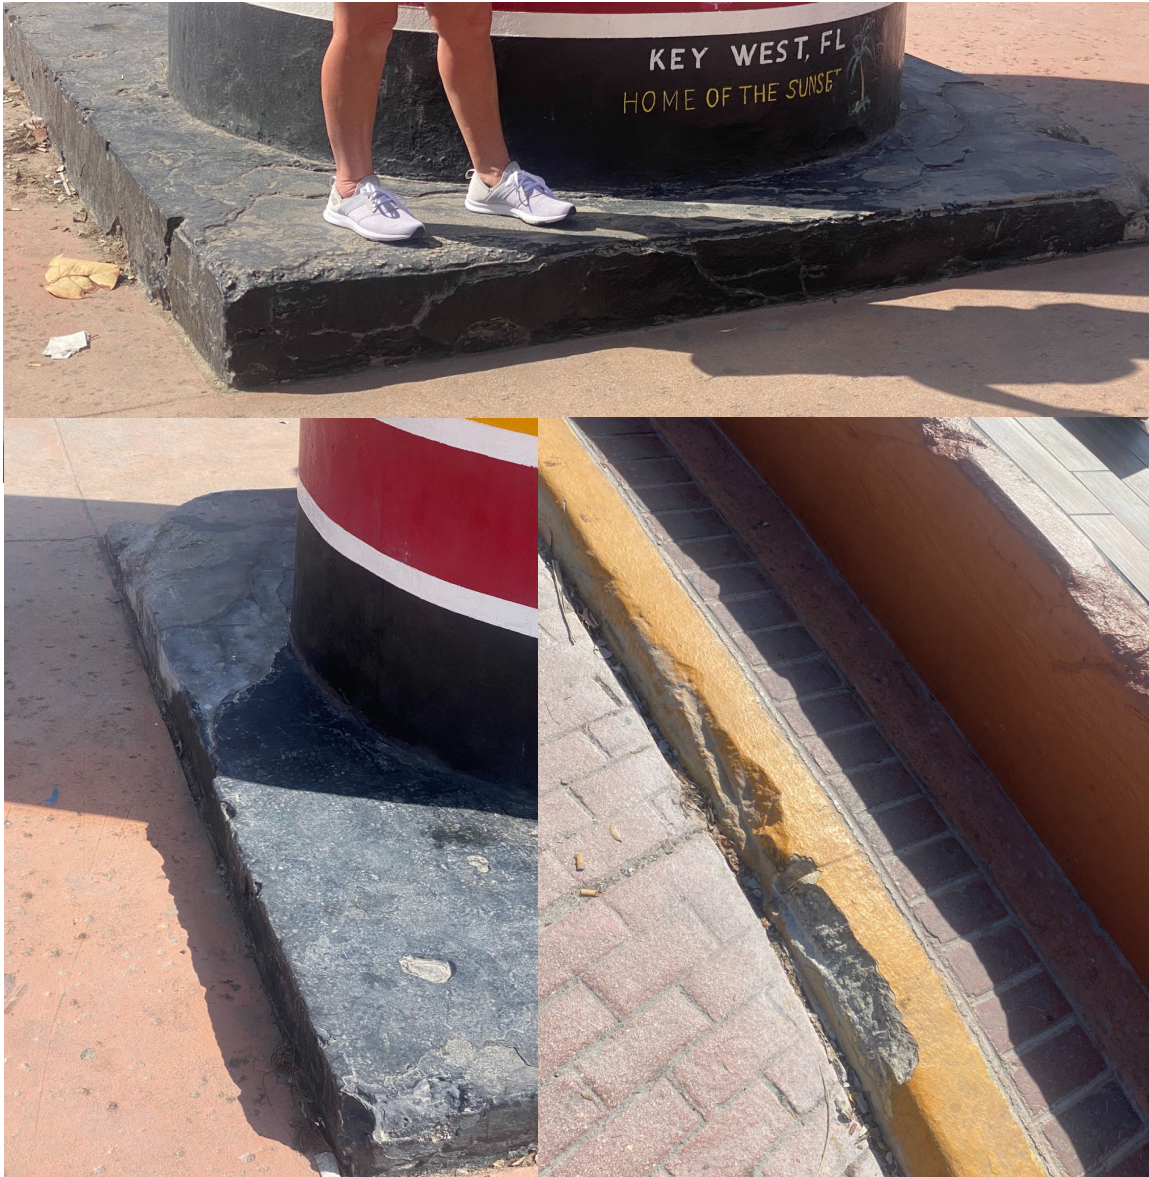
Location 7. Existing condition of Buoy concrete pad and the nearby curb of sidewalk
Issue: failing corners of concrete pad and curb, cracks in the surrounding concrete sidewalks.

Recommendations: Likely erosion of the supporting soils below sidewalks surrounding the landmark requires significant repairs of the area including the removal of the sidewalk. The Southernmost Point Buoy itself may need to be relocated for the duration of the construction activities to provide the access to the famous location and provide for a safe construction zone of the auger cast piled foundations, seawall reconstruction, etc.

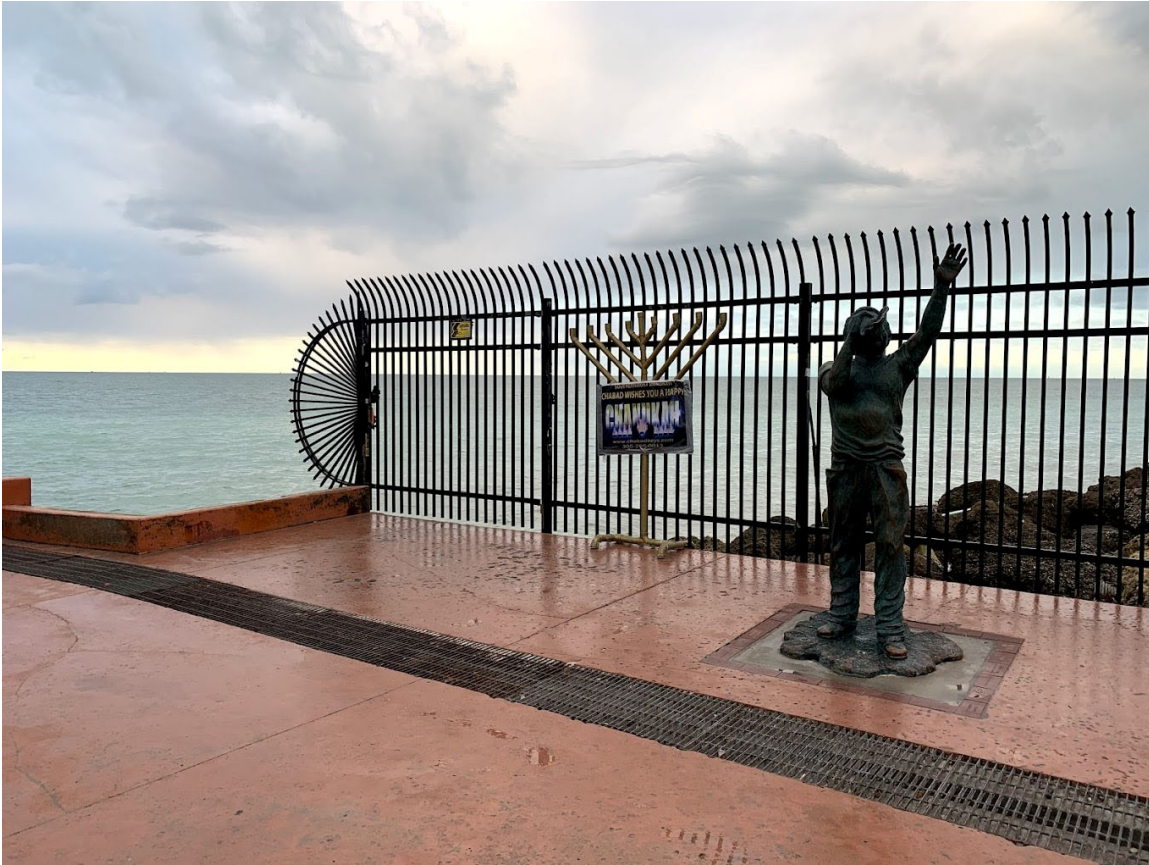
Historic Images: Photo Dated 01-01-2021 (Source: Google Maps). Demonstrating the intact seawall and sidewalk.

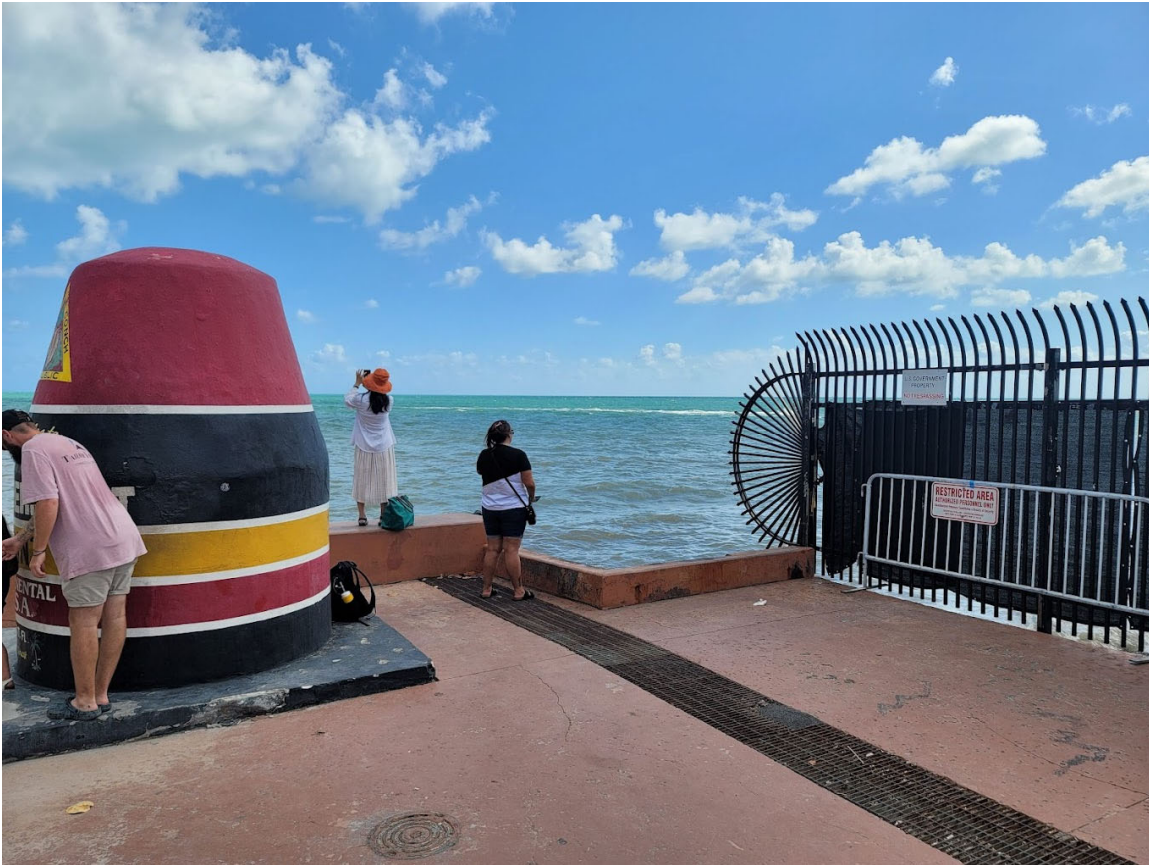
Historic Images: Photo Dated 10-02-2021 (Source: Google Maps). Demonstrating the intact seawall and sidewalk.
