# Florida Technical, Inc.

July 1, 2014

**Re: KRESS BUILDING – CANOPY INSPECTION**  
Key West, Florida

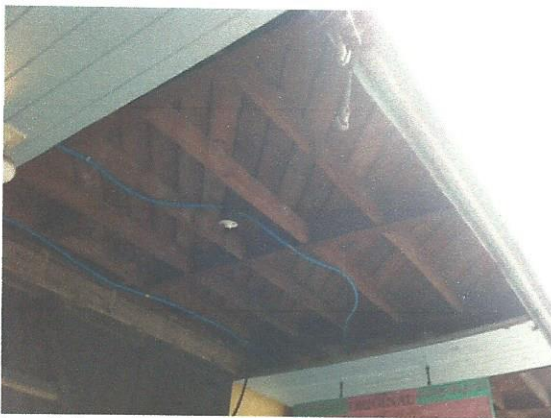
2 x 6 framing w/ 1 x 4 decking

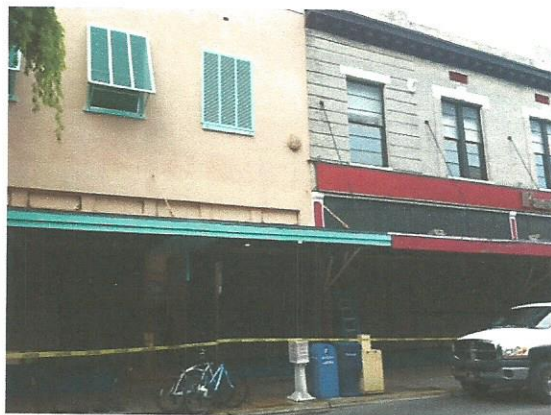
Duval Street – turnbuckle support above

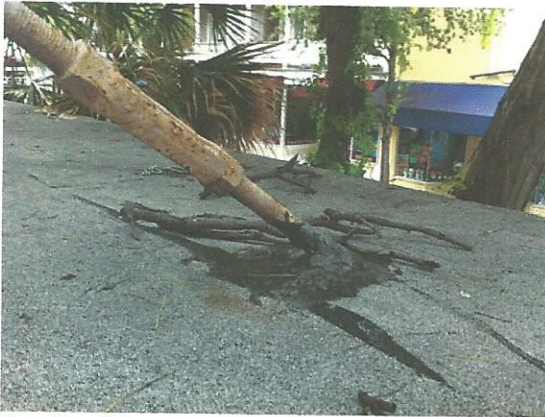
Turnbuckle attachment – Margaritaville

The canopy support over Margaritaville is rigidly attached. Interestingly, the support over the Fast Buck Freddie's portion of the canopy is a 'hooked' system, providing bearing support only. The canopy could be lifted, and the rod 'unhooked' from the canopy. Such a system could more easily fail in storm force wind conditions, than the system supporting the Margaritaville canopy portion.

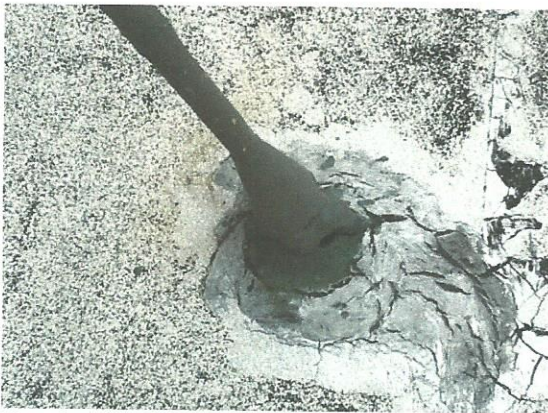
Turnbuckle attachment – Fast Buck Freddie's

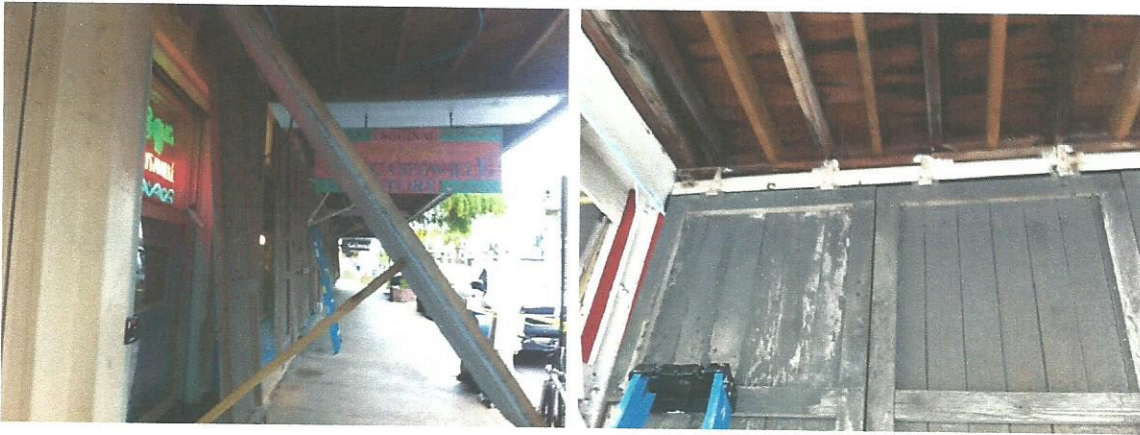
Not an integral component of the canopy structure, hinged wood panels area attached to the underside of the canopy intended to provide debris protection for the building store front glass below. Photos below:

The contractor assisting with the inspection, noted several pieces of broken hardware holding the panels in the 'up' position. The apparent intent is for the panels to be swung down prior to storm force winds impacting Key West to protect the store front glass. The panels do NOT provide adequate protection against wind borne debris, are NOT properly fastened in the 'down' position, and do NOT cover all doorways. In addition, with several broken fasteners, the panels DO pose a safety risk to pedestrians.

**In my professional opinion, the storm panels can NOT adequately function to protect the adjacent tenancies, and DO pose a risk to the public. The panels should be properly secured or fastened in the 'up' position. Adjacent tenancies should purchase/provide proper wind borne debris protection against storm force winds.**
