RESOLUTION NO. 23-314

A RESOLUTION OF THE CITY COMMISSION OF THE CITY OF KEY WEST, FLORIDA, APPROVING AN ENVIRONMENTAL PERMITTING TASK ORDER FOR CHARTER BOAT ROW SEAWALL REPLACEMENT TO TETRA TECH, INC. IN THE AMOUNT OF \$160,952.00, UNDER THE CITY'S ENVIRONMENTAL ENGINEERING SERVICES CONTRACT; AUTHORIZING THE CITY MANAGER TO EXECUTE NECESSARY DOCUMENTS UPON CONSENT OF THE CITY ATTORNEY; PROVIDING FOR AN EFFECTIVE DATE

Tetra Tech is pleased to submit this revised seawall assessment summary report for your review. The report discusses the condition of the City Marina at Garrison Bight (Charter Boat Row) seawall along the Southeast side of the Palm Avenue Causeway and provides our recommendations.

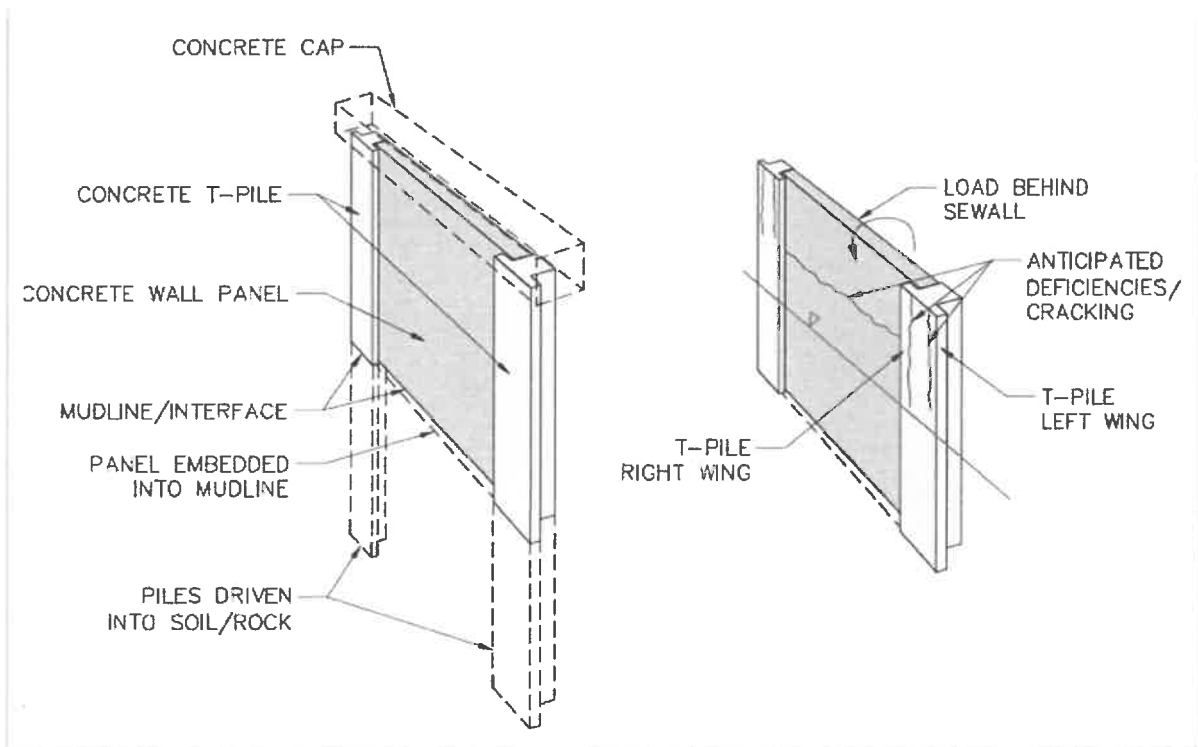
*Figure 3: Typical Observed T-Pile Layout (left) and Anticipated Deficiencies (right)*

With respect to “T-pile” wall systems, one of the anticipated modes of failure is typically from cracking of the wings/flanges of the piles as they tend to be too thin to allow proper cover of the rebar reinforcement, leading to corrosion of the rebar and spalling of the concrete. Given that concrete “T-pile” wall systems are no longer in wide use, and the markings on some piles (i.e. “9-4-64”) indicating that they were cast in 1964, it can be assumed that the seawall is approximately 55+ years old. Many “T-pile” walls were constructed in South Florida in the 1960’s. “T-pile” walls have fallen out of favor due largely to the failure of the wings/flanges and have been replaced by other more reliable joining methods. Concrete pile & panel bulkhead systems typically have an anticipated service life of about 50-60 years.

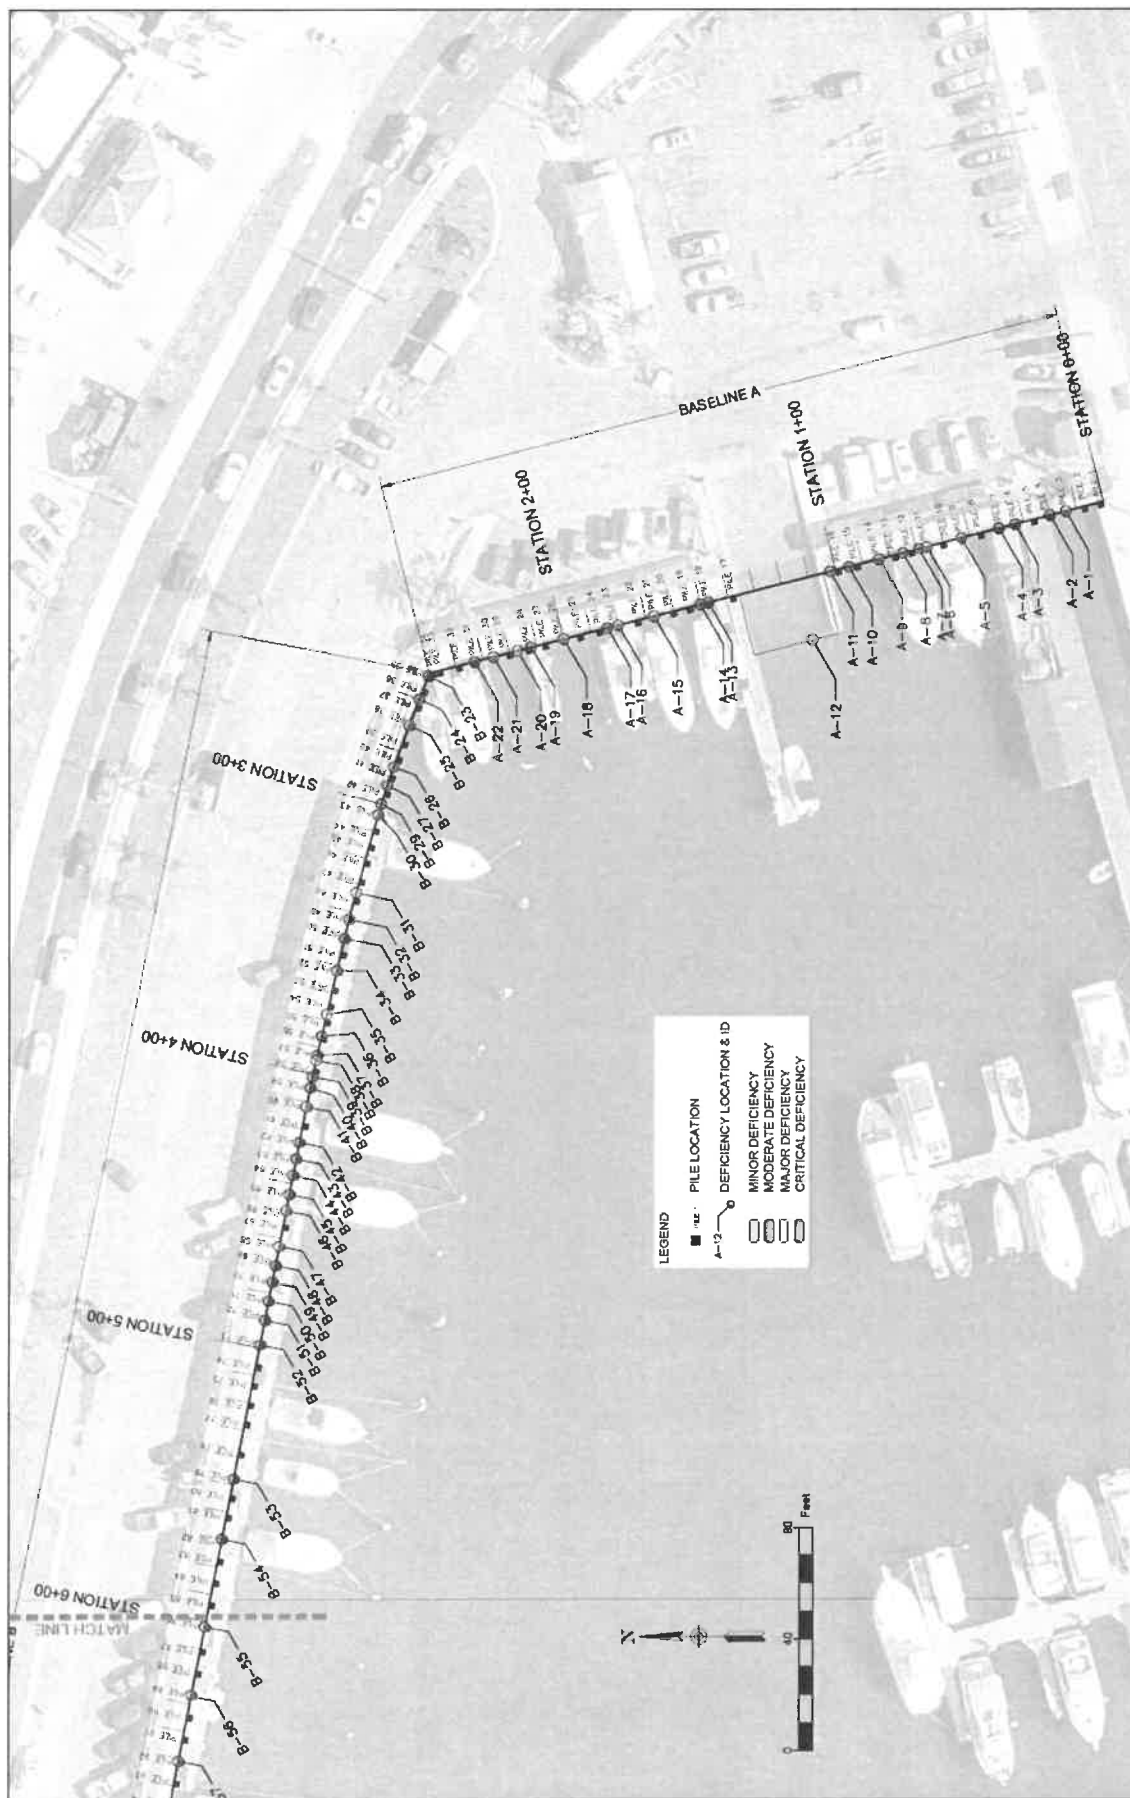
Figure 5: Deficiency Locations - Station 0+00 to Station 6+00

Deficiencies have been quantified/described in Table 2 and their general locations can be seen on Figure 5 and Figure 6. Each deficiency has been given a numerical value preceded by the Baseline (A or B). The "location/pile #" indicates the structural component for the deficiency being addressed (referenced to the nearest pile), followed by a station which generalizes the location along the inspection transect.

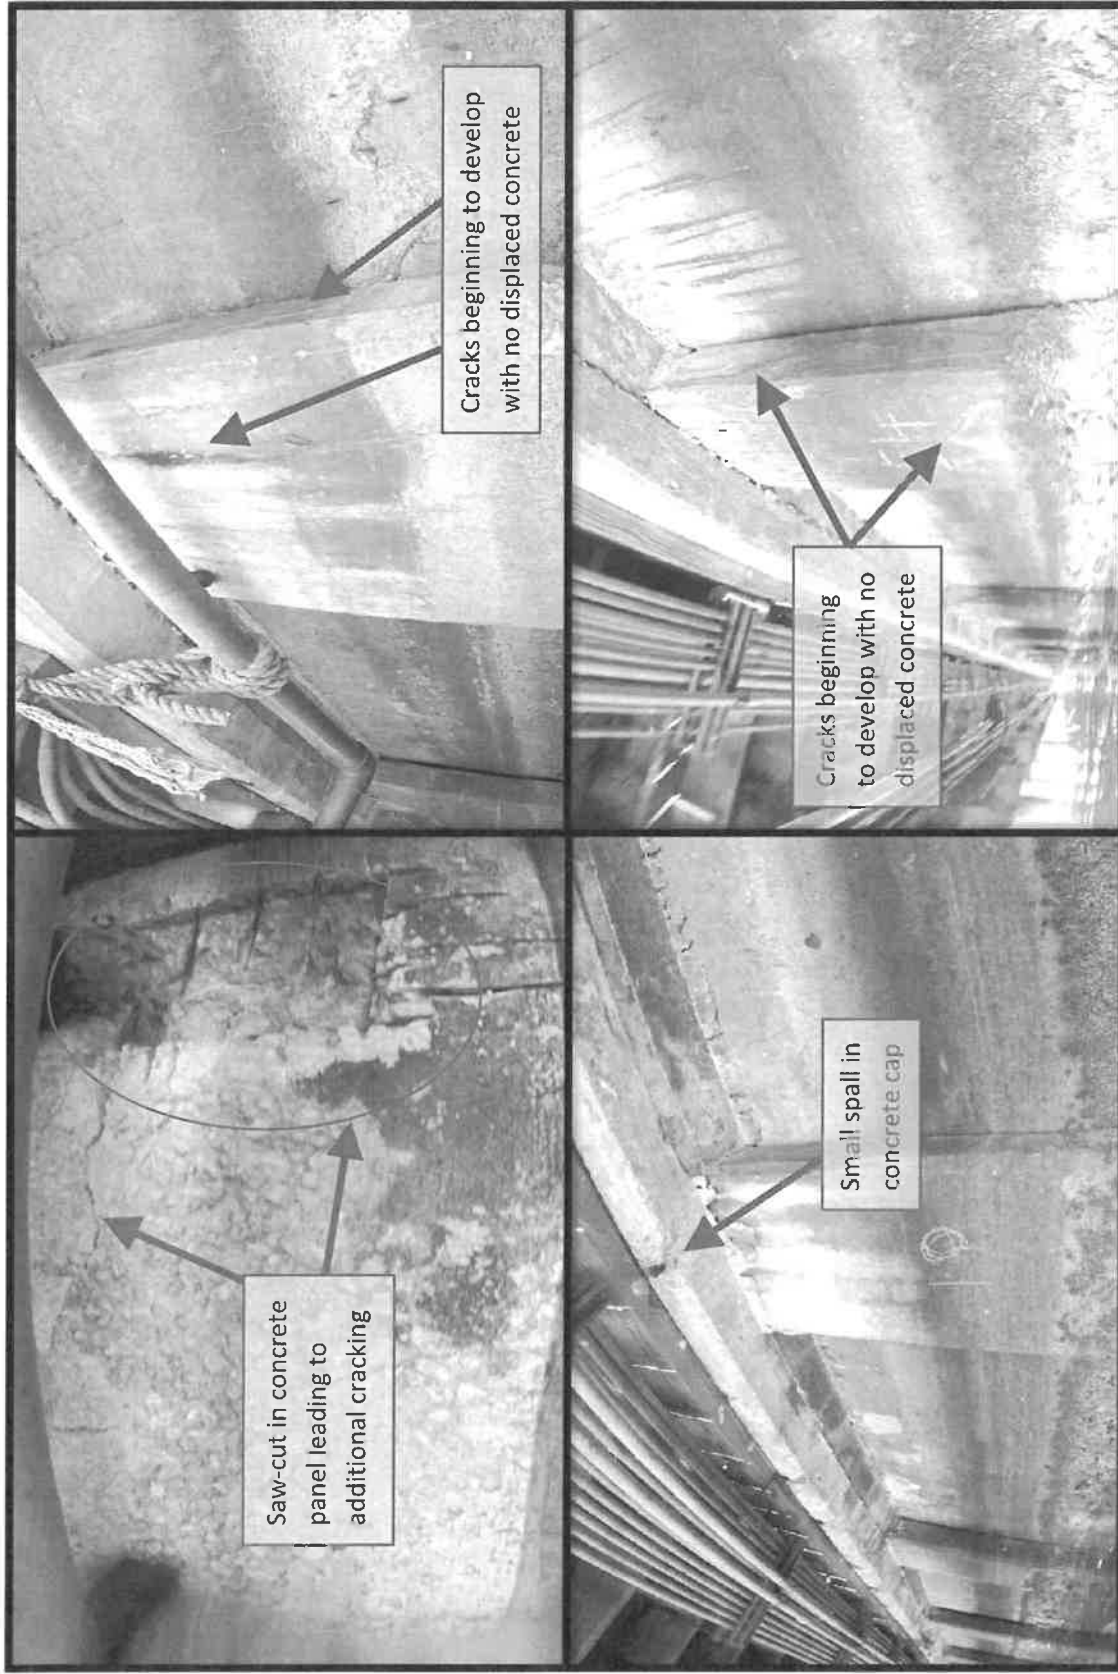
| Baseline / Deficiency ID | Location / Pile # | Approx. Station Center | Deficiency Type | Description |
|---|---|---|---|---|
| A-1 | Panel 3-4 | 0+14 | Minor | 14"x8" saw-cut hole in panel beside Pile 3 with some cracking extending from the cuts. |

Figure 7: Typical Minor Deficiencies – [Top Left] A-1 (Station 0+14), [Top Right] B-30 (Station 3+04), [Bottom Left] B-34 (Station 3+62), [Bottom Right] B-59 (Station 6+82)

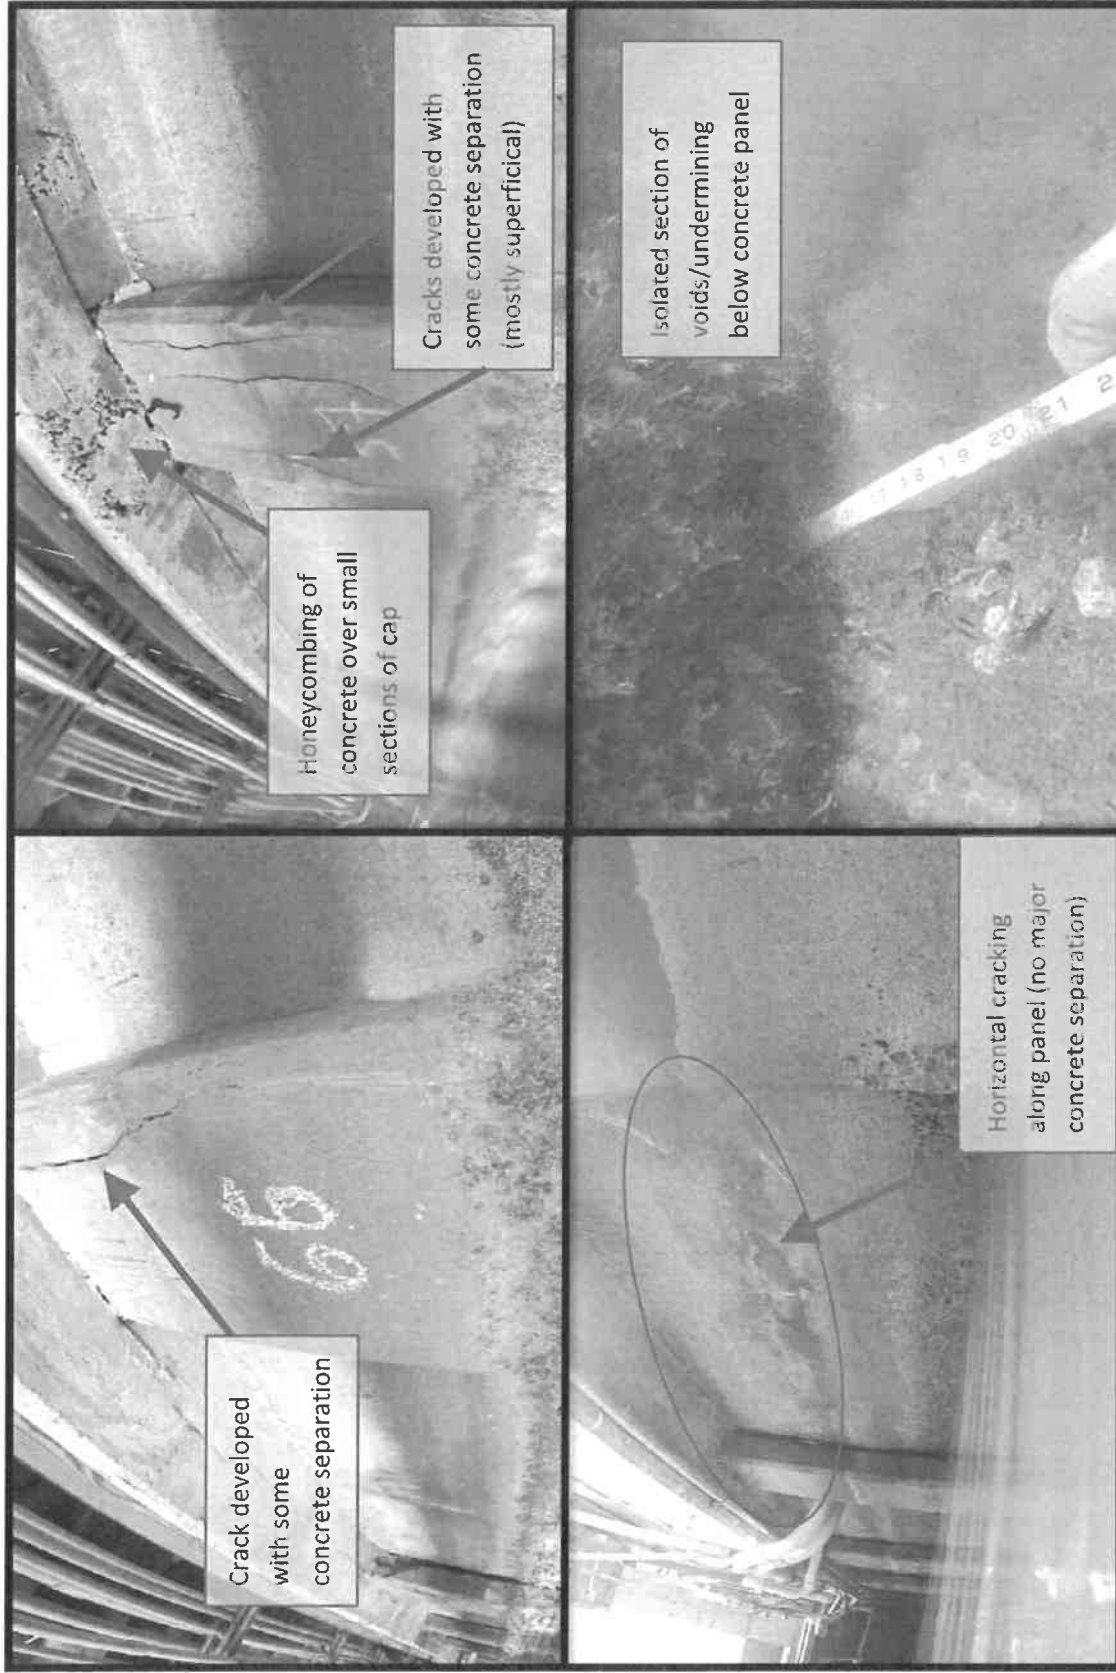
Figure 8: Typical Moderate Deficiencies – [Top Left] B-70 (Station 7+86), [Top Right] B-53 (Station 5+48), [Bottom Left] B-26 (Station 2+86), [Bottom Right] B-102 (Station 10+06)

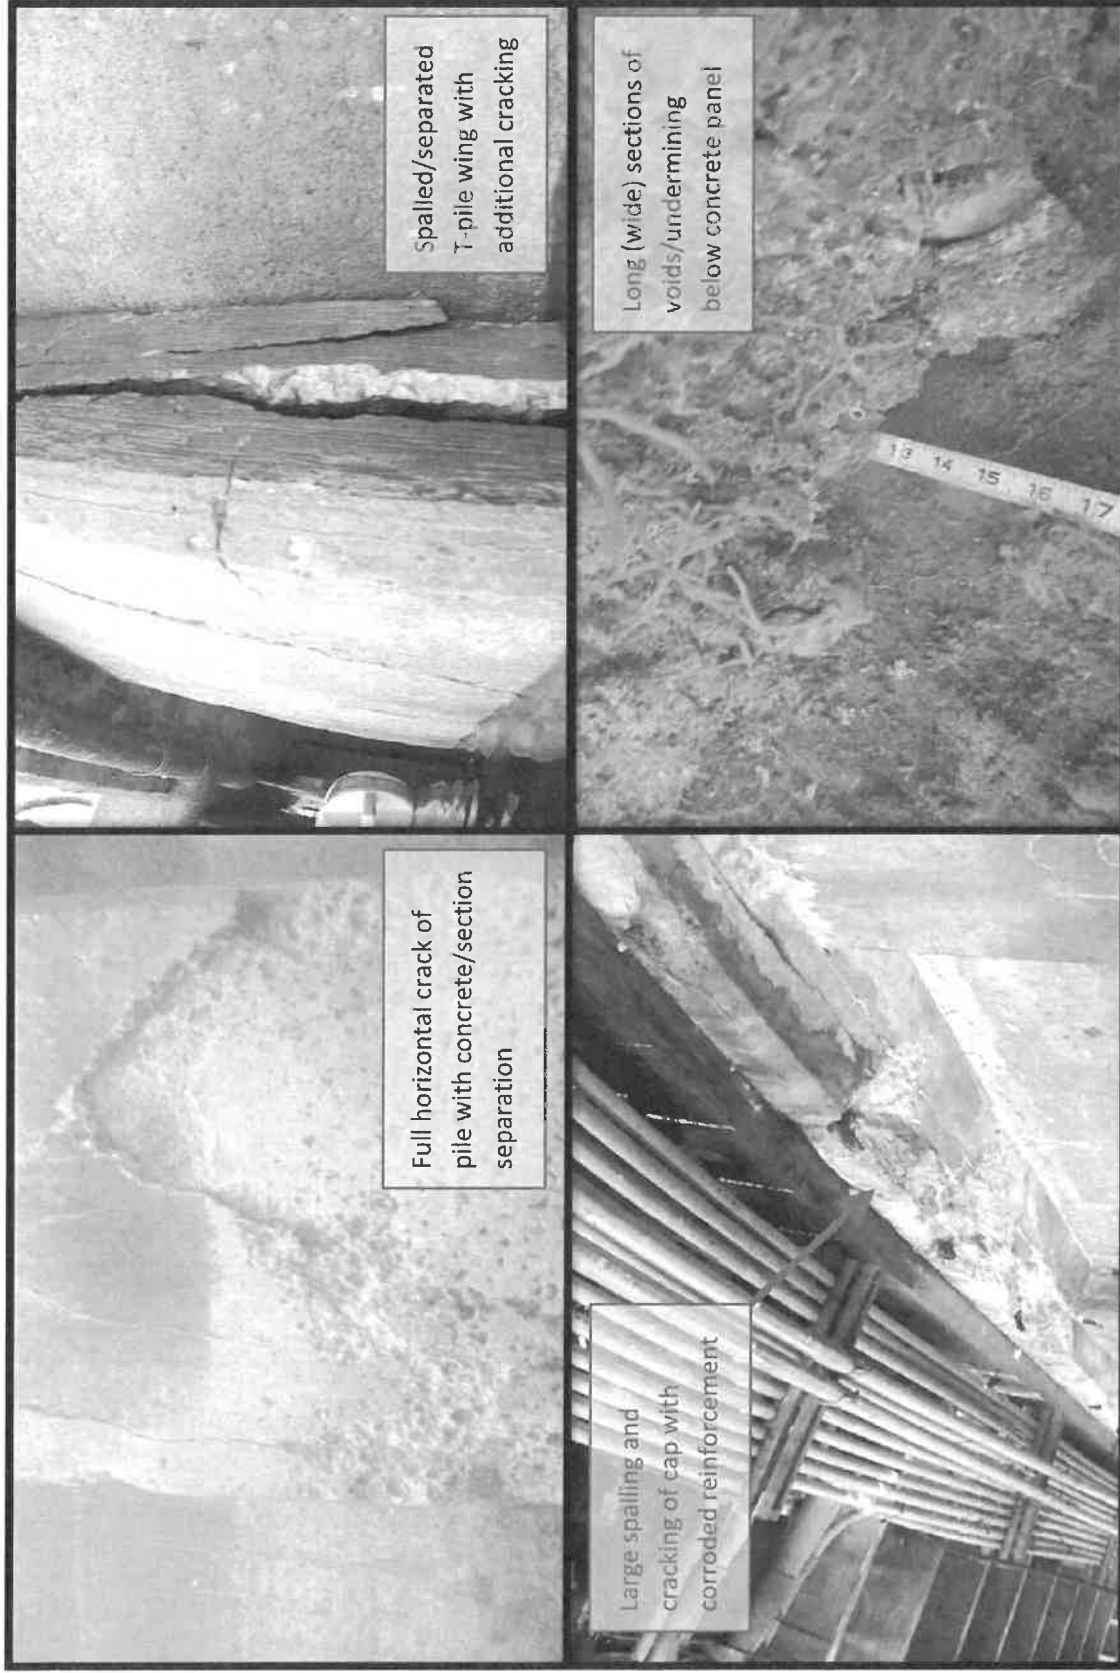
For Major deficiencies as noted above, the deficiencies consisted of damage to the structural elements that can then significantly lead to damage of other adjacent structural elements. Mostly consisting of cracks/spalls on the piles, the weakened sections of the pile wings would lead to the concrete panel walls to begin tilting waterward. As most of the observed cracks/spalls were observed at the splash zone and above, it is clear that the loads behind the seawall will continue to add pressure to the seawall (greater along the top) escalating the damage already observed. With void/undermining areas beneath the concrete panel walls, the “rolling” effect of the seawall can become greater. The other possible effect of undermining is the loss of material behind the seawall which could lead to damage of upland structures (i.e. sidewalks, pavement, etc.). Areas most notably affected by these types of deficiencies, where compounding effects could lead to further damage and failure extend from approximately Station 7+38 to Station 7+96 and Station 8+42 to Station 9+86. Typical images of major deficiencies are shown on Figure 9.

Figure 9: Typical Major Deficiencies – [Top Left] A-6 (Station 0+66), [Top Right] A-15 (Station 1+67), [Bottom Left] B-35 (Station 3+78), [Bottom Right] B-77 (Station 8+42 - 8+75)

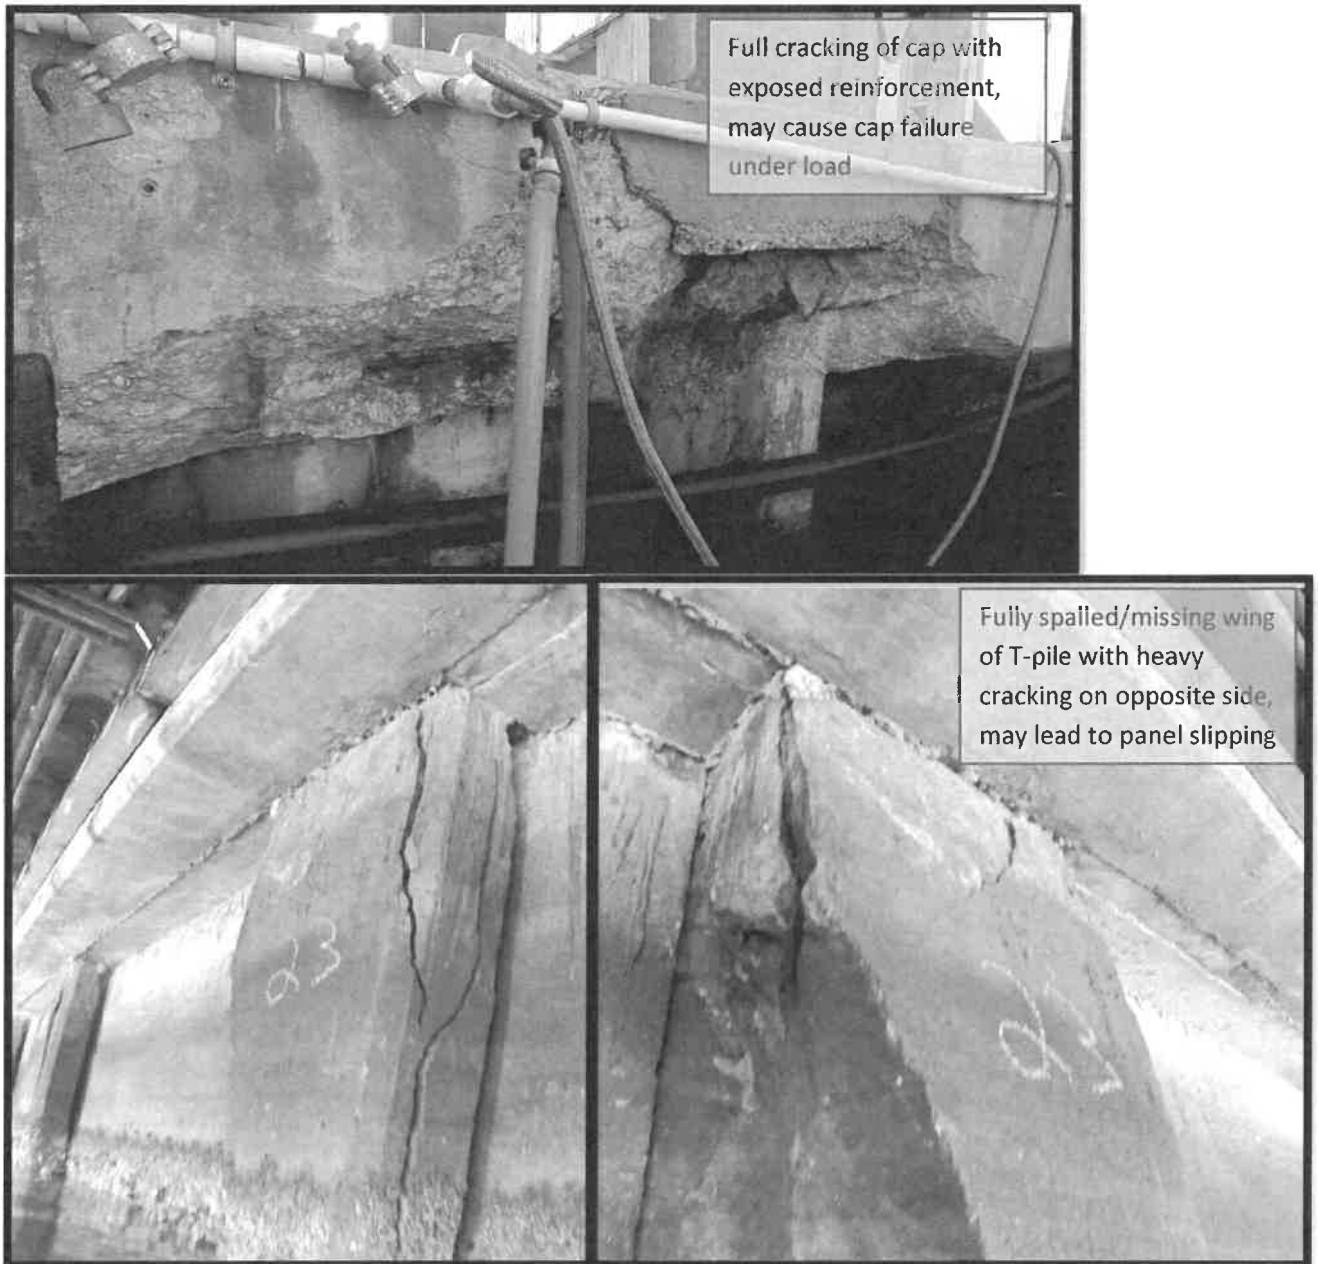
For the Critical deficiencies noted above, of which there were only two (2), the deficiencies showed a failure of the structural element which can then have a cascading effect on the seawall system. At Station 0+39 the spalled concrete cap has exposed rebar that is regularly exposed to additional seawater, causing additional corrosion and leading to separation of the bond/delamination between the concrete cap and seawall. At Station 4+44 the spalled/missing concrete on the pile (Pile 65) appears to already be causing the shifting of the concrete panel wall, as evidenced by the visibility of the panel edge and the damage observed on Pile 66. Images of the critical deficiencies are shown on Figure 10.

*Figure 10: Critical Deficiencies – [Top] A-4 (Station 0+39), [Bottom] B-45 (Station 4+44)*

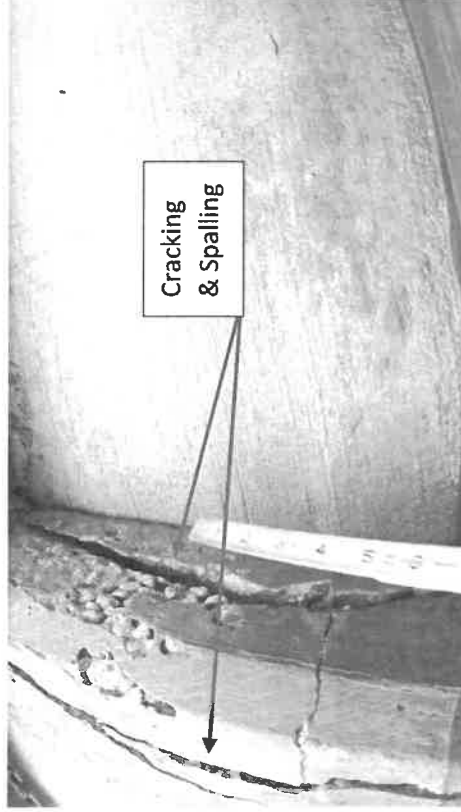
Deficiency A-16: Pile 23 (Station 1+80)

Cracking &  
Exposed Aggregate

Cracking  
& Spalling

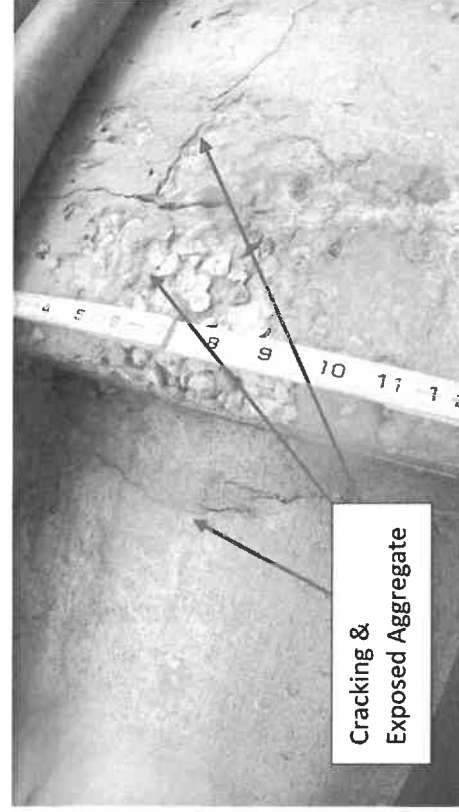
Deficiency A-18: Pile 26 (Station 2+00)\_2 of 2

Cracking &  
Exposed Aggregate

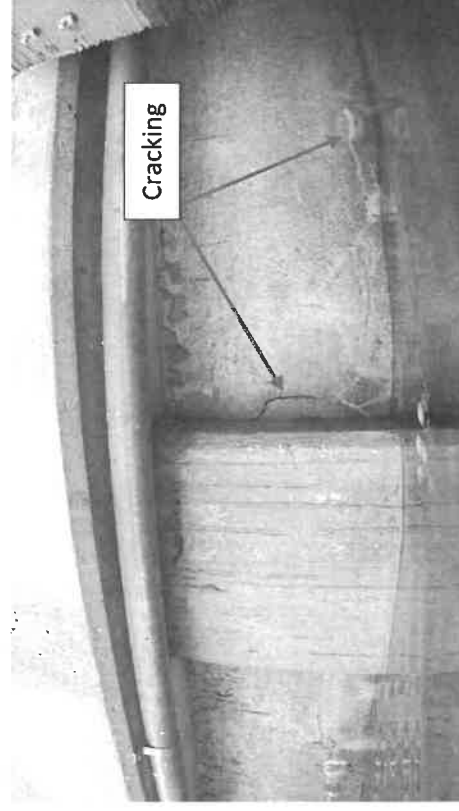
Deficiency A-19: Panel 27-28 (Station 2+12)

Cracking

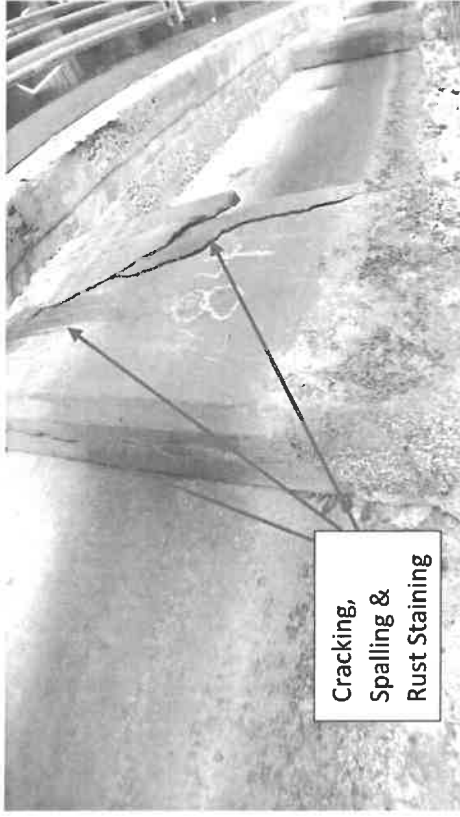
Deficiency B-85: Pile 126 (Station 9+23)

Cracking,  
Spalling &  
Rust Staining

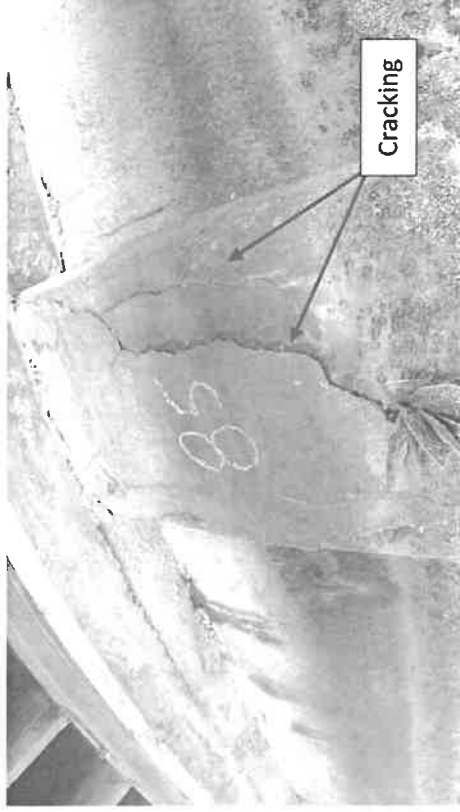
Deficiency B-86: Pile 127 (Station 9+31)

Cracking

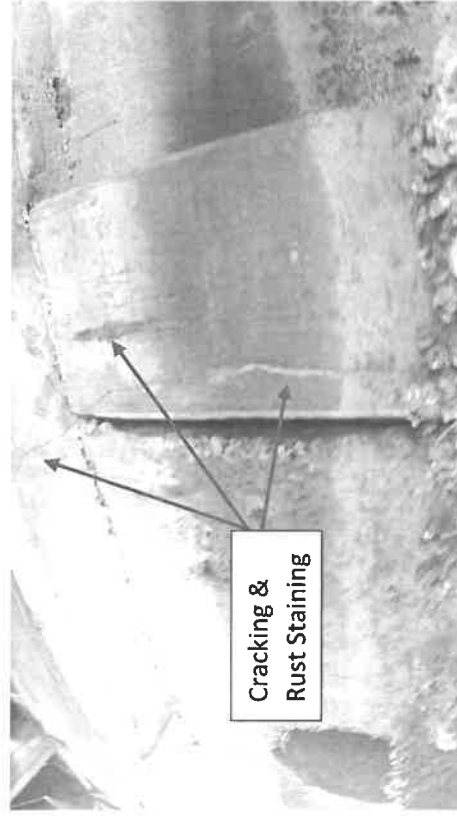
Deficiency B-87: Pile/Cap 128 (Station 9+39)

Cracking &  
Rust Staining
