PRE-RENOVATION ASBESTOS CONTAINING MATERIALS SURVEY

101-111 Geraldine Street | Key West, Florida
PM Project Number 06-3668-2

**Re: Pre-Renovation Asbestos Containing Materials Survey
For the Former Key West Gas and Electric Company
Located at 101-111 Geraldine Street in Key West, Florida
PM Environmental, Inc. Project No. 06-3668-2**

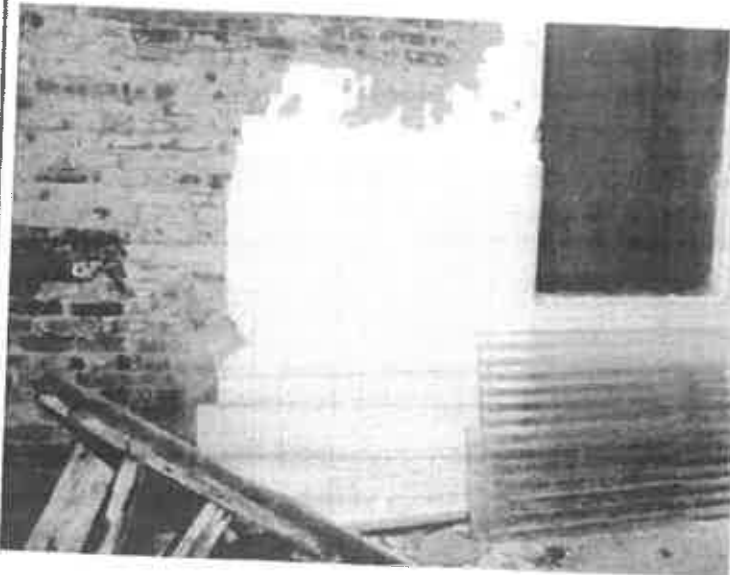
Photograph 2

Tile on the wall of the former showers at the
subject property

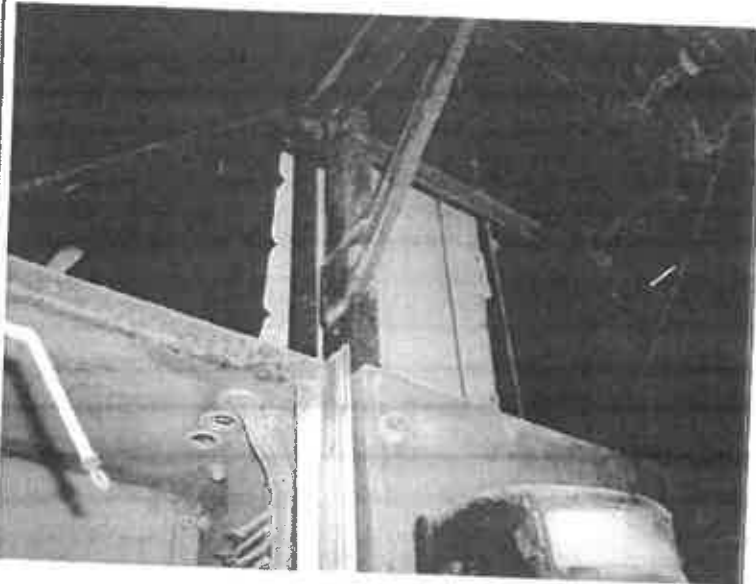
Photograph 4

PM identified the above suspect materials within the building. The results of the laboratory datasheets indicate that Transite panels, wire insulation, window glaze, and pipe insulation to contain regulated quantities of asbestos (above 1 percent). As noted in the summary table, the suspect ACM was also assessed to be in good condition at the time of the inspection. PM did not observe any significant damage to the identified suspect ACM. Laboratory analytical results are attached in Appendix B.

View of Transite panel in the switch station.

The identified ACM should be removed by a licensed Asbestos abatement contractor prior to renovation activities. PM is available to help solicit bids to abatement contractors if requested. PM also recommends facilitating a site walk through to aid abatement contractors in visually locating all identified ACMs.

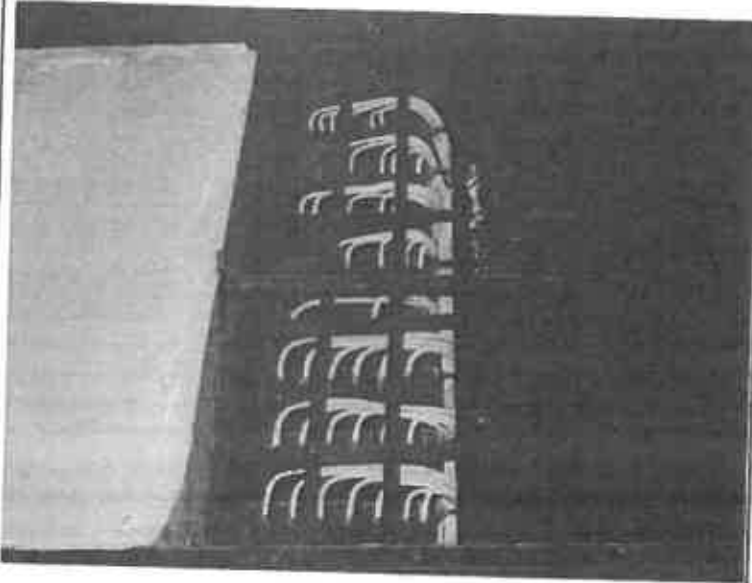
Photograph 5

Wires with ACM insulation at the switch station.

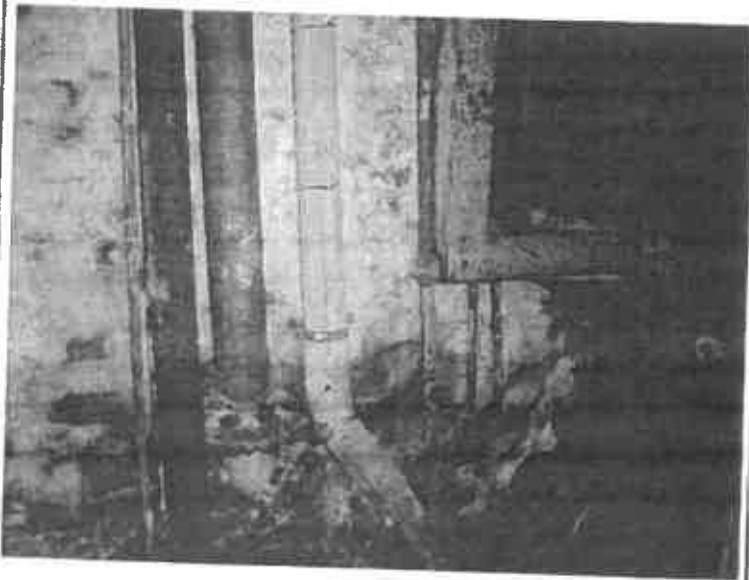
Photograph 6

Pipe insulation
