Cynthia's Blue Palms

638 United Street

Purpose: Following are my findings of evaluation concerning the above described property. Work is performed for Mr. Owen Trepanier, of Trepanier and Associates, INC, Land Planners & Development Consultants.

Tree survey of property was conducted on December 28, 2017. Tree description will be in clockwise manor beginning from southwest portion of property at tree number one (1) progressing to western periphery, north to front of property.

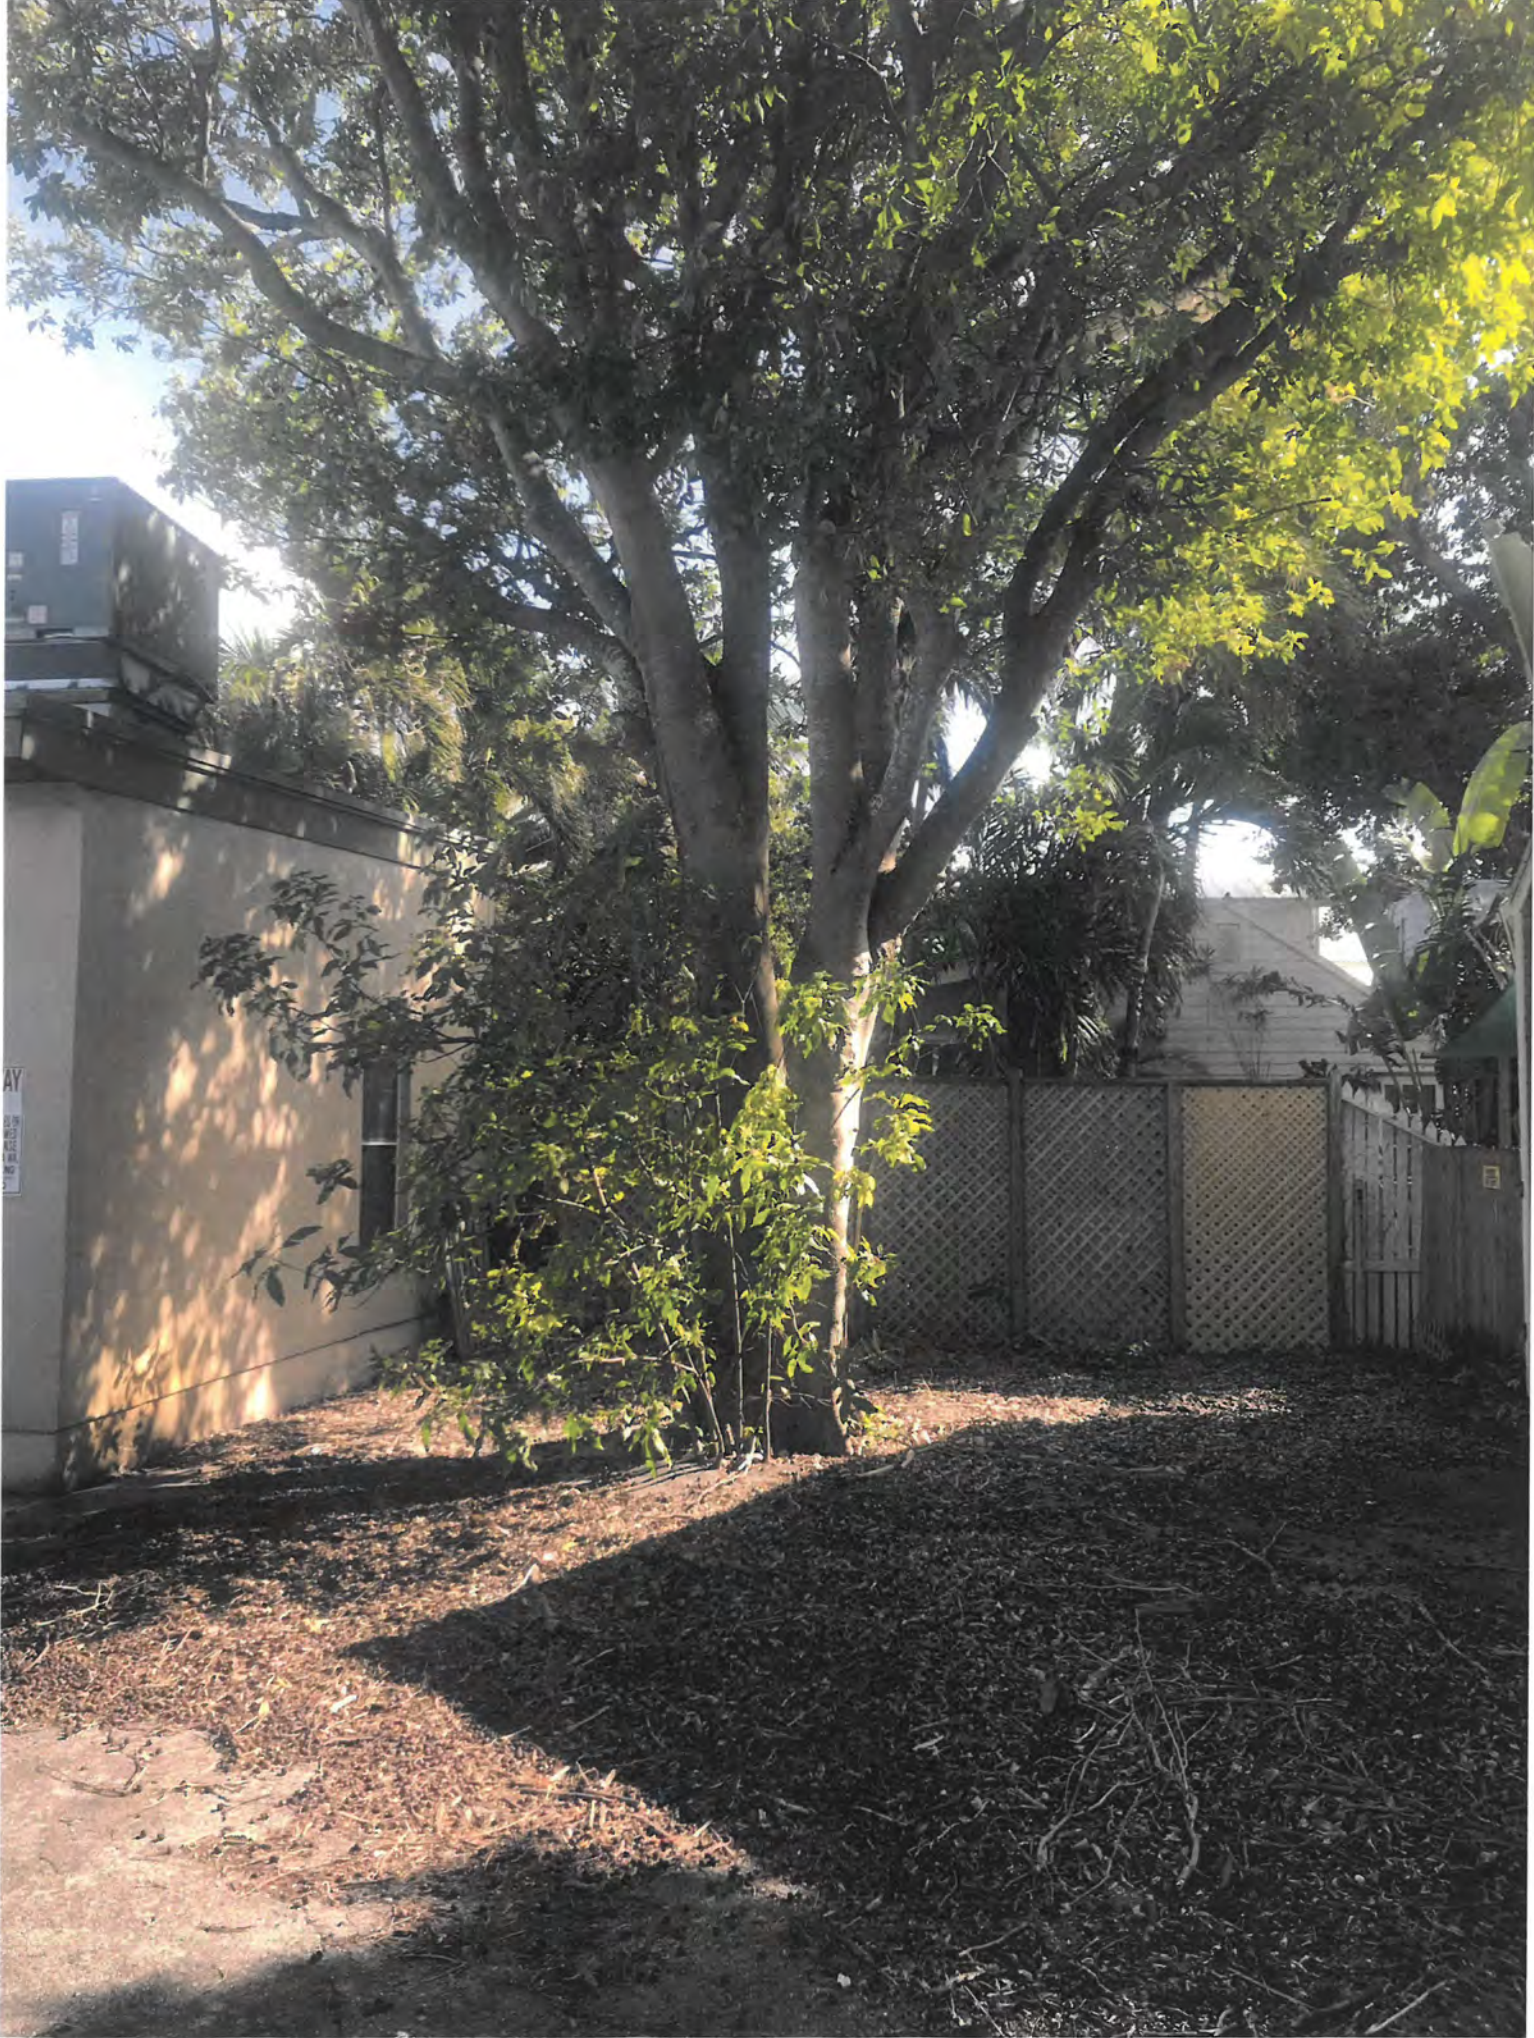
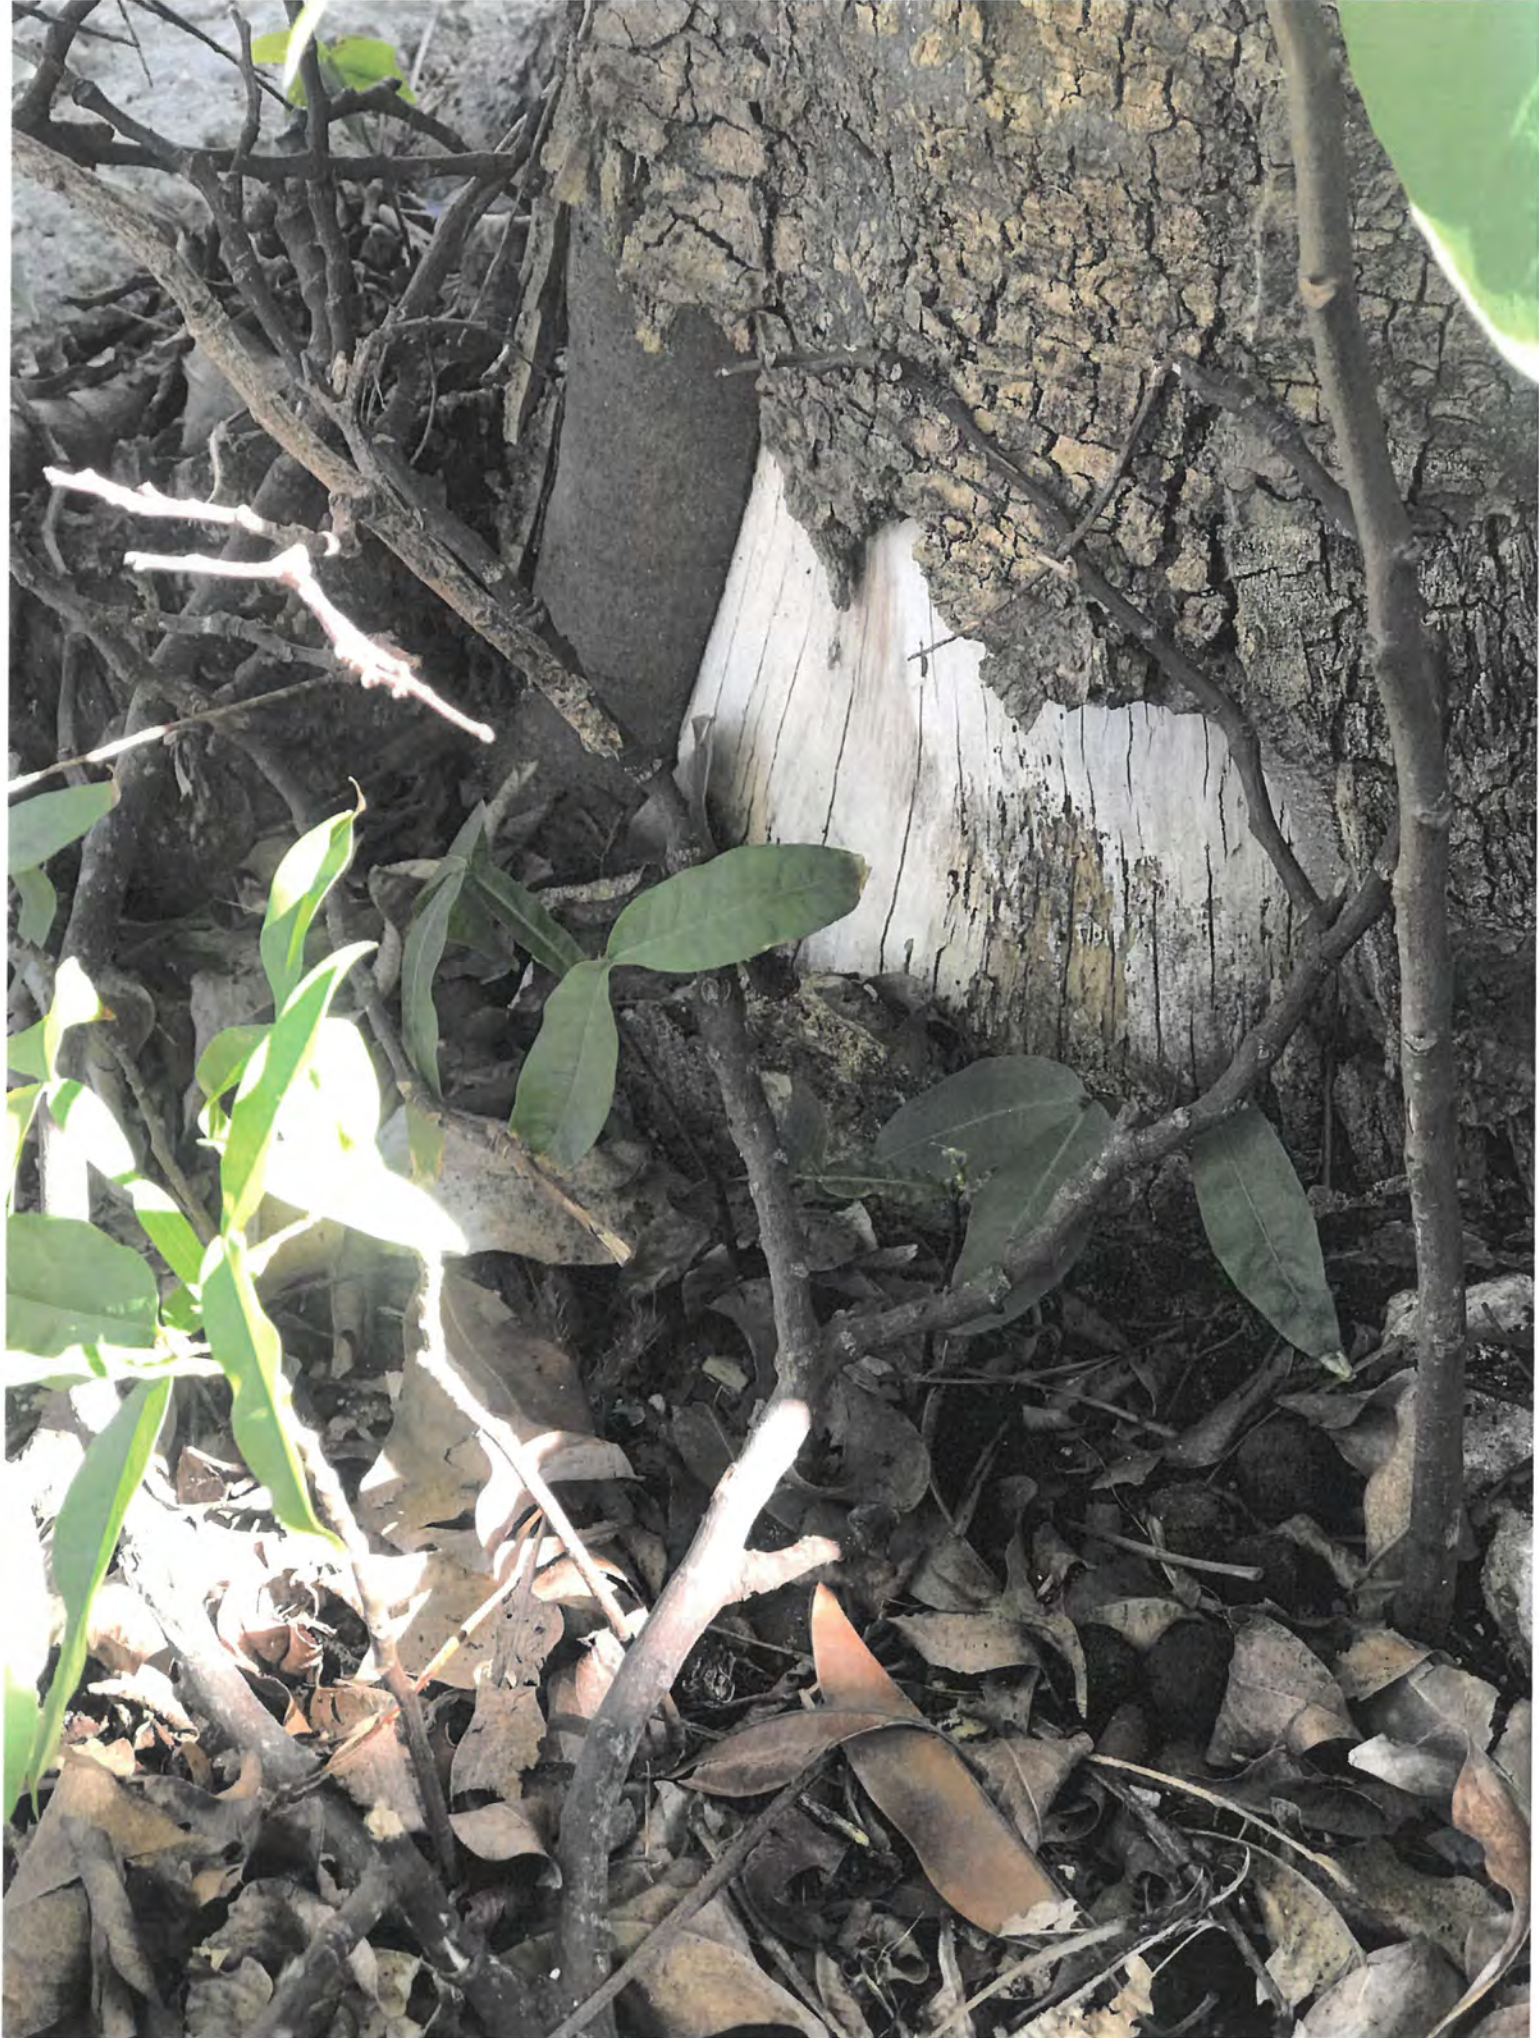
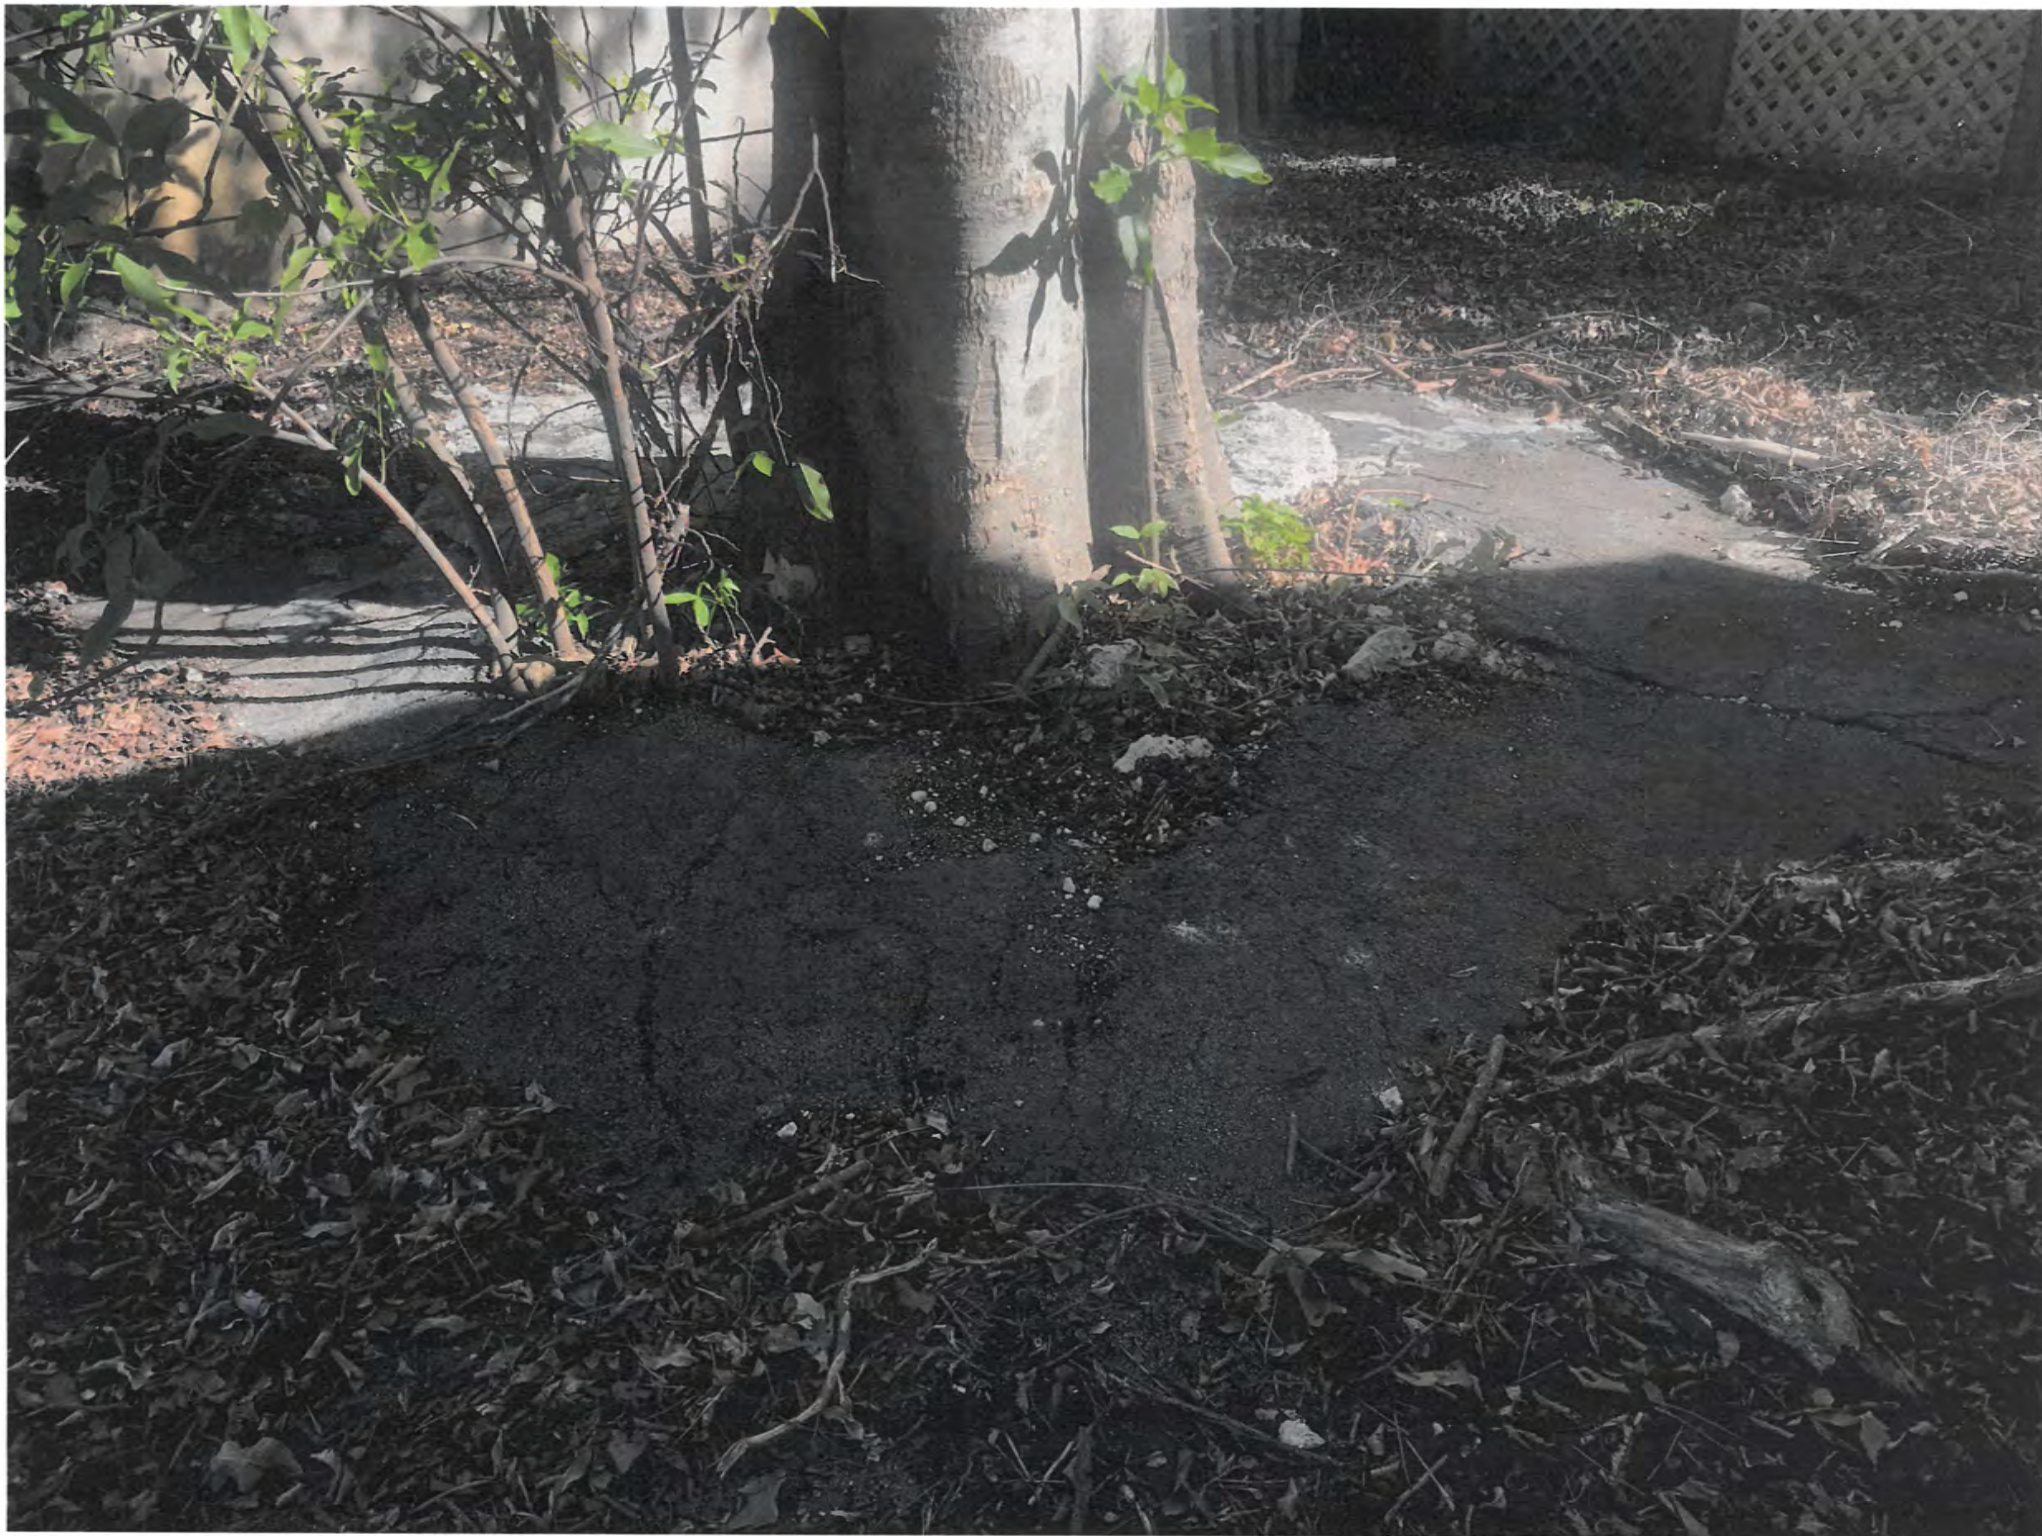
1 Spanish Lime/*Melicoccus bijugatus*. **29"** diameter DBH. Fair condition. Non-native, historically significant, protected tree. Permit required for removal or major maintenance pruning. The Spanish Lime tree is female, having fruit, with basal bark damage on north side of tree from mechanical means. The area of damage is approximately 5"x 10". Trunk has included bark at 3' and 1.5' in length. Canopy is thin with an abundance of tip die-back. Root system is completely encircled with asphalt. Recommend retention removing asphalt to dripline, and apply proper pruning techniques. **Photo 1, 2, 3.**

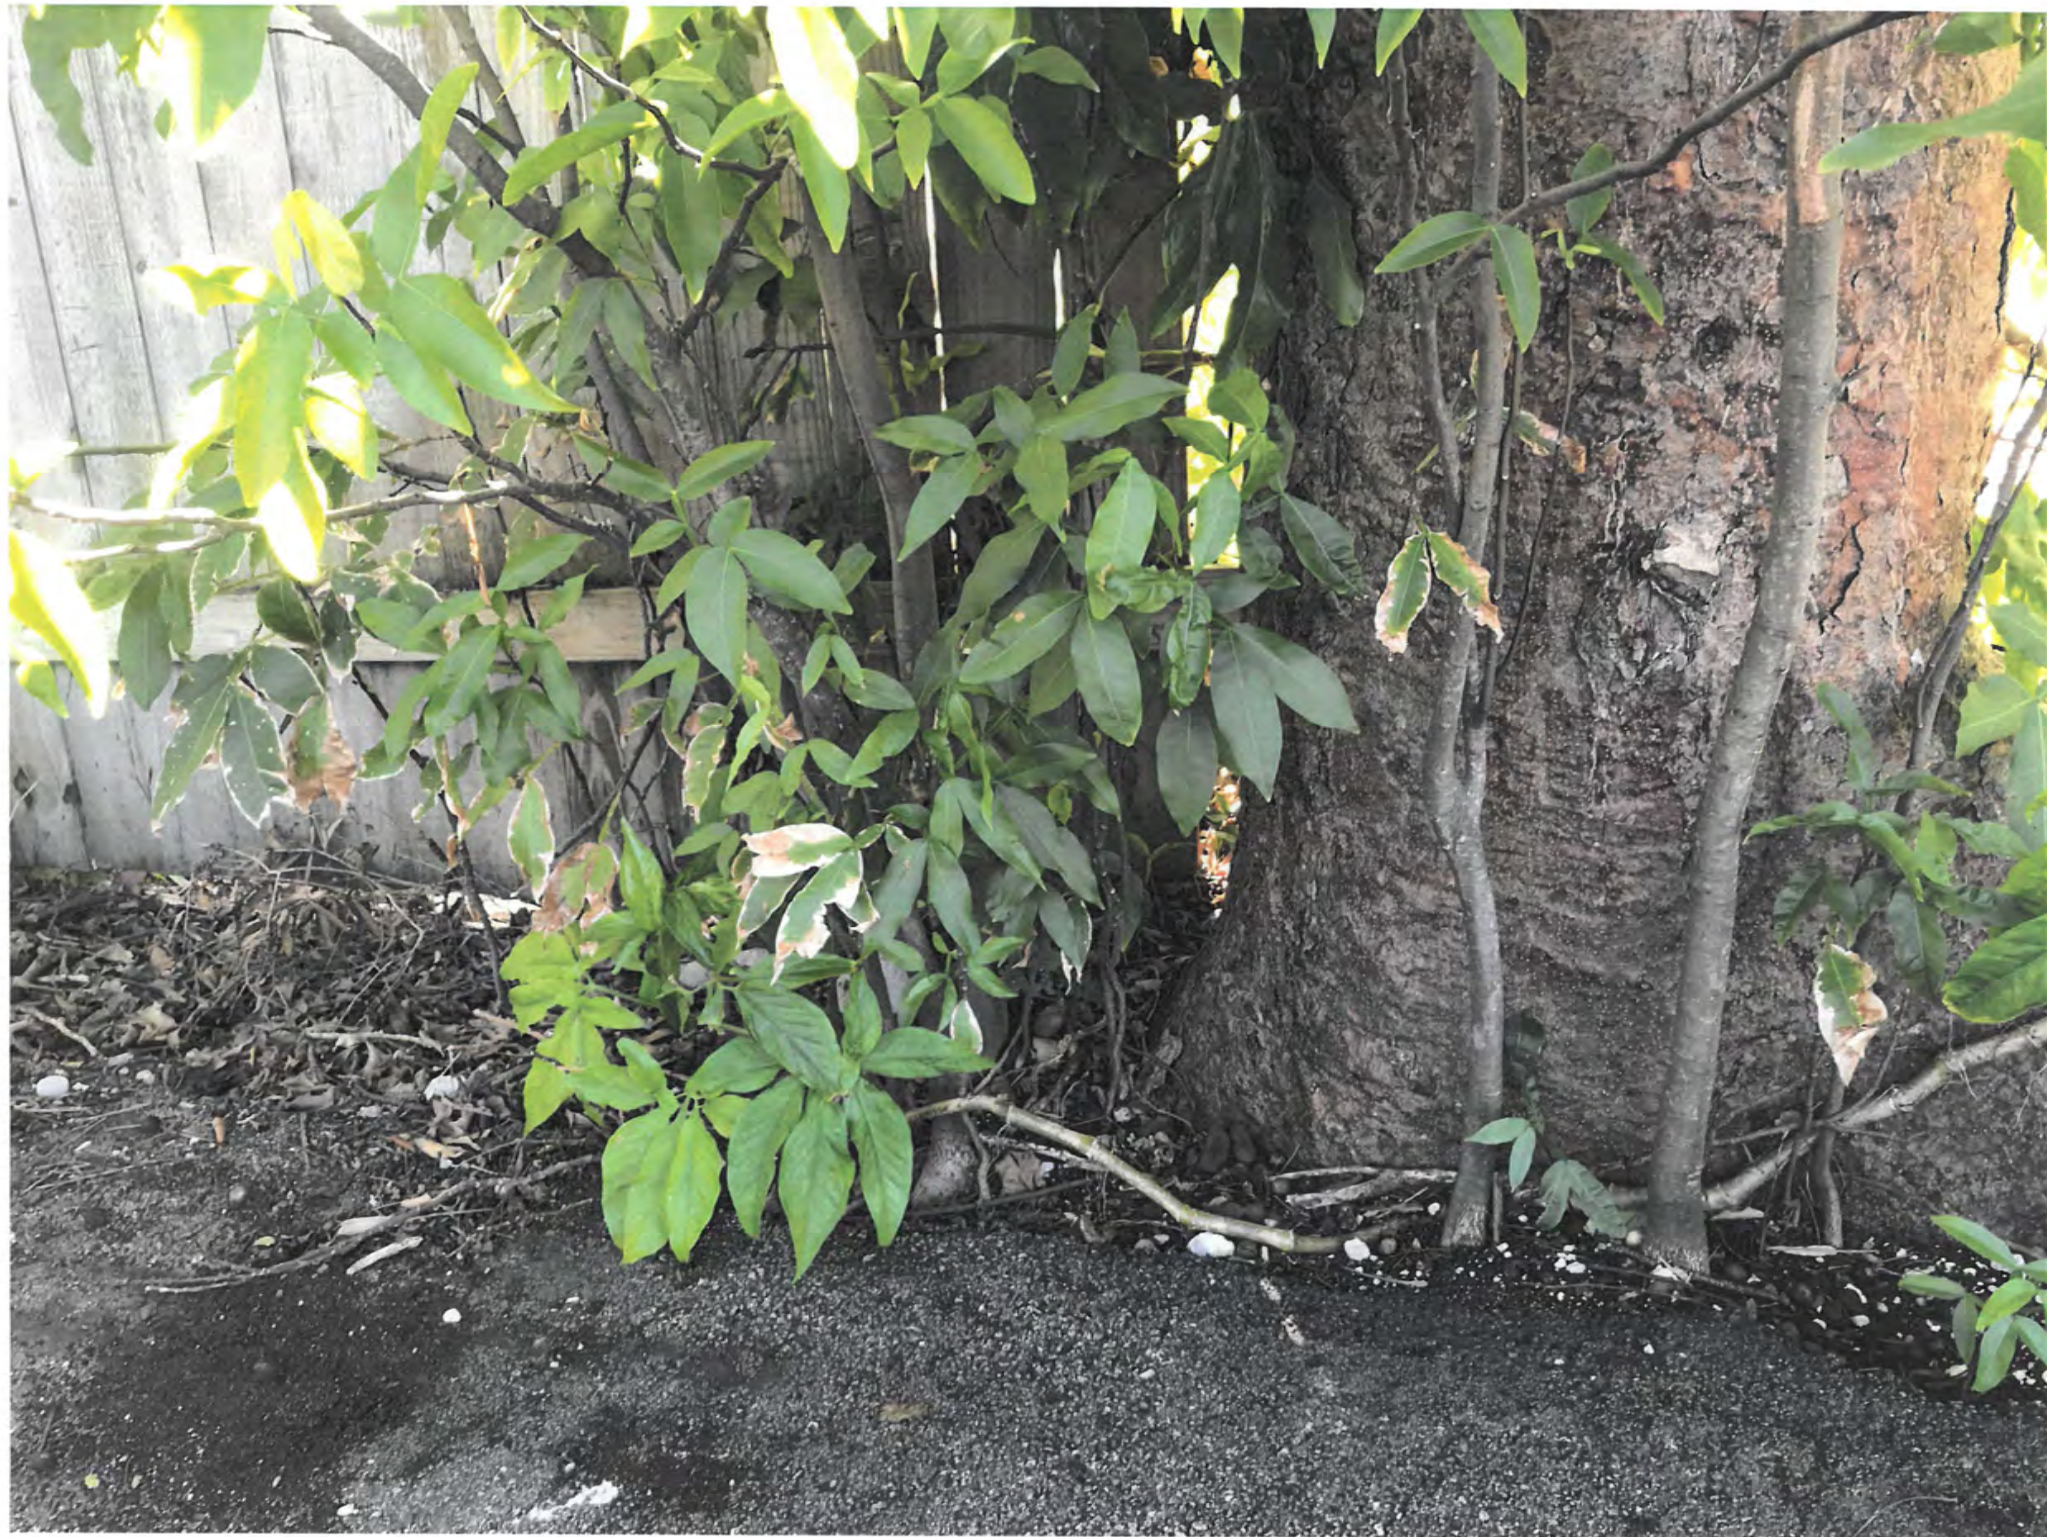
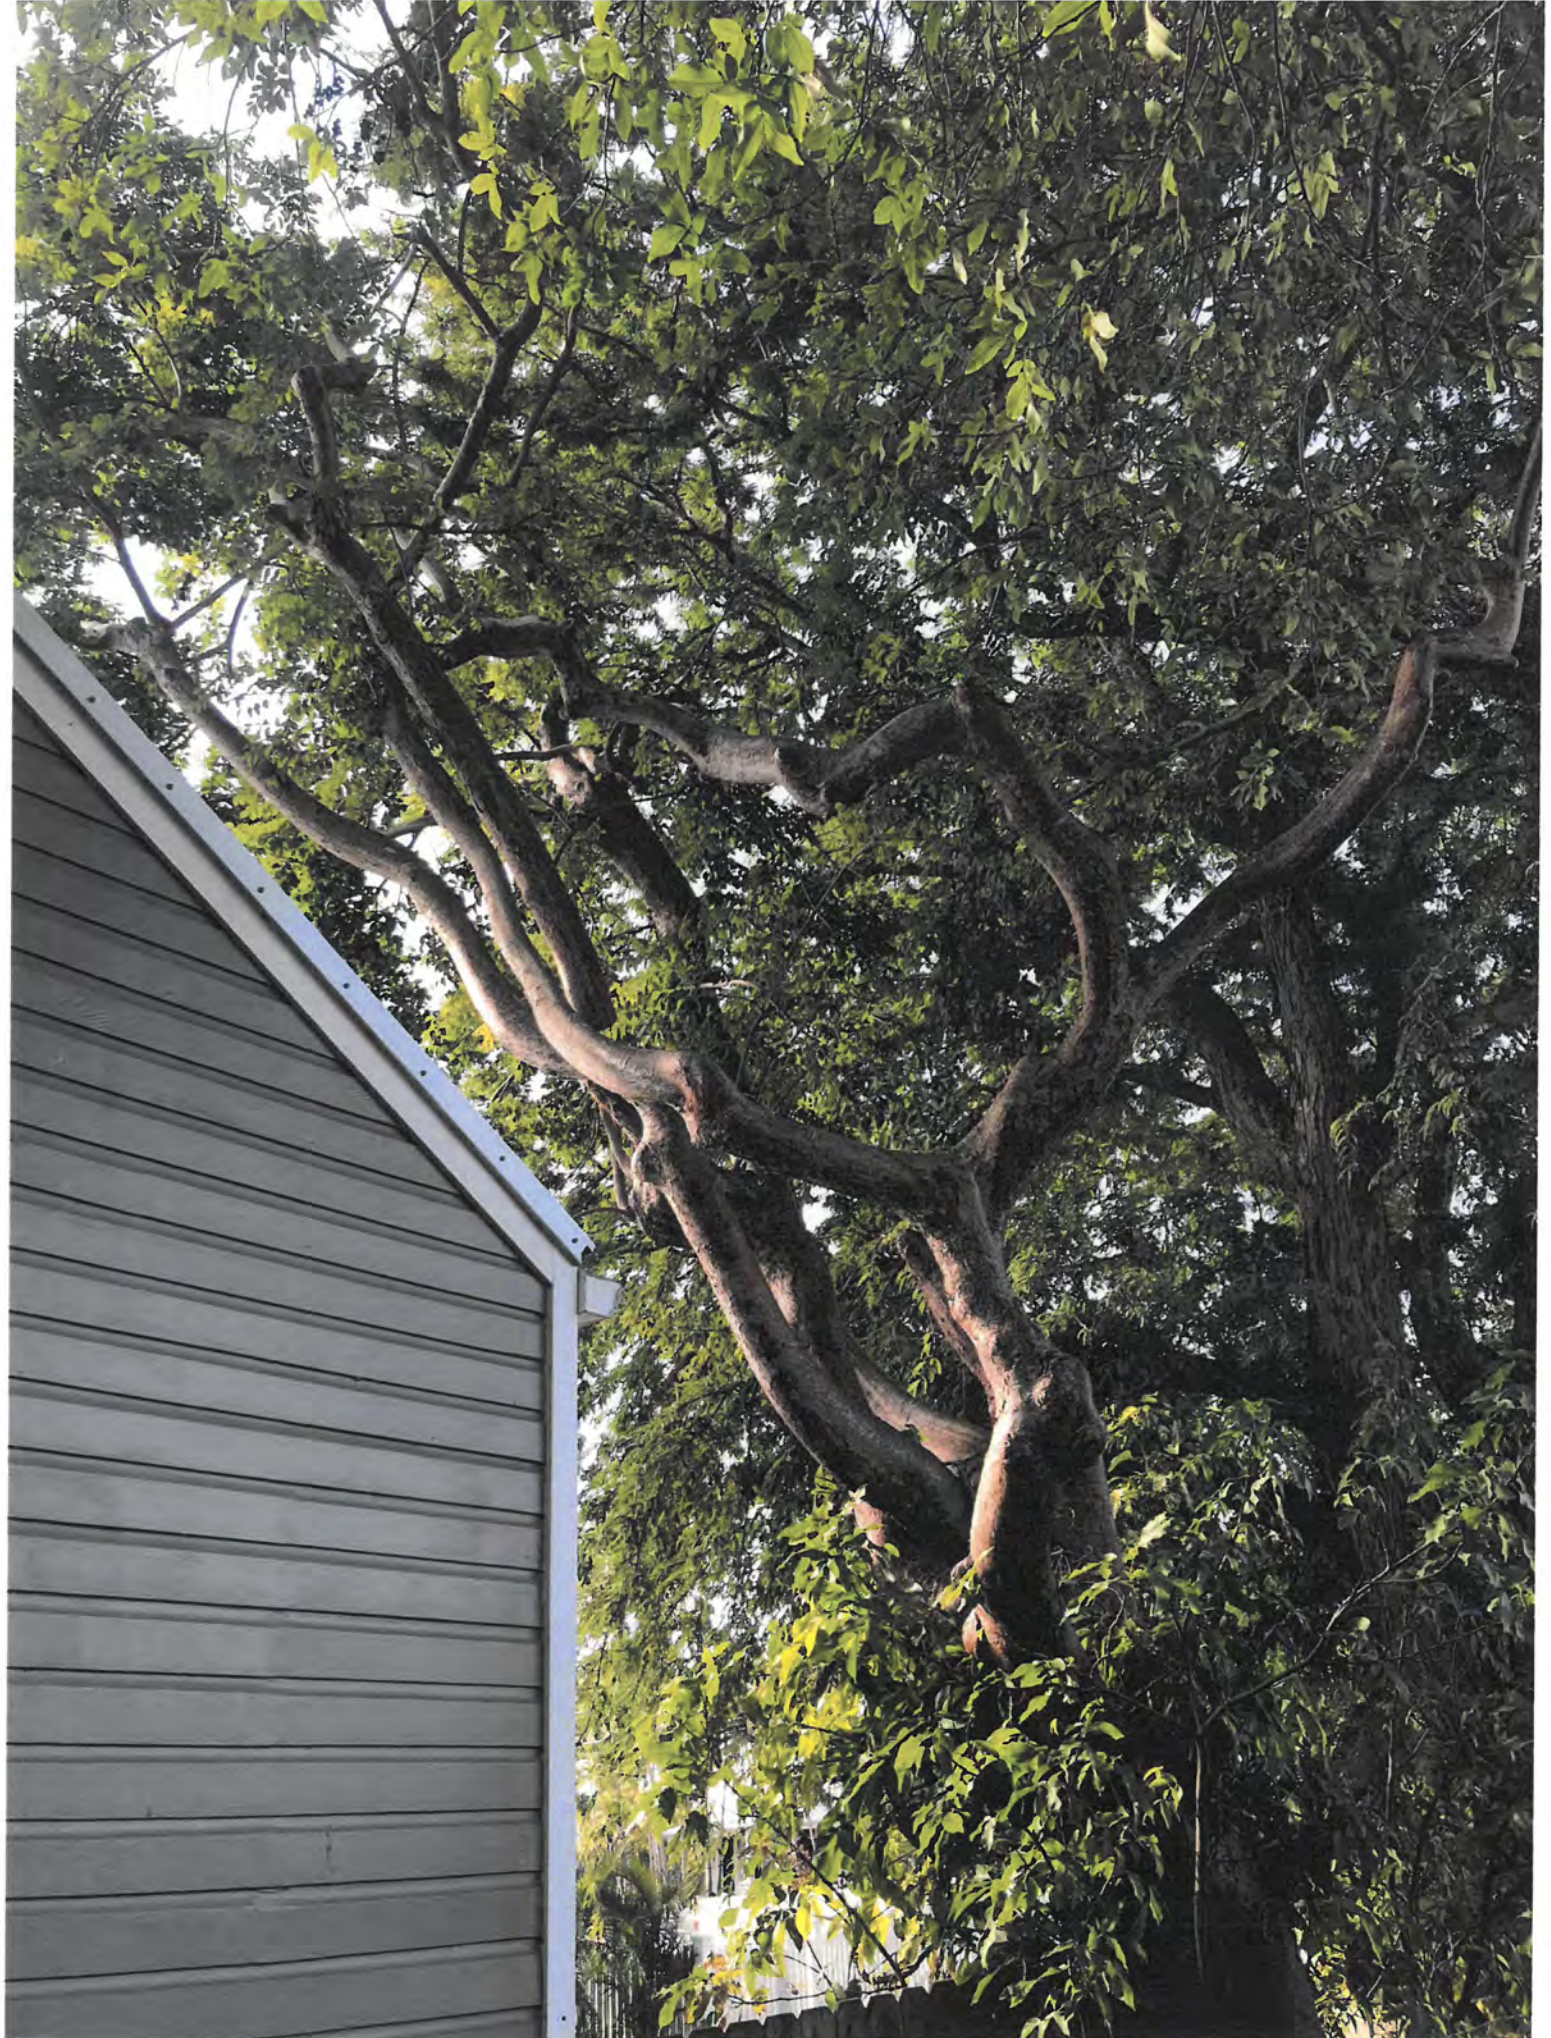
2 Gumbo Limbo/*Bursea simaruba*. **23.25"** diameter DBH. Fair condition. Native, protected tree. Permit required for removal or major maintenance pruning. The Gumbo Limbo tree is growing on the southwestern portion of the property boundary line. Consequently, the root system is shared with the adjacent property. There is a grade change of approximately 2'. The root system on the above described property is covered with asphalt to base of trunk while adjacent property is fill and cap-rock. Canopy is growing mostly to the west due to the larger canopy of the Tamarind tree, tree #4 and as a result of prior improper pruning of over-lifting and Lion-tailing. Recommend retention removing asphalt to dripline, and apply proper pruning techniques. **Photo 4, 5.**

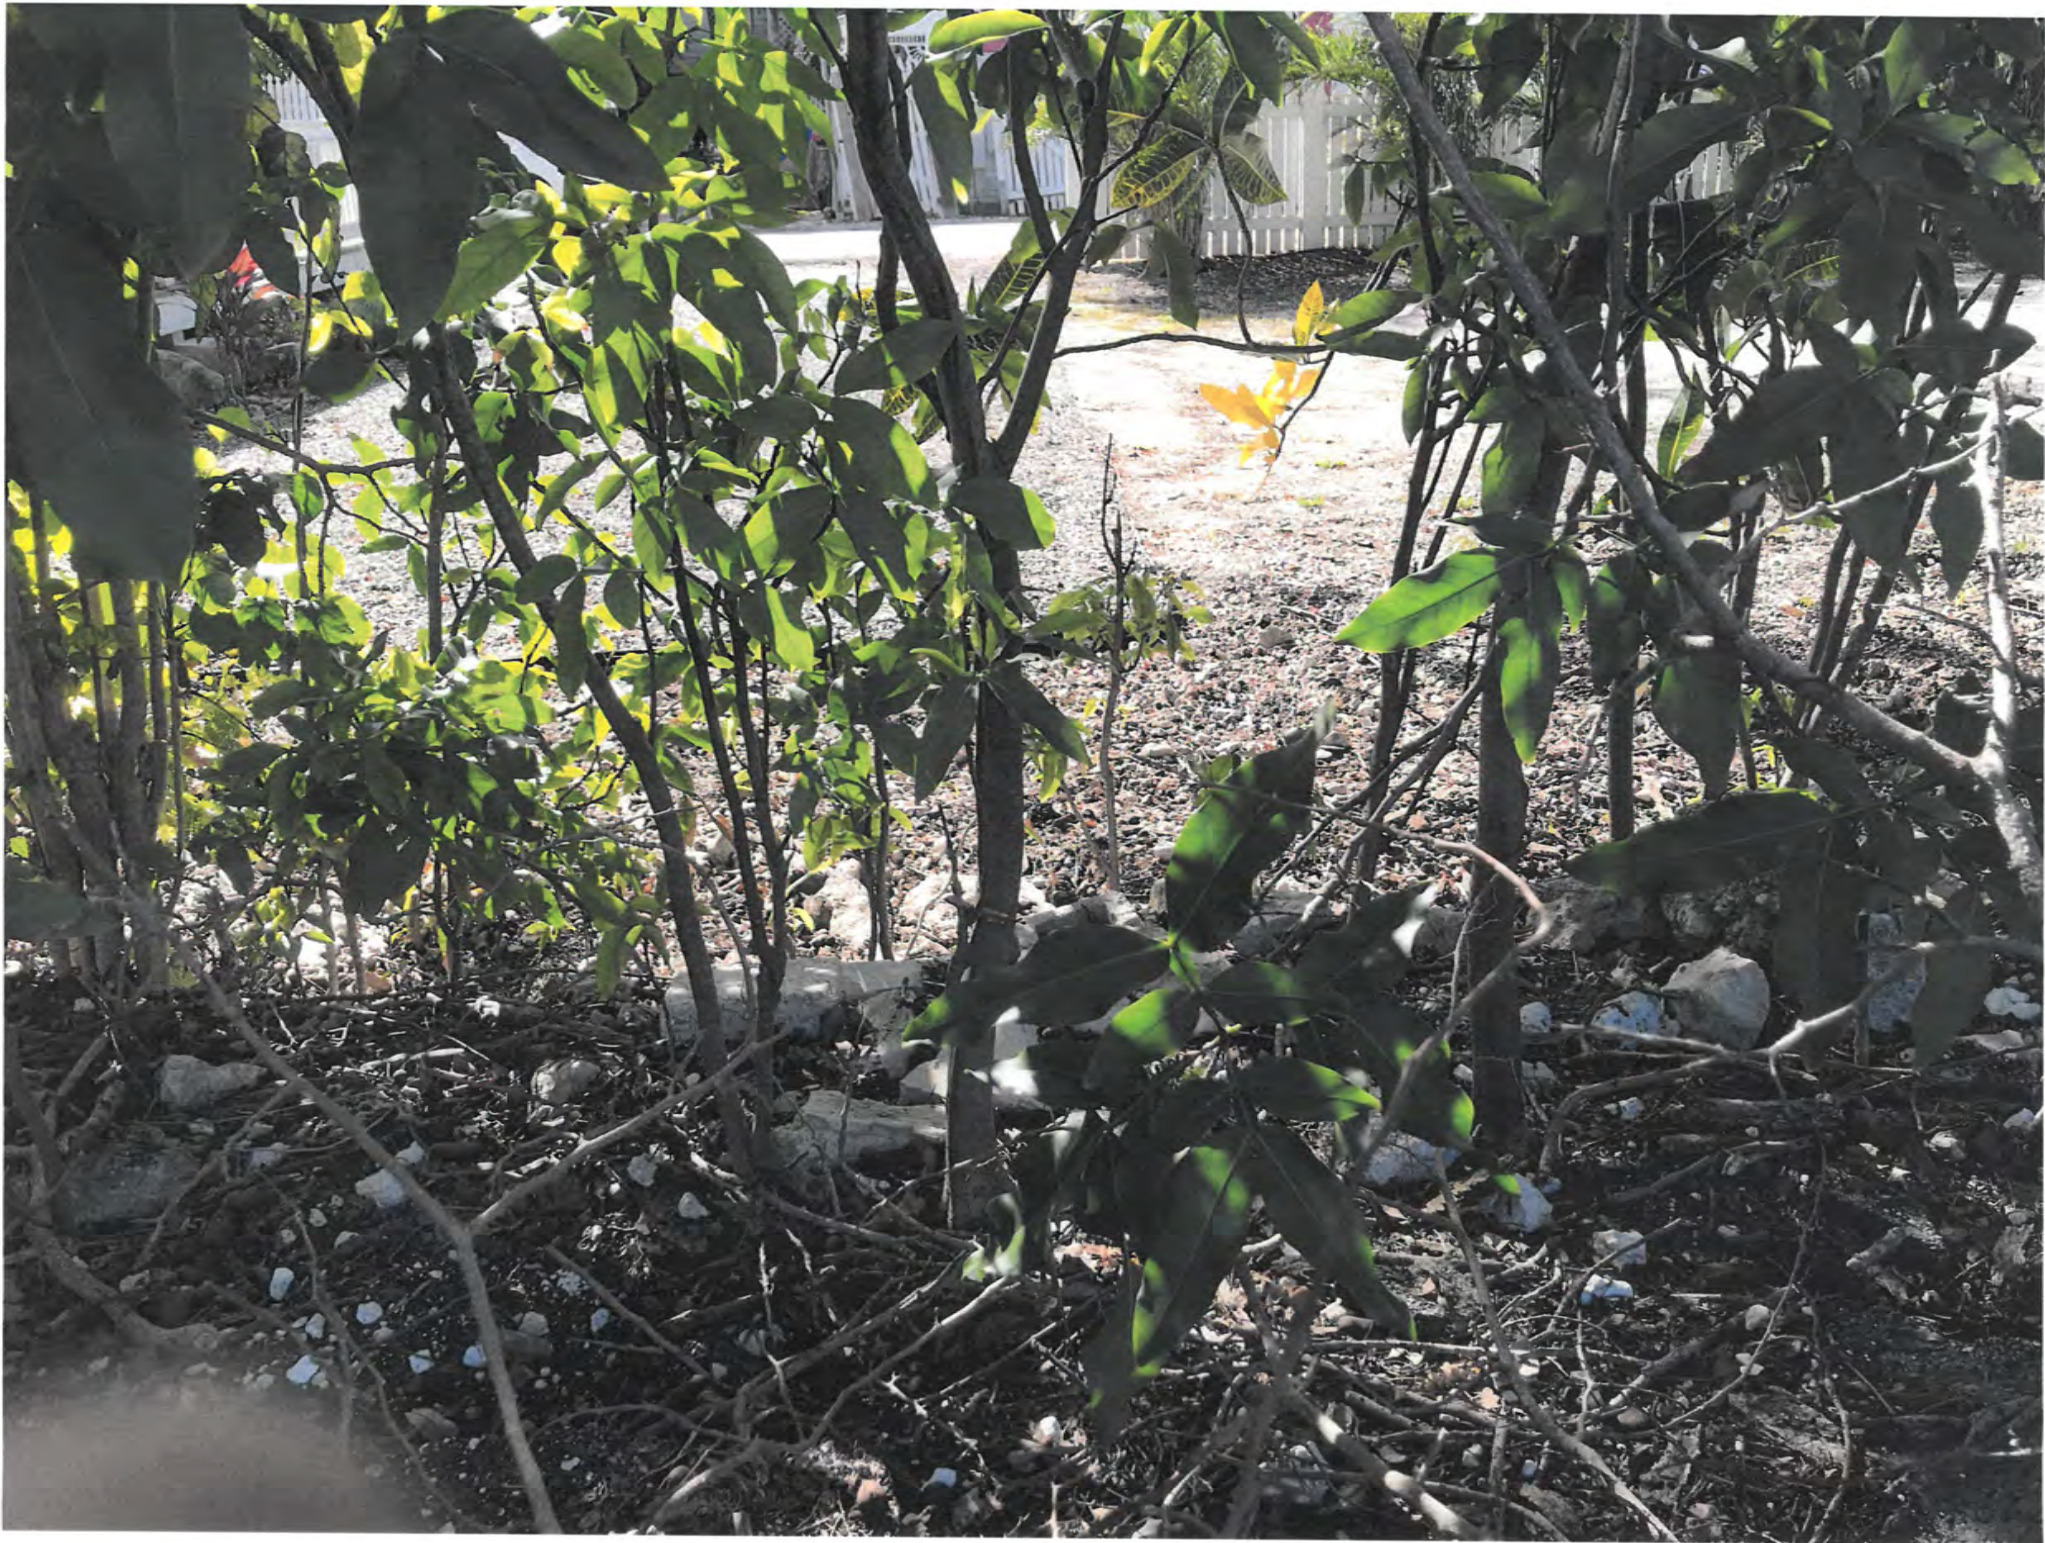
3 Spanish Lime seedlings. Numerous seedlings growing on property boundary line and under the canopies of Gumbo Limbo and Tamarind trees; an area of approximately 13' between trees. Seedlings range in size of <1" to <2". Recommend removing all seedlings, permit is required for seedlings over 1" diameter and over 5' in height. **Photo 6.**
