Cynthia's Blue Palms

638 United Street

Purpose: Following are my findings of evaluation concerning the above described property. Work is performed for Mr. Owen Trepanier, of Trepanier and Associates, INC, Land Planners & Development Consultants.

Tree survey of property was conducted on December 28, 2017. Tree description will be in clockwise manor beginning from southwest portion of property at tree number one (1) progressing to western periphery, north to front of property.

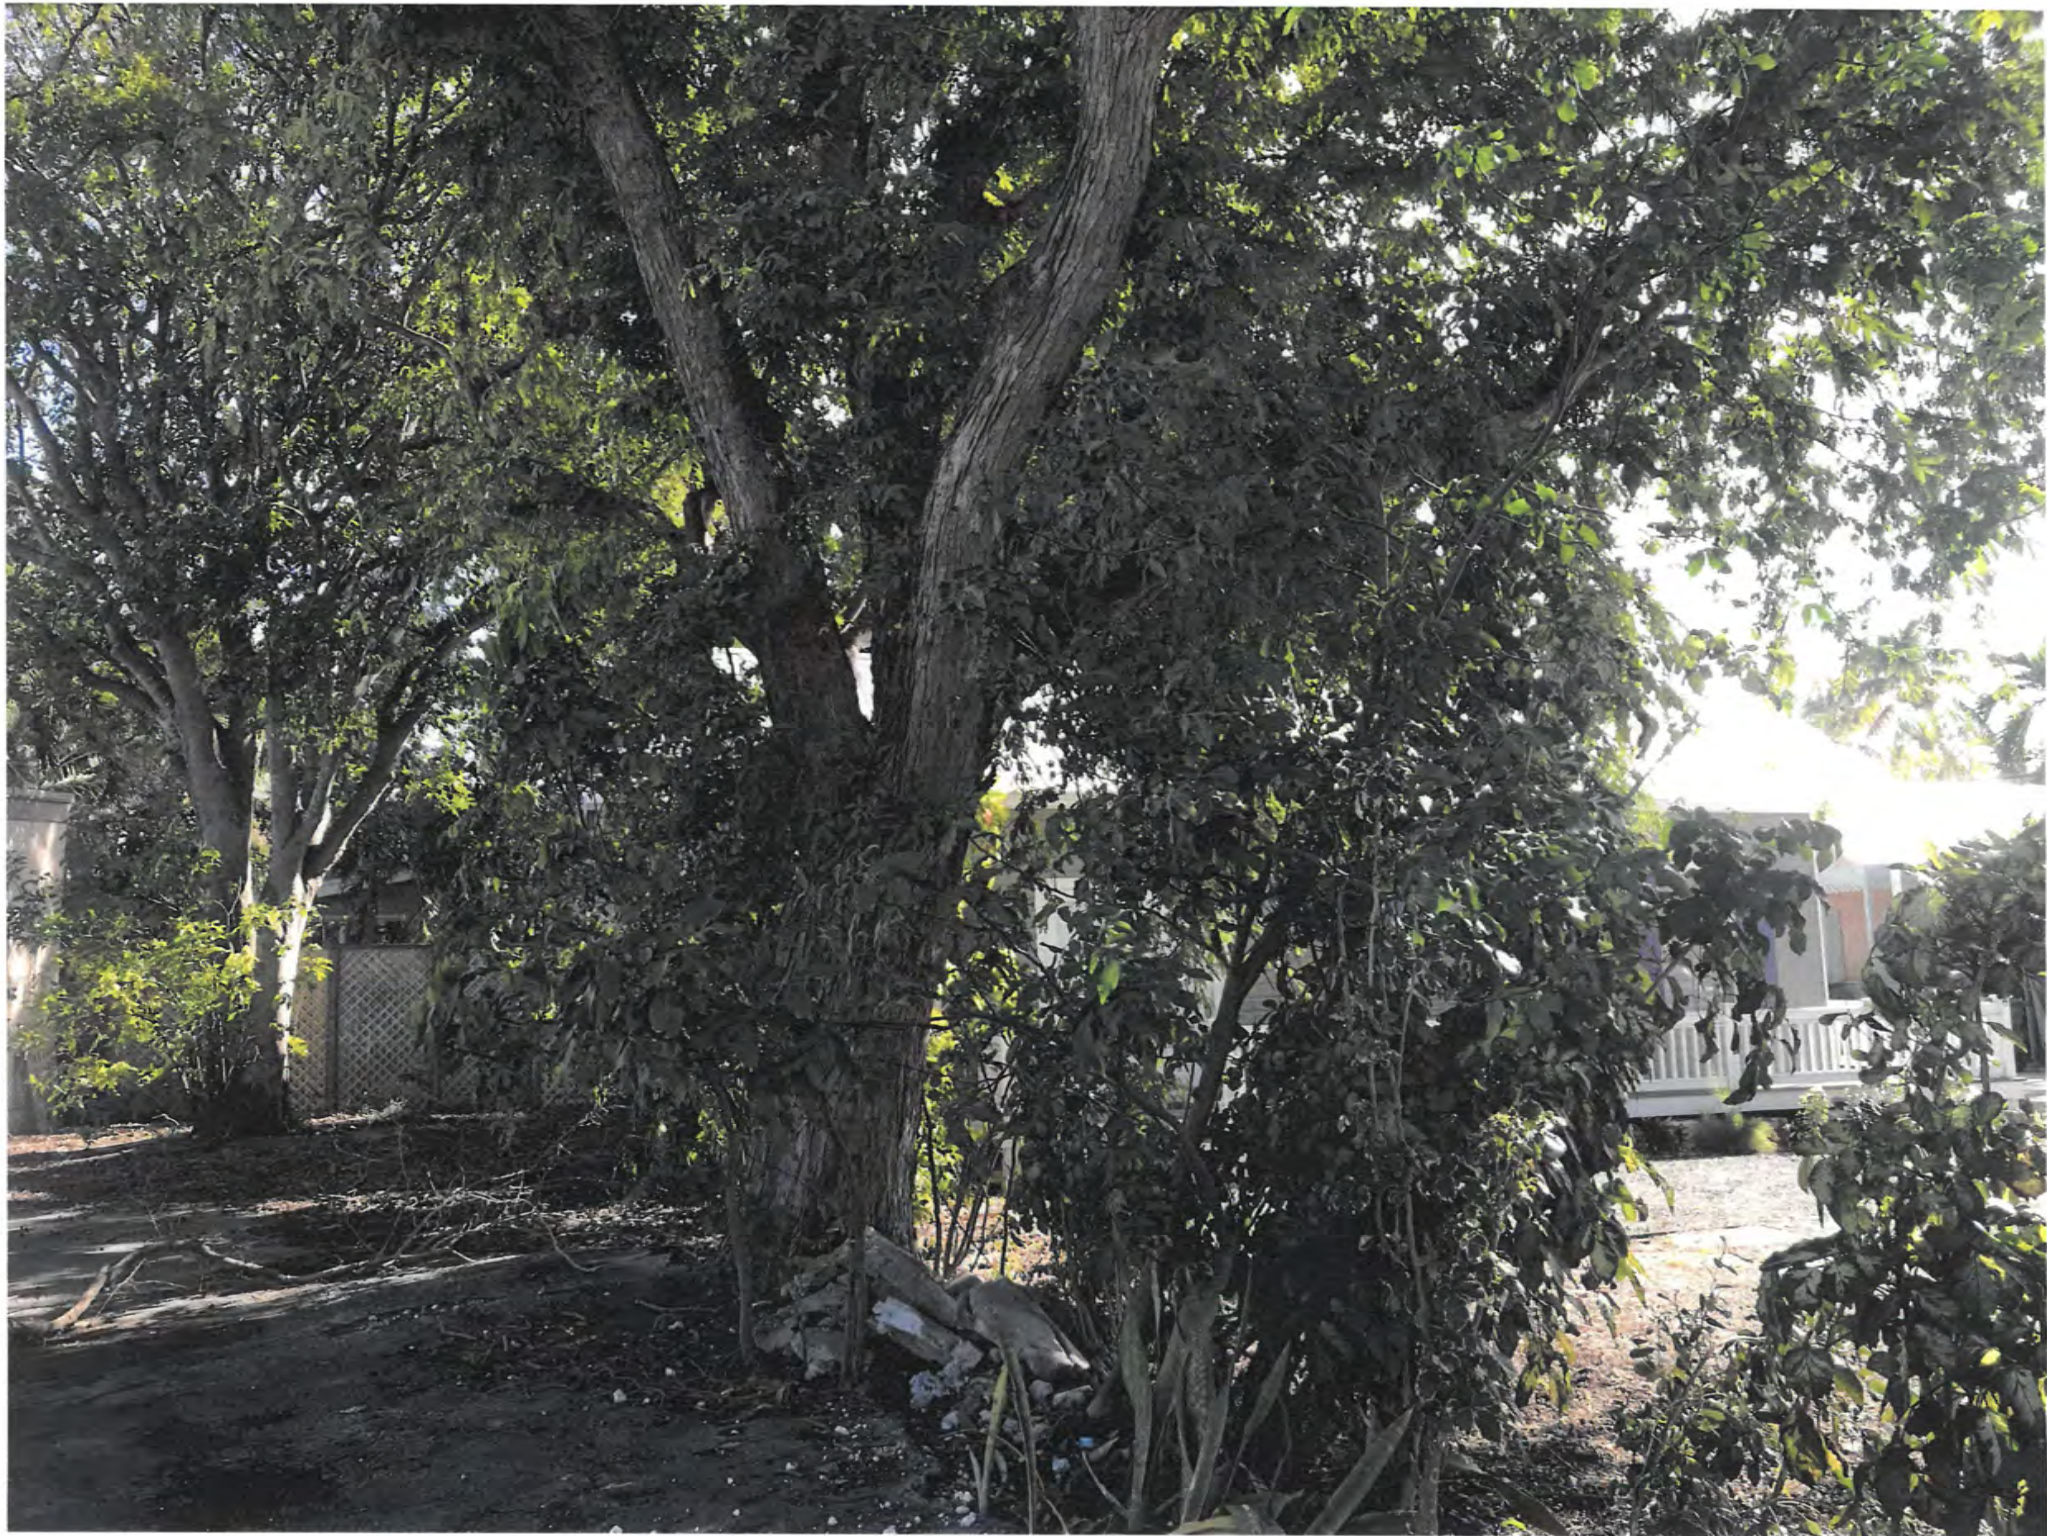
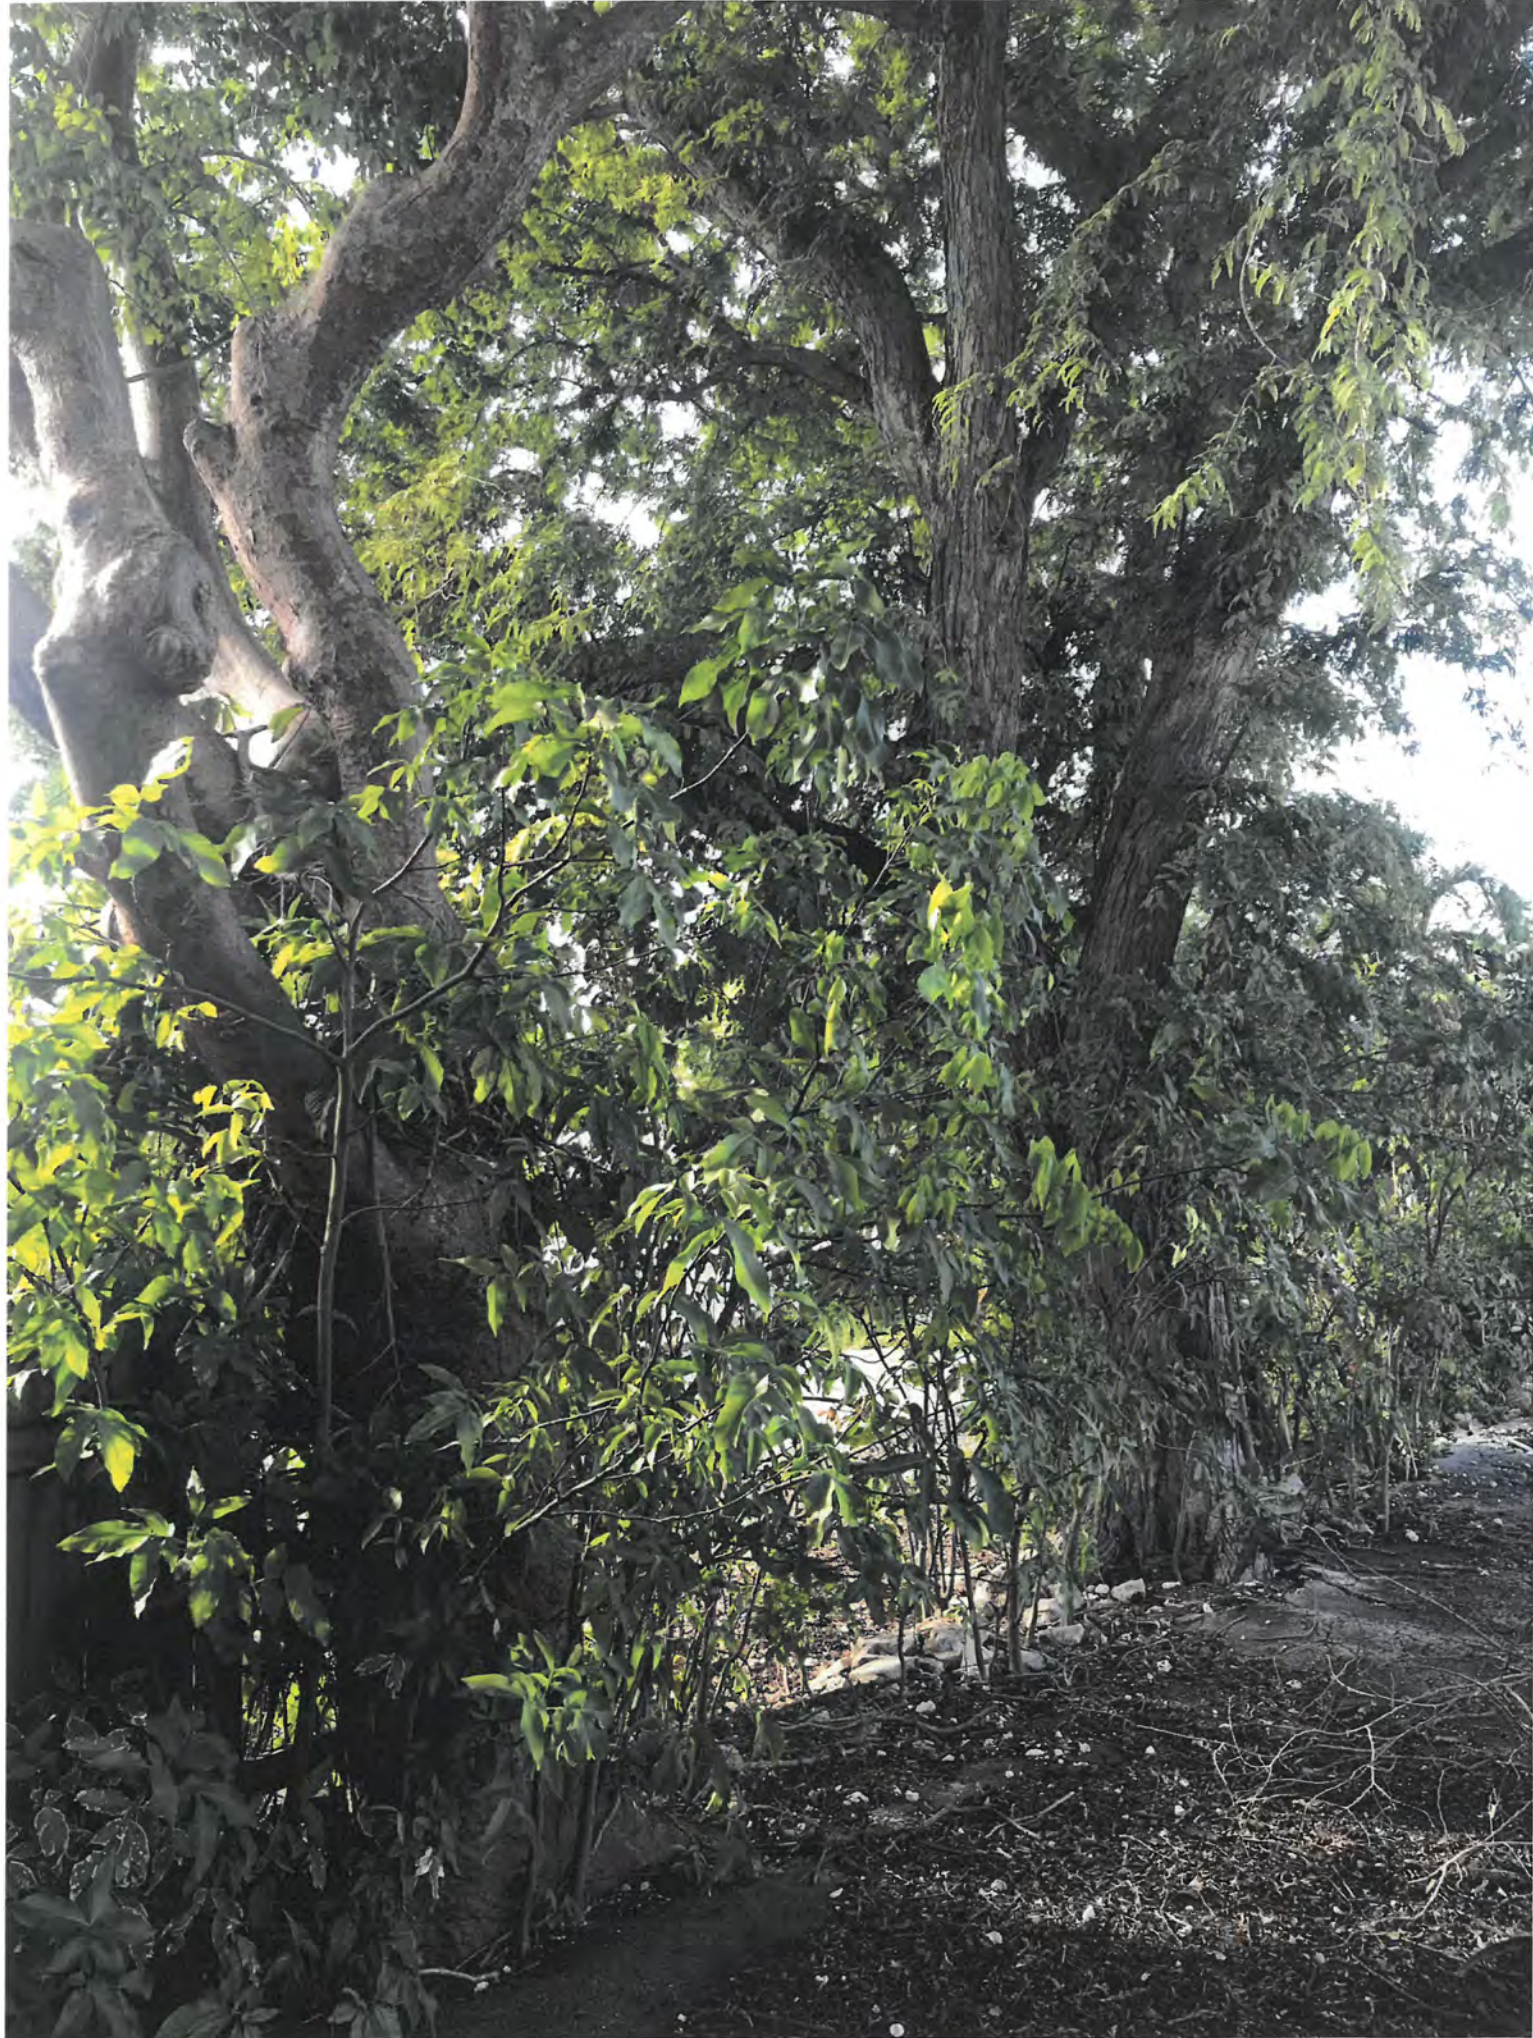
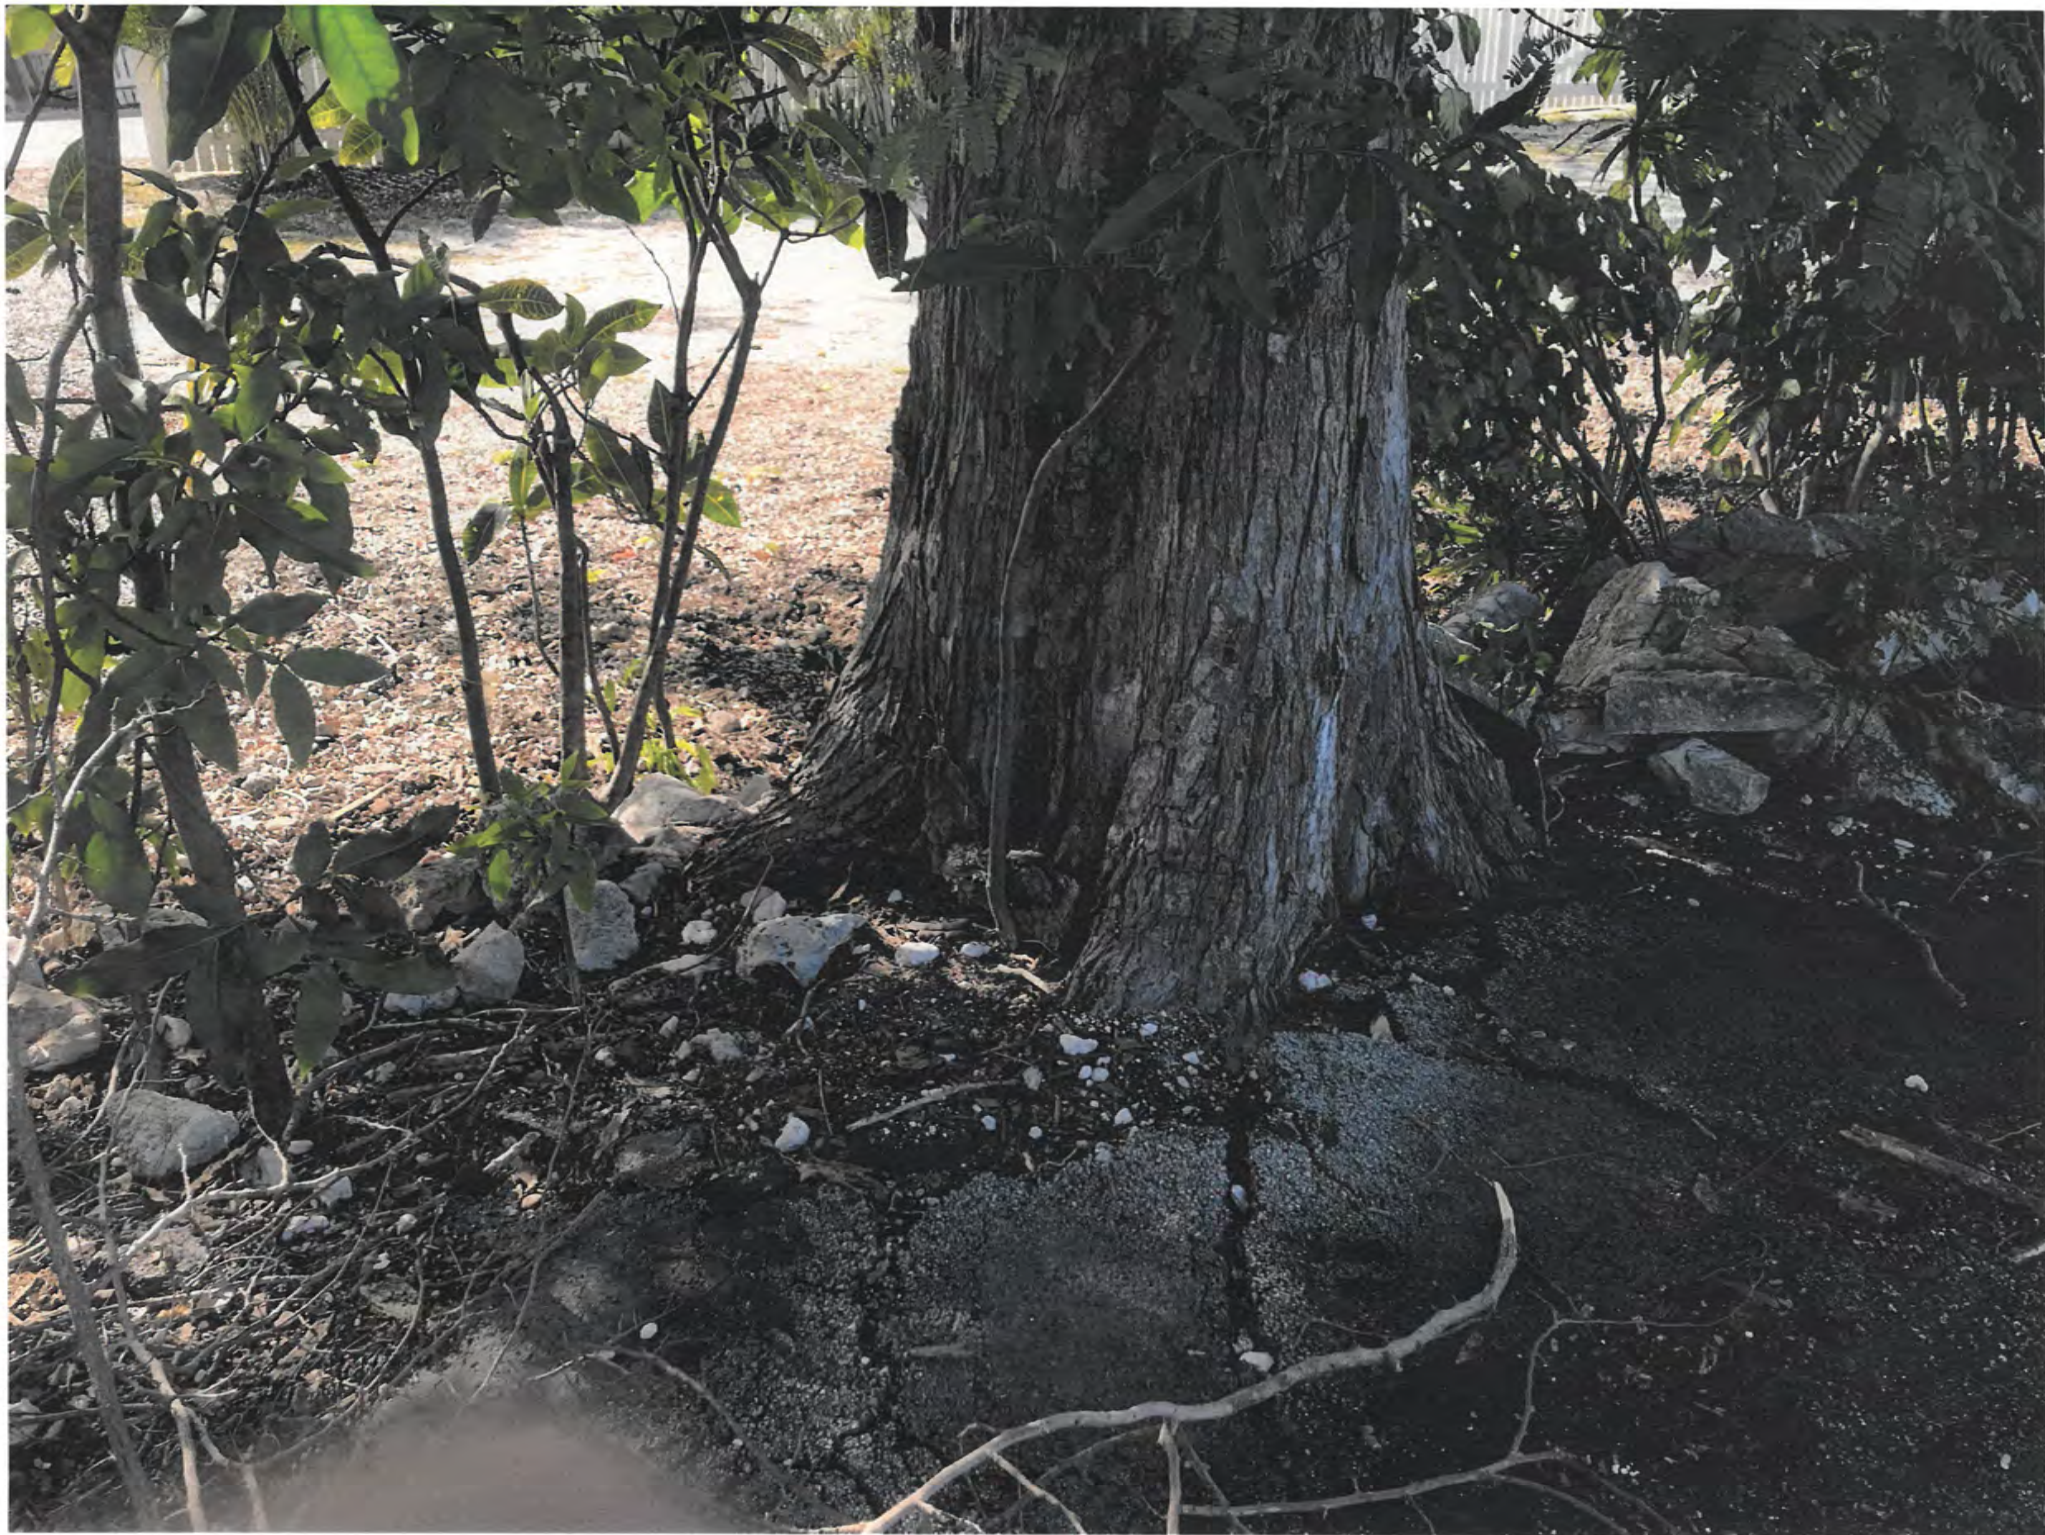
4 Tamarind/*Tamarindus indica*. 29.5" diameter DBH. Good condition. Non-native, protected tree. Permit required for removal or major maintenance pruning. The Tamarind tree is growing on the southwestern portion of the property boundary line 13' from the above mentioned Gumbo Limbo tree. Consequently, the root system is shared with the adjacent property. There is a grade change of approximately 2'. The root system on the above described property is covered with asphalt to base of trunk while adjacent property is fill and cap-rock. Canopy is flushing due mostly to recent hurricane. Recommend retention removing asphalt to dripline, and apply proper pruning techniques. **Photo 7, 8, 9.**

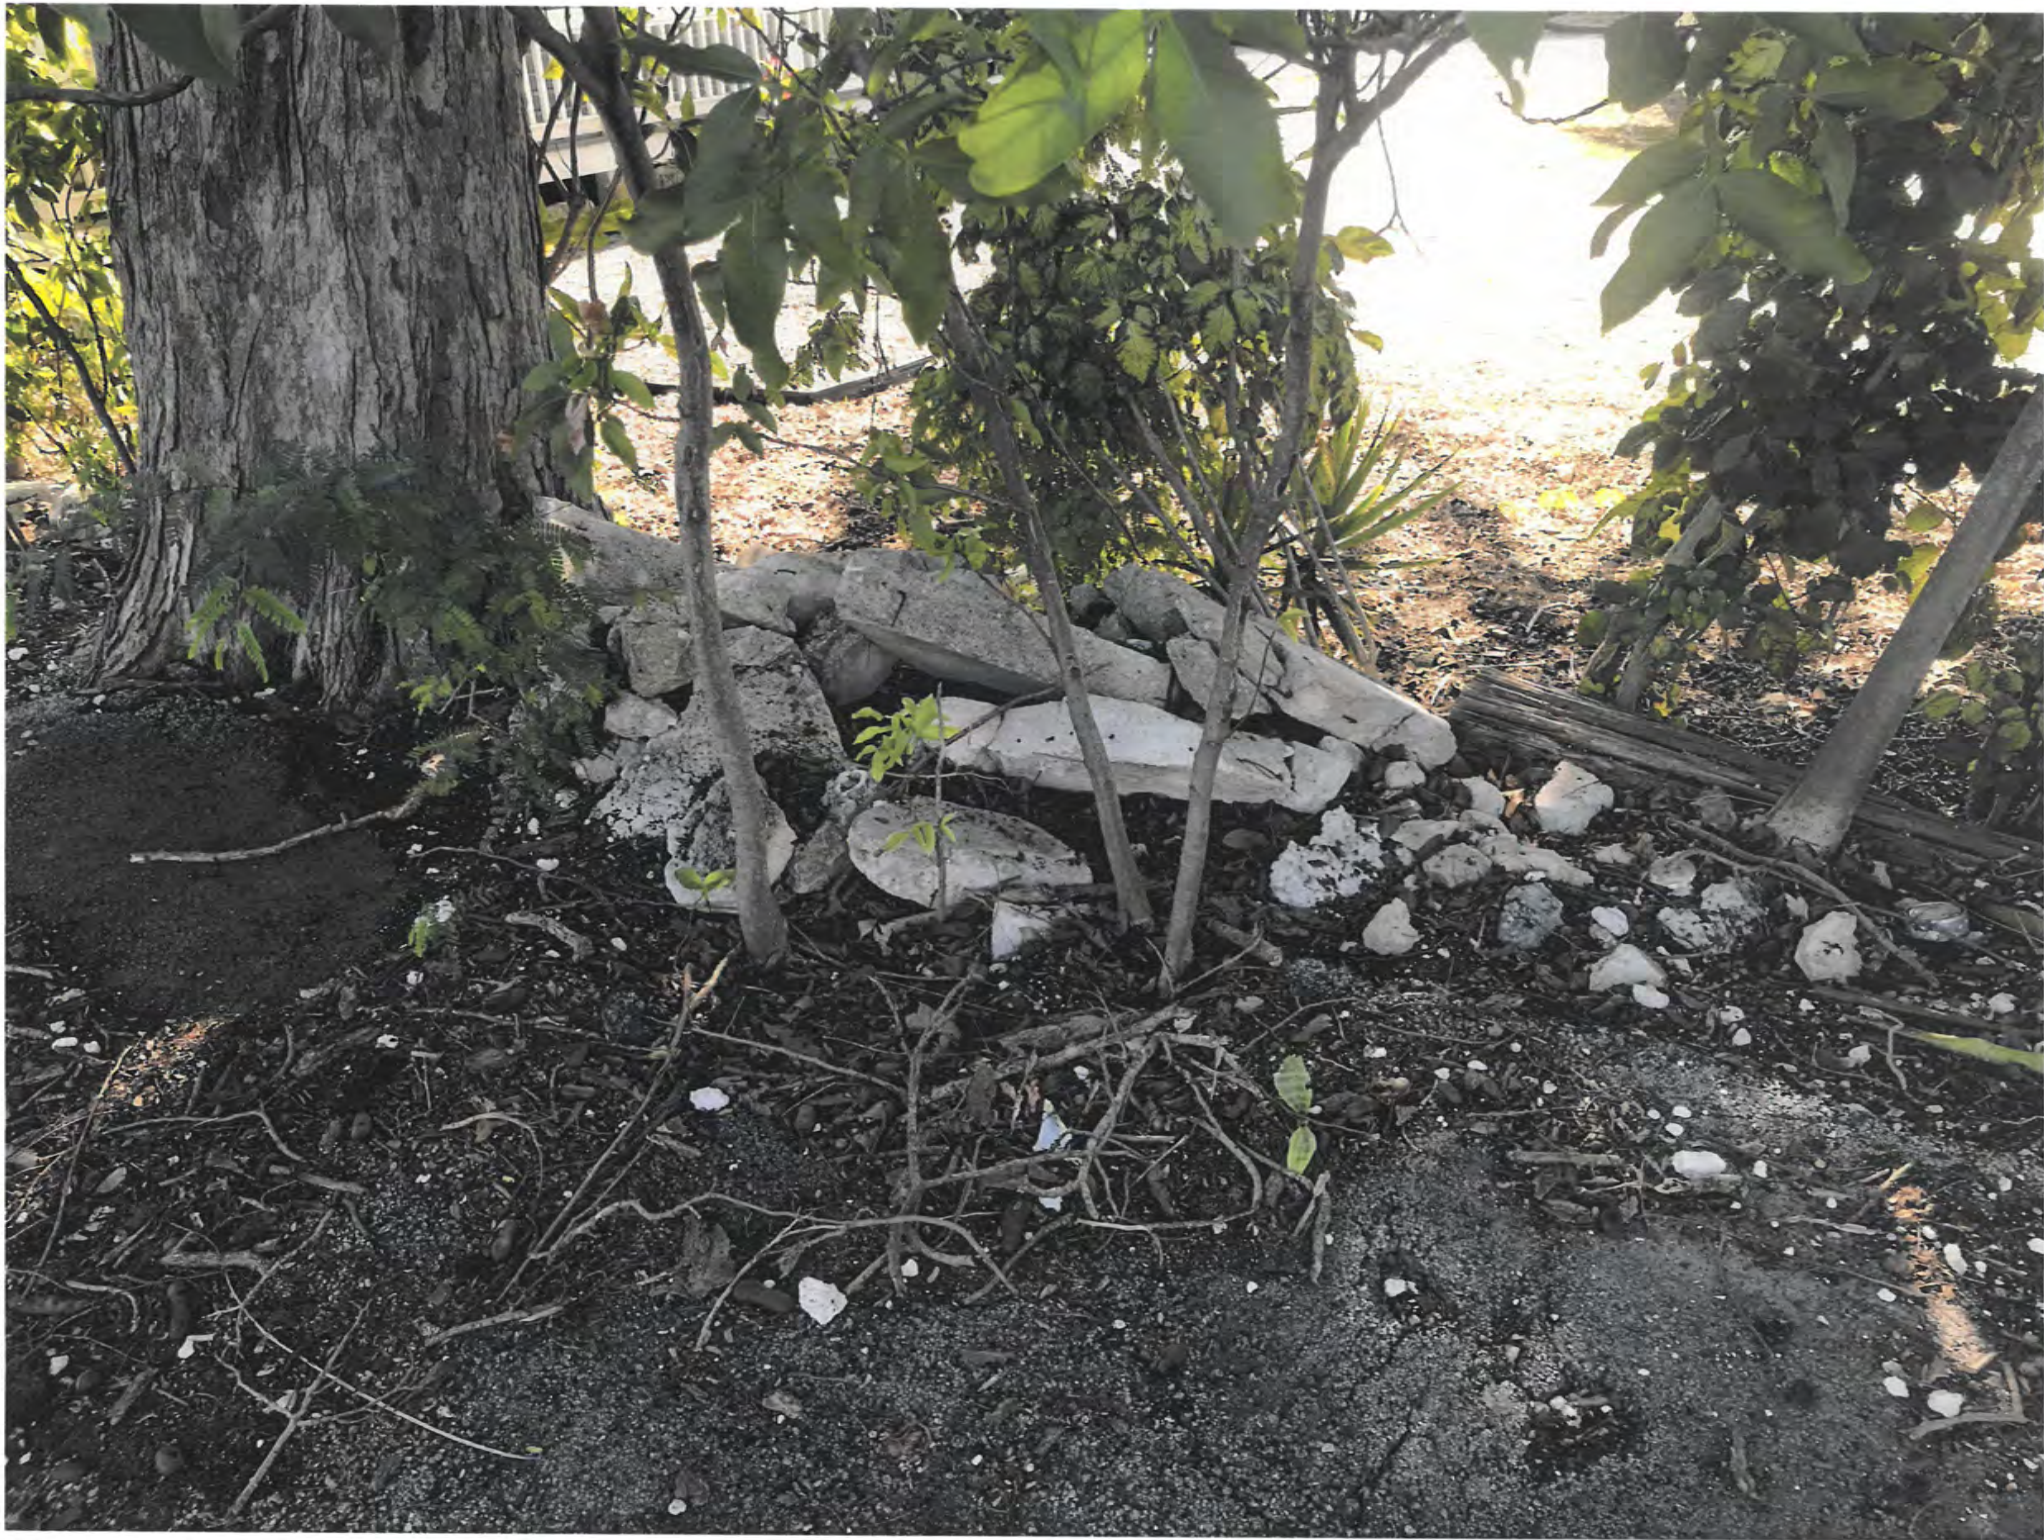
5 Spanish Lime seedlings. Numerous seedlings growing on property boundary line and under the canopy of Tamarind tree; an area of approximately 15'. Seedlings range in size of <1" to <3". permit is required for seedlings over 1" diameter and over 5' in height. Recommend removal of all seedlings. **Photo 10.**

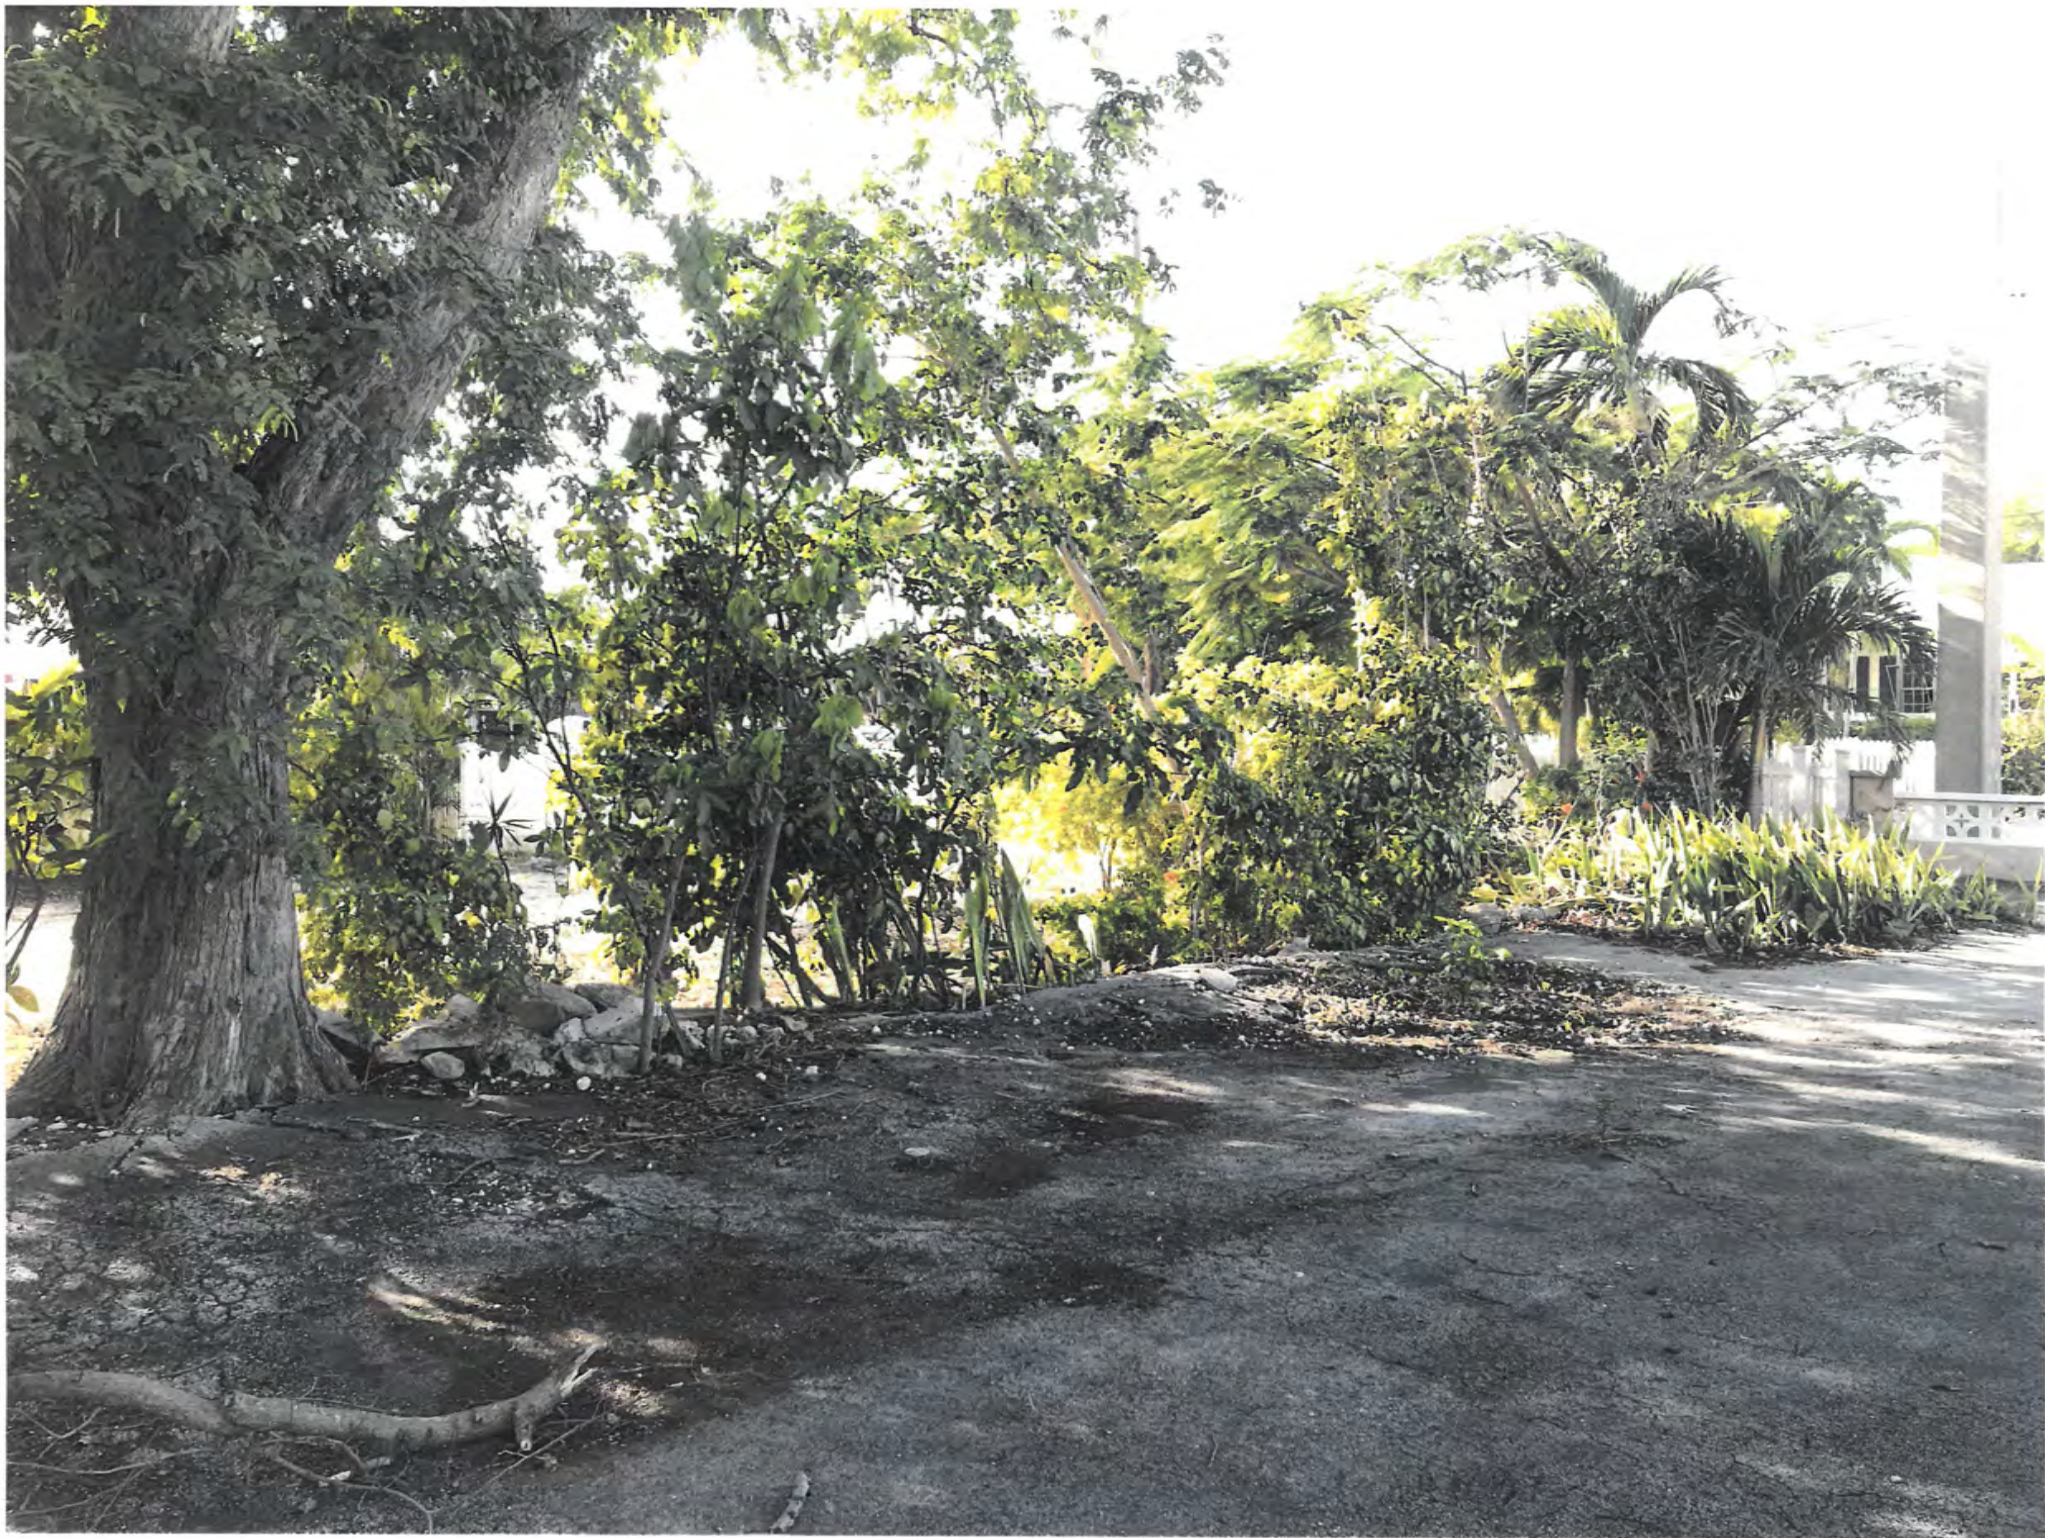
6 Snake Plant/*Sanseveria hyacinthoides* grouping. Non-native, invasive exotic Category 2 species. No permit is required for removal. Recommend removal. **Photo 11.**

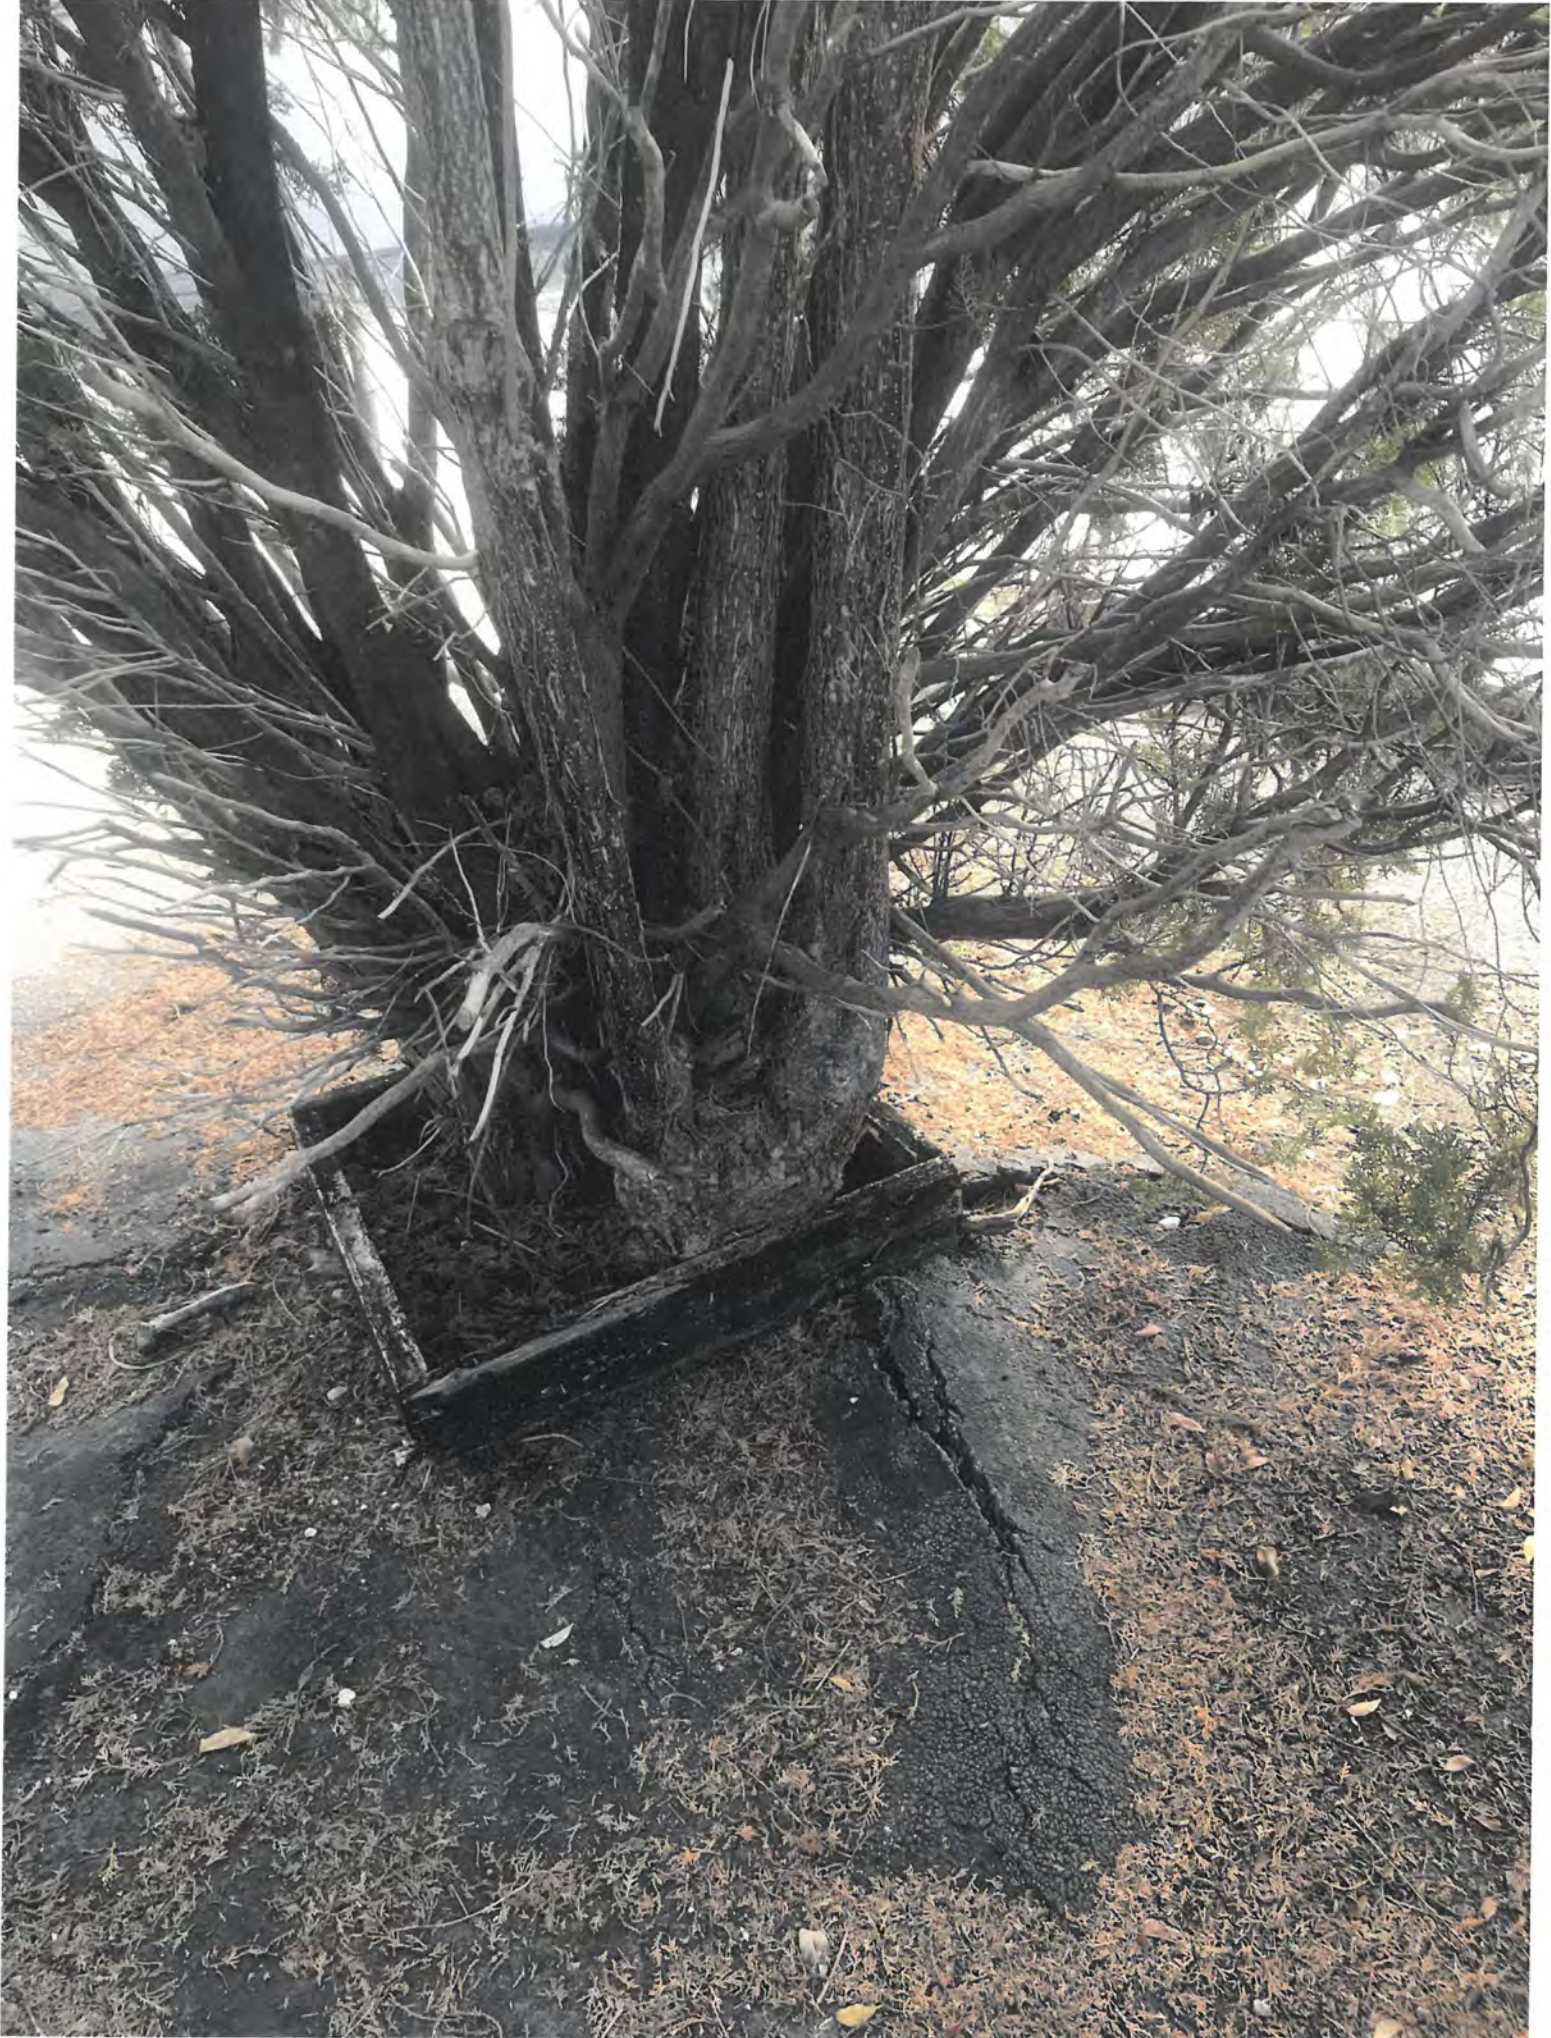
7 a, b. (a) Arborvitae/*Thuja occidentalis*. 15.25" diameter measured at base of tree. Poor condition. Non-native, protected tree due only to size of trunk. Permit required for removal. Due to the poor condition of the trees and current growing conditions; asphalt surrounding root system, removal is recommended. **Photo 12.**
(b) Gumbo Limbo/*Bursea simaruba*. 6.25" diameter measured at base of trunk. Poor condition. Native, protected tree. Permit required for removal. The Gumbo Limbo tree is seed grown from bird dropping. Tree has been removed at base several times prior; regrowth from stump. Due to the poor condition of the tree and current growing conditions removal is recommended. **Photo 13.**

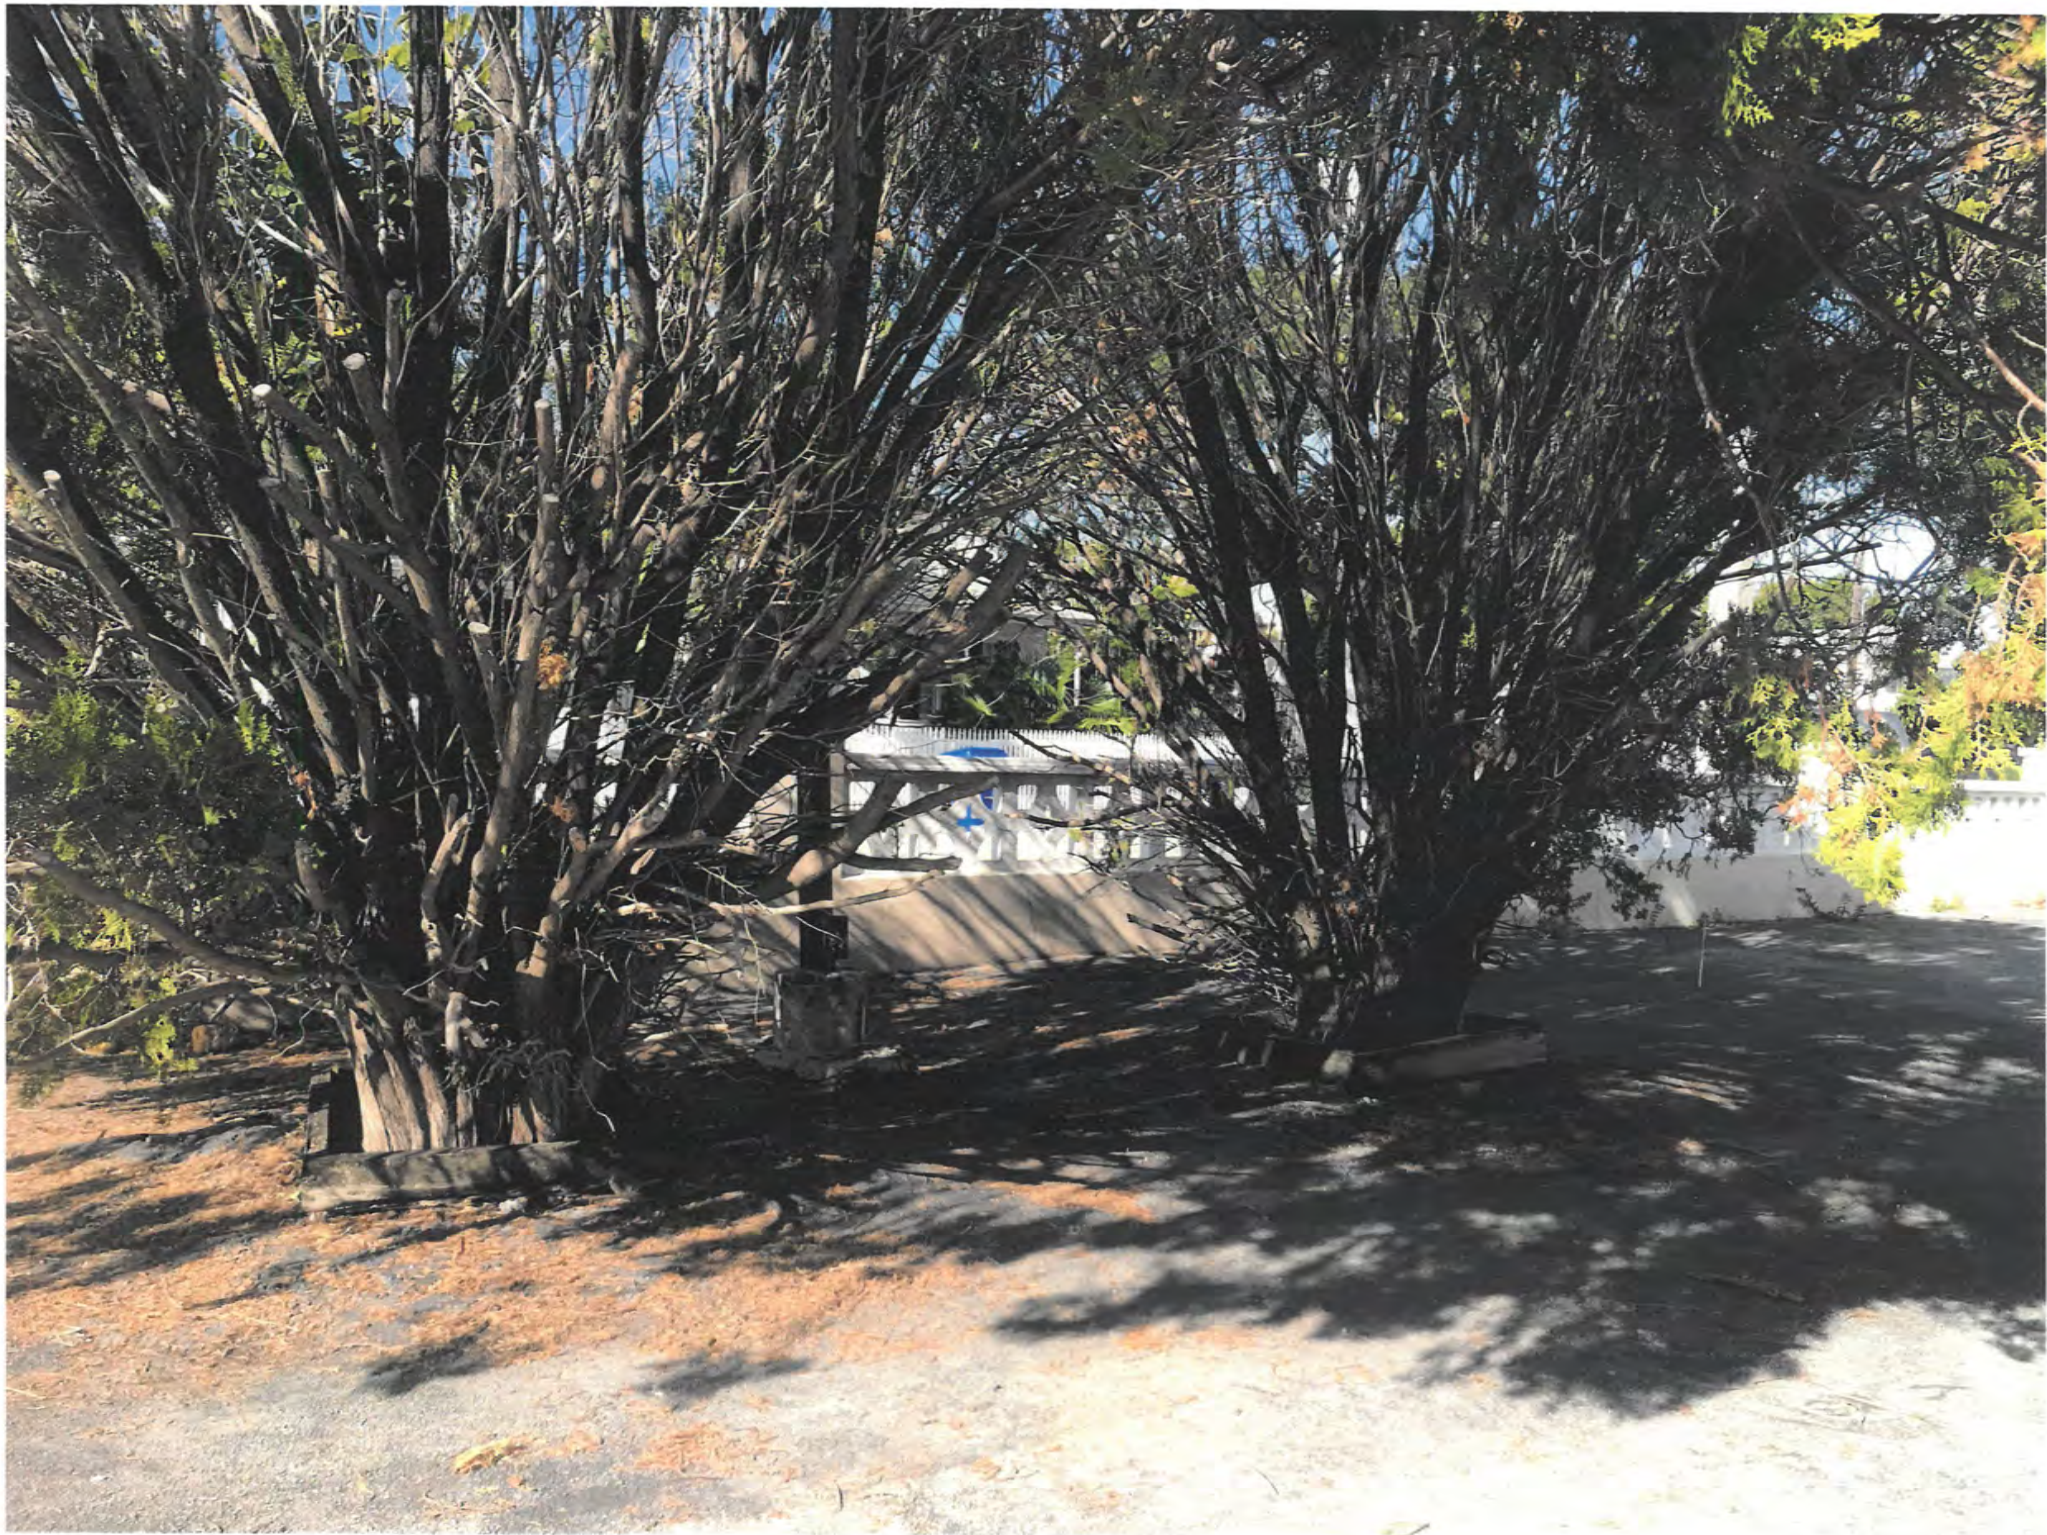
8 Arborvitae/*Thuja occidentalis*. 18" diameter measured at base of tree. Poor condition. Non-native, protected tree due only to size of trunk. Permit required for removal. Due to the poor condition of the trees and current growing conditions; asphalt surrounding root system, removal is recommended. **Photo 14.**
