TREE COMMISSION TREE REMOVAL REPORT
CITY of KEY WEST

PROPERTY: 714 Southard St.

APPLICATION NUMBER: T2025-0167

REQUEST: Property owner is seeking removal of (1) Spanish Lime Tree

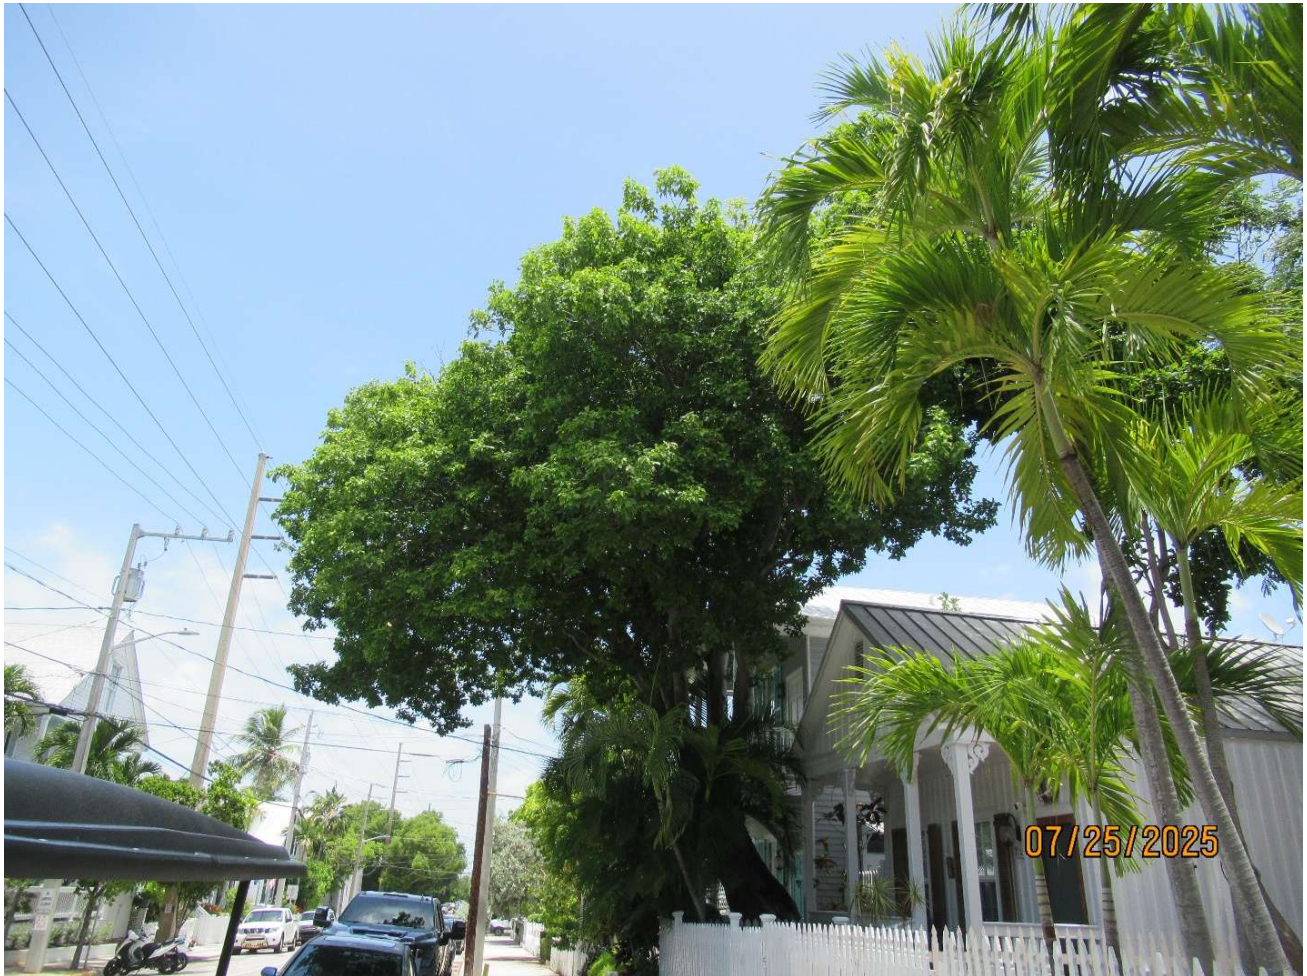
Looking Northeast standing on Southard St sidewalk.

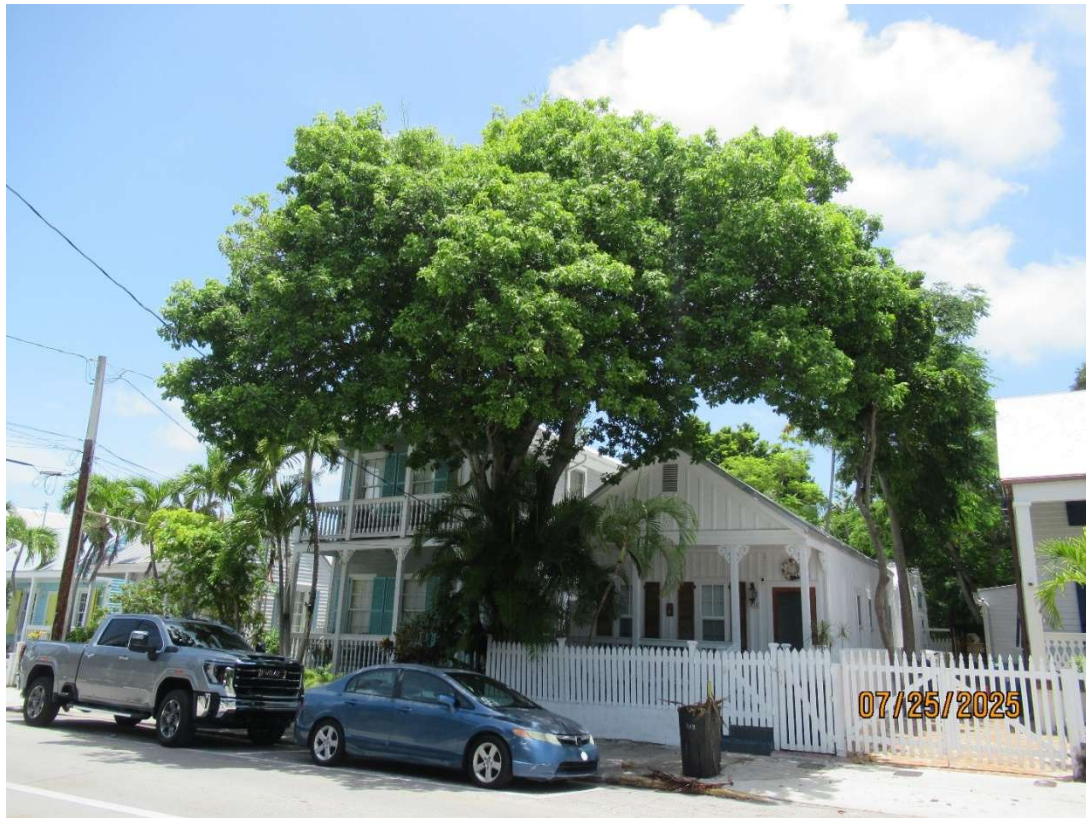
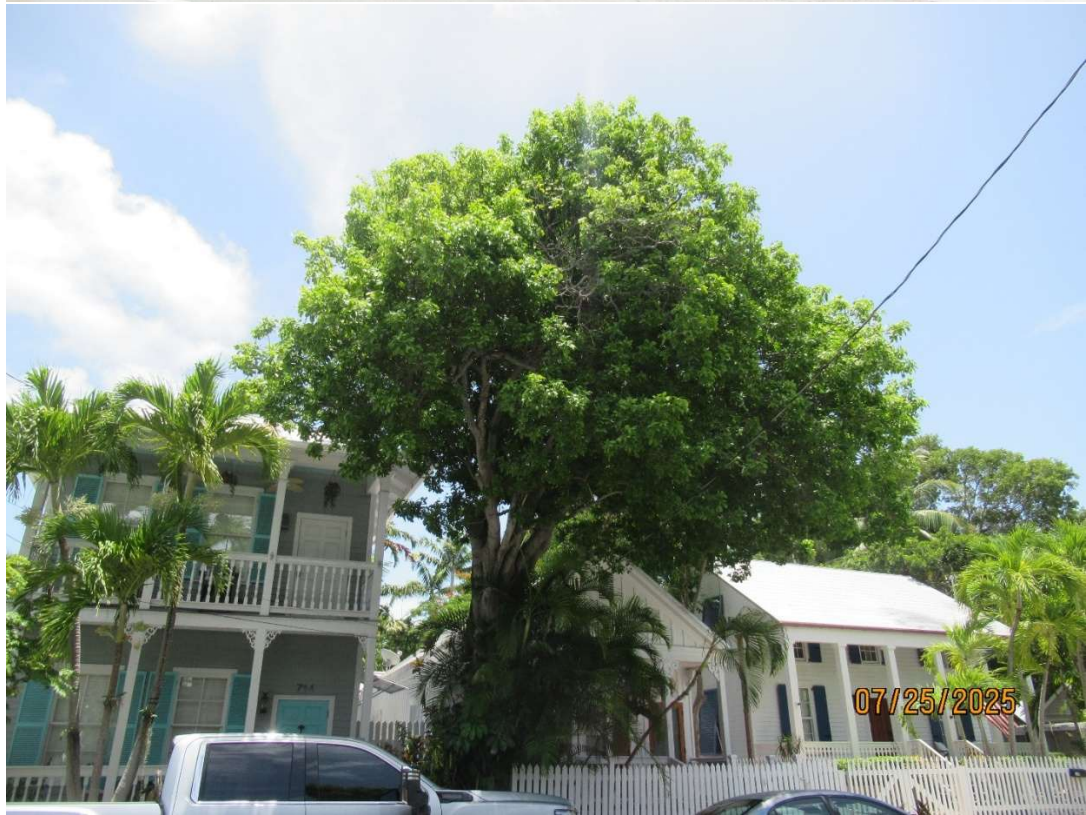
Top and bottom photo looking at tree from across the street.

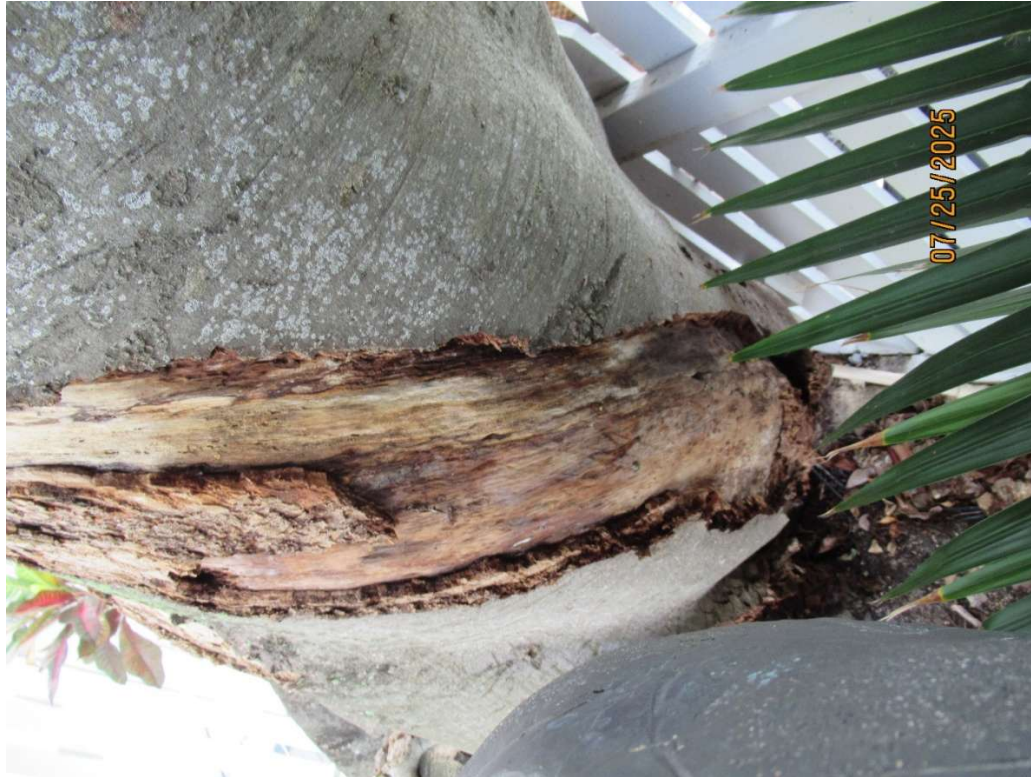
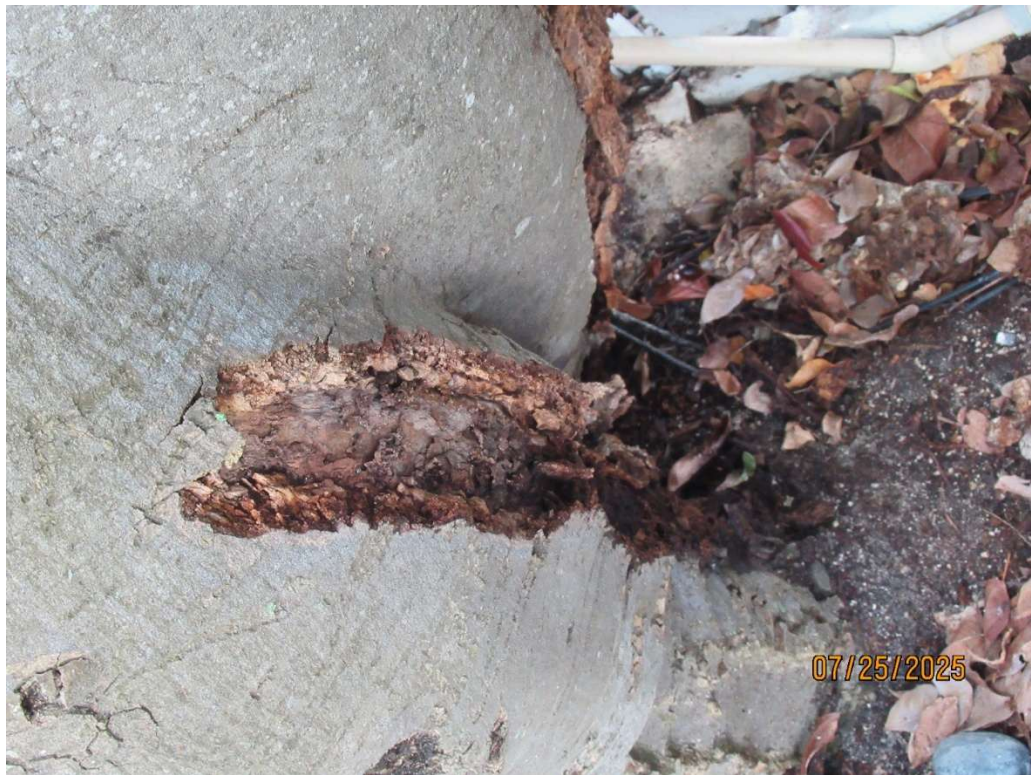
Top and bottom photo shows base of trunk missing some bark.

RECOMMENDATION/NOTES : This tree is very old. Likely over 100 years. The canopy is providing shade on a highly traveled road near Duval. The bark is flaking off in multiple places. The exposed wood has no fungal growth except near the base of the tree. I found no evidence of termites. It is uncommon for this species to have termites as the heartwood is very hard.

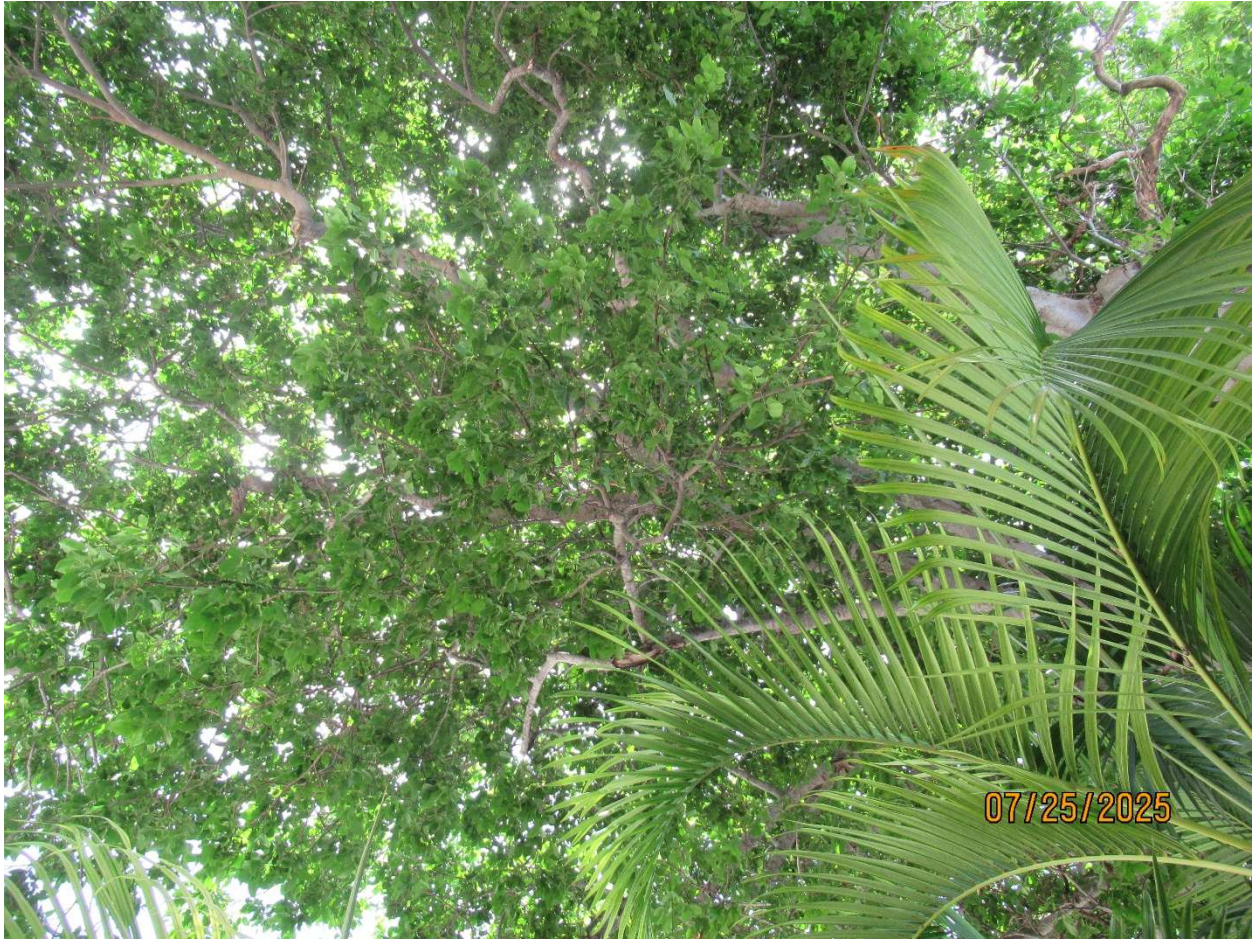
Looking up at massive canopy.

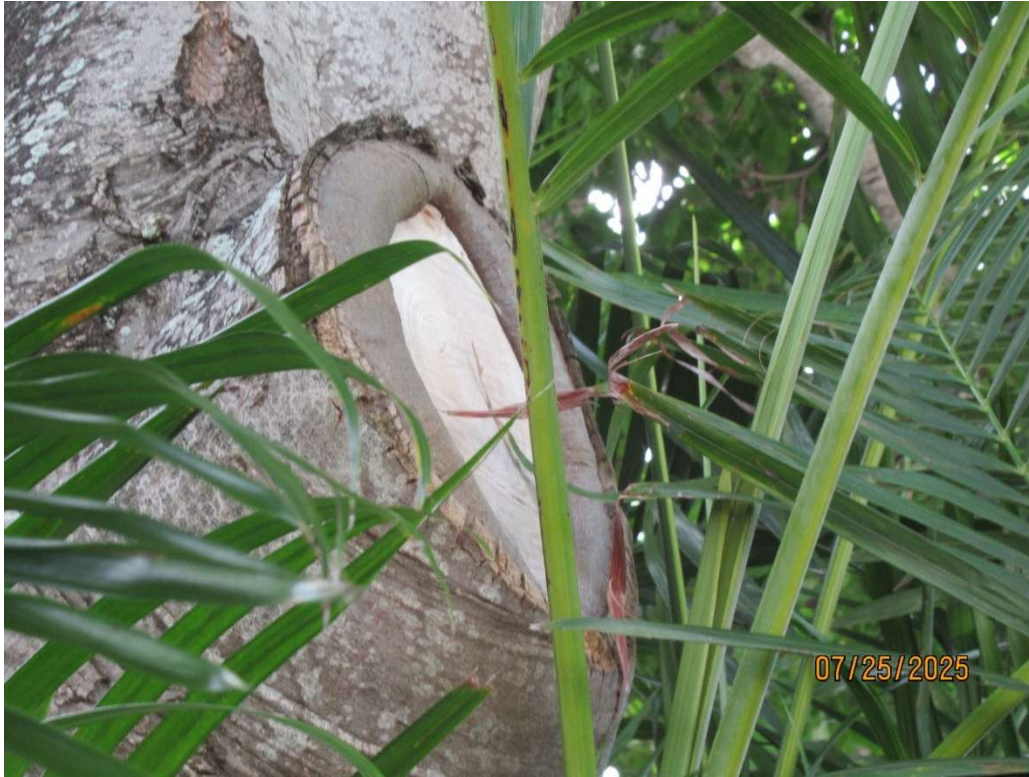
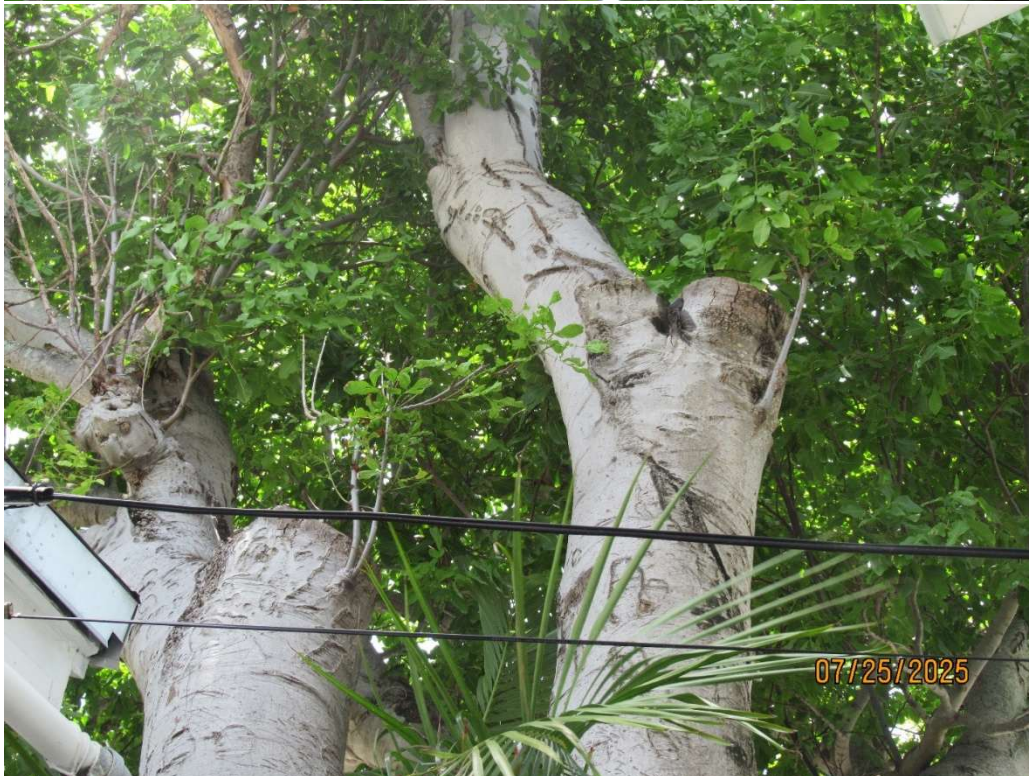
Photos of midsection showing how this tree has received multiple heavy pruning over the years.

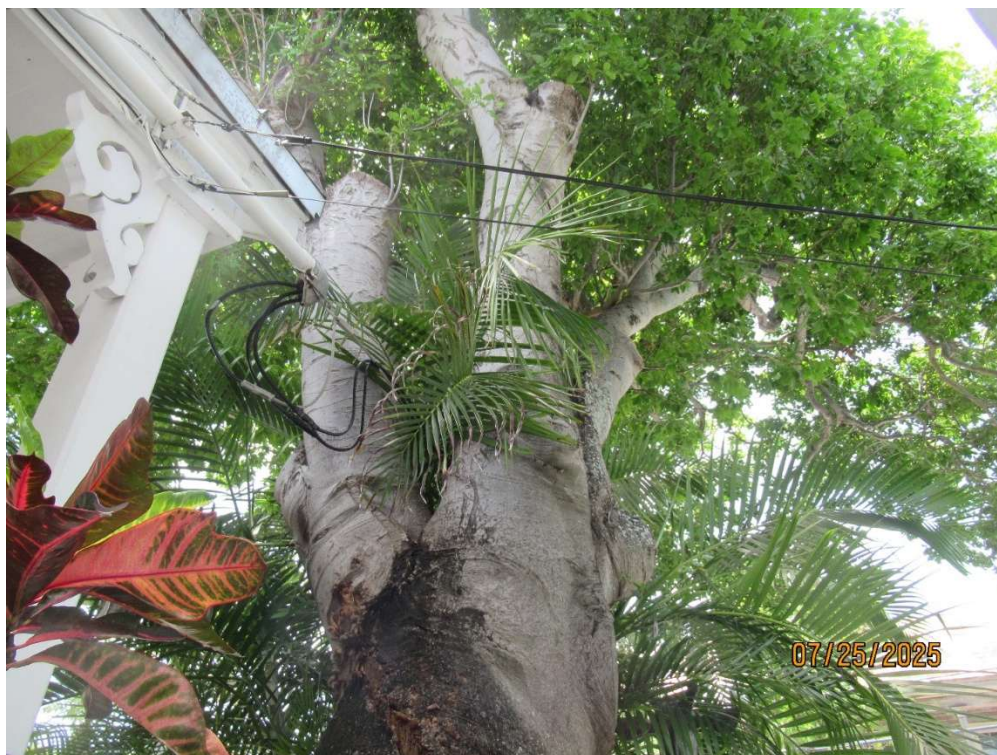
Standing at 712 Southard St. looking up at canopy.

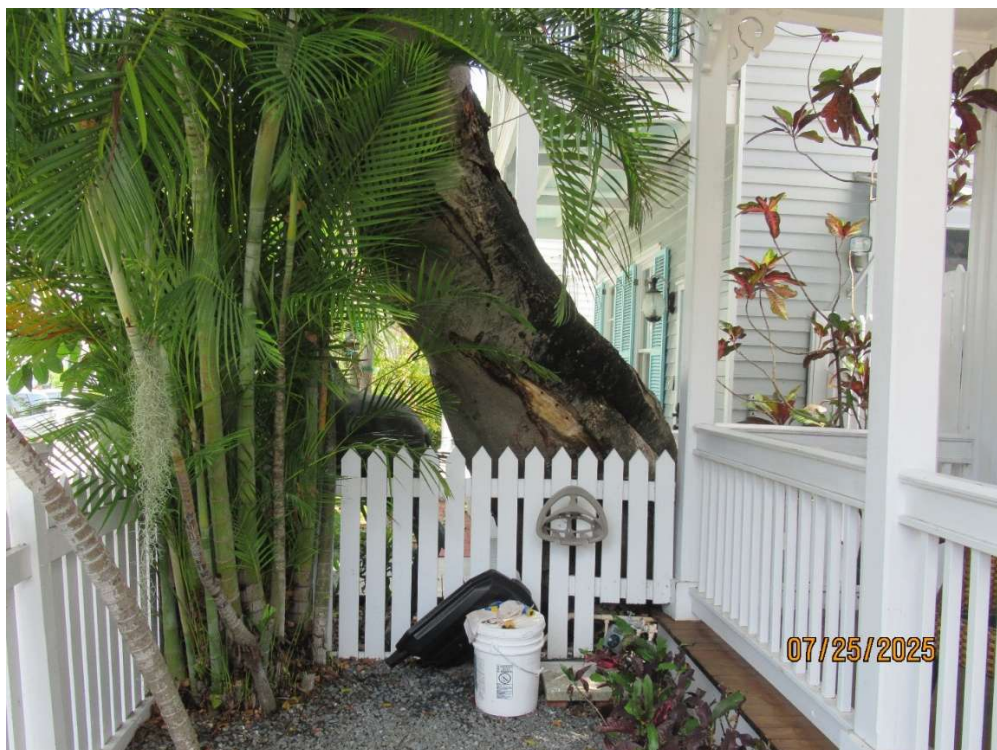
Standing at 714 Southard St. looking at trunk

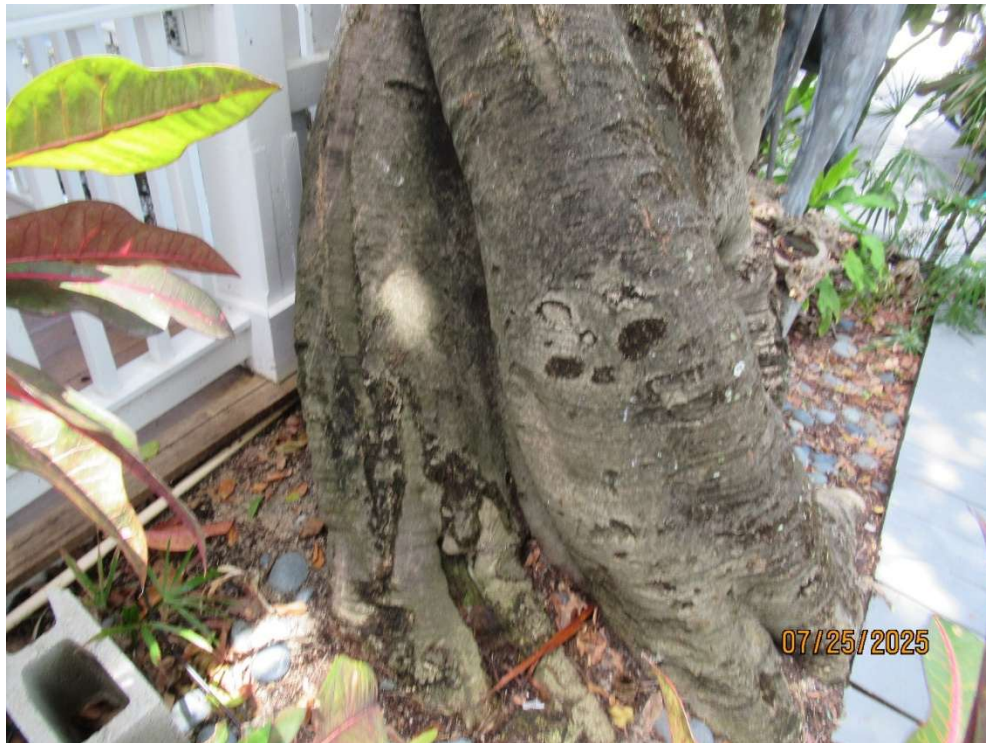
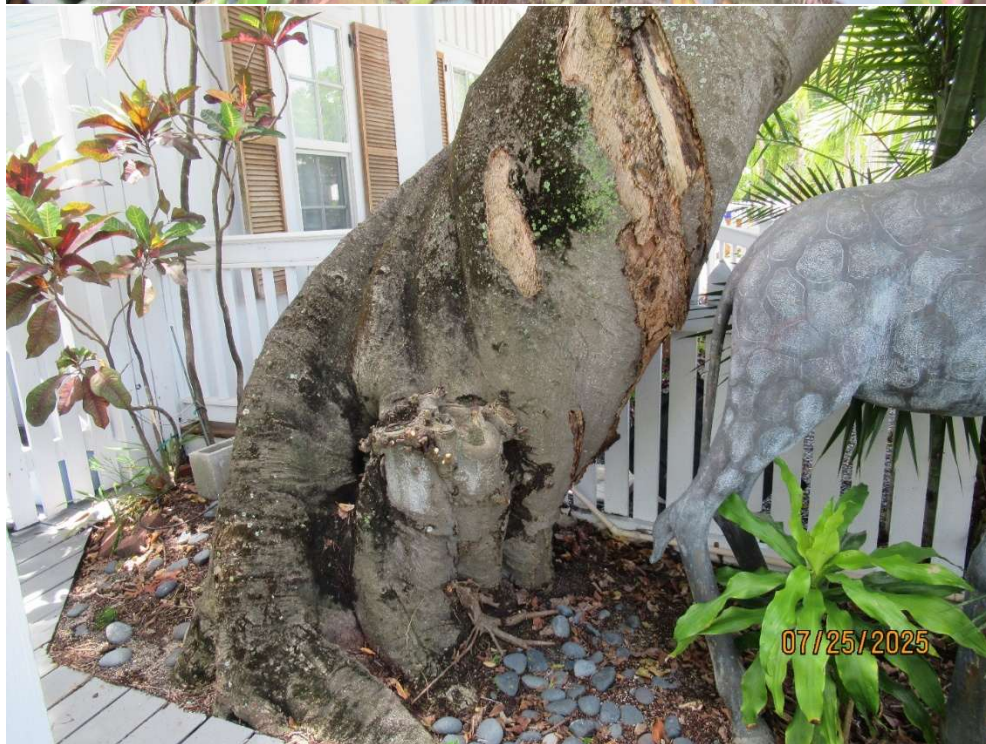
Photos of the trunk growing with a twist or helical growth. This is a natural phenomenon. It can be caused by various factors and is often an adaptation to environmental conditions, helping the tree withstand winds, distribute resources, and potentially even increase flexibility.

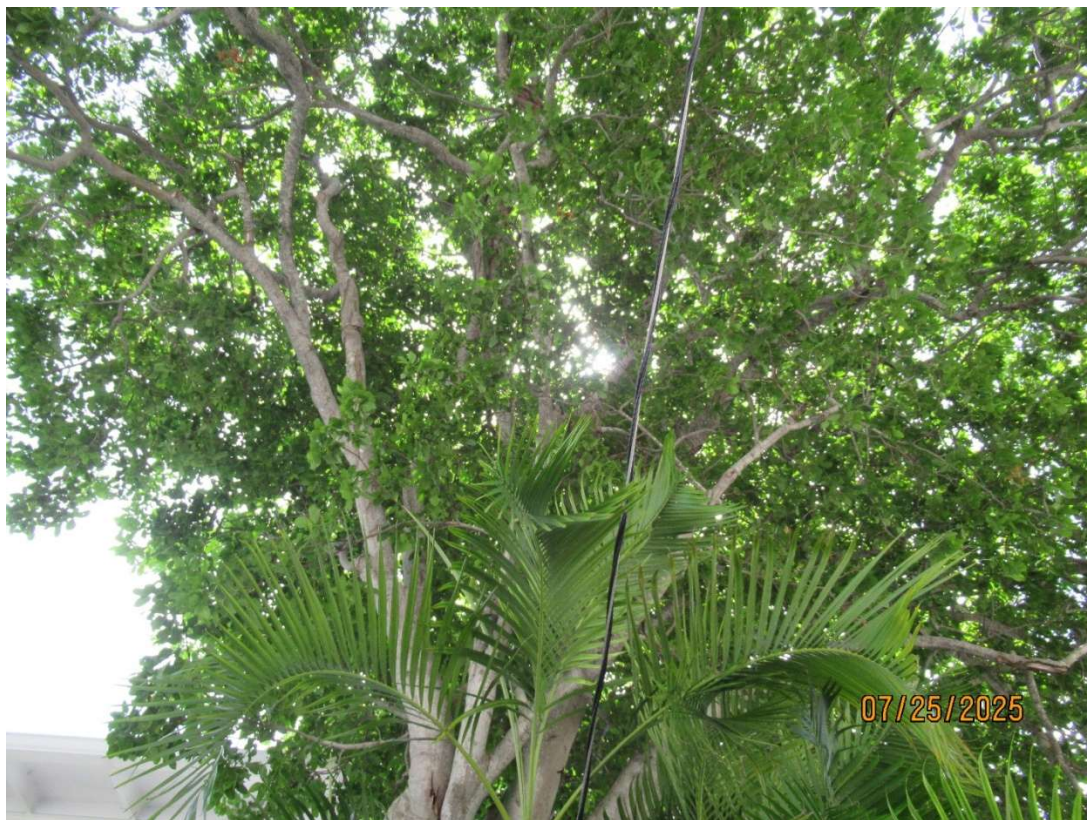
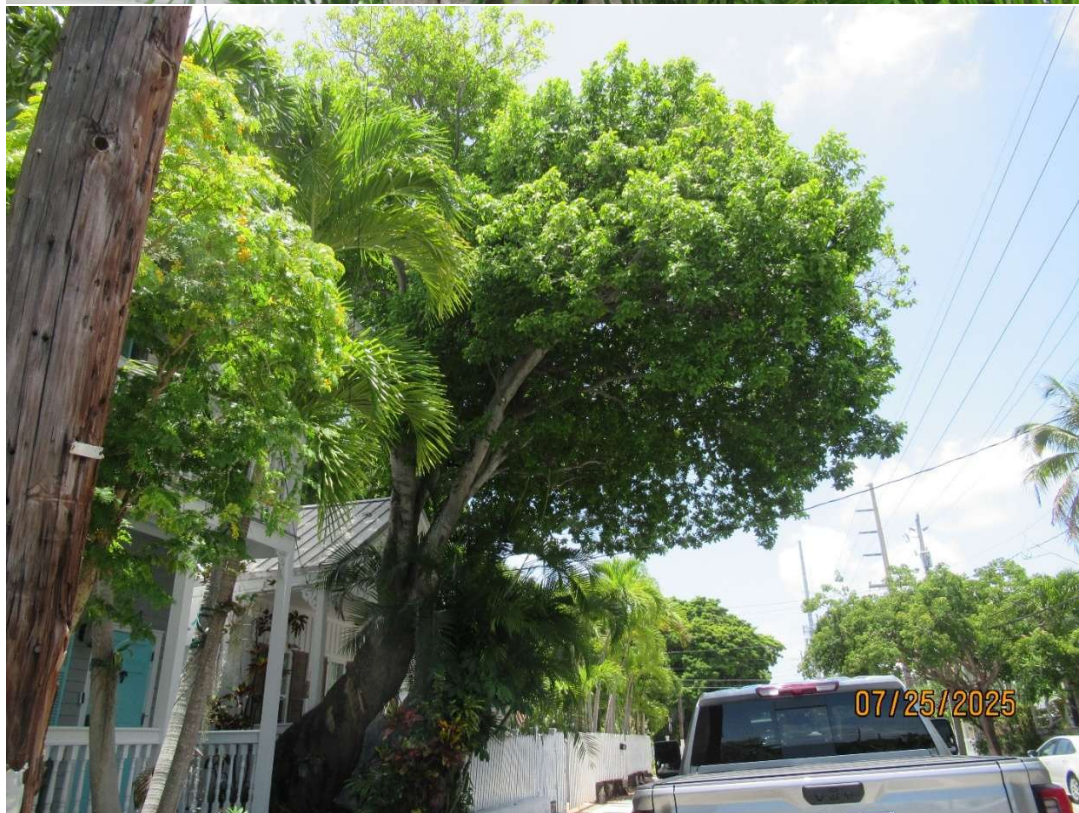
Photos of tree canopy looking Southwest.

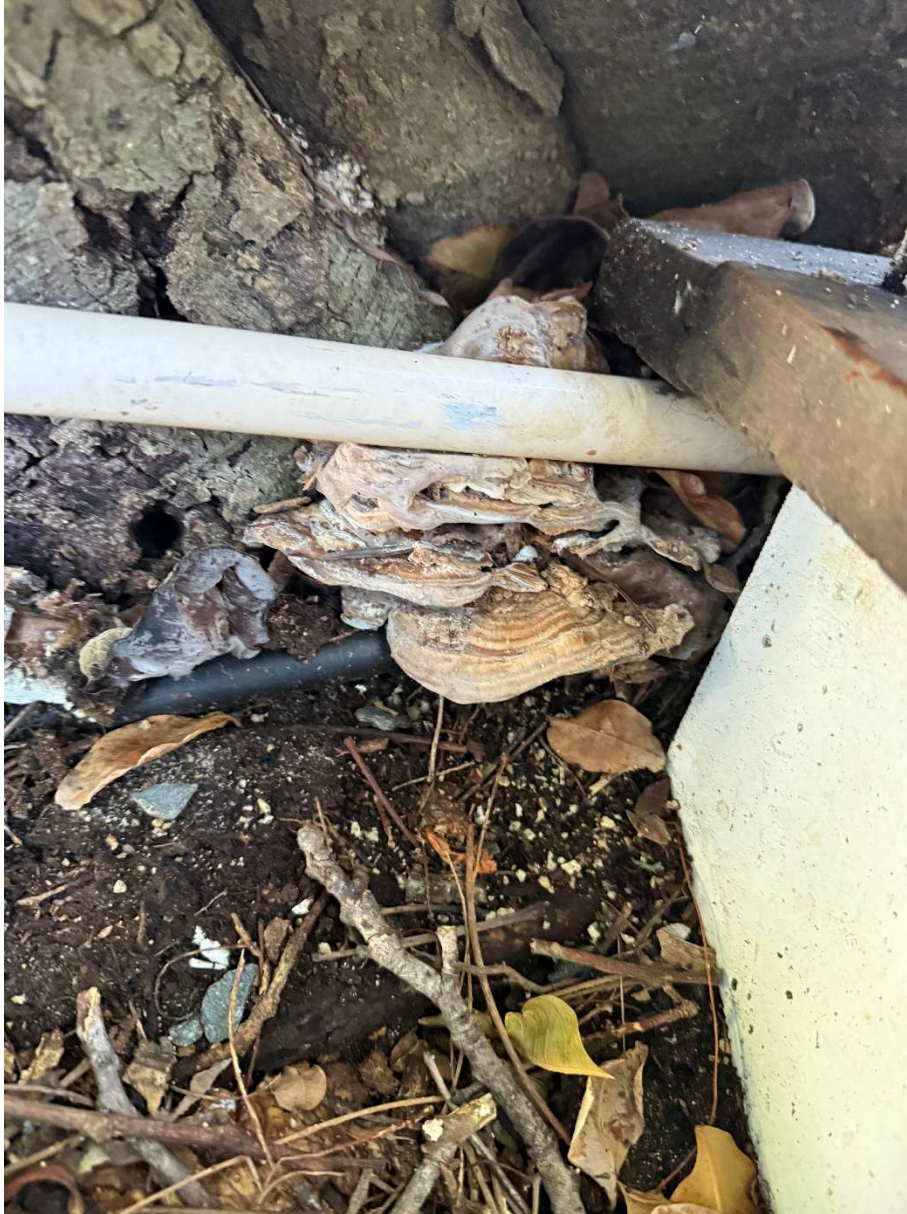
This fungi was pointed out to me by Sean Creedon. He believes it is Ganoderma. A genus of wood-decaying fungi known to cause significant tree diseases, particularly root and butt rot. Due to the fact that many species of fungi produce fruiting bodies such as this I have submitted photos to the environmental horticulture extension agent with University of Florida. I will have more info at the time of the Tree Commission Meeting in hopes of providing some degree of validation to this potential concern.
